**IMECE2015-53460**

**WEAR LOCATIONS IN STAINLESS STEEL PIPE FITTINGS FROM THE TURBULENT  
FLOW OF A LIQUID-SOLID SLURRY**

**Mark R. Duignan, Marissa M. Reigel, Kenneth J. Imrich,  
Michael L. Restivo and Mark D. Fowley**  
Savannah River Nuclear Solutions  
Savannah River National Laboratory  
Aiken, South Carolina, USA

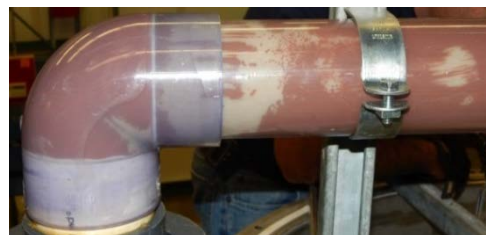
Figure 10. Elbow and straight transparent section used to monitor paint removal during test. The dark colored areas indicated paint on the inside surface and the light areas show where the slurry eroded the paint from the pipe wall.

when significant wear to the paint was evident in the transparent pipe, Fig. 10, which was surprising because one reference [9] indicated that for liquid-solid flows demonstrable wear would occur “within a few hours”. With significant paint eroded from the plastic pipe, after about 30 minutes, the slurry flow was stopped, the five pipe sections were drained, cleaned, and dried, after which the wear in those sections was documented with borescope equipped with a video camera. It was apparent that the metal pipe sections were still mostly covered with paint. While some sections showed erosive wear it was clear that the flow loop should have operated for a longer time to clearly show wear patterns. It was decided to reassemble the flow loop and run the test longer. During this interval most of the sand in the test was recovered and returned to the flow system. Once the flow loop was circulated for approximately another 60 minutes it was terminated to repeat the documentation so a comparison could be made. The time periods of stable slurry flow were estimated to be:

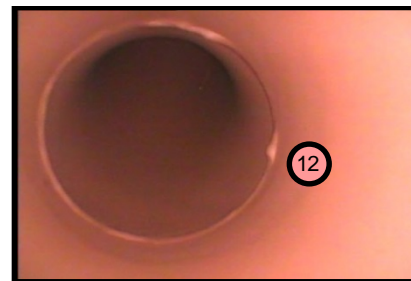
(A)

0 min - Weld is well covered with paint. [Photo (A)]

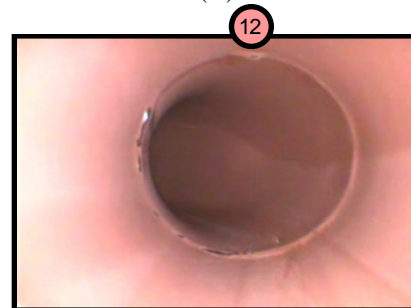
(B)

22 min - Some erosion to the weldment is evident as well as a start of wear on the intrados (inner wall) of the elbow, just behind the tack weld at 9 oc. The higher slurry velocity on the extrados (outer wall) of the elbow is evident by the streak of lighter colored paint at approximately 3 oc, which widens near the exit of the elbow. [Photo (B)]

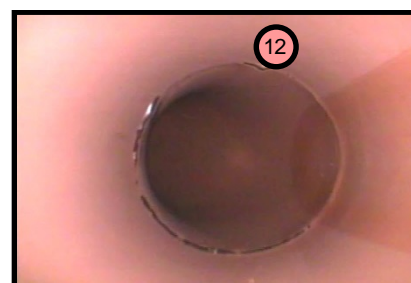
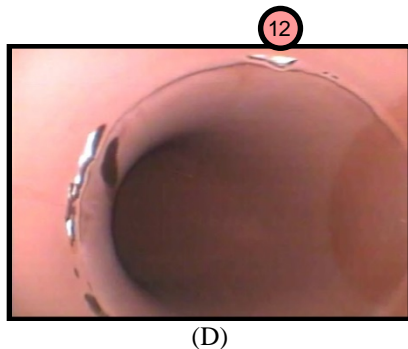
(C)

81 min - Erosion is evident around the weldment especially in the intrados portion of the elbow as the slurry changes direction. This can be seen in the close-up below of the intrados tack weld. The darker stain at 3 oc may have been where water dried after cleaning. [Photos (C and D)]

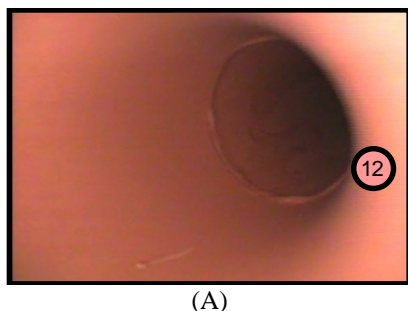
(A)

0 minute – Weld is well covered with paint. The drip seen on the bottom of the photograph was approximately at the 3 oc position. [Photo (A)]

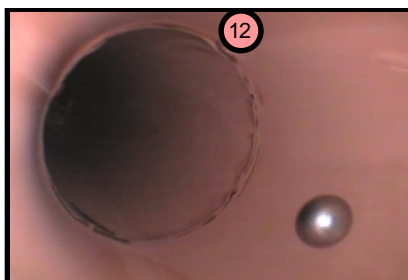
(B)

22 minutes – All the paint is discolored (lighter) and some wear is evident along the weld and the intrados. [Photo (B)]

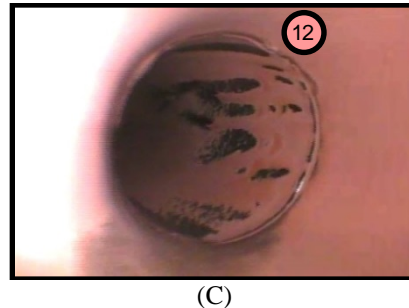
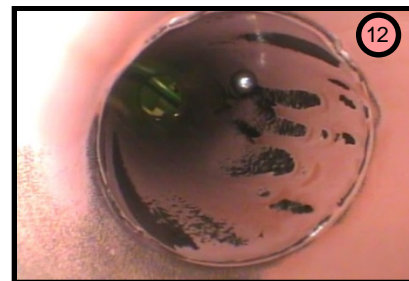
81 minutes – Wear is evident at approximately 90 to 100° (just downstream of the elbow) on the extrados, which is what was expected. There is also wear on the intrados, but closer to the bottom at around 7 oc and around the weld. [Photos (C and D)]

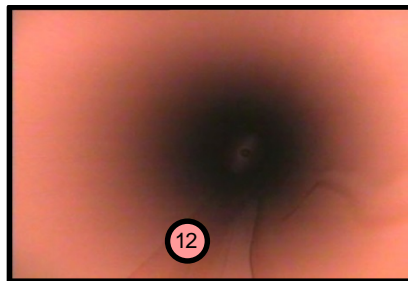
(A) [note - view against flow]

0 minute – There are a few uneven streaks of paint, but in general this pipe is well coated. Note, this view is against the flow direction because the pipe section was not filmed in the flow direction because of the inability to push the borescope through the pipe from around the tee fitting. This difficulty was overcome in subsequent evaluations by pulling the borescope up the tube. [Photo (A)]

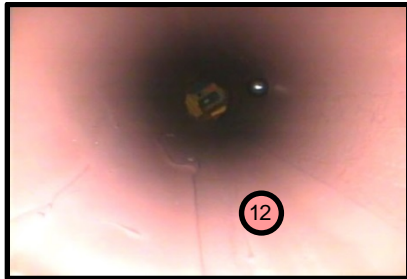
(B)

22 minutes – The pipe is still basically covered with paint, but the paint is lighter in color, which indicates some level of wear. From the video still it is not easy to see, but some exposed metal can be seen very close to the wall. [Photo (B)]

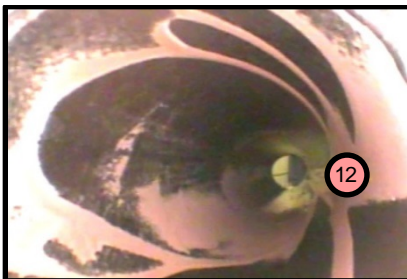
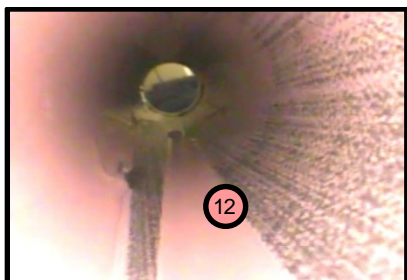
81 minutes – Photo (D) shows the vertical pipe from the bottom and Photo (C) is a location approximately half way up the pipe, i.e., the 5D location. Most of the paint is removed from the bottom as the flow comes out of the tee fitting indicating a lot of secondary flow scouring. However, as the flow moves up the pipe the largest wear appears to be on one side, from approximately 6 oc to 12 oc, clockwise.
