DESTRUCTIVE EXAMINATION OF SHIPPING PACKAGE 9975- 02019

SRNL-STI-2016-00324, Revision 0

Keywords: *K-Area
Surveillance
9975 Shipping Package*

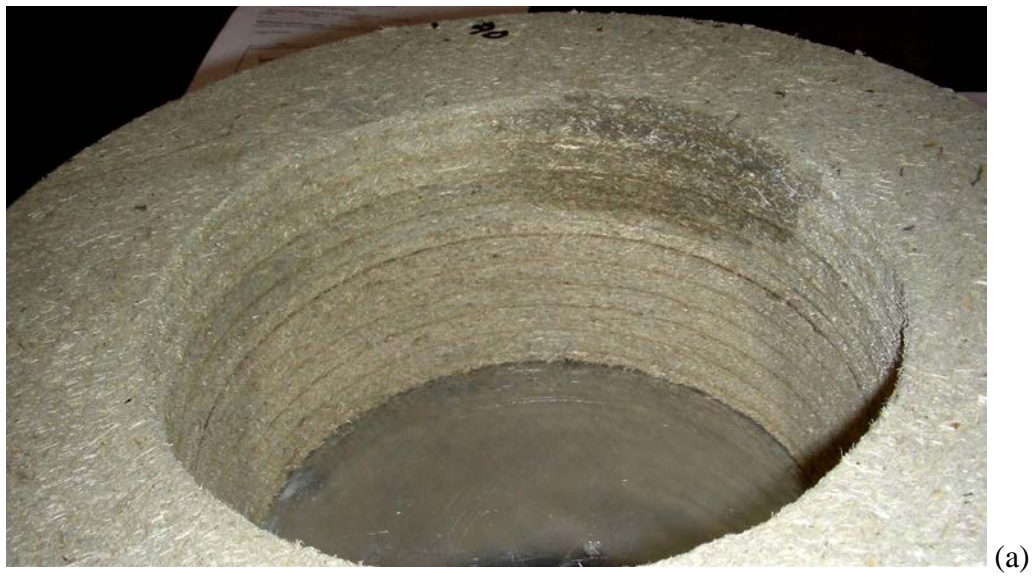
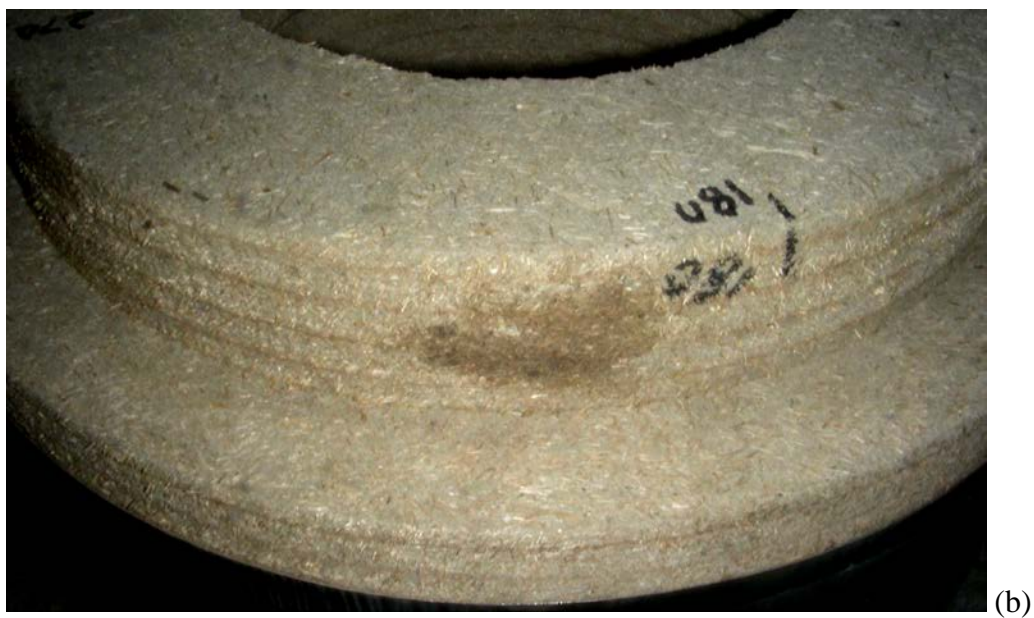
The field surveillance report included observation of dried glue residue on the upper fiberboard subassembly. Four such areas were observed during the SRNL examination, two of which are shown in Figure 1. One small (~1/4 x 1/2") dark stain was observed on the upper fiberboard subassembly OD surface. Mold was observed on and near the bottom of the lower fiberboard subassembly (Figures 2 and 3). In addition, dark staining from moisture was observed on the lower side and bottom of the lower fiberboard subassembly.

Figure 1. Two of the regions of the upper fiberboard subassembly with smeared glue.

Comments: From field surveillance, “Dried (hard, crusty) glue @ two areas of upper celotex” From DE: “Upper fiberboard assembly – dark stains from smeared glue, plus 1 small (~1/4 x 1/2”) dark stain on OD surface @ ~130°. Lower fiberboard assembly – mold on side and bottom, dark stains (saturated) on lower side and bottom.”

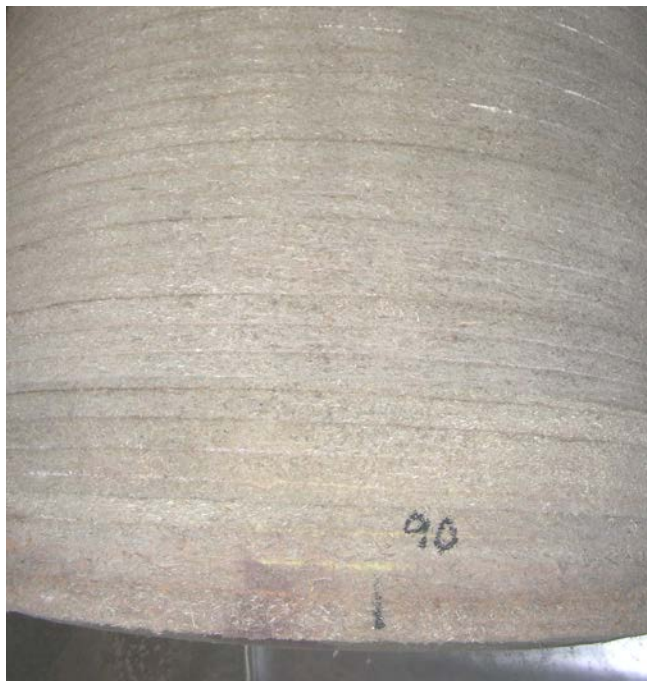
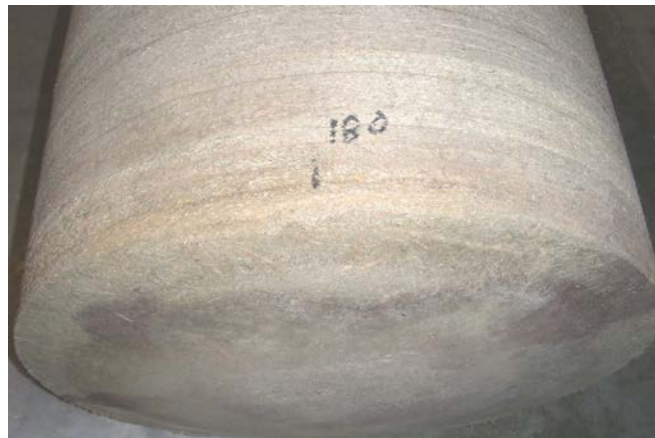
Figure 2. Mold on the side of the lower fiberboard subassembly

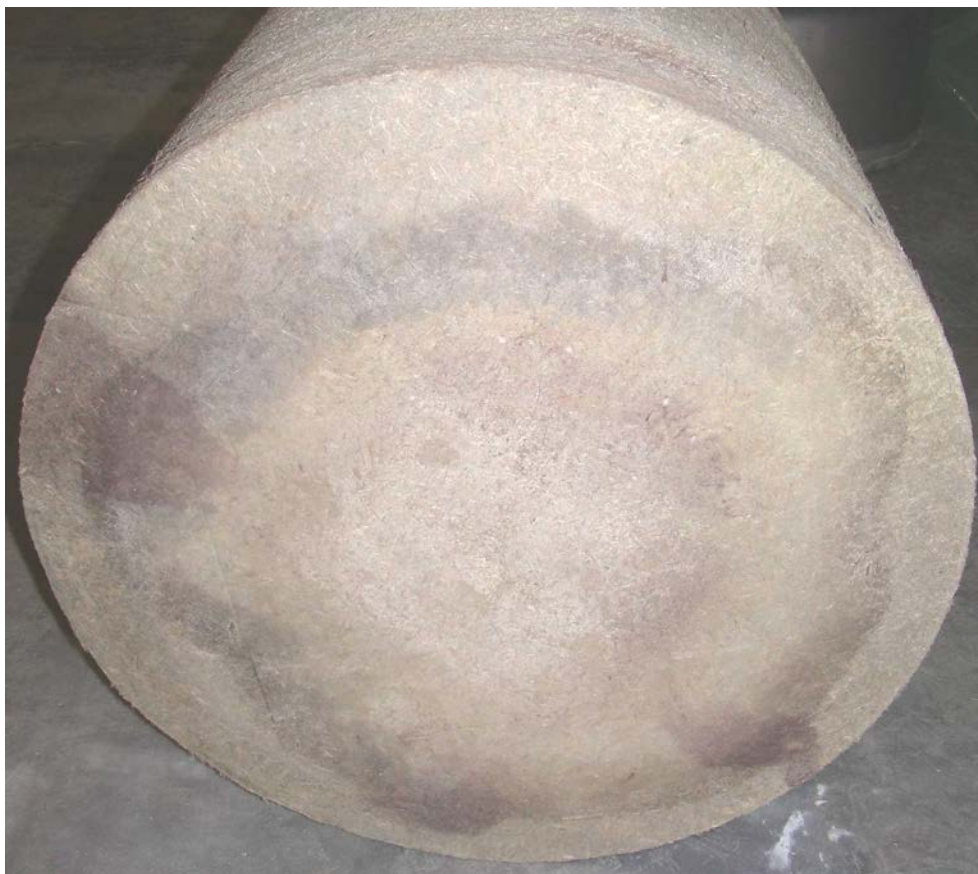
Moisture measurements were compared to those taken during previous destructive examinations. Based on the overall average moisture content, this package has a typical fiberboard moisture level. However, due to the relatively high heat load in the package, there is a concentration of moisture in the bottom fiberboard layers, similar to that observed in 9975-02101.

Figure 3. Mold and dark staining on the bottom of the lower fiberboard subassembly.

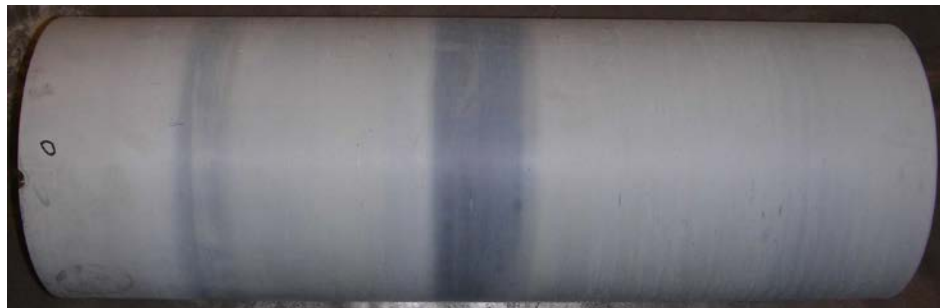
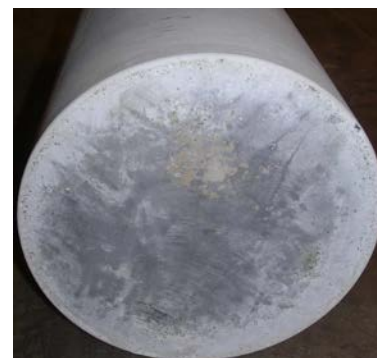
The entire surface of the lead shield was visually examined. It was found to be free from significant deformation and physical damage. The outer side surface is covered with white corrosion product, with varying thickness, as has been observed on other packages (Figure 11).

Figure 11. Lead shield with white corrosion product.

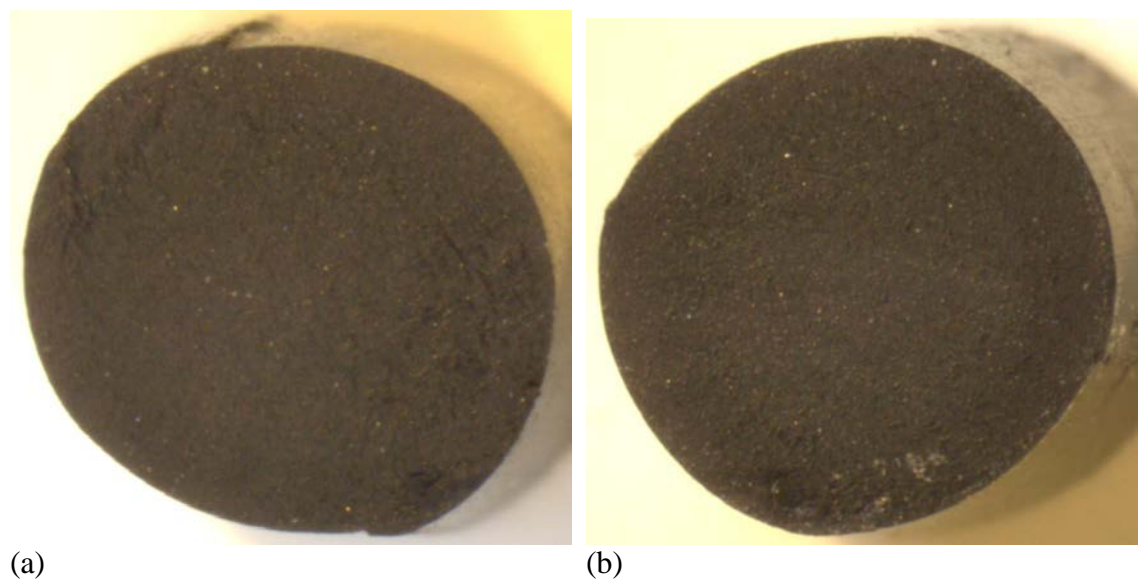
As with previous destructive examinations, visual (Figure 13) and SEM (Figure 14) examination of the cross sections identified a distribution of very small particles throughout each O-ring. Aside from carbon and fluorine (the primary constituents of Viton® fluoroelastomer) the SEM identified small amounts of zinc, aluminum and silicon. Though the actual compound is proprietary, Viton®-type fluoroelastomer compounds typically contain MgO, CaO, Ca(OH)₂, ZnO or lead compounds as acid acceptors and heat stabilizers [10]. Aluminum is present in hydrotalcite, which is used in both GLT and GLT-S compounds as a filler reinforcing agent. Silicon may be present as a trace contaminant.

Figure 13. Optical cross section of the (a) PCV outer and (b) SCV outer O-rings. Photos taken by 723-A Met Lab.

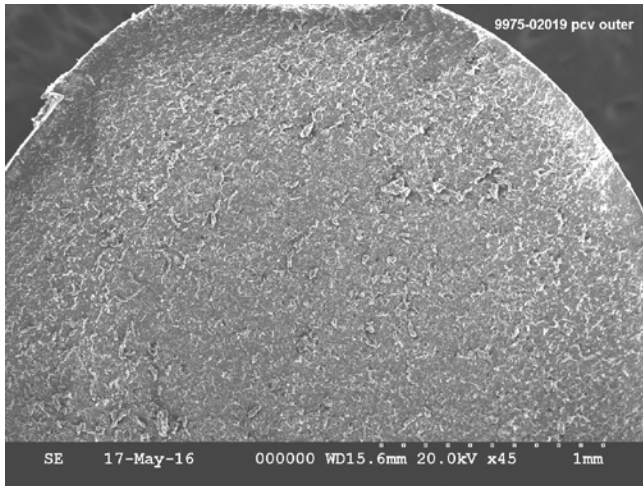
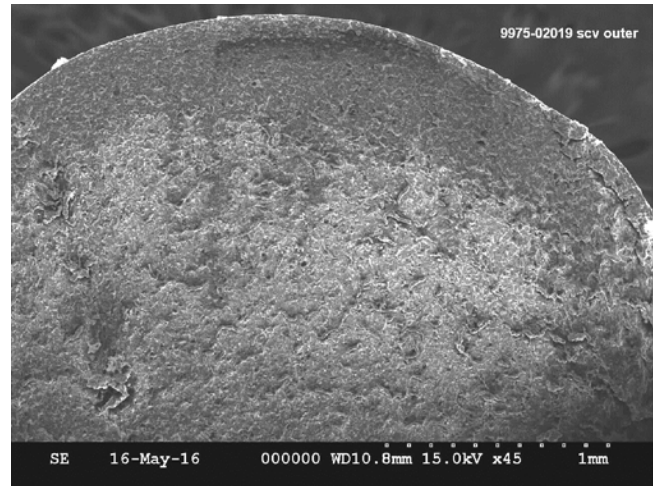
Figure 14. SEM cross section of the (a) PCV outer and (b) SCV outer O-rings. Photos taken by 723-A Met Lab.

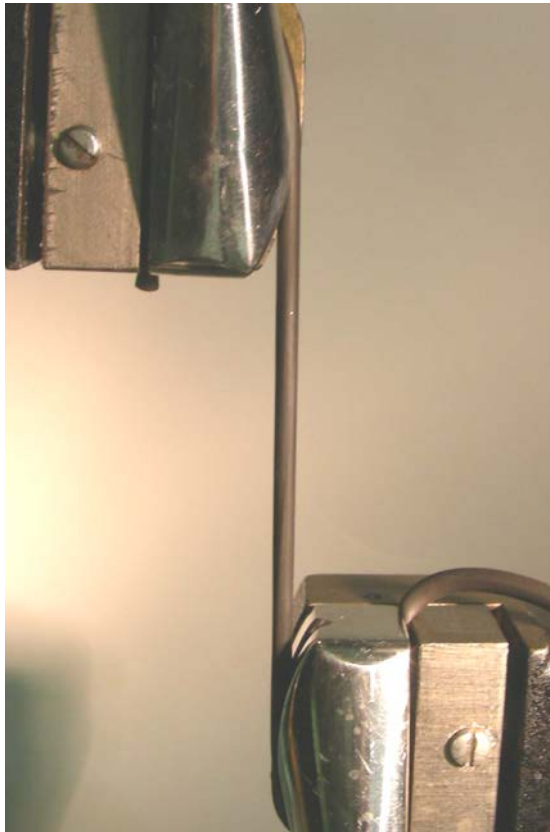
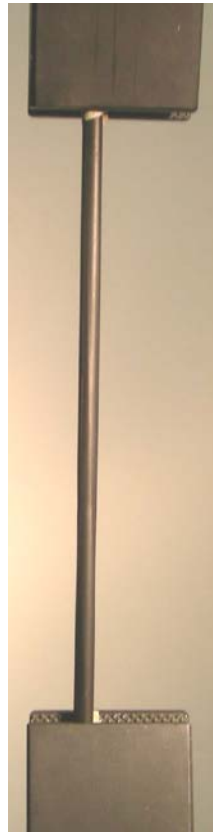
The PCV inner O-ring was tensile tested in accordance with ASTM D1414, using a cut (single strand) sample. The test was interrupted at 50% strain (Figure 15) to visually examine the O-ring for signs of cracking or other degradation. None were observed. The initial stress-strain curve for the PCV inner O-ring is shown in Figure 16, along with results of other tests with Viton GLT O-rings. In this first test, the O-ring failed after reaching 398% elongation. A re-test was performed with a different grip arrangement, and reached 157% elongation (Figure 17). The first test uses a yarn grip which would allow some stretch beyond the gage section, especially if the O-ring had any residual grease. To more accurately measure the elongation, the second test was performed with an alternate grip arrangement which does not allow such stretch. Since these alternate flat grips pose a greater risk of breaking within the grips (which would invalidate the test), the portion of O-ring within the grips was wrapped with tape for cushioning.

Figure 15. 9975-02019
PCV inner O-ring during
tensile test, at 50% stretch.

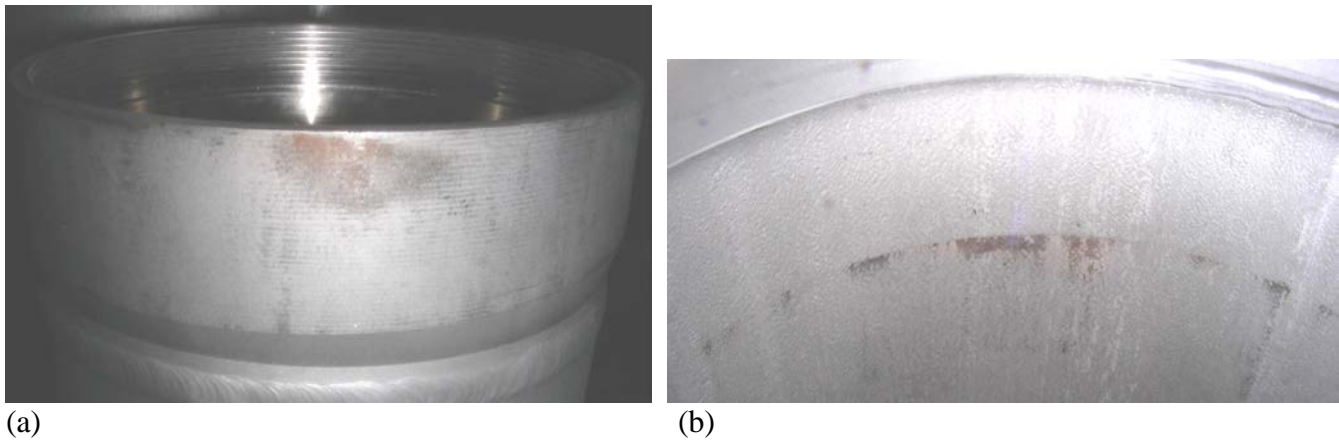
A general visual examination was performed on all metallic components. No significant damage or degradation of the containment vessels was observed. A dark spot was observed on the PCV top flange OD surface. This is assumed to be a rub mark, since there is a corresponding mark on the SCV ID surface (Figure 18). Both of these spots display coloration that could be indicative of light corrosion. Various fabrication markings were stamped or engraved on the containment vessels and lids. These markings appear to be identification numbers used during manufacture, prior to association of the parts with a final package number, and are consistent with those seen in other packages.

(a) (b)
Figure 18. Rub marks, with possible light corrosion, on the PCV flange (a) and SCV interior (b)

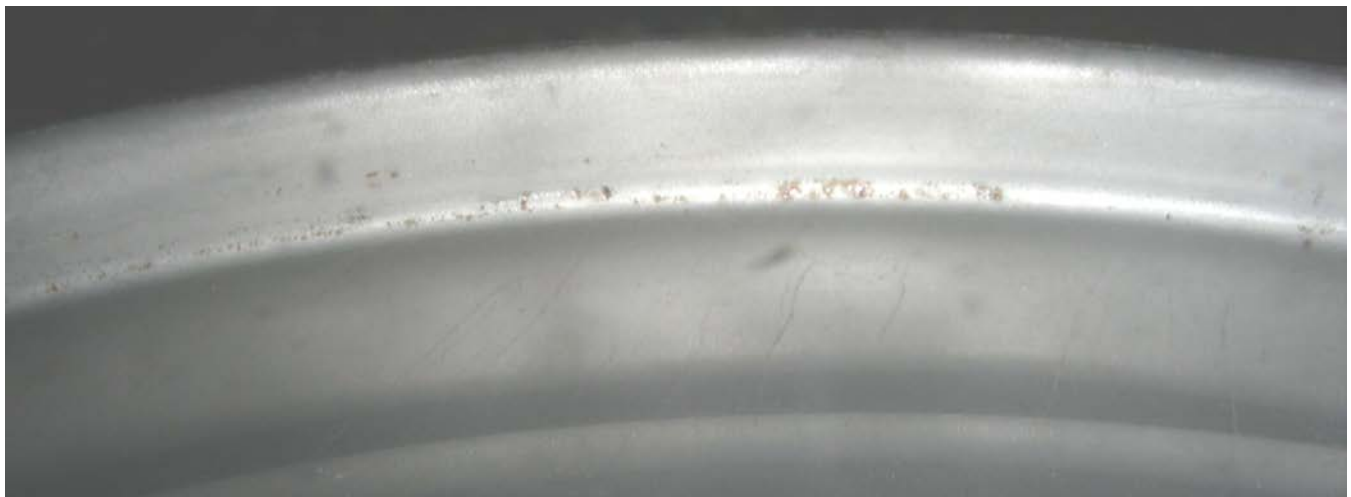
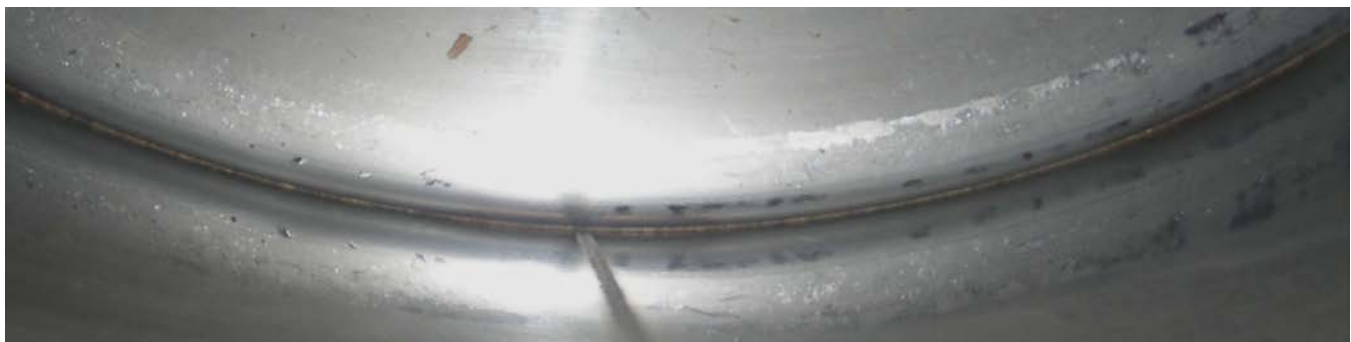
Numerous small spots of corrosion were observed along the bottom (underside) edge of the drum (Figure 19a). Similar corrosion has also been observed in this location on other packages. However, no corrosion was observed on the interior surface immediately opposite these spots (Figure 19b). Nor was any corrosion observed along the stitch welds around the bottom side of the drum. Therefore, it is unlikely that the corrosion on the bottom was driven by chlorides or other compounds leaking from the drum. Rather, it is judged that corrosion in this area results from the ambient storage environment, with influence from fabrication stresses, and the possible use of carbon steel tooling. While this corrosion, in the extreme, could lead to penetration of the drum, it currently appears to not compromise the overall integrity of the drum. In addition, the interior side of the drum had regions of staining or possible superficial corrosion (Figure 20).

Figure 19. Areas of corrosion on the drum exterior bottom along the outer corner (a). The corresponding interior region (b) shows some rub marks, but is not corroded.

Comment – Numerous small corrosion spots along edge on the bottom of drum (exterior) during DE exam.

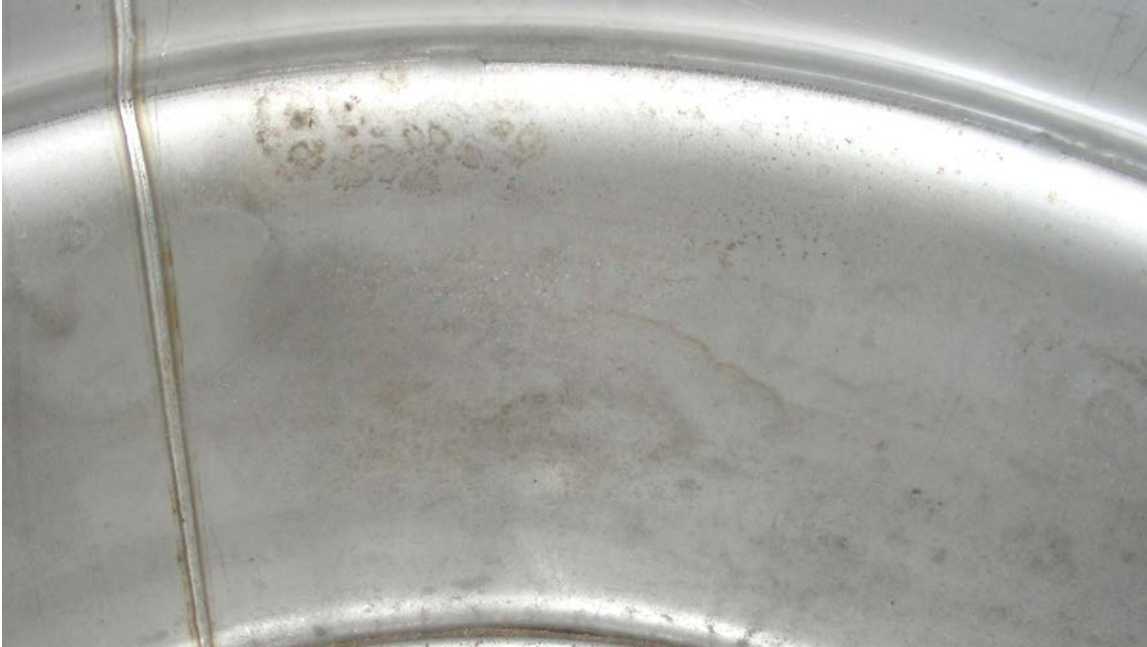
Figure 20. Region of staining and/or superficial corrosion on the drum interior
