EXAMINATION OF SHIPPING PACKAGES 9975-02694 AND 9975-02729

W. L. Daugherty

November 2016

SRNL-STI-2016-00655, Revision 0

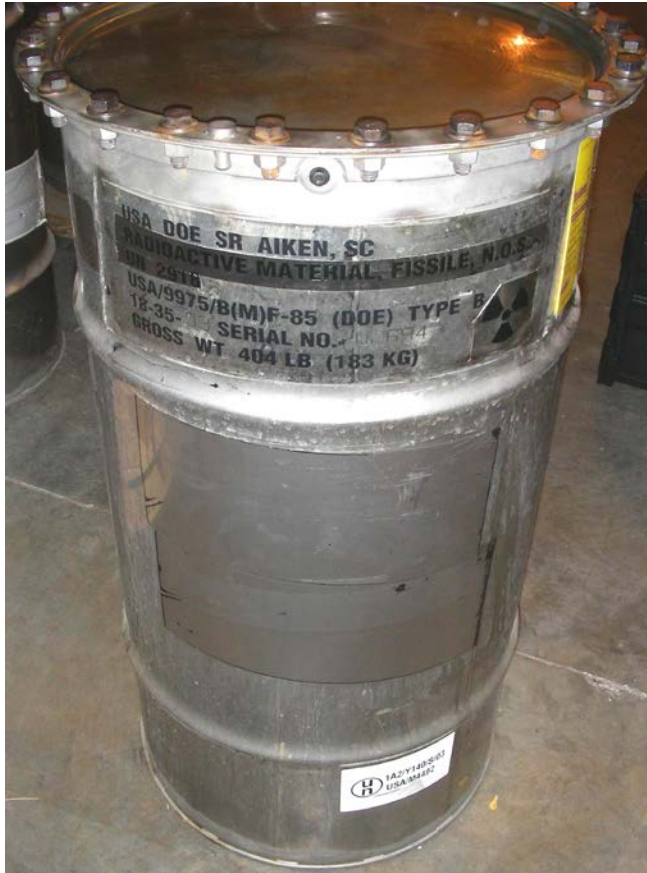
(a) 9975-02694

- Water stains on one side of the drum exterior, and corrosion of several closure bolts were observed * (Figure 1a).

Figure 1. Water stains on the side of the drum, and corrosion on several closure bolts.

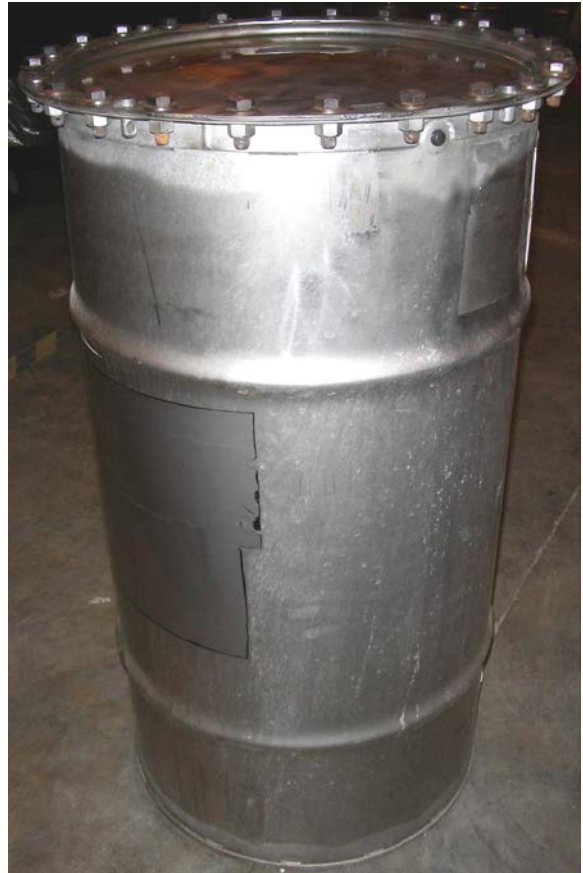
(b) 9975-02729

- Water stains on one side of the drum exterior, and corrosion of several closure bolts were observed * (Figure 1b).
- Subsequent light cleaning (with a wire brush) of the closure bolts removed much of the corrosion on the threads, showing the corrosion was superficial (Figure 2b).

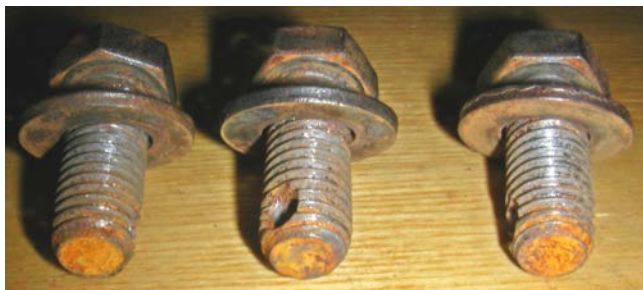
(a) 9975-02694

- Subsequent light cleaning (with a wire brush) of the closure bolts removed much of the corrosion on the threads, showing the corrosion was superficial (Figure 2a).
- Areas around the lower stitch welds on the drum OD surface were lightly corroded and/or stained (Figure 3a, b).
- An unusual yellow / brown color was mixed in with the normally white shield corrosion layer (Figure 4). There are also several nodules protruding from the side of the shield.
- The middle region of the drum bottom steps down below the outer ~2 inch wide ring. The fiberboard bottom surface was smooth where it rested on this outer ring, but not in the middle region, indicating compaction of the bottom fiberboard layer was limited (Figure 5a).
- The fiberboard had a moderate degree of mustiness, but no mold was observed. There were no significant stains / water marks on the fiberboard.

Figure 2. Detail of several closure bolts after light cleaning (with wire brush). The superficial corrosion in the thread area has been mostly removed, but remains on the end and under the head.

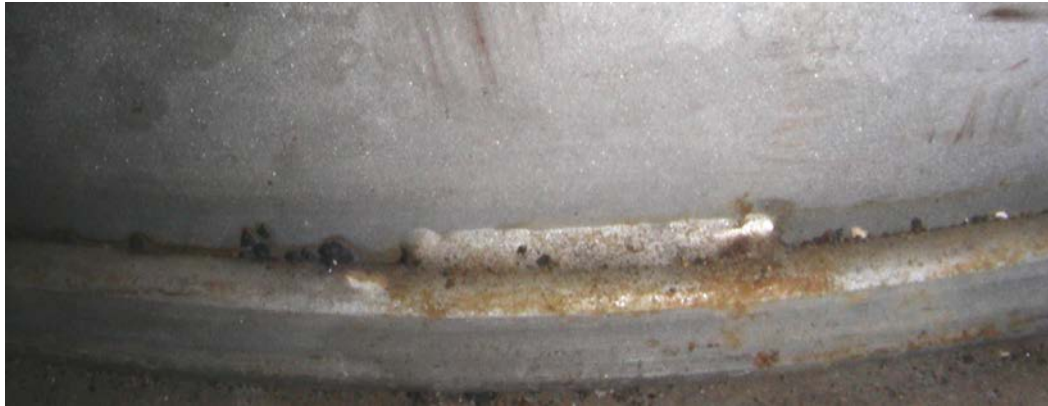
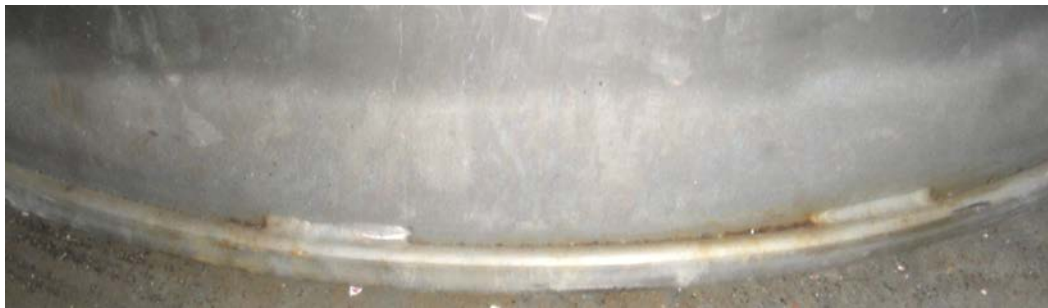
The observed corrosion on the drums is limited to the stitch weld area along the bottom edge. Any moisture in the fiberboard near the bottom of the drum can migrate through the bottom fold. Residual stresses around the ends of the stitch welds would tend to make these areas slightly easier leak locations, allowing chlorides or other corrosive species to deposit on the OD surface. Combined with the altered microstructure in the weld and heat-affected zone, these areas can be susceptible to corrosion if significant moisture moves through the drum. Corrosion in this area has been observed in previous packages to similar and greater degrees [3-5]. Alternatively, given the presence of water on the drum exterior from the expansion joint leak, the bottom lip on the drum provides a crevice that can trap and retain moisture and dissolved compounds running down the side of the package, leading to corrosion.

Figure 3. Light corrosion / staining on drum OD surface at the stitch welds.

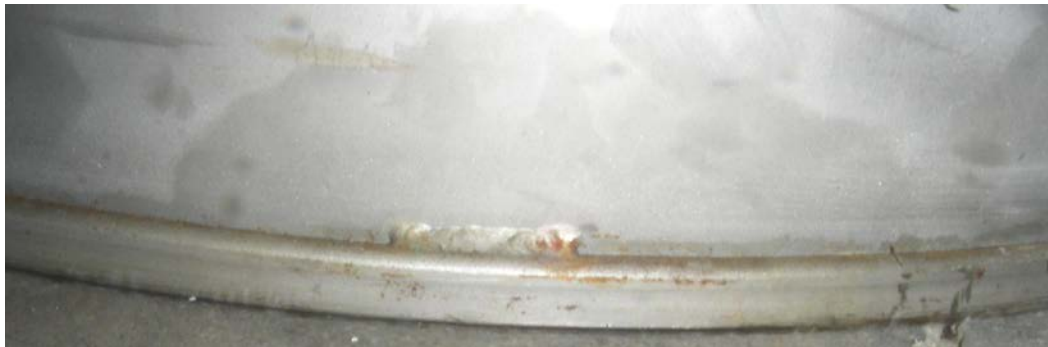
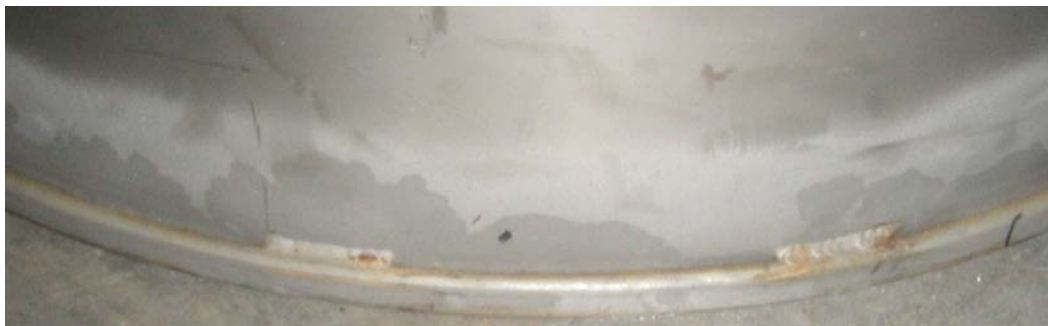
- Areas around the lower stitch welds on the drum OD surface were lightly corroded and/or stained * (Figure 3c, d).
- The fiberboard had a very slight musty odor, but no mold was observed. Several small, dark stains were observed on the upper fiberboard assembly * (Figure 6).

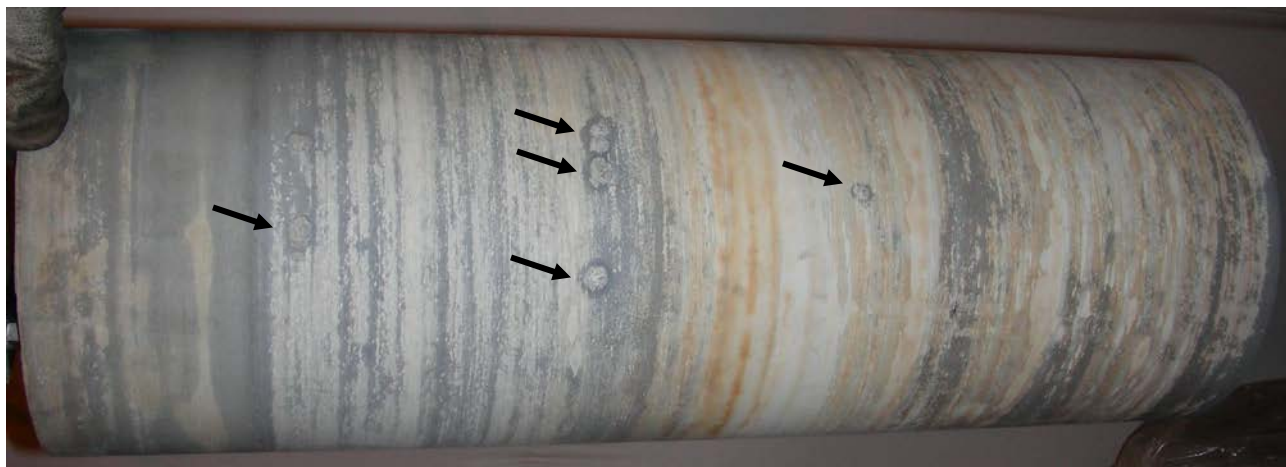
Figure 4. Unusual coloration of the shield corrosion product, and several nodules protruding from the side of the 9975-02694 shield (at arrows).

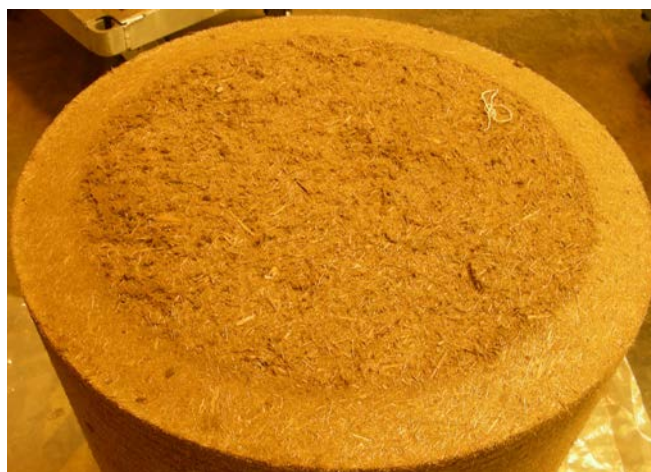
(a) 9975-02694

Figure 5. Lower fiberboard assemblies (upside down) showing compaction only in the outer ~2 inches.

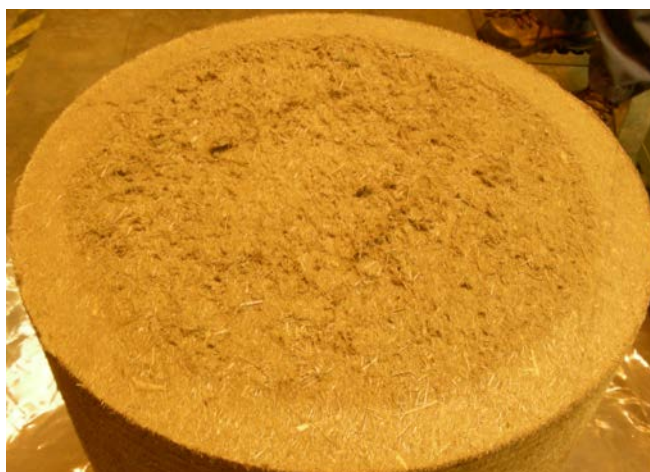
(b) 9975-02729

- The middle region of the drum bottom steps down below the outer ~2 inch wide ring. The fiberboard bottom surface was smooth where it rested on this outer ring, but not in the middle region, indicating compaction of the bottom fiberboard layer was limited (Figure 5b).

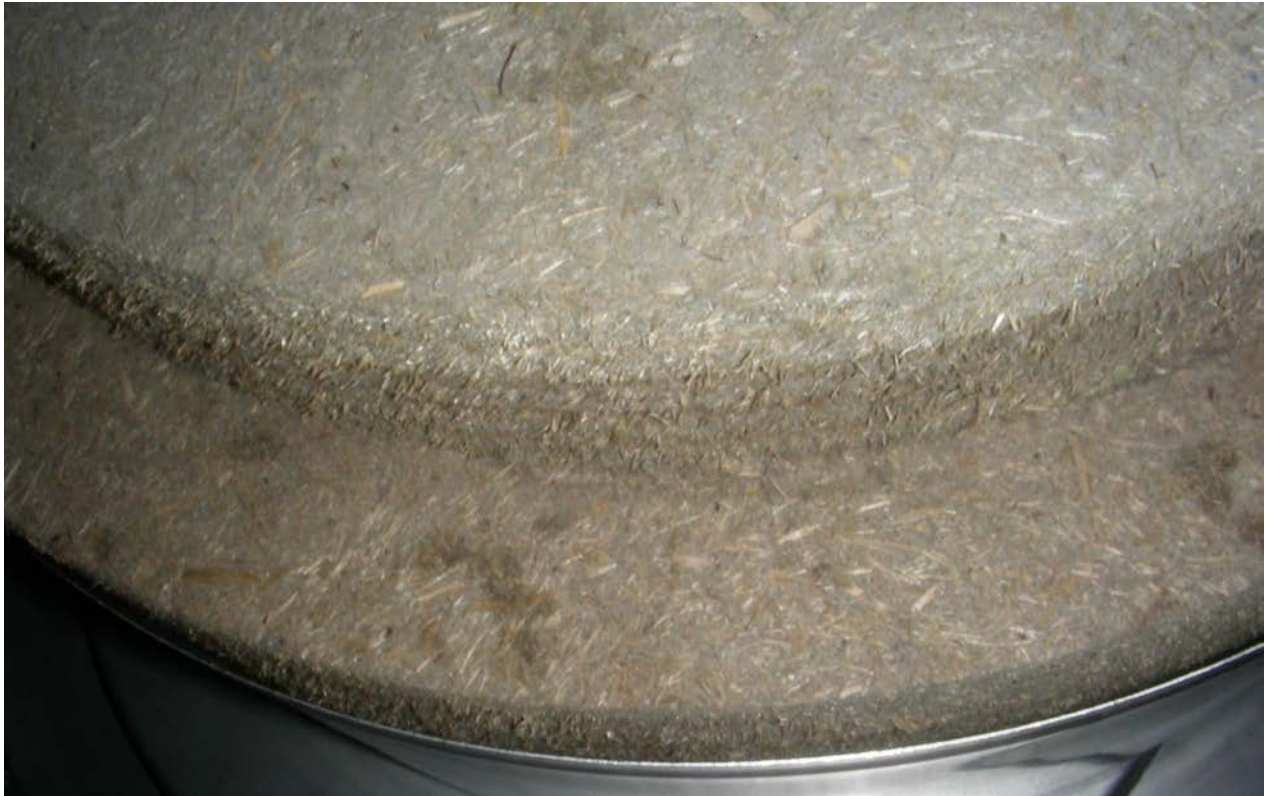
The shield and lower fiberboard assembly were easily removed from both packages, indicating some gap existed between components. No physical damage to the fiberboard was observed, and the layers remained well-bonded. Aside from a few small darkened areas on the 9975-02729 upper fiberboard assembly, no stains or discoloration were noted. The fiberboard assemblies had a solid feel and appearance, consistent with non-degraded material.

Figure 6. Stains on the 9975-02729 upper fiberboard assembly

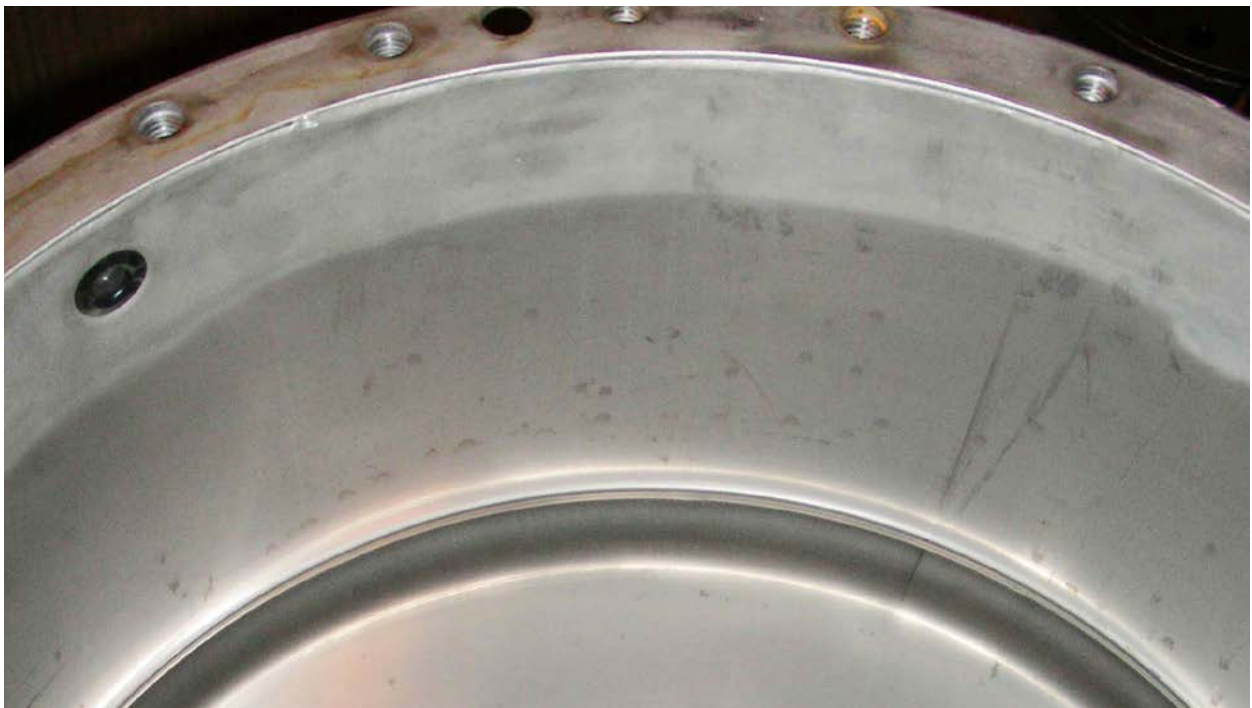
- Several water spot stains were observed on the drum interior (Figure 7).

Figure 7. Water spot stains on the 9975-02729 drum interior.

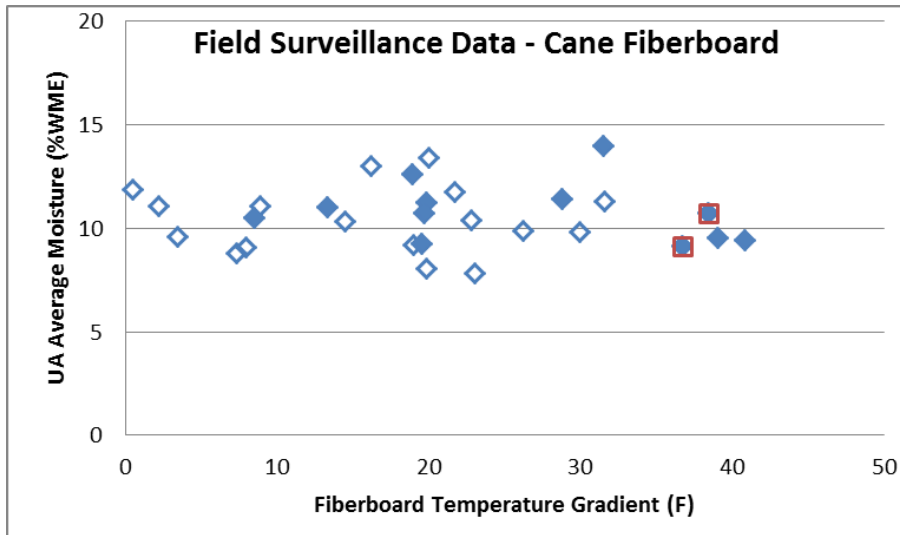
The thermal gradient across the fiberboard sidewall is approximated by the difference between the shield lid temperature and the drum OD temperature. The average upper fiberboard assembly moisture content is approximated by averaging the average OD moisture content and the average ID moisture content. These two parameters are compared in Figure 8 for a sampling of 30 surveillance packages with cane fiberboard.

- The average moisture content of the upper fiberboard assembly (Figure 8) does not vary with internal heat load. However, with average moisture content values ranging from 7.8 to 14.0 %WME, there is significant scatter in moisture content from package to package.
- The moisture gradient of the upper fiberboard assembly (Figure 9) varies with internal heat load, and a similar degree of scatter between packages is seen in these data.
- The average moisture content of the upper fiberboard assembly is an average of 10.4 %WME for the 17 packages with an axial gap < 1 inch, and 10.8 %WME for the 13 packages with an axial gap > 1 inch.

Figure 8. Comparison of average moisture content within the upper fiberboard assembly to the temperature gradient based on KAC field surveillance data of packages with cane fiberboard. The highlighted data are from 9975-02694 and 9975-02729. Packages with an axial gap > 1" are shown with solid symbols.

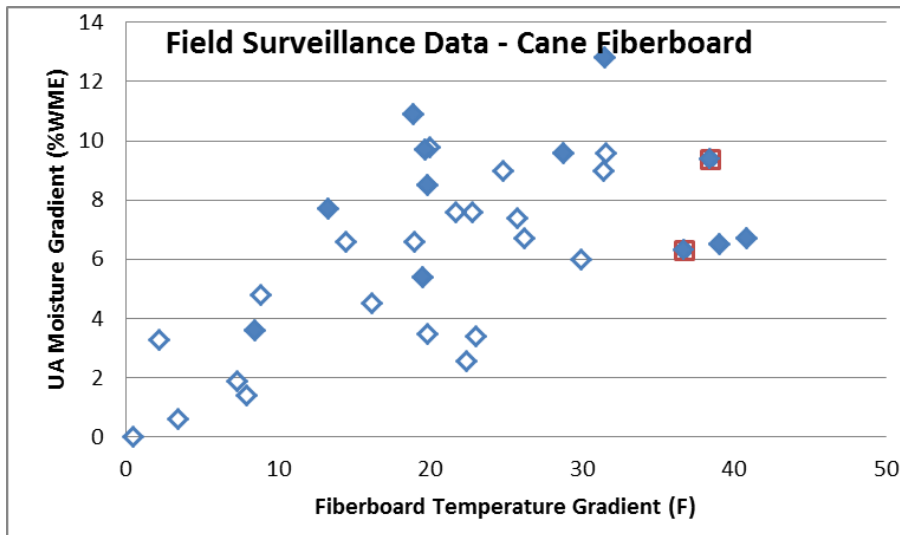
Similarly, the moisture gradient across the upper fiberboard assembly is approximated by the difference between the average OD moisture content and the average ID moisture content. These data are shown in Figure 9 as a function of the thermal gradient.

Figure 9. Comparison of moisture gradient across the upper fiberboard assembly to the temperature gradient based on KAC field surveillance data of packages with cane fiberboard. The highlighted data are from 9975-02694 and 9975-02729. Packages with an axial gap > 1" are shown with solid symbols.

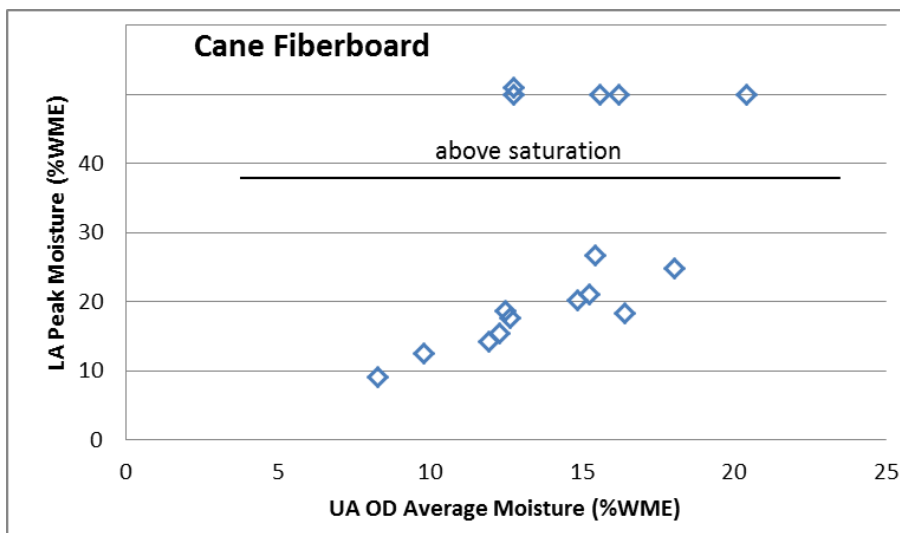
Since the lower fiberboard assembly is not removed from the drum during field surveillance, there are fewer packages for which peak moisture data in the lower assembly are available. Figure 10 compares the lower assembly peak moisture values with the upper assembly OD average moisture. This shows good correlation for packages that remain below saturation. However, those packages in which the bottom fiberboard layers exceed saturation are not predicted by this correlation.

Figure 10. Peak moisture measurement in the lower fiberboard assembly vs average moisture content of the upper assembly OD surface. Data are from cane fiberboard assemblies measured in KAC and SRNL.
