**Savannah River
National Laboratory™**

Analysis of an MCU HEPA Filter

January 2017

SRNL-STI-2016-00729, Revision 0

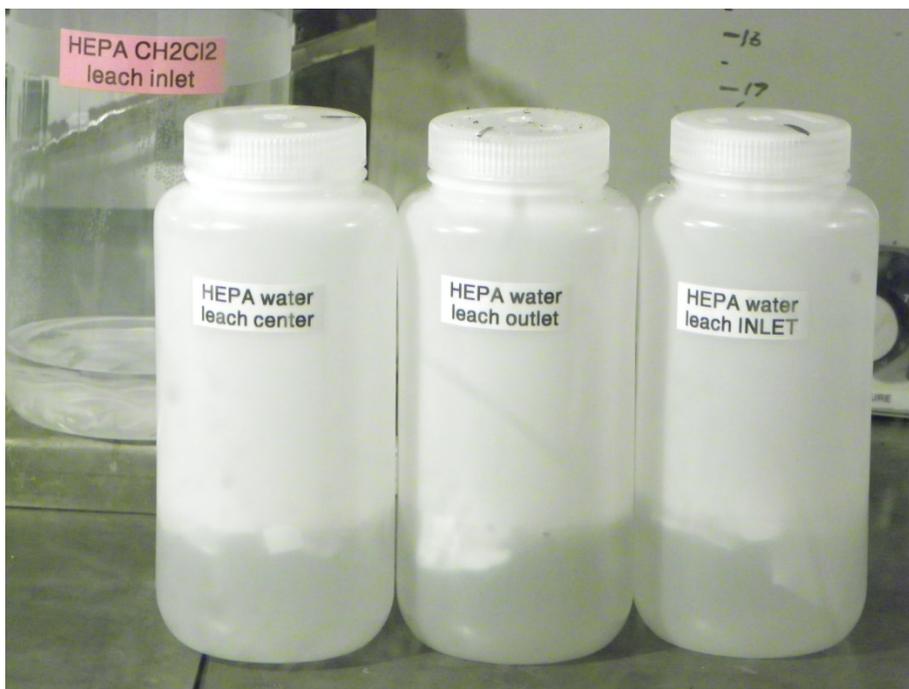
Figure 3. Water Leaching

Samples Inlet-B1, Center-B1, and Outlet-B1 were each soaked in 300 mL of DI water for a period of 24 hours. The samples did not appear to wet appreciably and mostly floated on top of the water solution. When the samples were first introduced into the water, vigorous mixing was used to ensure all the pieces had thoroughly contacted the water. The water solutions did not discolor to any notable extent. See Figure 3.

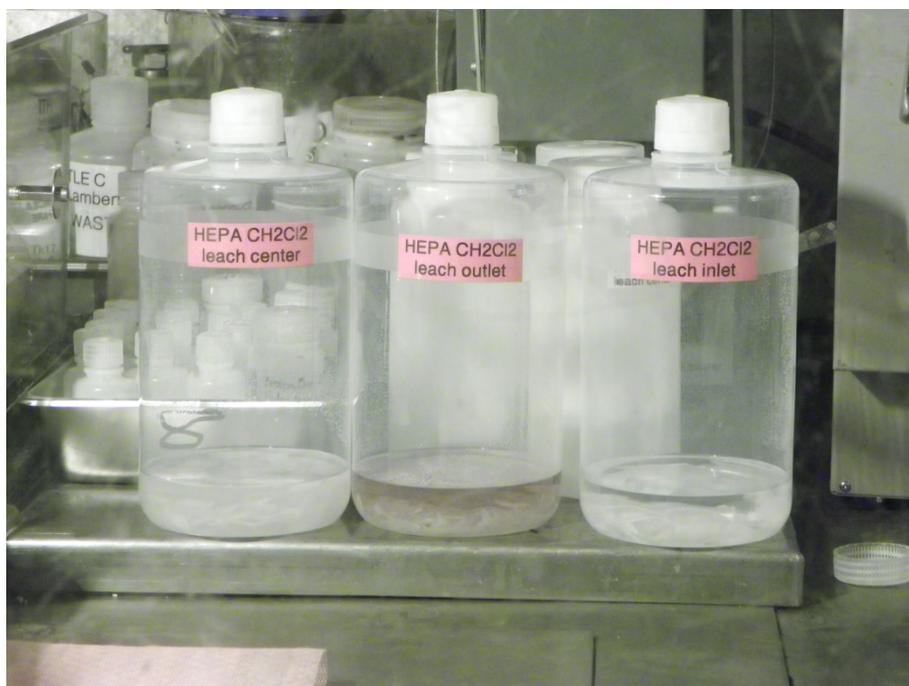
Figure 4. Dichloromethane Leaching

Samples Inlet-B2, Center-B2, and Outlet-B2 were each soaked in 300 mL of dichloromethane for a period of 24 hours. The samples did wet, and sank to the bottom, indicating thorough contact with the solution. The Outlet-B2 pieces discolored the darkened solution slightly, while the Inlet and Center pieces did not. See Figure 4. The reason for the color of the Outlet-B2 leachate solution is not known and none of the later analytical results provide a reason.

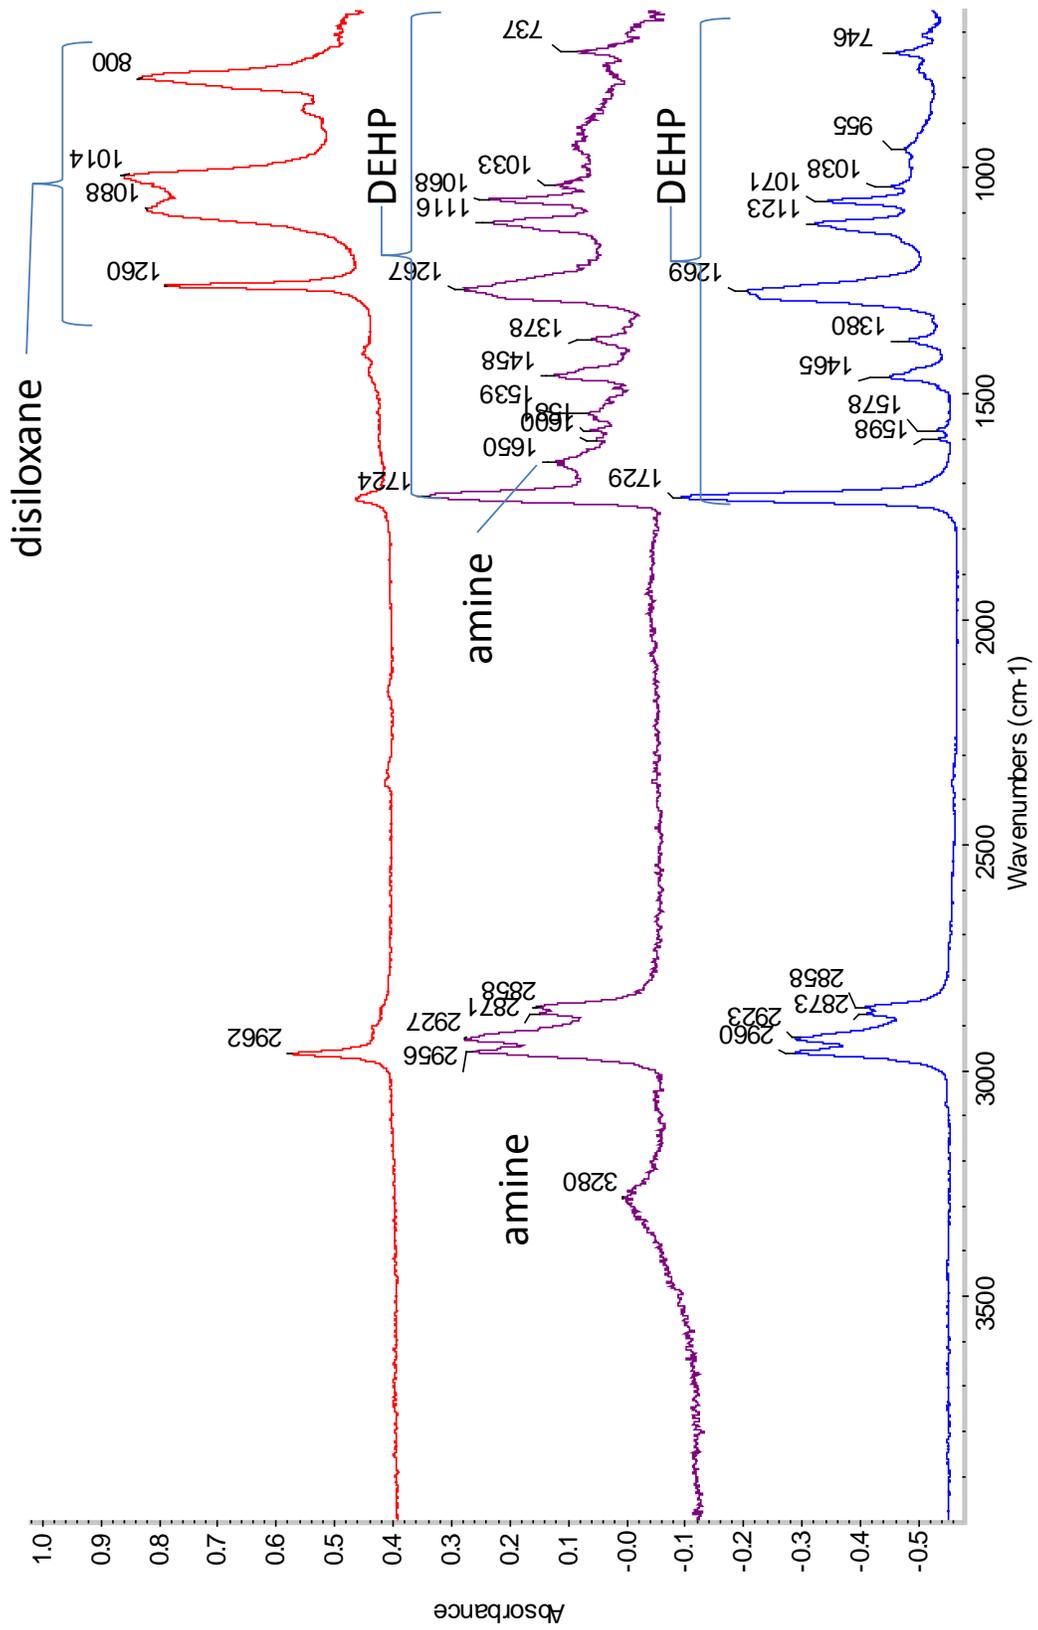
Figure 5. FTIR scan of an Unused Piece

Optical microscopy was used to locate spots of potential interest on the sample pieces. Once located, Raman FTIR was used to examine the points to determine composition. There were no obvious visual indications of contamination. Figure 5 shows the results of analysis of three points on an unused portion (a clean, different HEPA filter of the same type) of HEPA filter. The spot corresponding to the red trace showed evidence of disiloxane compounds. The spot corresponding to the purple trace showed evidence of diethylhexylphthalate (DEHP - a plasticizer) and some sort of an amine compound. The spot corresponding to the blue trace shows strong evidence of DEHP. Given that the sample was a clean, unused piece, we take these three compounds as background signals.

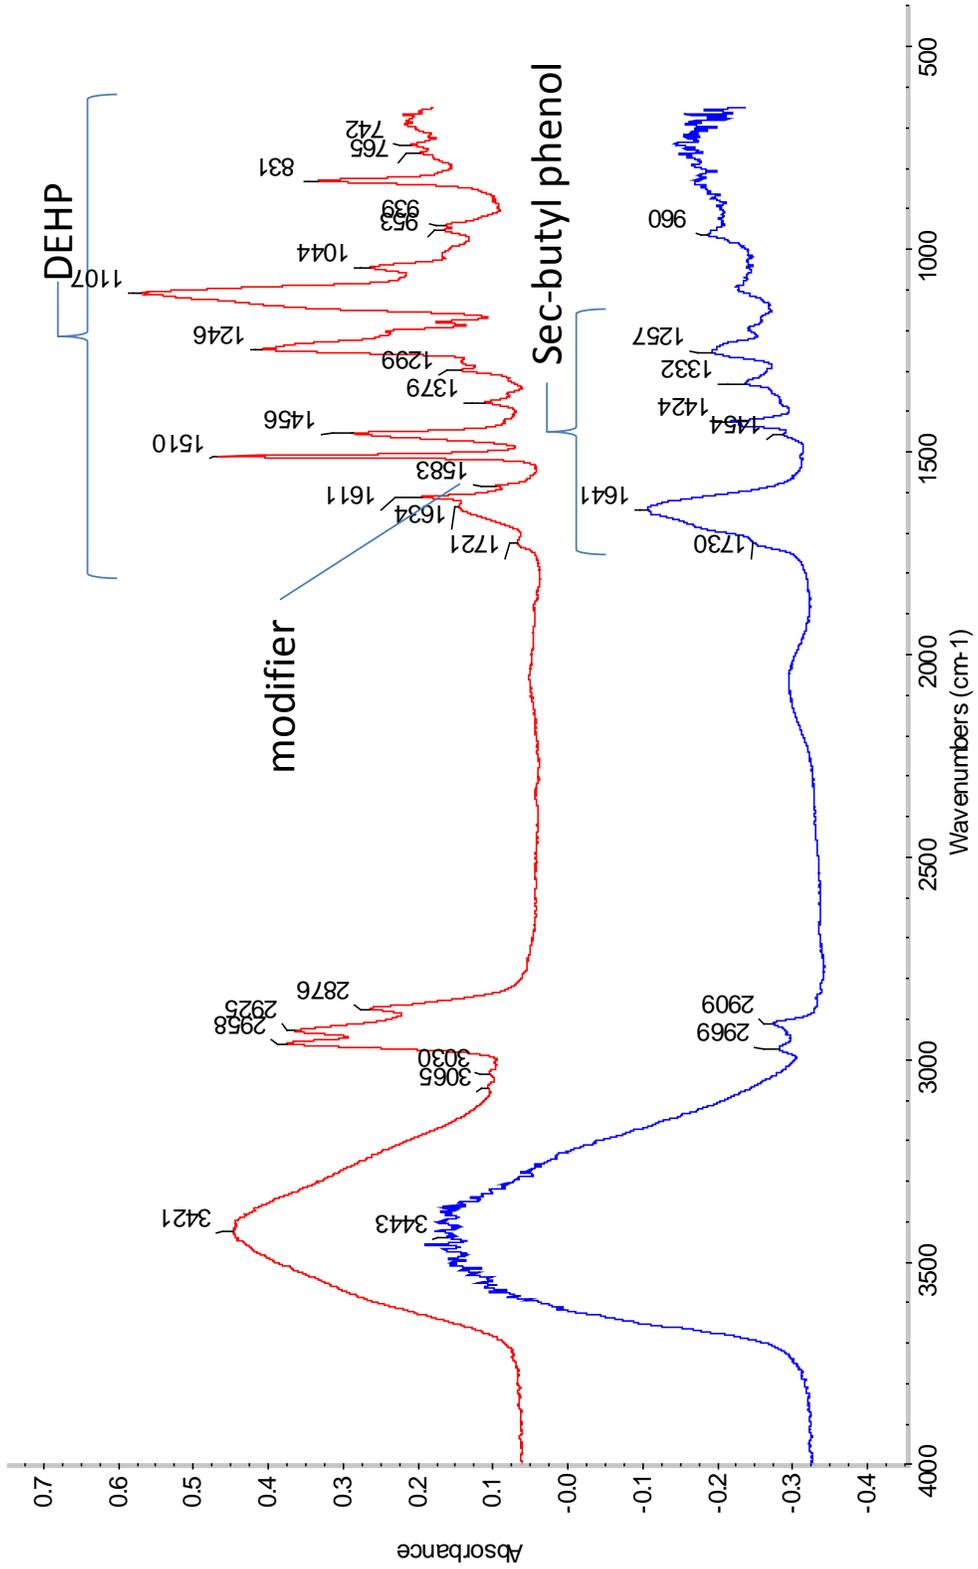
Figure 6. FTIR Scan of an Inlet Piece

Figure 6 shows the results of analysis of two points on a piece from the inlet portion of the HEPA filter. The spot corresponding to the blue trace showed evidence of sec-butylphenol (a decomposition product of the modifier) and DEHP. The spot corresponding to the red trace showed evidence of modifier and DEHP.

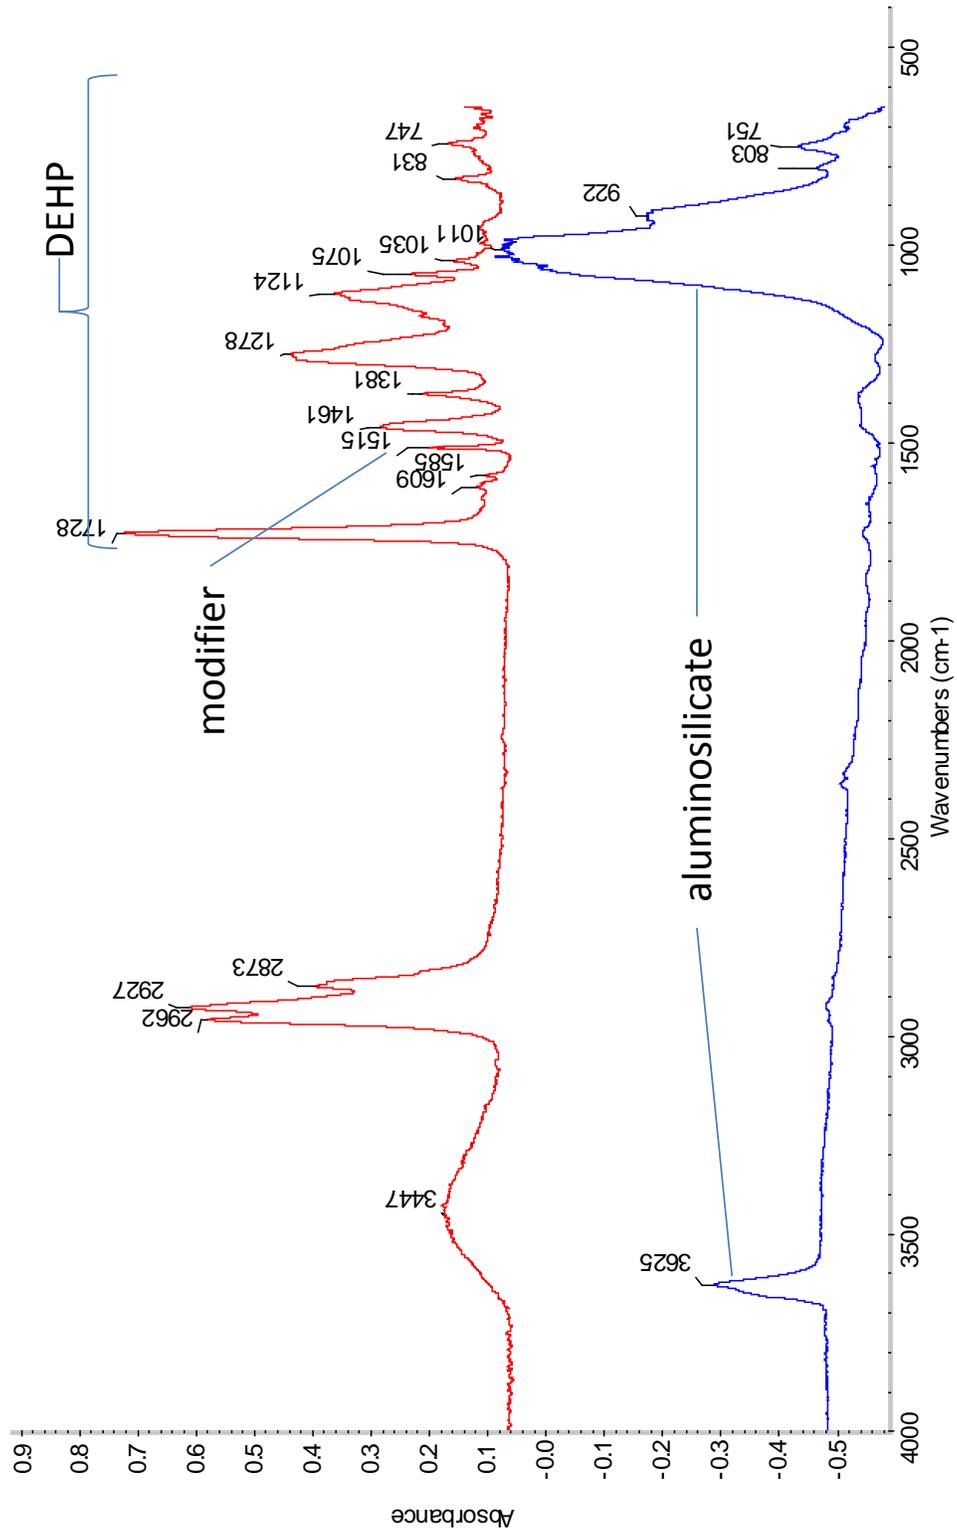
Figure 7. FTIR Scan of a Center Piece

Figure 7 shows the results of analysis of two points on a piece from the center portion of the HEPA filter. The spot corresponding to the blue trace showed evidence of aluminosilicates. The spot corresponding to the red trace showed evidence of modifier and DEHP.

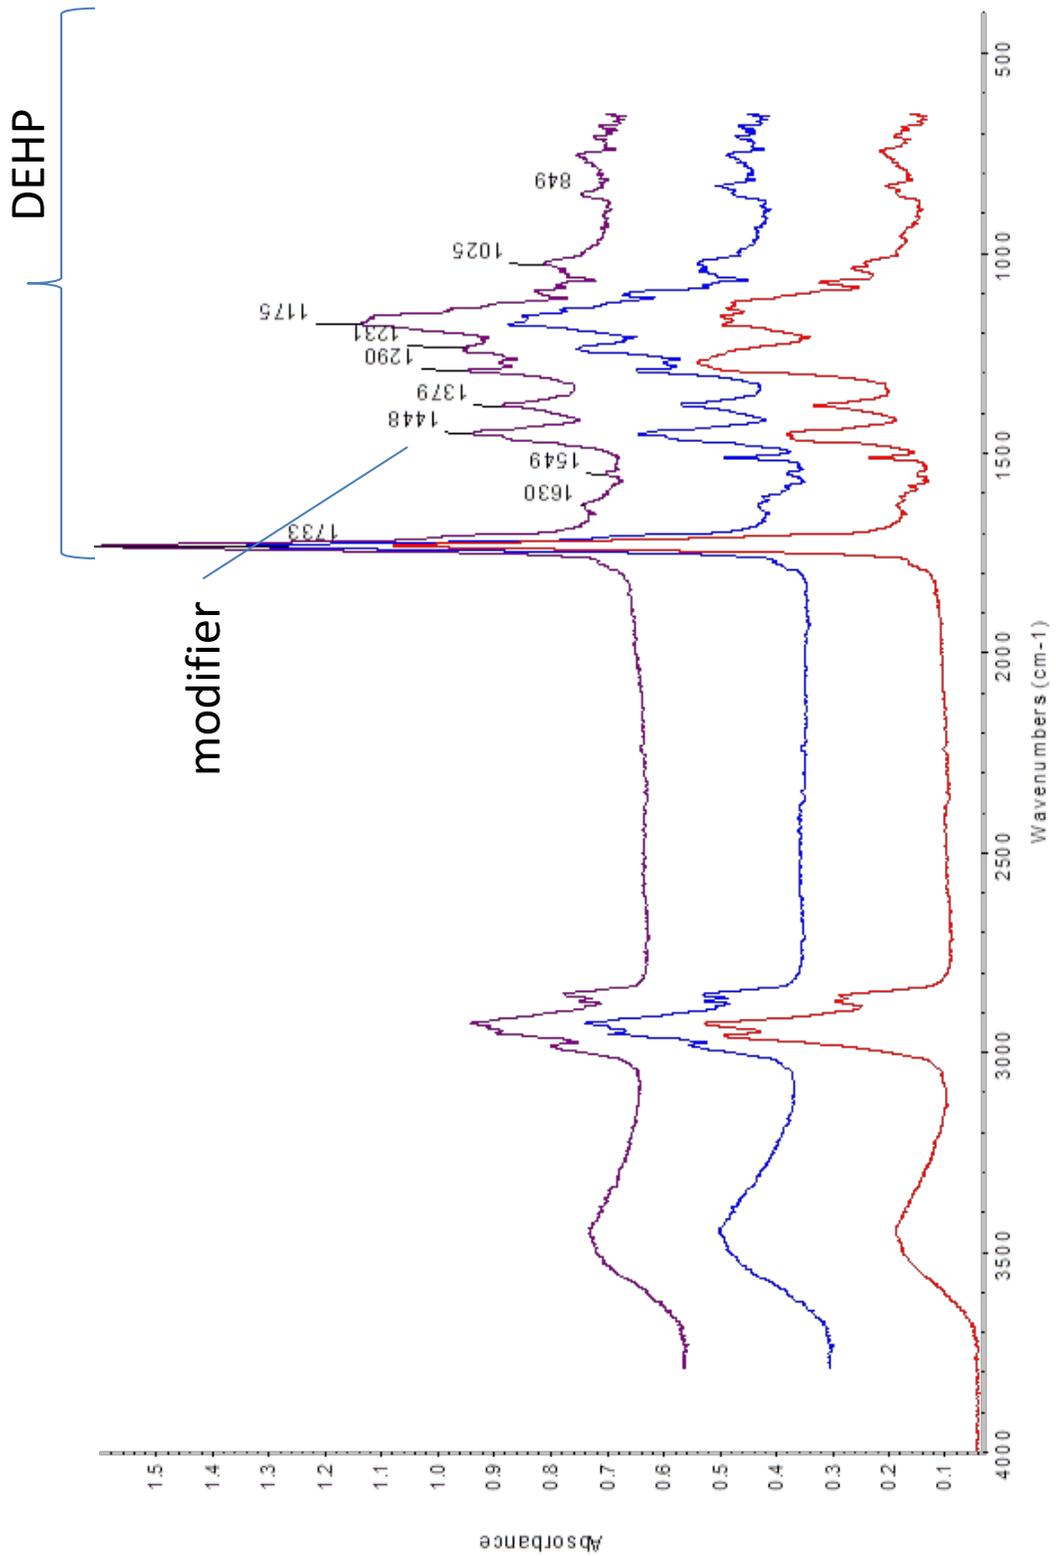
Figure 8. FTIR Scan of an Outlet Piece

Figure 8 shows the results of analysis of three points on a piece from the inlet portion of the HEPA filter. The spot corresponding to the red trace showed evidence of DEHP. The spot corresponding to the blue trace showed evidence of modifier and DEHP. The spot corresponding to the purple trace showed evidence of ethyl acrylate and DEHP.

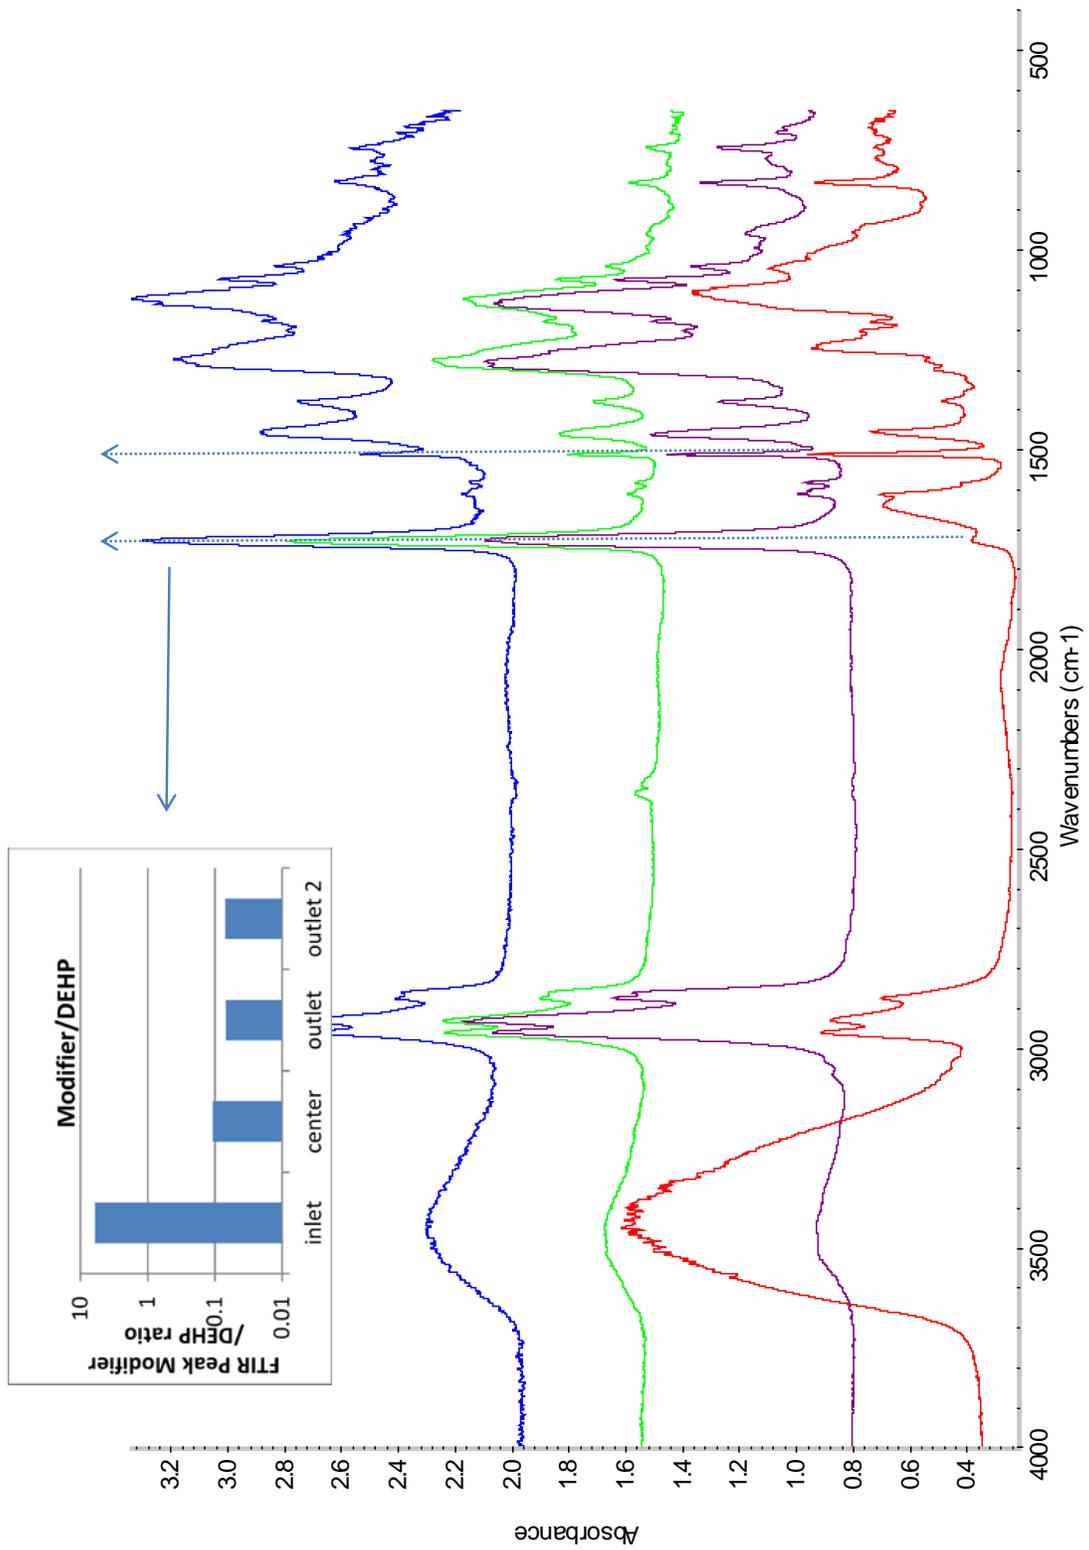
Figure 9. Modifier vs. DEHP Concentrations

Figure 9 shows an examination of DEHP and modifier at various spots, and shows that the modifier:DEHP concentration ratio changes from the inlet to the other pieces, corroborating the leaching results in Table 2.

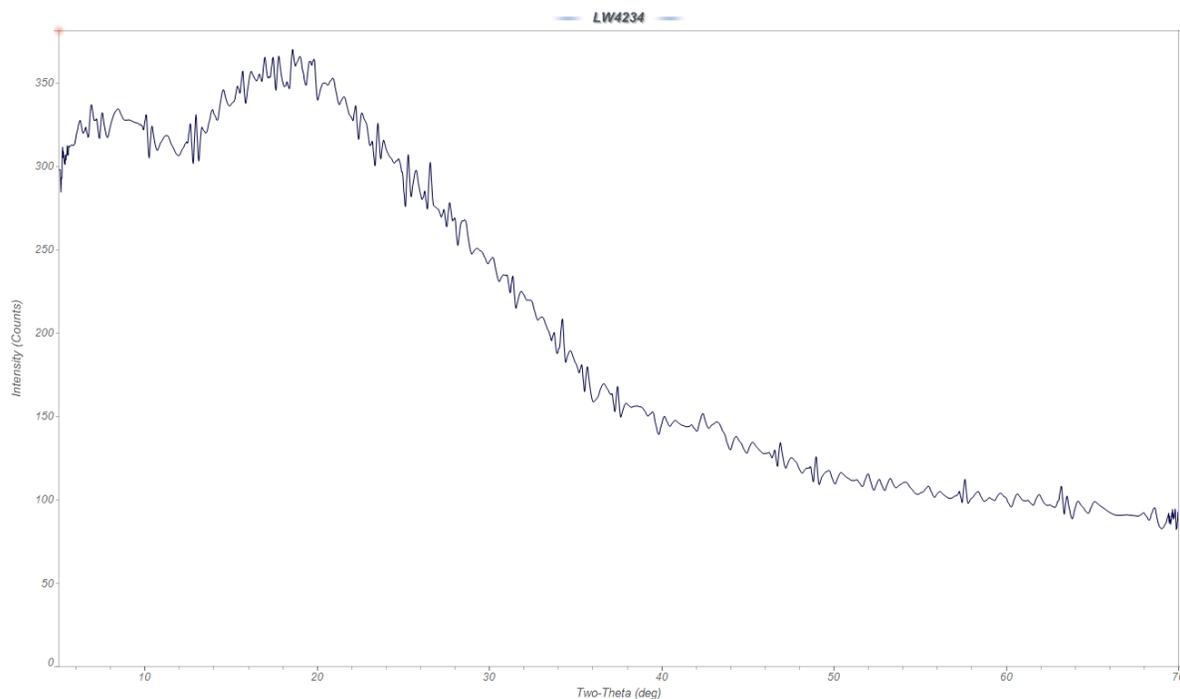
Figure 10. Typical Result from XRD

Both XRD and XRF methods are suitable for crystalline material, which is usually exhibited by inorganic salts. Both methods were used to scan spots on the filter material and compared to a blank, clean sample. In all cases, the samples gave results that appeared as the blank samples – no apparent crystalline materials were present (Figures 10 and 11).

The XRD result of a broad, featureless spectrum indicates a lack of crystalline signals.

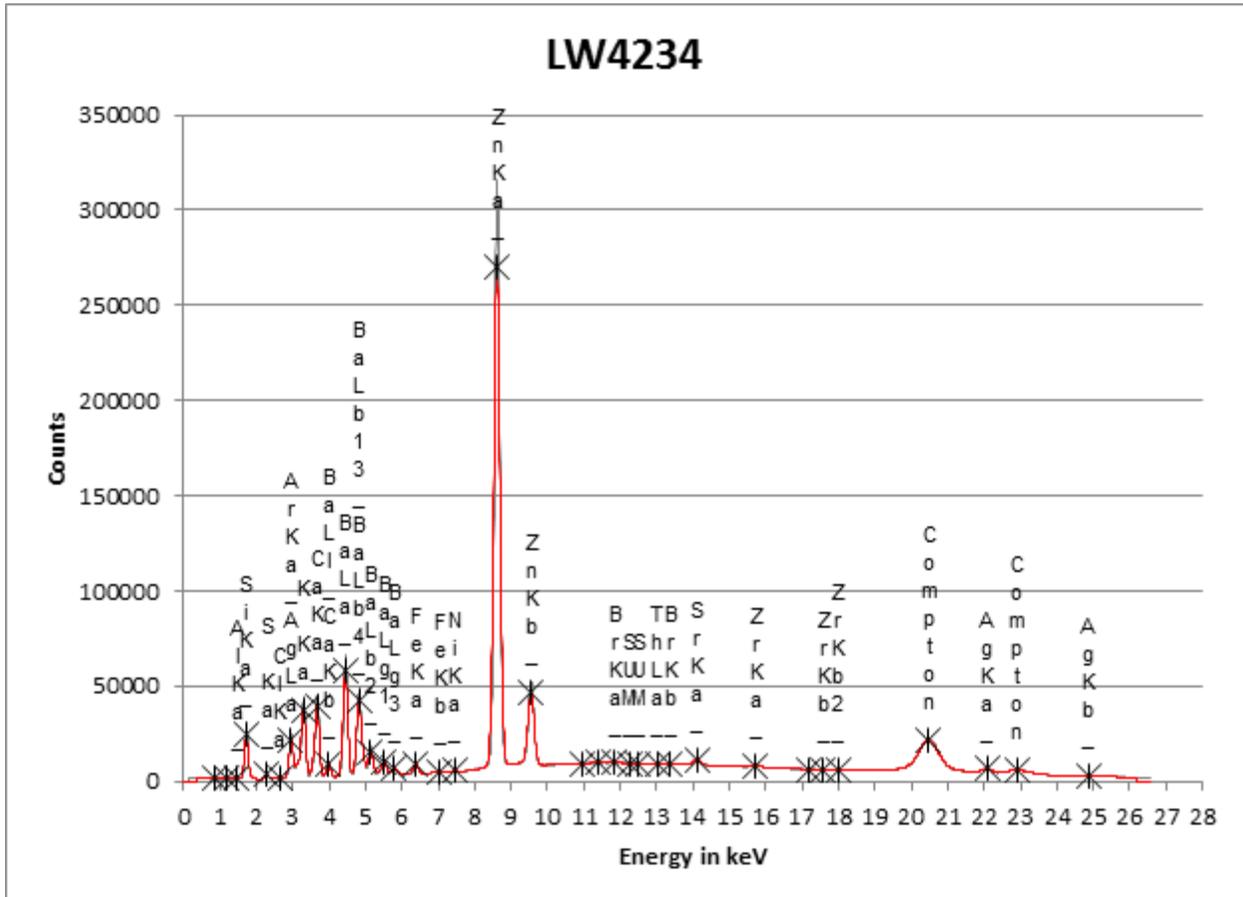
Figure 11. Typical Result from XRF

The XRF result indicates the major analyte is zinc, suggestive of some sort of zinc coating on the filter material.

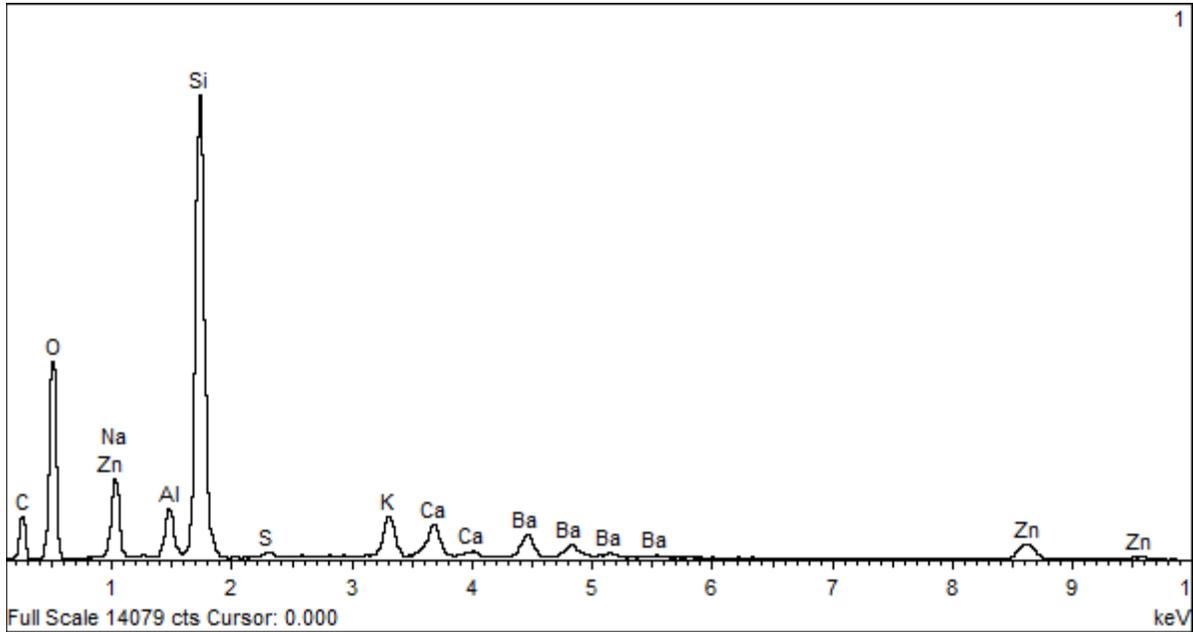
Figure 13. Spectrum of CSEM Blank

Figure 13 is an example spectrum of a clean, unused sample. This spectrum shows the expected silicon and oxygen (from the glass matrix) as well as zinc, barium and a few other peaks (the prevalence of the zinc and barium suggest some sort of coating as part of the substrate). Figure 14 is a spectrum from point #1 in Figure 12. While it shows the expected background peaks from the blank, it also shows a strong signal from iron, likely indicating some sort of particle of steel or rust from the system.

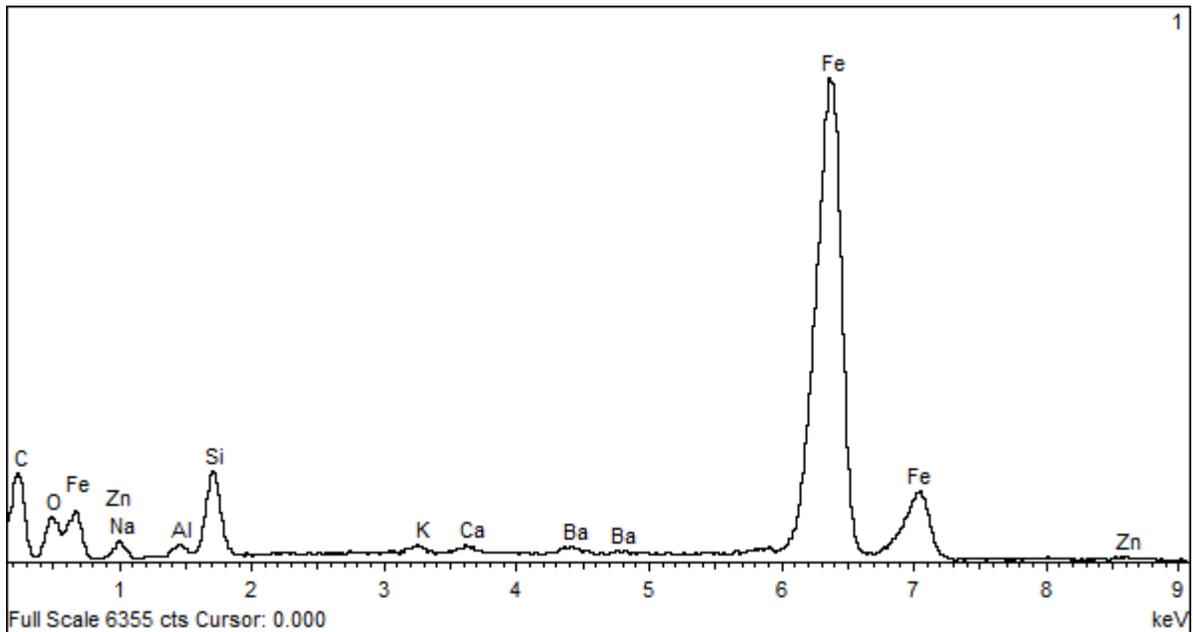
Figure 14. CSEM Spectrum of Point #1

Other than the background signals and spots which we attribute to steel or rust, there is very little to be seen in any of the SEM results that would be expected of salt solution. Figure 14 is a representative sample. Any amount of salt solution (feed or decontaminated) should dry out in the fibers of the filter to leave inorganic deposits such as aluminates, aluminosilicates, or carbonates.
