Visual Inspection of Defense Waste Processing Facility Melter 2 Interior after End of Service

April 2018

SRNL-STI-2017-00428, Revision 0

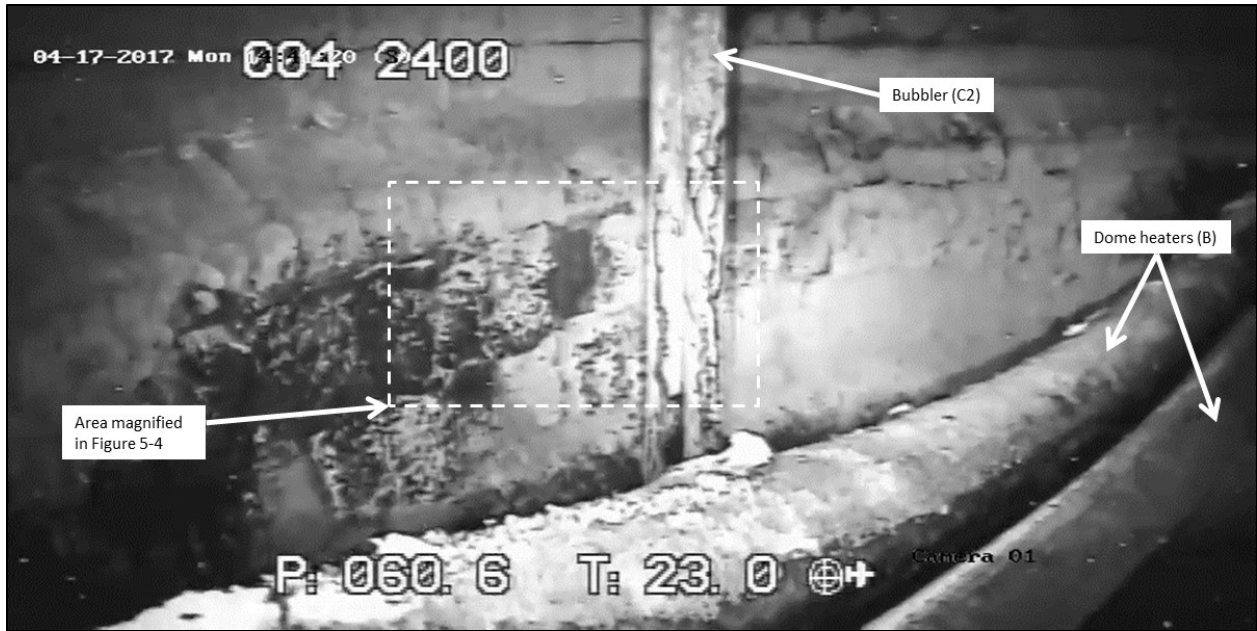
The visual inspection of the interior of DWPF Melter 2 started by inserting the camera system through the primary off-gas nozzle (Nozzle A). Overviews of the vapor space refractory and components are shown in Figure 5-1 and Figure 5-2. The melter feed tube was removed for reuse prior to cooling of the glass pool. The bubbler tubes and vapor space thermowell remained. The vapor space refractory appeared to be in good condition after nearly 14 years of melter operation. Deposition of material on the refractory surfaces was visible and significant, which precluded direct observation of most of the refractory. Some of this accumulated material appeared to have spalled off during cooling. Figure 5-3 shows an area of the Korundal XD refractory that appears to have been exposed after deposits spalled away from its surface. A closer view of this area, near to the C2 bubbler and level dip tube, is shown in Figure 5-4.

Figure 5-3. Deposition of material on vapor space refractory and exposed area near Bubbler C2 (west side of melter)

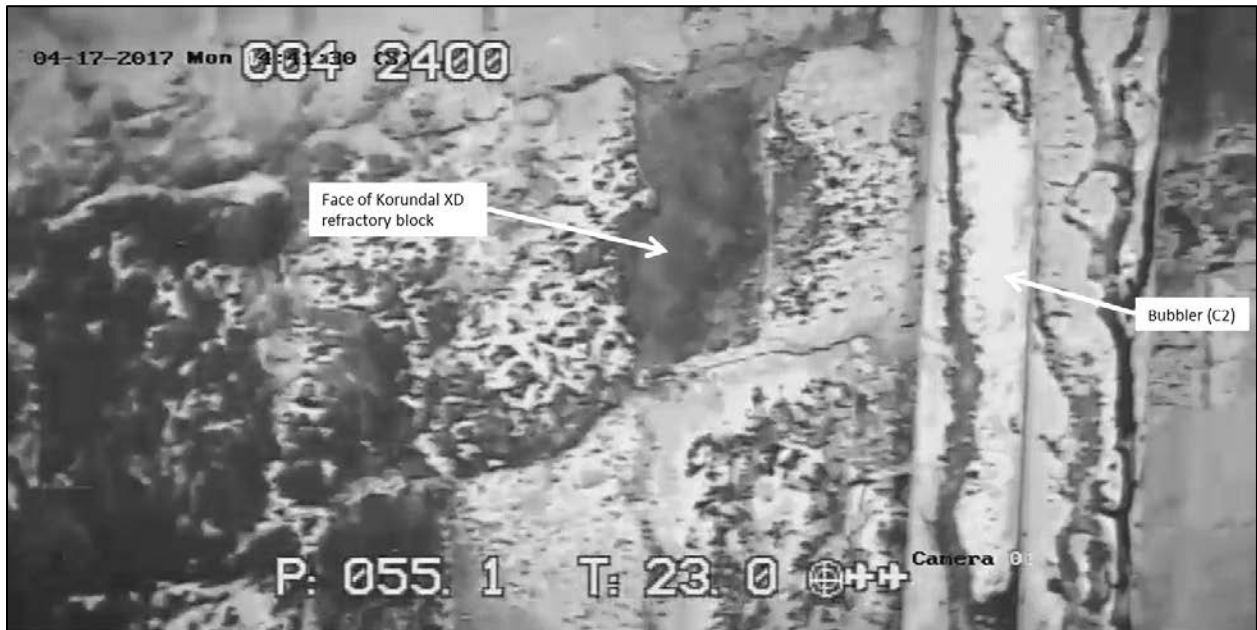
Figure 5-4. Exposed face of Korundal XD vapor space refractory near Bubbler C2

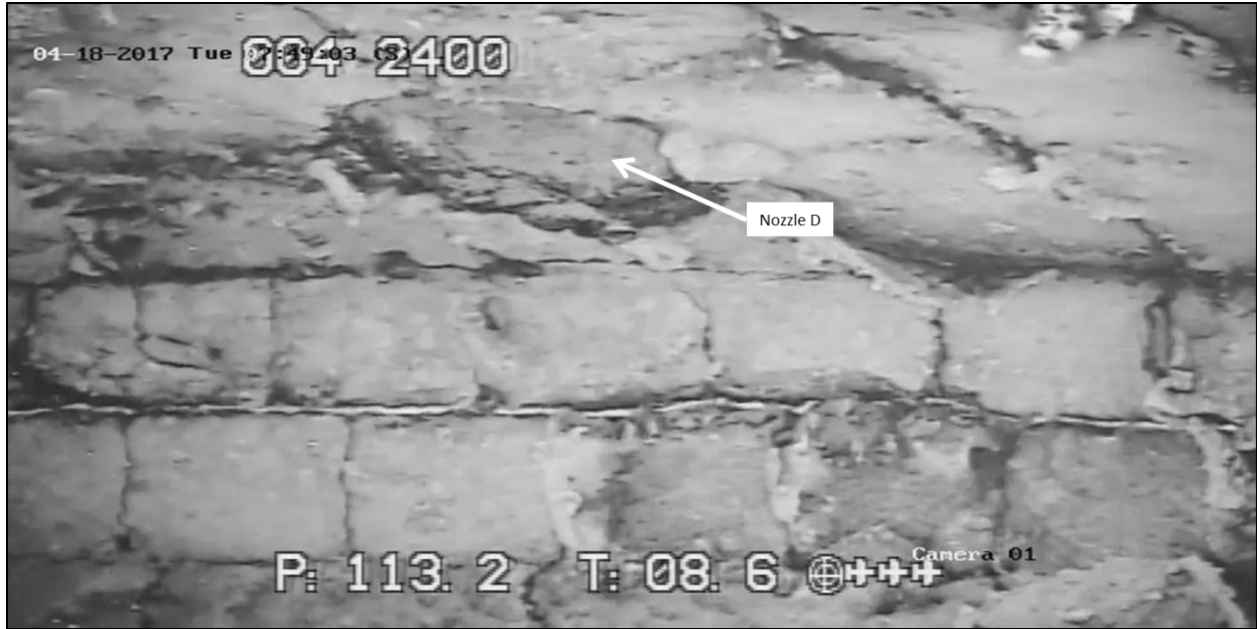
Figure 5-5 provides a view of the melter top head from below, captured by lowering the camera onto the solidified glass pool. Figure 5-6 provides a closer view of the vapor space refractory. The hole visible at the top, left of center in this image is a borescope nozzle (Nozzle D). In general, the vapor space refractory exhibited a level of wear expected after of 14 years of continuous operation. No missing pieces of refractory were observed. Joints between refractory blocks appeared to remain tight.

Figure 5-6. Vapor space refractory condition

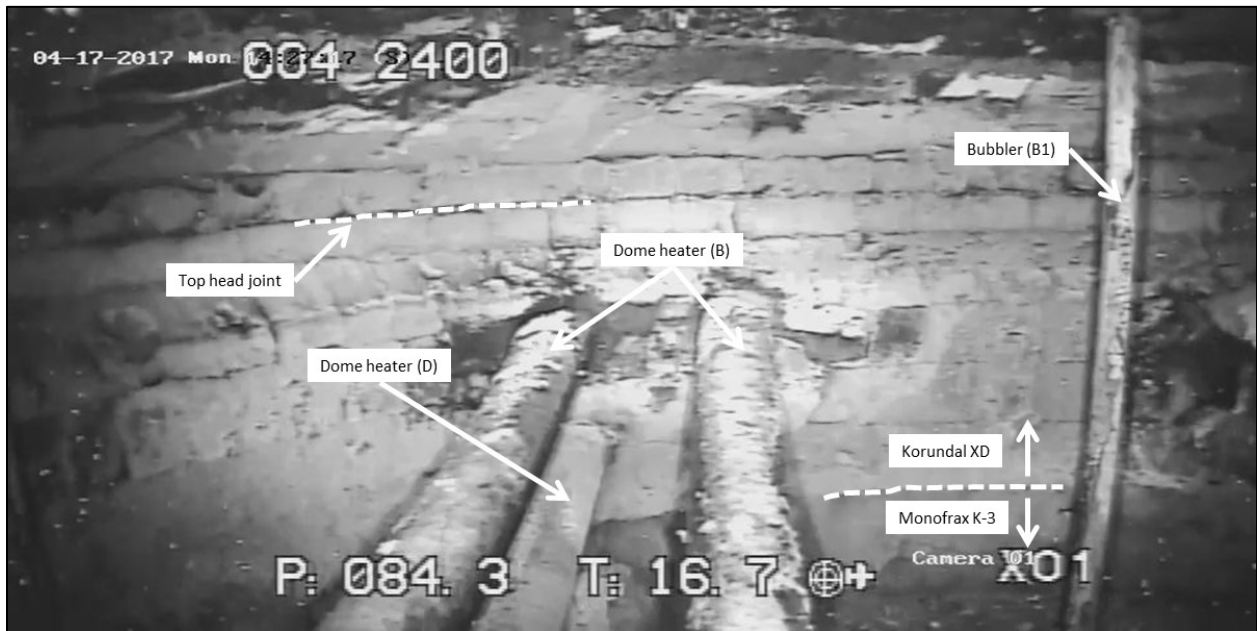
The dome heaters (also referred to as plenum heaters, vapor space heaters, or lid heaters) showed accumulated deposits of material and deformation (sagging). Figure 5-7 shows the top of the four dome heaters on the west side of the melter (sets B and D), including the penetrations through the refractory. Degradation of the refractory and deposits were visible at the penetrations where the dome heaters pass through the refractory walls.

Figure 5-7. Dome heater penetrations, northwest side of melter

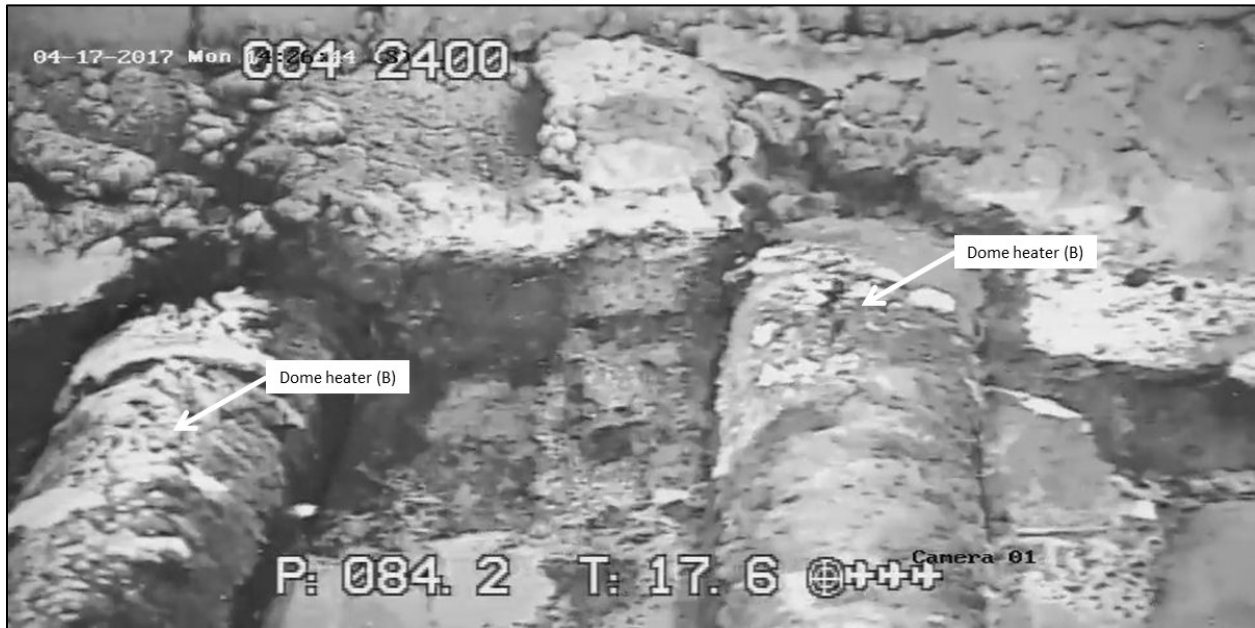
Figure 5-8 provides a closer view of the deposits and refractory degradation around the dome heater penetrations at the northwest side of the melter. This degree of deposition and degradation is to be expected considering the long service life of Melter 2. Figure 5-9 provides a closer view of the accumulated material present on the tops of the dome heaters. Note that the lower pair of dome heaters (D) in this image failed in February 2013. This inspection did not reveal an obvious cause for the failure.

Figure 5-8. Dome heater penetration detail

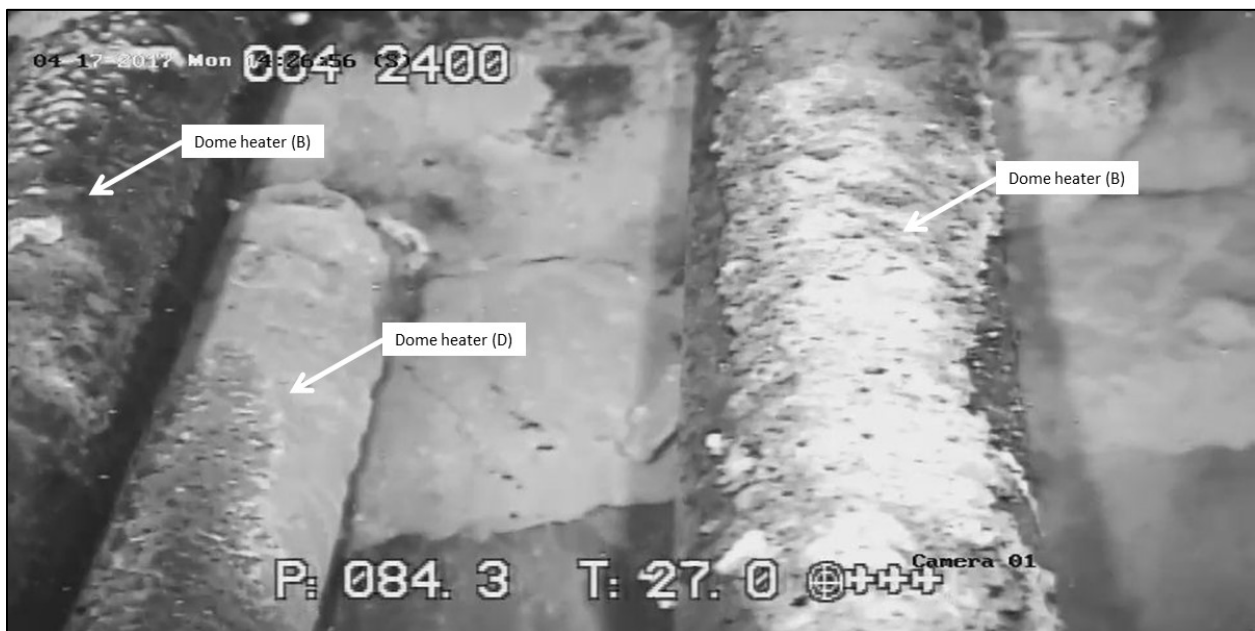
Figure 5-9. Deposits on dome heaters

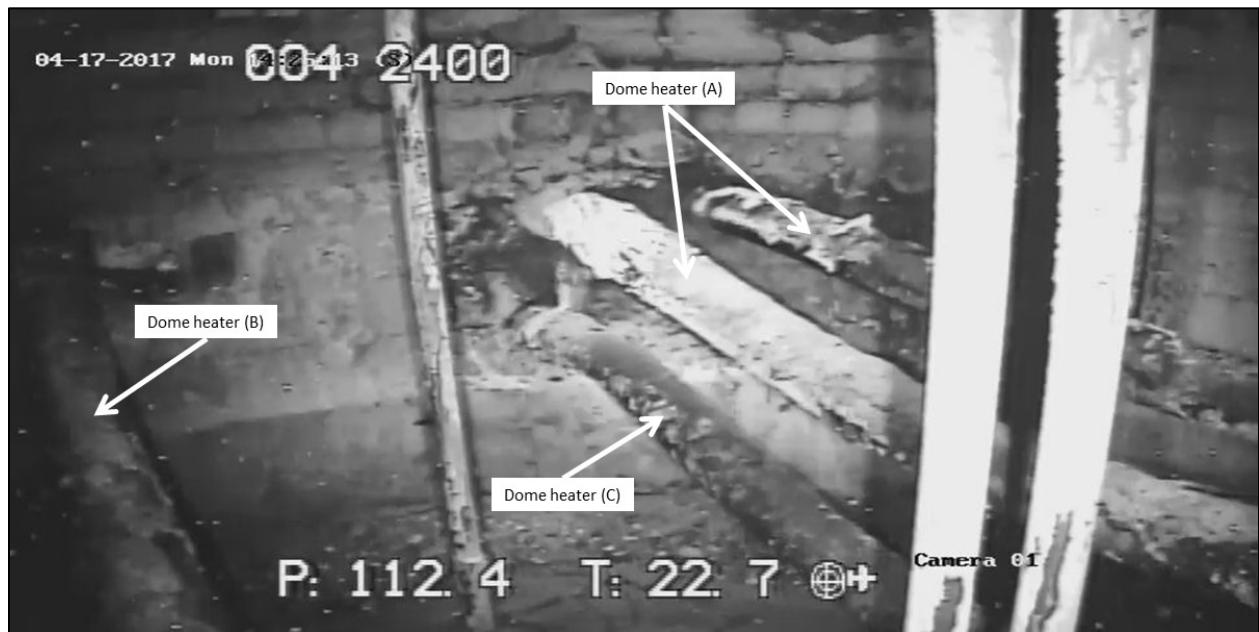
Figure 5-10 is an image of the dome heaters (A and C) on the east side of the melter and their penetration through the refractory on the northeast side. Deposits and degradation of the refractory are visible around the penetrations. A closer view of one of the dome heaters at this location is shown in Figure 5-11. The accumulated material on the top of the dome heater (A1) at this location is likely due to the air purge from the borescope nozzle (Nozzle D) above. An alternate view of this location (captured when the camera was inserted through the backup off-gas nozzle, Nozzle T) is shown in Figure 5-12. A closer view of the lower pair of dome heaters (A) is shown in Figure 5-13 at the northeast refractory wall penetration. Again, both degradation of the refractory and accumulation of material are visible at the dome heater penetrations. The inspection of Melter 1 after shutdown identified similar deposits, especially below the off gas film cooler nozzles.²

Deposition or accumulation of material may cause multiple issues for operation of the dome heaters. Deposits may serve as insulators causing a hot spot, which can result in distortion of the heater. Deposits can also reduce the amount of heat that is transferred into the vapor space.

Degradation of the refractory at the dome heater penetrations may allow chloride and sulfate salts to condense in areas where the surface temperature is reduced to the 500-600 °C range. This may leave these areas prone to rapid attack by breakaway corrosion or sulfidation. Closer inspections of these regions was not possible with the available camera. Overall, operation of the dome heaters does not appear to have been significantly hindered by the deposition and refractory degradation.

Figure 5-10. Dome heater penetrations, northeast side of melter

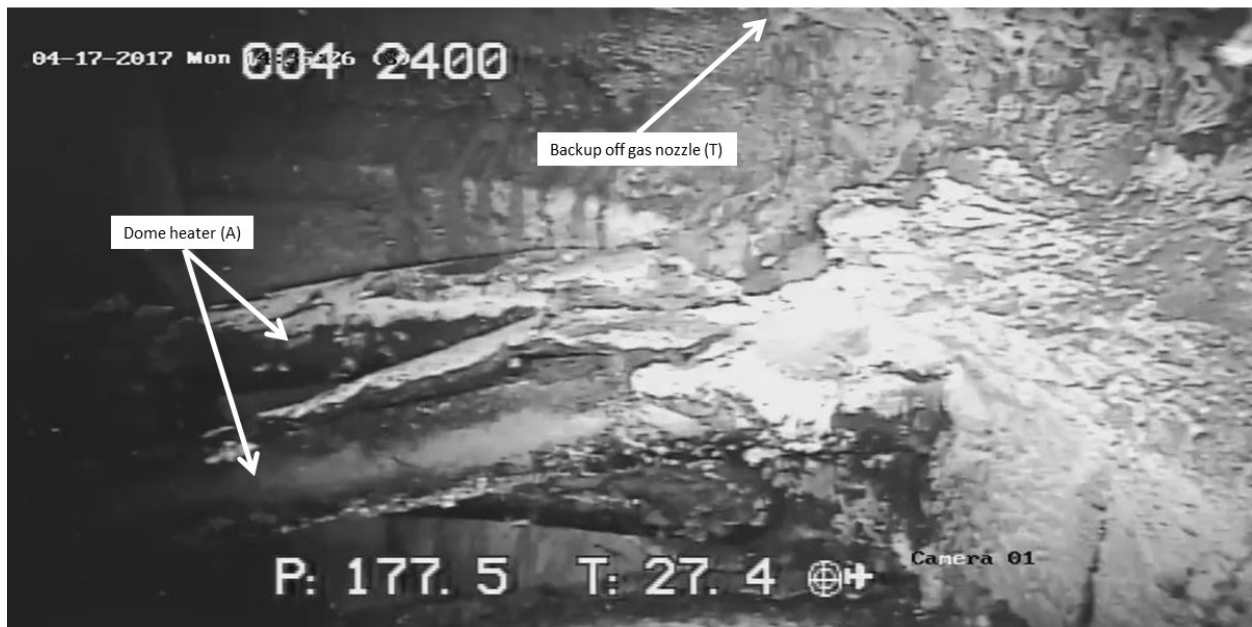
Figure 5-14 provides a view of deposits and degradation of the refractory around the dome heater penetrations at the southeast side of the melter. The additional deposition seen on the upper pair of dome heaters is likely due to quenching from the purge air entering through the backup off gas film cooler (Nozzle T) above this location. Material condensed in the film cooler may also spall off and accumulate in this area. A closer view of the penetration of the lower pair of dome heaters at this location is provided in Figure 5-15. An alternate view of the deposits on top of the dome heaters at this location is shown in Figure 5-16, where the camera was inserted through the backup off gas nozzle (Nozzle T).

Figure 5-14. Dome heater penetrations, upper pair, southeast side of melter

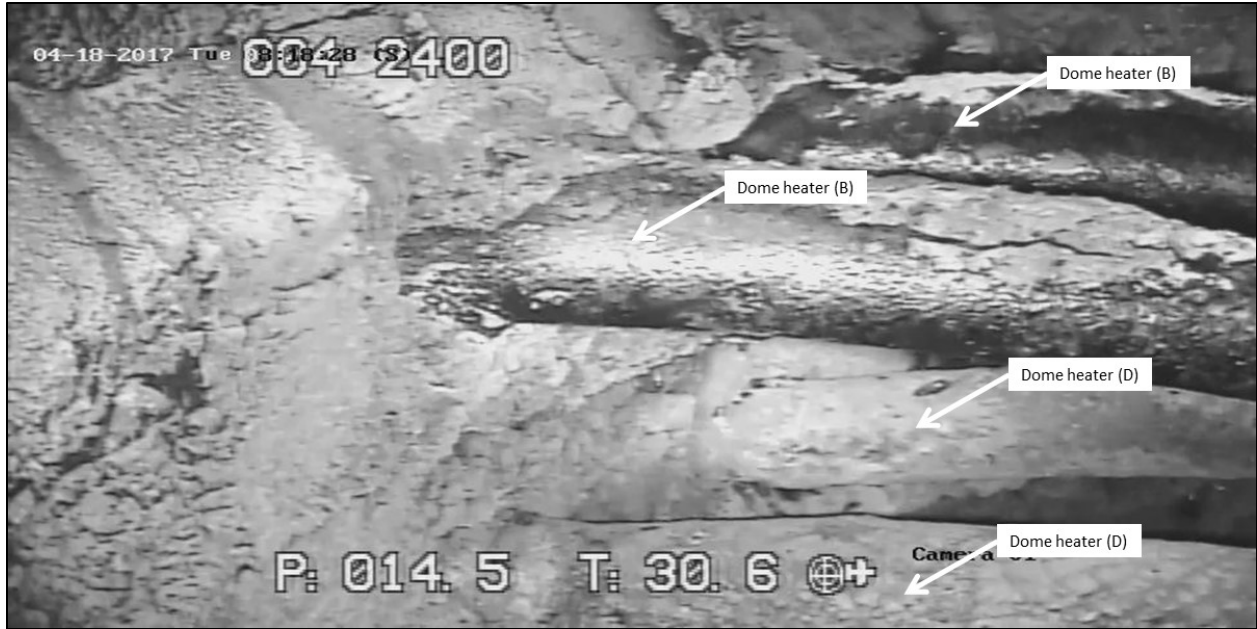
Figure 5-17 provides a view of deposits and refractory degradation around the dome heater penetrations at the southwest side of the melter. The condition of the refractory in this area appeared to be similar to that of the other dome heater penetrations.

Figure 5-17. Dome heater penetrations, southwest side of melter

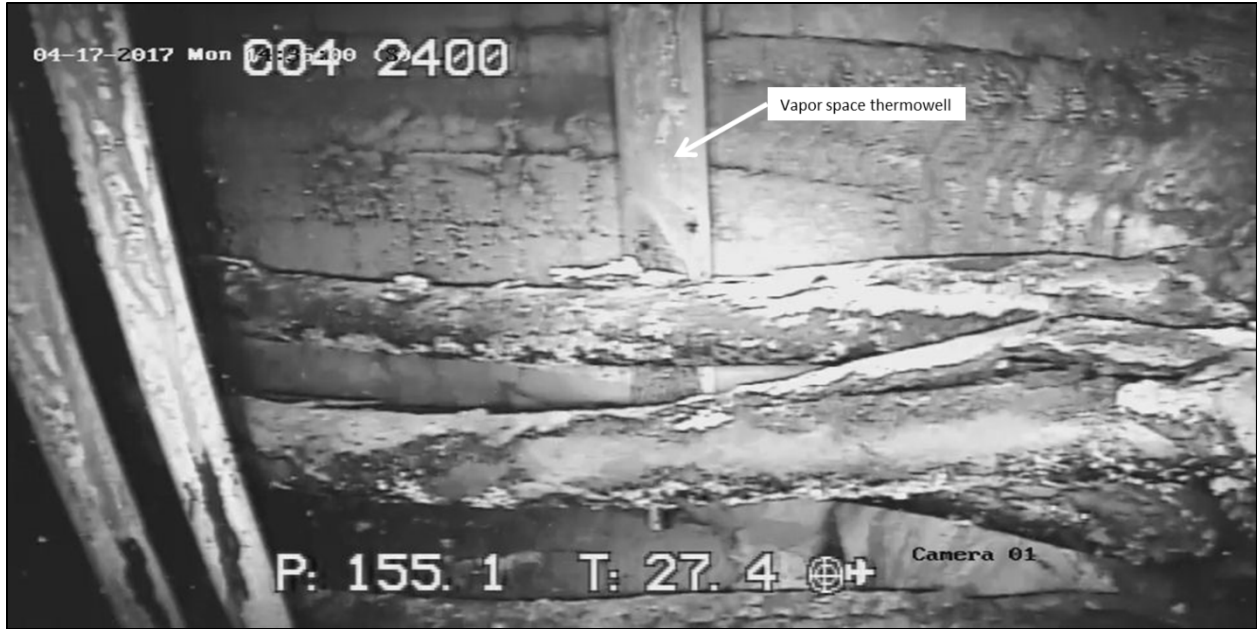
Deformation of the dome heaters was observed mainly as downward sagging across the length of the heaters, with some upward bowing near the refractory penetrations. An example of deformation of the upper pair of dome heaters on the east side of the melter is shown in Figure 5-18. Refer to Figure 4-4 for the original condition of the dome heaters. The deformation is likely due to a combination of factors over the service life of the melter, including creep, thermal gradients due to the insulating effects of deposits, and varying degrees of cold cap coverage causing uneven heating (shine) from the melt pool. The dimensions of the dome heaters may also have changed unevenly over time, due to wall thinning from oxidation. In reviewing dome heater operation data, there was a discernable increase in dome heater resistance over the life of Melter 2. However, this increase and the deformation of the dome heaters did not appear to detract from their operation, based on power consumption and the ability to control the vapor space temperature. Figure 5-19 shows similar deformation of the dome heaters on the west side of the melter.

Figure 5-18. Deformation of dome heaters, east side of melter

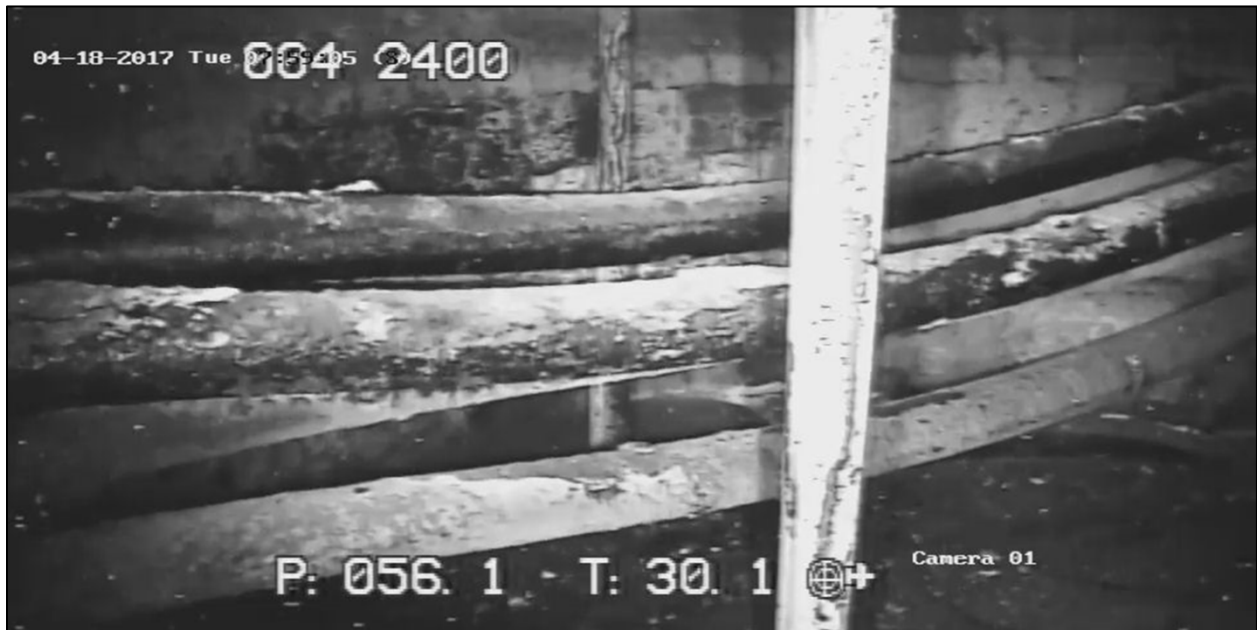
Figure 5-19. Deformation of dome heaters, west side of melter

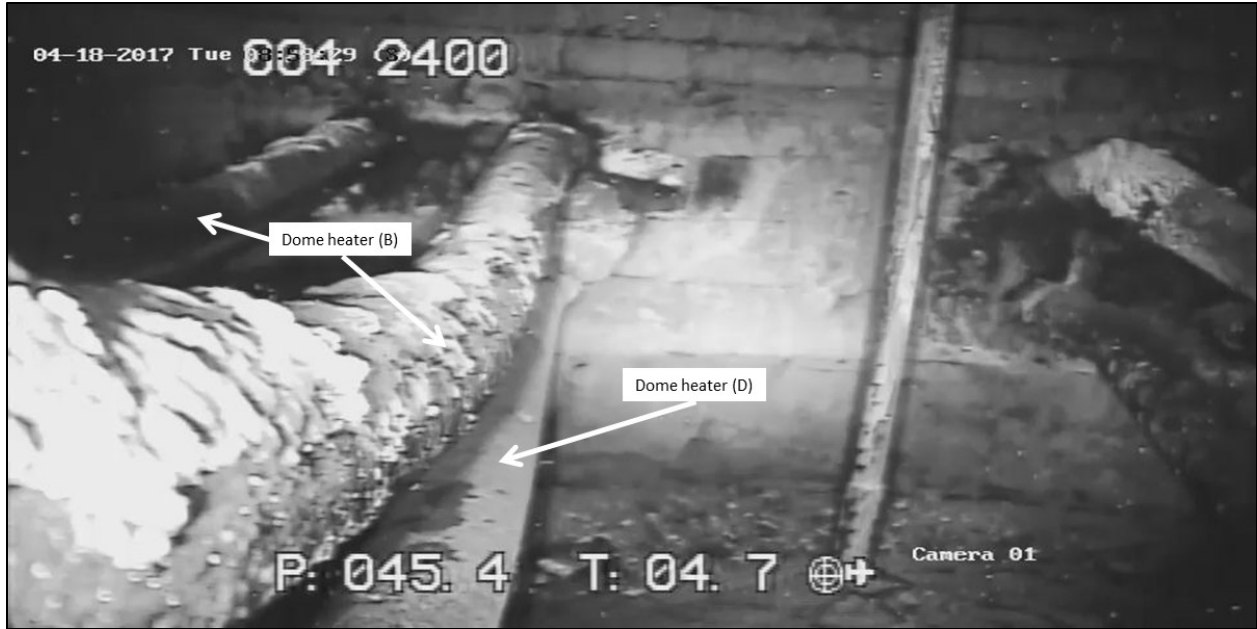
Further observation of the dome heater deformation was obtained by orienting the camera nearly parallel with the long axis of the heaters, as shown in Figure 5-20. The upper dome heaters on the west side of the melter appear to have sagged by an amount approximately equivalent to their diameter. The lower pair of dome heaters with light colored deposits is the “D” heaters that failed in February 2013. Deformation of these heaters was observed by lowering the camera further, Figure 5-21.

Figure 5-20. View along dome heaters showing deformation, west side of melter

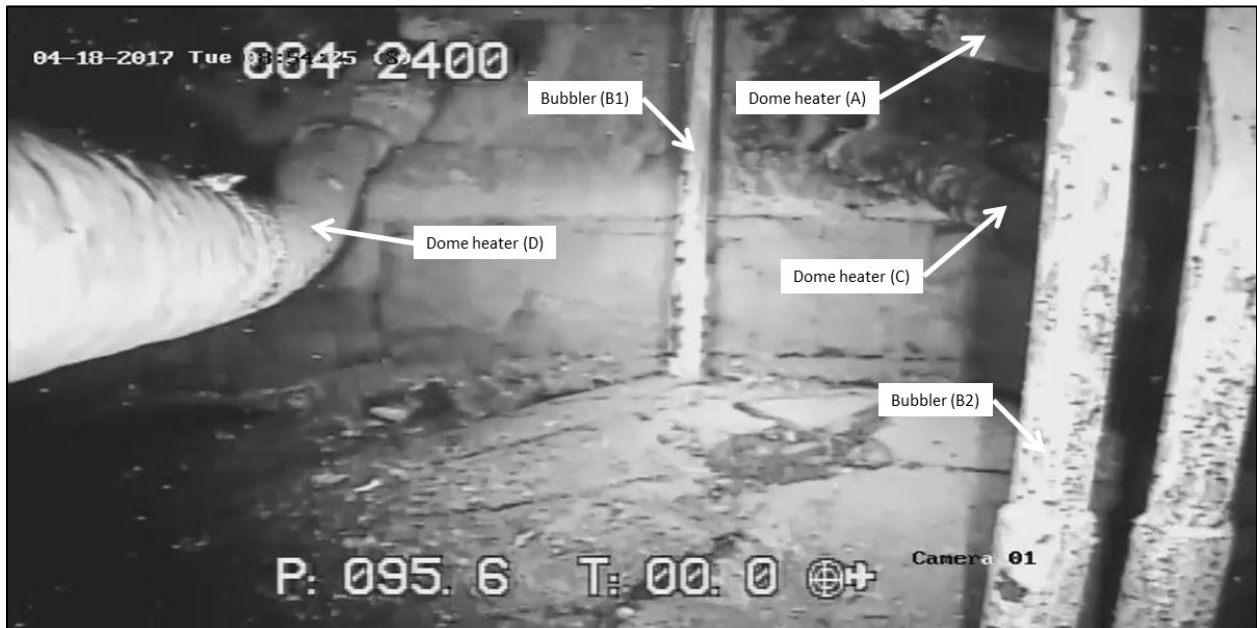
Figure 5-21. View along dome heaters showing deformation, lower pair, west side of melter

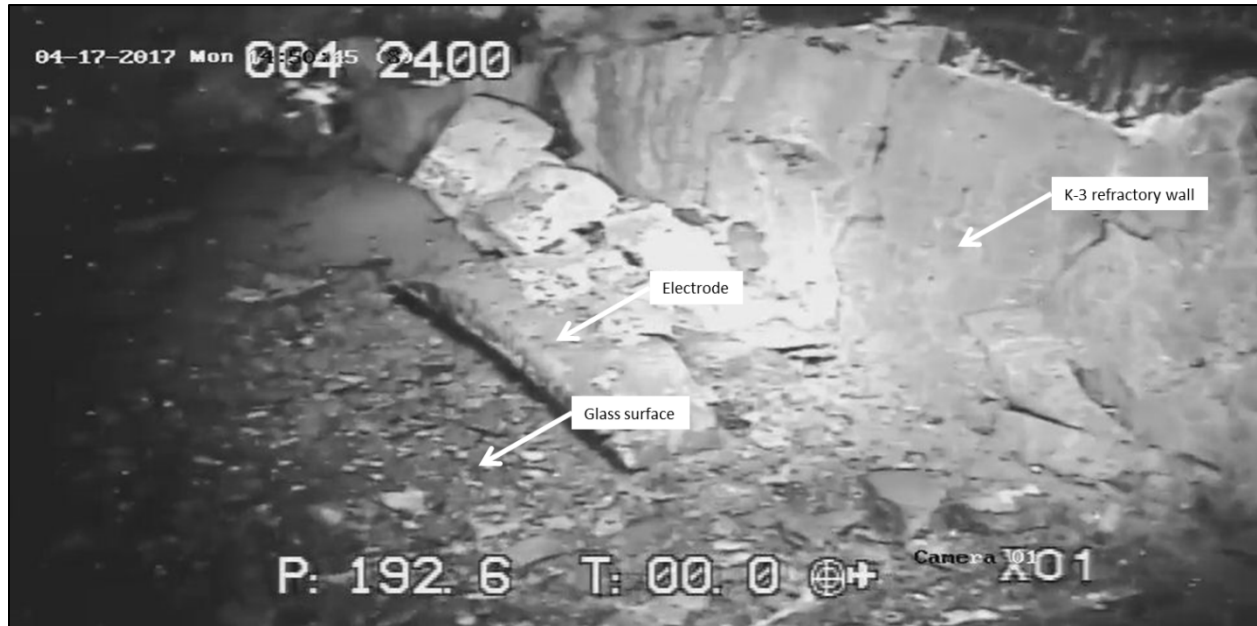
Melter 2 was shut down with a full inventory of glass, which prevented inspection of the melt pool electrodes. However, the top portions of the upper electrodes remained visible. The top of the L1 electrode at the southeast side of melter is visible in Figure 5-22. Pieces of what appear to be refractory material are visible behind the electrode, shown from a lower angle in Figure 5-23. It appears that these pieces spalled

Figure 5-22. Upper electrode, southeast side of melter

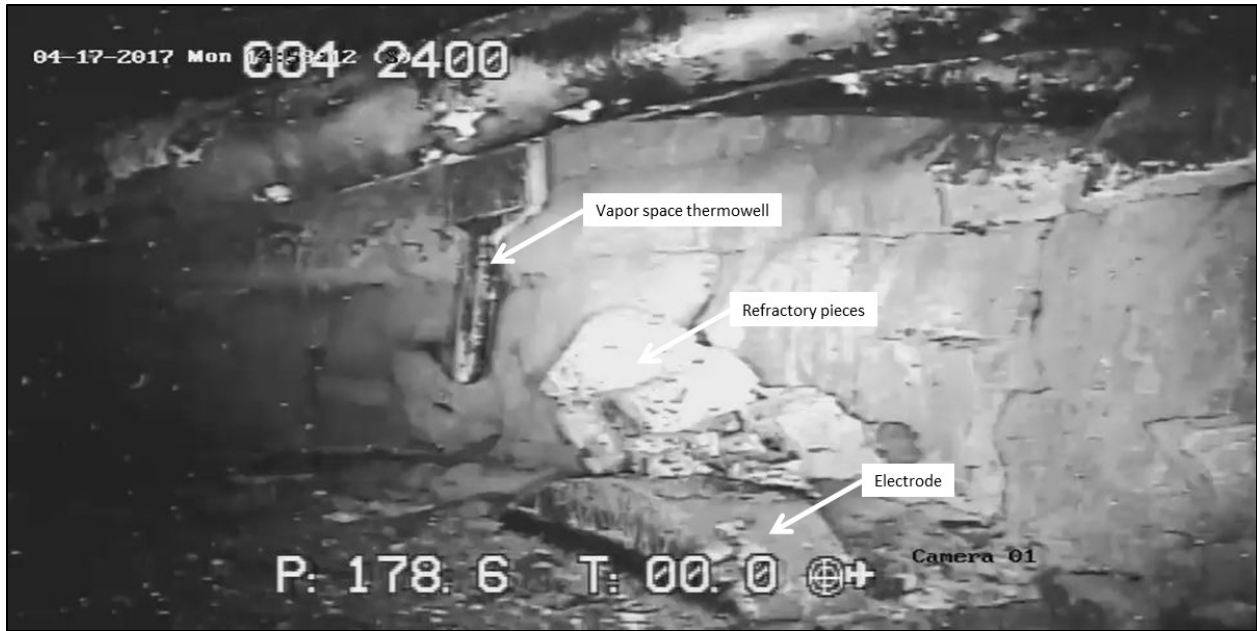
off of the refractory wall during cooling of the melter, as they would otherwise have been expected to fall into the melt pool. As shown in the drawing in Figure 5-24, the back of the electrode was originally up against the refractory wall. From Figure 5-22 and Figure 5-23, it appears that the refractory has worn or spalled away, leaving a gap between the electrode and the refractory wall that may be filled with glass. The width of the gap appears to be approximately equal to the thickness of the electrode (3 inches). The missing K-3 at this location is an un-retained “shelf” of K-3 formed as a result of producing the flat refractory surface for mounting of the electrodes (Figure 5-25). Similar significant material spalling or loss was not observed elsewhere around the circumference of the melter. Figure 5-26 shows the L1 electrode as viewed from above, via inserting the camera down through the backup off gas nozzle (T). The refractory pieces are again visible.

Figure 5-23. Refractory pieces visible behind upper electrode

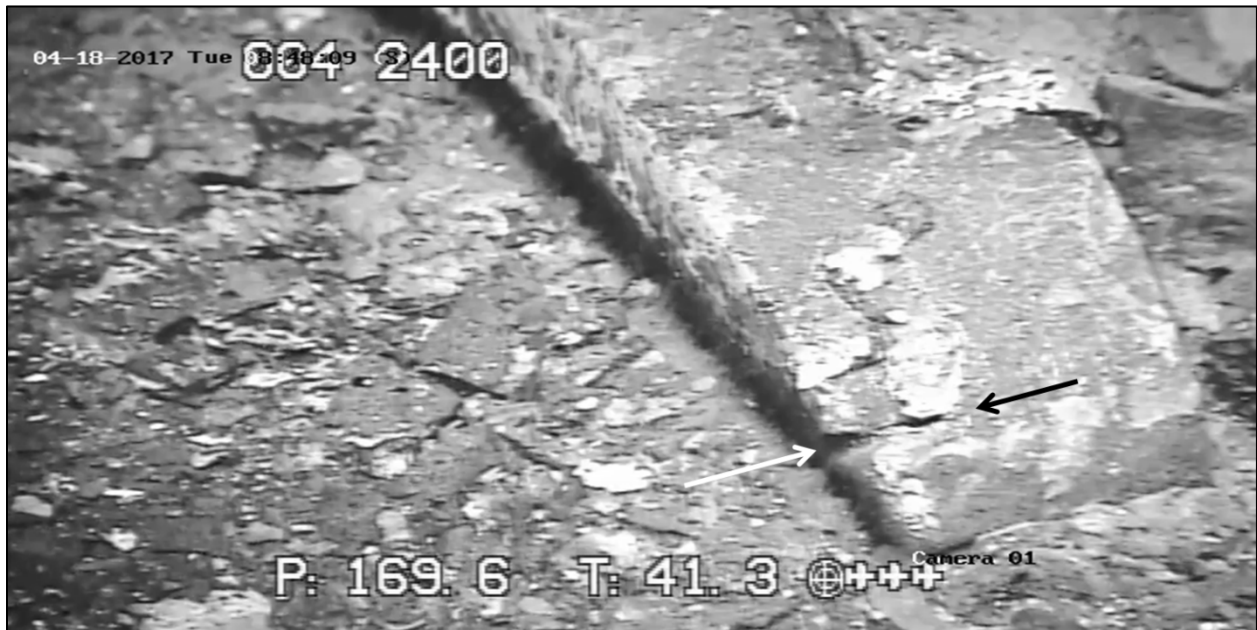
Figure 5-28. Larger crack visible on top of upper electrode, southeast side of melter

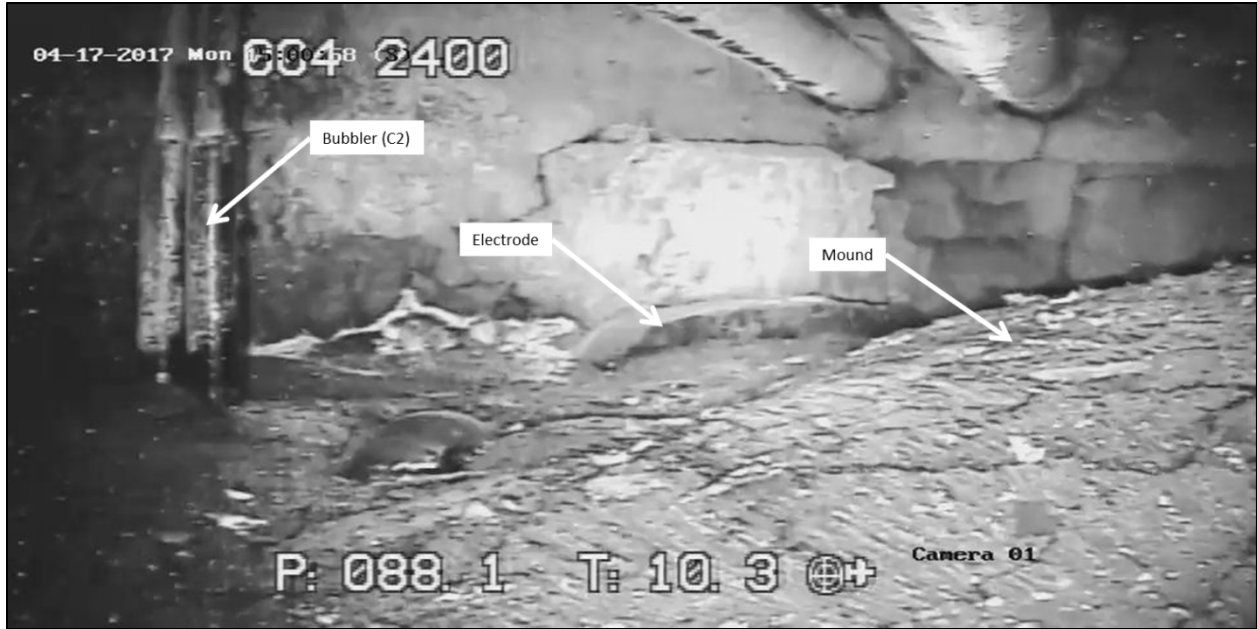
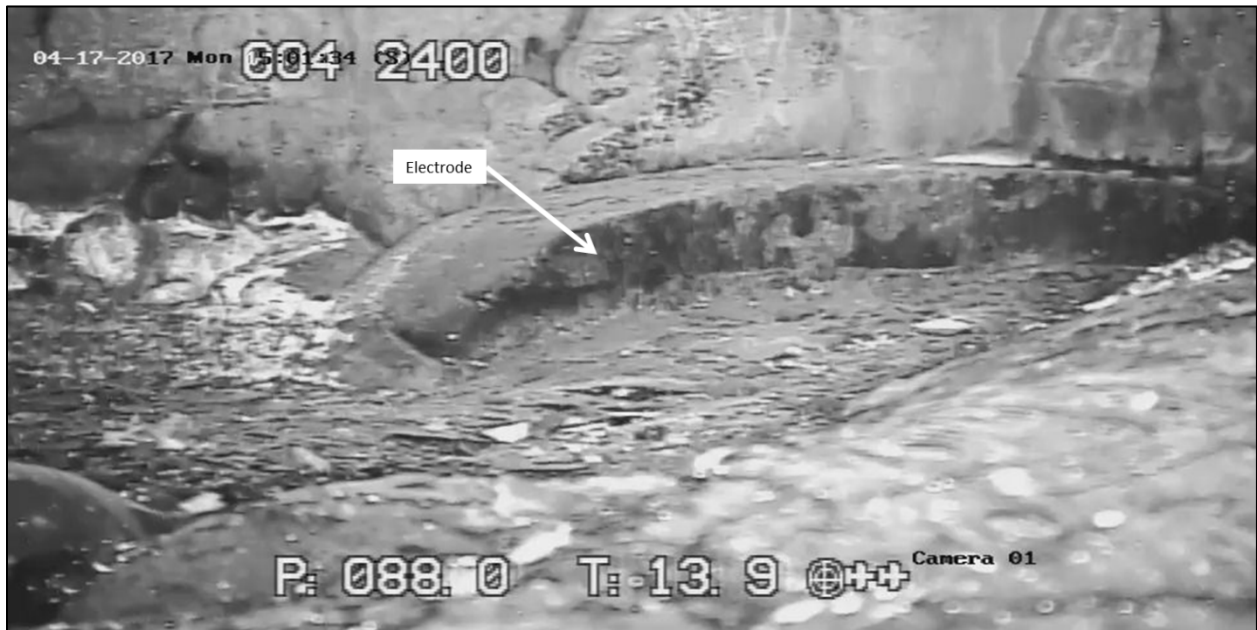
A view of the top portion of the L3 electrode at the northwest side of the melter is shown in Figure 5-29. A closer view is provided in Figure 5-30. Deposits are again visible on the electrode. There appears to be some deformation (slumping) of the electrode relative to its original shape, as depicted in Figure 5-31. This is not unexpected given the relatively long service live of Melter 2.

Figure 5-29. Upper electrode (L3), northwest side of melter

Figure 5-30. Detail view of upper electrode (L3), northwest side of melter

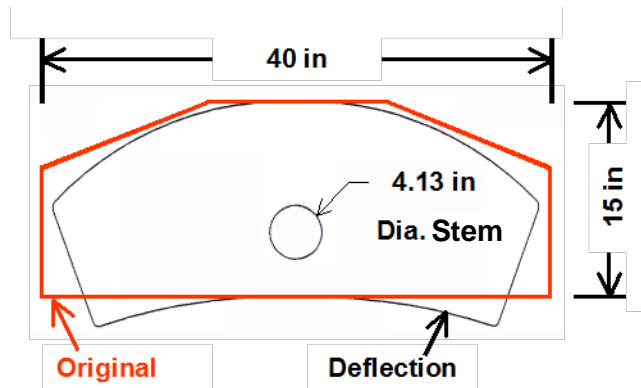
Figure 5-31. Approximation of observed upper electrode slumping (black outline) relative to original electrode shape (red outline)

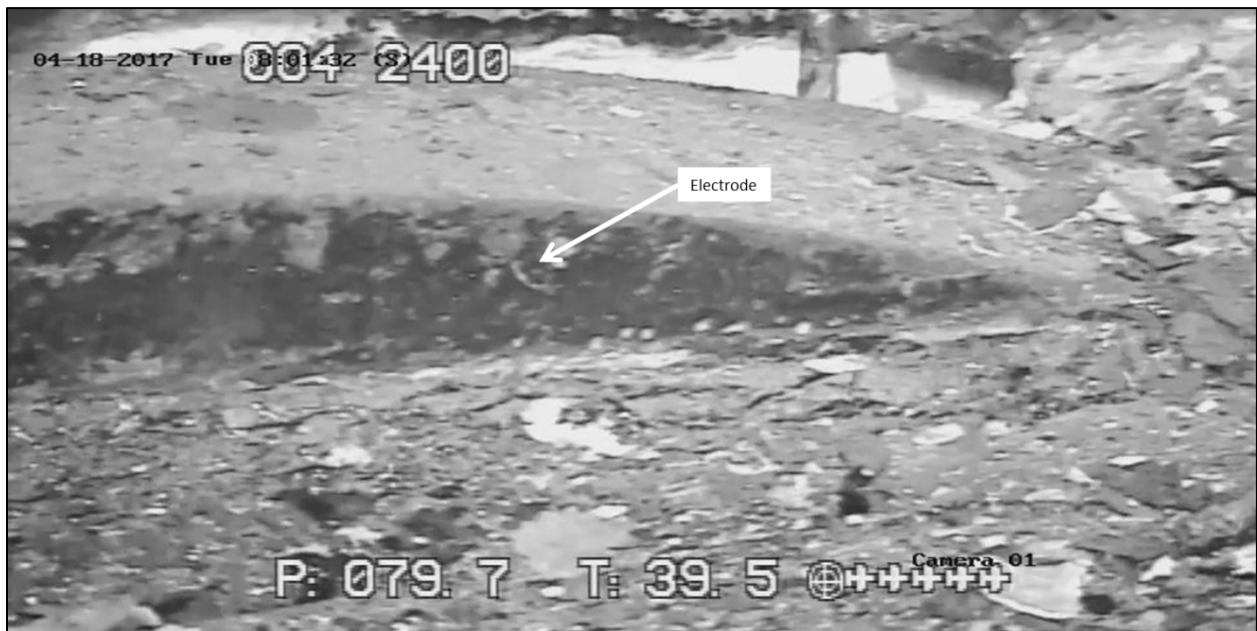
Another view of the L3 electrode is shown in Figure 5-32. Note that the edges of the electrode appear to have remained fairly sharp. However, this may mask internal degradation via the mechanisms described earlier.

Figure 5-32. Second detail view of upper electrode (L3), northwest side of melter

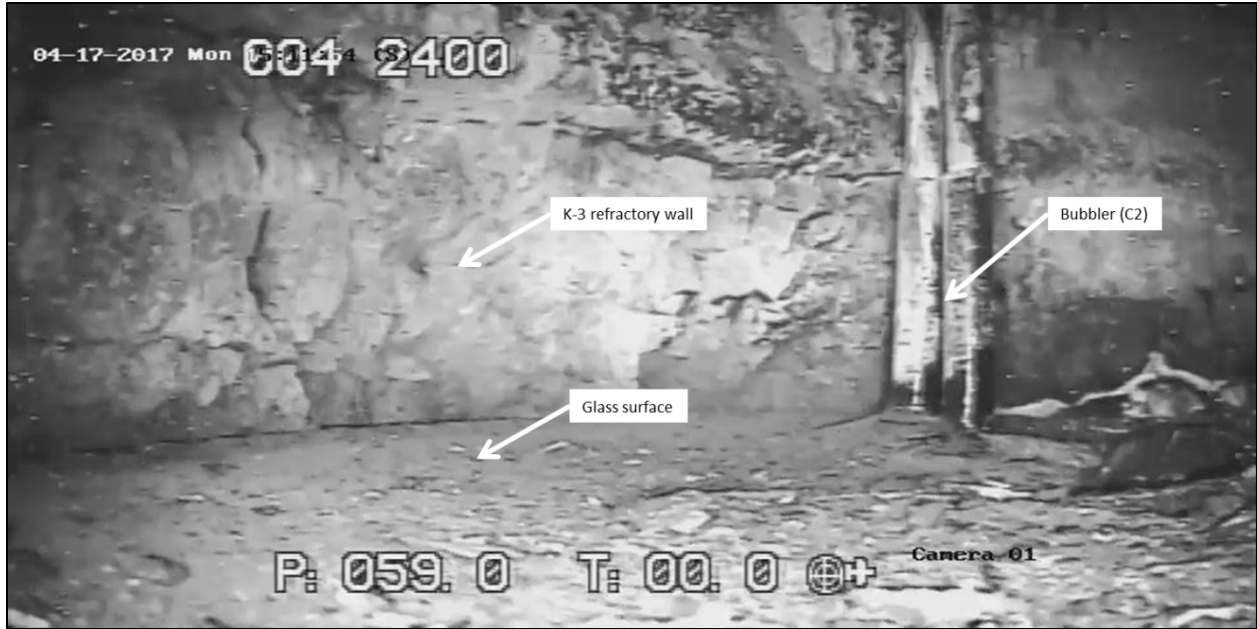
The condition of the glass contact refractory (Monofrax® K-3) at the melt line along the west side of melter is shown in Figure 5-33. The refractory appears to be undercut to some degree at the melt line. An estimate of the reduction in refractory thickness is difficult based solely on the visual inspection. Judging by the angular appearance of the refractory face, it appears that spalling has occurred.

Figure 5-33. Glass contact refractory at melt line, west side of melter

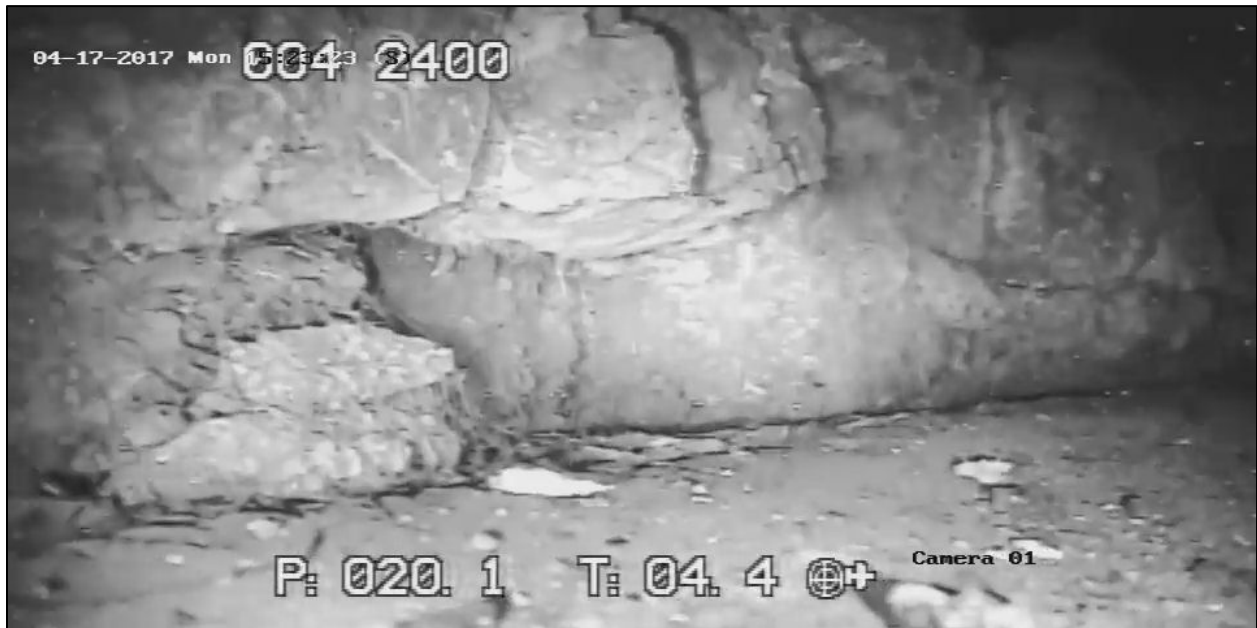
Figure 5-34 is a view of the glass contact refractory at the melt line in another area along the west side of the melter. Some of the refractory again appears to have spalled away. The degree of refractory spalling appears to be worse than what was observed in the Melter 1 inspection,² although the service life of Melter 2 was approximately double that of Melter 1. An accumulation of glass stringers (narrow filaments) is also visible.

Figure 5-34. Second view of glass contact refractory at melt line, west side of melter

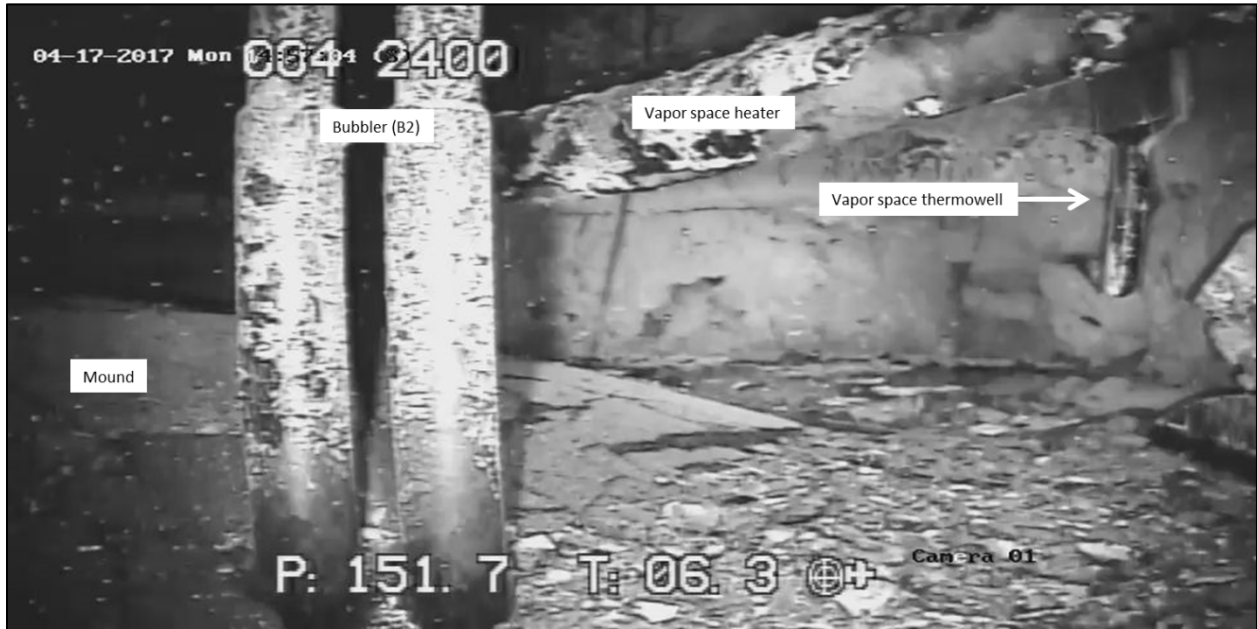
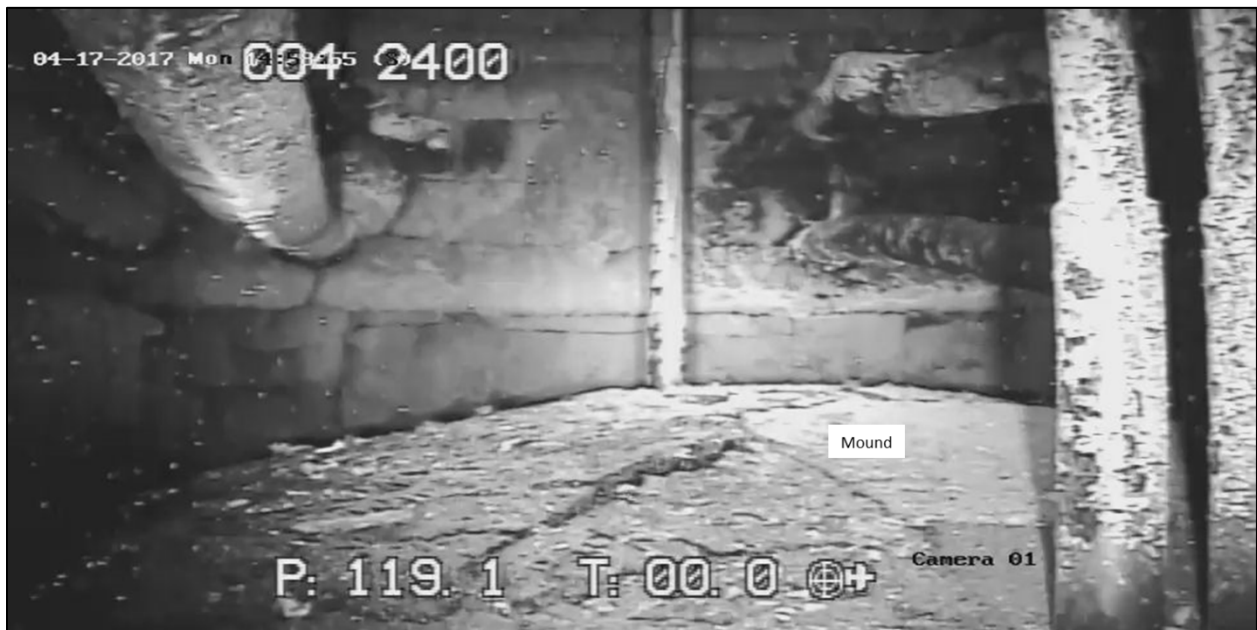
A mound of material at the center of the solidified melt pool was observed during the melter inspection, shown in Figure 5-35 and Figure 5-36. The cause of this mounding of material was not immediately apparent. The height of the mound was estimated to be twice the height of the exposed portion of the upper electrodes, about 6 inches.

Figure 5-35. Southeast edge of mound of material visible on glass pool

Figure 5-36. Mound of material at center of glass pool

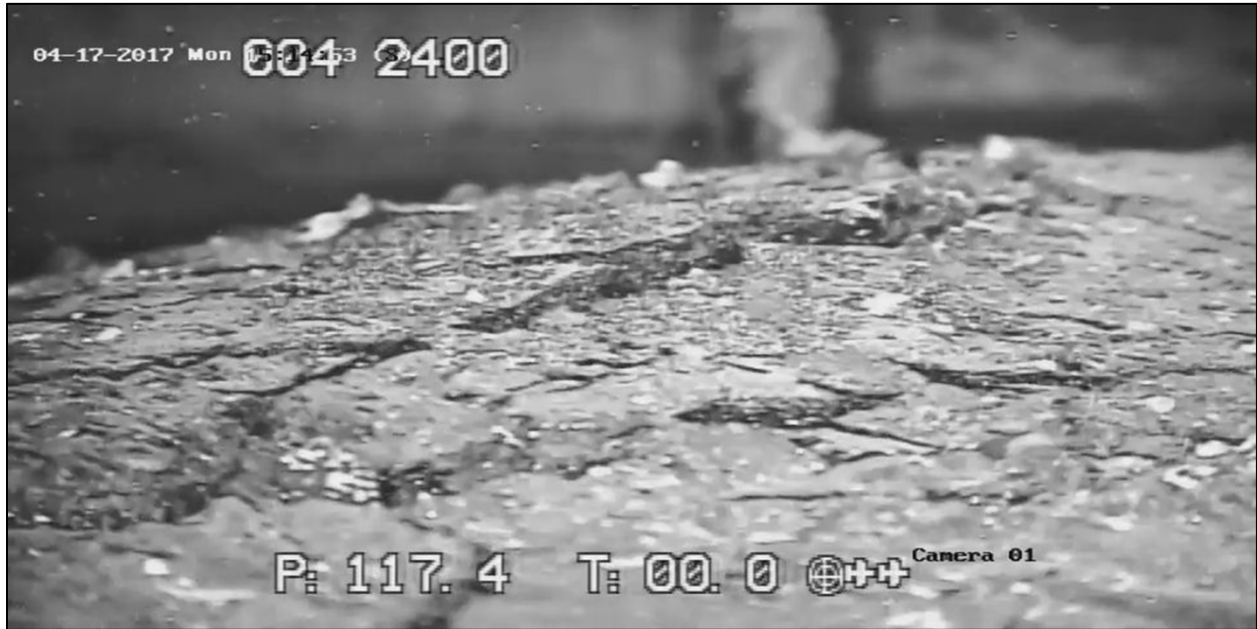
Upon closer inspection (Figure 5-37), it was postulated that the mound was composed of porous or “foamy” glass, a result of either the bubbling employed during cooling of the glass pool, the in-leakage of cooling water and subsequent steam generation at the L4 electrode stem, or both. It was also postulated that the mound could be unreacted feed material, although this was considered to be improbable due to the long idle period prior to melter shut down. Inspection of the fissures visible on the mound appeared to show either crystalline material or foamed glass. Observation was confounded by material that fell from the plenum refractory during cooling and settled on top of the solidified melt pool.

Figure 5-37. Fissures visible in mound of material
