Visual Inspection of Defense Waste Processing Facility Melter 2 Interior after End of Service

April 2018

SRNL-STI-2017-00428, Revision 0

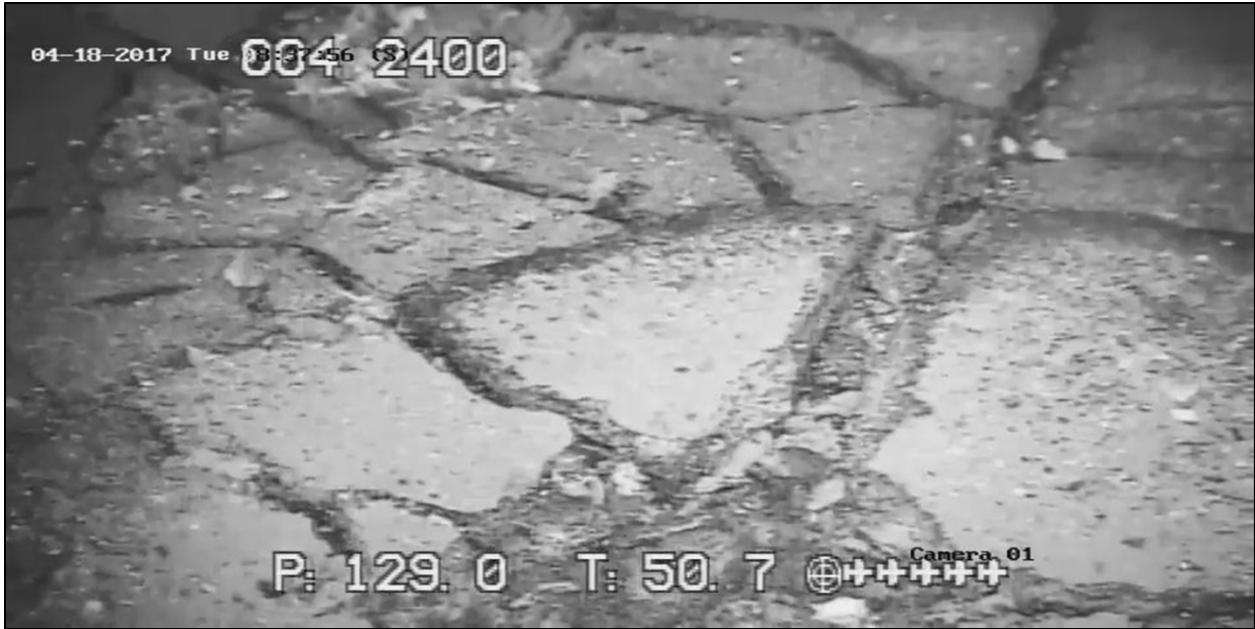
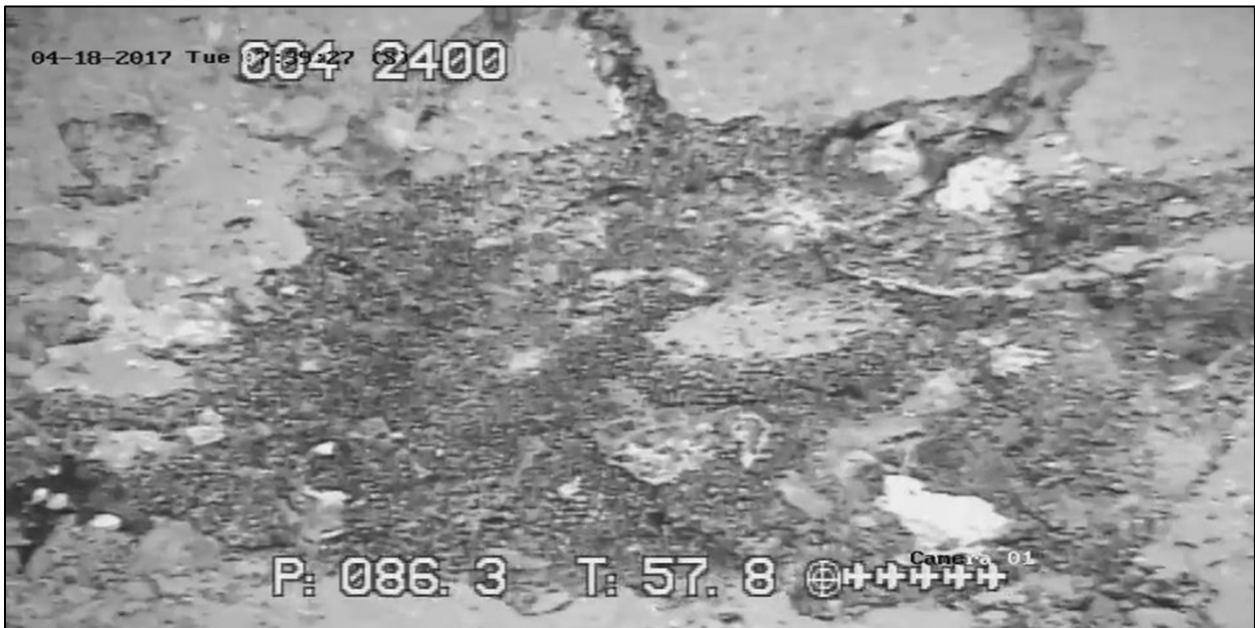
Figure 5-40 and Figure 5-41 are closer views of the area of the mound contacted by the glass pump. The surface of the mound appeared to have been broken into relatively large pieces. Inspection via the camera was determined to be insufficient for identifying whether the mound consisted of glassy or crystalline material. Therefore, a method for retrieving a sample of the mound material from the melter was developed and implemented, as described in Section 6.0.

Figure 5-40. Cracked material atop mound after contacting with glass pump through center nozzle

Figure 5-41. Closer view of cracked material atop mound

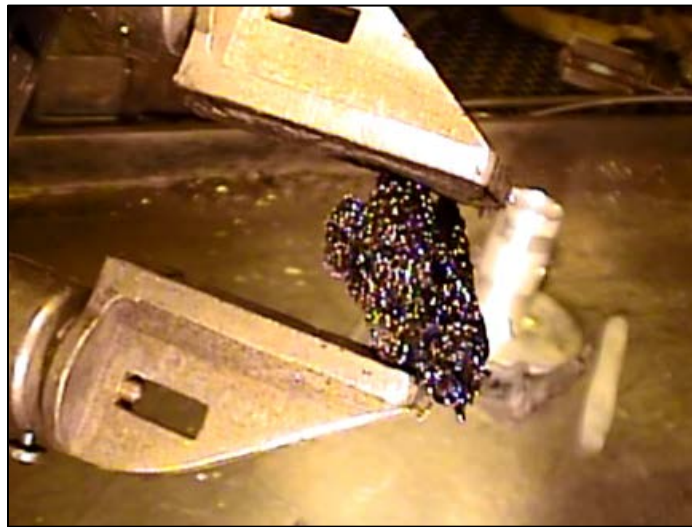
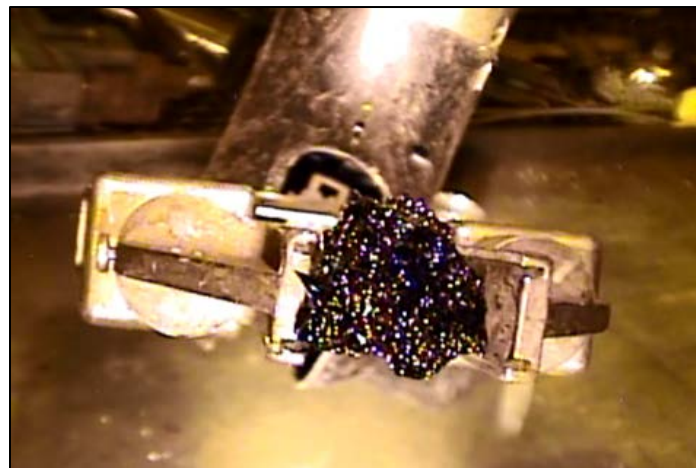
Two samplers were inserted and removed from the melter. Both were successful in retrieving samples of the mound material. The retrieved samples were inspected visually through the melt cell window and using the camera mounted to the tele-robotic manipulator. The samples appeared to be a porous or “foamy” glass, as shown in Figure 6-1 and Figure 6-2. The glass was black and shiny. No crystalline material or unreacted feed was observed.

Figure 6-1. Foamy glass retrieved from mound in Melter 2

Figure 6-2. Alternate view of foamy glass retrieved from mound in Melter 2

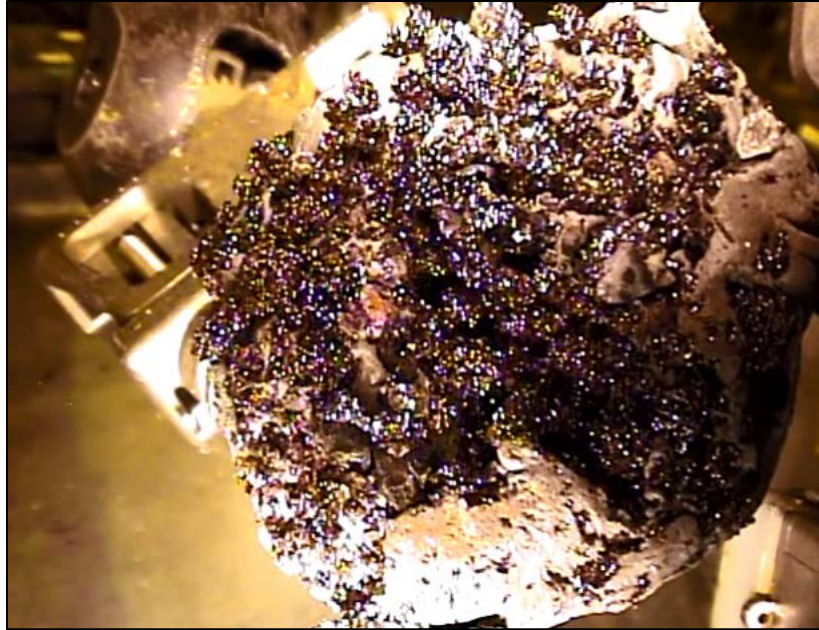
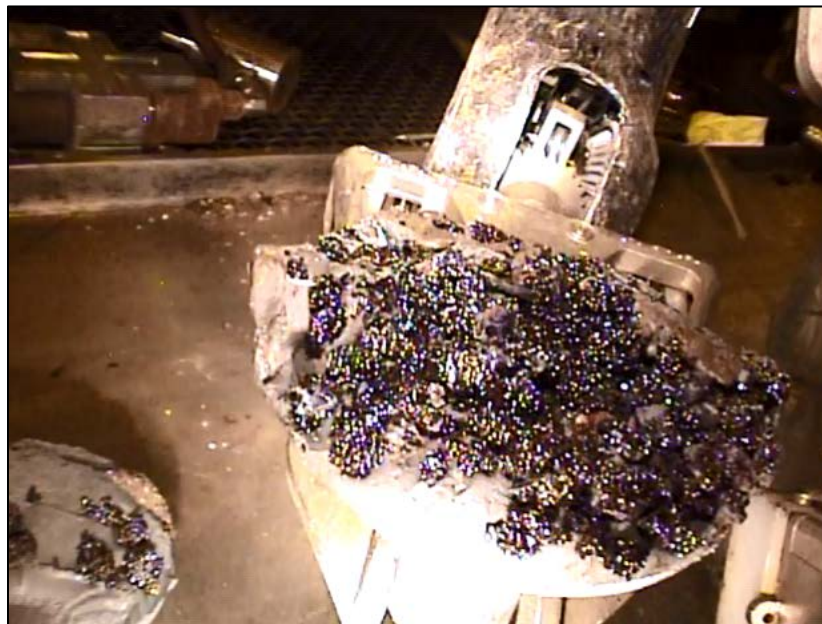
Images of the first sampler are shown in Figure 6-3 and Figure 6-4. All of the material collected appeared to be black, shiny, porous glass. Similar foamy glass was generated in the past during stirred melter testing via rapid gas evolution in the glass pool, an example of which is shown in Figure 6-5.

Figure 6-3. First sampler with glass collected from mound

Figure 6-4. Alternate view of first sampler with glass collected from mound

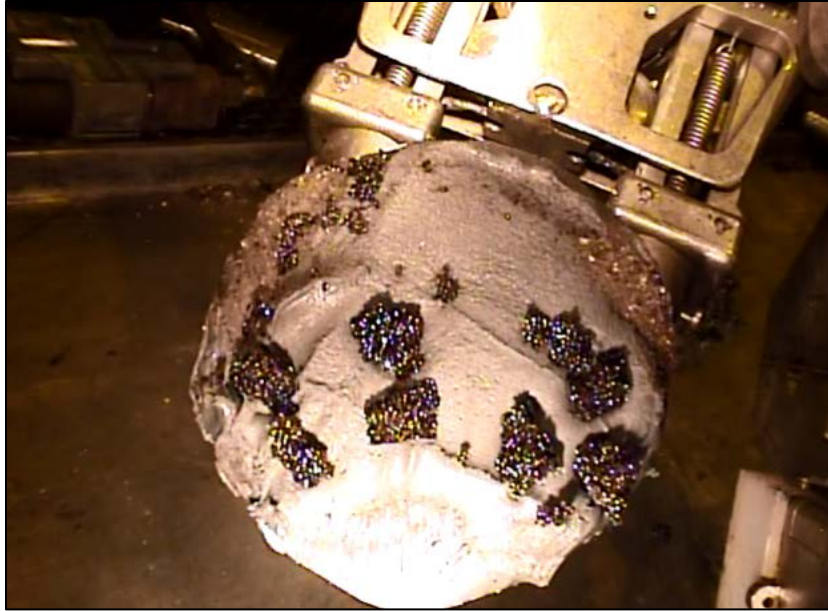
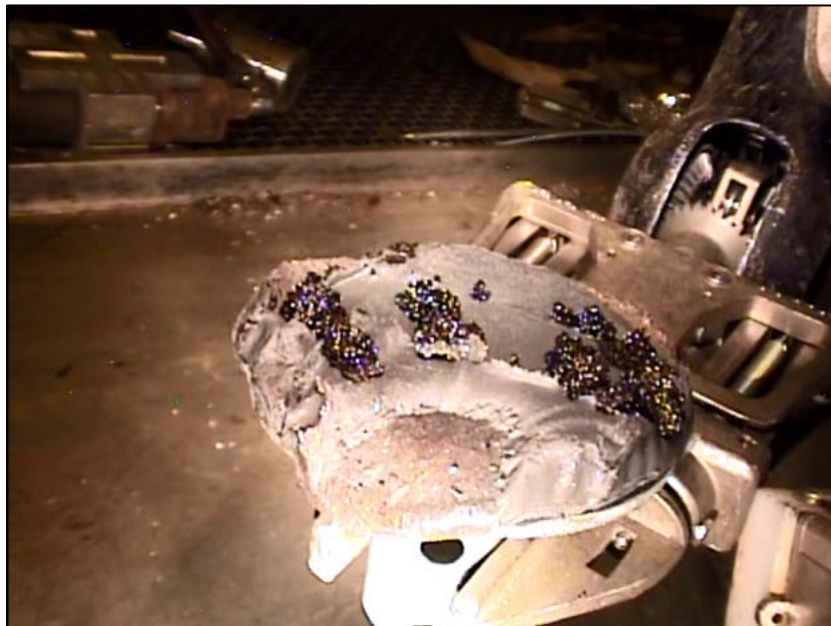
Images of the second sampler are shown in Figure 6-6 and Figure 6-7. Again, all of the material collected appeared to be black, shiny, porous glass. None of the material collected appeared to be crystalline or unreacted feed. Some of the collected material was placed into sample container PC0129 for further analyses, if needed at a later date.

Figure 6-6. Second sampler with glass collected from mound

Figure 6-7. Alternate view of second sampler with glass collected from mound

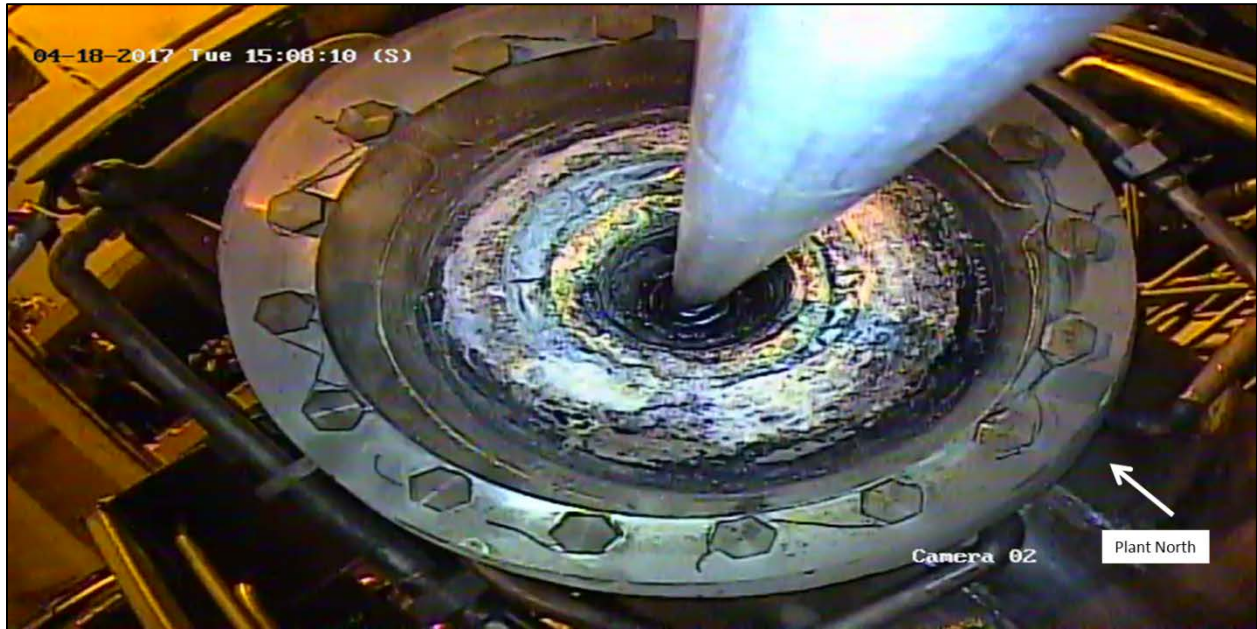
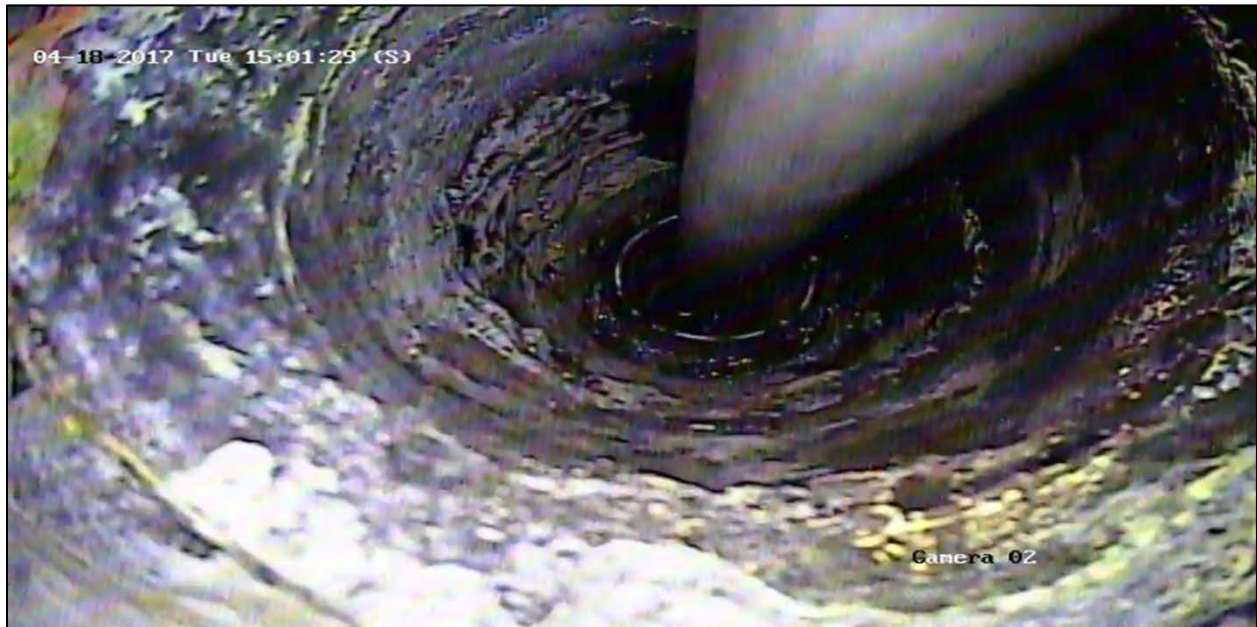
Visual evaluation of the condition of the riser and pour spout glass pour over point was not feasible due to poor imaging with the camera. For future inspections, the focal length of cameras used for this type of inspection will need to be reduced. The tele-robotic manipulator camera captured images of the lower portion of the pour spout, as shown in Figure 7-1. Portions of the removable insert, or glass disengagement point, were visible upon closer inspection (Figure 7-2). This region of the pour spout appeared to have remained in better condition compared to similar observations of Melter 1. This may be because of the

Figure 7-1. View of pour spout looking up toward top of melt cell with inspection camera system inserted

Figure 7-2. Closer view of pour spout showing region of removable insert with inspection camera system inserted
