# Evaluating All-Metal Valves for Use in a Tritium Environment

September 2017

SRNL-STI-2017-00516, Revision 0

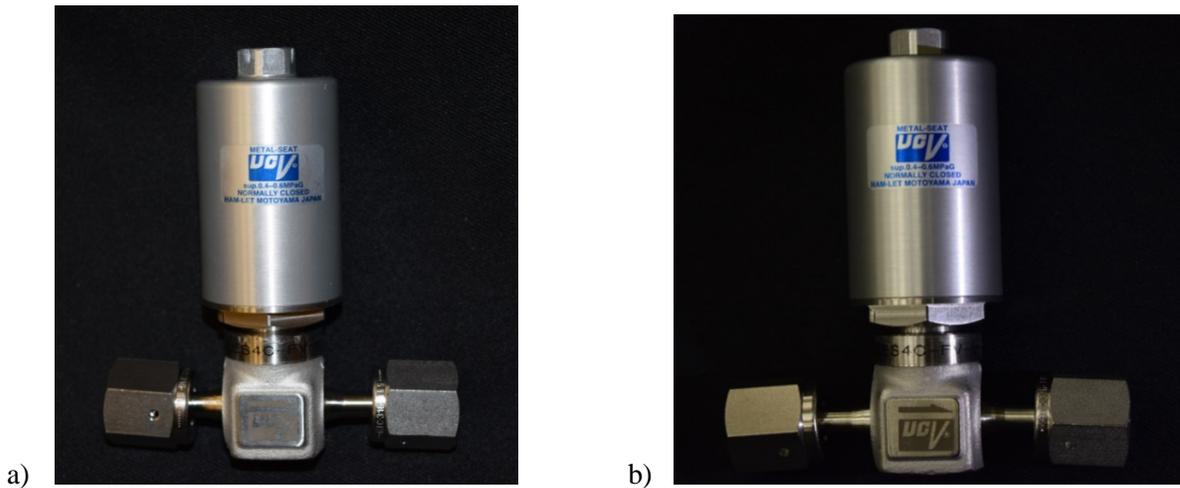
**Figure 3-2. Photos of Valves after Pressure Tests a) V01, Pressure on the Inlet b) V04, Pressure on the Outlet**

Examination of the valves after pressure testing, showed no obvious exterior damage Figure 3-2. One of the pressure tested valves was radiographed to determine whether any damage occurred internally. Radiographs (Figure 3-3) of the “as received” valve (a) and the pressure tested valve (b) show the asymmetry of the valve and do not reveal damage from pressure testing. This lack of symmetry is likely the source of the significant differences in the inlet or outlet pressures needed to cause the valve to leak.

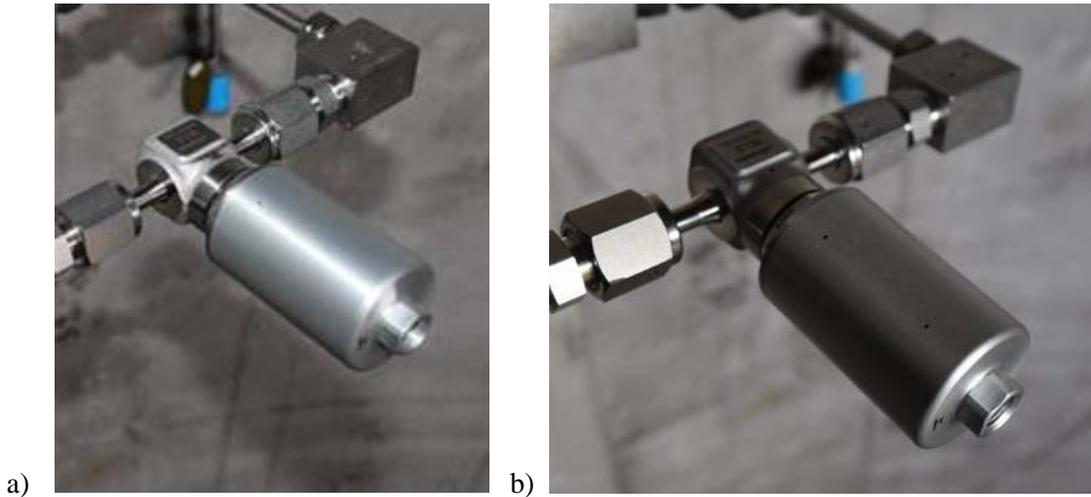
**Figure 3-6. Burst Photographs a) Pre-Burst Test b) Post-Burst Test**

Photographs of the burst tested valve, Figure 3-6, revealed no exterior damage.

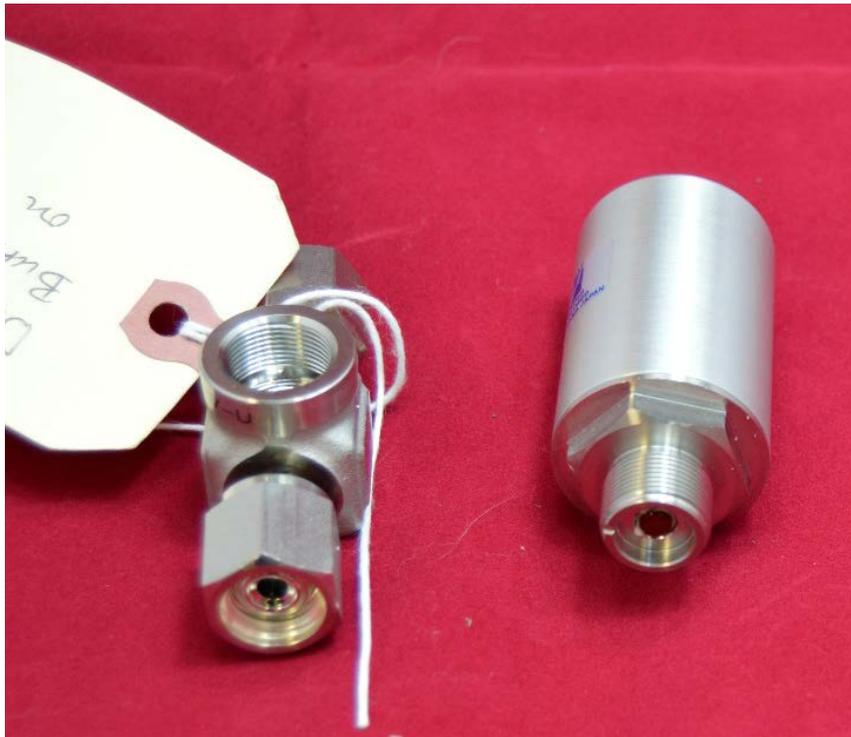
**Figure 3-7. Photographs of Burst Tested Valve Body and Actuator**

The valve was then taken apart to inspect for damage to inner components. Photographs of the body and actuator, Figure 3-7, reveals no exterior damage. Further investigation of the body components revealed damage to the diaphragms, Figure 3-8 and Figure 3-9.

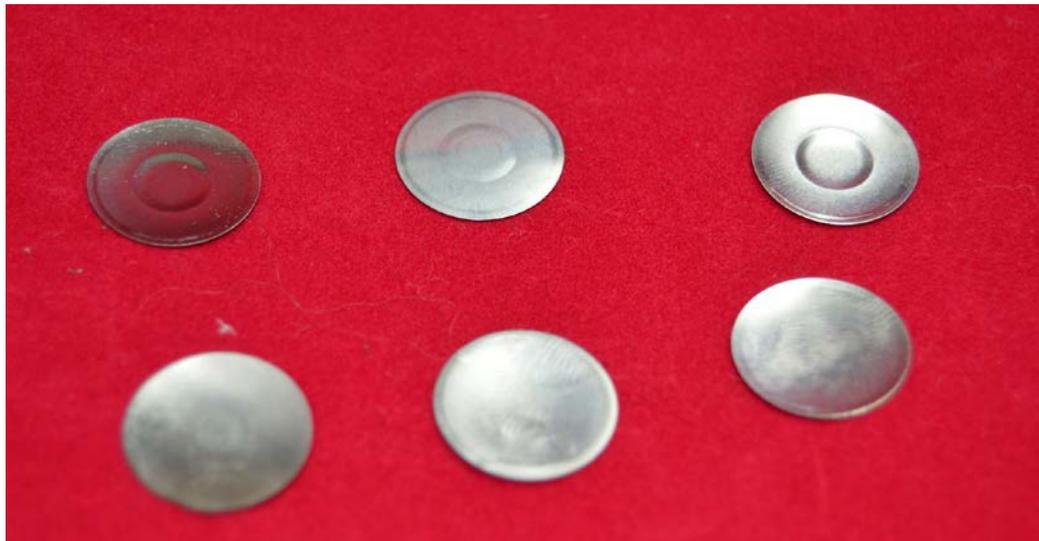
**Figure 3-9. Photograph Comparing the Burst Tested Diaphragm (top) to the Pressure Tested Diaphragm (bottom)**

Comparison of the burst test valve diaphragms (top) to diaphragms from a pressure tested valve (bottom) shows clear dimpling, Figure 3-9.

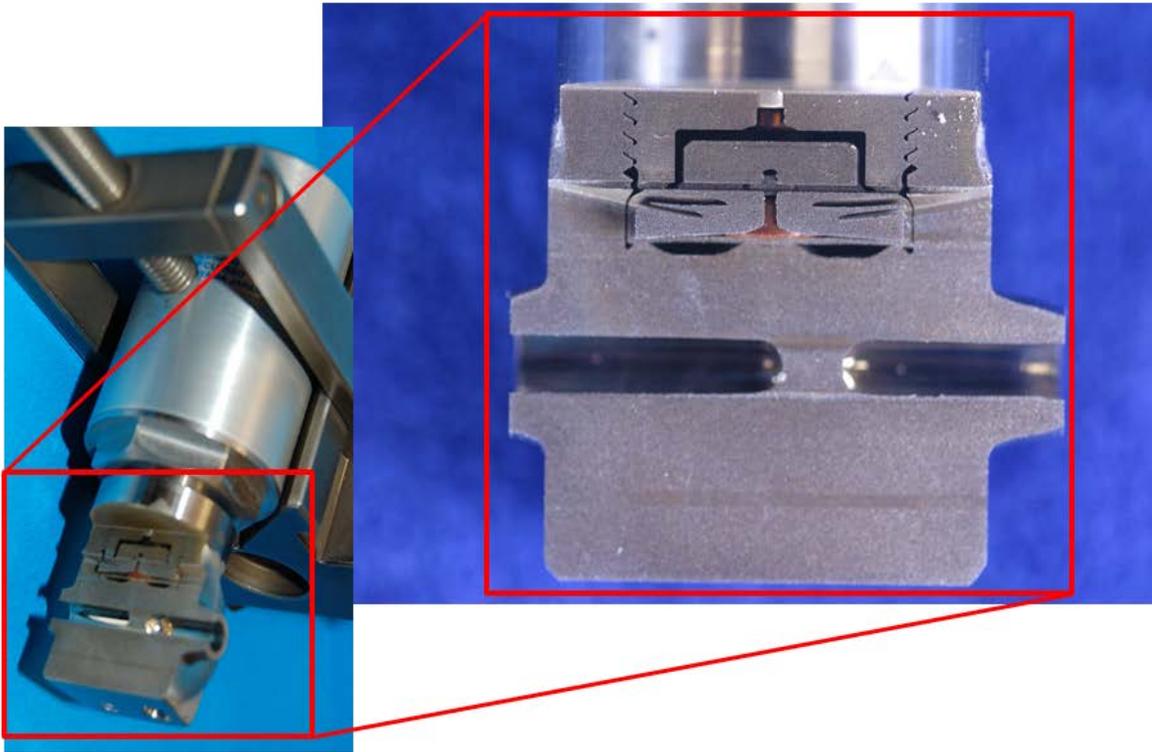
**Figure 3-12. EDM Valve along with a detailed image of the cross section of the body**

Difficulty during Electrical Discharge Machining (EDM) of the valve indicated the possible presence of a non-conductive component [10]. Examination of the cut valve, Figure 3-12, revealed a small dark orange/brown disk.

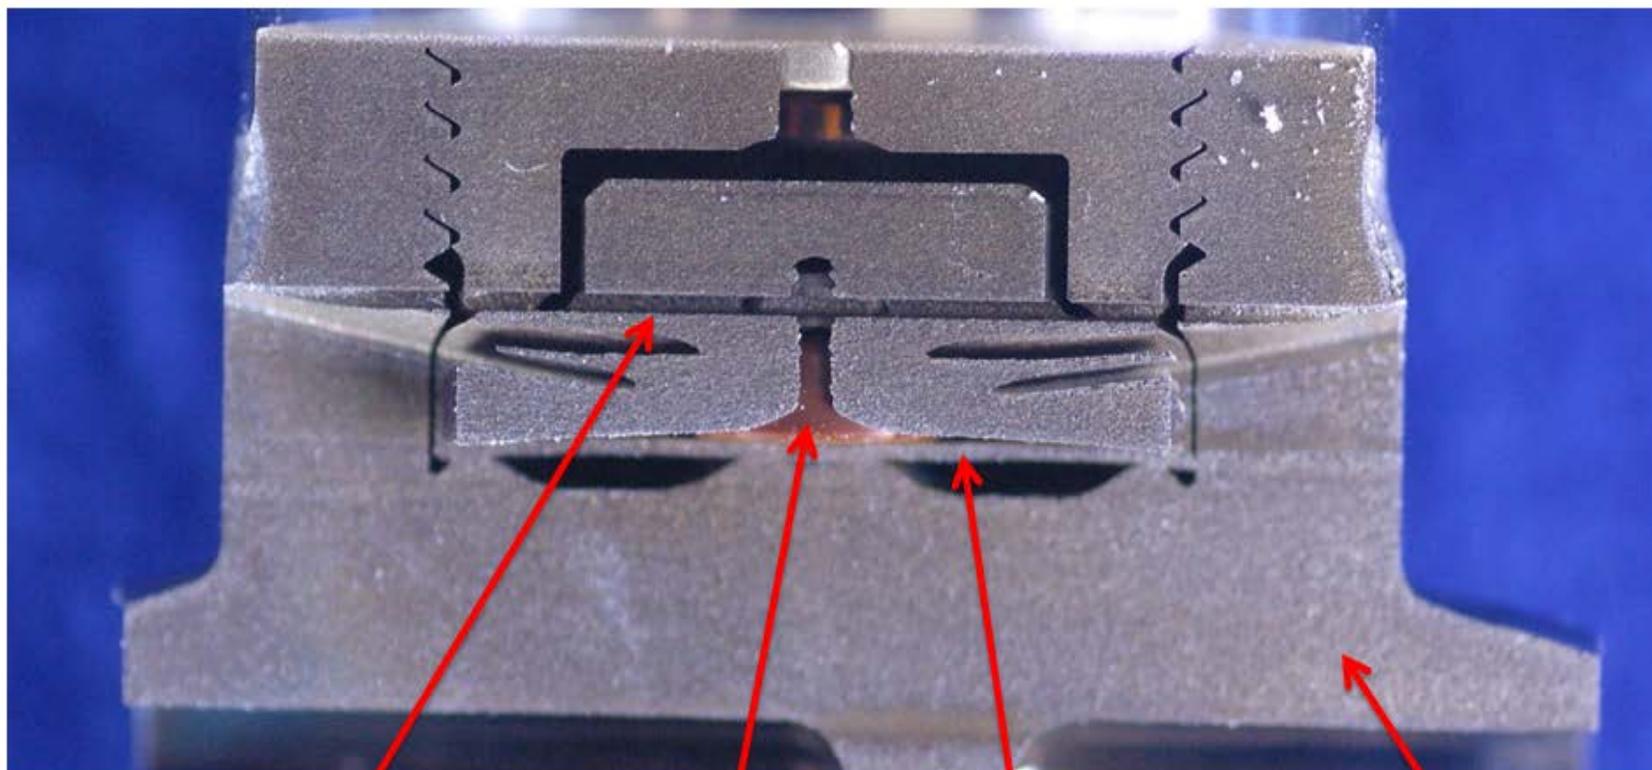
**Figure 3-13. Detailed cross sectional image of valve body with main parts labeled and materials identified.**

A closer look at the cross section of the body is given in Figure 3-13. The dark orange disk is easily seen. The Actuator Button Set rests between the Diaphragm, part 2 and the Actuator Button Holder, part 4. A different perspective, Figure 3-14, is of the same region as Figure 3-13, but was taken with an optical microscope.

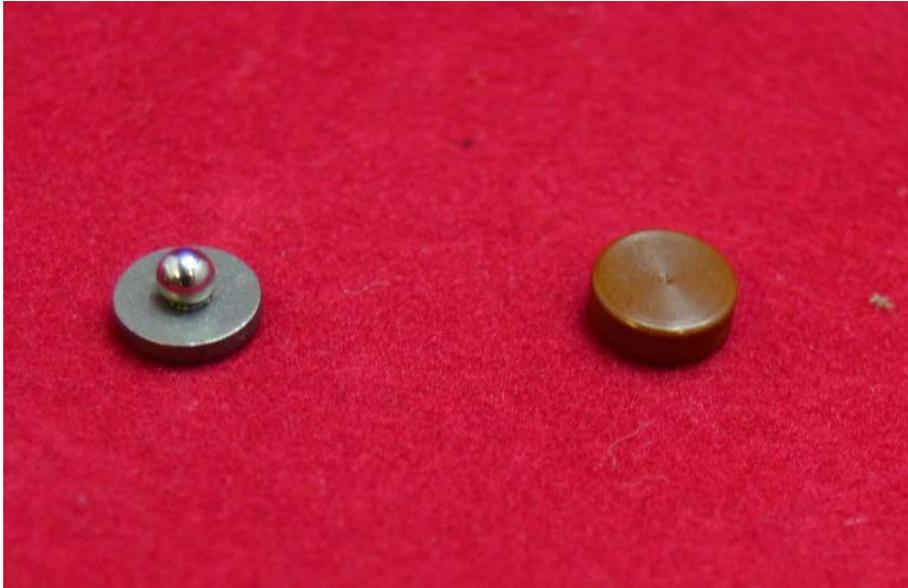
**Figure 3-15. The two components of the Actuator Button Set, on the left is the top part of the set (closer to the actuator) and the right is the bottom part of the set (closer to the diaphragm)**

The images from the camera and optical microscope make it clear that both materials of Actuator Button Set are not the same material. To investigate further, a different valve was disassembled, Figure 3-15.

From the SEM with EDS and ATR-FTIR, the Actuator Button Set is comprised of two materials, contradicting the specifications in the Ham-Let catalog. The top button is a metal, suspected to be 304L Stainless Steel, and the bottom button is a polymer, belonging to the polyimide family.

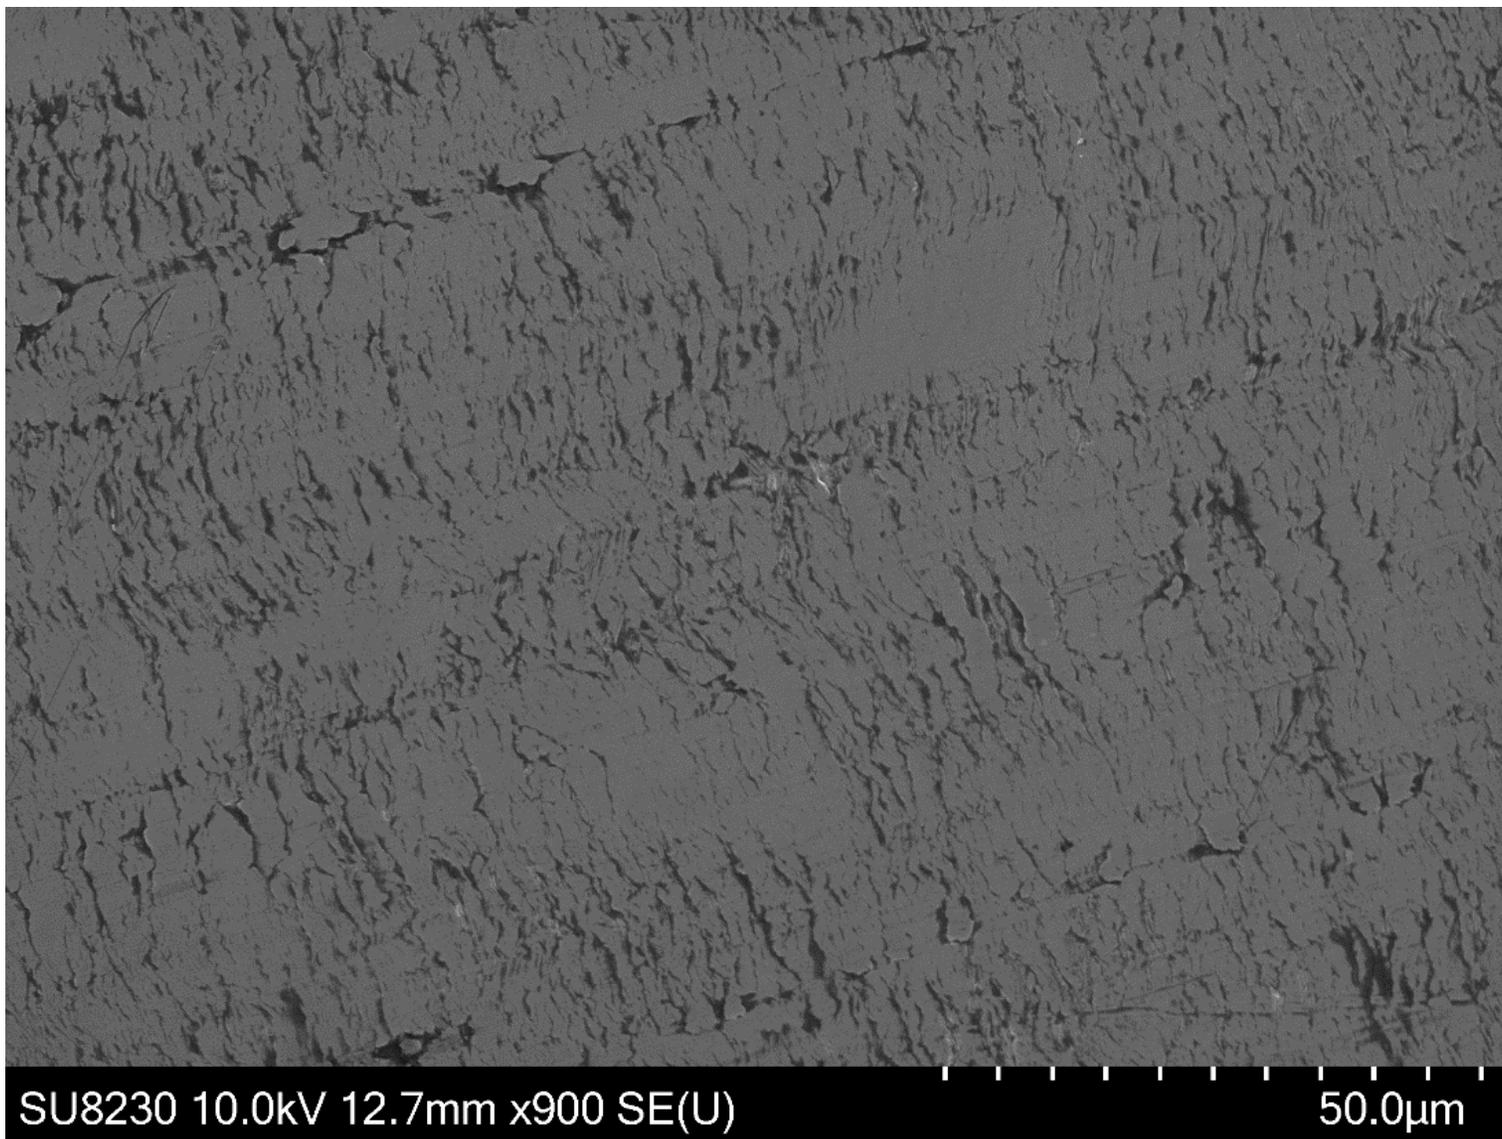
Figure 3-24. Low Resolution SEM Image of Diaphragm

SEM images were also obtained to analyze the surface of the diaphragm. As shown in Figure 3-24, the surface appears somewhat rough with cracks all over. A higher resolution image of the diaphragm is given in Figure 3-25. A cross sectional image of the diaphragm that was cut by EDM was also viewed in the SEM, Figure 3-26.

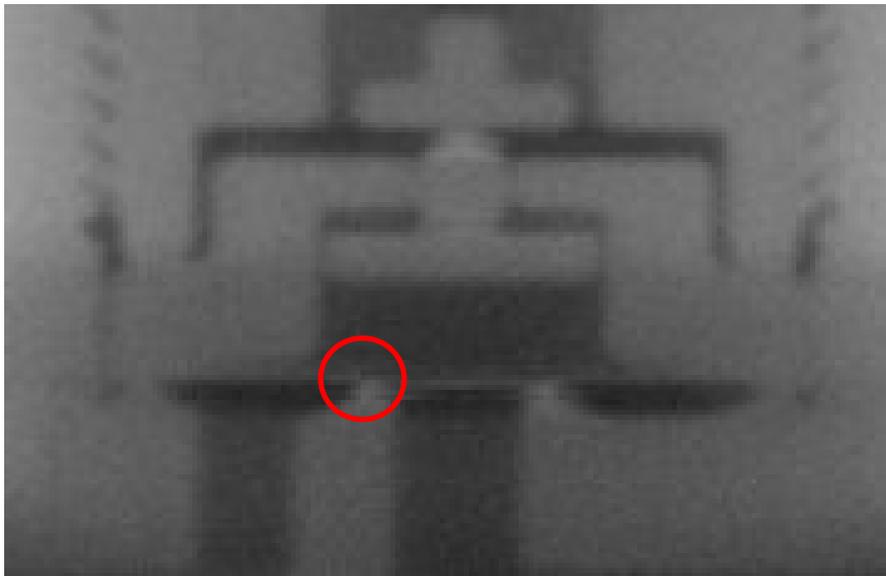
**Figure 3-27. Possible Damage to Diaphragm in Radiographed Image**

Although TV01 failed leak testing at 20,000 cycles, testing continued until it had been cycled for 150,000 times. At that point, the valve was radiographed to see if any failure mechanisms could be observed. The additional cycling was conducted to help accentuate any faults that may have caused the valve to fail. While inconclusive, it appears that there could be a small gap at the entrance of the inlet at the diaphragm, in Figure 3-27.

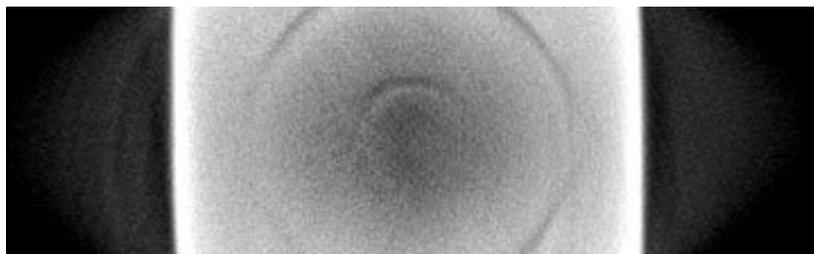
**Figure 3-28. Top-Down View of Radiographed Image of Damaged Valve**

Viewing the diaphragm from the top-down, Figure 3-28, also shows an irregularity at the center of the diaphragm. The diaphragm may be slightly deformed due to particulate contamination or it could be an artifact from imaging. The polyimide Actuator Button Set, directly above the diaphragm, is not visible with X-Ray imaging.

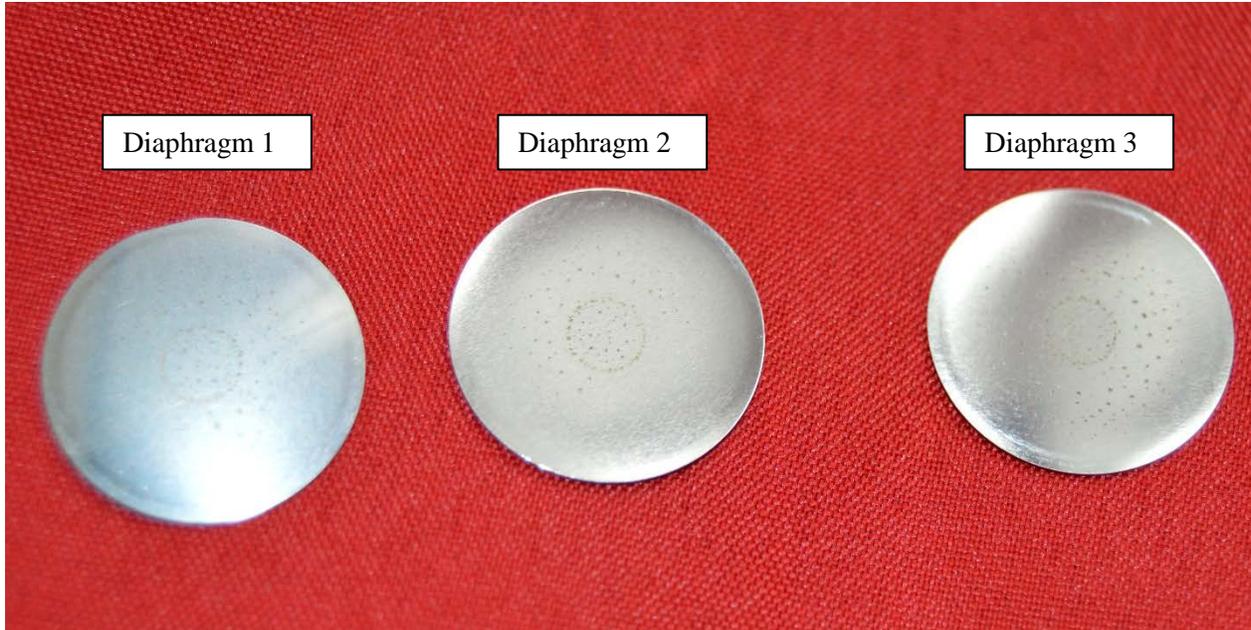
**Figure 3-29. Spots on Actuator Facing Side of Diaphragms from TV01**

After TV01 was radiographed, the valve was disassembled. Figure 3-29 shows the actuator facing side of all three diaphragms (from left: wetted, middle, actuator). Spots and/or divots were observed on one side of all of the diaphragms as was a slight irregularity in the wetted diaphragm, Diaphragm 1. Only the middle diaphragm, Diaphragm 2 had the markings on both sides, Figure 3-30 shows the diaphragms that face towards the fluid. Figure 3-31 is a closer view of Diaphragm 2. The source of these spots or divots is unknown; they were not detected in pressure and burst tested valves that were not cycled. Disassembly of other cycled valves may provide additional insight.
