DESTRUCTIVE EXAMINATION OF SHIPPING PACKAGE 9975- 02644

W. L. Daugherty

October 2017

SRNL-STI-2017-00666, Revision 0

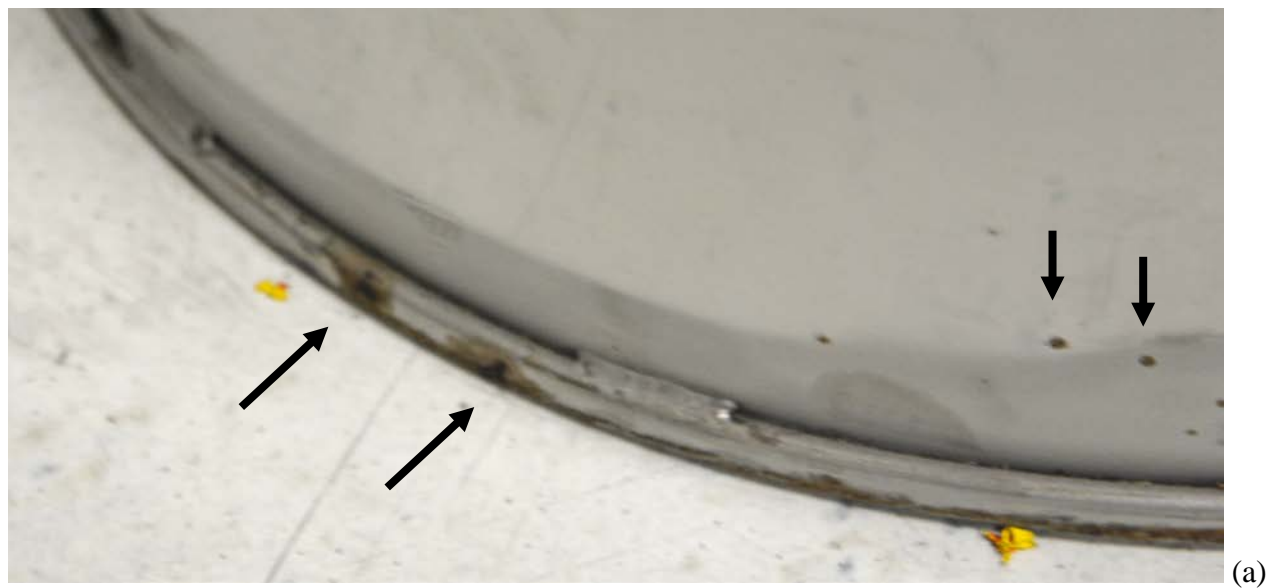
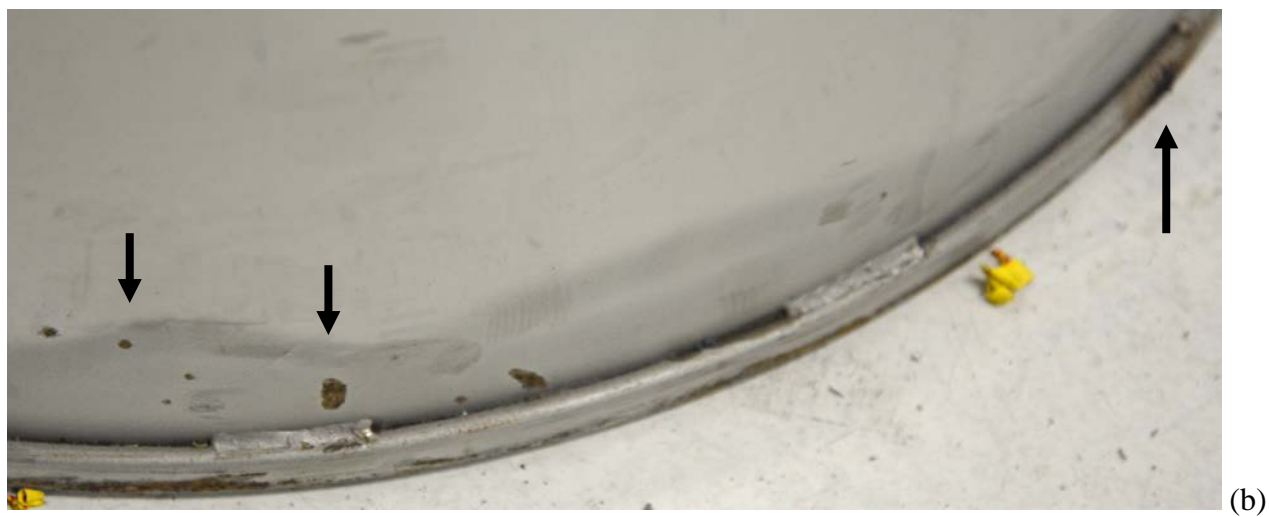
Figure 1. Corrosion observed along the bottom lip of the drum during field surveillance. Photographs taken by KAC personnel.

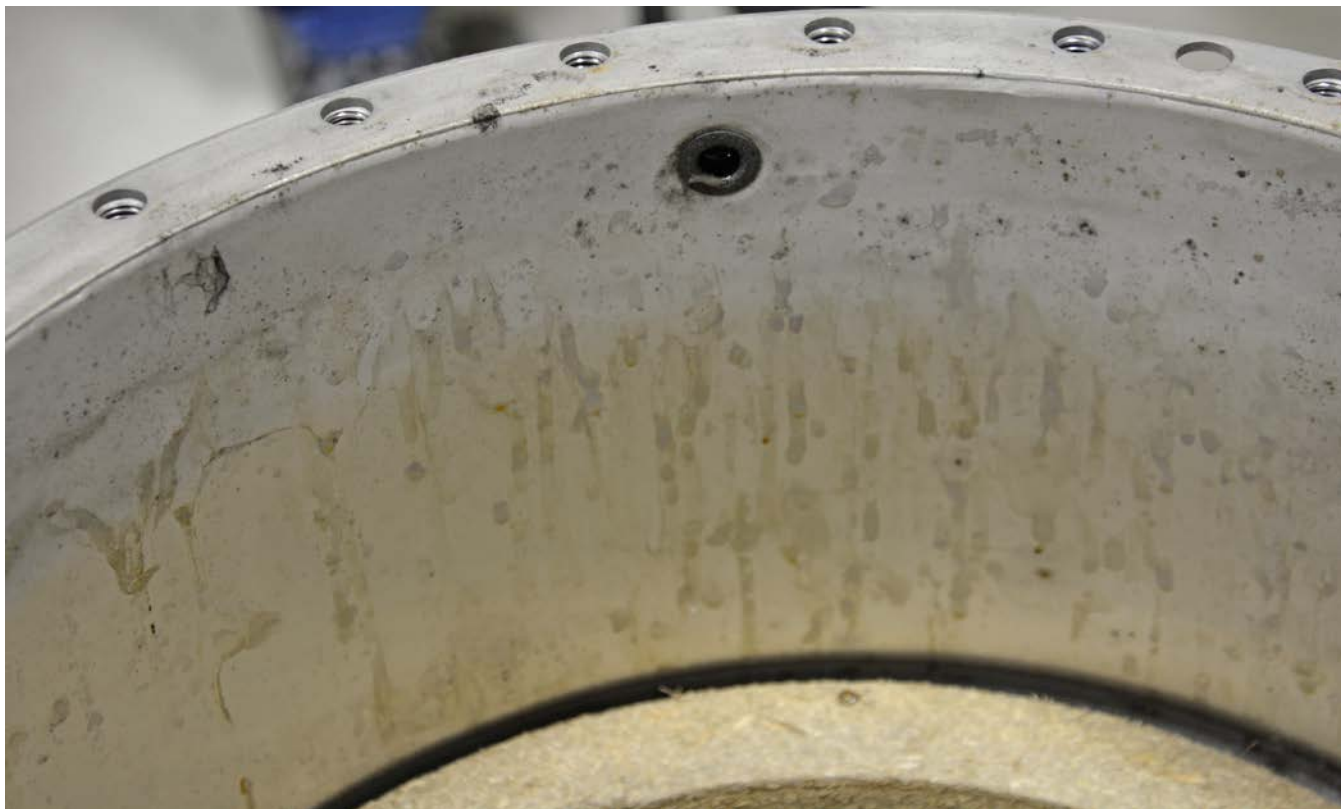
- The exposed height of the lead shield was greater than the 4.65 inch maximum criterion.
- The difference between the upper assembly inside height and the exposed height of the lead shield was less than the 0.425 inch minimum criterion.
- The axial gap (1.389 inch) exceeded the 1 inch maximum criterion.
- Although the surveillance report noted as satisfactory that the drum was free from corrosion, photographs taken at the time show small spots of corrosion along the bottom lip of the drum (Figure 1). In addition, photographs of the drum interior show water stains along with areas that were later identified as light corrosion (Figure 2).

Figure 2. Staining on the drum interior with areas that were later identified as light corrosion. Photograph taken by KAC personnel during field surveillance.

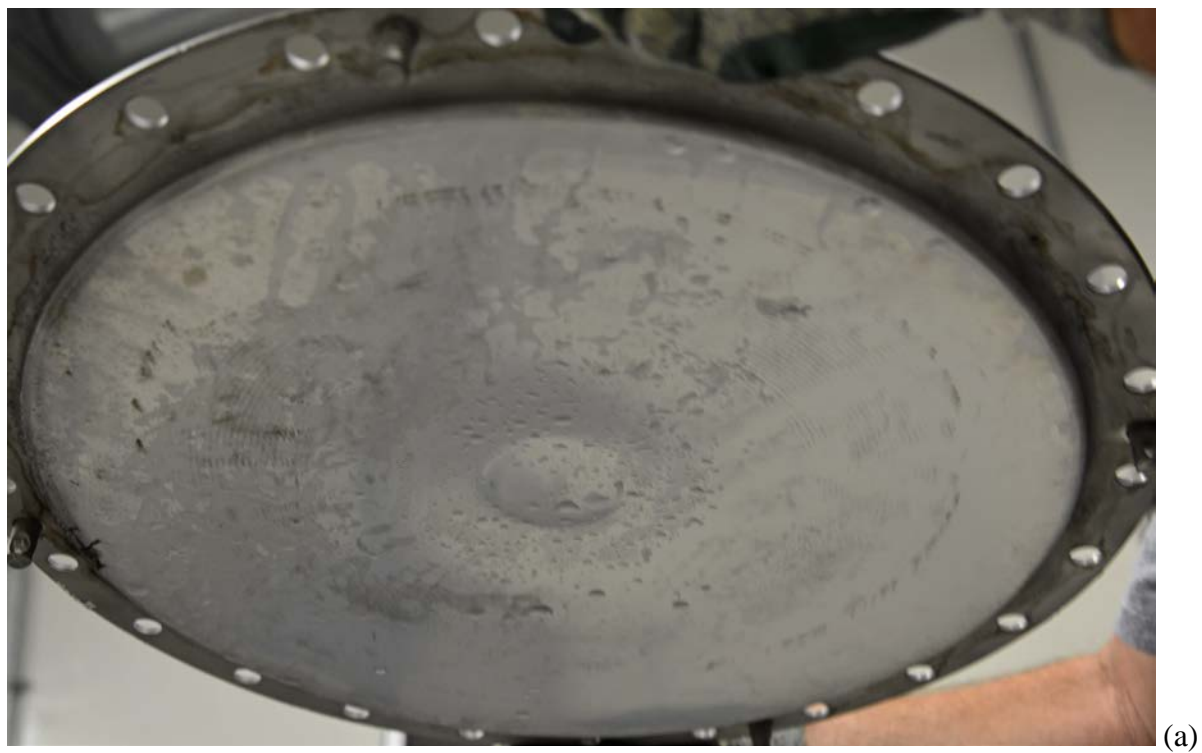
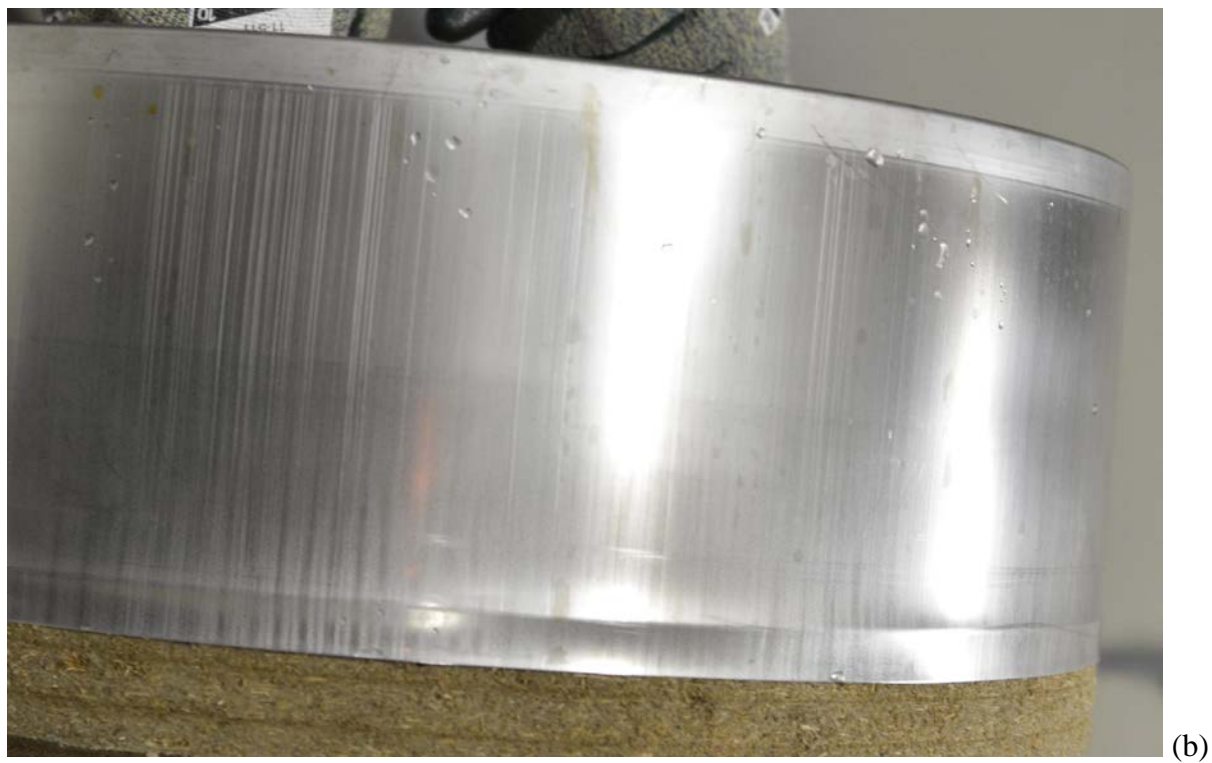
It was also noted during field surveillance that water droplets were present on the underside of the drum lid (Figure 3a) and on top of the thermal blanket. In addition, field surveillance photographs show water on the side of the upper assembly air shield (Figure 3b). Condensation can occur in these areas after a package is moved from its warm storage location to a cooler room if the package contains elevated moisture levels. Elevated moisture levels can result from fiberboard degradation (water is a by-product of cellulose decomposition) or higher-than-average moisture could have been present when the package was first assembled.

Figure 3. Water droplets on the underside of the lid (a) and on the side of the air shield (b). Photographs taken by KAC personnel during field surveillance.

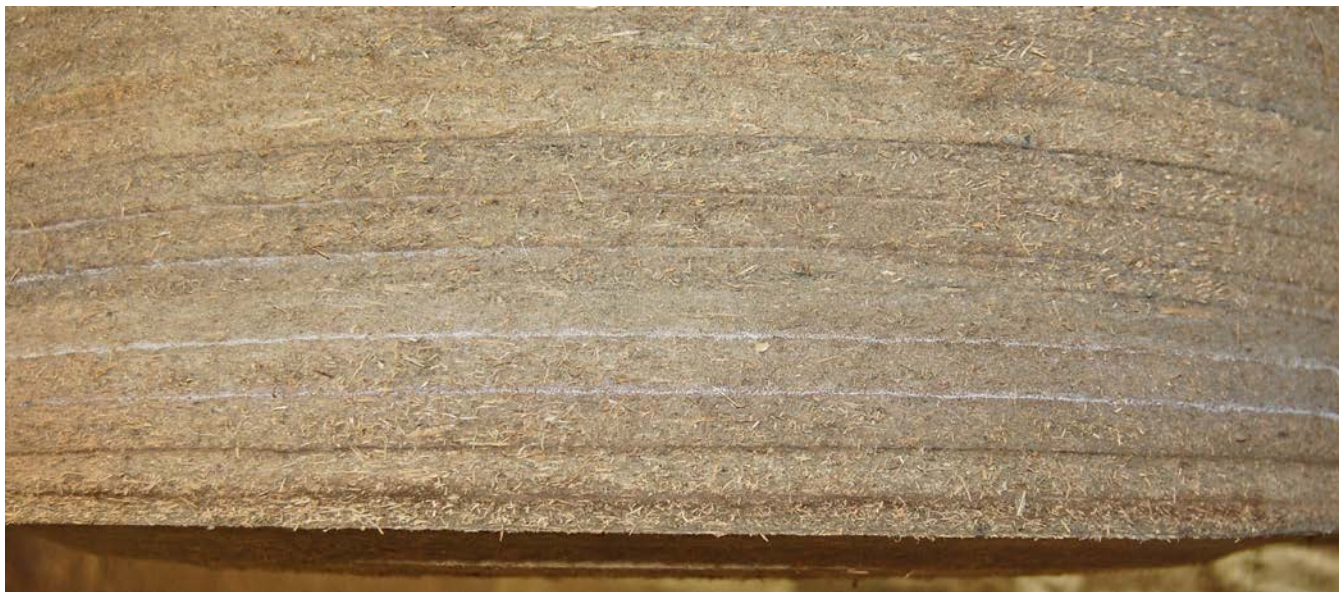
A musty odor was noted when the lower fiberboard subassembly was removed and sectioned. Mold was observed near the bottom of the lower fiberboard subassembly, primarily along the glue joints (Figure 4). However, the mold generally appeared to be dormant, as evidenced by a lack of filaments and spore sacs on the surface. The bottom of the lower fiberboard subassembly contained a step, resulting from compaction against the step in the bottom of the drum (Figure 5). Inboard of the step, the bottom surface of the fiberboard is partially compressed in a ring about 2 inches wide, indicating this region was in partial contact with the drum bottom. Near this step (and generally within the 2 inch ring of partial contact) a water stain was observed, indicating the extent of penetration by liquid water (condensation on the top and sides of the drum, which ran down the sides to the bottom).

Figure 4. Mold on the side of the lower fiberboard subassembly, primarily visible as white lines along the glue joints.

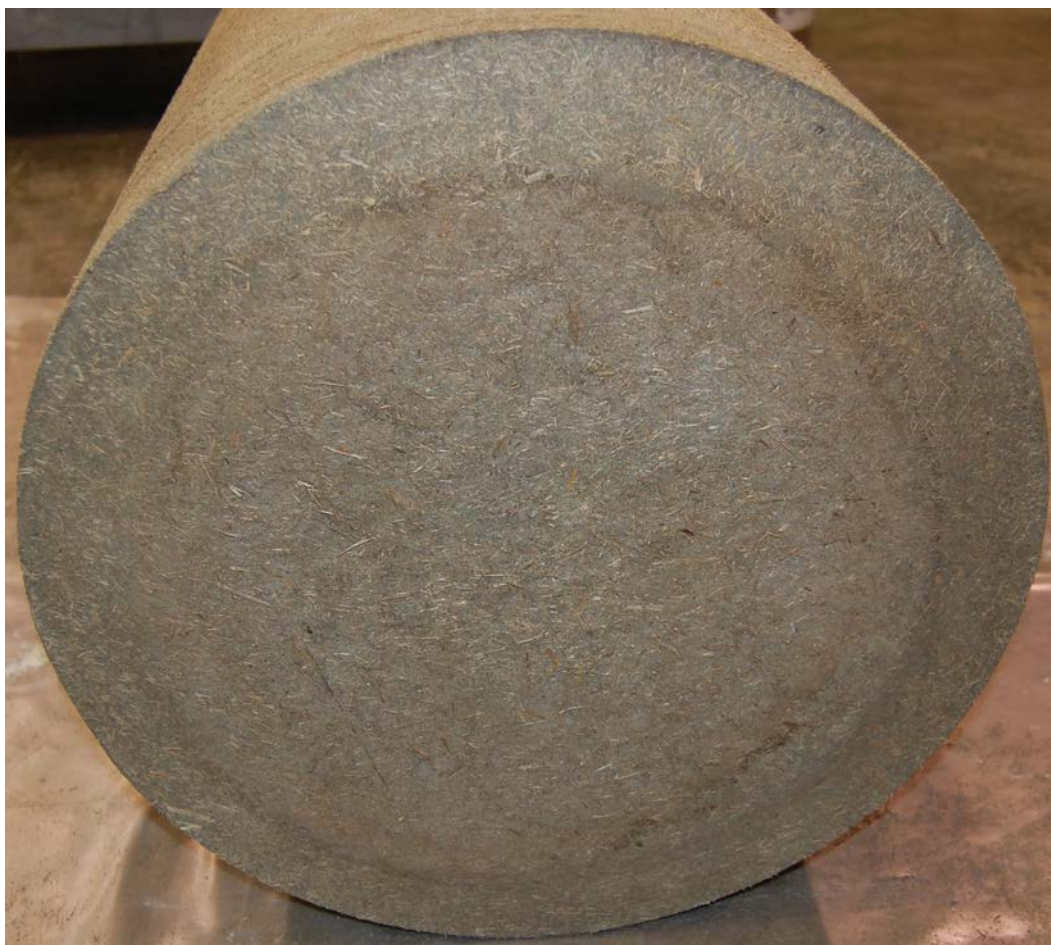
Figure 5. Dark staining (water marks) on the bottom of the lower fiberboard subassembly. In addition, an impression of the step on the bottom of the drum is visible.

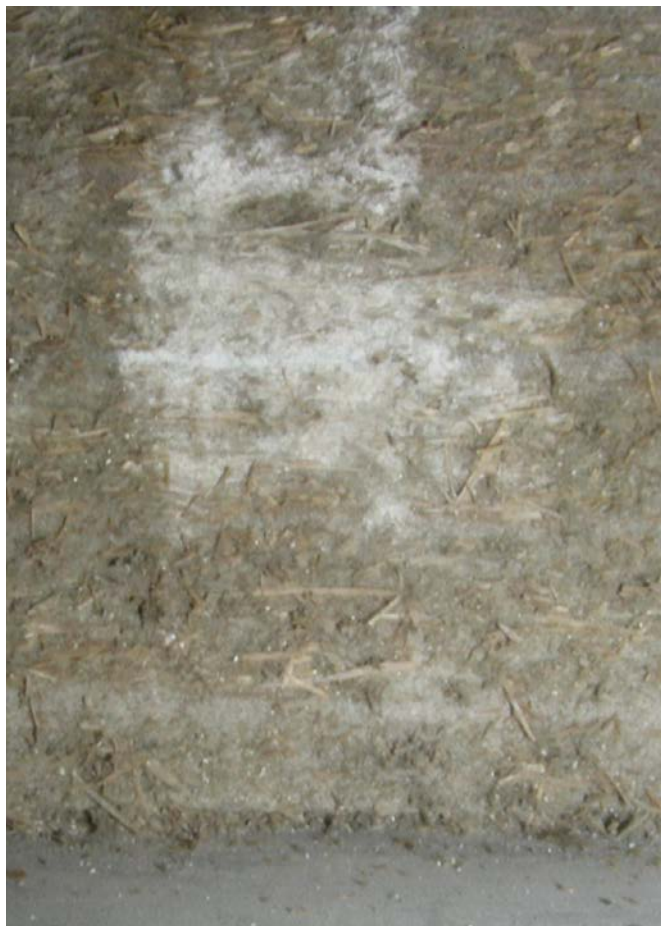
Figure 6. ID surface of the lower fiberboard subassembly immediately adjacent to a rectangular feature near the bottom of the lead shield, at about 90 degrees orientation.

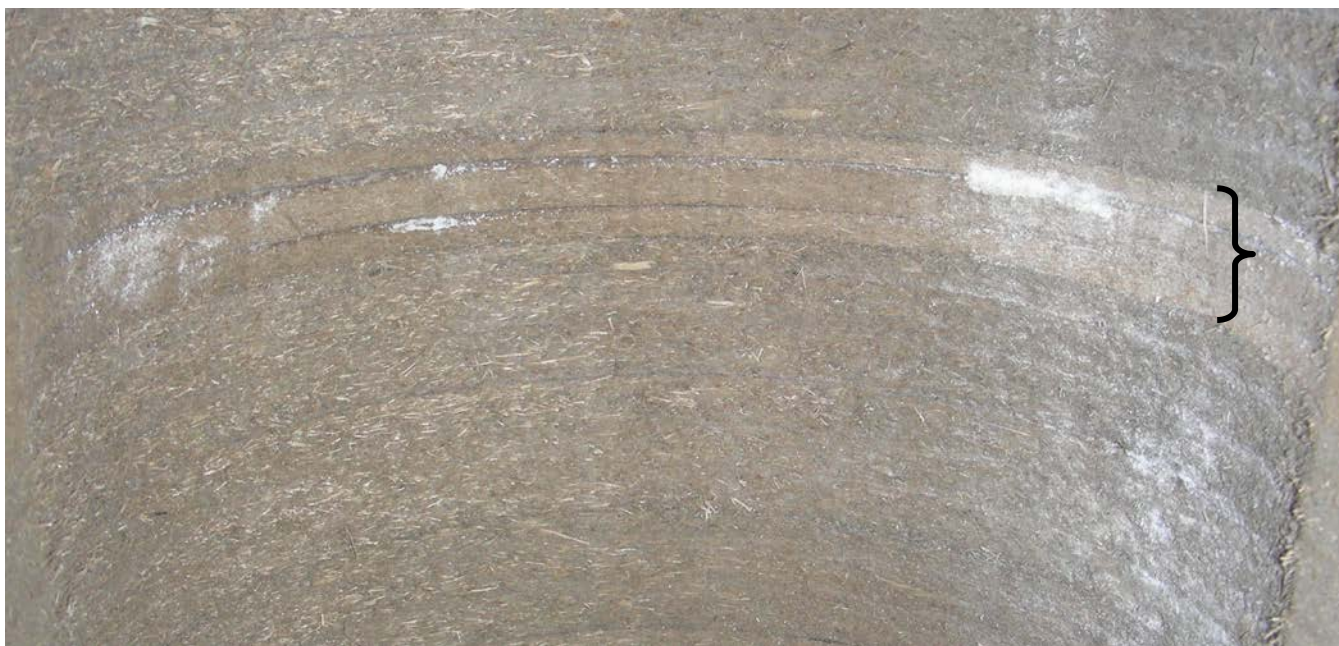
Figure 7. ID surface of the lower fiberboard subassembly at about mid-height. The identified band of 3 fiberboard layers has some of the heavier deposits of lead carbonate from the shield at about 315 degrees orientation.

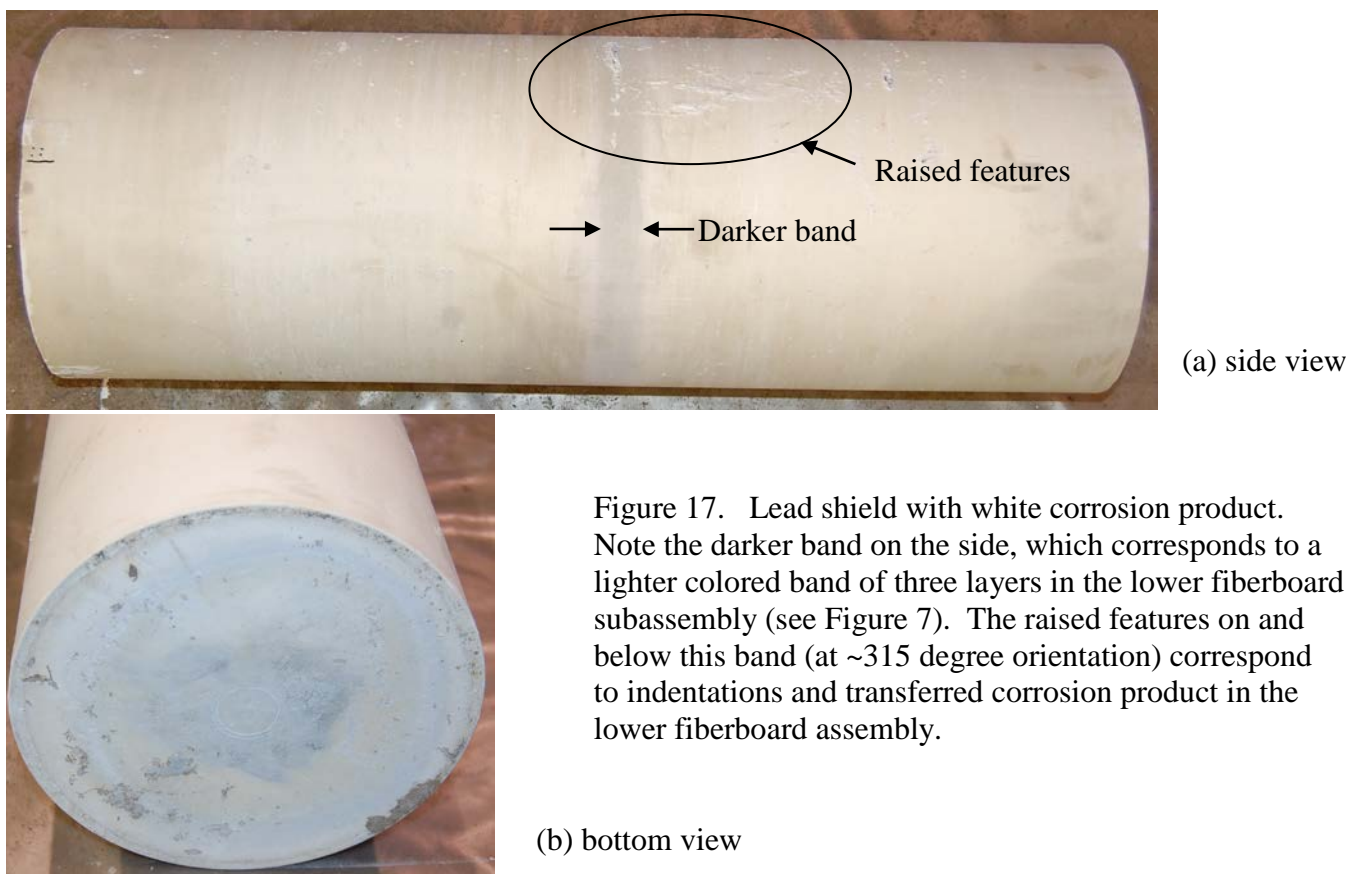
The entire surface of the lead shield was visually examined. It was found to be free from significant deformation and physical damage. The outer side surface is covered with white corrosion product (Figure 17), as has been observed on other packages. The corrosion product was scraped away from 8 locations around the top edge, and the shield thickness was measured at these locations before and after scraping (Table 3). The difference provides an estimate of the corrosion product thickness, ranging from 0.005 to 0.015 inch.

The corrosion product thickness varied around the shield circumference, with the thinnest and thickest readings on opposite sides. At some locations, portions of the corrosion product had flaked off from handling before the initial measurements were made (where flaking has occurred, the remaining corrosion product is whiter in appearance). Measurements immediately adjacent to a flaked area indicate that minimal amounts had been removed. However, the locations with the thickest and thinnest corrosion product were measured with the full corrosion product thickness intact.

An upper bound estimate of the amount of metal consumed is provided by assuming that 0.45 mil of metal is lost for every mil of corrosion product [13, 14]. This relationship indicates that approximately 2 to 7 mils of metal was lost to corrosion. This gives an average corrosion rate of 0.7 mils/year or less. Reference [13] recommended a corrosion rate of 2 mils/year as a conservative estimate for 9975 packages. The calculated corrosion rate for this package is significantly less than this bounding value.

A band around the center of the shield is darker in color than the rest of the shield, indicating a thinner layer of corrosion product. This band corresponds to a three-layer section of the lower fiberboard assembly which is lighter in color than the rest of the assembly (Figure 7). Raised features within and near this band correspond to the heaviest lead carbonate deposits shown in Figure 7. The largest of these features on the shield had very little corrosion product remaining on it. An additional raised feature was observed on the lower side of the shield at ~90 degrees orientation (Figure 18) corresponding to the lead carbonate deposits seen in Figure 6. While this rectangular feature is similar in size to the four bolting lugs around the top of the shield, the specific cause of this feature was not identified.

Figure 17. Lead shield with white corrosion product. Note the darker band on the side, which corresponds to a lighter colored band of three layers in the lower fiberboard subassembly (see Figure 7). The raised features on and below this band (at ~315 degree orientation) correspond to indentations and transferred corrosion product in the lower fiberboard assembly.

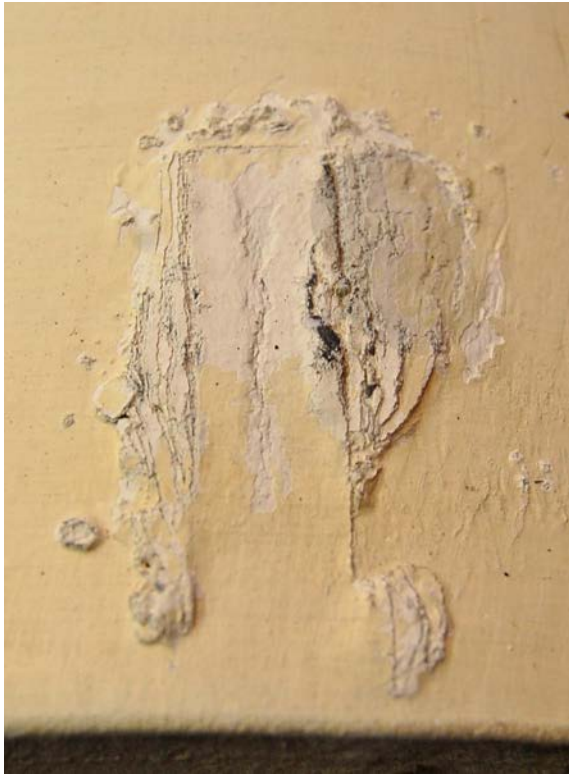
Figure 18. Anomalous feature on the side of the shield at about 90 degrees orientation, corresponding to the lower fiberboard subassembly region shown in Figure 6.

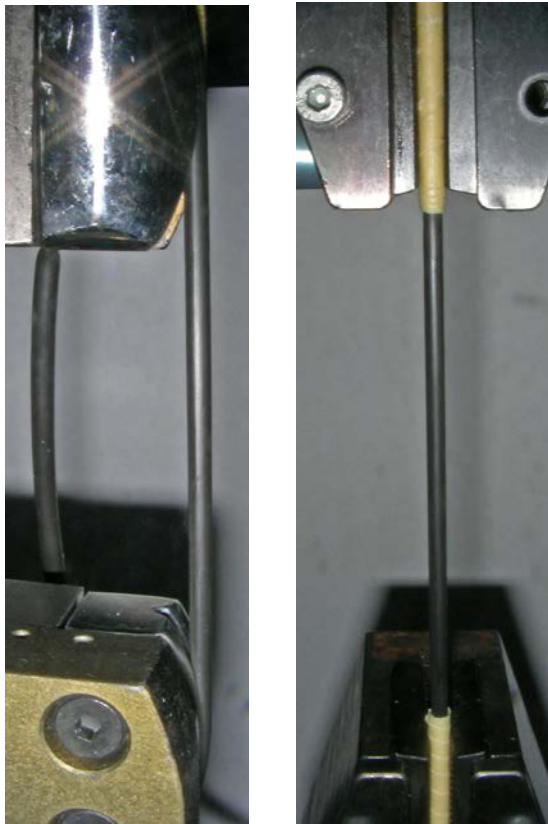
The PCV inner O-ring was tensile tested in accordance with ASTM D1414, using a cut (single strand) sample. The test was interrupted at 50% strain (Figure 22) to visually examine the O-ring for signs of cracking or other degradation. None were observed. The test was performed twice, with different grip arrangements. With yarn grips, some additional stretch beyond the gage section is possible, especially if any grease remains on the O-ring, which causes the elongation to be over-reported. The elongation is measured more accurately with flat grips, but they pose a greater risk of breaking within the grips (which would invalidate the test). Therefore, the portion of O-ring within the flat grips was wrapped with tape for cushioning.

Figure 22. 9975-02644
PCV inner O-ring during
tensile test, at 50% stretch.

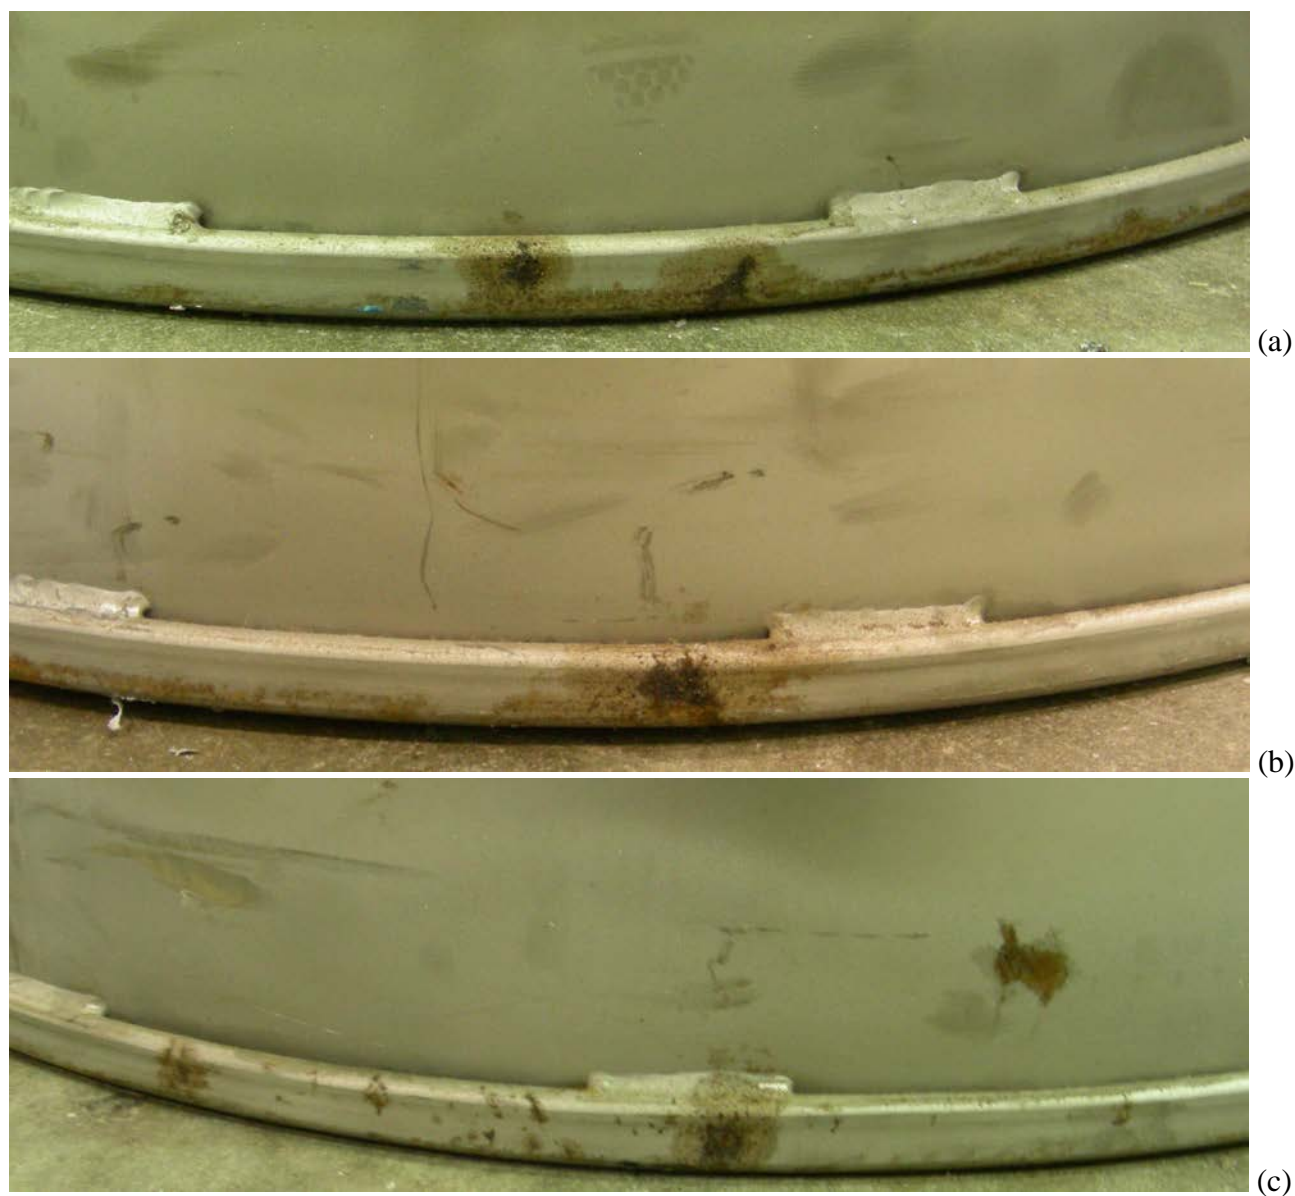
- Several corrosion spots were observed on the rolled bottom edge of the drum (Figure 24) and in the crevice between the rolled bottom edge and drum side (Figure 25). Corrosion in or connected to this crevice may be related to moisture seeping through the rolled edge, and could signal additional internal corrosion. However, this corrosion does not appear as severe

as that observed previously on 9975-02101 [16]. The corrosion on the rolled edge that does not connect to the crevice is more likely caused by factors external to the package.

- Corrosion was observed on the drum OD side just above the stitch welds (Figures 24(c) and 26). The corrosion in Figure 24(c) is high enough above the rolled edge that the ID surface opposite this spot is accessible. No corrosion was observed on the ID surface at this location, indicating that the corrosion likely initiated from the outside. The ID surface opposite the corrosion in Figure (26) is not accessible.

Figure 24. Corrosion along the bottom rolled edge of the drum at approximately 110° (a), 210° (b) and 340° (c) orientations

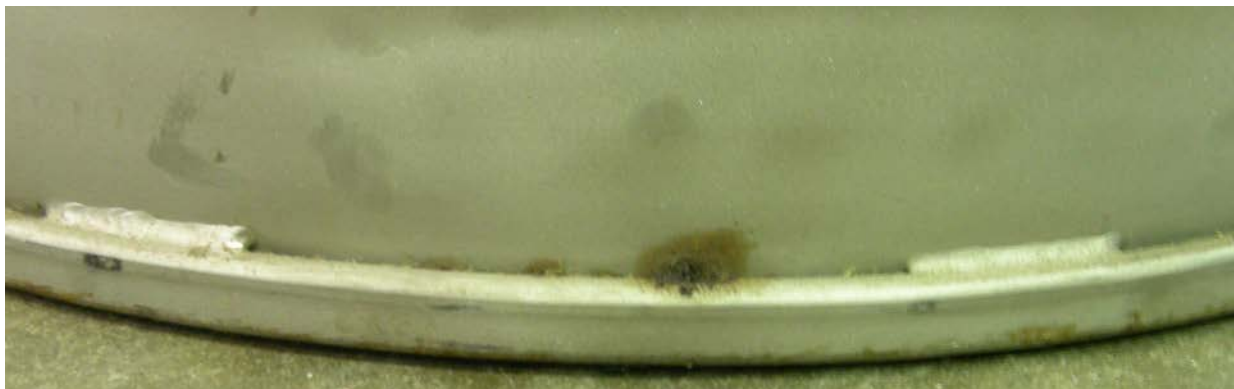
Figure 25. Corrosion along the crevice between the bottom rolled edge and the OD side of the drum, at about 30° orientation

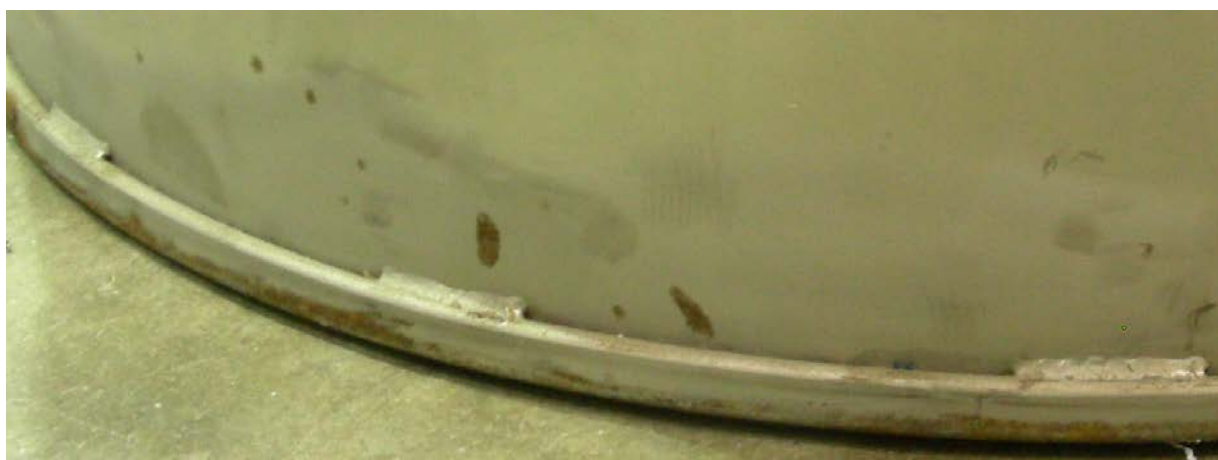
Figure 26. Corrosion on the OD side of the drum at about 170° orientation

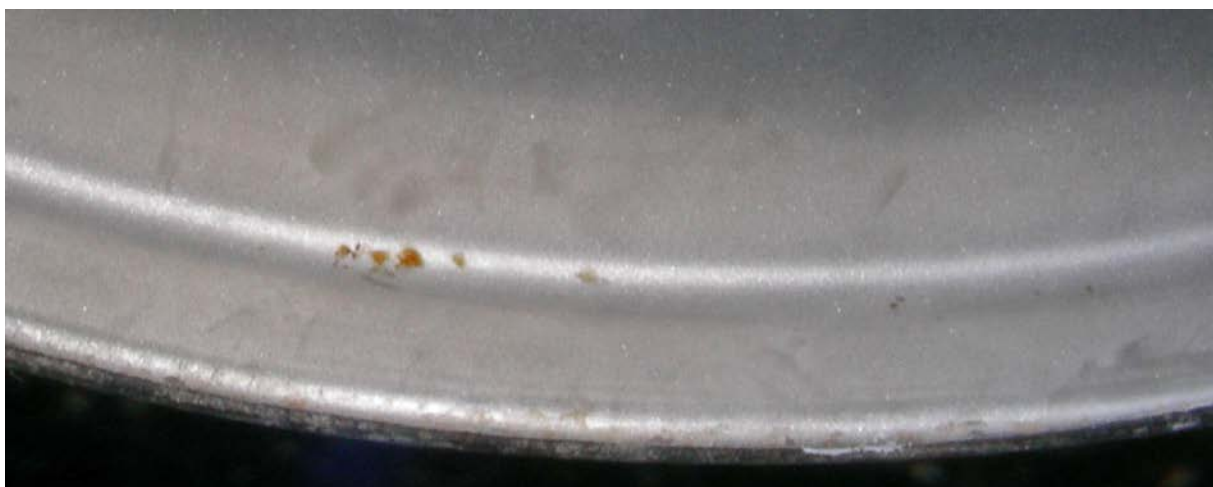
- Small corrosion spots were observed on the bottom of the drum along the outer corner (Figure 27). These spots are superficial and are much less severe than observed previously on other packages [16, for example]. In addition, one spot of corrosion was observed on the drum bottom close to the center (Figure 28). Cleaning of this area was attempted by increasingly aggressive methods - wiping, brushing with a soft-bristle brush, and brushing with a wire brush. Each step removed additional material, with the wire brush removing essentially all corrosion product. Numerous small pits were observed under the corrosion product (Figure 29). No corrosion was observed on the drum interior opposite this spot, indicating that this corrosion also likely initiated from the outside.

Figure 27. Small spots of corrosion along the bottom corner of the drum at about 270° orientation

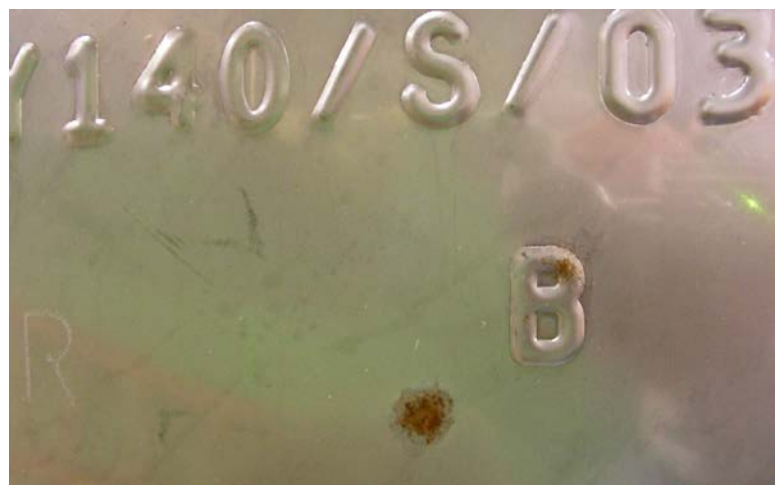
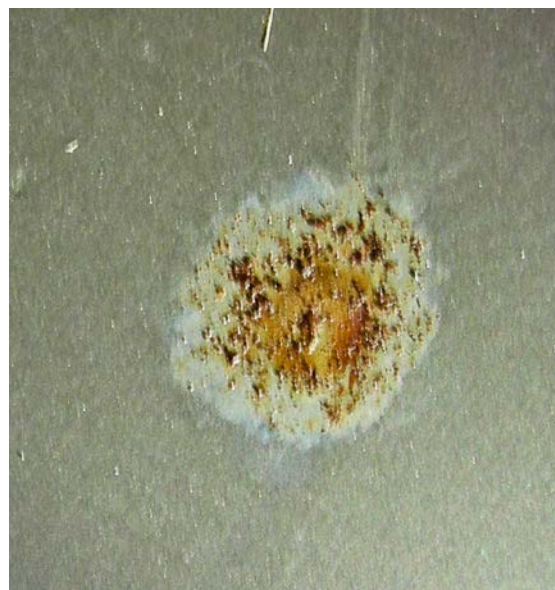
(a) (b)
Figure 28. Corrosion on the bottom of the drum (a), with close-up in (b)

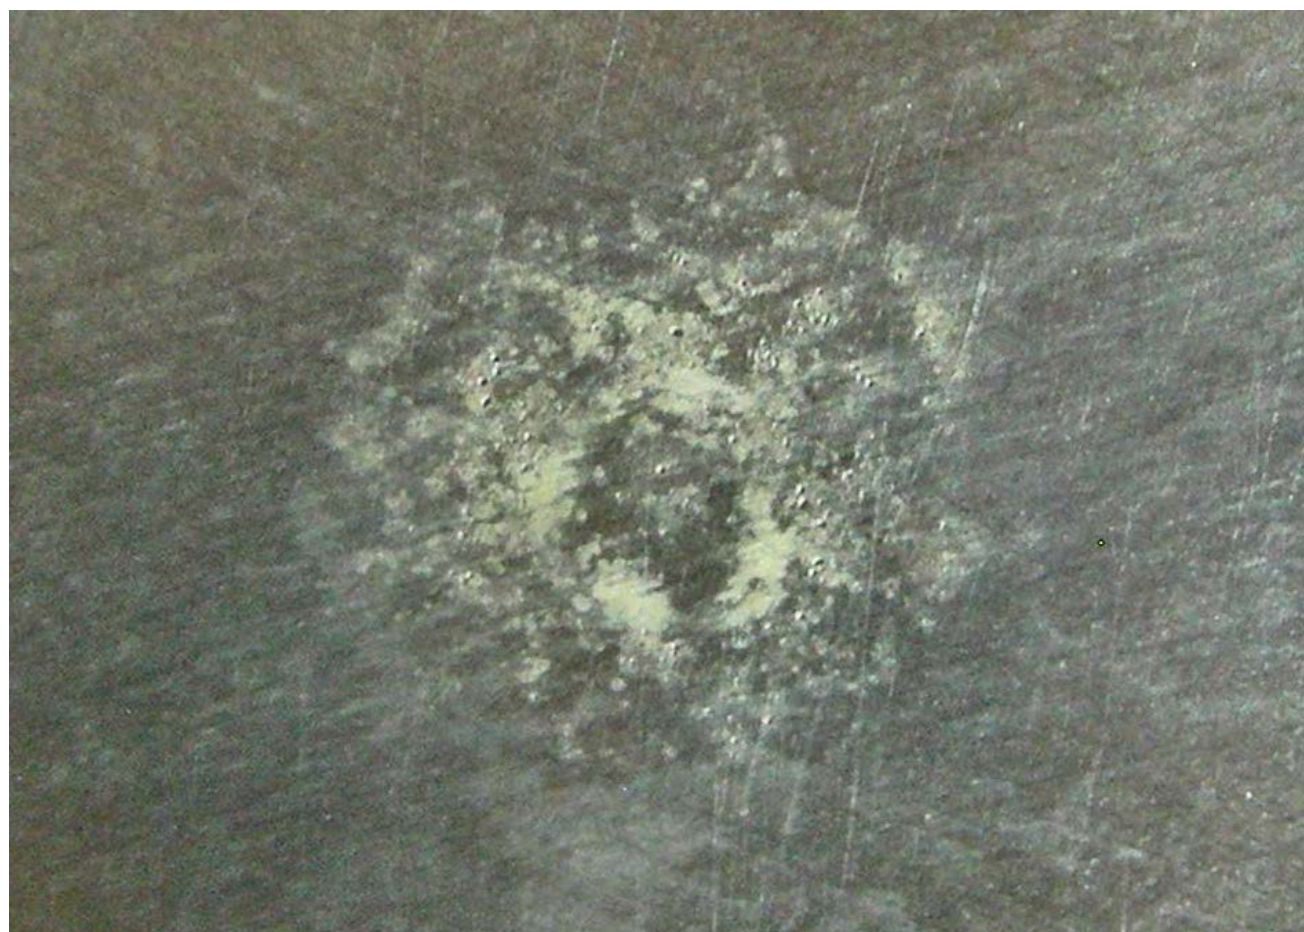
Figure 29. Corrosion spot on the drum bottom after the corrosion product was removed, showing numerous small pits.

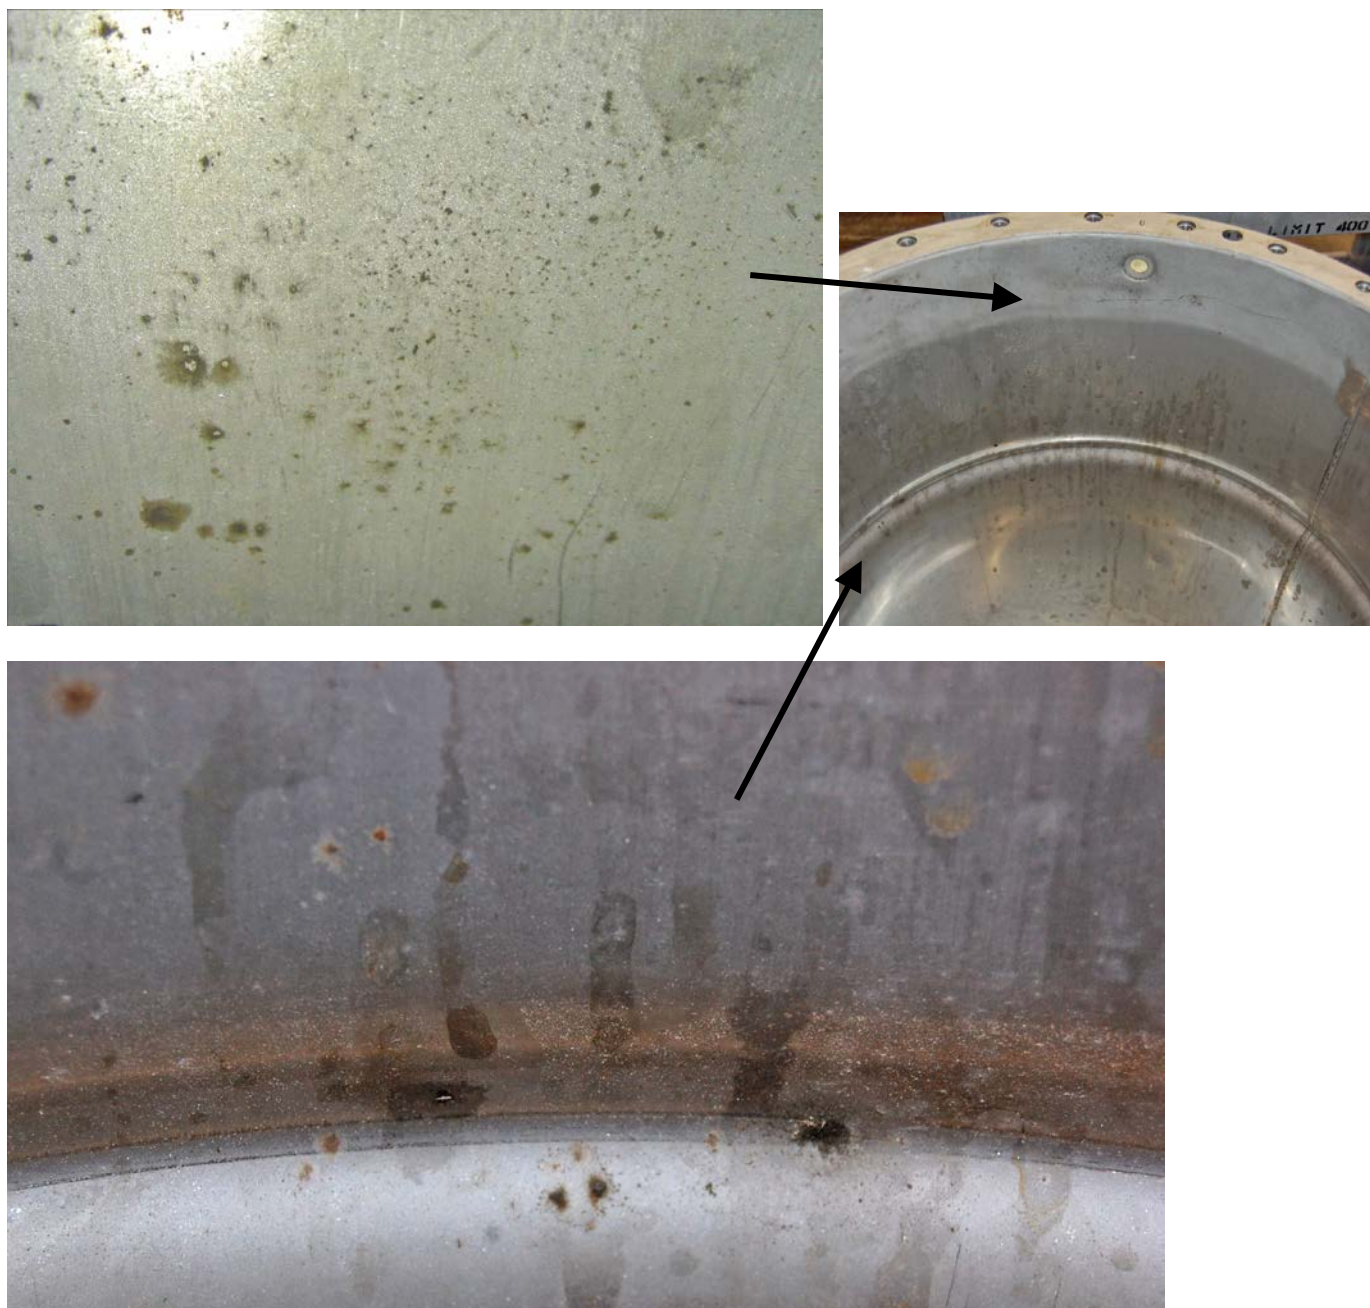
- Numerous small corrosion spots were observed on the drum ID surface along with water staining (Figure 30). A portion of this area was cleaned by wire brushing. Most of the corrosion product was removed, but a degree of staining remained. No significant pitting was observable compared to the as-fabricated roughness of this ID surface.

Figure 30. Corrosion and water staining on the drum interior surface, near 0° orientation

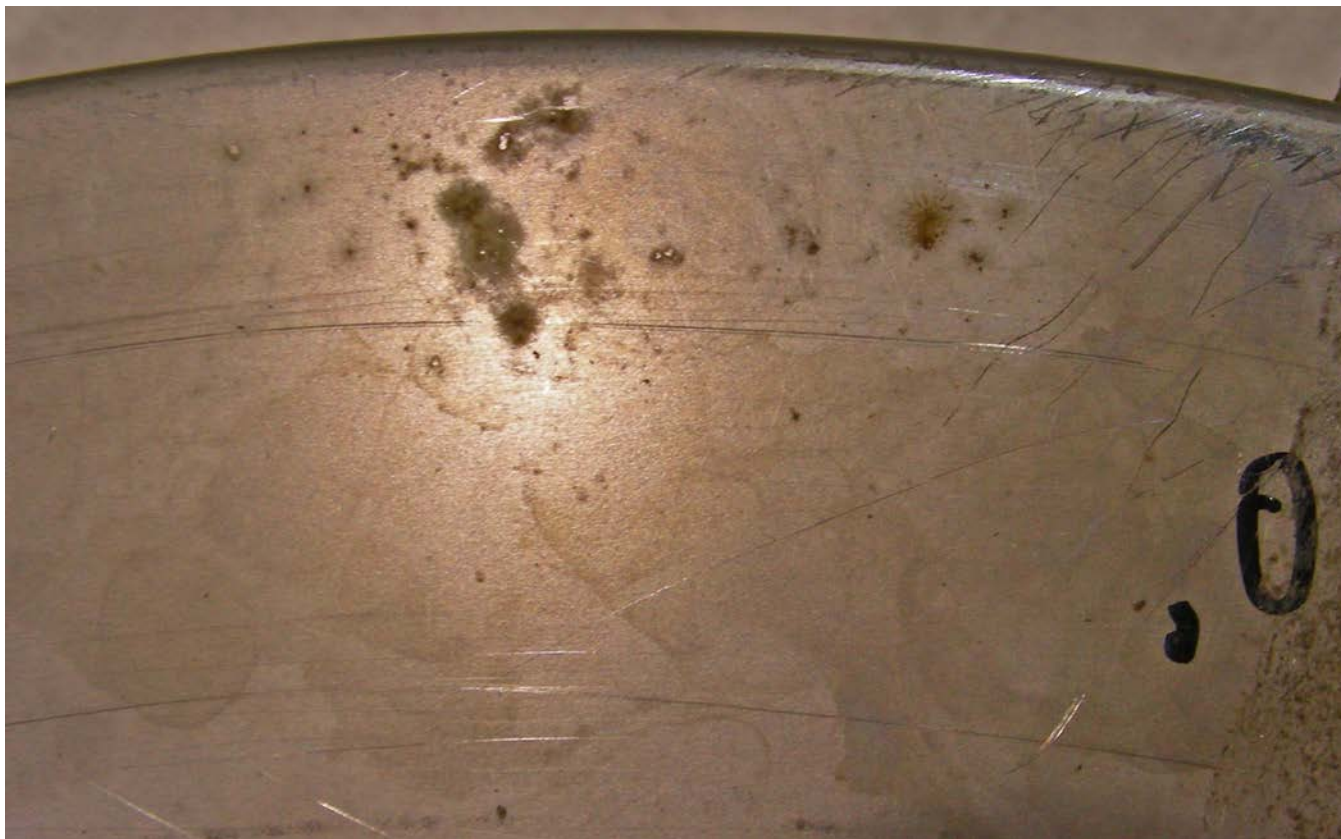
Figure 31. Corrosion on the air shield near the 0° orientation
