Date: September 29, 2022

E-Area Corrosion Coupon Recovery and Evaluation

Scope Abstract: The recovery and evaluation of selected E-Area corrosion coupons were completed in FY2022. This is the second time coupons have been recovered from the E-Area Corrosion Monitoring Test Site, with the first recovery effort occurring in FY2017. Coupons recovered during the FY2022 extraction have now been exposed to the subsurface for approximately 17 years. This effort is part of an ongoing study where a subset of coupons is recovered at each determined time interval over a 100-year period. Results from this effort, as well as updates to the schedule for future recovery and evaluation efforts, are included in this report revision. This report is issued as a revision to the 2018 report and maintains similar formatting.

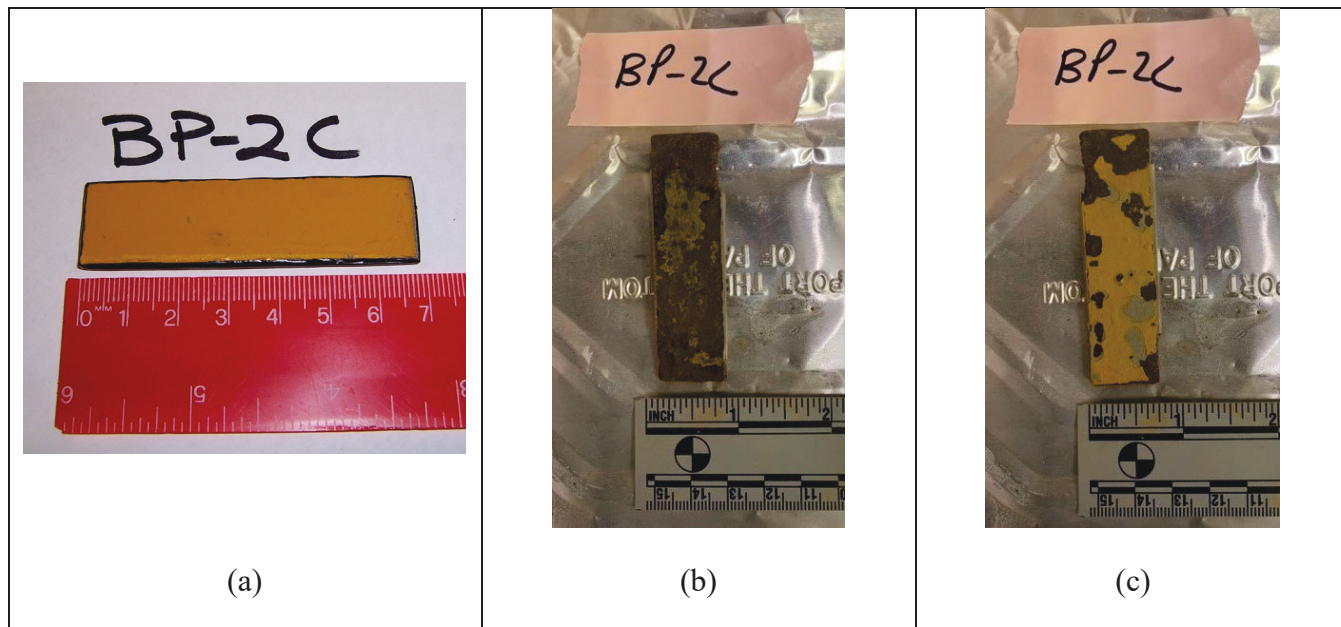
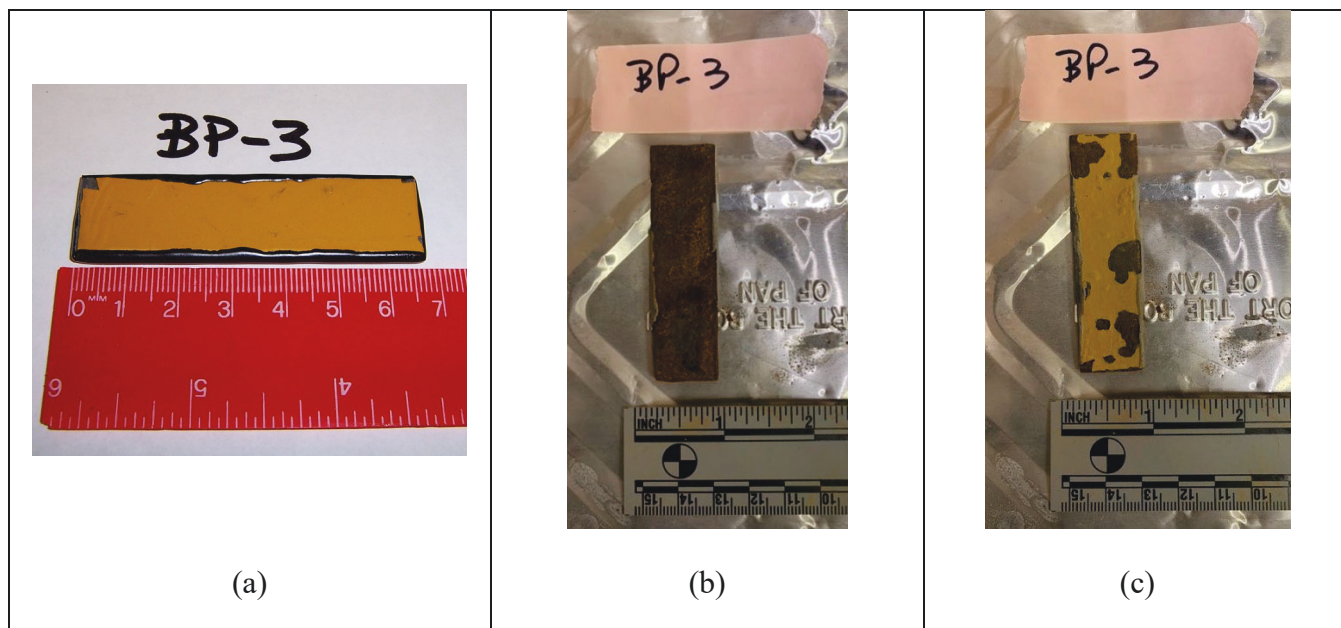
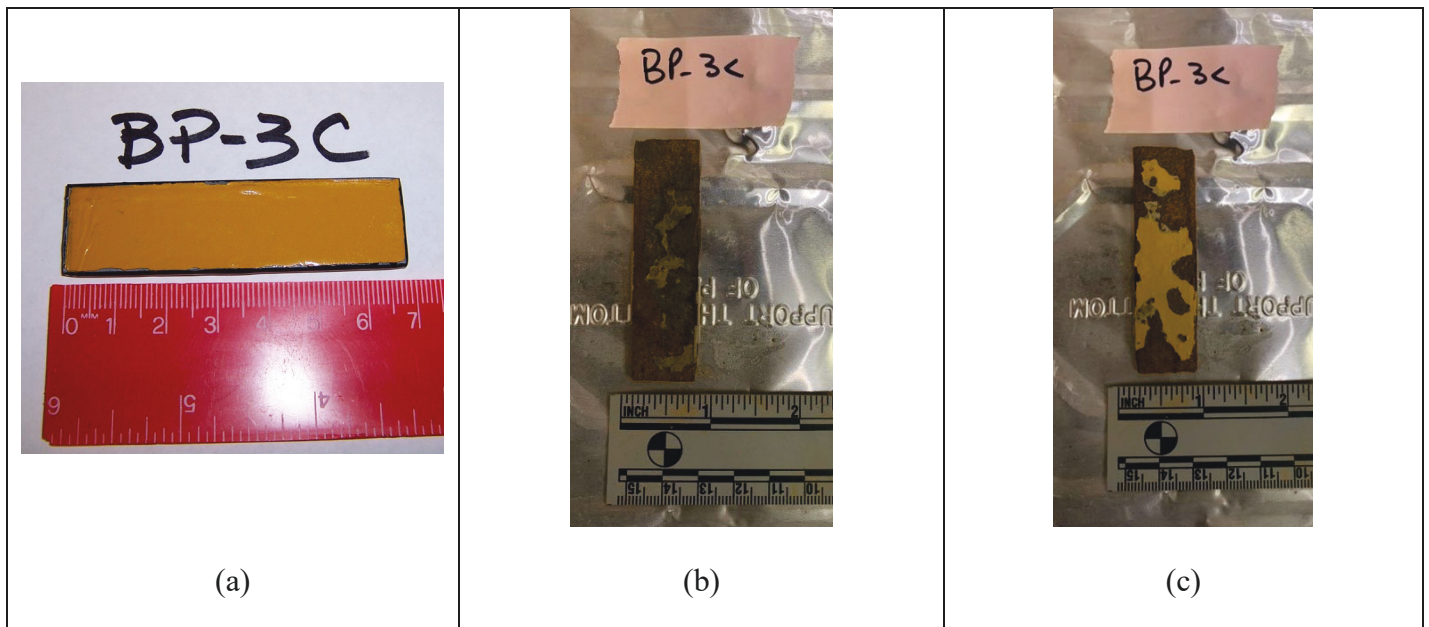
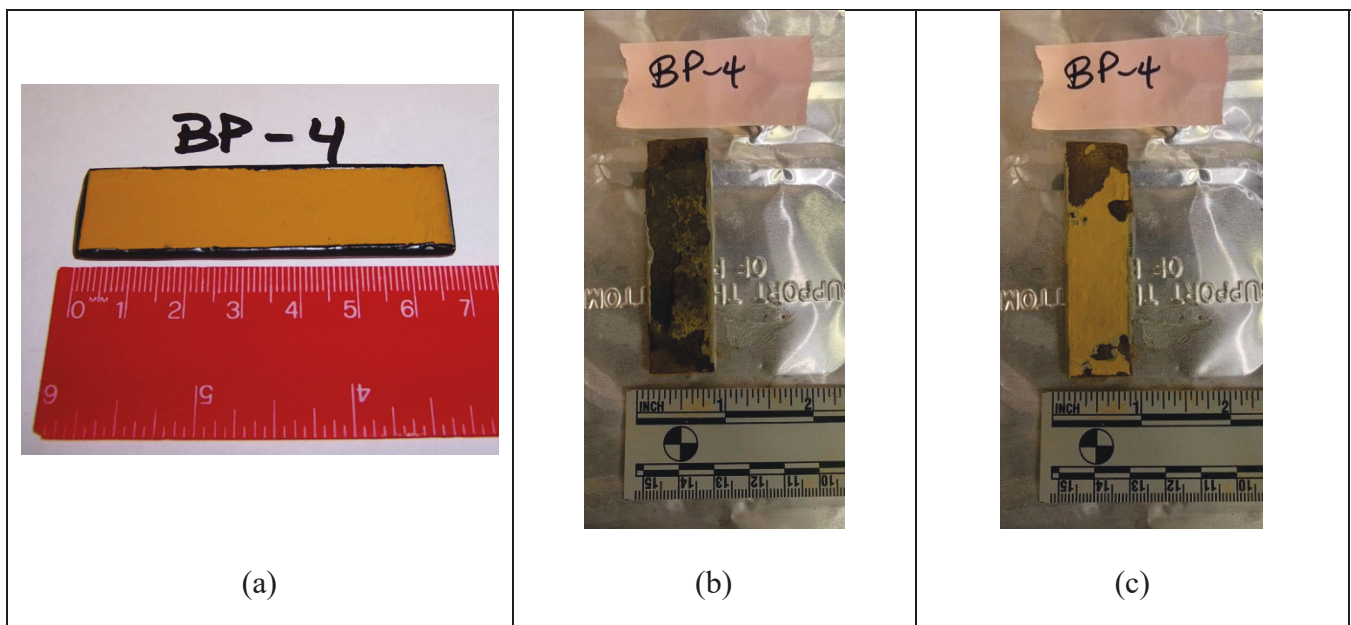
Figure 3 through Figure 6 show the painted B-25 coupons before burial, after excavation but before cleaning, and after cleaning was complete. The four painted B-25 coupons exhibited similar corrosion rates. The arithmetic mean for this subset was 0.40 mpy. As buried, the initial thickness of the painted B-25 coupons was about 112.3 mil. Assuming a uniform corrosion rate of 0.40 mpy, it will take approximately 283 years to penetrate the entire thickness of the coupon. Two of the four painted coupons (BP-2C and BP-3C) were retrieved from the covered trench (Trench 3). The calculated corrosion rates for these coupons were comparable to rates for the coupons collected from the uncovered trench, but BP-3C experienced the largest amount of corrosion within that grouping (0.48 mpy). The corrosion rates for the other three coupons (BP-3, BP-4, and BP-2C) were more tightly clustered, exhibiting corrosion rates between 0.33 and 0.40 mpy.

The B-25 box specification requires the interior and exterior of the box to be coated with a rust-inhibiting, gray-colored primer. The exterior of the box is covered with a yellow alkyd enamel coating. Some blistering and delamination of the alkyd enamel coating is noted for all four coupons. Dunn (2001)

describes the alkyd enamel coating as water permeable and observed similar blistering and delamination of the coating on the lid of a buried B-25 box. As with the B-25 box evaluated by Dunn (2001), pitting is observed on the coupons at the locations where the alkyd enamel coating degraded. The backside of the coupons is coated with the gray rust-inhibiting primer which also showed signs of minor general corrosion.

Figure 3. Coupon BP-2C prior to installation (a) and following recovery in 2022 (front and back views, b and c).

Figure 4. Coupon BP-3 prior to installation (a) and following recovery in 2022 (front and back views, b and c).

Figure 5. Coupon BP-3C prior to installation (a) and following recovery in 2022 (front and back views, b and c).

Figure 6. Coupon BP-4 prior to installation (a) and following recovery in 2022 (front and back views, b and c).

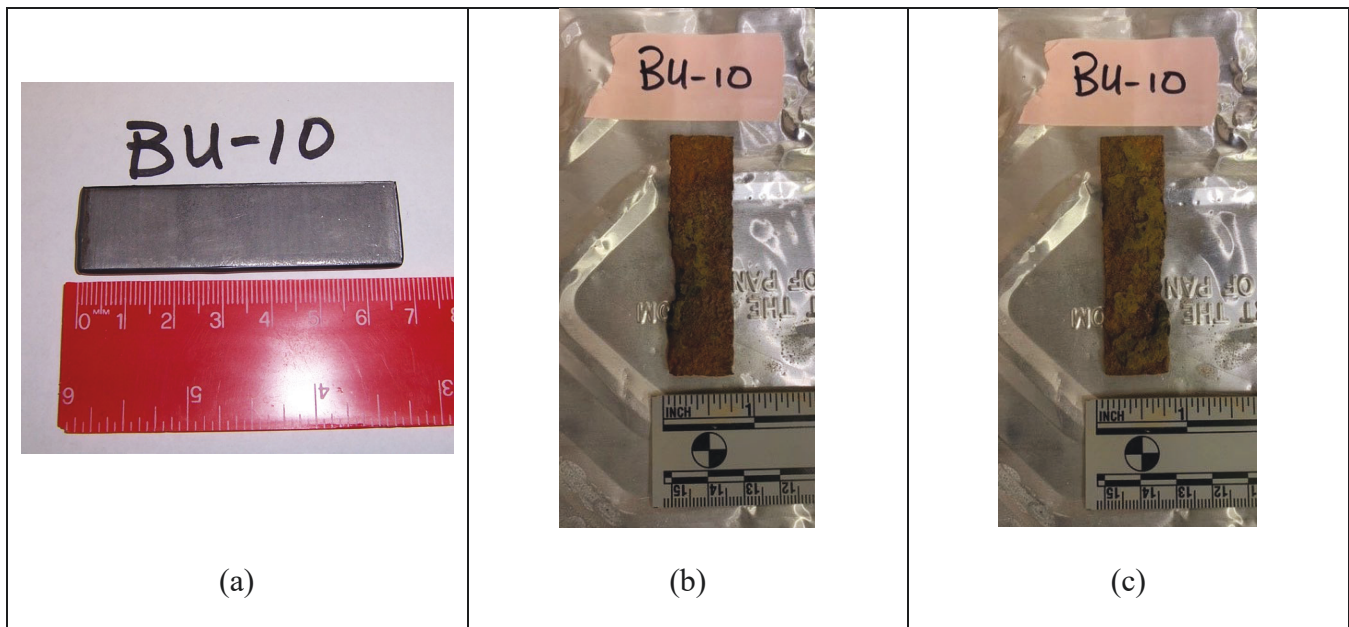
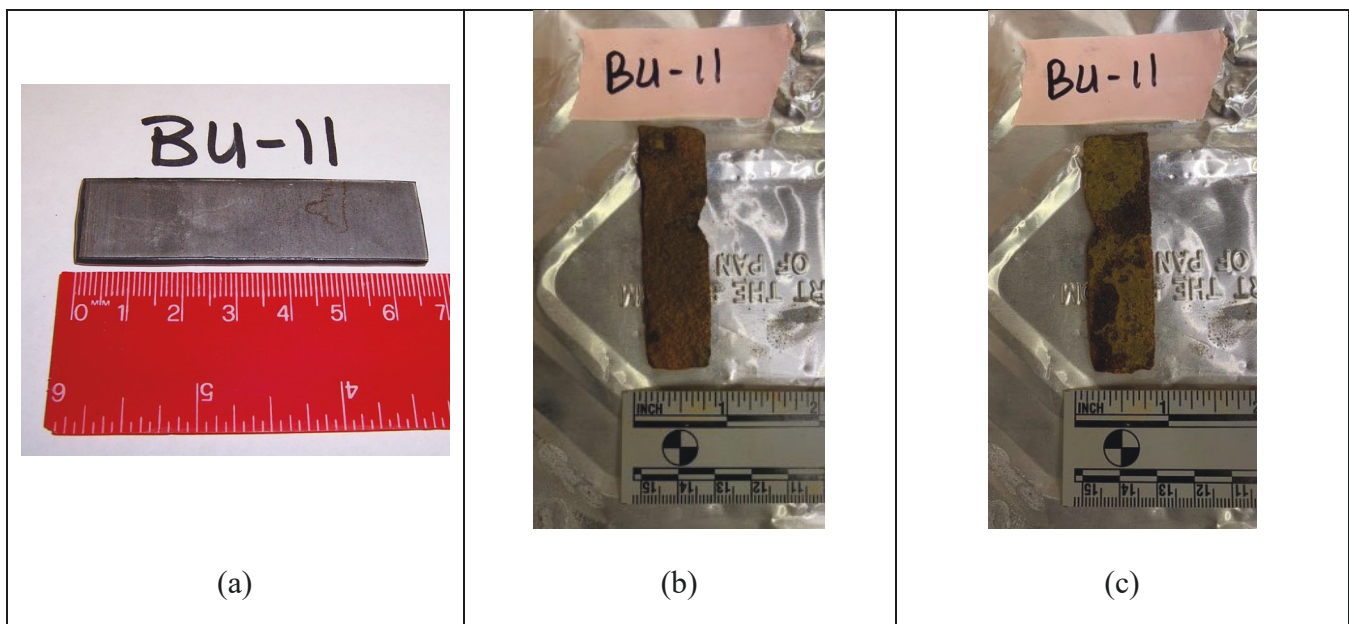
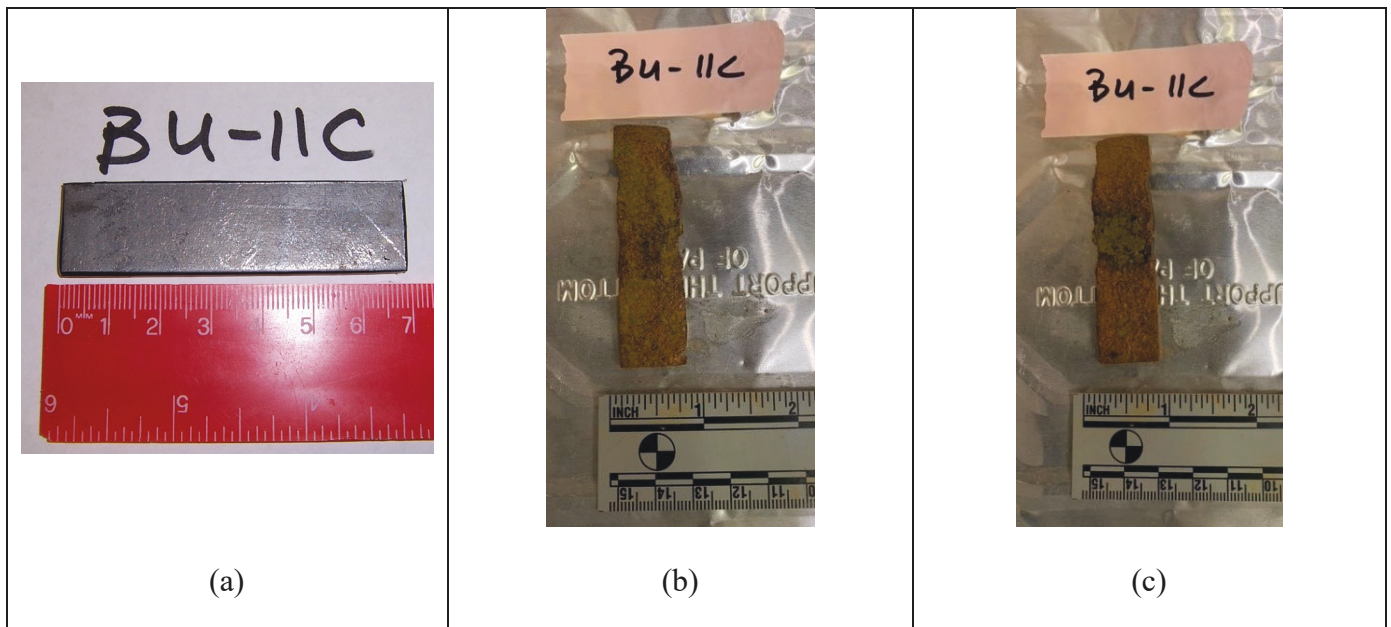
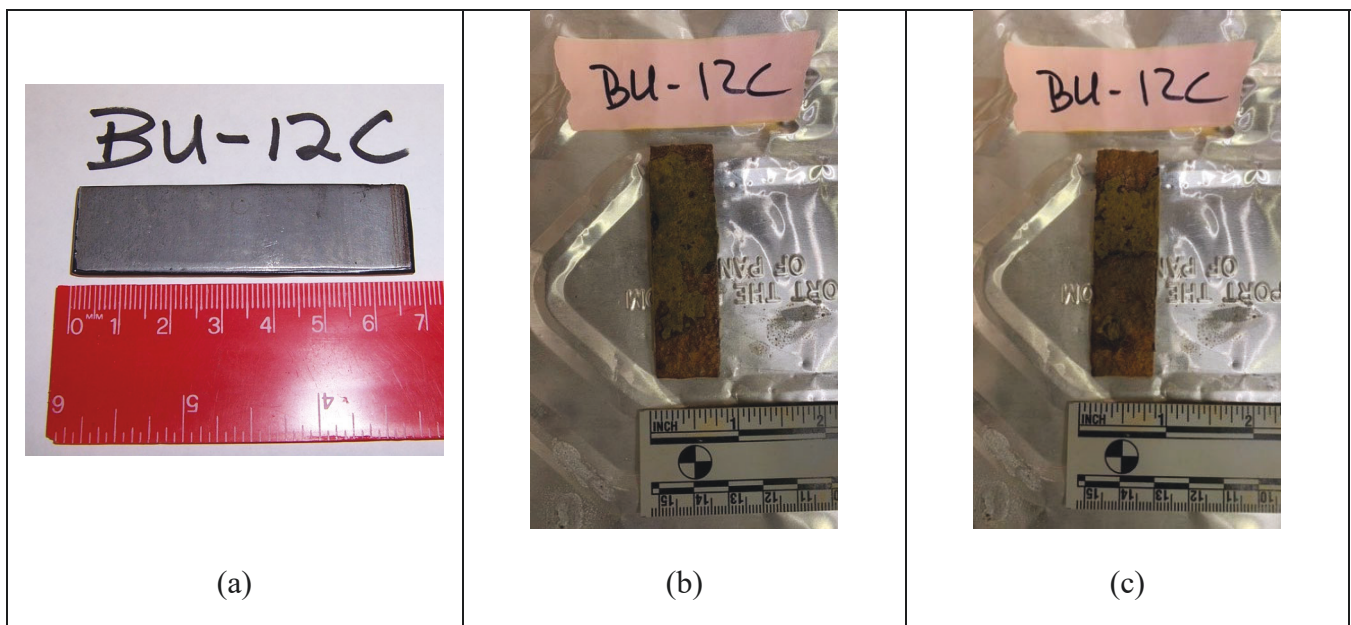
Figure 7 through Figure 10 display the recovered unpainted B-25 coupons. Calculated coupon-averaged corrosion rates for the four unpainted coupons were similar for both covered and uncovered trenches and had an arithmetic mean of 0.73 mpy. This average corrosion rate is about 43% higher than that of the painted B-25 coupons. The more aggressive rate determined for the unpainted coupons is corroborated by visual inspection as these coupons are much more noticeably degraded than the painted coupons. The unpainted B-25 coupons were estimated to have an initial thickness of 109 mil before burial. Therefore, at a mean uniform corrosion rate of 0.73 mpy, it will take approximately 149 years to penetrate the full thickness of the coupon. All unpainted B-25 coupons also showed signs of substantial degradation around the edges of the coupons. Loss of material from the edges of each coupon in this grouping was experienced. The edges of all coupons were coated with an epoxy prior to burial to prevent corrosion on the edge surfaces; however, the degradation observed on the edges of the coupons is due to corrosion of the exposed surfaces instead of a breakdown of the epoxy coating.

Figure 7. Coupon BU-10 prior to installation (a) and following recovery in 2022 (front and back views, b and c).

Figure 8. Coupon BU-11 prior to installation (a) and following recovery in 2022 (front and back views, b and c).

Figure 9. Coupon BU-11C prior to installation (a) and following recovery in 2022 (front and back views, b and c).

Figure 10. Coupon BU-12C prior to installation (a) and following recovery in 2022 (front and back views, b and c).

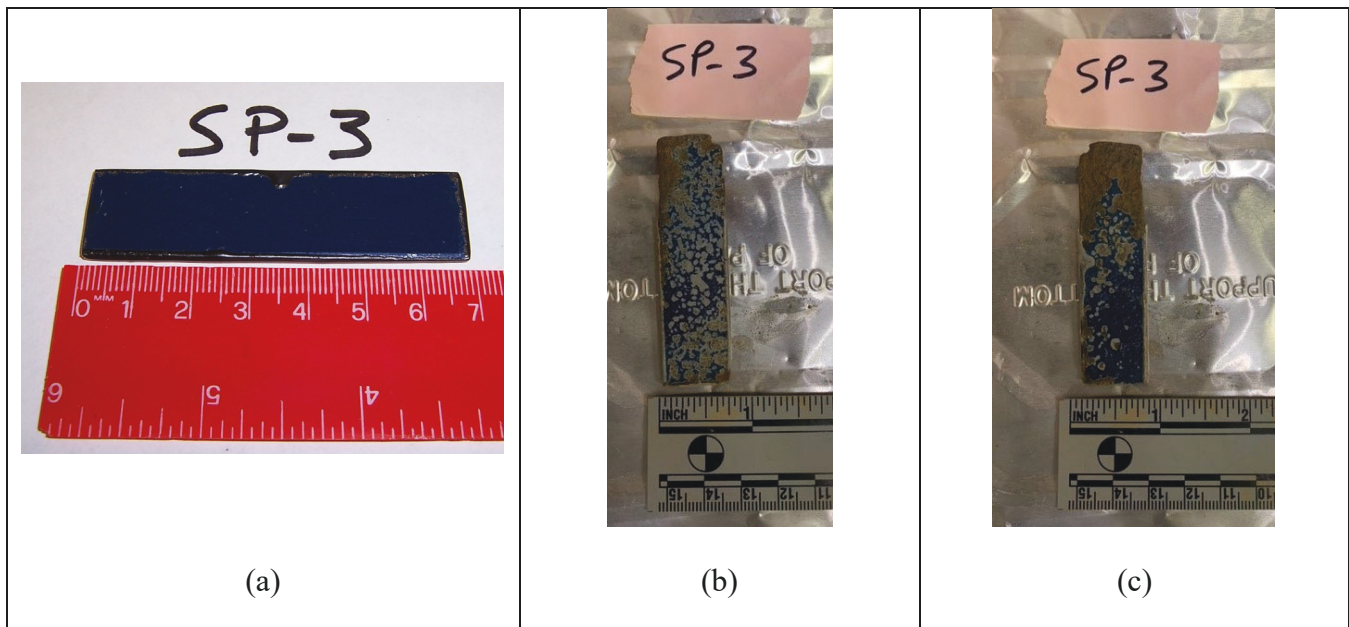
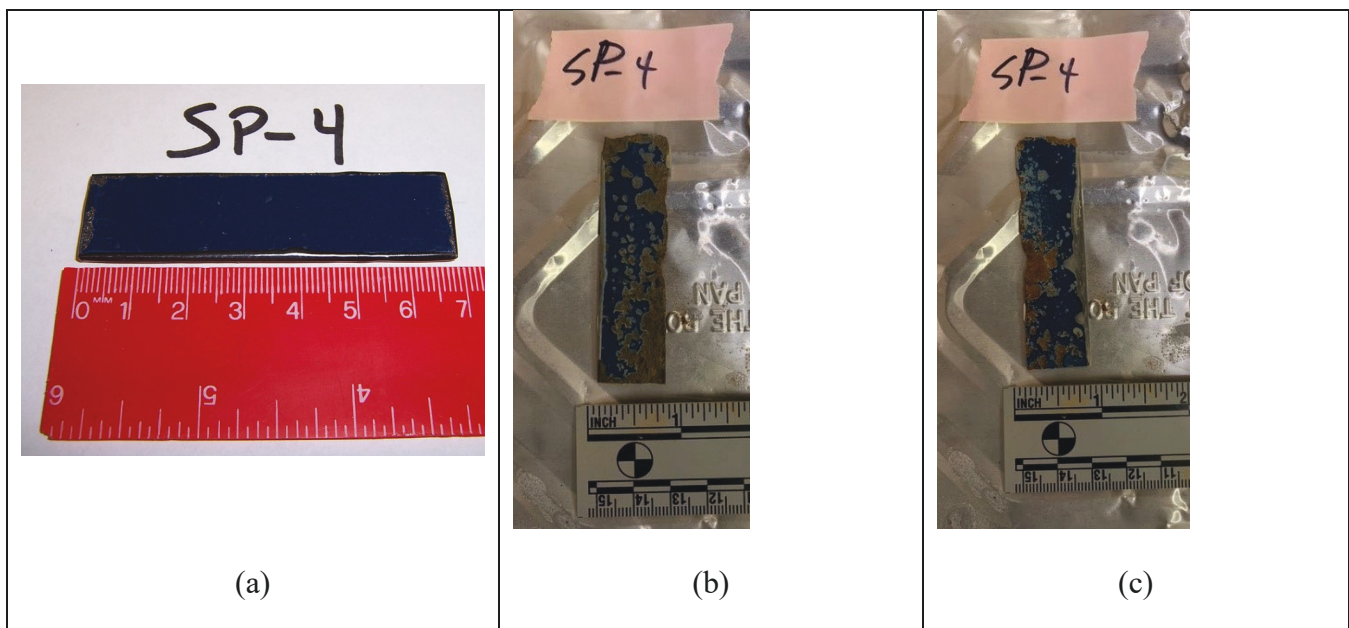
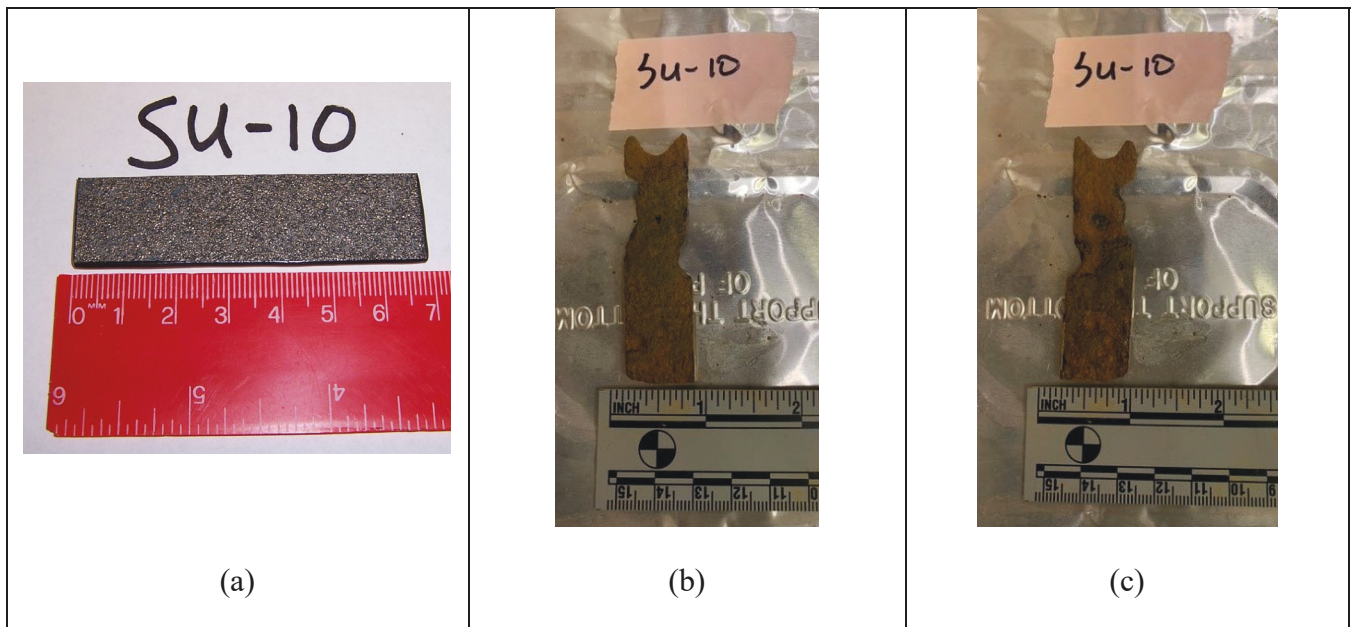
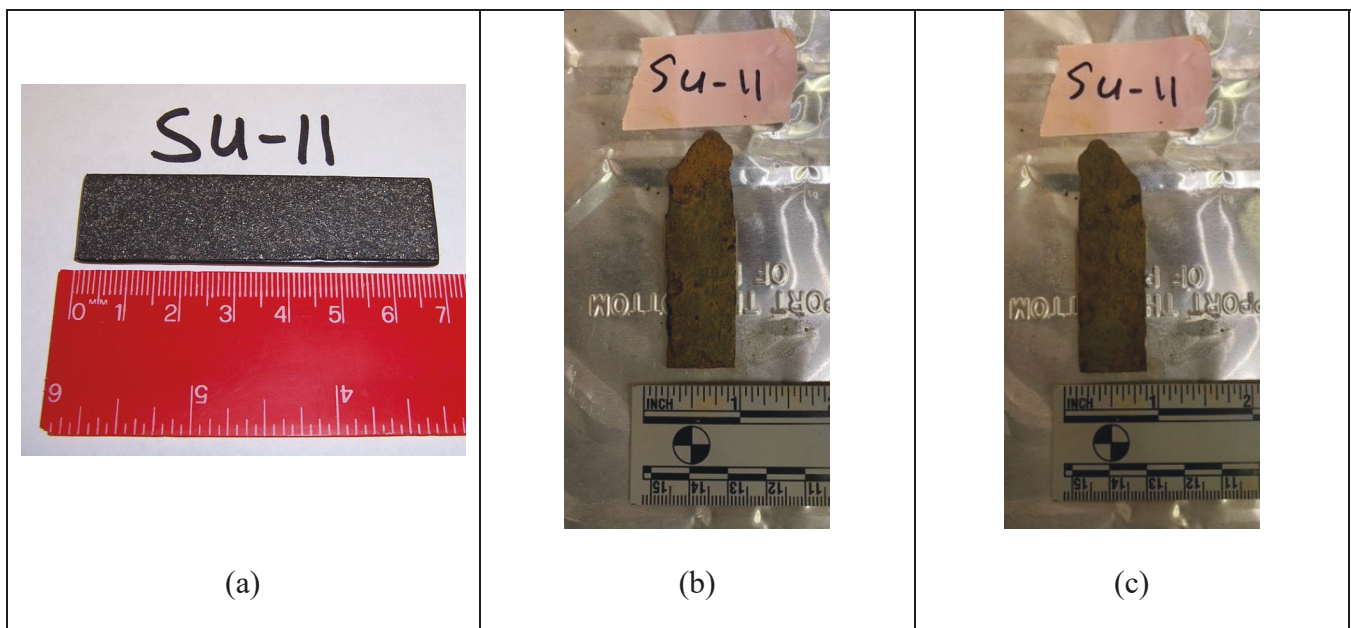
Figure 11 through Figure 14 show the painted and unpainted SeaLand coupons. The coupon-averaged corrosion rates for the two painted SeaLand coupons (SP-3 and SP-4) had an arithmetic mean of 0.25 mpy. With an estimated thickness of 87 mil, it will take approximately 344 years to penetrate the entire thickness of the coupons at this corrosion rate. Both coupons show signs of both general and pitting corrosion; particularly where the paint is no longer present. Coupon SP-3 shows material loss around the edges, but the loss from SP-4 is much more severe. The unpainted coupons (SU-10 and SU-11) show

much more substantial degradation, which is indicative of extensive corrosion. Extensive degradation of this material type was also observed during the previous excavation effort. The arithmetic mean of the coupon-averaged corrosion rates for the unpainted Sealand coupons was 0.87 mpy. With an estimated thickness of 85 mil, it will take approximately 97 years to fully penetrate the coupon at this corrosion rate. Some coupon material was lost during cleaning as a result of the metal becoming thin and brittle. Areas where metal had broken off these samples were excluded during surface area measurements to prevent them from biasing the corrosion rate calculations. Interestingly, the calculated corrosion rates for these two coupons (average of 0.87 mpy) are comparable to the unpainted B-25 coupons (average of 0.73 mpy), which visibly fared much better. This is attributed to the fact that the B-25 coupons are thicker (109 mil) than the SeaLand coupons (85 mil).

Figure 11. Coupon SP-3 prior to installation (a) and following recovery in 2022 (front and back views, b and c).

Figure 12. Coupon SP-4 prior to installation (a) and following recovery in 2022 (front and back views, b and c).

Figure 13. Coupon SU-10 prior to installation (a) and following recovery in 2022 (front and back views, b and c).

Figure 14. Coupon SU-11 prior to installation (a) and following recovery in 2022 (front and back views, b and c)

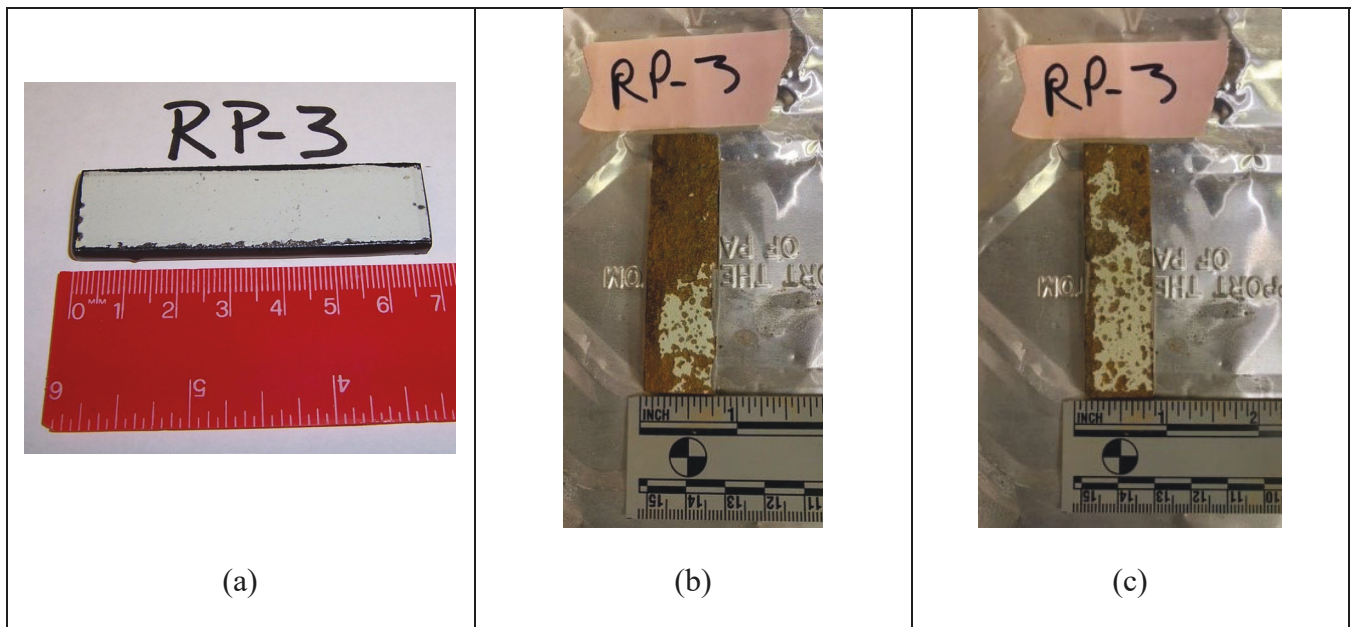
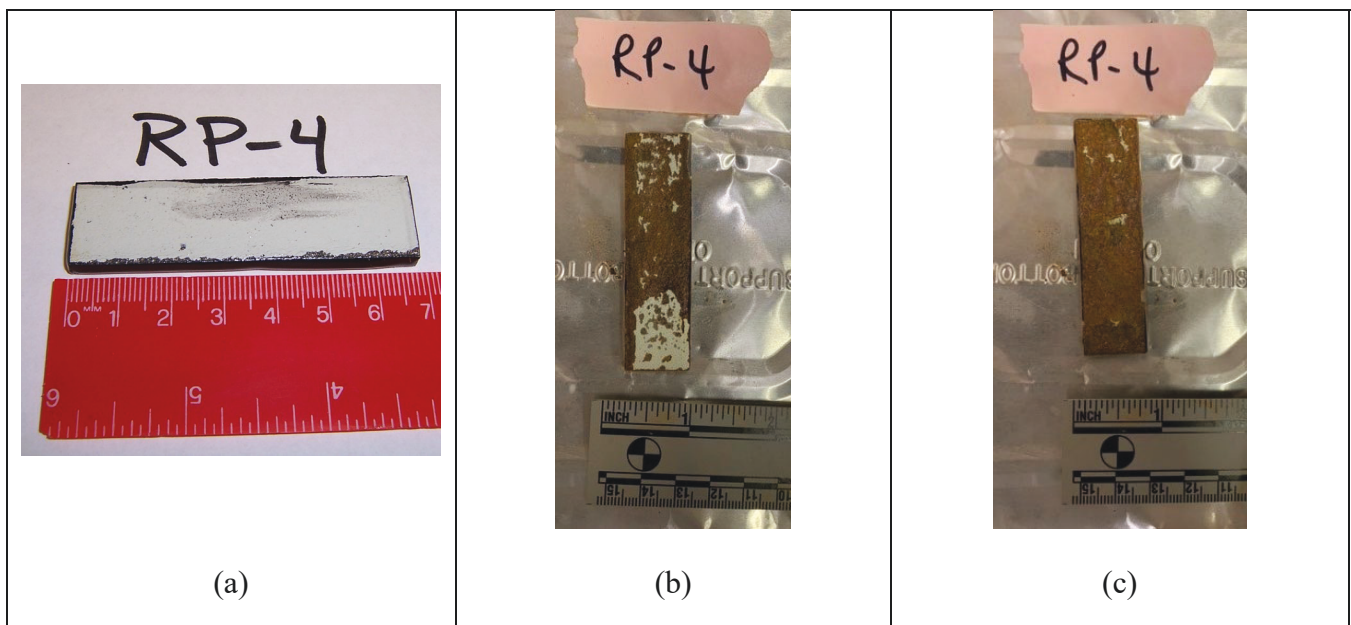
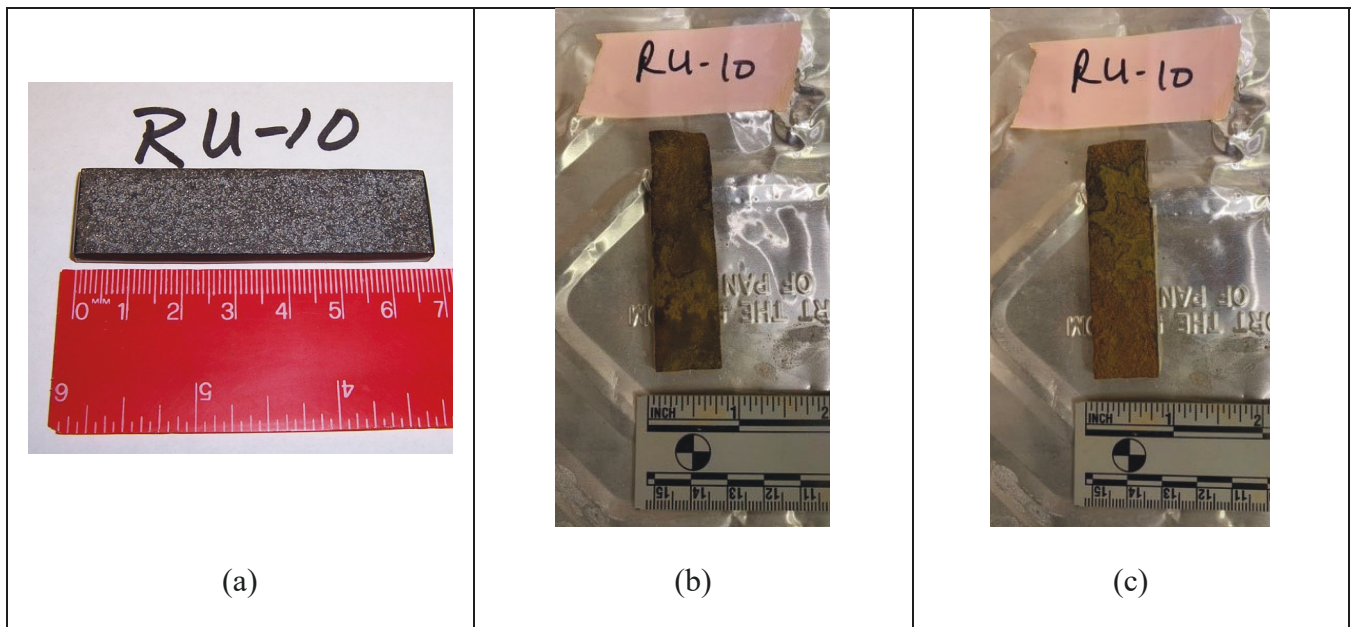
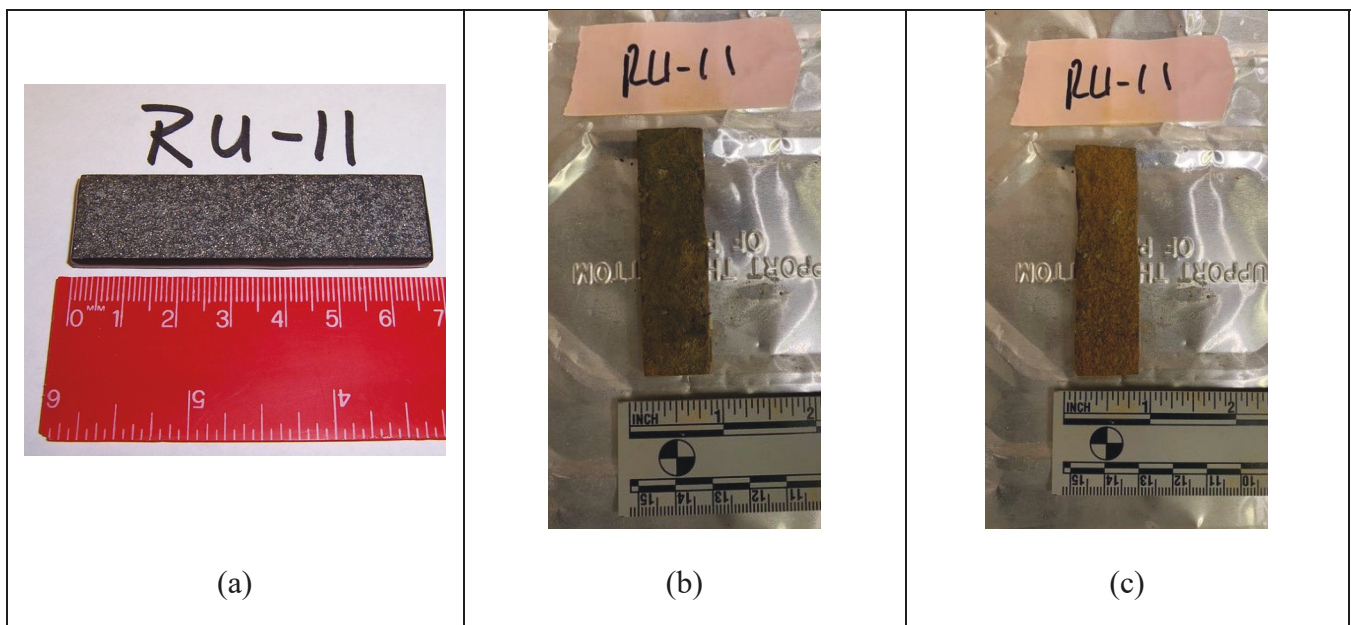
Figure 15 through Figure 18 show the SeaLand reinforcing material coupons. The calculated corrosion rates for these coupons (both painted and unpainted) were comparable to those calculated for the coupons of other material types. The coupon-averaged corrosion rates for the two painted SeaLand reinforcing material coupons had an arithmetic mean of 0.57 mpy. The thickness of the painted SeaLand reinforcing coupons was estimated to be 194 mil, so at a mean corrosion rate of 0.57 mpy it will take approximately 343 years to fully penetrate the coupon. Paint is delaminated from a majority of the coupons' surface. Pitting is noted for both coupons in places where the paint has been delaminated. The coupon-averaged corrosion rates for the two unpainted Sealand reinforcing coupons had an arithmetic mean of 0.86 mpy. With an estimated thickness of 192 mil, it will take approximately 223 years to fully penetrate the coupon at this corrosion rate. In contrast to the painted coupons, the unpainted coupons appear more affected by general corrosion than by pitting.

Figure 15. Coupon RP-3 prior to installation (a) and following recovery in 2022 (front and back views, b and c).

Figure 16. Coupon RP-4 prior to installation (a) and following recovery in 2022 (front and back views, b and c).

Figure 17. Coupon RU-10 prior to installation (a) and following recovery in 2022 (front and back views, b and c).

Figure 18. Coupon RU-11 prior to installation (a) and following recovery in 2022 (front and back views, b and c).

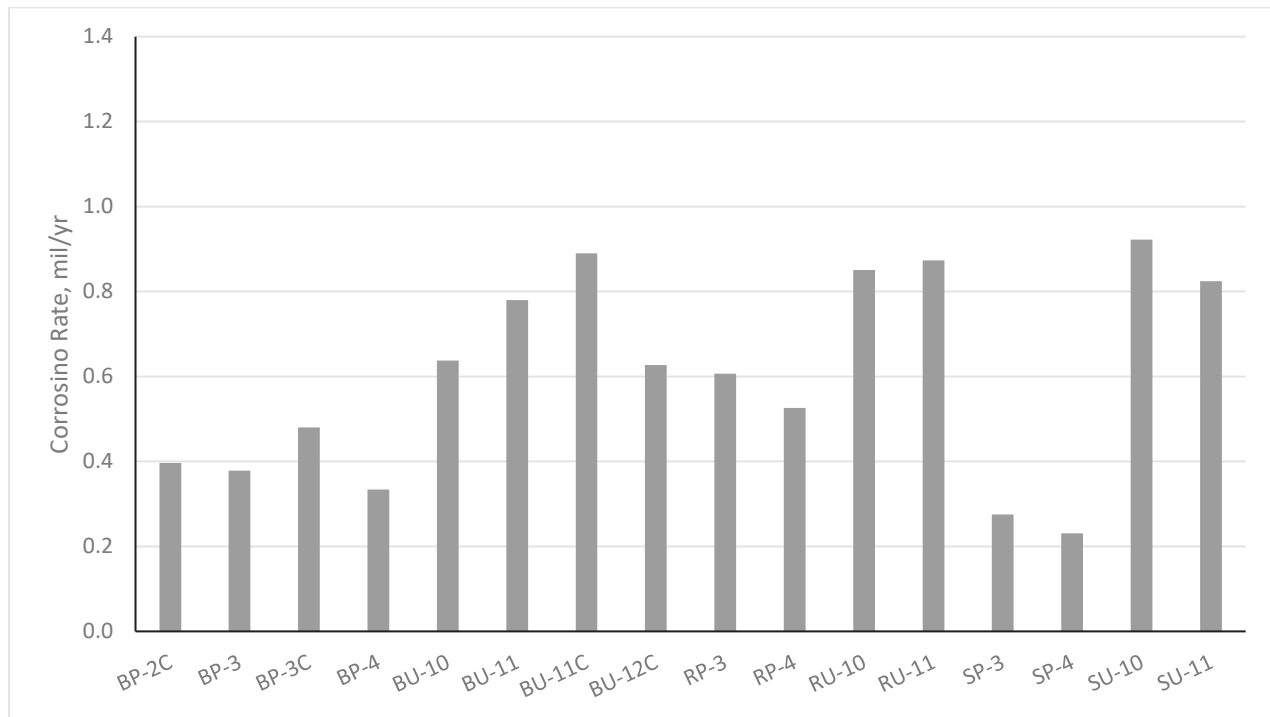
Figure 19. Corrosion rates using ASMT G1-03 for all coupons recovered in 2022.

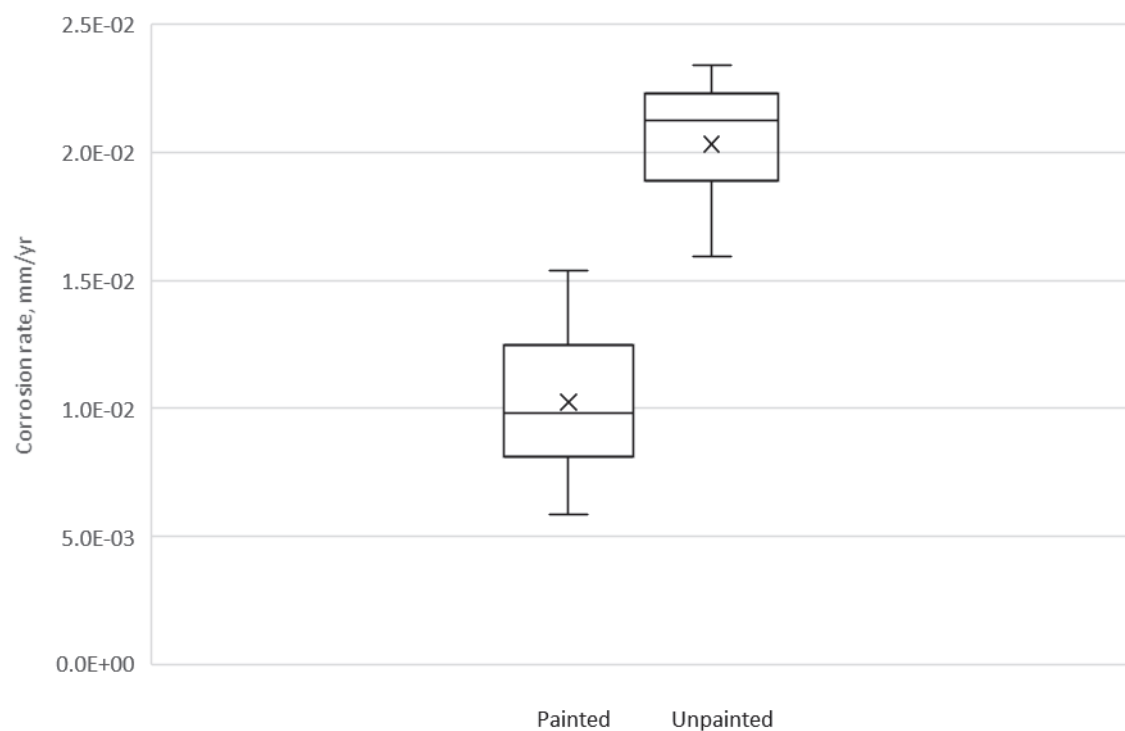
Calculated corrosion rates for all unpainted coupons, regardless of material type, were typically about two times greater than rates for the painted coupons. This was expected, because the purpose of including unpainted coupons in the study is to help accelerate the corrosion process upon burial. Because there were not enough corrosion coupons to conduct a meaningful statistical analysis of corrosion rates within each material type, the data were grouped based only on whether the coupon is painted or unpainted. A Mann-Whitney test was conducted to compare the difference between painted and unpainted corrosion coupons. The Mann-Whitney test is nonparametric and tests whether two independent sample sets are drawn from the same distribution (i.e., if they are statistically different or not). If the means of the ranks in the two groups are different, the P value will be small (less than the significance value). The results of this analysis displayed a statistically significant difference ($P = 0.001$) between the painted and unpainted corrosion rates, thus reinforcing that the corrosion rates for painted coupons are, statistically, significantly different from rates for the unpainted coupons.

Figure 20. Comparison of median corrosion rates for painted and unpainted coupons.
