Examination of Shipping Package 9975-04194

May 2018

SRNL-STI-2018-00228, Revision 0

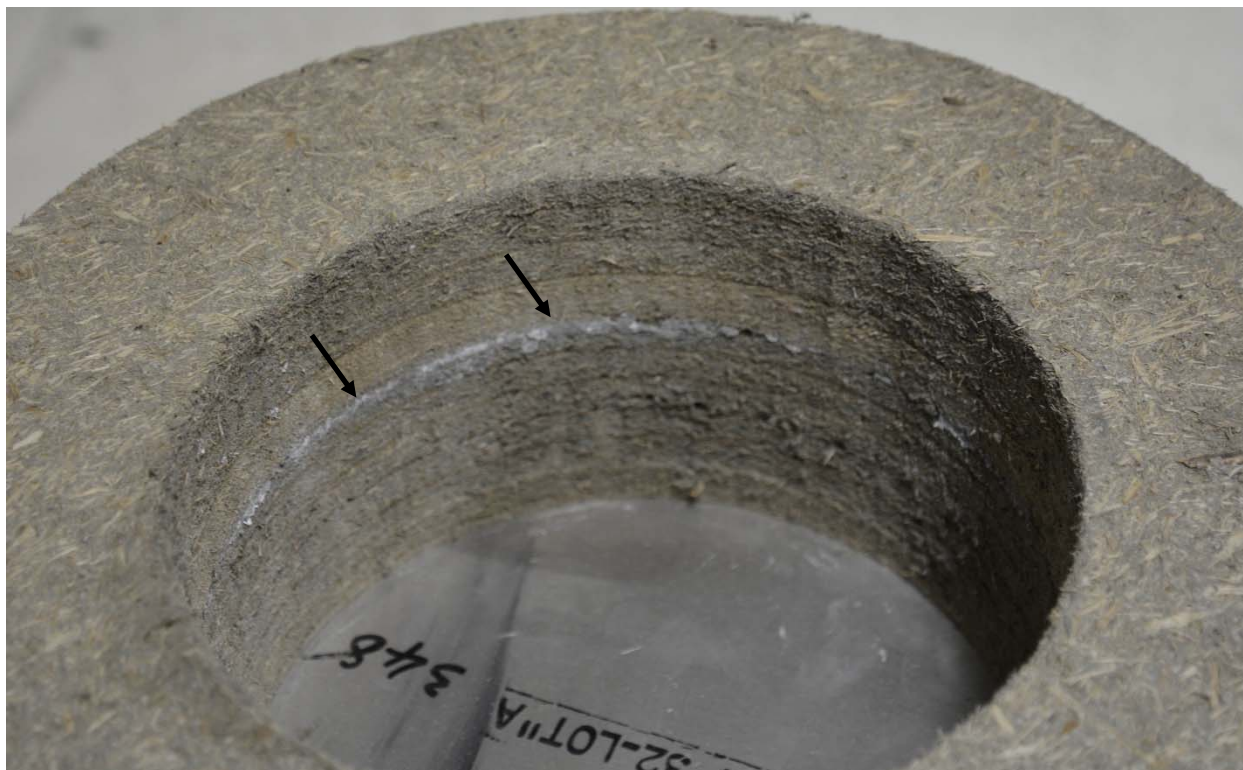
- A line of material from the shield is seen embedded in the fiberboard within the 6th fiberboard layer (about 2.5 to 3 inches) from the bearing plate (Figure 1).
- A portion of the bottom edge of the upper fiberboard assembly suffered flaking / peeling damage from dragging against the shield as it was removed (Figure 2).

The height of several blisters was measured to be 0.05 – 0.09 inch high. Given a number of larger blisters all around the shield, one might assume they add ~0.07 – 0.08 inch to the effective outer radius, or ~0.15 inch to the effective OD of the shield. With this amount added to the measured OD (not including blisters), the effective shield OD was ~8.59 inches at the top, and 8.47 inches further down. This increase in the effective OD of the lead shield would create interference between the measured fiberboard ID and the top edge of the shield, but would not create significant interference away from the top edge. It should be recognized that the highest blisters may have been knocked off during the initial package opening. In fact, Figure 1 shows such material that likely transferred from the shield to the fiberboard assembly.

Figure 1. 9975-04194 upper fiberboard assembly after removal on December 11, 2017. Note the line of shield corrosion material that remained embedded in the fiberboard (arrows). Photo taken by KAC personnel.

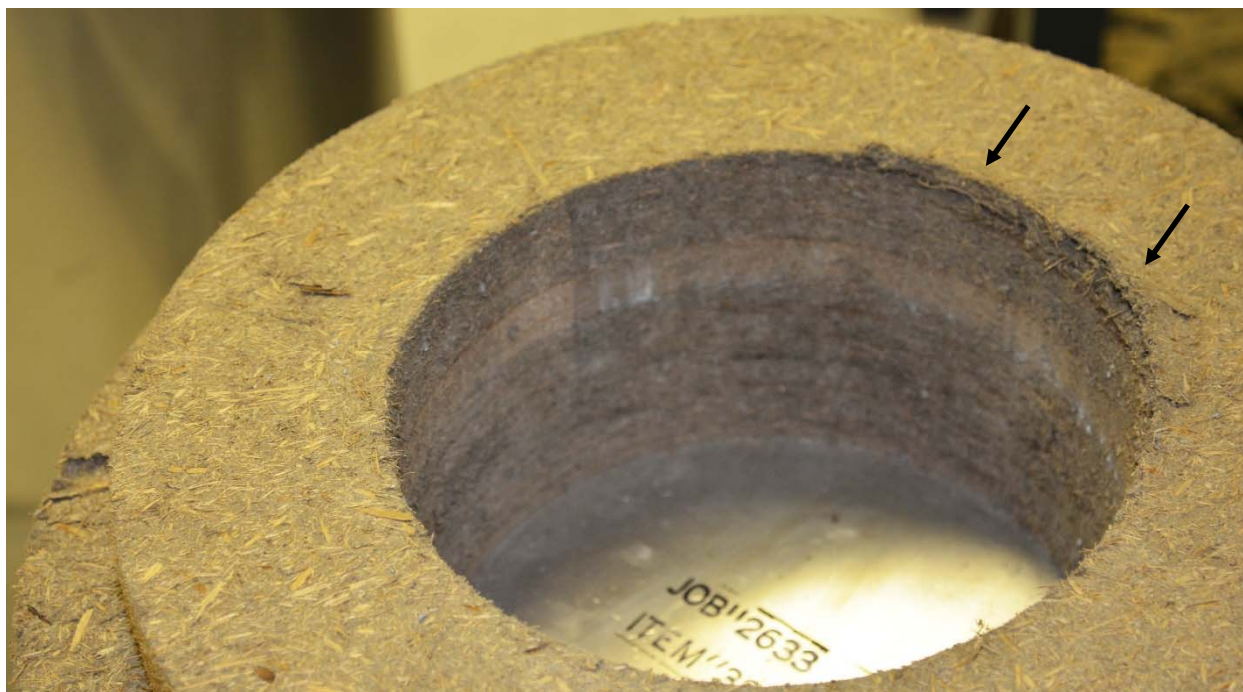
Figure 2. 9975-04194 upper fiberboard assembly showing region of flaking/peeling damage (arrows). Photo taken December 11, 2017 by KAC personnel.

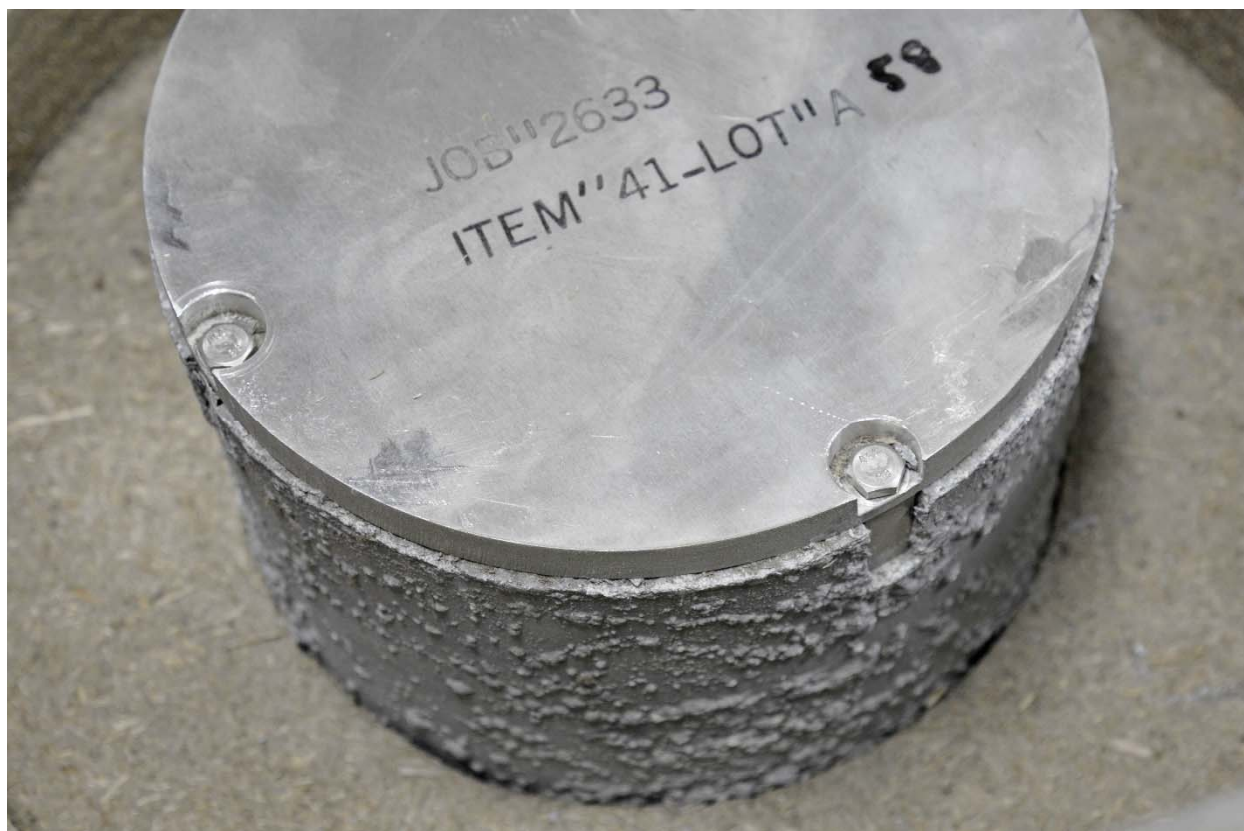
- The shield contains numerous blisters on the exposed surface, and the diameter of the shield is seen to extend significantly beyond that of the shield lid (Figure 3).

Figure 3. 9975-04194 shield when the package was first opened. Note the surface roughness and the extent to which the shield extends out past the shield lid. Photo taken December 11, 2017 by KAC personnel.

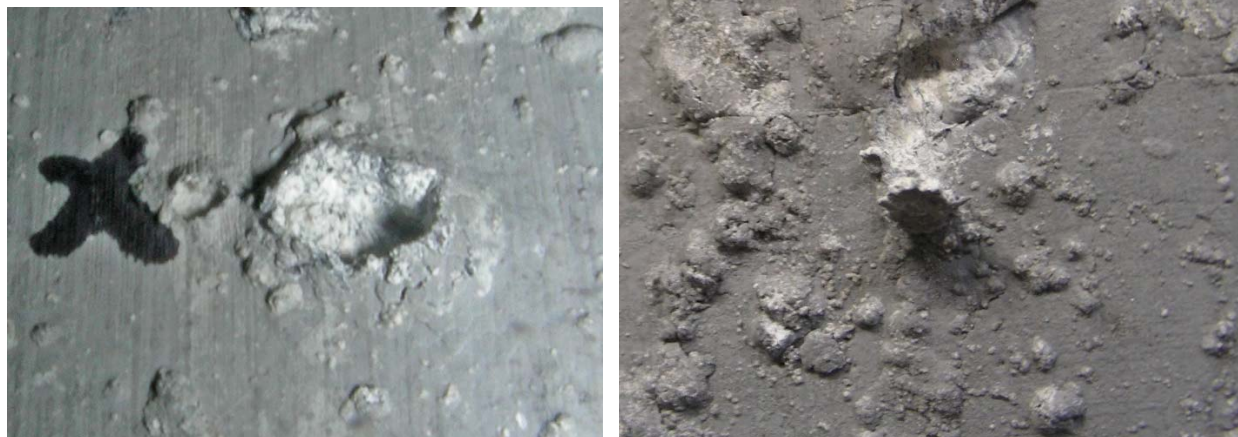
The height of several individual blisters was measured, and ranged from ~0.05 to 0.09 inch. In addition, the surface layer over two blisters was pried back, and the corrosion product underneath was scraped away (Figure 6). The cavity under one of these blisters extended about 1/8 inch below the surrounding shield surface, while the other had minimal depth below the surrounding shield surface.

Figure 6. The surface layer over two blisters was peeled back, and the corrosion product underneath was scraped away.

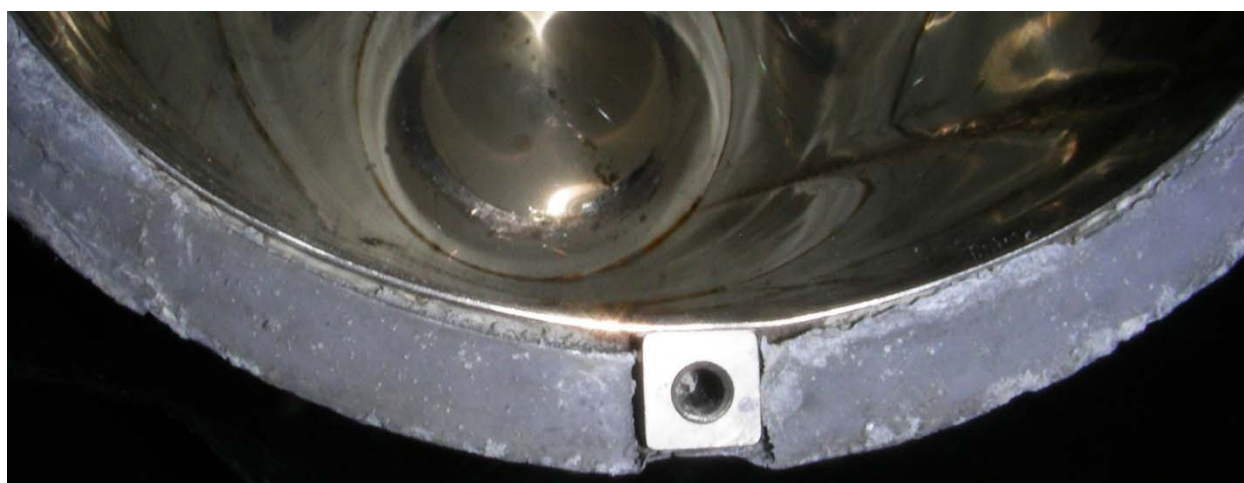
The lead had separated from the inner stainless steel liner and bolting lugs in two regions along the top edge of the shield. Figure 7 shows one of these regions. Some corrosion product is visible in the gap this created. The width of the gap between the lead and inner stainless steel liner appears consistent with the increased OD along the top edge of the shield. Measurements at several locations on the top edge show the lead ranging from 0.463 to 0.523 inch thick, with an adjacent gap of 0.073 to 0.087 inch thick and the inner stainless steel liner about 0.033 inch thick. The average measured radial gap of 0.082 inch corresponds closely to the observed diameter increase in the top 1 inch of the shield of ~0.14 inches.

In package 9975-04194, there is a gap between the lead and the internal stainless liner around much of the circumference, with the lead flaring outward over the top ~1 inch or so. This increased the shield OD by about 0.14 inch at the top, creating the limiting location that would have hindered removal of the fiberboard assembly the most. Most of the packages with surveillance photos that appeared to show blistering also showed some degree of gap between the lead and liner, although most were much less extreme. Based on a cursory look, many of the shields without blistering also show some degree of gap between the lead shield and stainless steel liner, but it seems less frequent and less severe than in the blistered shields. It is suspected that if such a gap is present, then the degree of flaring is proportional to the overall amount of corrosion around the top of the shield, whether there is blistering or not.

Figure 7. Top edge of the 9975-04194 shield showing a gap between the lead and the internal stainless steel liner.

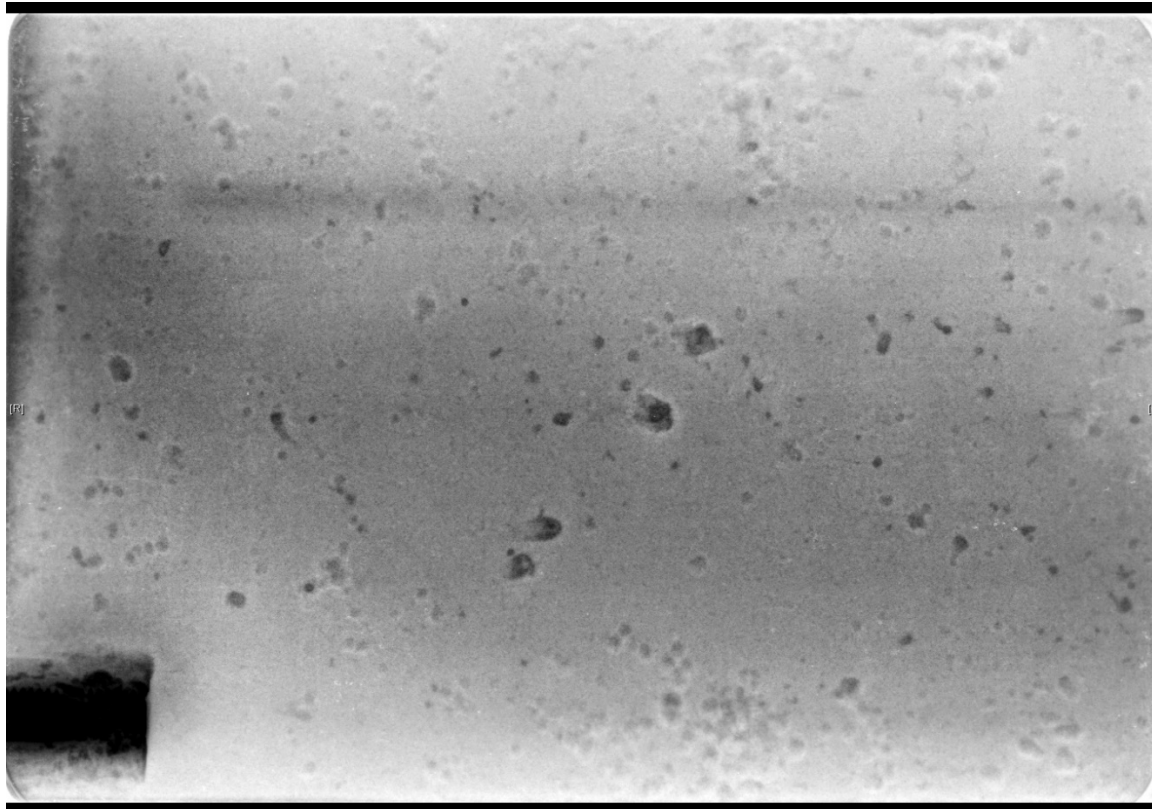
“The first image was made using Ir192 and is a shot of one wall of the shield. It appears the pitting goes from just forming and then to fairly advanced with apparently some depth. The second image was made using Co60 with a technique to demonstrate the sidewall (side profile) view of the shield to determine if any porosity was below the surface. No evidence of porosity throughout the side wall thickness was evident. Appears all pitting started on the surface and not from within.” [1]

None of the blisters imaged in the radiograph (Figure 8) show as much contrast as the stainless steel bolting lug, indicating X-ray attenuation at the blisters (the net shielding created by the lead and lead corrosion product) is greater than that of the bolting lug. Since the density of stainless steel is 70% that of lead (8.0 g/cc vs 11.3 g/cc [2]), and the shield curvature increases the effective thickness at the lug location (~1.5 inches from radiograph center) by about 9%, significantly more than 77% of the nominal lead thickness remains at the blister locations. However, since the radiographs show dark spots at the blister locations (indicating less material), it is concluded that these locations were initially pores in the lead casting. Any pores, cracks or gaps open to the surface would become filled with corrosion product, but the added carbon and oxygen would not significantly change the X-ray density.

Figure 8. X-ray image taken through a single side wall with Ir192 source.

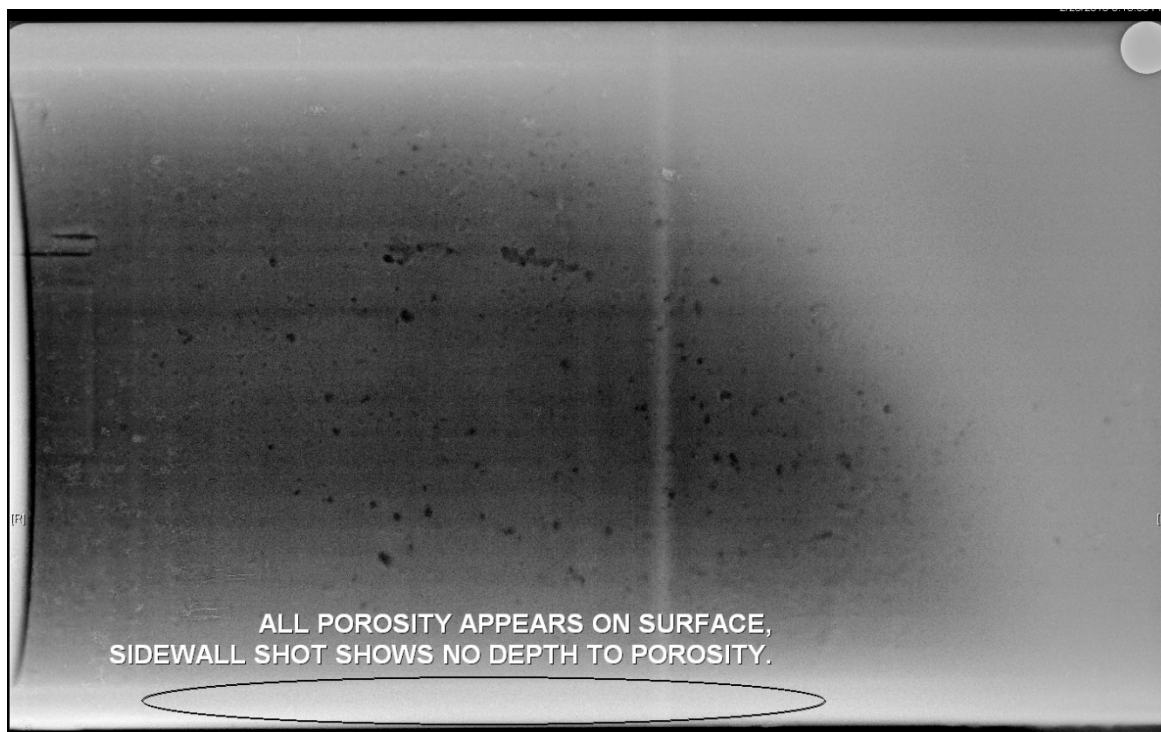
Figure 9. X-ray image taken through entire shield (double side wall) with Co60 source. Note – this is not the same region of the shield shown in Figure 8.

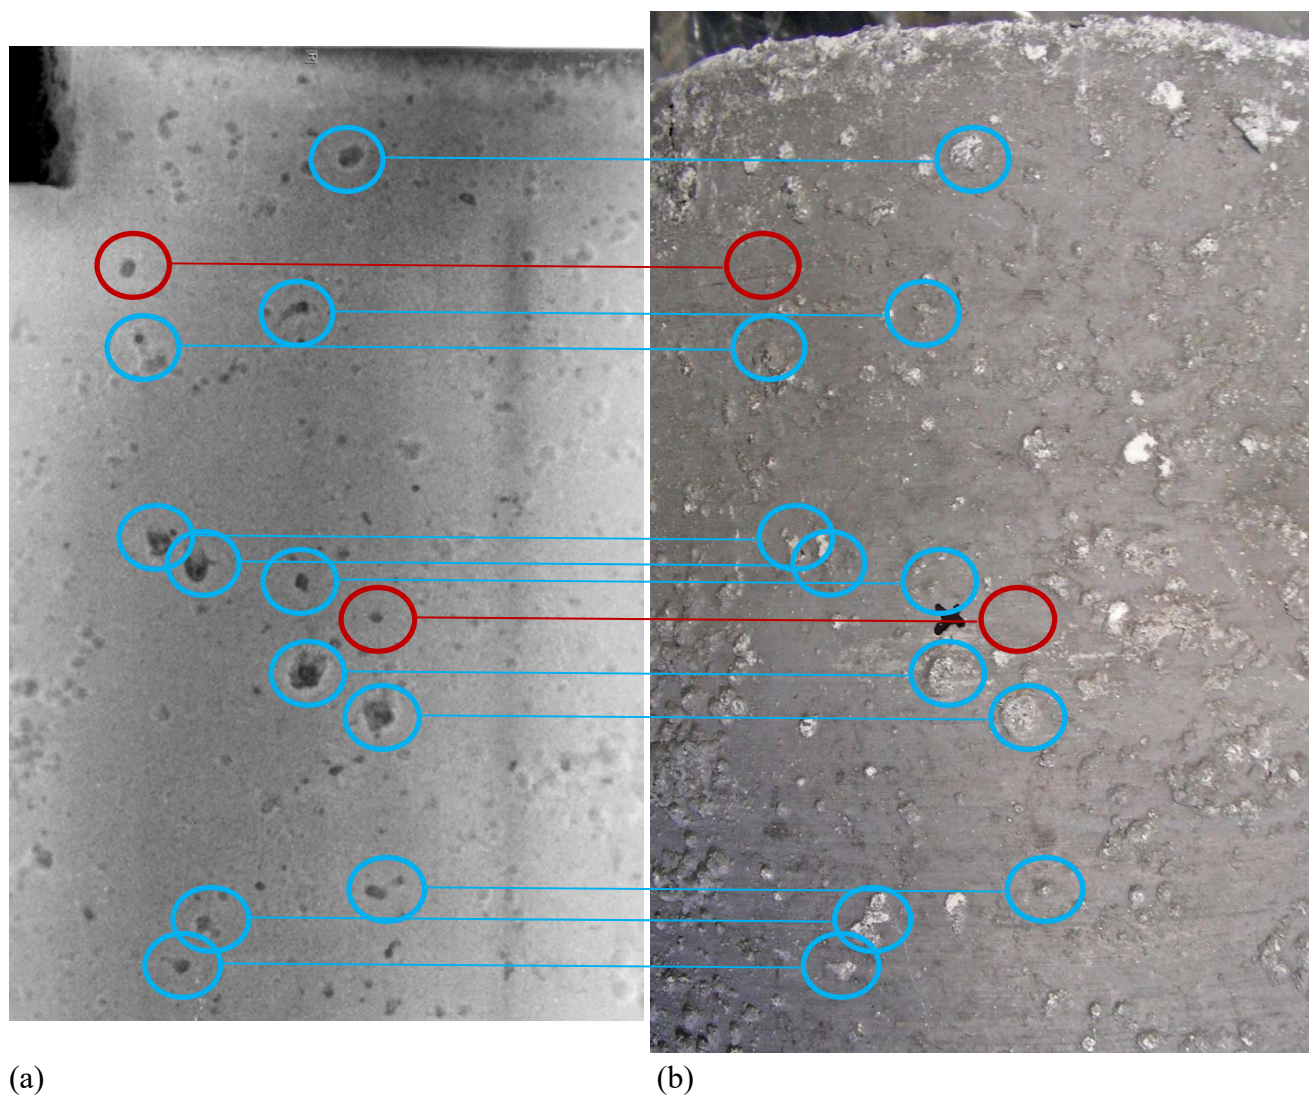
The region of the shield shown in the Figure 8 radiograph was examined visually and photographed. Figure 10 compares some of the more prominent features imaged in the radiograph with those on the photograph. Most of the features in the radiograph correspond to blisters in the photograph, and vice versa, but a few do not. Two radiographic features that do not correspond to visible surface features are highlighted in red in Figure 10. These features could represent subsurface porosity.

Figure 10. Comparison of features from radiography (a) and photography (b). Most of the features seen by radiograph correlate to visible features (blisters) on the surface, indicated in blue. The radiograph features indicated in red do not correlate to visible features on the surface.
