Characterization of Oxyhydroxides on a Dry-Stored Fuel Plate From L-Basin

October 2018

SRNL-STI-2018-00428, Revision 0

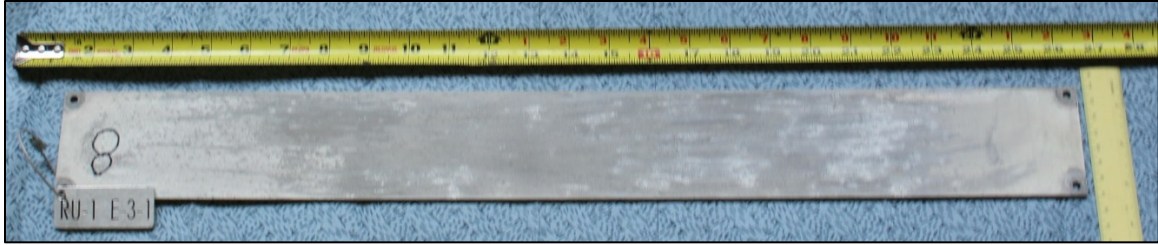
Figure 2 As-received Uruguay RU-1 fuel plate prior to characterization at SRNL.

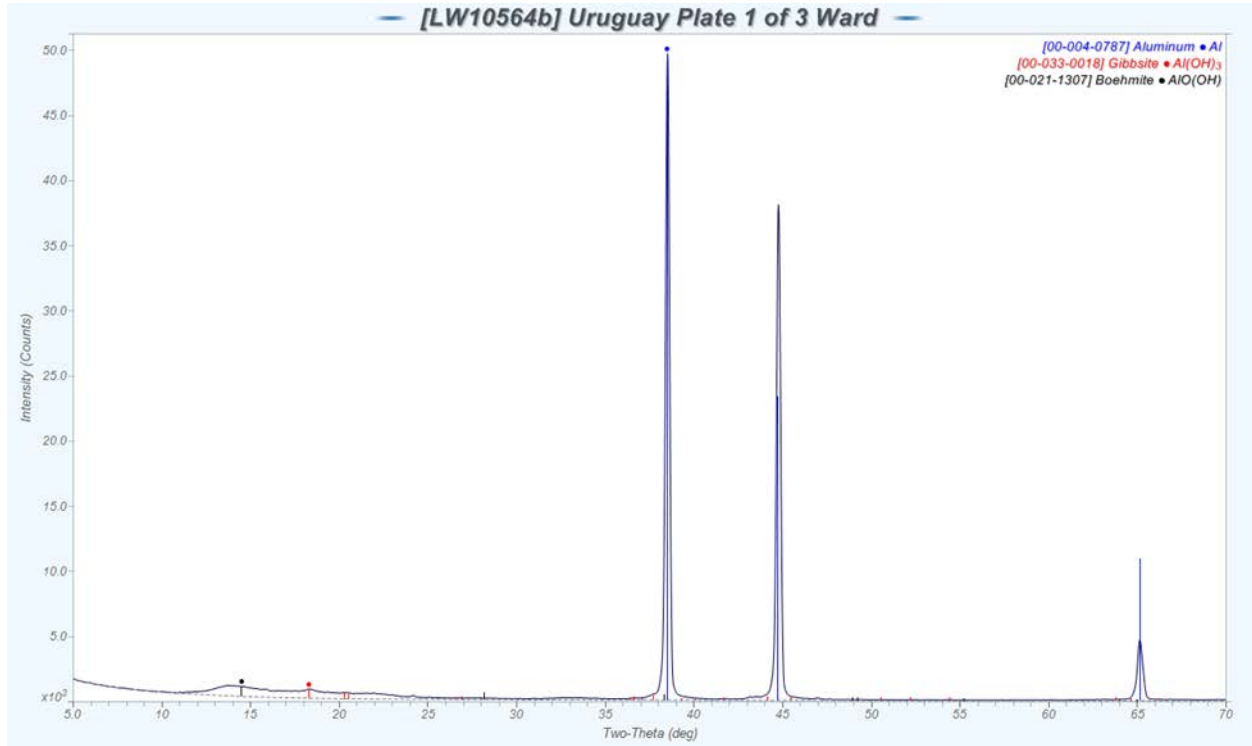
Figure 6 XRD spectrum of Sample 3 oxide.

The XRD analysis detected the base aluminum metal as well as a layer of gibbsite on the surface. This is expected since the RU-1 pool type reactor operated at low power, 10 kW, and the surface of the cladding was expected to be ~70 °C in service. Trihydroxides such as gibbsite form at temperatures below ~80 °C [8]. A shifted peak at 15 degrees may correspond to boehmite on the sample; however, this identification was less certain and would be unexpected given the known service and extended storage history.

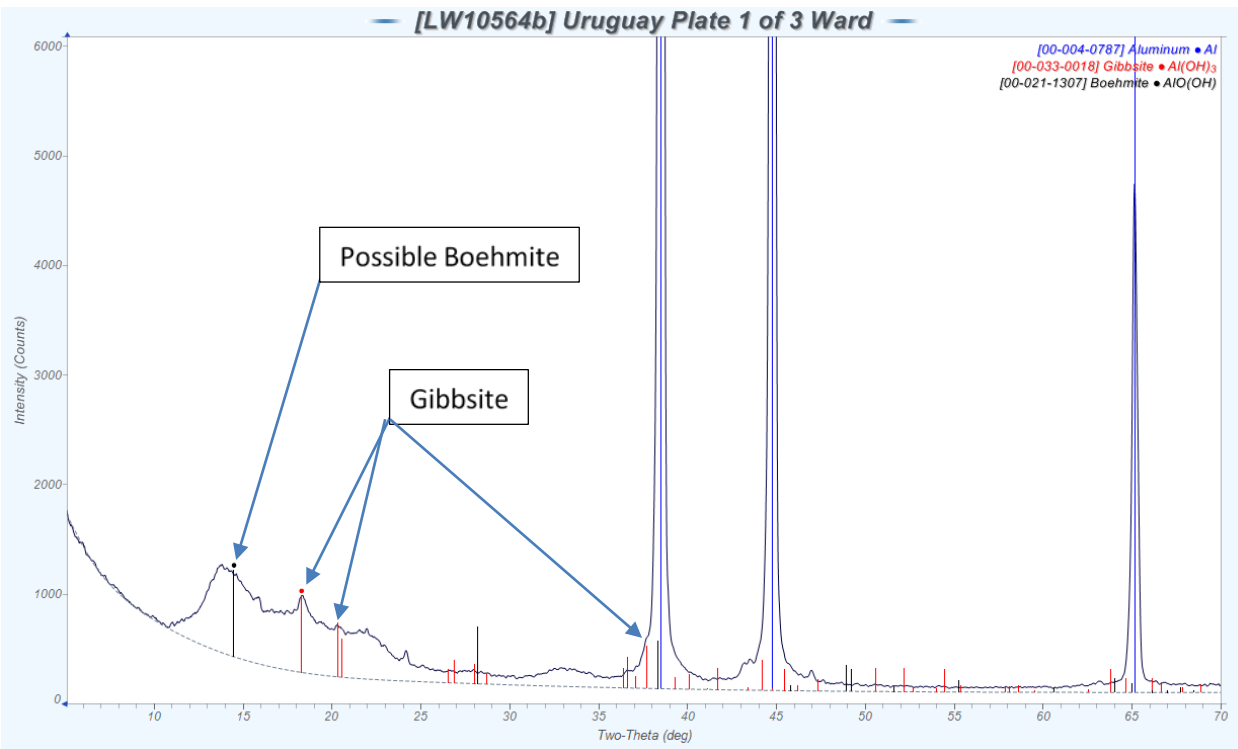
Figure 7 Scale adjusted XRD spectrum of Sample 3 oxide to more clearly show the oxide peaks.

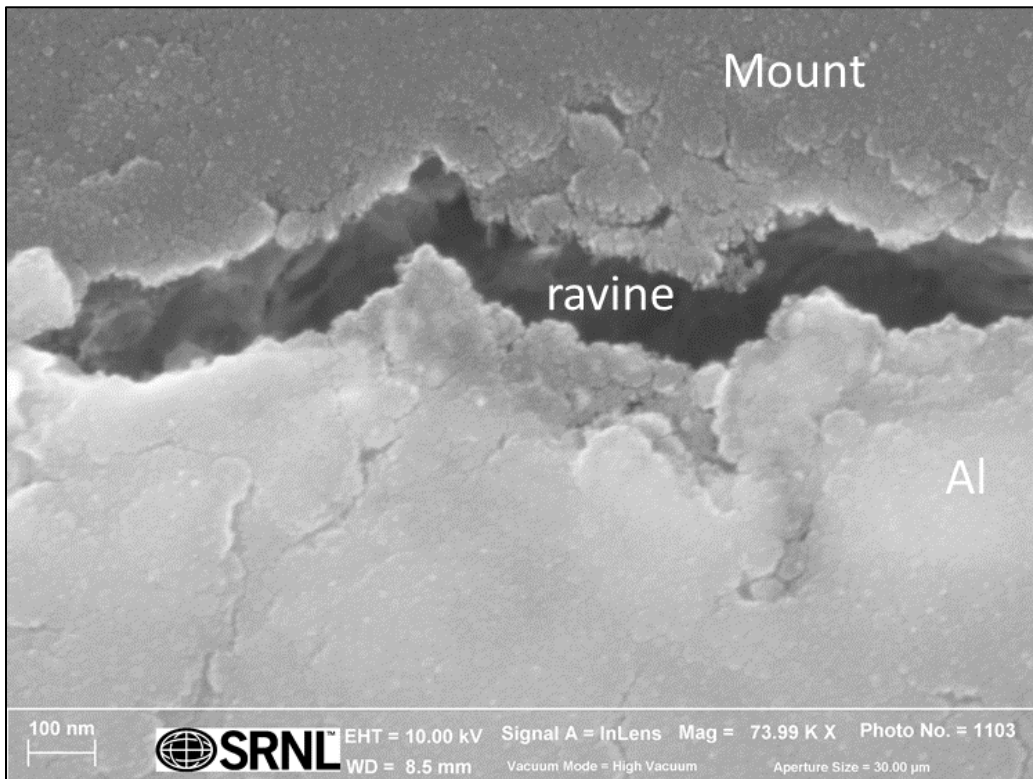
Sample 3 (Figure 3) was mounted in EpoFix without the application of a nickel plating to the oxide surface. A gap was observed to be present between the sample and the mounting material along the entire edge of the sample, Figure 8 and Figure 9. It is believed that the EpoFix mount medium likely pulled away from the oxide surface during curing to produce this gap.

Figure 9 Sample 3 In-lens image reveals "pull away" between mount & sample (74kX magnification).

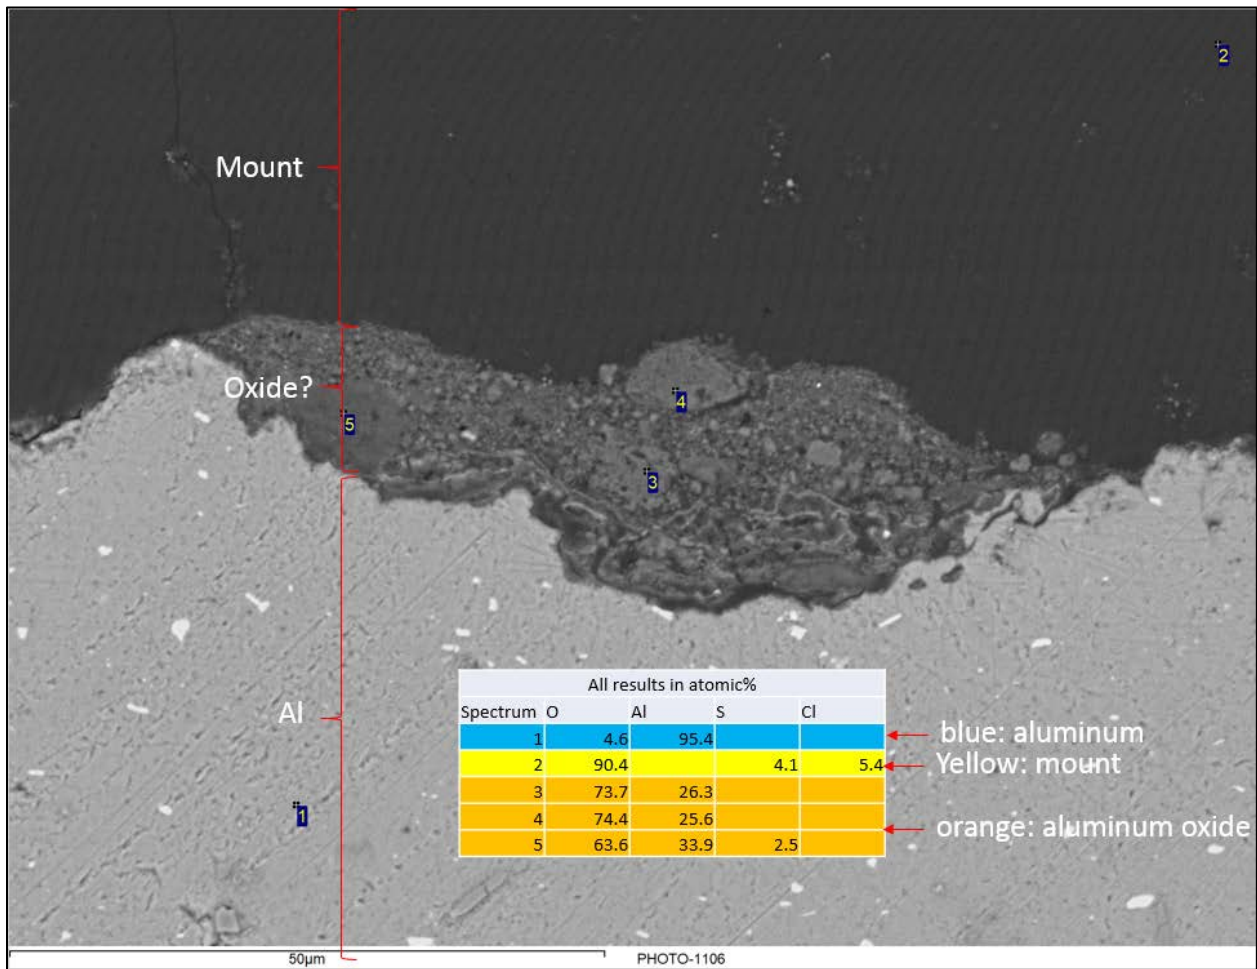
In other cross-sectioned SEM images of Sample 3, there is ambiguity between oxide and polishing debris. Debris could be introduced if the mount medium were to infiltrate the oxide or if polishing-related liquids infiltrated cracks in the oxide surface. The EDS results of these regions did reveal some oxide content (Figure 10). The EDS results should be interpreted with caution. In general, EDS spatial resolution can often be assumed to range from a micron to several microns in diameter on sample surface and into the sample.[11] More accurately, the spatial resolution is a function of the sample chemistry, density, and SEM accelerating beam voltage.[12] Using the Anderson and Hasler model for x-ray generation range, the spatial resolution for Al and O in a material with a density of 2.7 g/cm³ (aluminum) is about 3.6 μm, but the spatial resolution for Al and O in a material with a density of 4 g/cm³ (Al₂O₃) is about 2.5 μm.[12] In Figure 10, the O/Al ratios at EDS points 3 (O/Al=2.8), 4 (O/Al=2.9), and 5 (O/Al=1.9) are consistent with Al(OH)₃ (gibbsite or bayerite), Al(OH)₃ (gibbsite or bayerite), and AlOOH (boehmite), respectively.

Figure 10 Backscatter Electron Detection (BSD) image showing possible oxide layer at 1080X magnification.

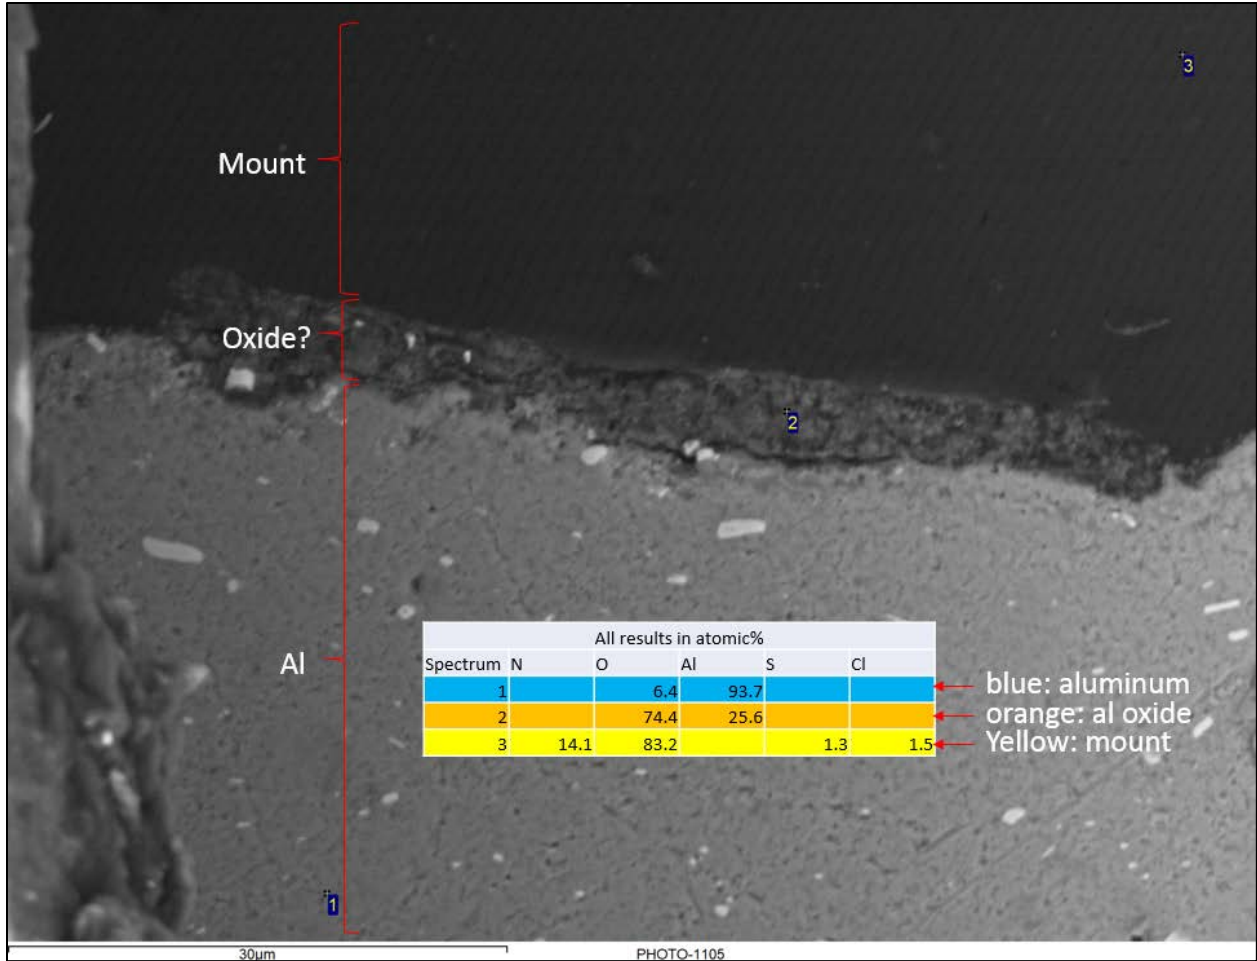
Another potential oxide is shown in Figure 11. In Figure 11, the O/Al ratio of the oxide at EDS point 2 is 2.9, which is consistent with a trihydroxide, Al(OH)₃ (gibbsite or bayerite). Image postprocessing, using the software package ImageJ, was used to determine the cross-sectional thickness of the oxide. In Figure 10, the oxide thickness ranged from 5.6 μm to 22.3 μm; in Figure 11, the oxide thickness ranged from 3.1 μm to 7.3 μm.

Figure 11 BSD image showing possible oxide layer at 1500X magnification.

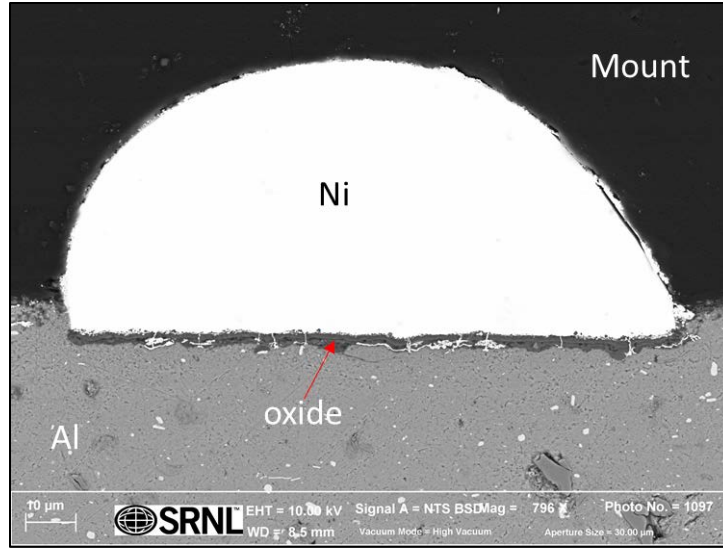
Sample 1 (Figure 3) was mounted in EpoFix after the oxide surface was nickel-plated. In general, the cross-sectional oxide image appears well defined owing to the contrast created by the nickel-plating applied prior to mounting and polishing (Figure 12). Figure 13 provides a magnified view of the oxide and the nickel plating, revealing that some nickel migrated through cracks in the oxide during the plating process. The effect of this migration of nickel through the oxide on the oxide structure is unknown. Furthermore, the oxide layer in Figure 13 appears to have a layered structure. This layered structure may be indicative of episodic oxide growth. The overall oxide thickness in Figure 13 is 2 µm. EDS performed at point 2 in Figure 13 provides an O/Al ratio of ~2.8, which is consistent with Al(OH)₃ (gibbsite or bayerite).

Figure 12 Sample 1 BSD image showing “Ni droplet” on surface of oxide at 796X magnification.

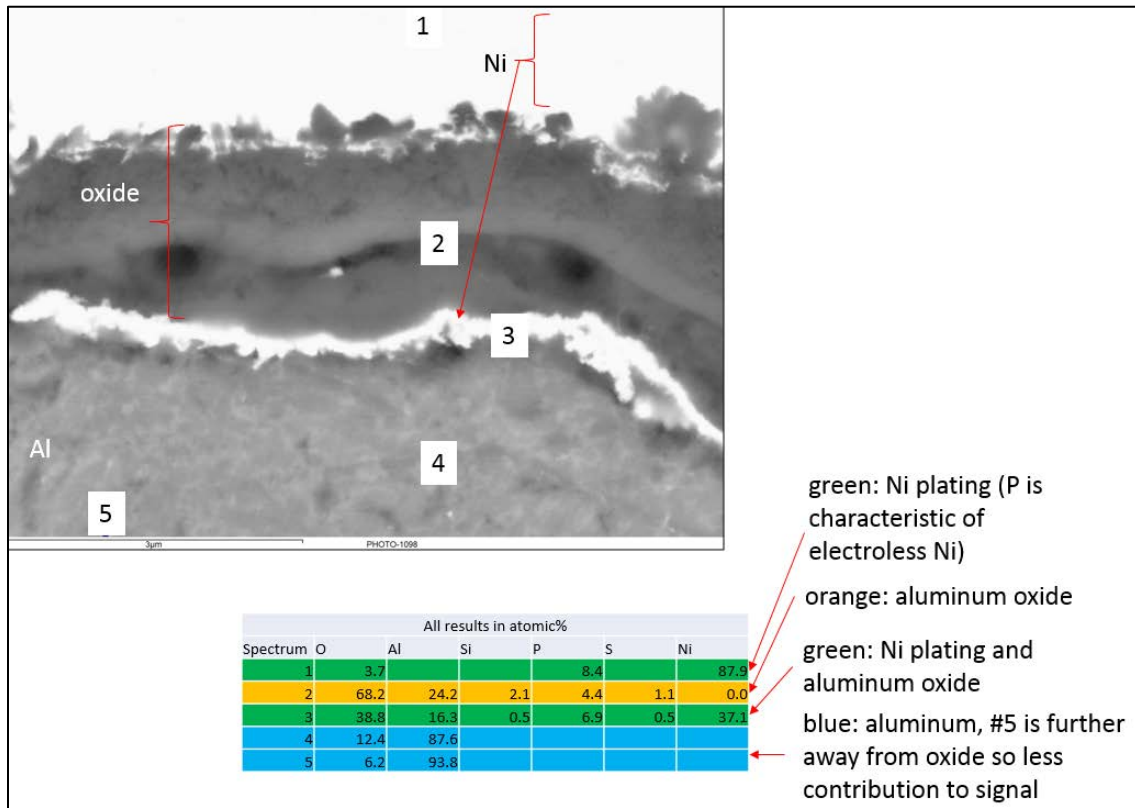
Figure 13 Sample 1 BSD image and EDS analysis of Al, oxide, and nickel surfaces (15,560X magnification)

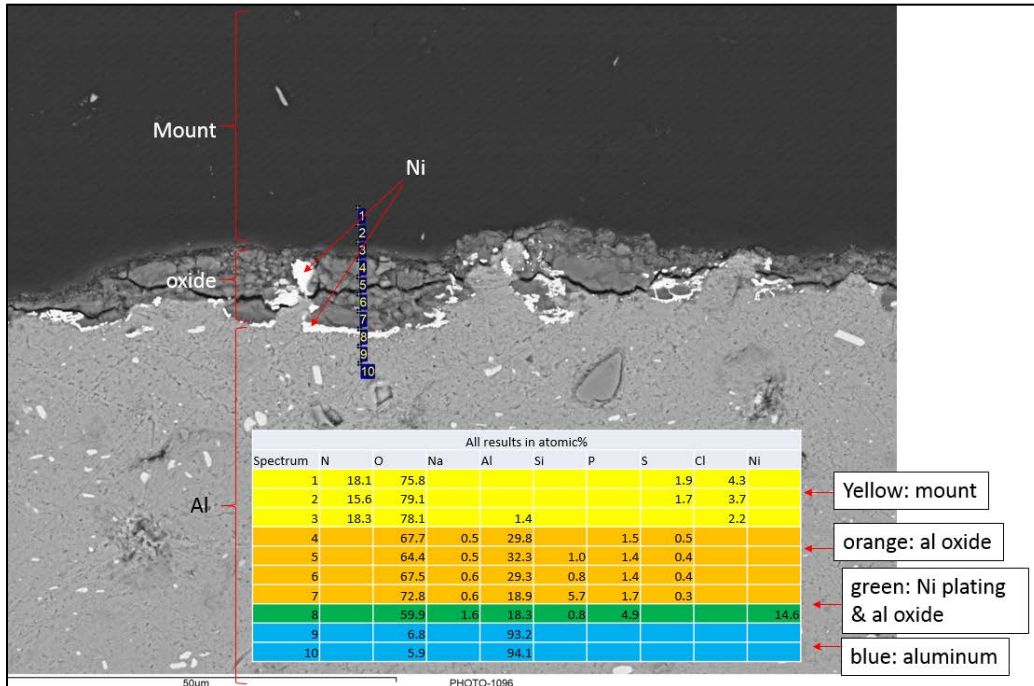
An EDS line scan was performed through the oxide as shown in Figure 14, with the EDS line-scan overlaid on an SEM image in Figure 15. These figures show how the EDS spectra change as measured across a thick oxide. The high oxygen levels of the mounting material likely contribute to the oxygen signal for the first few points into the oxide near the mounting material. As observed in Figure 13, it is apparent that the nickel migrated through the oxide and reached the region between the oxide and the aluminum surface. The oxide thickness in Figure 14 ranged from 0.5 μm to 9.6 μm. In Figure 14, the O/Al ratios at EDS points 4

(O/Al=2.27), 5 (O/Al=1.99), 6 (O/Al=2.3), 7(O/Al=3.85), and 8 (O/Al=3.27) indicate varying composition through the oxide thickness. Near the oxide-mount interface, the ratio is close to 2, suggesting AlOOH (boehmite) as the composition; however, near the oxide-Al interface, the ratio is higher (3+) suggesting Al(OH)₃ (gibbsite or bayerite).

Figure 14 Sample 1 BSD image and EDS analysis of Al, oxide, and nickel surfaces (1000X magnification).

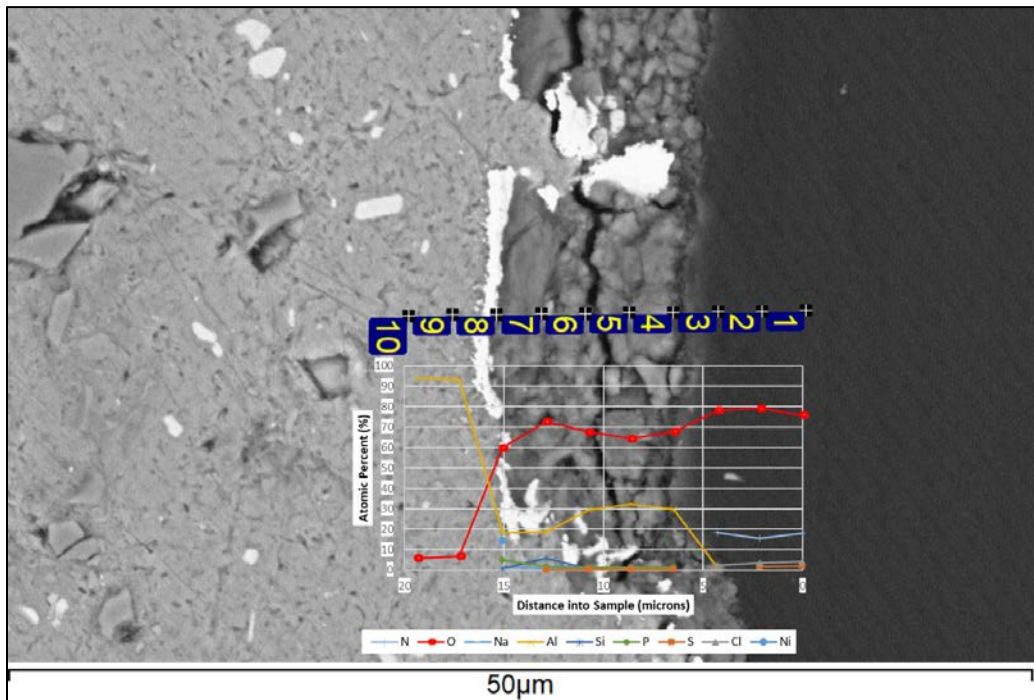
Figure 15 Sample 1 EDS line-scan overlaid on BSD SEM image of oxide.

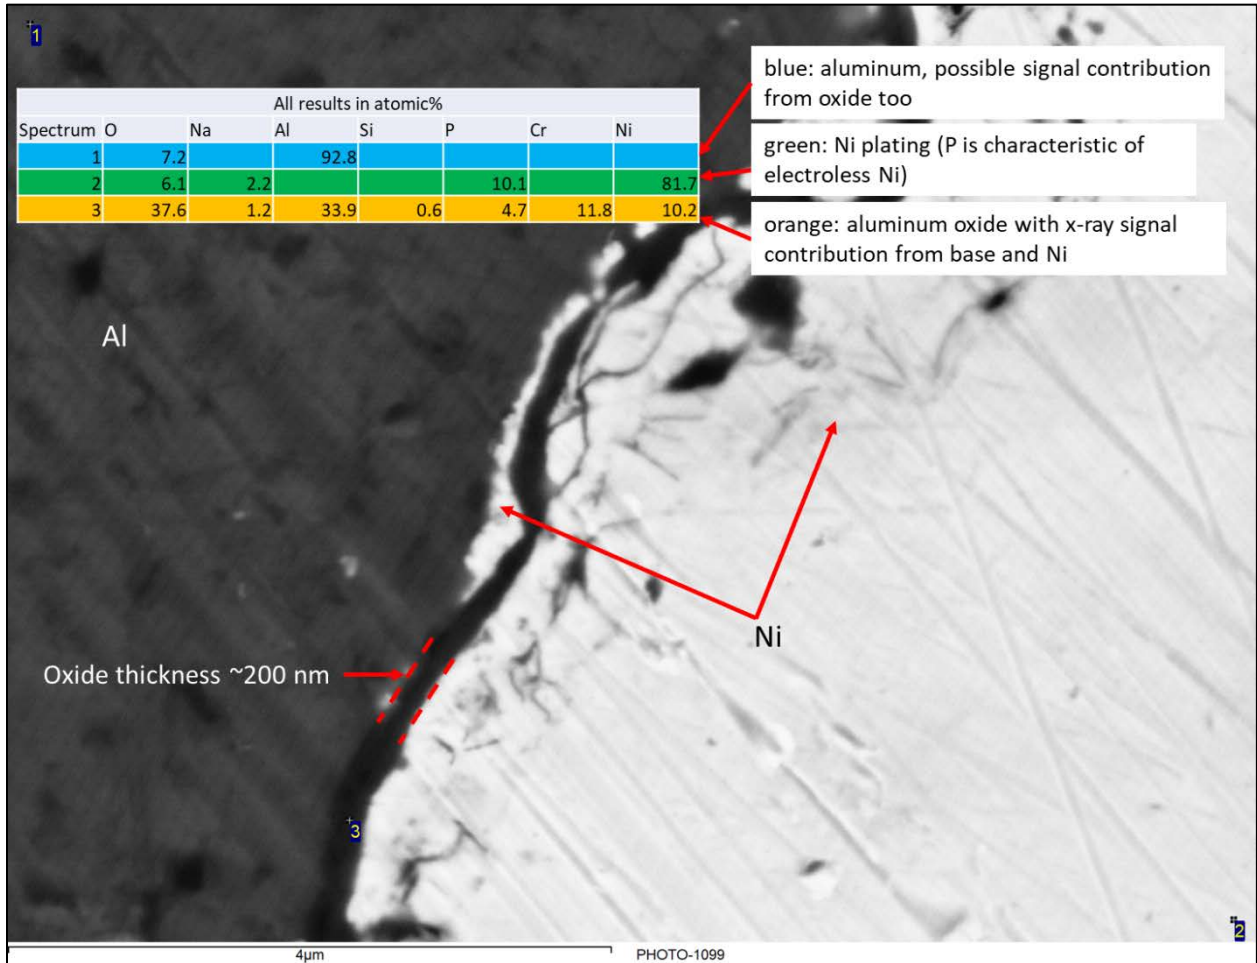
In other regions, a thin oxide layer of ~ 200 nm in thickness was retained on the nickel-plated samples, Figure 16. The EDS point scan indicates that the thin film between the Al and the nickel-plate is an oxide, but the EDS signal also has a large contribution from the nickel-plating and the Al substrate.

Figure 16 BSD image and EDS analysis of Al, oxide, and nickel surfaces (13600X magnification).

- Most of the nickel-plated sample had only very thin oxide (~200 nm thick), as shown in Figure 16. The thin oxides were observed on the nickel-plated sample, but not in the as-cut and mounted/polished sample. This may be due to damage or contamination of the thin oxide during the epoxy-mounting process. In general, the oxides were more readily visible in the nickel-plated sample. However, the potential for the nickel plating process exposure to change the native oxide chemistry and morphology is unknown.

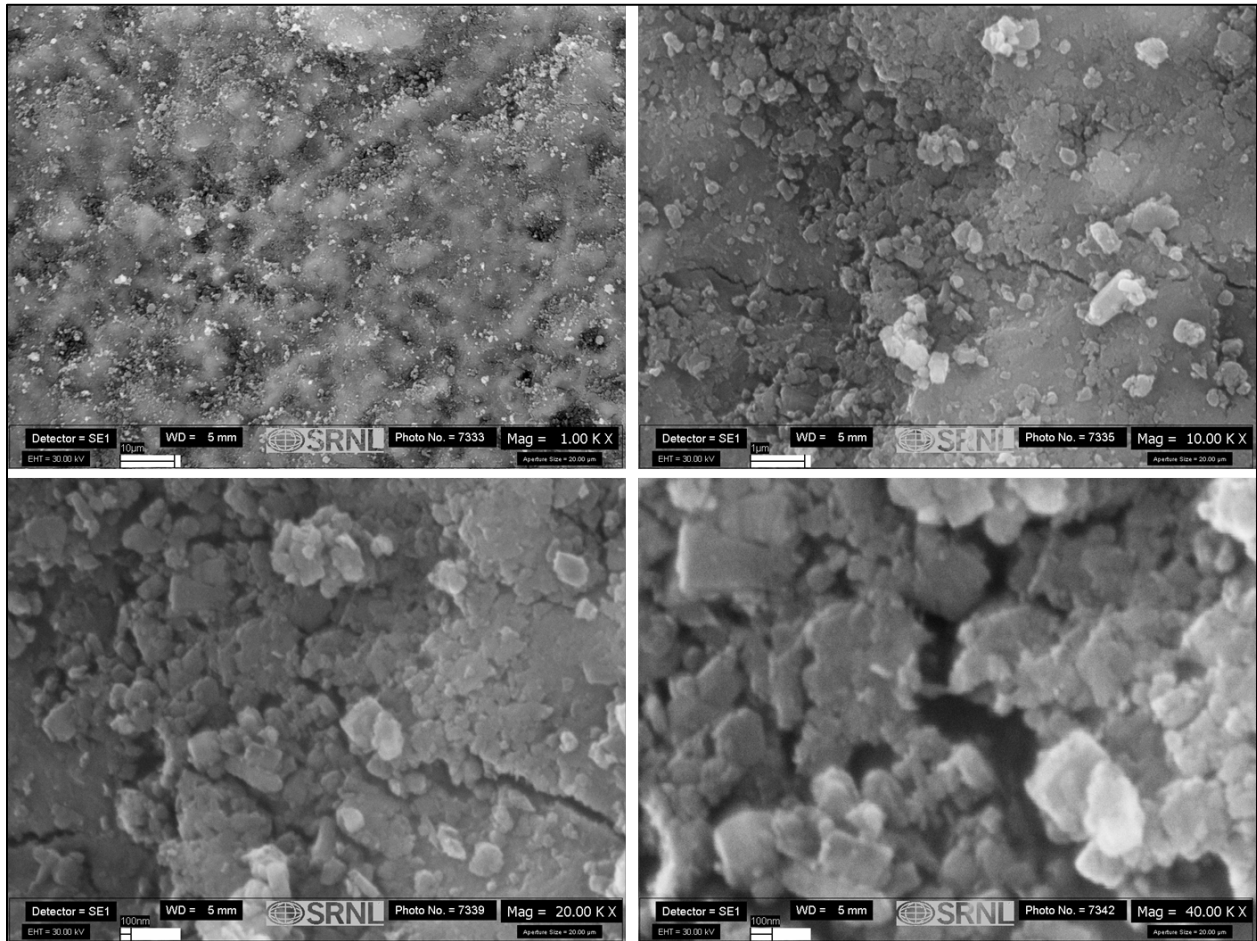
Most of the RU-1 sample surfaces were covered in a thin oxide layer, shown in cross-section in Figure 16, with thicker oxides sparsely present on the surface. From the SEM images observed previously, the majority of the RU-1 surface appeared to be covered in a thin oxide layer, ~200 nm thick, with occasional oxides ranging from ~5 to ~25 microns thick. Figure 17 shows a plan-view of this thin oxide. The thin oxide appears to be blocky and dense. The ~200 nm thick oxide is thinner than predicted from the model in section 2.3, which predicted an oxide thickness of 4-5 μm . However, Draley et al. [2] also reported that when oxides broke off, the underlying Al retained a shiny appearance and did not significantly regrow oxide, indicating that a thinner, more passive oxide would remain after sloughing. Also, as mentioned in section 2.3, Kim et al. [5, 6] reported thicker oxides (~10-45 μm) in practice on fuel exposed to similar temperature and pH conditions with the addition of water flow past the fuel.

Figure 17 Thin oxide plan-view at several magnifications.

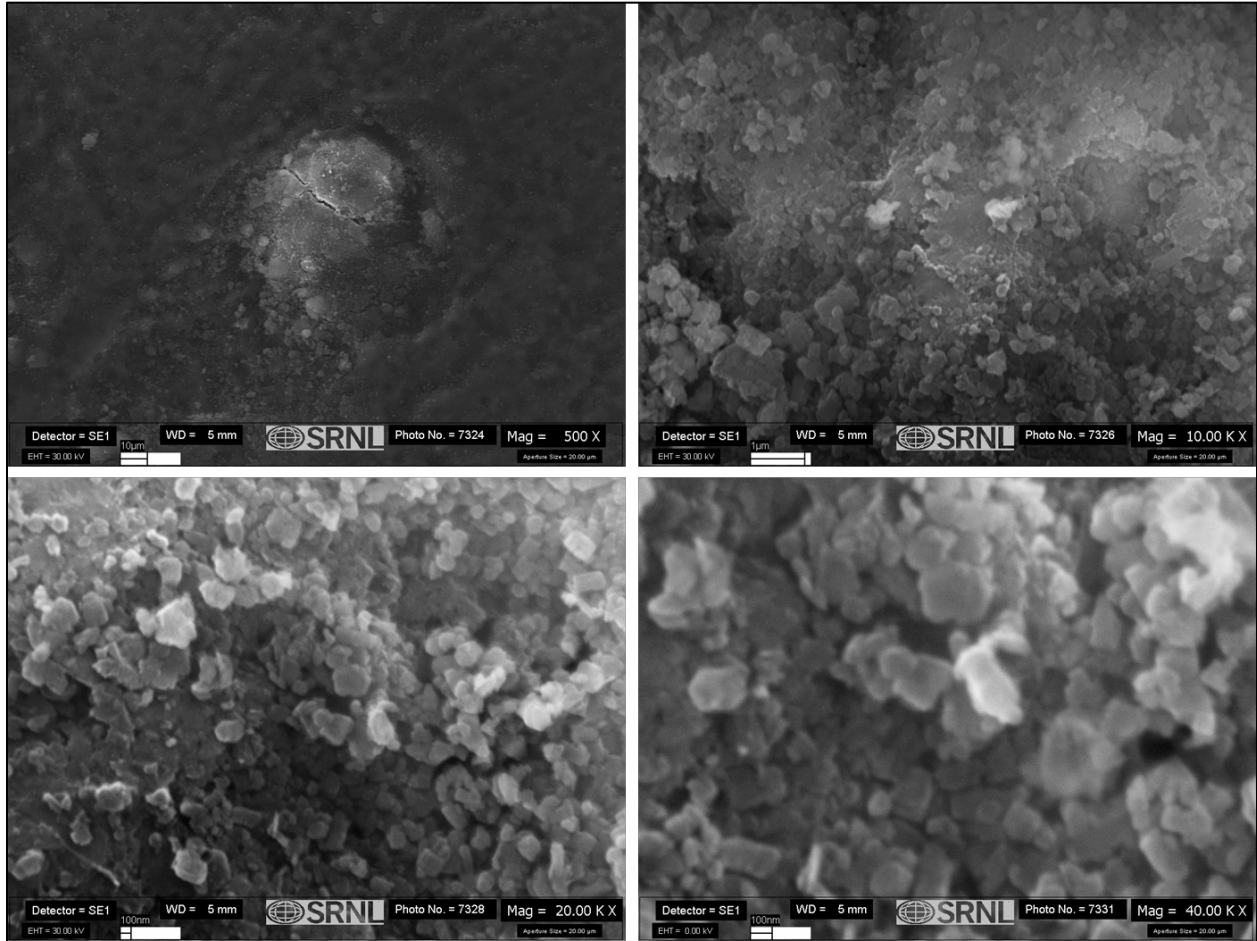
Figure 18 shows a plan-view of a region of thicker oxide. Like the thin oxides, the thicker oxides also had a blocky and dense appearance. In fact, the morphology of the thick and thin oxides appears to be indistinguishable at high magnification.

Figure 18 Thick oxide plan-view at several magnifications.

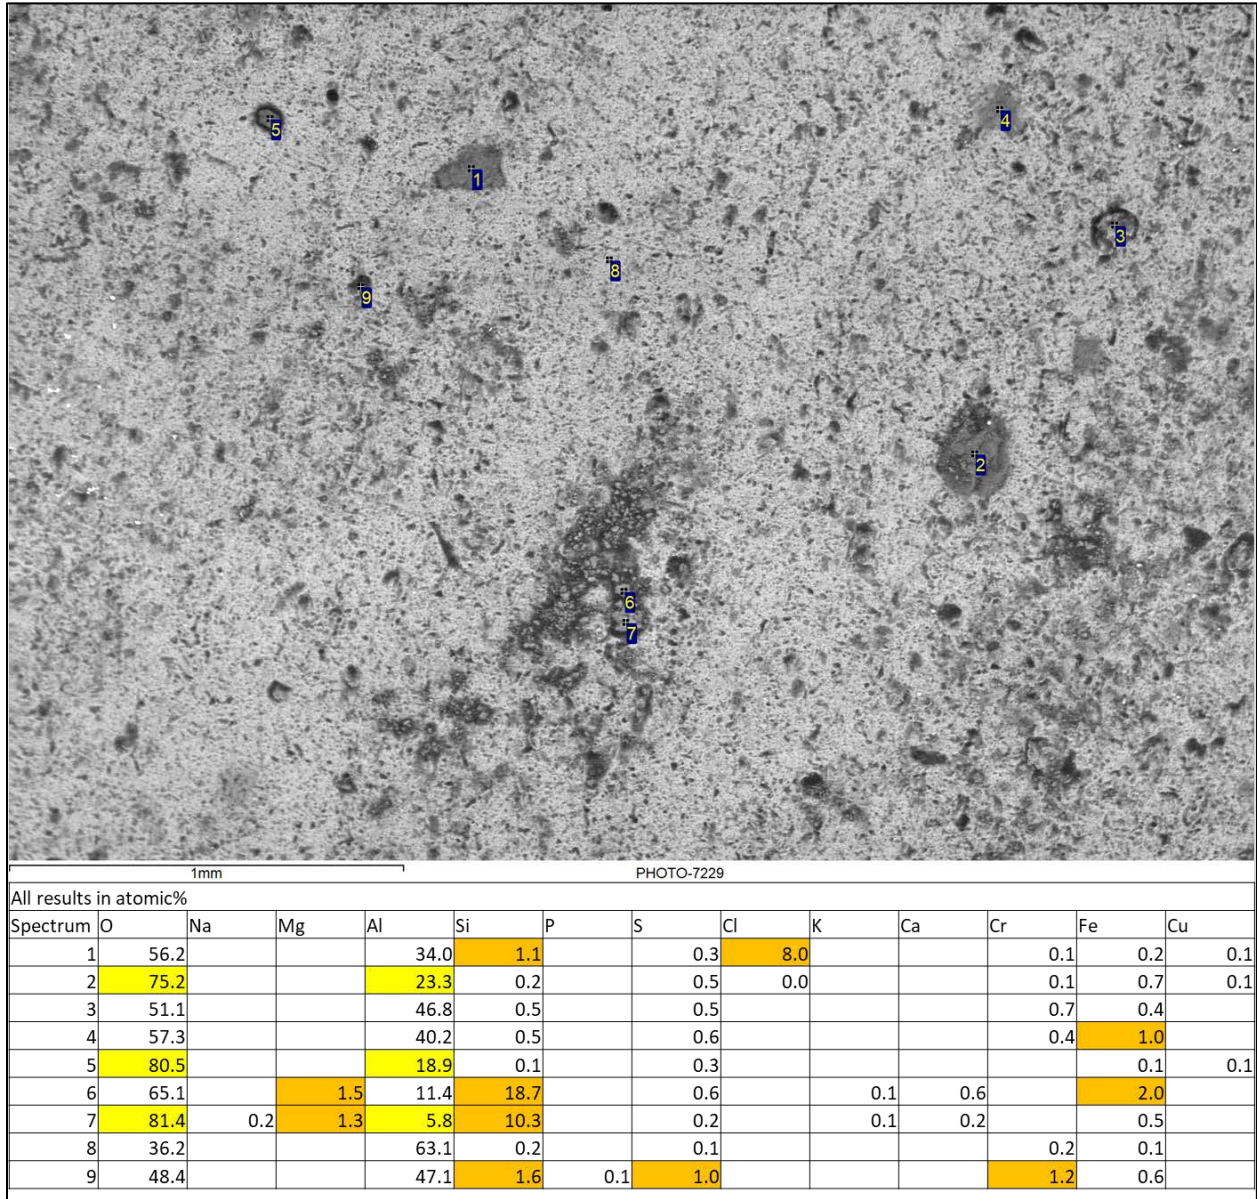
Figure 19 shows plan-view EDS point scans on the surface on the thin oxide as well as several of the thicker oxide patches. Due to topological and orientation effects of the electron beam, sample, detector, and unknown underlying substrates, the EDS results could have large error. In the EDS results in Figure 19, the oxygen and aluminum results are highlighted yellow for what are believed to be thick oxides, and other elements are highlighted orange which are above 1% atomic concentration but not aluminum or oxygen.

Figure 19 SEM plan-view with EDS points and corresponding composition results.
