Stainless Steel Corrosion during H-Canyon Resin Digestion

E. A. Kyser
J. I. Mickalonis

October 2018

SRNL-STI-2018-00603

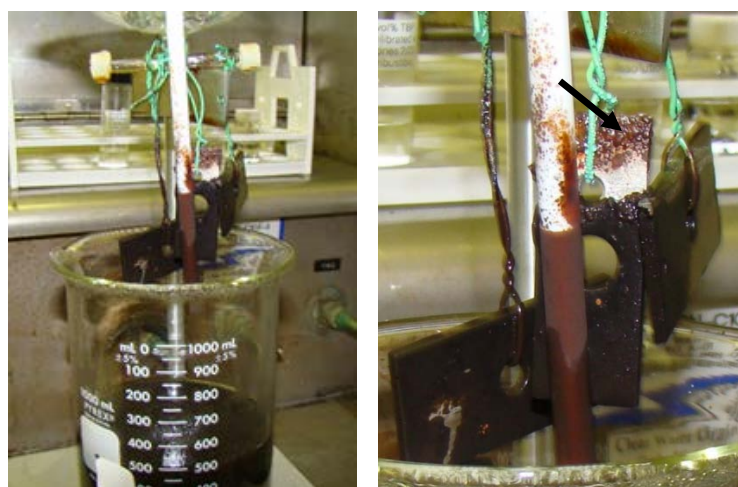
The non-welded coupon (304L #10) has a corroded area near the hanger wire in the upper portion of the coupon. In Figure 3-1, this area is covered with reddish rust as indicated with the black arrow. In Figure 3-2, this area is discolored. The coupon weight loss was not consistent with the

Figure 3-1. Coupon appearance at the end of a 15-h acidic digestion - Test 1 chloride form resin.

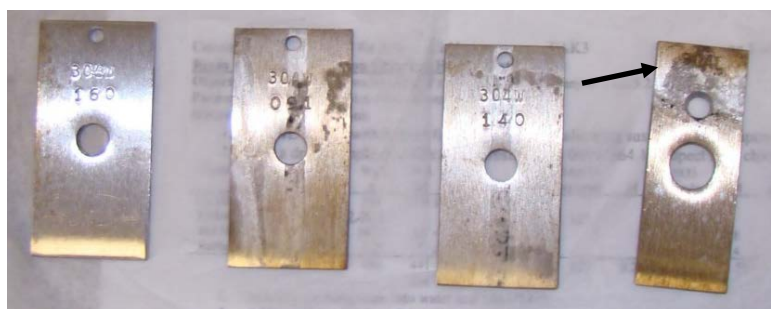
Figure 3-2. Coupons from Test 1 after cleanup. (from left to right) vapor, interface, submerged welded coupons, and non-welded coupon at the interface. Black arrow denotes area with accelerated corrosion near position of uncoated hanger wire.

other coupons and it was postulated that condensation of acidic fumes may have corroded the end of the copper-based hanger wires used to suspend the coupons. In subsequent tests, the ends of these wires were coated with epoxy to avoid this potential problem. Generally, these coupons had some visible corrosion and suspect pitting as determined macroscopically like that observed in the HGR testing.

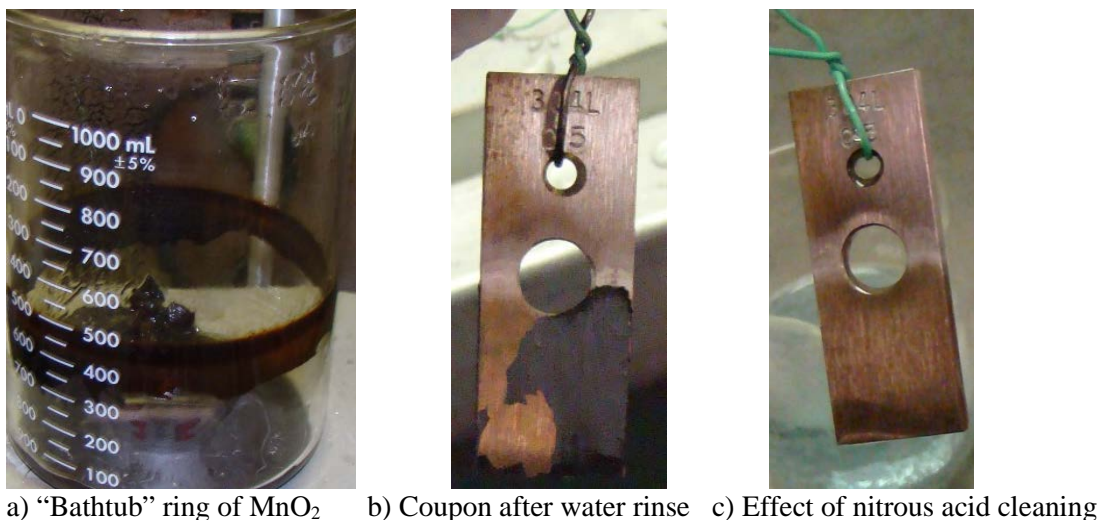
Figure 3-5b shows the MnO_2 coating that remained on a coupon after the initial water rinse. Further cleaning by immersion into a nitrous acid solution removed all the bulk MnO_2 but a small amount of stain remained (Figure 3-5c). After cleaning, there was visual evidence of corrosion on the submerged welded areas of the coupons but not in the vapor phase (Figure 3-6). There was some residual stain from the MnO_2 but there was no evidence of suspect pitting as observed in Test 1.

Figure 3-5. Test 2 cleanup showing MnO₂ coating on beaker and coupon #05.

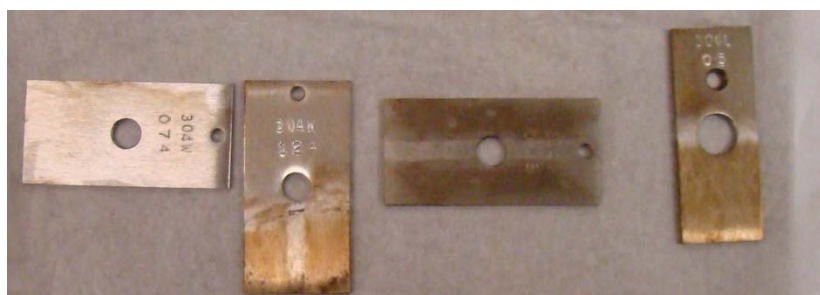
Figure 3-6. Coupons from Test 2 after cleanup: (from left to right) welded vapor, welded interface, welded immersed, and non-welded interface. Staining is prevalent on the coupons.

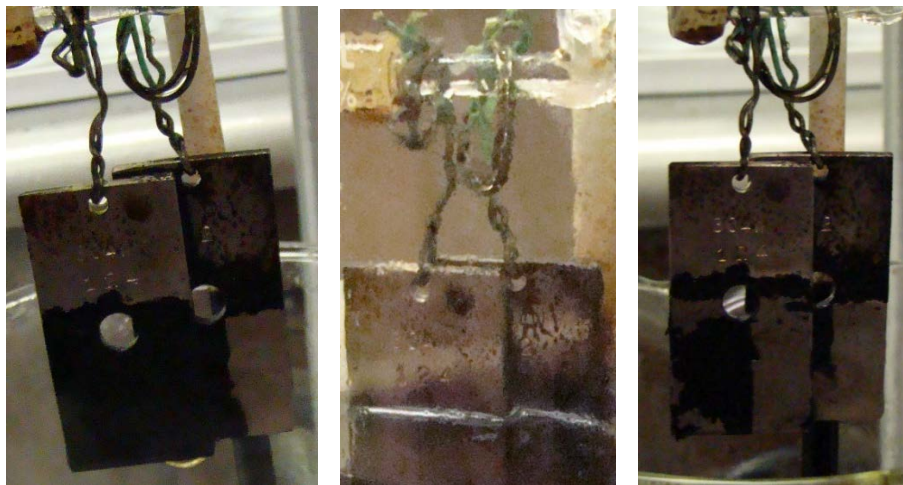
This test used the same chemical conditions as Test 2 but was performed during the day-shift so that the test could be monitored periodically (~ hourly) and was performed for only 5 hours, whereas Test 2 was performed for 15 hours. The persistence of permanganate and the development of the MnO₂ layer was monitored. Additionally, this test provided the opportunity to re-expose a coupon to the acid digestion to simulate the two acid digestions conducted in Tank 5.2. Coupon #124 from Test 2, which was exposed in a vertical interfacial position, was re-exposed in Test 2a in the same type position. Figure 3-7 through Figure 3-12 show the progression of the MnO₂ layer and the coupon surfaces over the course of the test. Figure 3-7 shows the appearance of the coupons at the beginning of the test and the solution level on the coupons. Figure 3-8 shows the splatter of permanganate on the coupons and the thermocouple and wire supports just 30 minutes into the test. After three hours into the test (Figure 3-9) the purple color of permanganate was not prevalent on the coupons, but the solution was still purple. The rate of gas bubble formation was significantly reduced from the initial hour of the test. Four hours into the test (no picture shown), a drawn sample of the solution was noticeably paler in color but still purple. After five hours of heating, the solution color was obviously different. Figure 3-10 shows the coupons at that time. Even though there is a drop of purple-colored solution hanging from a wire, the coupons and supporting hardware have been washed down with condensed liquid leaving minimal permanganate on the upper surfaces of the test vessel. Figure 3-11 shows that the pH adjustment with caustic had a slight effect on the

MnO₂ coating but most of the coating remained intact until the coupons were cleaned with water washing and then nitrous acid treatment (Figure 3-12).

Figure 3-11. Coupons before and after caustic adjustment.

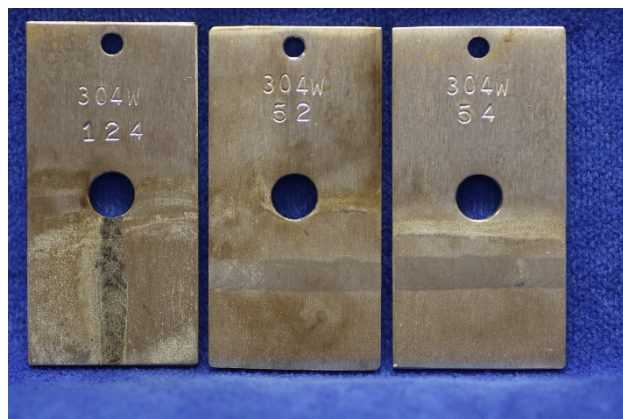
Figure 3-12. Corrosion coupons from Test 2a after cleaning. (304W #124 exposed to both Test 2 and 2a, 304W #124 and #52 exposed through neutralization step, 304W #54 removed prior to neutralization step)

The test results for Test 2a show several factors about the corrosion during acid digestion. First, a comparison of the corrosion rate of Coupons #52 and #54 from Test 2a to that for Coupon #124 from Test 2 show corrosion rates (83 and 91 mpy from Test 2a versus 44 mpy for Test 2) are double for test times that are approximately half as long (8 hours for Test 2a and 15 hours for Test 2). These differences indicate that the most corrosion occurs early during the process, which is probably associated with the permanganate activity. As stated earlier, a Test 2a observation was that permanganate activity appeared to be reduced after 4-5 hours of testing.

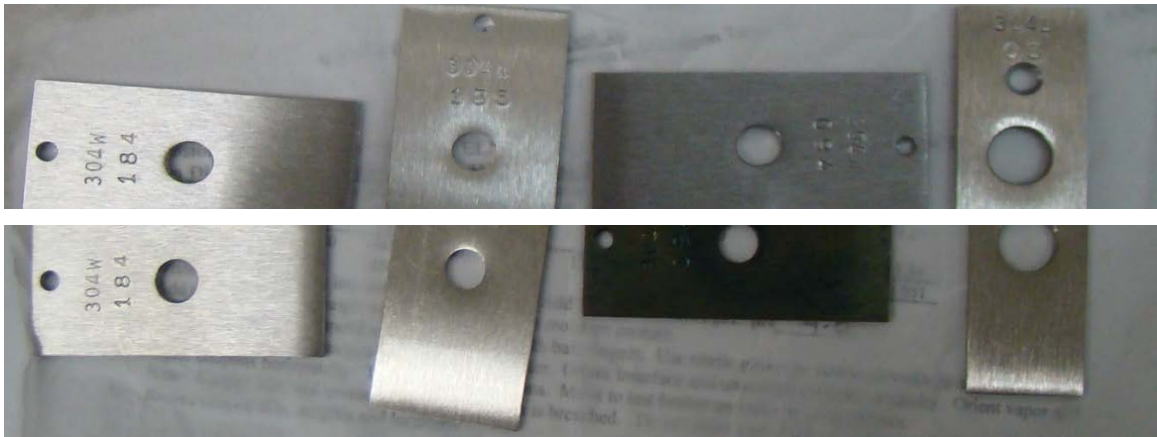
The submerged coupon from this test was not nitrous acid cleaned. The weight loss (see Table 3-1) was essentially zero for this test for all coupons. Figure 3-16 shows the appearance of all four coupons before and after the test.

a) Above-pre-test b) Below post-test-submerged coupon not cleaned
Figure 3-16. Test 3 Pre- and post-test appearance of coupons.

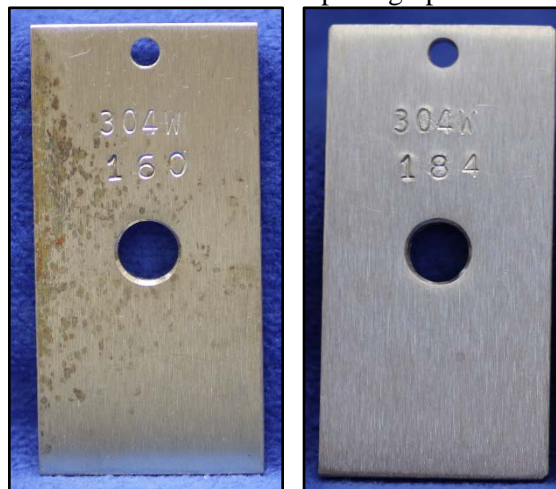
In all three tests, the vapor exposure conditions were the least corrosive with minimal localized corrosion occurring on the stainless steel coupons, which coincided with low general corrosion rates. The acid digestion coupons showed some rust staining and oxide discoloration, while the neutral pH digestion coupons appeared almost like new with limited oxide discoloration. Figure 3-17 shows the vapor-exposed 304W coupons from Tests 1 (chloride form resin with acid digestion) and 3 (nitrate form resin with neutral pH digestion). The rust staining on the coupon from Test 1 can be seen on the left-hand side of the photograph.

Figure 3-17. Vapor-exposed coupons from Tests 1 (#160, acid digestion) and 3 (#184, neutral pH digestion) using nitrate form resin

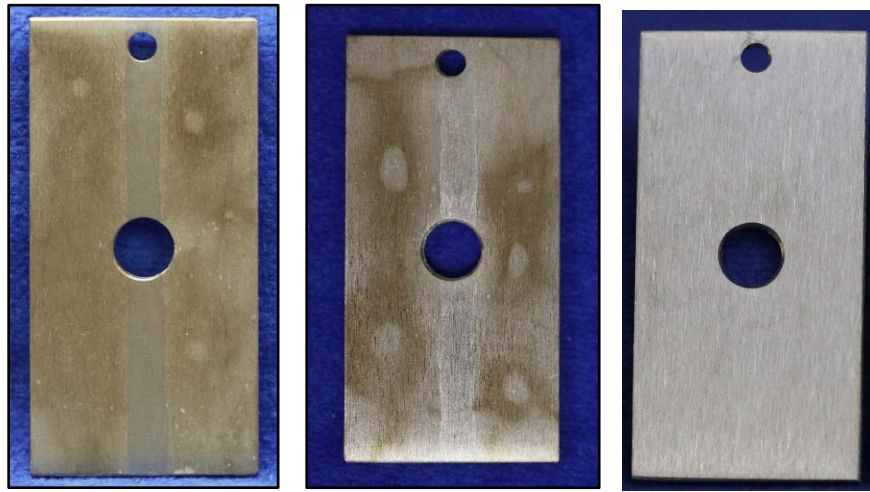
The presence of chloride ions could further accelerate the observed depth of attack, but with the measurements made this was not observed. The depth of penetration in Figure 3-20 measured $27\text{ }\mu\text{m}$ (1.1 mils). On the coupon from the chloride form resin digestion (Test 1) depths generally measured between 10 and $15\text{ }\mu\text{m}$ (~0.5 mils). In welds, maximum measured depths were higher ($36\text{ }\mu\text{m}$ (1.4 mils)). The more significant corrosion in the weld was measured as the greater width of this pit. The weld corrosion occurs by preferential corrosion of the interdendritic areas first, similar to IGA for the base metal (see Figure 3-24 for an example of interdendritic attack).

Figure 3-18 Liquid-exposed coupons from Test 1 (left, acid digestion) and Test 2 (middle, acid digestion) and the vertical interfacial coupon from Test 3 (right, neutral pH digestion).

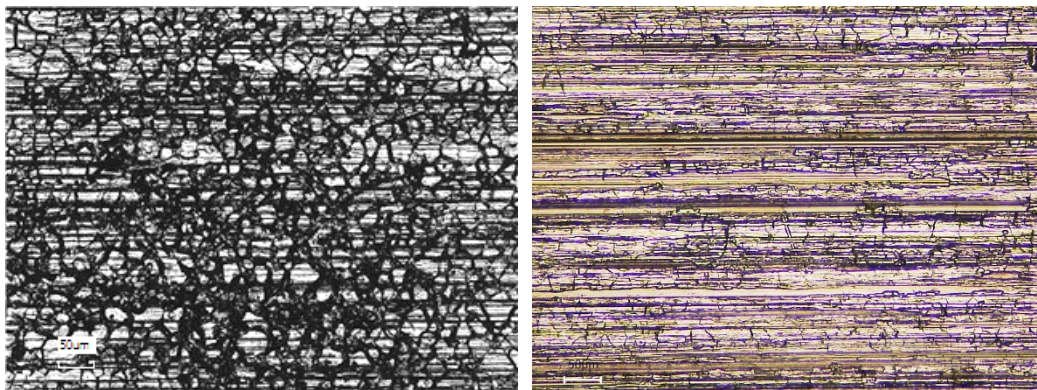
Figure 3-19 Micrographs (200x) showing the intergranular attack observed on the immersed coupon from Test 1 using the chloride form resin acid digestion

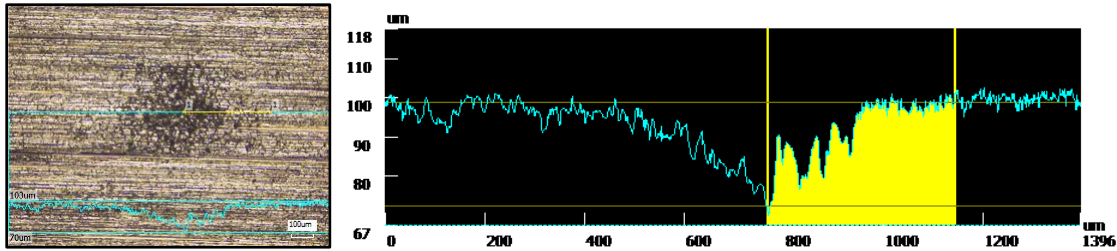
Figure 3-20. Micrograph (100x) of immersed 304W coupon (#148) after a 15-hour acid digestion of the nitrate form resin at 76 °C (Test 2) showing IGA on the surface along with an area of grain drop out; line profile through area of grain drop out

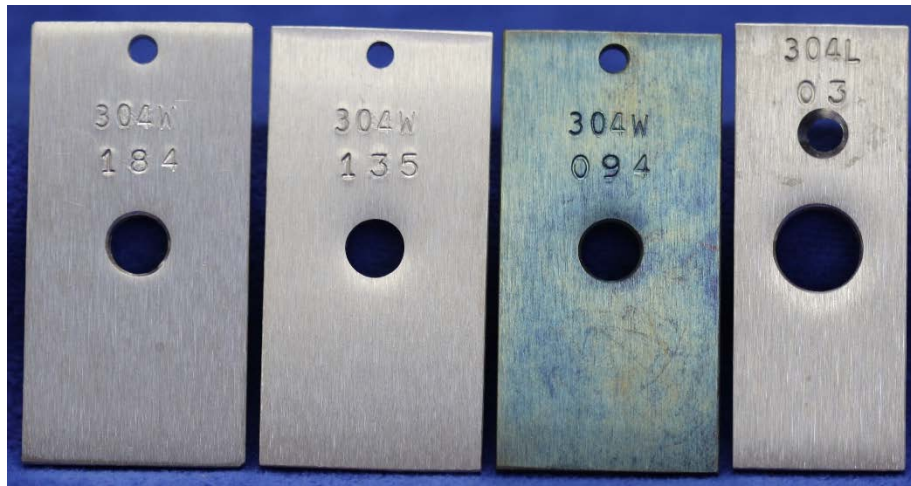
Figure 3-21. Test coupons from Test 3 after 15 hours of the nitrate form resin neutral pH digestion performed at 76 °C; coupons are shown in the following order: 304W vapor-exposed only, 304W interfacial exposure, 304W liquid-exposed only (not cleaned in nitrous acid), 304L interfacial exposure.

As shown in Figure 3-21 the neutral digestion coupon (304W #094) from Test 3 was different in appearance with a residual blue stain at the surface since it was not cleaned in nitrous acid like the other coupons as discussed earlier. However, the interfacial coupons (304W #135 and 304L #03) with approximately half the surface immersed in the liquid, which were cleaned in the nitrous acid as all the other test coupons, were not colored. The surfaces on these coupons showed no signs of intergranular attack or accelerated attack of the weld to highlight its presence.

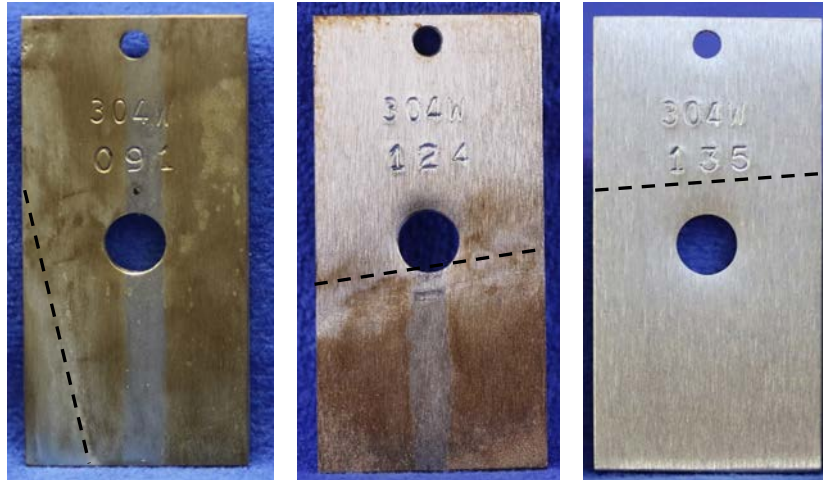
For Test 1, the coupon had similar corrosion morphologies on the vapor-exposed and liquid-exposed portions of the coupons as those discussed previously. The vapor-exposed portion showed some staining and slight IGA since most of the vapor-exposed area was close to the liquid. The liquid-exposed portion had IGA, grain drop out and pitting similar to that discussed above for the liquid exposed coupons. The pit-like features had similar depth measurements 10-15 μm (0.4-0.6 mil). At the interface, however, the corrosion was more extensive as noted by wider areas of IGA and trenching (a coalescence of individual areas of grain dropping or pitting) with a depth of 35-40 μm (1.4-1.6 mils) resulting from localized attack near the interfaces. Figure 3-23 shows this attack in a LCM micrograph and corresponding height scan for an interfacial area on the Test 1 304W coupon. Point measurements in the weld found a depth at 44 μm (1.7 mils).

Figure 3-22 Interfacial 304W coupons after resin digestion tests with: (left) Test 1- acid digestion, chloride form resin; (middle) Test 2 - acid digestion, nitrate form resin; and (right) Test 3 - neutral pH digestion, nitrate form resin

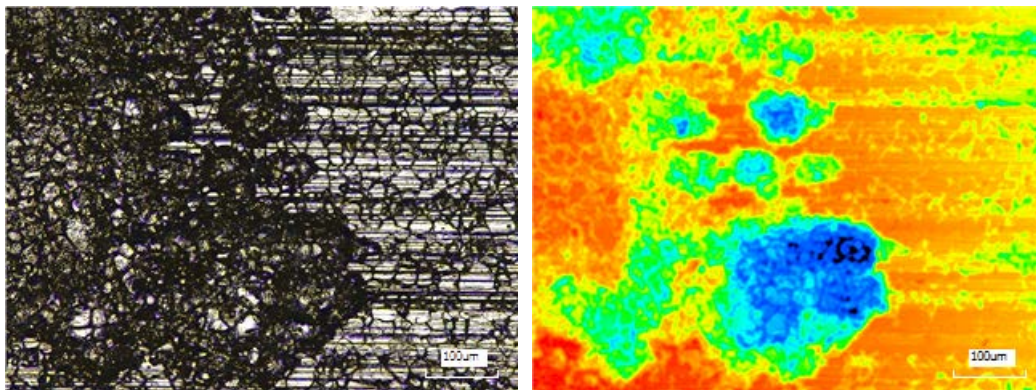
Figure 3-23. Interfacial region from 304W coupon after 15-hour acid digestion at 76 °C of chloride form resin (Test 1)

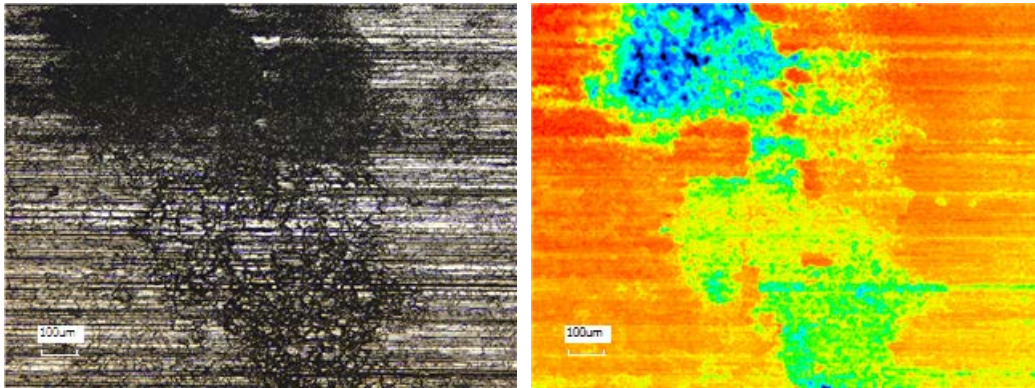
For the Test 2 coupon, the overall degradation was similar to that observed on the vapor only and liquid only exposed coupons. The vapor portion of the interfacial 304W coupon had greater staining and some slight IGA, while the liquid portion had IGA prominent along with areas of grain drop out. The depths of these areas were approximately 20 μm or 0.8 mils. At the air/liquid interface as shown in Figure 3-24, the corrosion was more extensive with wider areas of IGA; the measured trenching was 12-18 μm (0.5-0.7 mil). The corrosion in the weld as noted by a depth of

~36 μm (1.4 mil) was greater than the surrounding base metal. These measurements were comparable to those measured on the coupon from Test 1 during the chloride form resin digestion.

Figure 3-24. Interfacial region near the weld from 304W coupon after 15-hour acid digestion at 76 °C of nitrate form resin; weld is the upper half of micrograph and height scan (Test 2)

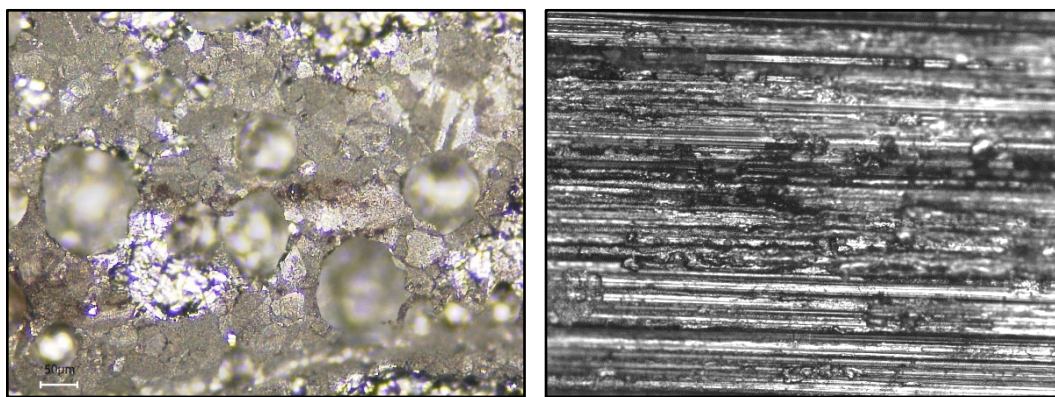
The interfacial 304L coupons had similar corrosion to the other coupons in each test except for Test 1. As previously discussed, the Test 1 (chloride form resin) coupon had a preponderance of pitting and surface etching in the vapor portion that resulted from the wire condensate dripping on to the coupon. The presence of the copper ions in the condensate may have added to the aggressiveness of the condensate, which otherwise would be nitric/nitrous acid. The impact of the copper ions in the solution was not expected to be significant because of dilution. The corrosion observed on the remainder of the coupon was far less severe with no significant IGA and random pitting on the liquid portion. The corrosion morphologies of the vapor and liquid portions of the interfacial 304L coupon are shown in Figure 3-25.

of the coupon had significant widening of the IGA as compared to the immersed portion of the coupon. Widths of 25 μm (1 mil) were measured while on the immersed portions widths were not measurable at the examination magnification (100-200x). The degree of IGA decreased in either direction towards the vapor or immersed portion of the coupon as shown by the micrographs in Figure 3-26.

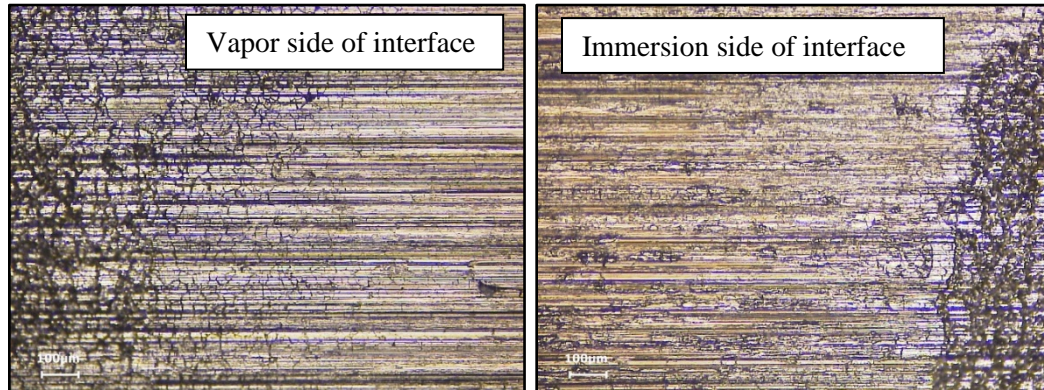
Figure 3-26.. Micrographs (100x) of the air/liquid interface 304L coupon (#05) from nitrate form resin acid digestion test after 15 hours at 76 °C (Test 2)

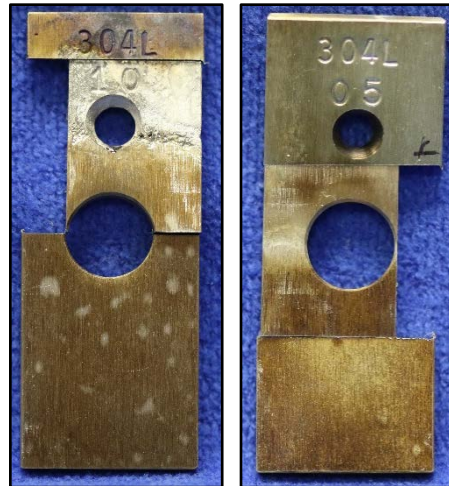
Figure 3-27. Sectioned interfacial 304L coupon from Tests 1 (left) and 2 (right); missing section was mounted for cross-sectional examination.

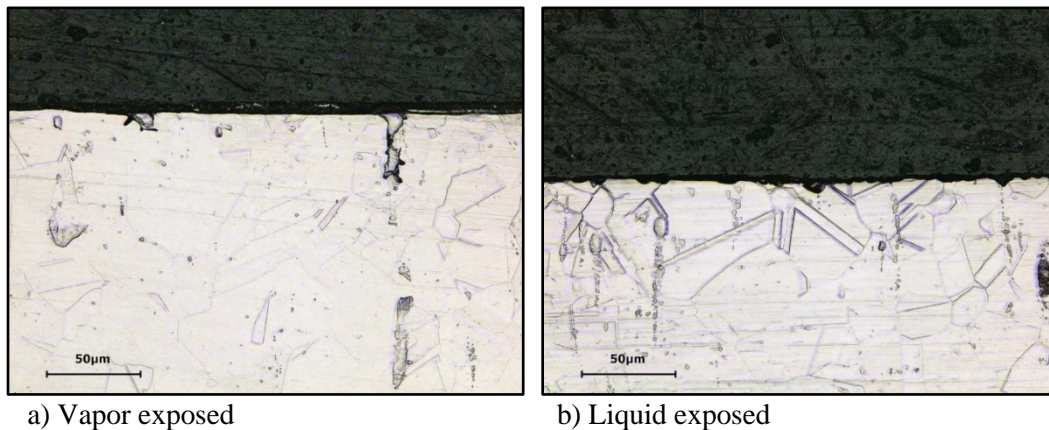
For the Test 1 coupon, the cross-sectional examination revealed that the IGA and pitting appear to be working synergistically as shown in Figure 3-28. In many of the pit-like features shown in these two micrographs, the corrosion appears to be progressing along a grain boundary. IGA may have occurred initially due to oxidizing conditions, but the presence of chloride could assist in transitioning to a pit with the lateral growth of the initial IGA. Additionally, pitting may have initiated at a location within a grain, growing into a boundary thereby setting up conditions for IGA.

Figure 3-28. Micrographs (500x) showing attack of the air/liquid interface 304L coupon (#10) from chloride form resin acid digestion test after 15 hours at 76 °C (Test 1)

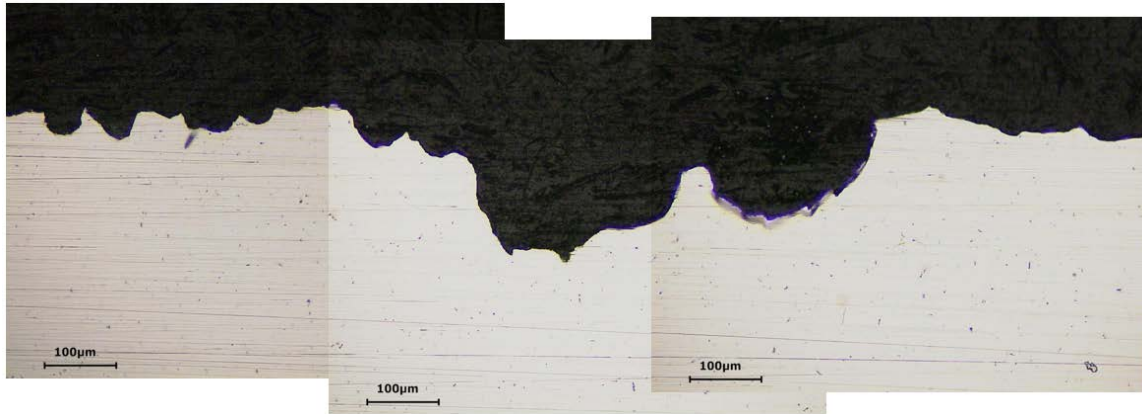
The greatest penetration of depth was observed in the interfacial region which is shown in Figure 3-29 by the montage of several micrographs. The approximate depth of this penetration is 200 μm or 8 mils so the combined effect of IGA and chloride along with highly oxidizing conditions of the air/liquid interface contributed to this material loss. Only one cross sectional plane was examined however.

Figure 3-29. Micrograph montage (200x) showing attack in the interfacial region of the air/liquid interface 304L coupon (#10) from chloride form resin acid digestion test after 15 hours at 76 °C (Test 1)

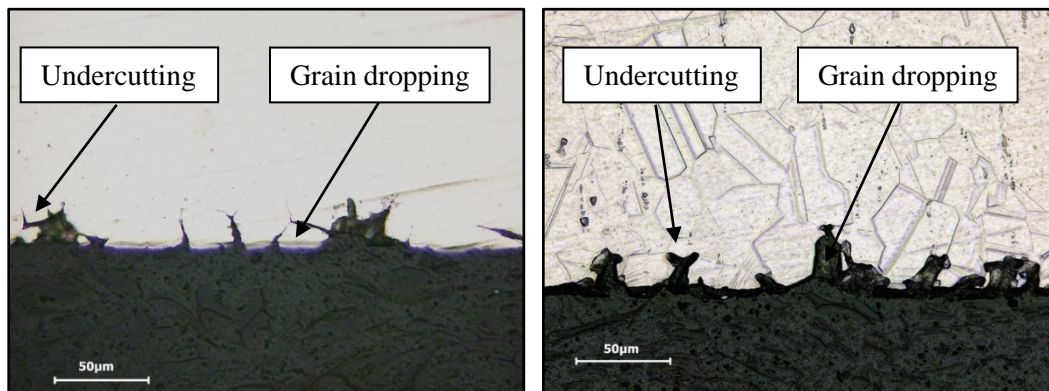
For the Test 2 coupon, the unetched mounted coupon sections showed a maximum depth of penetration of approximately 2 mils although most depths of penetration were on the order of 1 mil, like the LCM measurements. In Figure 3-30, the undercutting and process of grain dropping is clearly observed for the 304L coupon in both the etch and unetched conditions. Only one cross sectional plane was observed so a greater maximum depth of 2 mils may be possible.

Figure 3-30. Micrographs (500x) of the unetched and etched cross section of an interfacial portion of 304L coupon (#05) from nitrate form resin acid digestion test after 15 hours at 76 °C (Test 2)

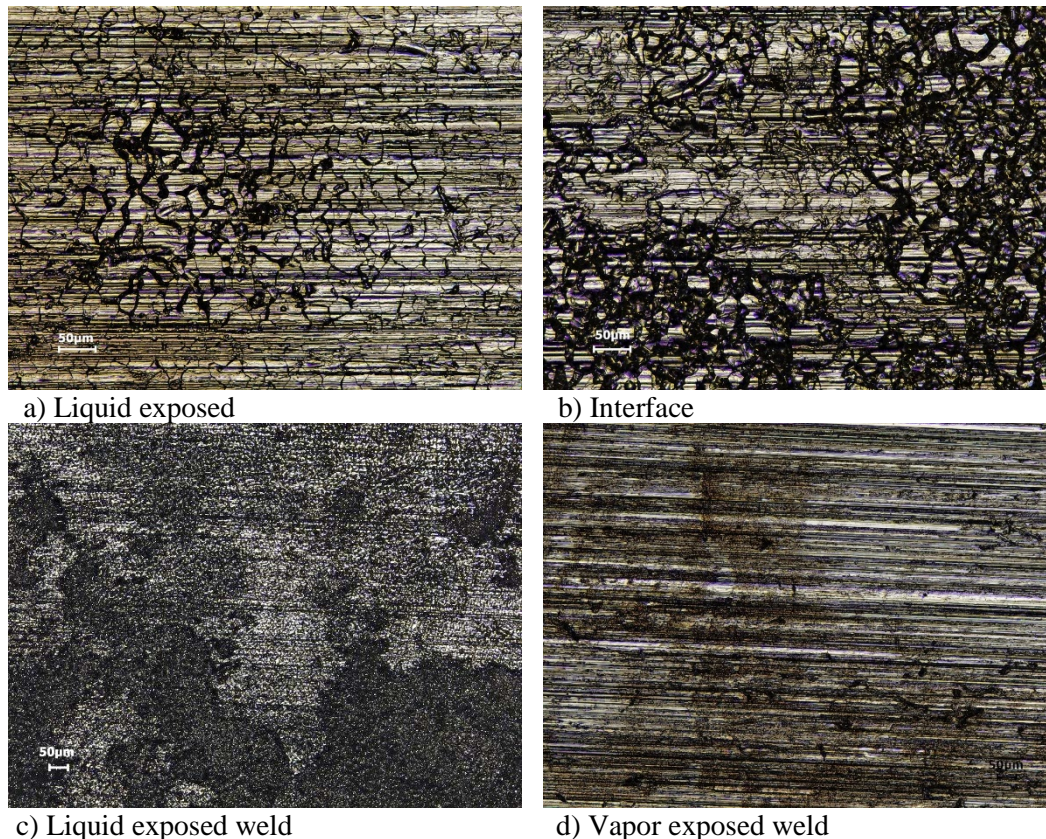
Two coupons, #52 and #54, were examined using the LCM with height scans of typical areas obtained to compare depths and types of attack. As stated above, the observed corrosion was the same as seen in Test 2. Figure 3-31 shows LCM micrographs of typical views for the liquid-exposed area, at the interface, in the vapor-exposed area and for liquid-exposed area of the weld. Depths of attack were similar for these two coupons. Figure 3-31a shows a common spot of accelerated IGA where the depth of attack ranged from 25 - 35 μm (1-1.4 mil) for both coupons, while smaller pit like areas measured $\sim 20 \mu\text{m}$ (0.8 mil). At the interface, depths of attack (Figure 3-31b) measured 30 - 50 μm (1.2-2 mil) or less while in the welds (Figure 3-31c) depths were closer to 50 μm (2 mil). In the vapor portion (Figure 3-31d), depths of attack were less than 10 μm (0.4 mil).

Figure 3-31. Surface corrosion morphology for Coupons #52 and #54 from Test 2a:

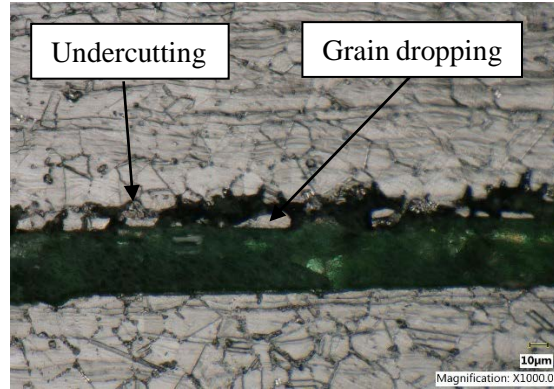
The coupon exposed in both Test 2 and Test 2a #124, was found to have similar depths of attack as to those measured for other coupons with weld attack measuring up to 50 μm (2 mil) while areas of grain drop out measured 10-15 μm (0.4-0.6 mil). These measurements were made using the LCM. The interface formed during Test 2a on Coupon #124 did not appear to be coincidental with the interface that formed from Test 2 (see Figure 3-12). So, two sections were removed from Coupon #124 through the interfacial area along the two sides of the coupon to examine the depth of attack from a cross section. The pieces were mounted together and prepared similar to the 304L coupons. Depths up to 60 μm (2.4 mil) were found as shown in the micrograph in Figure 3-32. In this figure, significant undercutting of grains can be seen at numerous locations. Again, only one cross sectional plane was examined.

Figure 3-32. Cross section view of interface area for Coupon #124 from Test 2a

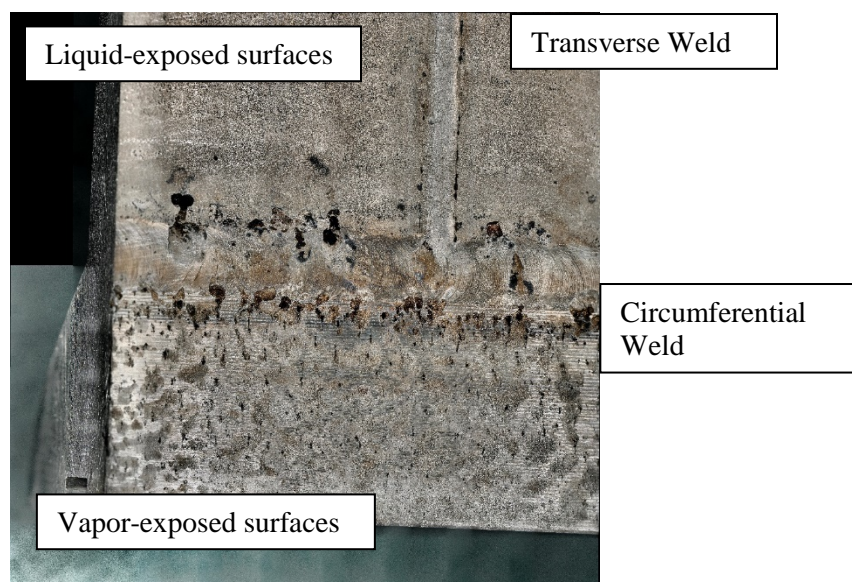
The three components were examined microscopically to perform a preliminary evaluation of the degradation and to determine plausible corrosion mechanisms. All three components were found to have intergranular attack (IGA) with areas of grain dropping. The IGA was on both liquid-exposed and vapor-exposed surfaces of the test vessel, which can be seen in Figure A-1. In this photograph, the graininess of the surfaces indicates the IGA observed on a microscopic level. This graininess can also be seen in Figure A-2 for the surfaces of the heater rod and thermocouple. While the IGA is over the entire surface for the 304L test vessel and Inconel 600 sheathed thermocouple, the IGA appears to be concentrated near the air/liquid interface for the Alloy 800 heating rod. One cause for IGA in stainless steels is very oxidizing conditions like those that occurred during this testing caused by the high molar nitric acid concentration, elevated temperature and presence of oxidizing species. These species are the added permanganate salt as well as Cr^{+6} which over time result from corrosion of the stainless steel.

Figure A-1. 304L test vessel near joint of transverse and circumferential welds highlighting the IGA observed on all surfaces and the more severe corrosion in the circumferential weld, which was coincidental with the air/liquid interface

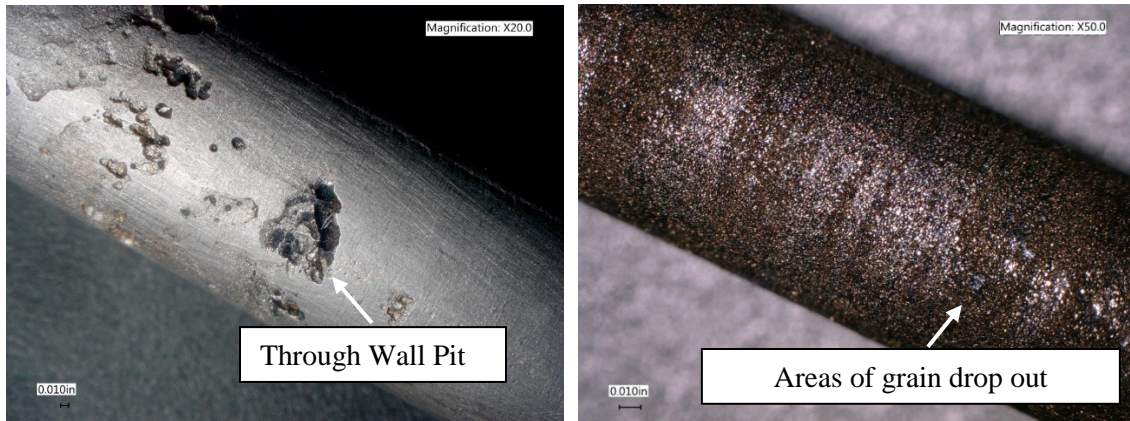
Figure A-2. Alloy 800 heater rod (left) and Inconel 600 sheathed thermocouple (right) showing surface graininess indicative of IGA; the failure spot of the heater rod is also shown

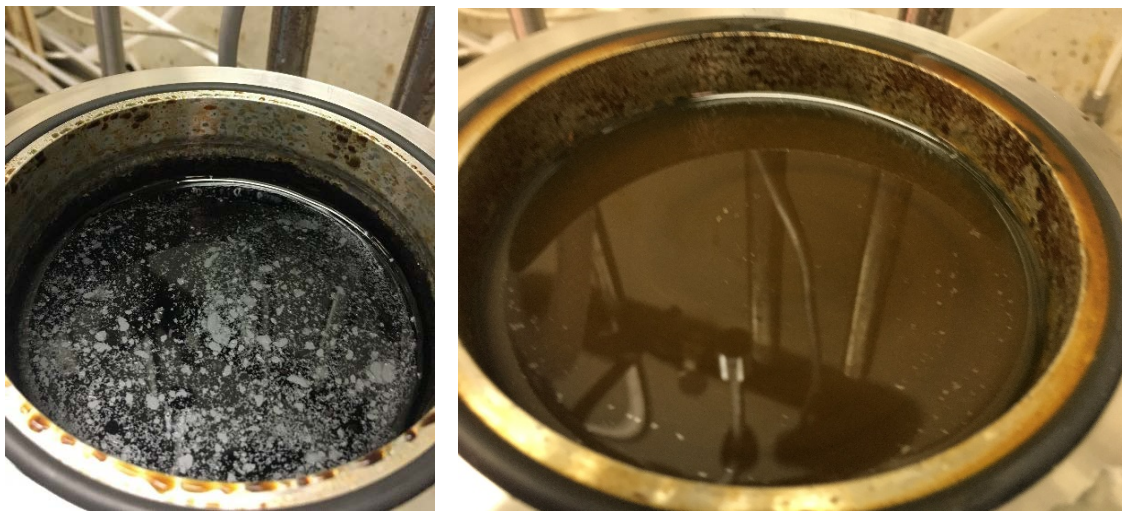
The actual mechanism for possible pitting was initially unclear since there was not a known source of chloride. Subsequent review of the HGR test conditions revealed that a chloride form resin was inadvertently used in the test. In heating situations, chlorides can concentrate due to evaporation. Since the suspect pitting appeared to be associated with the air/liquid interface, sufficient chloride concentration (>250 ug/g) may have occurred especially if floating resin particulate seen in Figure A-3 attached to material surfaces to form a crevice-type condition.

Figure A-3. Air/liquid interface initially (left) with the nitric acid and resin present and at the end of the test (right) after the NaOH has been added indicating the air/liquid interface was not stagnant during testing

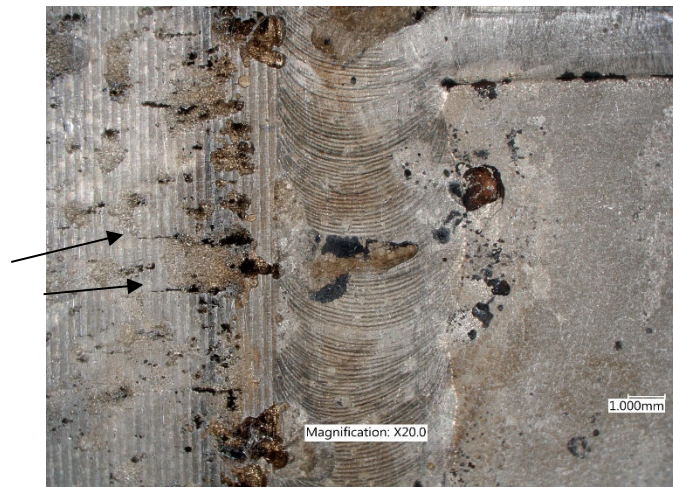
Some of the morphologies observed on the test vessel sidewall along the circumferential weld (Figure A-4) also indicate the possibility of stress corrosion cracking, which would require a high chloride concentration within a pit. The perpendicular linearity of degraded spots emanating from the weld and pit-like or crevice-like features are some indication. A cross section through the weld would be needed to confirm.

Figure A-4. Micrograph (200X) of circumferential and transverse weld joint showing linear indications of possible stress corrosion cracking (see arrows).
