Tank Inspection NDE Results for Fiscal Year 2019, Waste Tanks 25, 26, 33, 34, 41 & 50

James B. Elder III and Rodney W. Vande Kamp

October 28, 2019

SRNL-STI-2019-00519

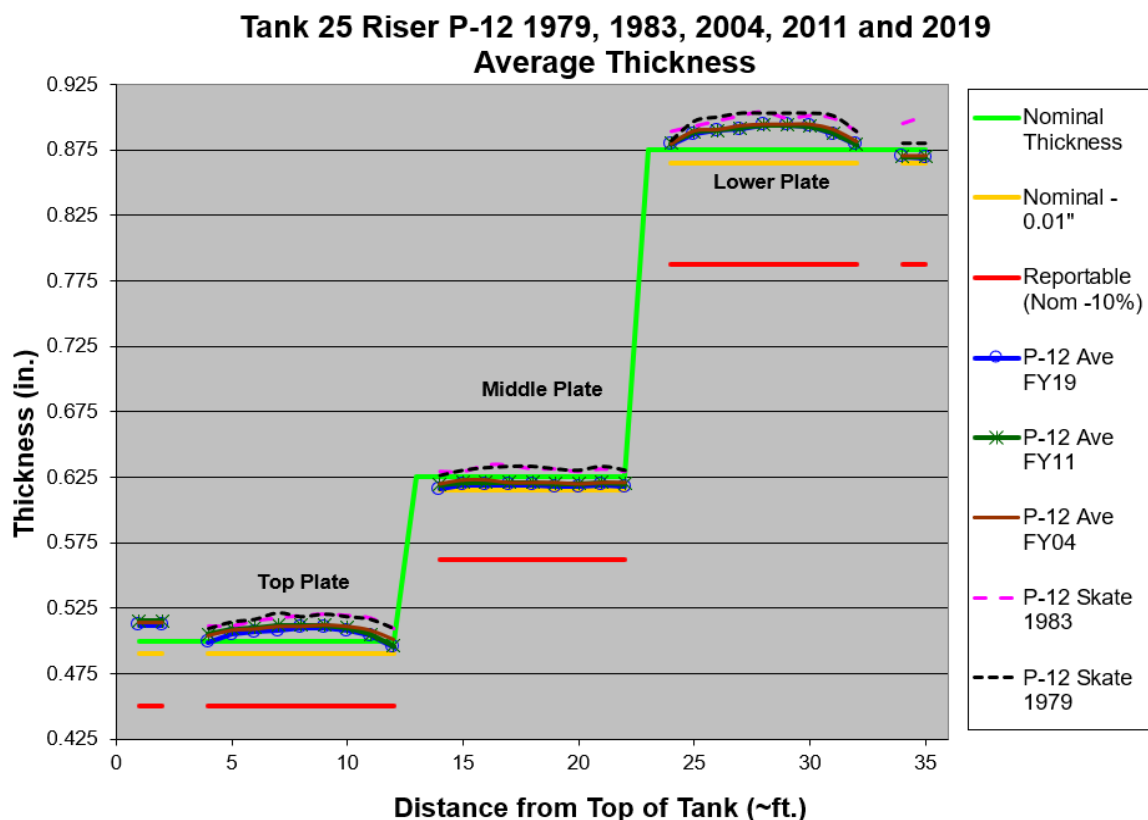
Figure 10: Tank 25 Thickness Data Comparison Over 40 Years

Primary tank completed with no service induced, reportable thinning or pitting and no cracking detected. The FY 2019 average thicknesses were at or above the construction minimum thickness in all but one plate. One plate has an average thickness below the construction minimum:

No reportable pitting was noted in any of the primary wall plates examined.

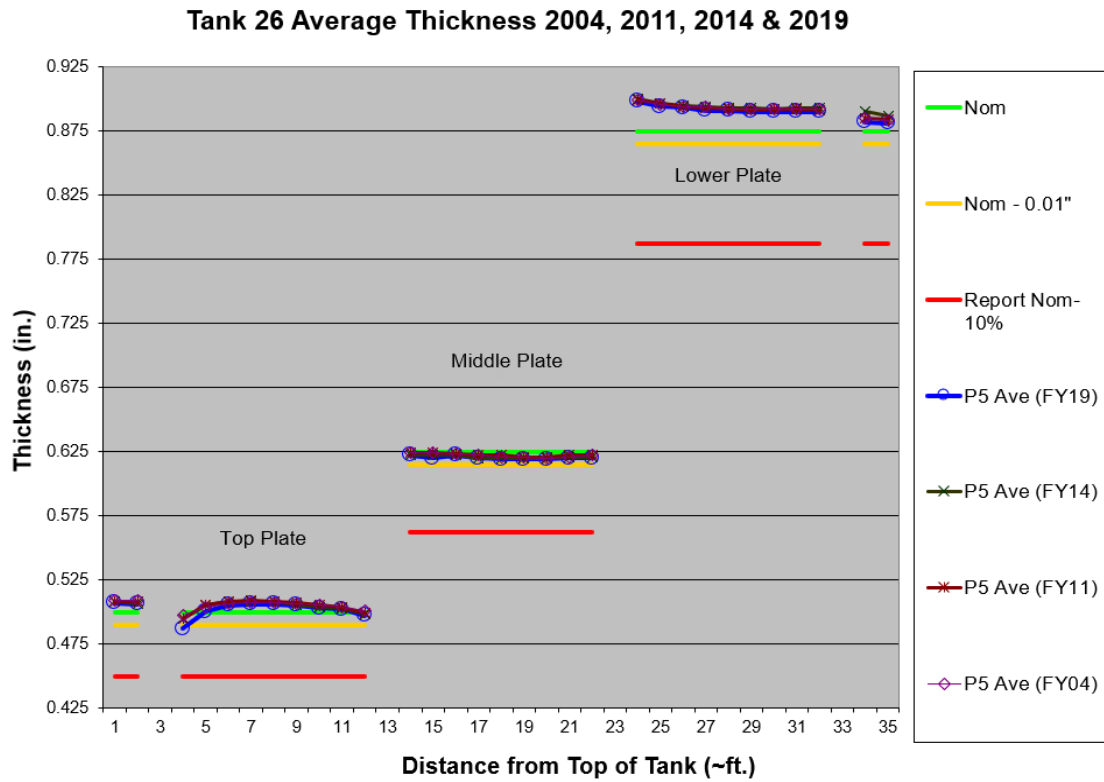
Figure 12: Tank 26 Thickness Data Comparison Over 15 Years

Primary tank completed with no service induced, reportable thinning or pitting and no cracking detected. The FY 2019 average thicknesses were at or above the construction minimum thickness in all but two plates. Two plates have an average thickness that is below the construction minimum and three areas with a minimum thickness below the 10% value.

No reportable pitting was noted in any of the primary wall plates examined.

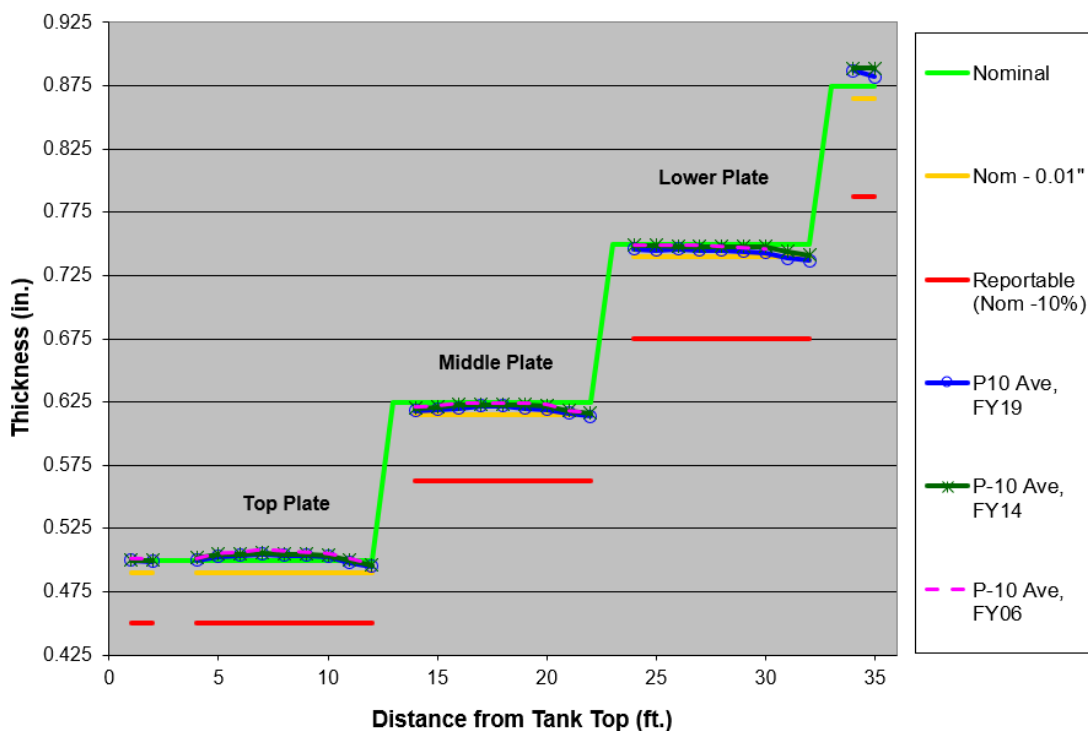
Figure 14: Tank 33 Thickness Data Comparison Over 13 Years
Chart Tank 33 Average Thickness 2006, 2014 and 2019

Primary tank completed with no service induced, reportable thinning or pitting, and no cracking detected. The FY 2019 average thicknesses were at or above the construction minimum thickness in all but three plates. Three plates have an average thickness below the construction minimum and one has a minimum thickness below the 10% value.

No reportable pitting was noted in any of the primary wall plates examined.

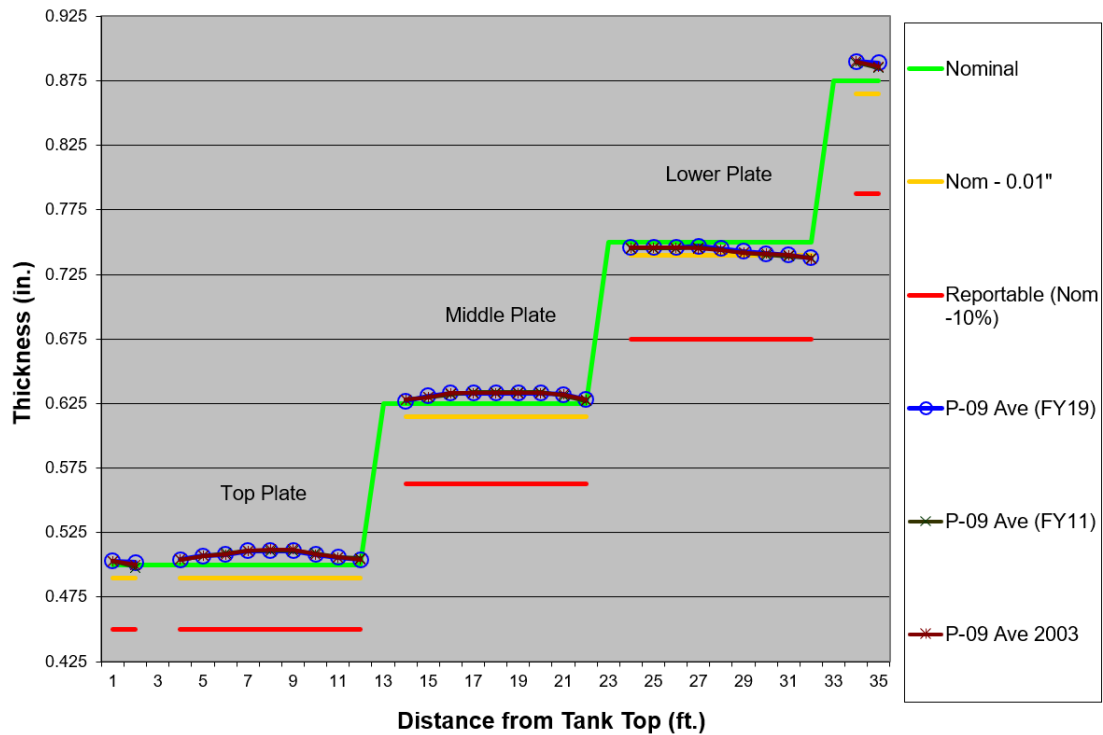
**Figure 16: Tank 34 Thickness Data Comparison Over 16 Years
Tank 34 Average Thickness 2003, 2011 and 2019**

Primary tank completed with no service induced, reportable thinning or pitting, and no cracking detected. The FY 2019 average thicknesses were at or above the construction minimum thickness in all but one plate.

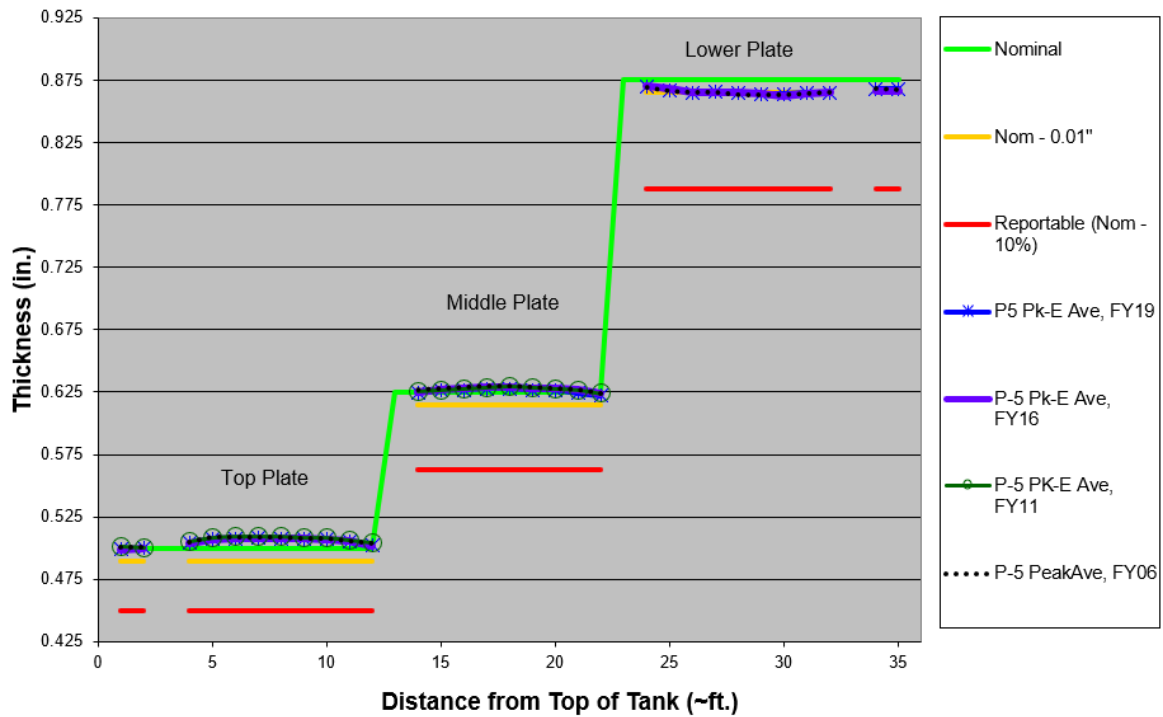
Figure 18: Tank 41 Thickness Data Comparison Over 13 Years

Vertical strip scans beneath P5 and P13 completed with no reportable thinning, pitting or cracking detected.

No signs of accelerated corrosion, pitting or cracking were detected in either strip.

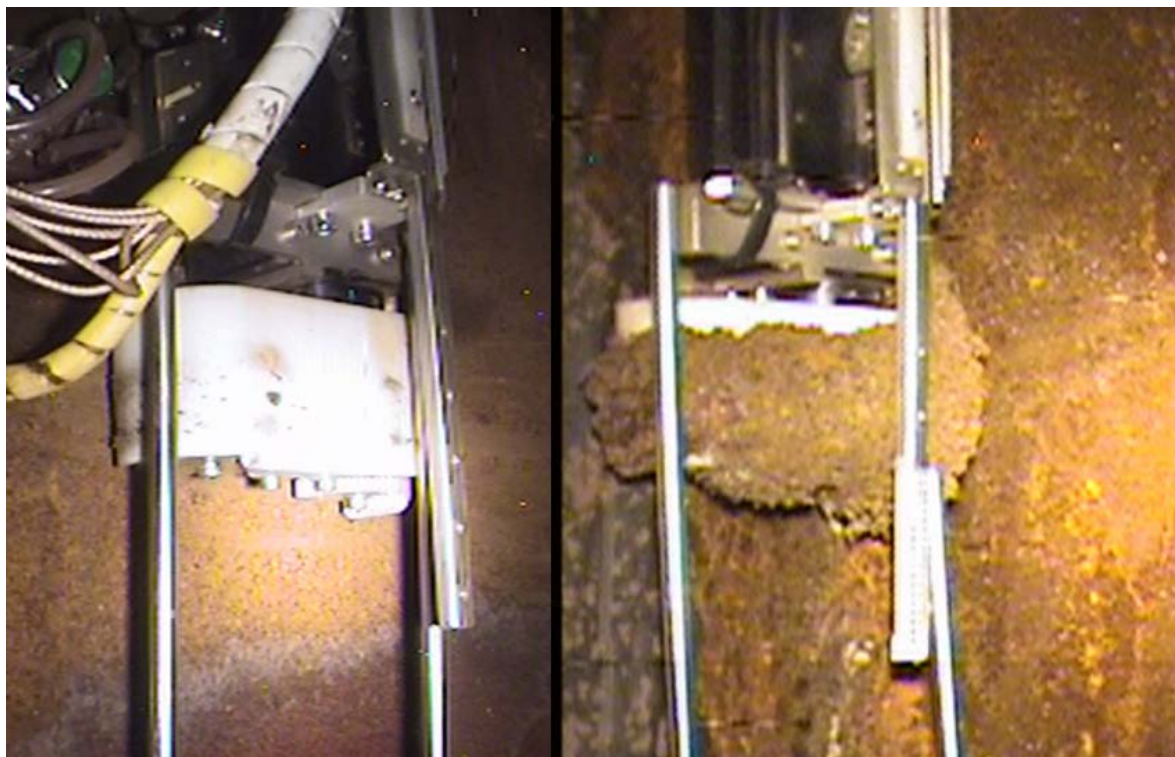
Figure 20: Comparison of buildup on wall crawler wheels

During a routine visual examination in the annulus of Tank 50, surface corrosion was noted on the secondary wall beneath the A2 riser. An ultrasonic thickness inspection was requested to be performed in the area beneath riser A2 to determine the extent of corrosion and the remaining wall thickness in the area. Although there was heavy corrosion and sheets of material fell off the wall during scanning, the remaining wall thickness is at or above the construction minimum thickness.

Due to the heavy surface corrosion product on the surface the crawler was unable to drive up the secondary wall on the top plate. Figure 20 shows a comparison of the wall crawler wheels. The image on the left shows the normal wheel fenders during a typical inspection and the image on the right shows the corrosion product collected on the wheels during the inspection in Tank 50. Figure 21 shows an image of the wall crawler wheels being completely engulfed during the vertical strip scan. This surface condition prevented the crawler from backing up the top plate and from scanning the lower plate. A vertical strip was scanned beneath the A2 riser. The strip started at the bottom of the top plate. The scan included the second and third plates and a small section of plate 4, the lower plate.

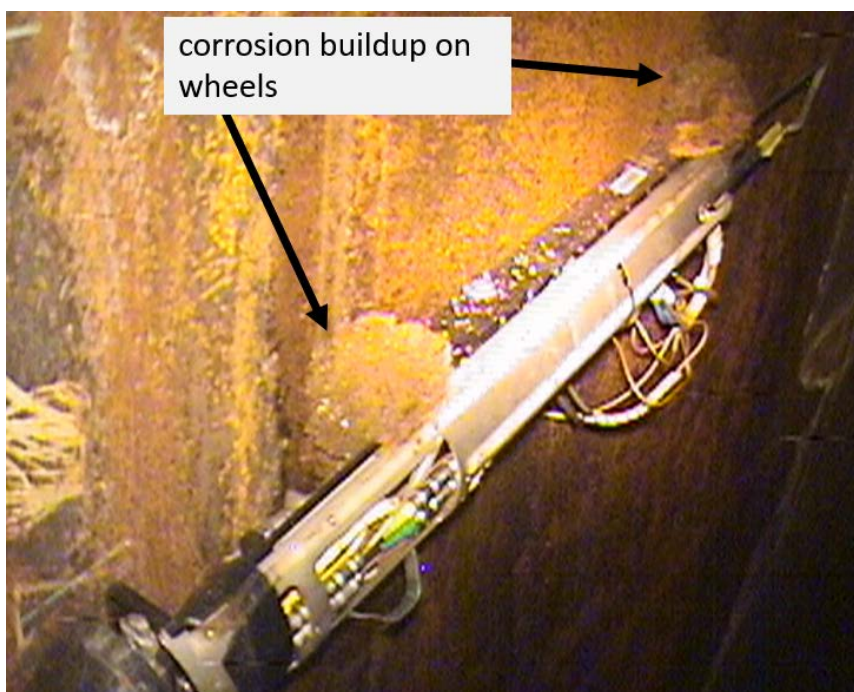
Figure 21: Corrosion product buildup on wall crawler wheels
