# **Augmented Monitoring and Condition Assessment Program (AMCAP) Material Test Reactor (MTR) Fuel Inspection Program Report**

August 2020

SRNL-STI-2020-00152, Revision 0

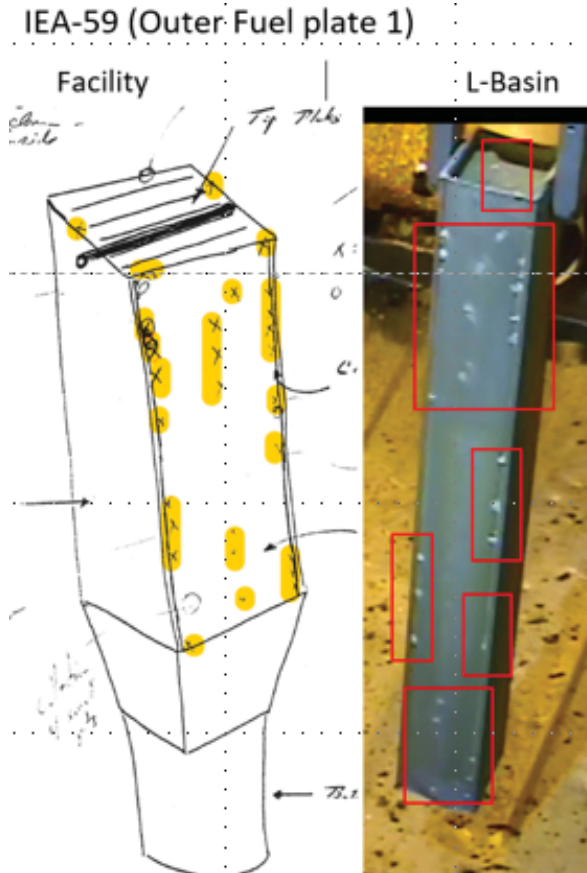
At the debundling station in the saw row, there were five assemblies debundled. All assemblies showed signs of intermittent random sets of crevice corrosion within the outer edge of exterior fuel plates at the side plate interface. Assemblies showed random intermittent clusters of pronounced nodules/prominent pits over the fuel meat region. Both types of corrosion occurred on each of the two outer fuel plates. The corrosion observed during debundling closely followed the previous facility inspection. See below picture for debundled assembly IEA-59. Observations from debundling showed no increase in the extent or severity of corrosion degradation for any of the five (5) debundled assemblies from the IEA-R1 inspection bundle. For other debundled fuel comparisons refer to [Appendix 3](#).

**Figure 4-4 IEA-59 Previous Facility Inspection versus L Basin Debundling of IEA-59**

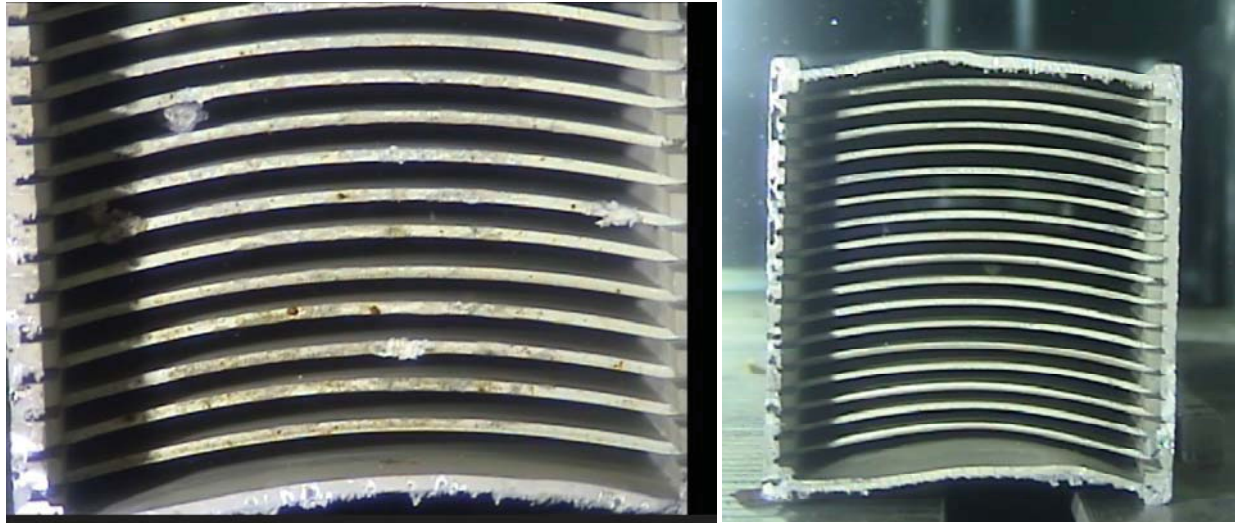
Detailed inspection of the outer aluminum plates, which were determined not to be outer fuel plates, showed concentrated clusters of densely populated pitting corrosion nodules. These clusters were in a dense pattern on the concave side of the assembly but sparser on the convex side. Also, some end grain irregular shaped and sporadically populated, end-grain corrosion pockets forming on the edge of cropped fuel plates.

**Figure 4-5 Top End View of IEA-79 (left) and Bottom End View (right), for comparison**

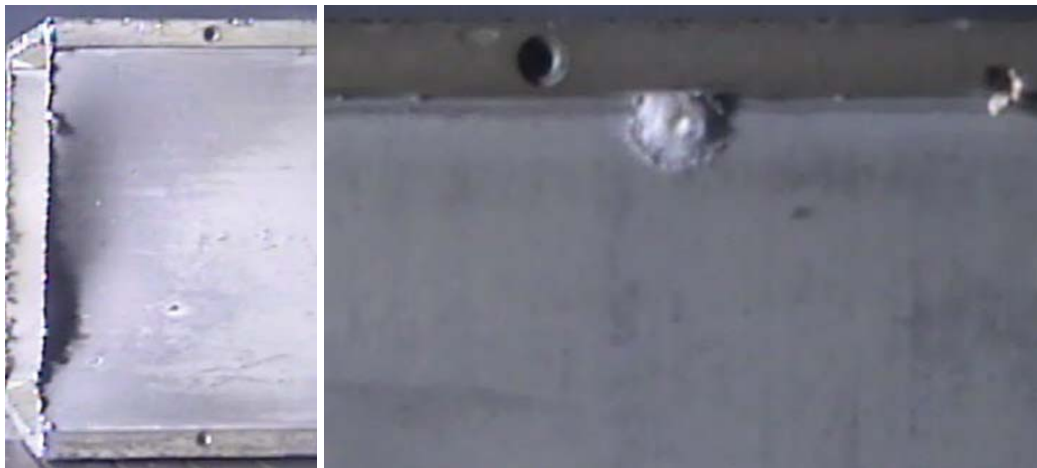
**Figure 4-6 Exterior Fuel Plate IEA-79 showing cropping damage on edge of fuel plate (left) and crevice corrosion nodule with Side plate damage/pit (right)**

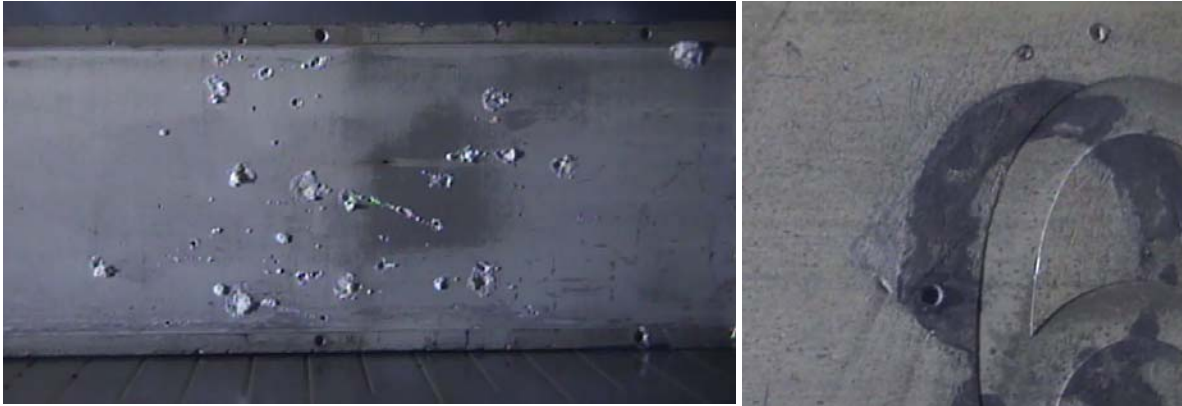
**Figure 4-7 Exterior Fuel Plate IEA-79 showing a population of raised nodules and pits (left) and (separate image) side plate pitting (right)**

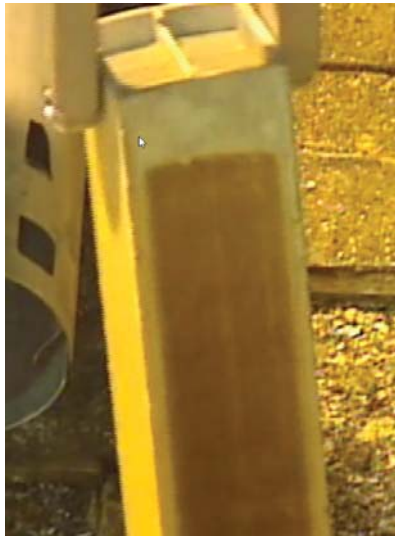
Standard assemblies 138 and 195 were debundled with the inspection control assembly. One of the two standard assemblies in the bundle had a pronounced dark discoloration over the whole fuel meat region. The other standard assembly in the bundle had the same patchy dark discolorations over the fuel meat region as the debundled inspection assembly. Both standard debundled assemblies showed edge corrosion on the side plates.

***Figure 4-8 RA-3 debundled Standard Assembly 138 showing pronounced dark discolorations over the fuel meat region of an exterior fuel plate***

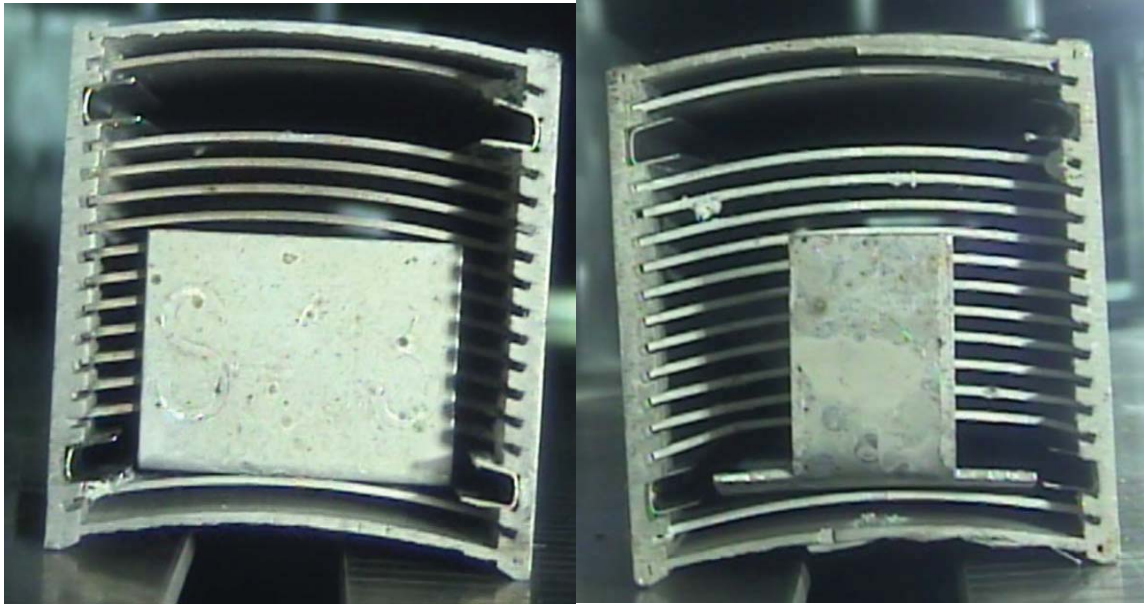
The two control rod guides are easily viewable from either end of the inspection assembly. One control rod guide serves as a channel for installation of the tagging system which uses the guide for installation of the tag. The control rod guide is stainless steel. The inner fuel plates do not touch the control rod guides. Galvanic induced crevice corrosion is evident on the upper right and lower left control rod guides, noting in the upper right guide (see below, left picture) is a dark corrosion crevice pocket.

**Figure 4-9 Top End View of S-113 Control Assembly (left) and Bottom End View (right) with inserted tag**

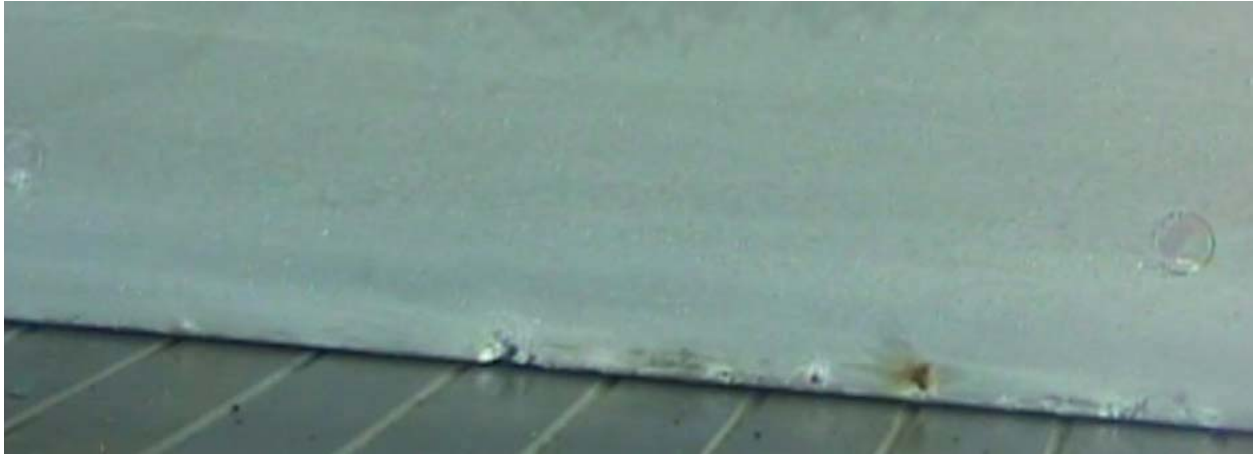
For the side plates, edge corrosion had prominent pitting along the edges and few instances of brownish discoloration in the pits. Formations of pitting corrosion nodules with a foaming appearance are apparent in prominent gouges or scratches along the edges of both side plates. There was a similar white, lighter colored formation on the side plate hole groove of one rivet. Marking and grooving of the side plate faces are evident from the use of parallel grippers on the assemblies. Reevaluation of these mechanical defects resulting from fuel handling operations if this assembly is to be reinspected during a later campaign could provide valuable information on the extent of corrosion, or lack thereof, in L Basin wet storage.

***Figure 4-10 S-113 Side plate edge corrosion with pitting and discoloration***

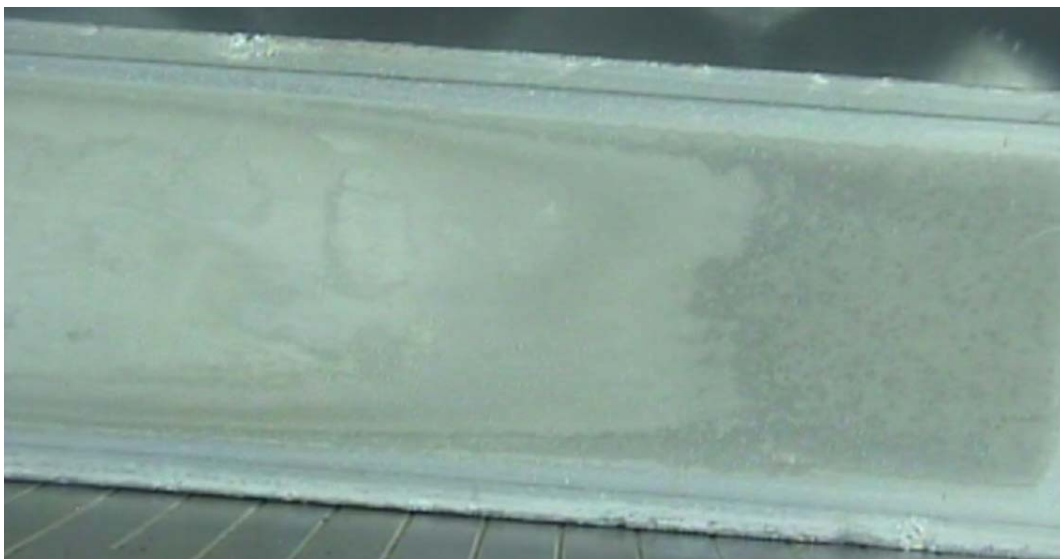
White-washing lighter discoloration patches are prevalent on both sides of the exterior fuel plate. Generally, a change in lighter or darker silver color is apparent over the fuel meat region, clearly distinguishing its boundaries. One side of an exterior fuel plate had noticeable dark discolorations isolated and along one fuel meat edge in two spots, on one side and in one spot of the opposite exterior fuel plate. Dense formations of very small surface area pitting corrosion nodules are evident over the fuel meat region of the assembly.

***Figure 4-11 White-washing lighter discolorations over fuel meat area of S-113***

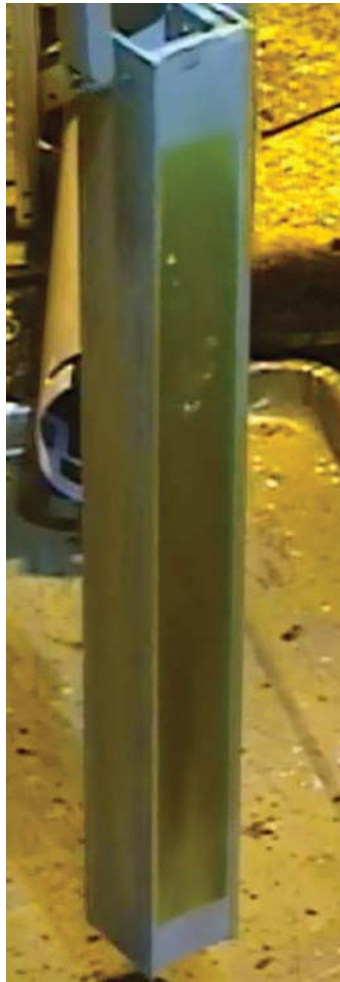
At the debundling station, video was taken of all four debundled assemblies. Inspection assembly 160 showed minor side plate edge pitting corrosion. Assembly 110 showed darker fuel meat region discolorations with abundant patches of raised nodules (sparsely populated) over one exterior fuel plate and somewhat less on the opposite side. Also, one end of assembly 110 had rough, jagged cropped edges. This was also observed with assembly 139. This assembly also displayed pitting corrosion to the side plate edge and crevice corrosion at the interface of the fuel and side plates. CNEA-301 assembly had only blotchy white patchy discolorations shown over the fuel meat area.

***Figure 4-12 Debundling of Assembly 110 showing exterior fuel plate pronounced, dark discoloration over the fuel meat area and a population of heavy pitting corrosion nodules also over the fuel meat region***

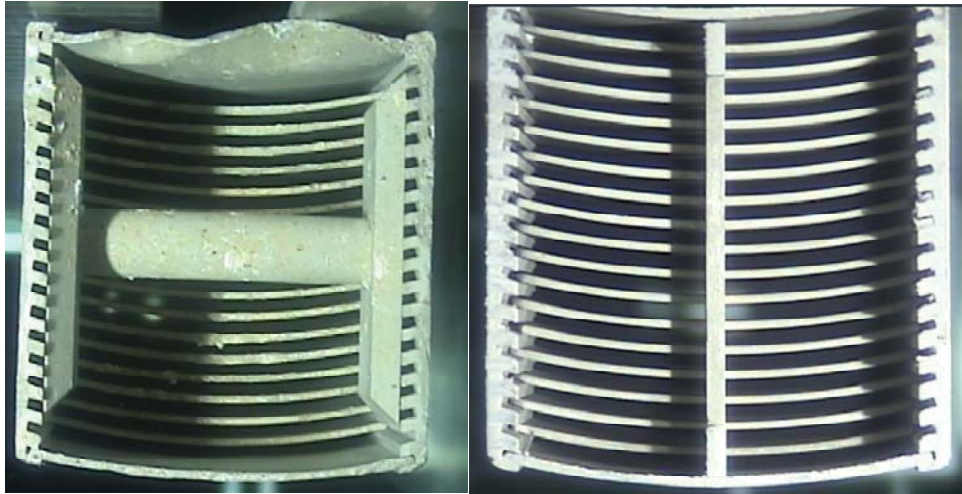
Both ends of inspection assembly 160 showed minor end-grain corrosion formations on the edge of interior fuel plate ends. Crevice corrosion was found in the slotted fuel comb pockets, where the fuel plates adjoin into the side plates. The bail on the top end view showed moderate pitting and raised nodule corrosion. The bail was fabricated of the same material as the side plates, Aluminum 1050.

**Figure 4-13 Top End (left) and Bottom End (right) of Inspection Assembly 160**

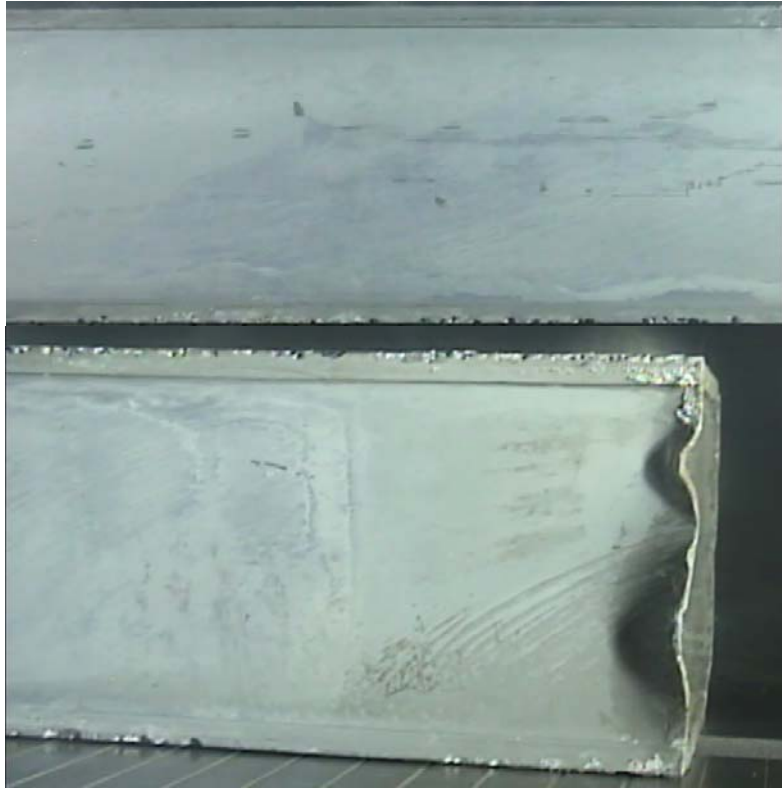
There was no galvanic-induced corrosion evident adjacent to the stainless steel screws mounted into the aluminum side plates for the bail.

**Figure 4-14 RA-3 Inspection Assembly 160 Exterior Fuel Plates (two different exterior fuel plates shown) showing substantial pitting edge corrosion on side plate edges.**  
**Note the RA-3 fuel was pressure washed prior to being loaded into casks for SRS Shipment.**  
**No new white, lighter corrosion clusters were found during its inspection.**

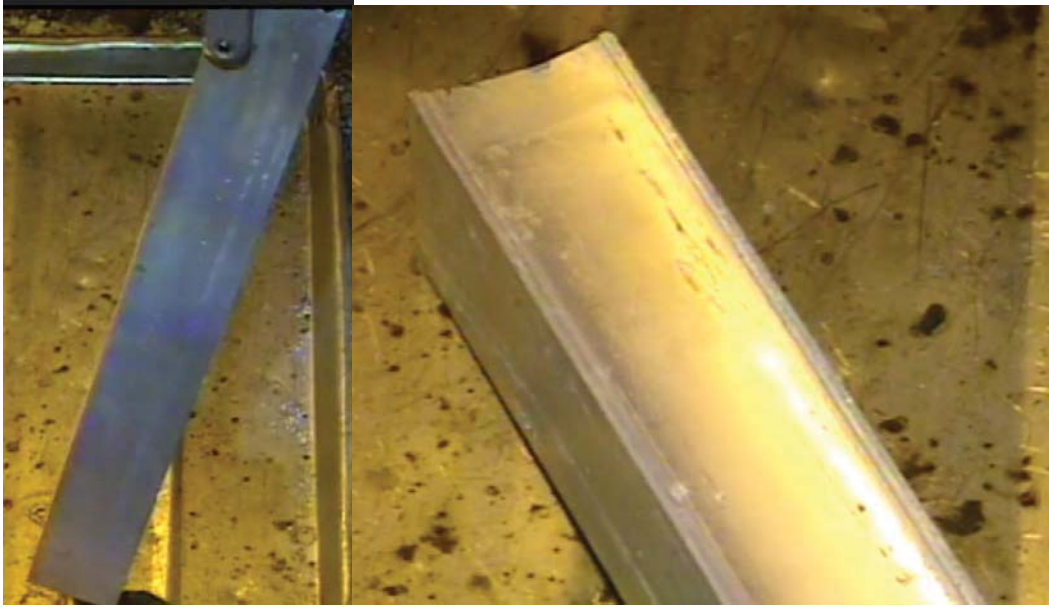
Control assembly S-121 had some internal pitting corrosion on the side plates and crevice corrosion along the side plate to fuel plate interfaces.

**Figure 4-15 Debundled Control Assembly S-121 External Fuel Plates showing pitting corrosion (left)  
Close-up of concave curved exterior fuel plate (right)**

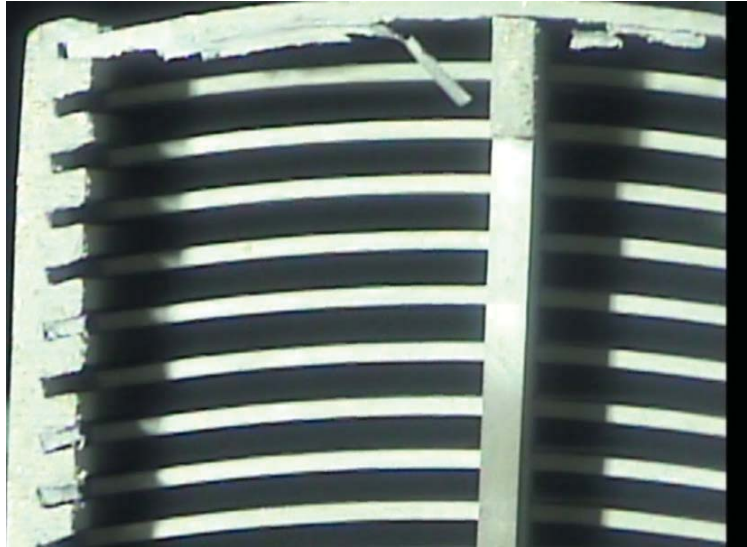
The ends of the inspection assembly 30 showed cropping fragment frays on one end, and on the top bail end there was one isolated spot of crevice corrosion in the side plate slots.

**Figure 4-16 Crevice corrosion in three of the fuel plates in side plate comb slots which could be cropping fragments. Note cropping fragments in the top part of the picture.**

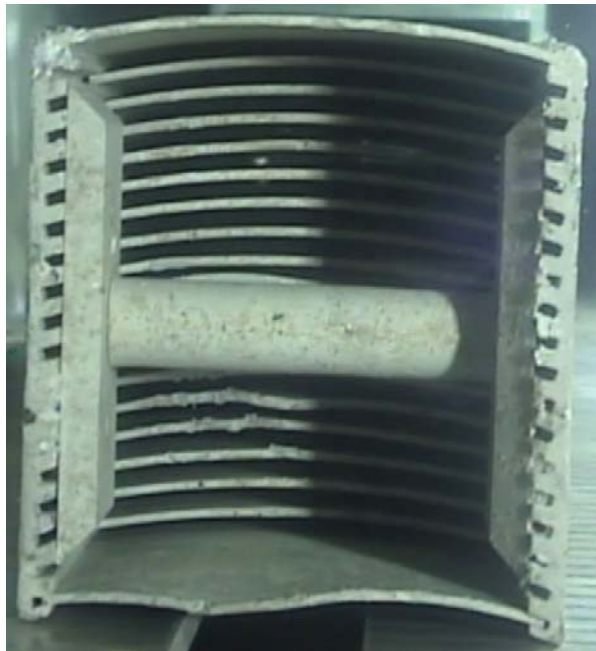
At the inspection table, the end views of assembly 236 displayed edge corrosion to the end of the side plates as well as on the end of several fuel plates. Crevice corrosion was also evident at the fuel plate grooves in the side plates.

**Figure 4-17 Top end of inspection assembly 236**

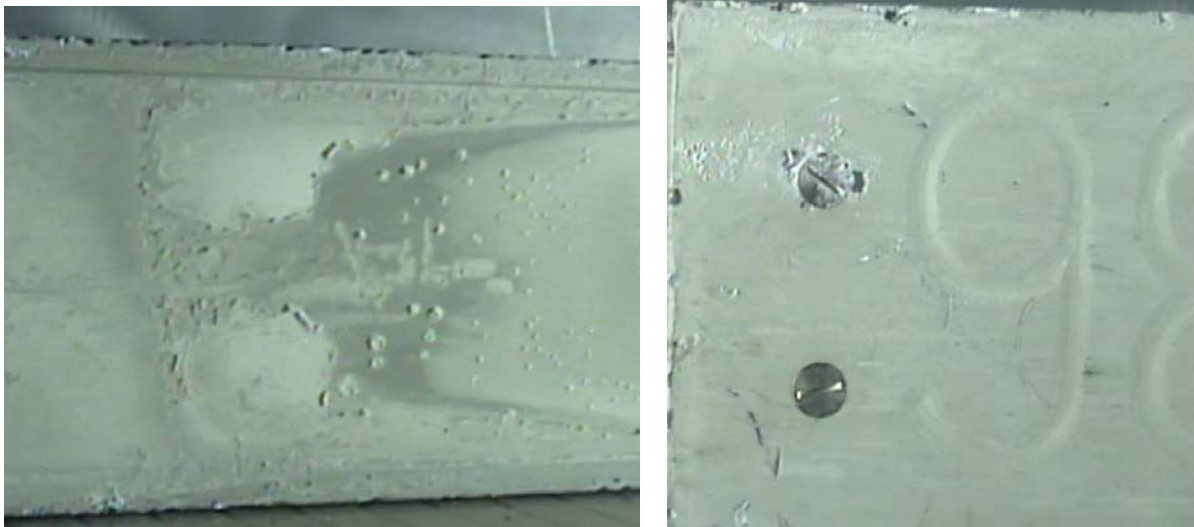
of the fuel core region of the plate. The feature appeared to be a region of exfoliated/spalled oxide. The cause of the exfoliated/spalled oxide could be due to the greater thickness of oxide that would be expected to form over the higher temperature and higher heat flux region of the growing oxide in reactor service.

**Figure 4-18 Region of exfoliated/spalled oxide with surrounding pitting corrosion nodules (left) and galvanic corrosion action on a stainless steel bail screw (right)**

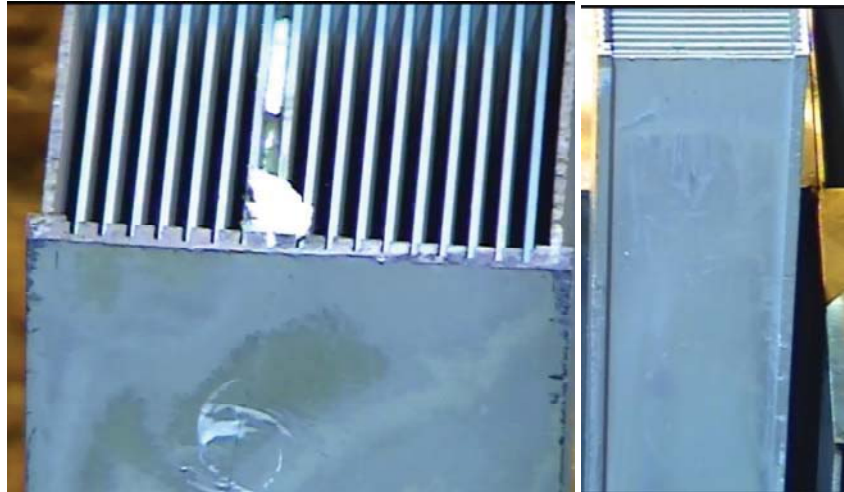
Standard assembly CMN7 had some metal fabrication anomalies (could be construed as corrosion) on one end and some discoloration noted on the opposite end of the assembly. The two-side plate and two exterior fuel plate faces were clean and free of defects or corrosion. Some pronounced scratching near the top of one side was observed.

**Figure 4-19 CMN7 Assembly (left); GA12 Assembly (right)**

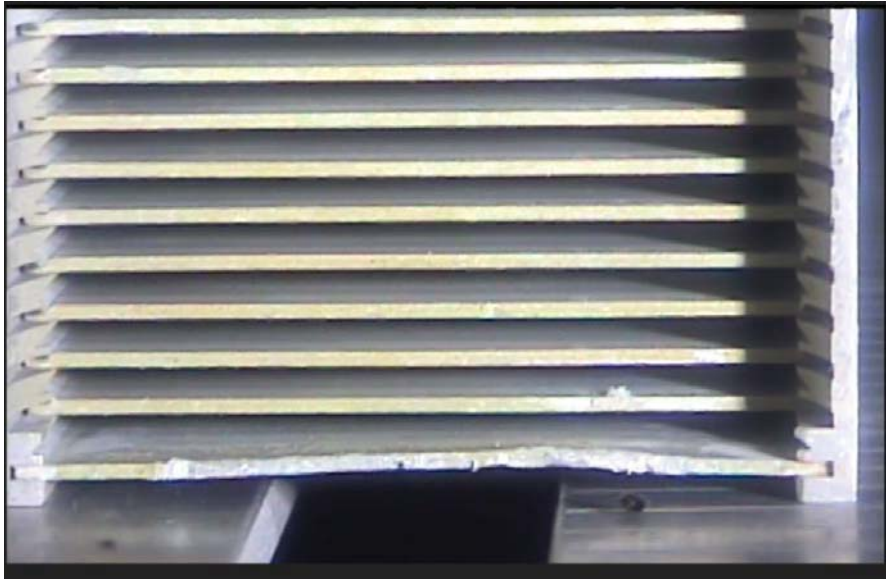
**Figure 4-22 Bottom End of Inspection Assembly GA67 on the MTR Fuel Inspection Table.**  
**Note crevice corrosion product on one fuel plate (next to the exterior fuel plate).**

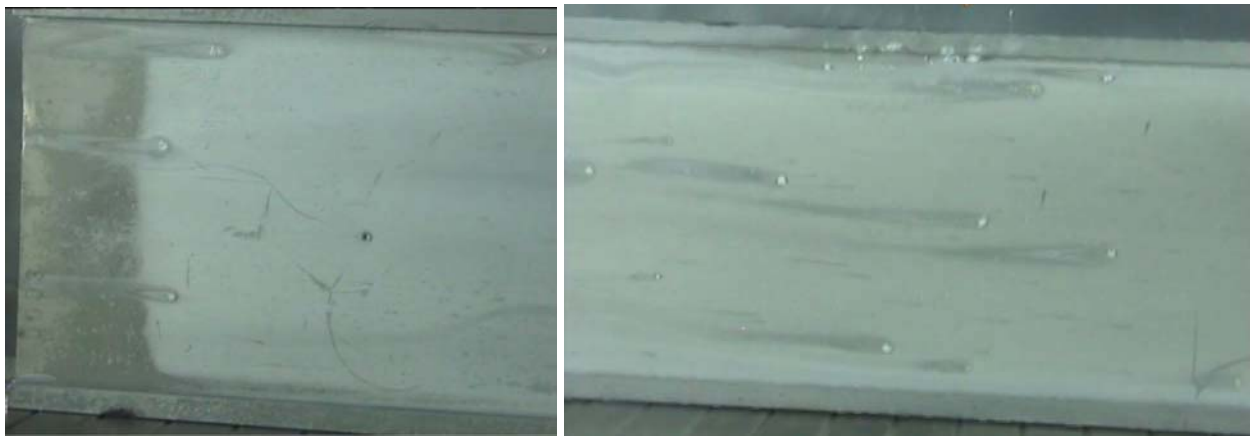
**Figure 4-23 Singular nodules/pits with trailing “shooting stars” phenomenon (both pictures) over the fuel meat region of an exterior fuel plate. Note characteristic pit (left) and crevice corrosion (right)**

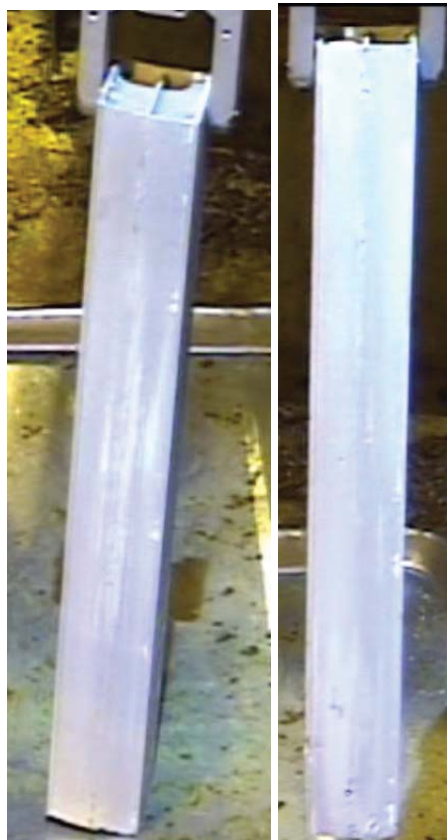
**Figure 4-24** *ISPRA Debundled assembly 3-5-1X showing crevice corrosion on concave dummy fuel plate (left);  
Crevice corrosion concave outer dummy fuel plate 3-51-VI (right)*

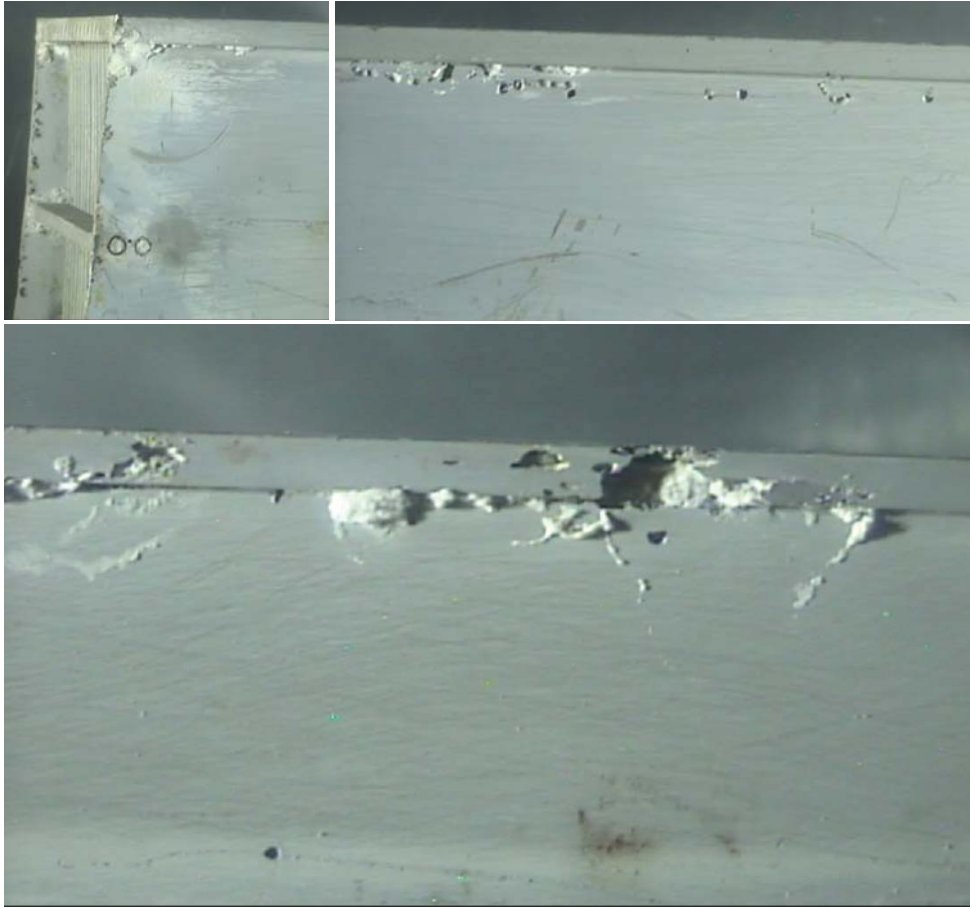
ENEA ISPRA Reactor fuel assembly 3-9-IX is also recommended for reinspection. Extensive crevice corrosion and corrosion of the side plates was observed, in addition to end-grain corrosion observed on the ends of the assembly. Because of these extensive, identifiable corrosion features, this assembly is a valuable candidate for reinspection to determine if the good water quality conditions of L-Basin are effectively mitigating additional corrosion attack in areas where accelerated attack has occurred. In addition, a higher burnup assembly is recommended within the same bundle. Assembly 3-51-VI is selected for inspection during future inspection campaigns. This assembly has a 60% burnup compared to 3-9-IX with a burnup of only 30%. A comparison of the recommended inspections could elucidate the impact, or lack thereof, of burnup on the extent or type of corrosion.

**Figure 4-26 Outer dummy fuel corrosion features of Inspection Assembly 3-9-IX**

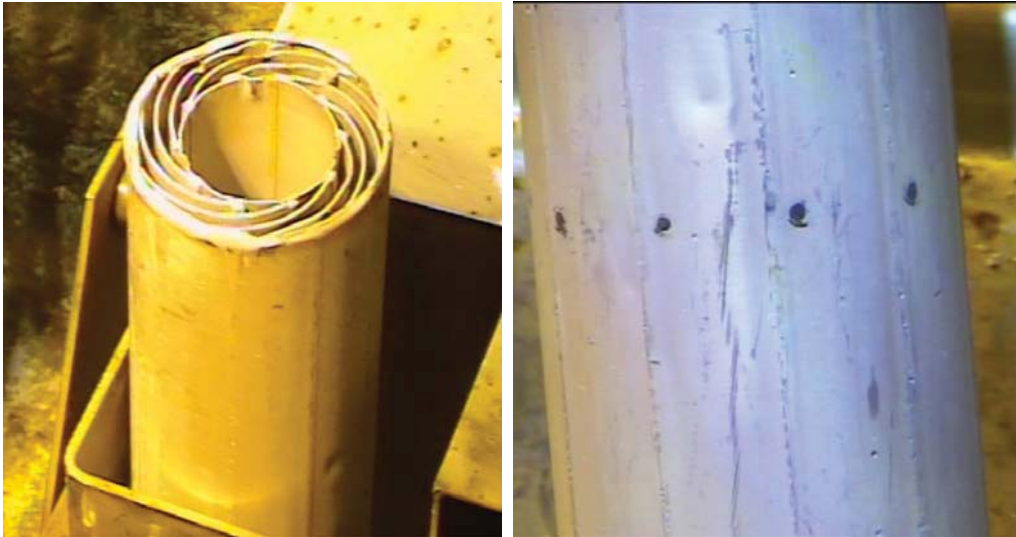
**Figure 4-27 Assembly 1556 cropped top end sitting in a lug bucket (left) and side view showing minor individual pits – holes with a symmetrical pattern were part of its fabrication (right)**

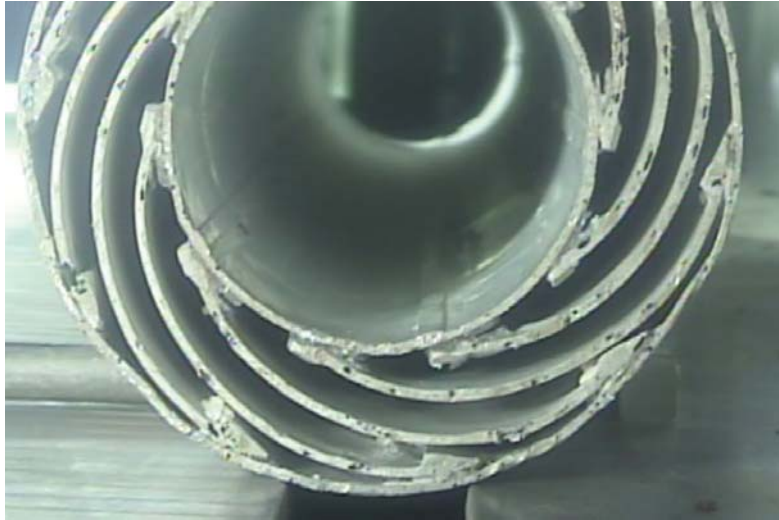
**Figure 4-28 Viewable end of the inspection assembly's involute fuel plate.  
Note the potential end grain corrosion with corrosion product in the bottom middle of the picture.**

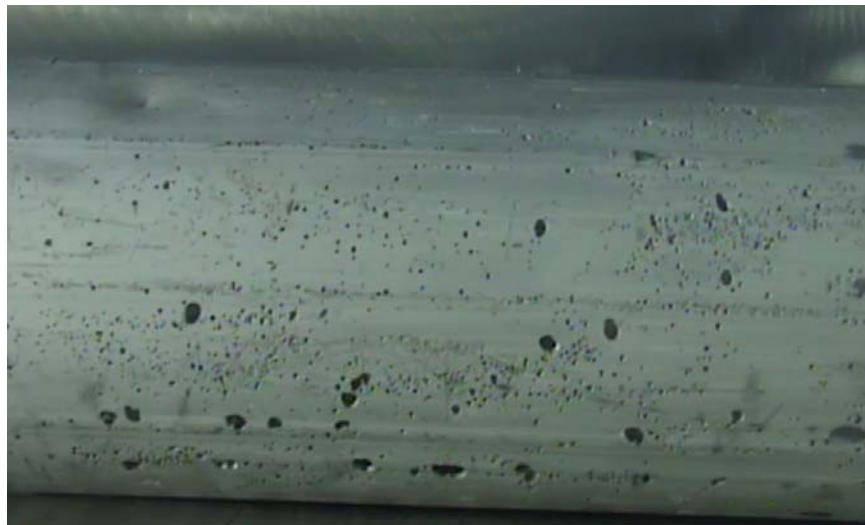
**Figure 4-29 Characteristic pitting of the inspection assembly UED 1567 that was typical for some assemblies, but not all the Mark III E assemblies. The outer tube contains no fuel, but had numerous, varying surface area pitting such as this could provide a corrosion pathway for corrosion to the inner involute fuel plates.**

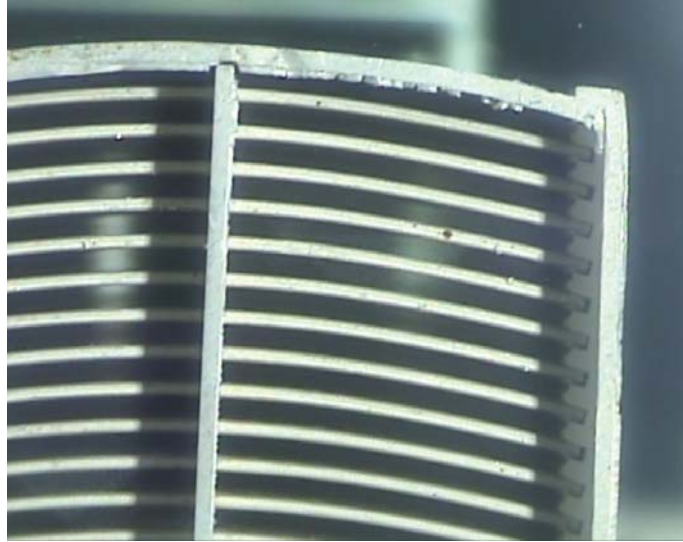
On the side plates, only some blemishes and scratches were found with no corrosion present.

**Figure 4-31 Bottom end detail of Inspection Assembly F950**

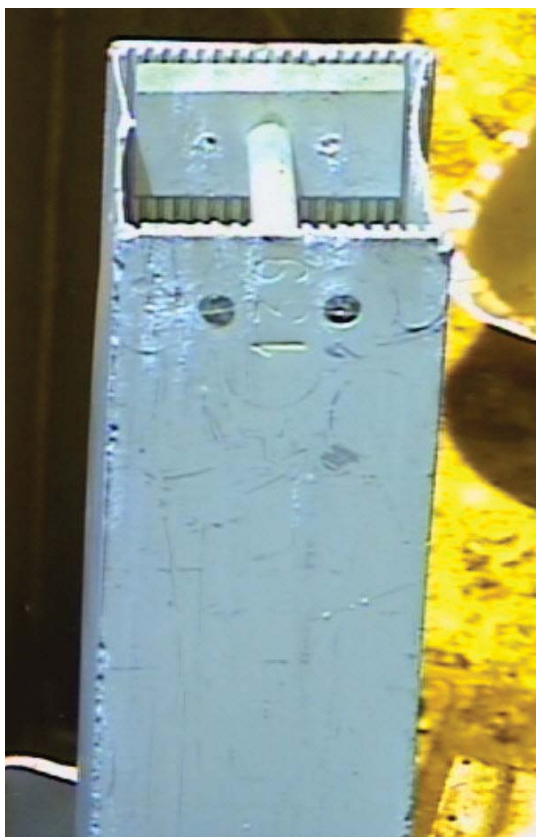
**Figure A5-5** Assembly 139 debundled sitting in a slug bucket. Edge of concave fuel plate bent inwards. Several types of corrosion shown. Galvanically induced corrosion found on the interior of the fuel bail screw holes (2). Surface and edge corrosion on the facing side plate. Edge corrosion on the side plate length also shown.

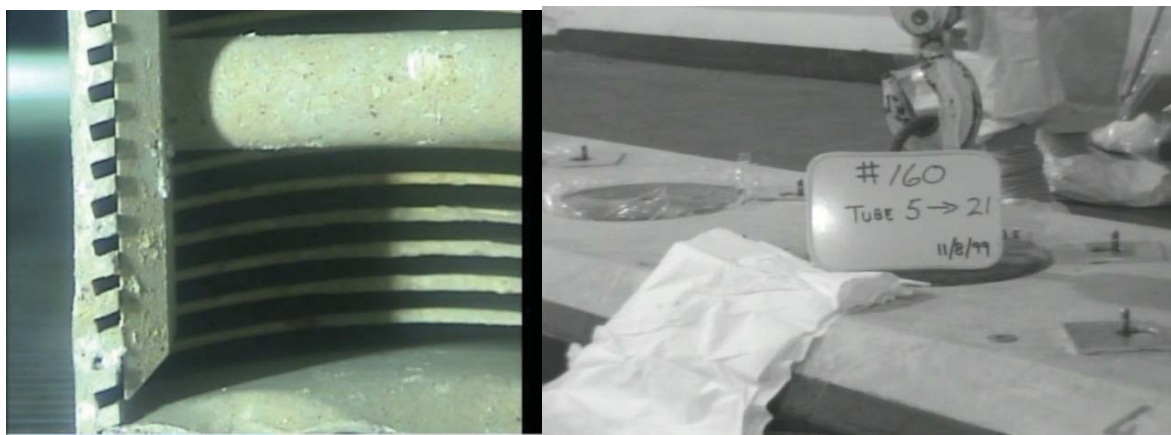
**Figure A5-6** (Left) Substantial crevice corrosion at the interface (Right) Concrete Fuel Tubes at the Ezeiza, Argentina of an inner fuel plate and a side plate groove. Storage Facility for Inspection Assembly 160 (1999).

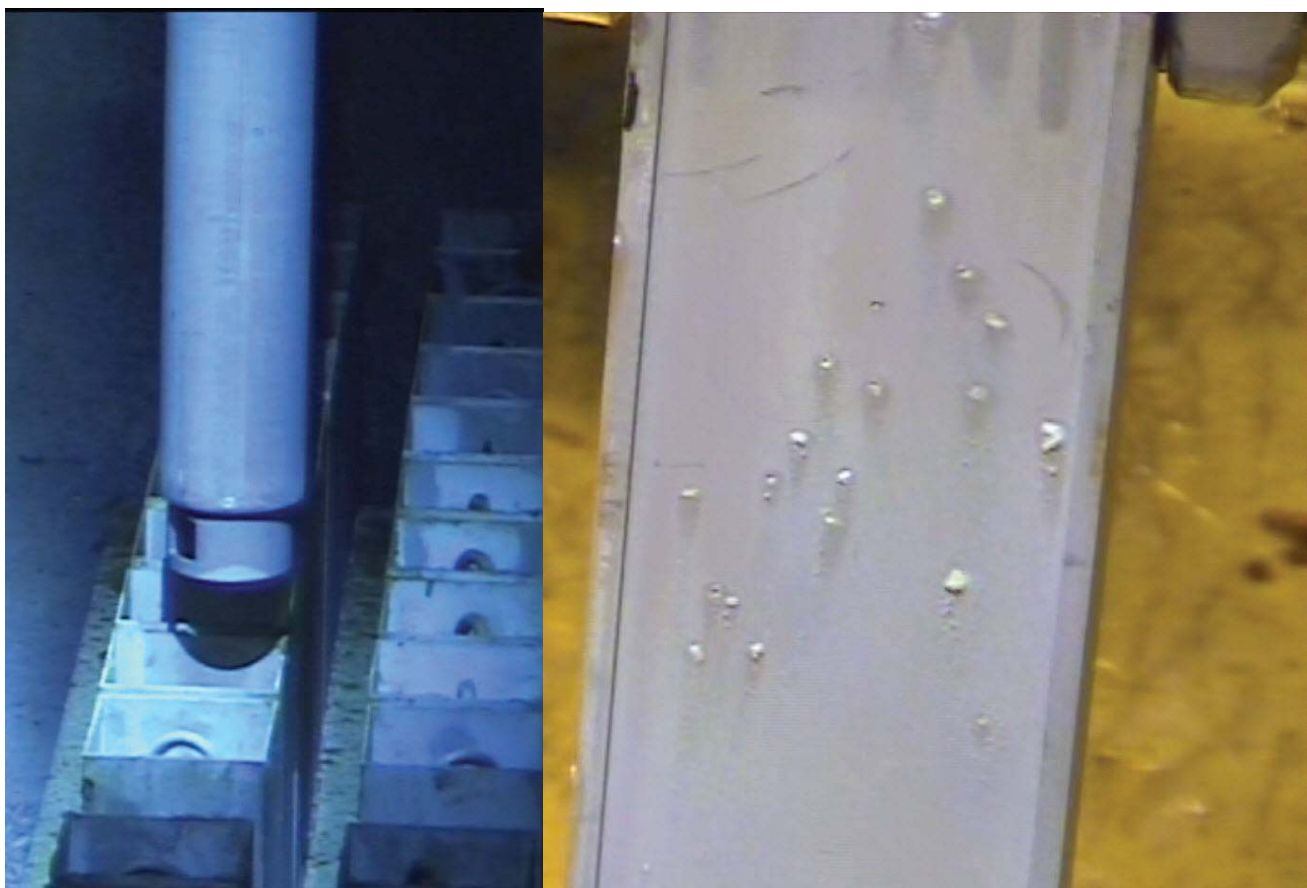
**Figure A5-10 (Left) Bundle L-ENEA-0352 clearing the rack (Right) Closeup of 71-GA77 exterior fuel plate with noting L Bundle "impact limiter" bottom distinct raised nodules in the fuel meat region.**

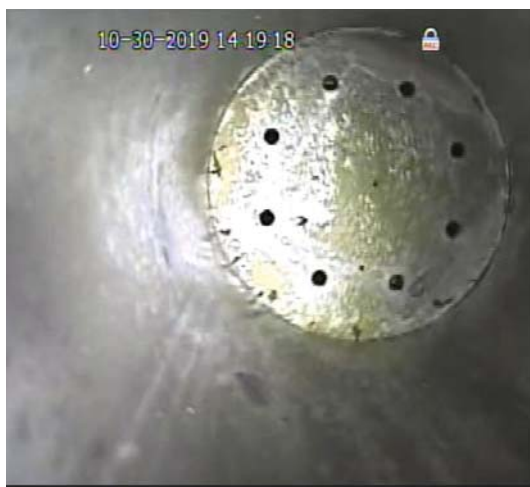
**Figure A5-11 Debris and staining but no corrosion found after inspecting L-ENEA-0351 emptied bundle.**

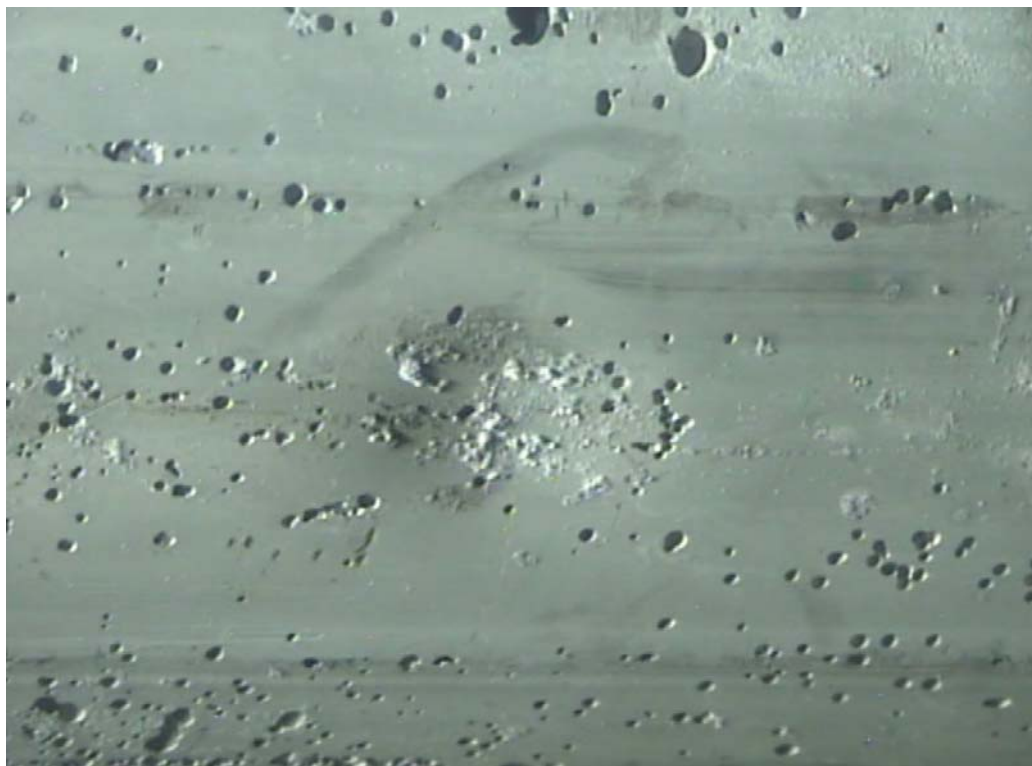
**Figure A5-14** Unique corrosion formation inspection assembly 1567 in the midst of a multitude of pitted holes.

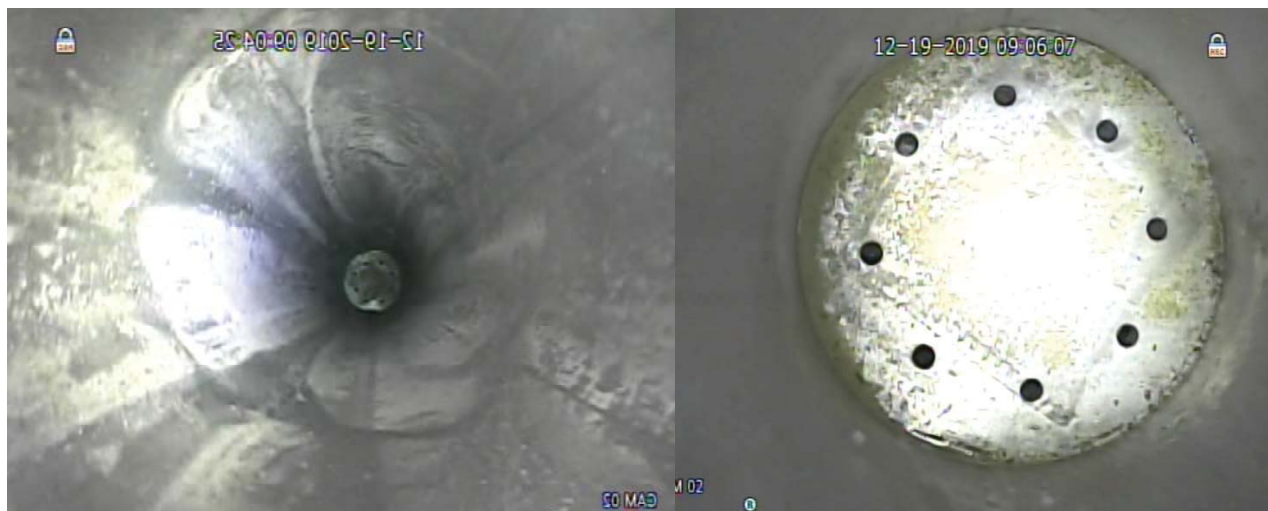
*Figure A5-17 Inside of vacated bundle L-RA3-0787 two-thirds down inside (left) no corrosion on bottom crevice (right).*

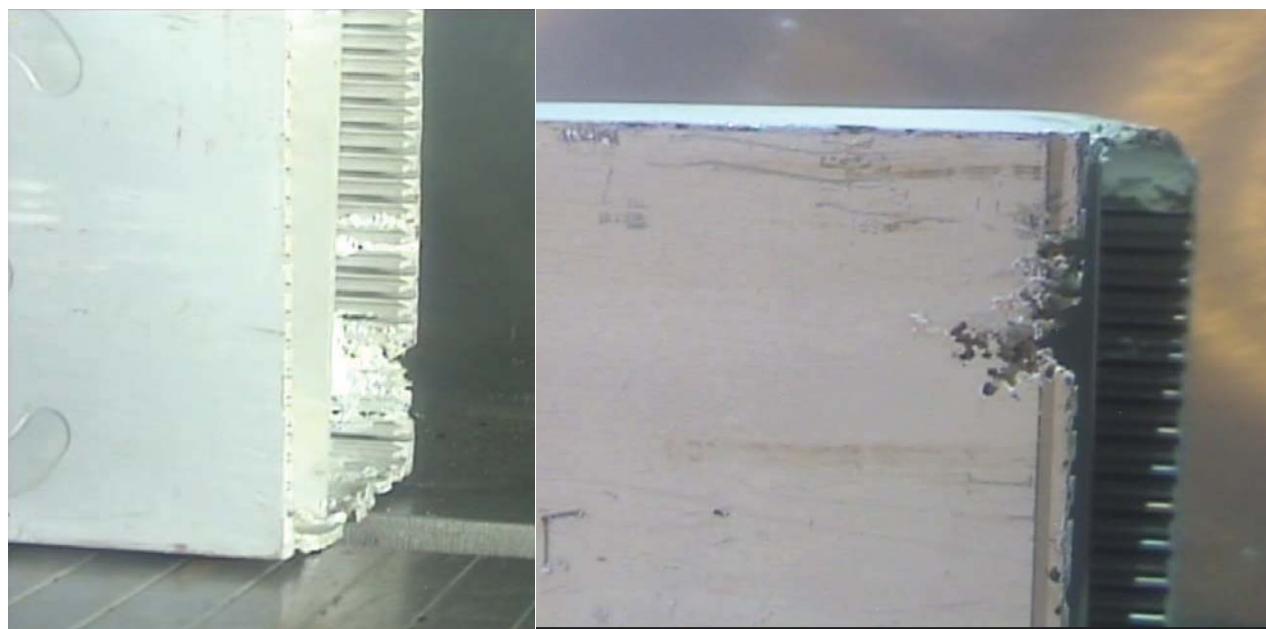
*Figure A5-18 (Left) Crevice corrosion inside of top end  
(Right) Opposite side of side plate from left view of inspection assembly 3—9-1X*
