LiDAR Inspection of GPS Denied Hazardous Environment Exhaust Tunnel

William Willie Wells,* Jean R. Plummer*, Jane M. Carter†

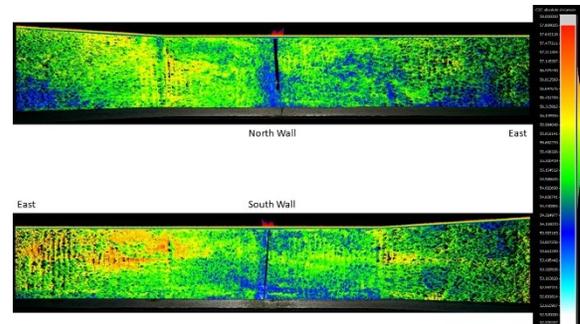
Fig 4. HCAEX wall to artificial plane comparison method.

Analysis of the region indicated in Fig 4 revealed uneven erosion on North and South walls as well as areas of interest that have eroded further than their surroundings. Features identified in previous camera inspections were validated as correct. These results establish the baseline from which surface change measurements from future deployments can be monitored. Previous visual inspections were taken at approximate 10' to 20' intervals based on the camera resolution and location making it difficult to accurately establish feature location within the tunnel. The LiDAR provides a more complete view of tunnel conditions especially with the identification of physical locations of those areas of interest along the inspection route.
