## **Inspection of Aluminum SNF Subject to Corrosion Under Extended Basin Storage – 21218**

Michelle A. Hromyak\*\*, Christopher G. Verst\*, Joshua T. Boerstler\*, Richard W. Deible\*\*, Robert L. Sindelar\*, Kristine E. Zeigler\*

\*Savannah River National Laboratory, Aiken, SC

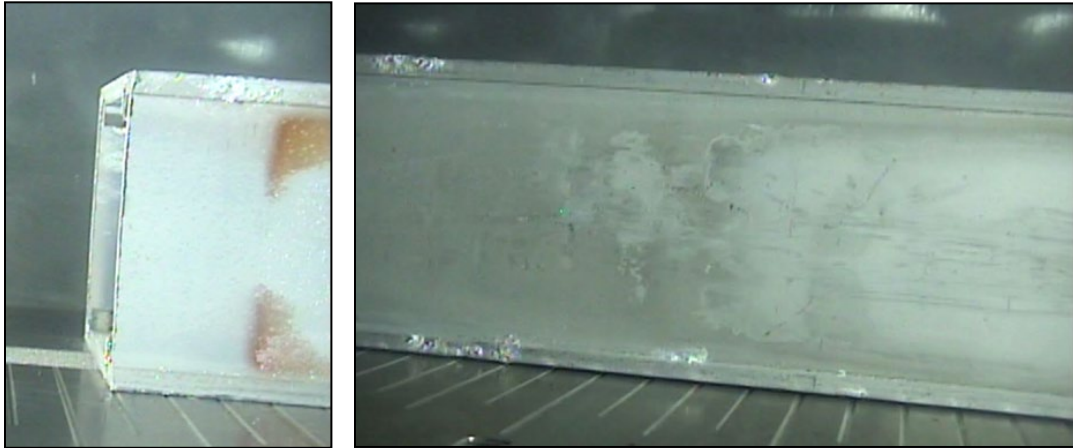
Figure 3. RA-3 S-113 Concave outer fuel plate showing edge pitting corrosion, crevice corrosion, pitting corrosion and discoloration.

For the RA-3 fuel it is recommended two of the four assemblies be re-inspected in 5 years. This includes the first RA3 assembly, S-113, a control assembly with stainless steel guides, and the last inspected RA3 assembly, 236, which was a high burnup standard assembly with unique exfoliated/spalled oxide formations and stainless steel screws. All RA-3 assemblies showed similar corrosion features in the same places for edge corrosion, crevice corrosion, fuel meat corrosion both pits and nodules and end-grain corrosion on the ends of the assemblies, as seen in Figure 3. Additionally, there was a standard assembly 138, within the first inspection assembly bundle, that had complete dark discolorations over one face of the fuel meat region of an exterior fuel plate that is also recommended for inspection. Three RA-3 assemblies are recommended for future fuel inspections.

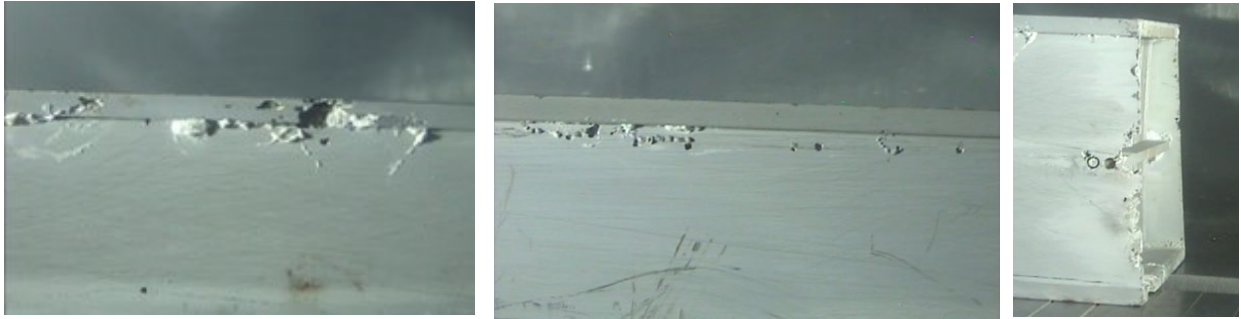
The ENEA ISPRA Reactor fuel assembly 3-9-IX is also recommended for reinspection. It has some severe crevice and side plate corrosion, seen in Figure 4, and gross end-grain corrosion with corrosion products on the ends of the assemblies, as seen in Figure 5. It will be interesting to reinspect for a future campaign to determine a worsening condition. It is also recommended that a high burnup assembly be selected from in the same bundle and inspect it (Assembly 3-51-VI). Assembly 3-9-IX has a 30% burnup and 3-51-VI has a 60% burnup for the fuel assembly.

Figure 4. ENEA ISPRA Assembly 3-9-IX showing side plate edge and fuel plate pitting corrosion, crevice corrosion, and end grain attack.

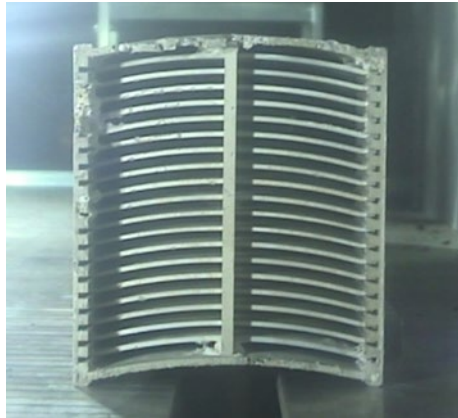
Figure 5. ENEA ISPRA Assembly 3-9-IX showing end grain attack.

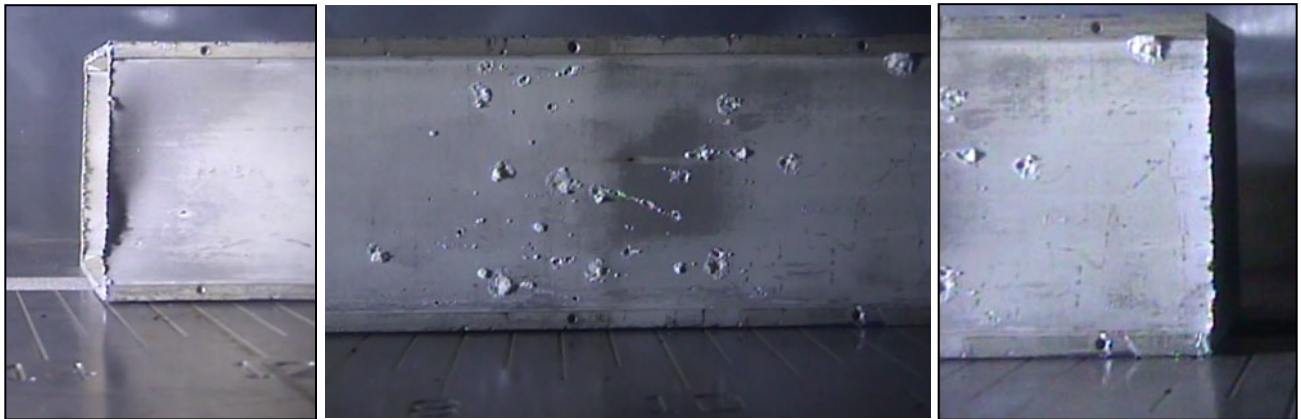
The IEA-R1 reactor assembly IEA-79 is also recommended for reinspection. This assembly contained pits in the fuel meat region, as seen in Figure 6, that appeared to indicate decladding and fuel failures, in addition to a number of other corrosion phenomena, which in many cases were some of the most severe of the ten assemblies inspected. It was a low burnup assembly. It is also recommended that a high burnup assembly IEA-77 (in an adjacent stored fuel bundle, same rack) also be added for the next fuel inspection. This higher burnup fuel selection for inspection is contingent on the availability of previous facility inspection data that can be used for comparisons.

Figure 6. IEA-R1 Assembly 79 concave outer fuel plate showing nodular pitting and crevice corrosion.

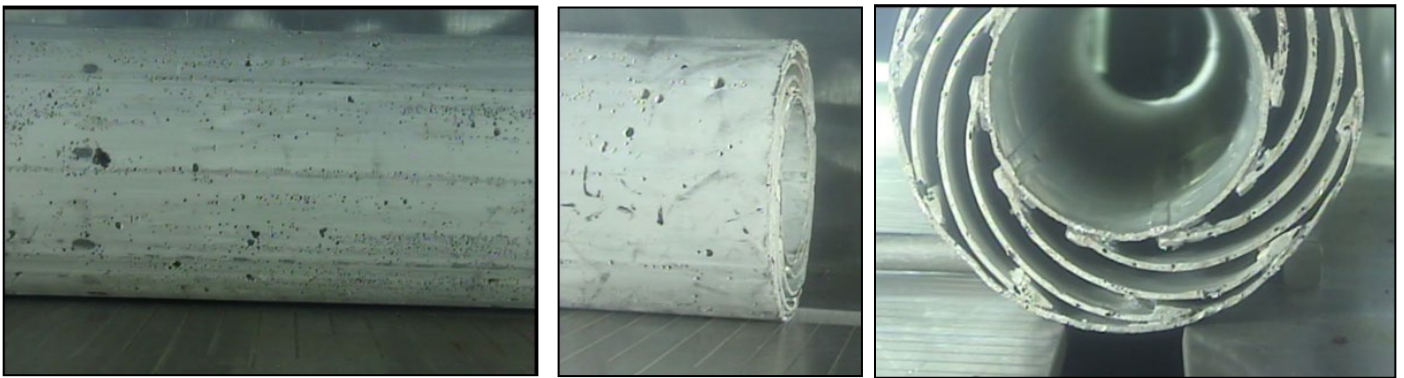
The inspected Australian Mark III fuel UED 1567, Figure 7, had limitations for inspecting fuel plates. Since the outer tube was only aluminum and one of the ends had a fuel ID plate installed, which prevented the ability to view one end of the fuel plate ends, the only useful fuel inspection information observed was one end view of the involute fuel plates. Based on previous facility inspection data, outer fuel plates with numerous varying surface area pits indicate a potential corrosion path to the outermost assembled involute fuel plate. However, even if both ends were exposed, it would be difficult to ascertain the fuel plates condition. There were many pictures of HIFAR inspection assembly UED 1567 taken at the time of the previous facility fuel inspection. Additionally, there was a careful inspection sheet formulated to go along with previous fuel inspection pictures. The results of the AMCAP MTR fuel inspection for assembly UED 1567 indicated no increase in corrosion than that found at the origination facility. If a Mark IV assembly was selected or another Mark III, the same observations limitations would exist for observing fuel condition (i.e., only one end of the fuel plates could be observed). Although the HIFAR assembly has limited fuel inspection value a reinspection of the assembly would be good to check on regular aluminum corrosion rates within a stored bundle, focusing on the exterior aluminum tube condition over storage time.

Figure 7. HIFAR UED 1567 (left two pictures) outer casting (non-fuel) showing pitting attack. Right picture, bottom view of HIFAR UED 1567 showing crevice corrosion and end grain attack.
