Visual Examination of Aluminum Containers for Extended Wet Storage of Non-Aluminum-Clad Spent Nuclear Fuel – FY21

June 2021

SRNL-STI-2021-00311, Revision 0

L.N. Ward
M. Trimm
C. Verst
S. Boland

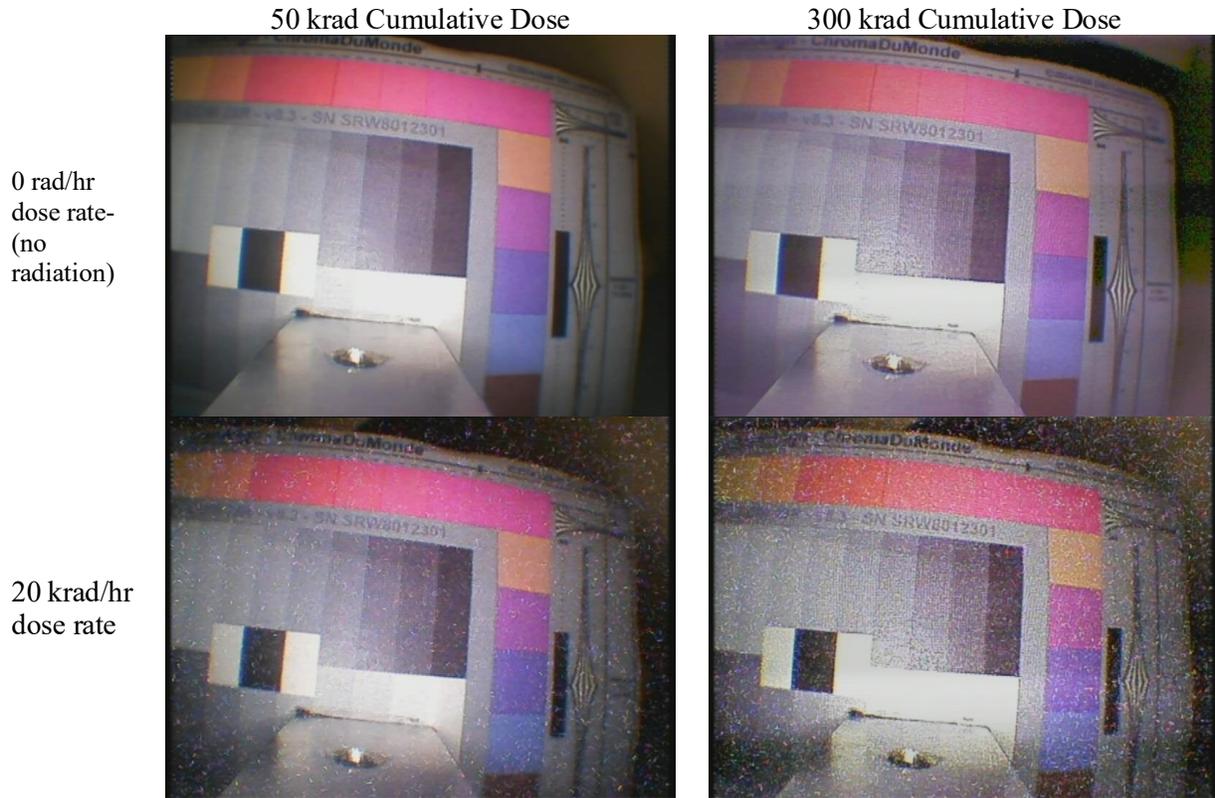
Figure 1-4. Images taken from Mini 13 during gamma irradiation testing. Cumulative Dose of 50 krad (left) and 300 krad (right). Dose rates of 0 rad/hr (top) and 20 krad/hr (bottom).

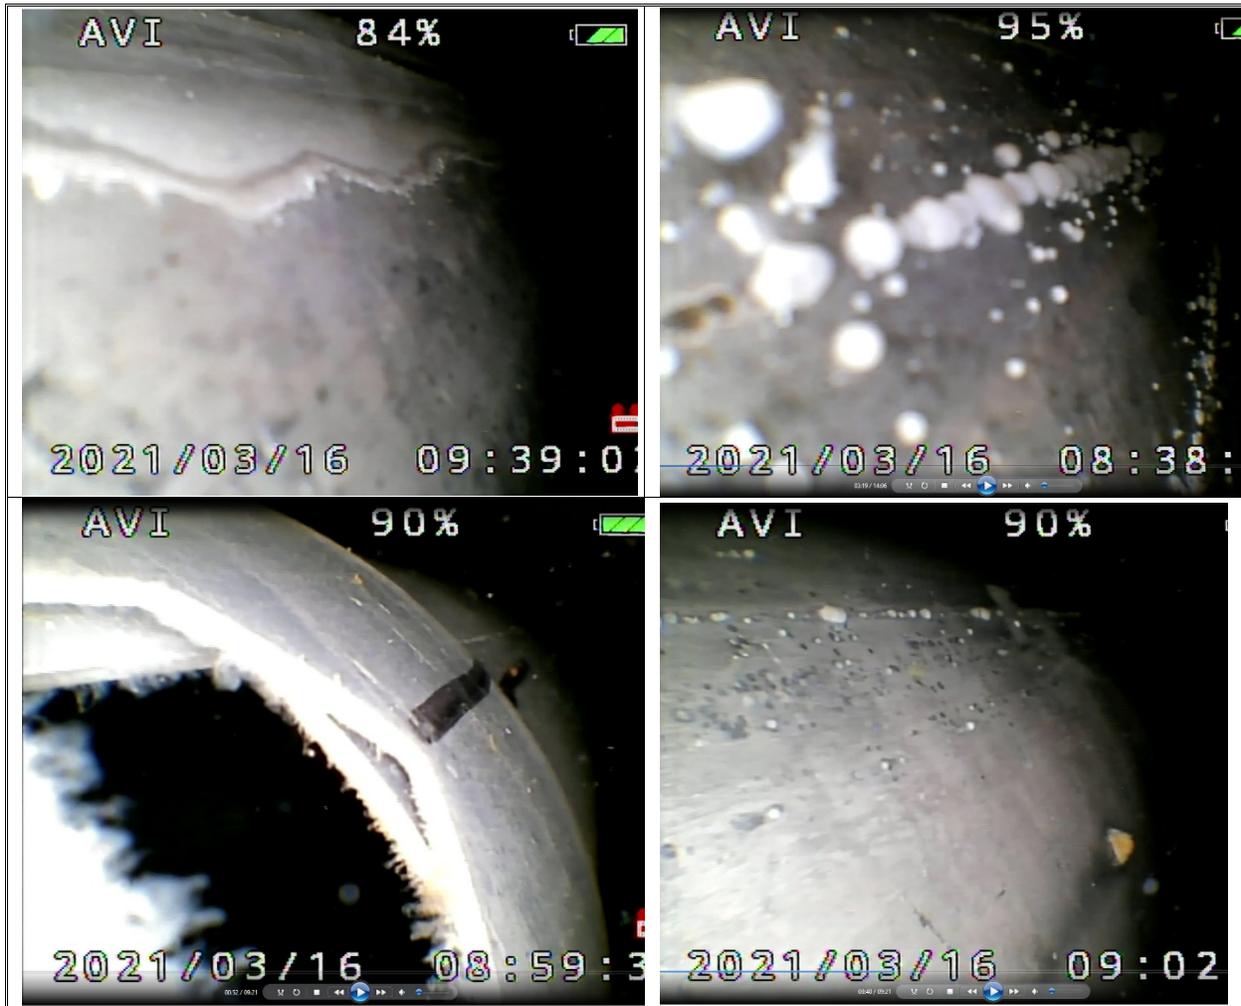
L bundle 1051 was inspected on March 16, 2021. There were masses of orange-brown microbial cobweb growth on the top of the bundle, which partially occluded the identifying number from view. The tabs were not visible from any corner in the 0° or 45° position. There were raised grayish-white nodules of aluminum oxide corrosion. Nodules increased in size and connected into one long line of corrosion, closer to the bottom of the bundle. Also noted were orange-brown corrosion typically associated with iron oxide rust (perhaps due to previous steel interaction before being placed in basin) but aluminum chloride deposition is a possibility; orange-white nodules with highly raised surfaces from the bundle surface (these nodules are more likely aluminum chloride); some minor scratches; minor pitting; light gray to white discoloration,

resembling liquid interface prior to being placed in the basin; and white plated corrosion. Most corrosion was noted near the bottom of the bundle. All the corrosion can be considered general corrosion and there were no serious noted issues on the surface area. There was initially minimal particulate, but it increased as the camera moved down the bundle and subsequently removed corrosion and microbial product from the bundle surface area. The camera experienced radiation effects eight minutes into the first bundle examination, but overall imaging was still clear (Figure 3-1).

Figure 3-1. Representative Images of L Bundle 1051. Upper left – Discoloration resembling liquid interface. Upper right – White nodular corrosion. Lower left – Tab hole with microbial growth. Lower right – White and yellow nodular corrosion with darker spots resembling pitting.

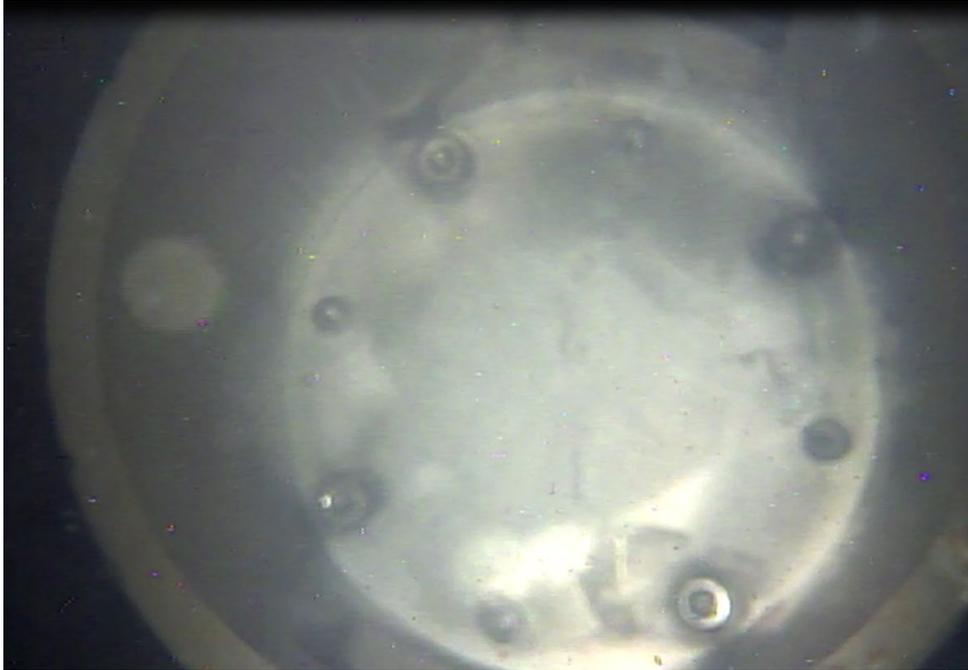
In deploying the side view FF camera for viewing the bottom of the bundle, radiation effects to the camera were immediately noticeable. The camera still produced reasonably clear images of the bundle bottom without noticeable corrosion, discoloration, or deformation of the weld (Figure 3-2). The bolts for the OCP are visible and intact as well.

Figure 3-2. Bottom of L Bundle 1051.

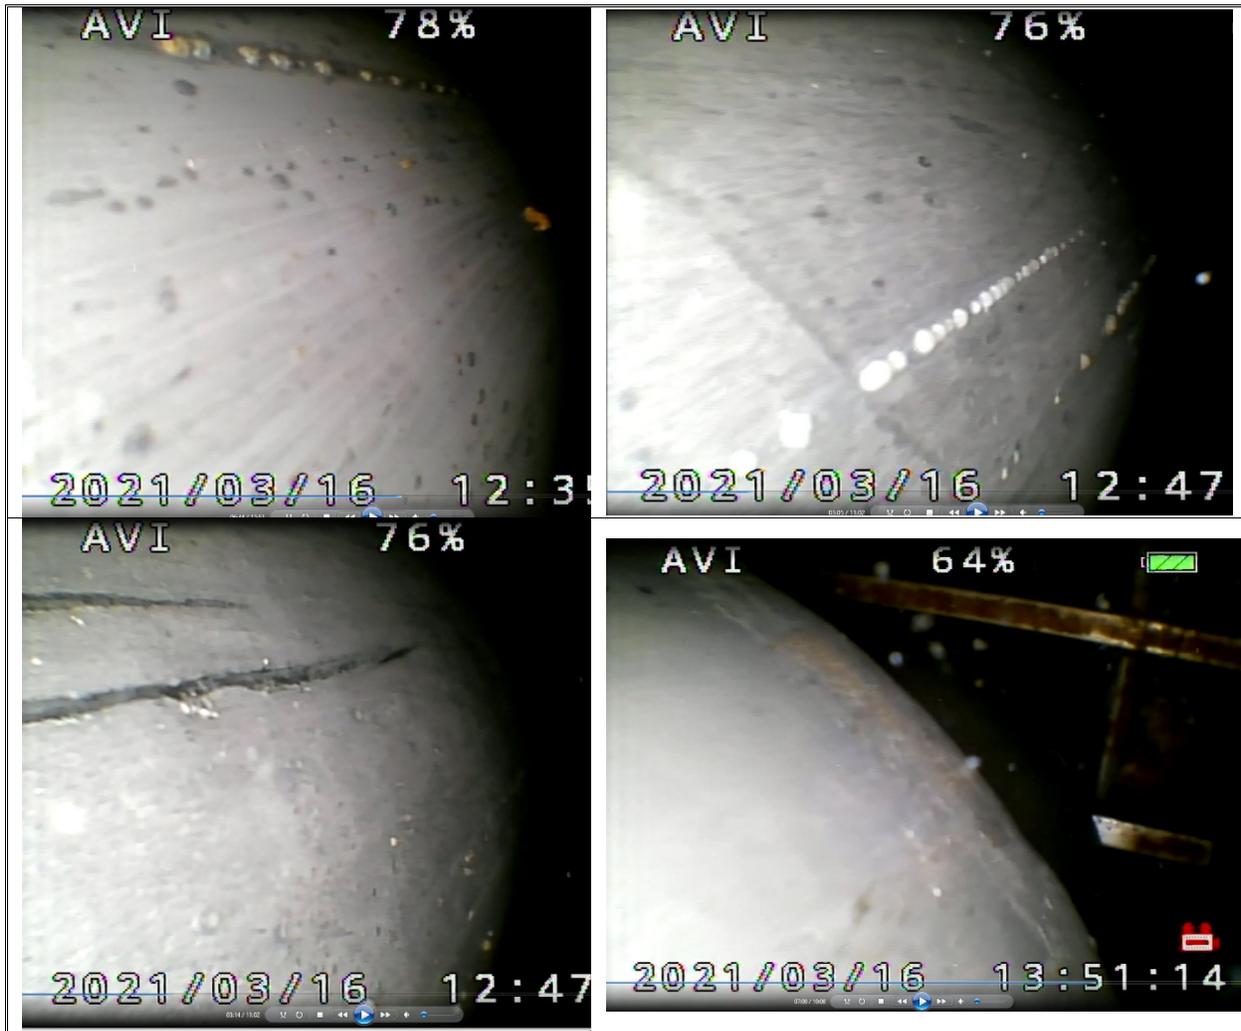
examination. Slight pitting was noted, along with various scratches and circumferential scrapes with orange discoloration. This is most likely due to a steel piece causing the scrape and leaving behind some steel within the scrape that subsequently rusted on the aluminum bundle. Some scaling corrosion was noted near the bottom of the bundle. While there were items to note in every corner, this bundle had very little overall general corrosion. This also contributed to less particulate in the camera images, as the camera was not dislodging corrosion into the water. The bundle bottom looked clean, intact, and without any weld deformation or corrosion (Figure 3-3).

Figure 3-3. Representative images of L Bundle 105

- 6. Upper left – Nodular corrosion. Upper right – Nodular corrosion following scratch on surface.
Lower left – Scratches with depth. Lower right – Corrosion on bottom sidewall edge of bundle.**

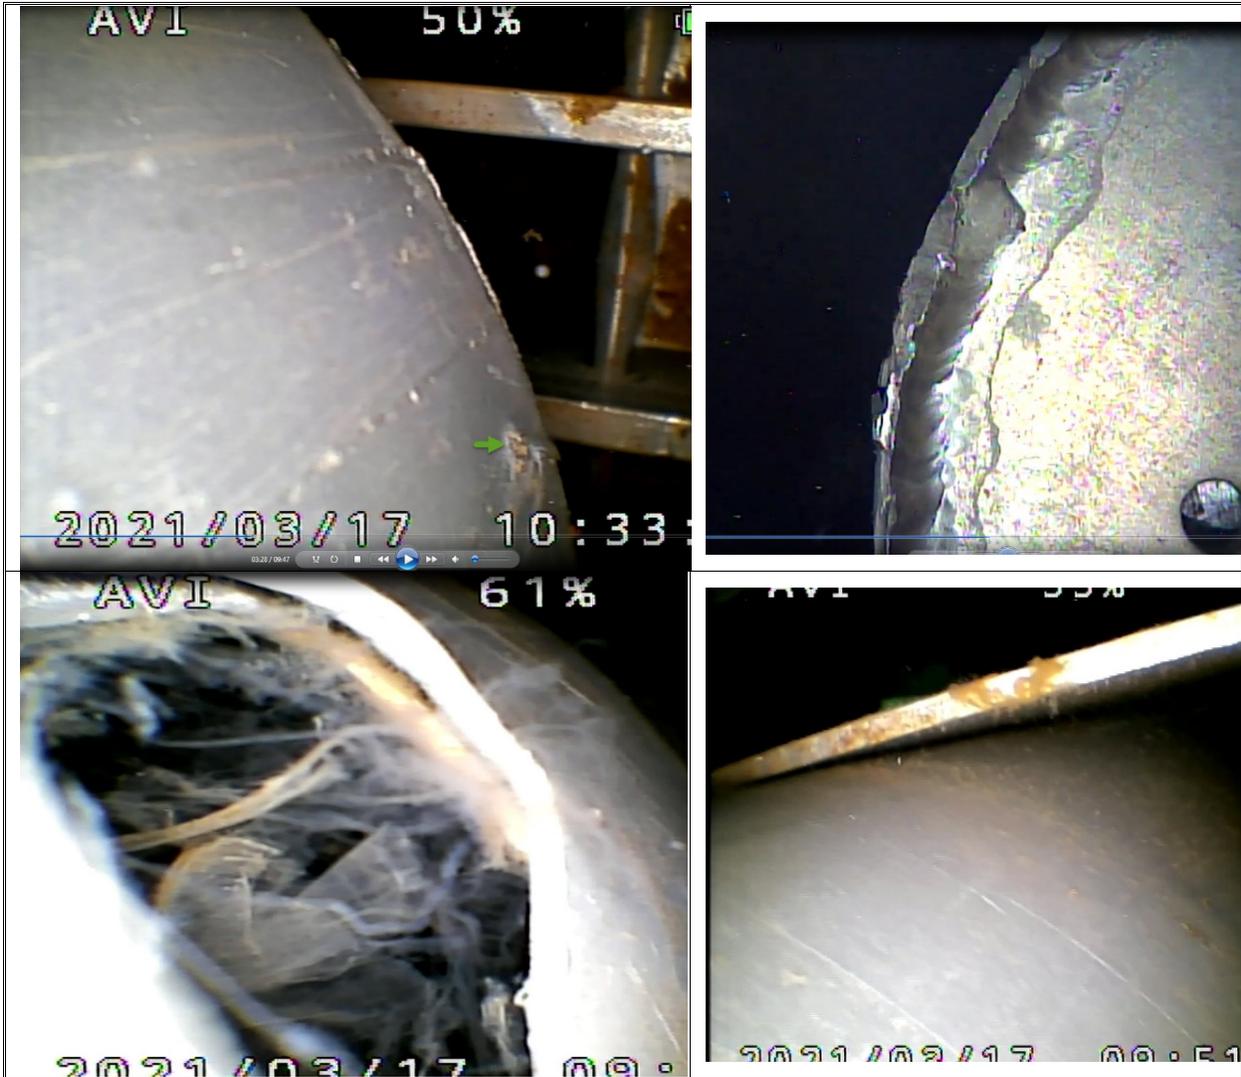
corrosion was also seen just below the tab opening. It was unclear from the camera angle whether this was growth or corrosion, due to the color of the growth noted inside the bundle. Bundle number 4302 was etched on the side of the bundle and black writing was seen. Upon passing the top of the bundle with the camera wedge, a fine particulate powder was noted. This was the corrosion or growth product dislodging from the bundle. A deep scrape was noted above the rack with brown discoloration (most likely deposited iron oxide) along with other circumferential scrapes. Other items of note include very few orange-white nodules, some small scratches with and without associated corrosion, some pale orange growth or corrosion above the rack, minor pitting associated with an axial scratch, some small concentrated areas of corrosion with orange discoloration and pitting, some circumferential scratches with significant depth, a large diameter pit with minimal depth, and one small area on the sidewall at the bottom of the bundle that appears to be a deformation or protrusion with associated orange-brown discoloration. Particulate increased as the camera moved to the bottom of the bundle with the camera wedge dislodging corrosion or growth product from the bundle sidewalls. The bottom lip of the bundle from the sidewall camera viewpoint had some minor deformation. The bottom of the bundle was intact and shiny with some dull areas that could be corrosion initiation. The weld was intact, also with one noted dull area. Overall, the bottom had no noticeable issues associated with structural integrity (Figure 3-4).

Figure 3-4. Representative images of GP Tube 4302. Upper left (green arrow) – Nodular protrusion at bottom edge of sidewall. Upper right – Small dull area in weld on bottom of bundle. Lower left – Tab hole with microbial growth inside bundle. Lower right – Orange brown microbial growth on bundle sidewall growing down into the rack.

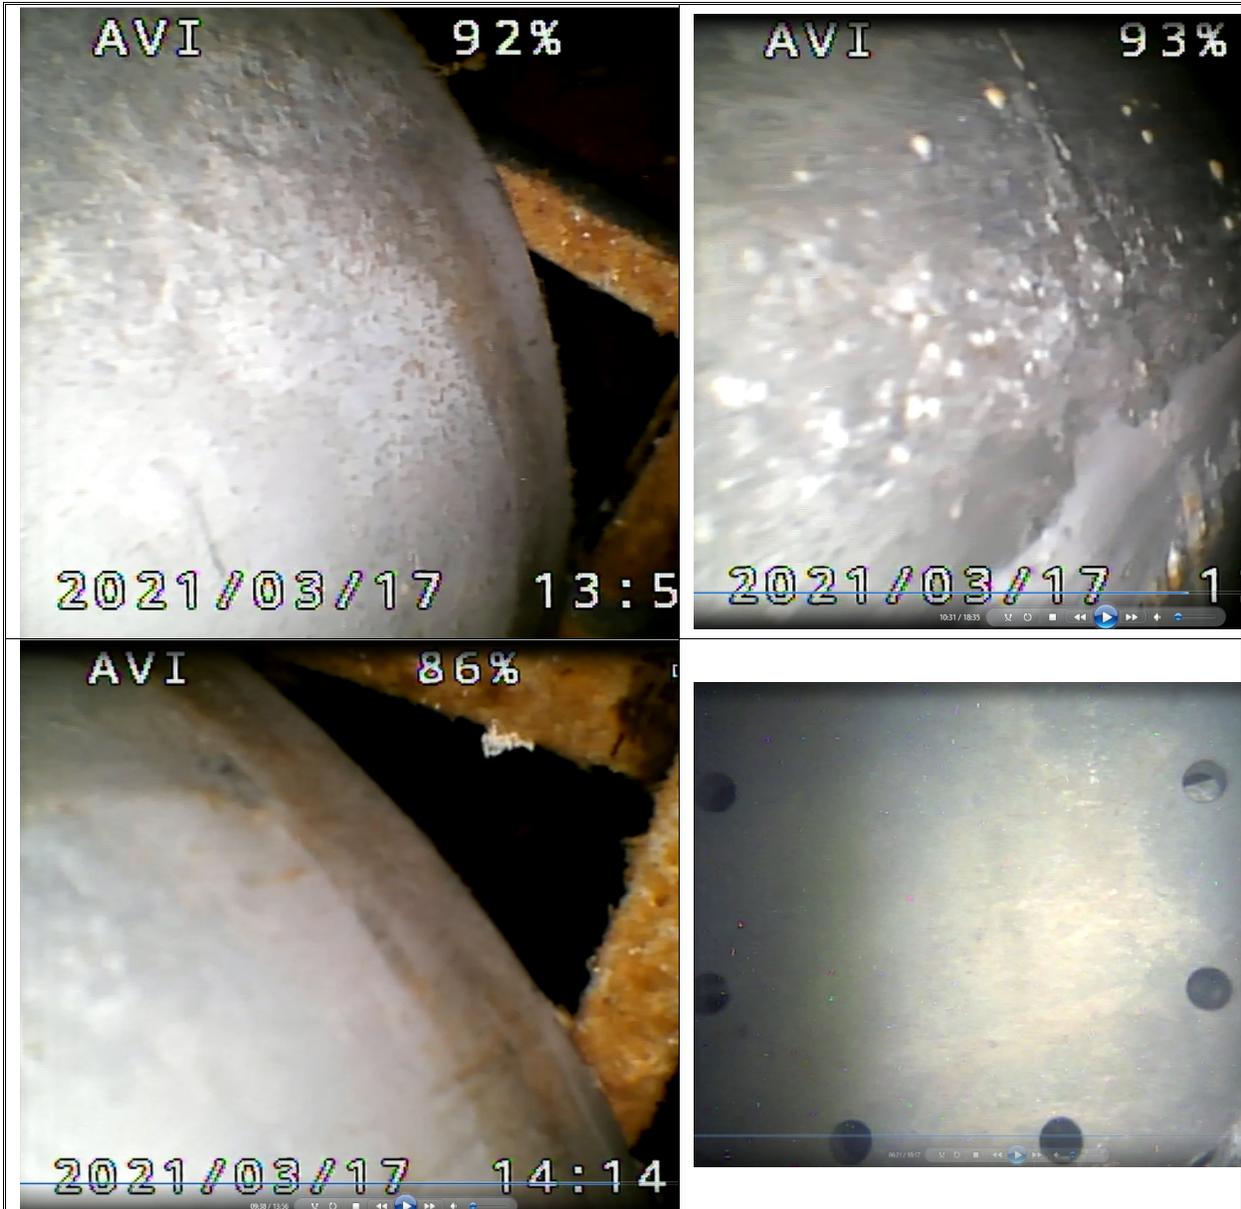
Upon turning the bundle, several small gas bubbles emanated from the lid holes. This gas release was much less in volume than L bundle 1051. However, GP tube 7999 was also loaded with a can and so the same possibilities for gas origination can be used. The gas is most likely either due to trapped air upon loading the can into the bundle or hydrogen product from uranium fuel reaction with water.

Figure 3-5. Representative Images of GP Tube 7999. Upper left – Bulge at bottom edge of sidewall. Upper right – Nodular and pitting corrosion. Lower left – corrosion at bottom edge of sidewall. Lower right – Material visible through holes on bottom of bundle.

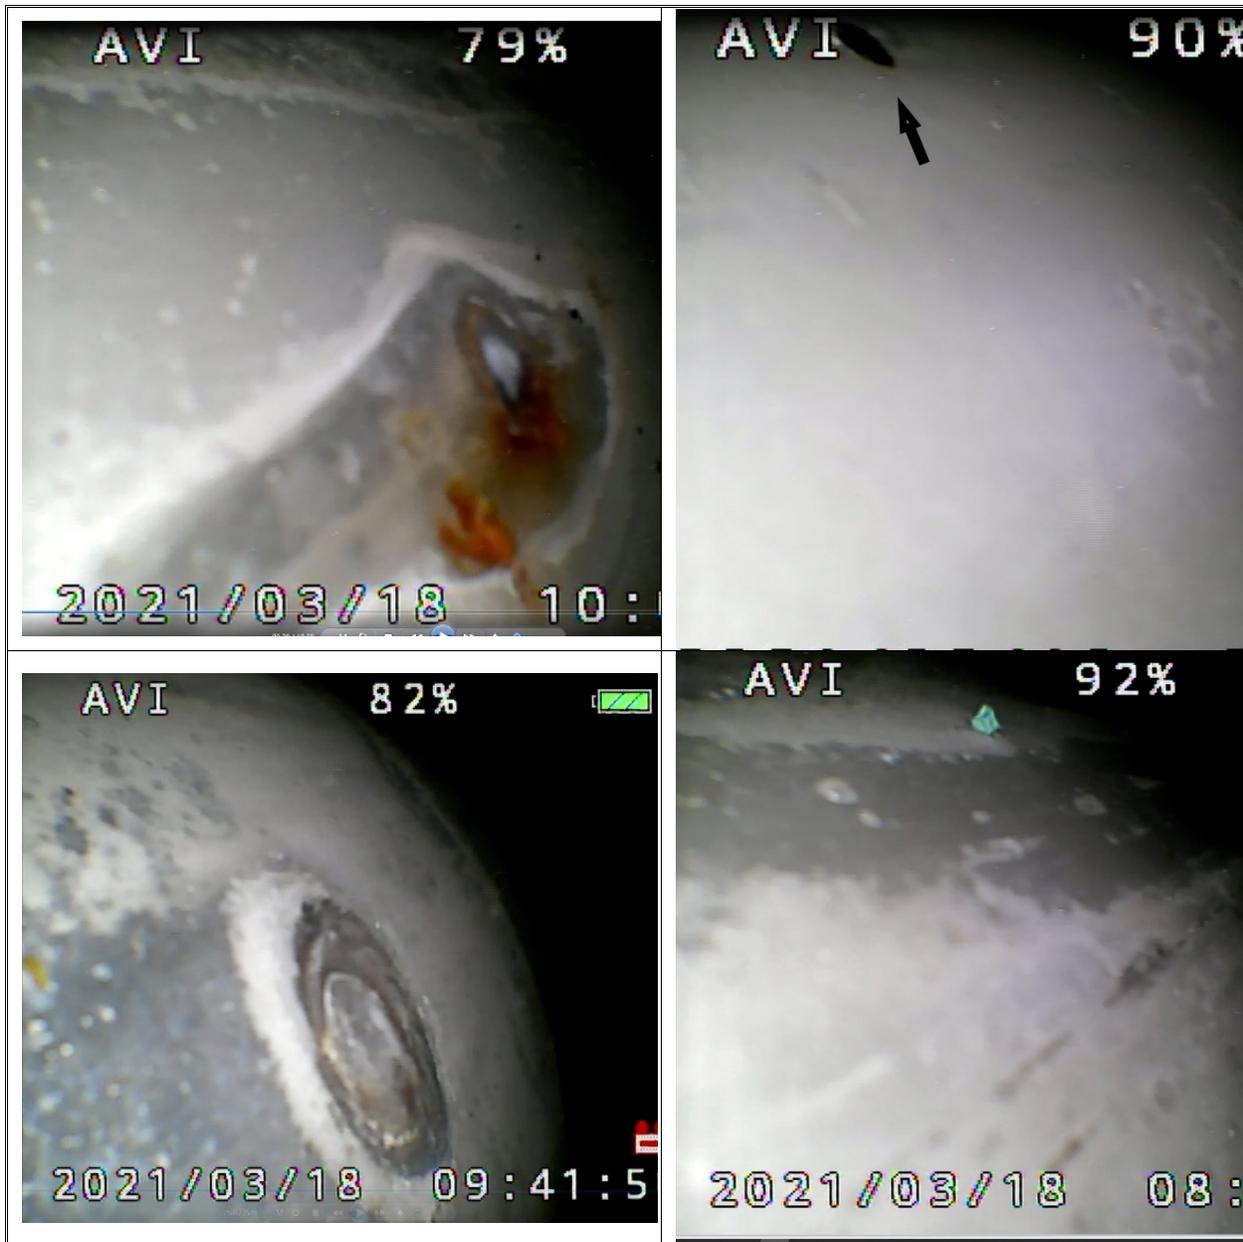
The bottom of the bundle was intact with no noticeable corrosion. The impact limiter partially occluded total view of the weld, but visible portions showed no corrosion or deformation (Figure 3-6).

Two very small gas bubbles emanated from this bundle upon turning it to the 45° position. While this bundle contained no cans, there is still the smaller possibility of hydrogen generation with the low uranium content fuel. These bubbles were so small as to be relatively inconsequential in comparison to the two other bundles with gas emanation.

Figure 3-6. Representative Images of L Bundle 0845. Upper left – Corrosion with discoloration and nodule. Upper right (arrow) – Moderate black feature resembling hole. Lower left – Large raised corrosion feature. Lower right – Pale green crystalline growth, unique to this bundle.

One bundle (#0845) will be removed from the storage rack and re-inspected (summer 2021) to help identify the cause of the single large (~3/4" diameter) surface area anomaly observed during March inspection.
