Destructive Examination of Shipping Package 9975-02731

June 2022

SRNL-STI-2022-00234, Revision 0

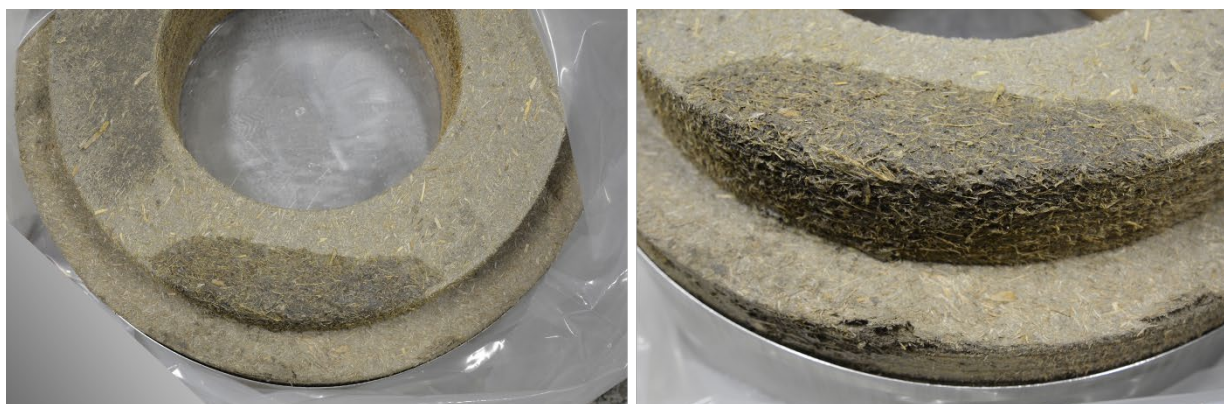
Dark discoloration was noted on the upper fiberboard subassembly during unpackaging in KAC (Figure 2). The large stain on the flat surface and side of the upper fiberboard indicates a substance was spilled on the fiberboard assembly and then dried. Similar but smaller dark stains have been observed along glue joints in other DE packages and the stains were attributed to dried and smeared glue [11-12]. Figure 3 shows pictures of the upper fiberboard assembly with excess dried glue residue. Chemical analysis of the discolored fiberboard was performed using FTIR. Samples were taken of the upper fiberboard assembly from areas with and without the discoloration. Elmer's[®] Carpenter's wood glue, a water-based poly(vinyl acetate) adhesive used in laminating the fiberboard, was applied on a separate fiberboard sample. The FTIR spectra of the fiberboard samples and the wood glue are presented in Figure 4. The FTIR spectra of the fiberboard samples with and without discoloration are very similar although the peaks are more pronounced for the former. This could be due to the contribution from poly(vinyl acetate) adhesive as the glue has peaks that overlap with the fiberboard sample, such as at 2924 cm^{-1} (-CH), 1422 cm^{-1} (-CH₂), and 1024 cm^{-1} (-C-O). Optical microscope images show both the discolored fiberboard and sample with dried wood glue have glossy surfaces (Figure A-1). The visual and chemical examination of the upper fiberboard assembly indicate the discoloration is consistent with dried wood glue residue.

Figure 2. Pictures of upper fiberboard subassembly with large discoloration attributed to dried glue (photos taken by KAC personnel during unpackaging).

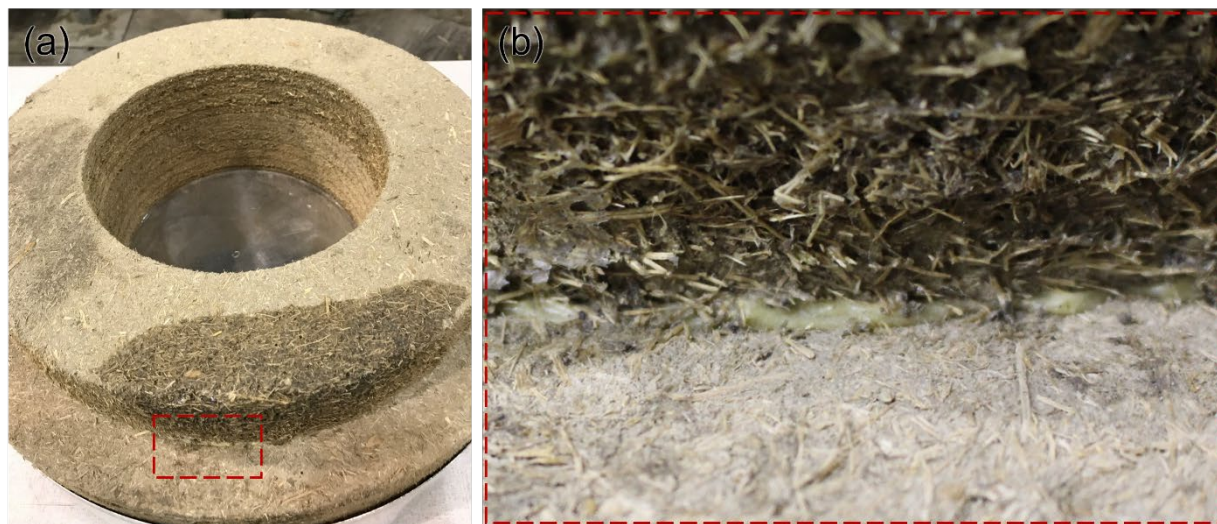
Figure 3. Pictures of (a) upper fiberboard assembly with discoloration and (b) close-up of excess dried glue in the fiberboard junction.

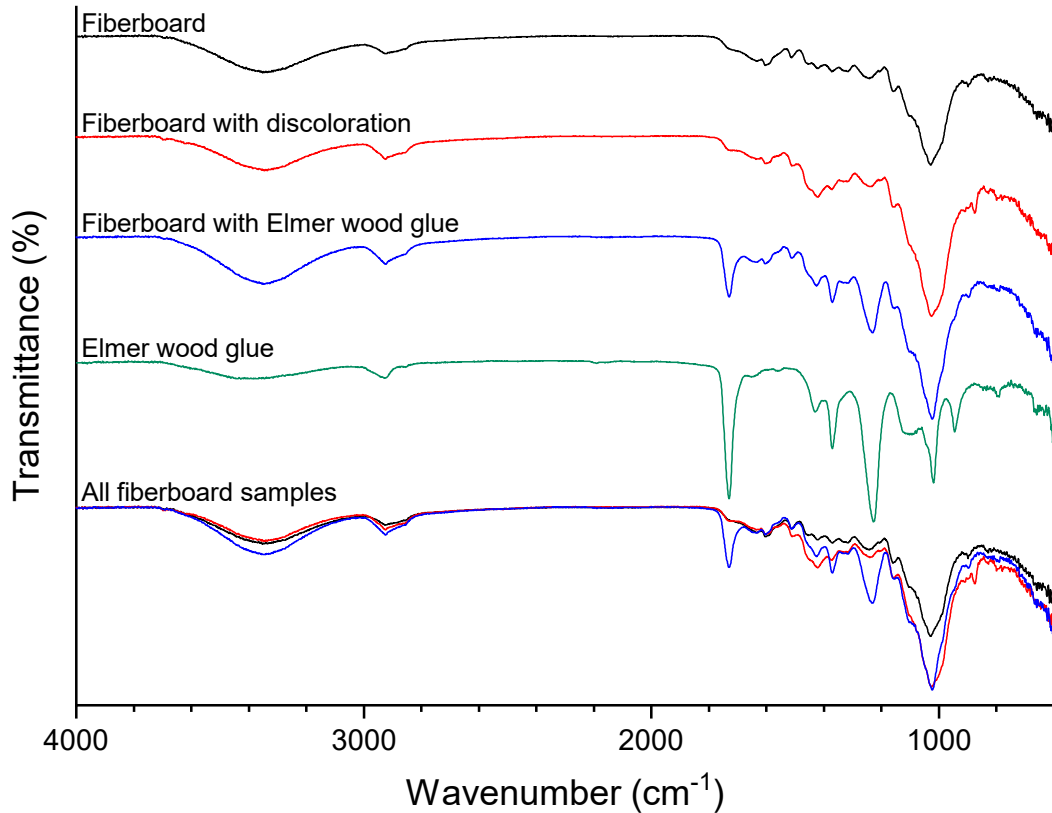
Figure 4. FTIR spectra of the upper fiberboard samples with and without discoloration, and with applied Elmer wood glue.

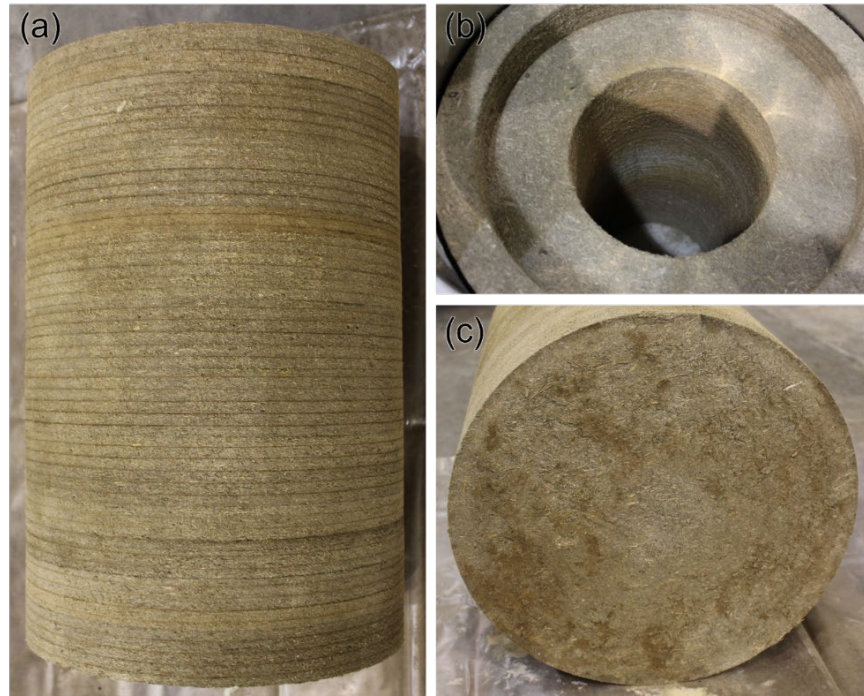
The lower fiberboard assembly came out smoothly from the drum and appeared visually consistent with undamaged fiberboard (Figure 5). There was no dark staining from dried glue residue on the surfaces. A white band was observed in the cavity of the fiberboard assembly due to contact with the corrosion products on the lead shield. The contact with the lead shield was superficial as the lead shield was lifted easily from the fiberboard assembly.

Figure 5. Pictures of (a) side, (b) inside, and (c) bottom of the lower fiberboard assembly.

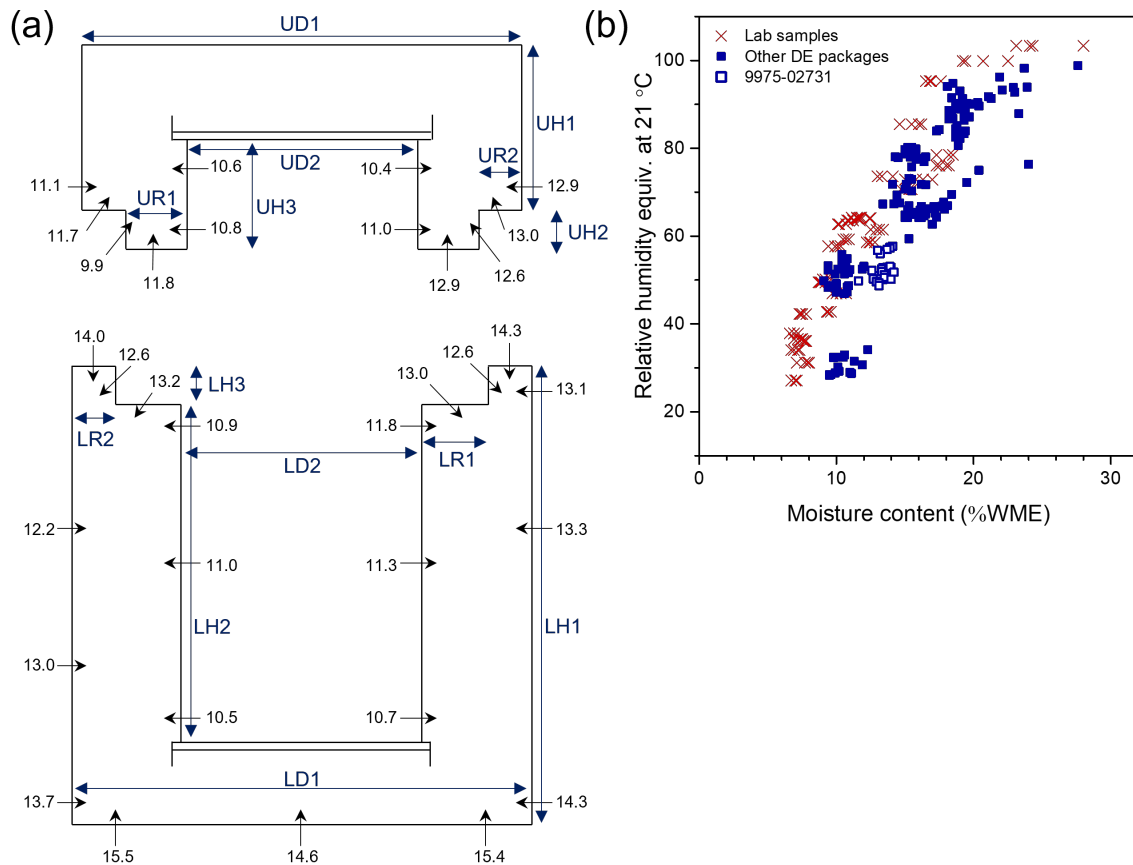
Figure 6. (a) Moisture content (% WME) data of the fiberboard subassemblies. (b) Plot of measured fiberboard moisture content and the relative humidity of the adjacent air.

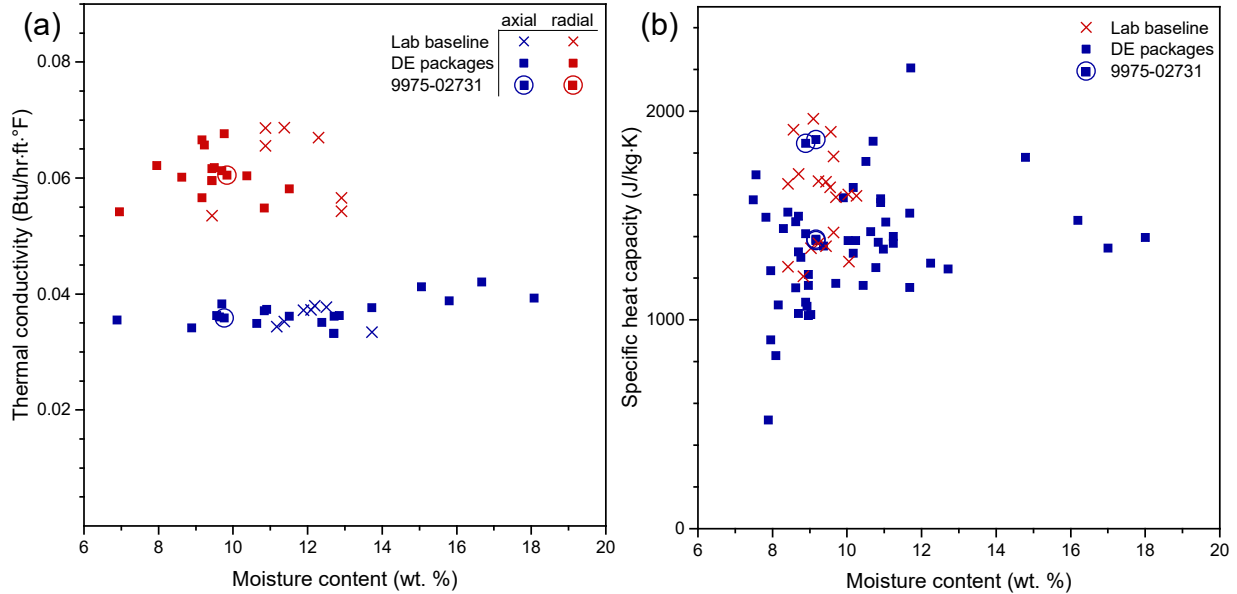
Physical measurements and testing results for 9975-02731 fiberboard test samples are recorded in Table 2. The thermal conductivities, λ , are 0.0358 and 0.0605 Btu/hr·ft·°F for the axial and radial samples, respectively. These values are within the acceptance range and in reasonable agreement with DE package and laboratory baseline data as shown in Figure 7a. The average specific heat capacities were 1383 and 1855 J/kg·K for the base and side samples, respectively (Figure 7b). Multiplying the specific heat capacity, C_p , by the density of the lower subassembly (283 kg/m³) and converting units yields an average heat capacity of 5.835 Btu/ft³·°F for the two base samples and 7.826 Btu/ft³·°F for the two side samples. These fiberboard samples meet the required minimum specific heat capacity of 3 Btu/ft³·°F and are consistent with previous DE packages and laboratory baseline data. Thermal conductivity and specific heat capacity increase with increasing moisture content of fiberboard samples. The fiberboard subassembly, used for over 13.8 years as a thermal insulator in 9975-02731, met the thermal property acceptance criteria.

Figure 7. Thermal properties of fiberboard from destructively examined packages and laboratory baseline samples including (a) thermal conductivity and (b) specific heat capacity.

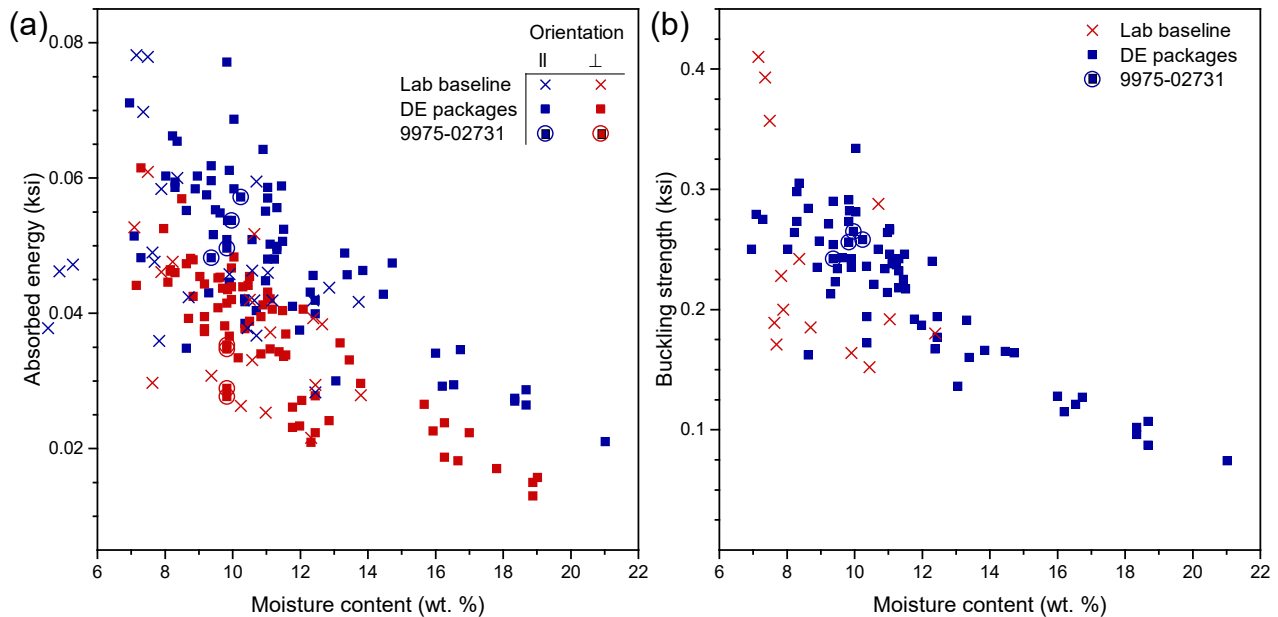
Compression test results are shown in Figure A-2 and Figure 8 along with baseline fiberboard data. A series of photographs showing typical compression behavior of the sample under parallel orientation is presented in Figure A-3. As shown in Figure 8, energy absorption and buckling strength tend to decrease with increasing moisture content. The samples from 9975-02731 are consistent with other fiberboard samples, although on the lower end of the trend compared to other DE packages (Figure 8).

Figure 8. Calculated (a) absorbed energy and (b) buckling strength from compression testing of destructively examined packages and laboratory fiberboard samples.

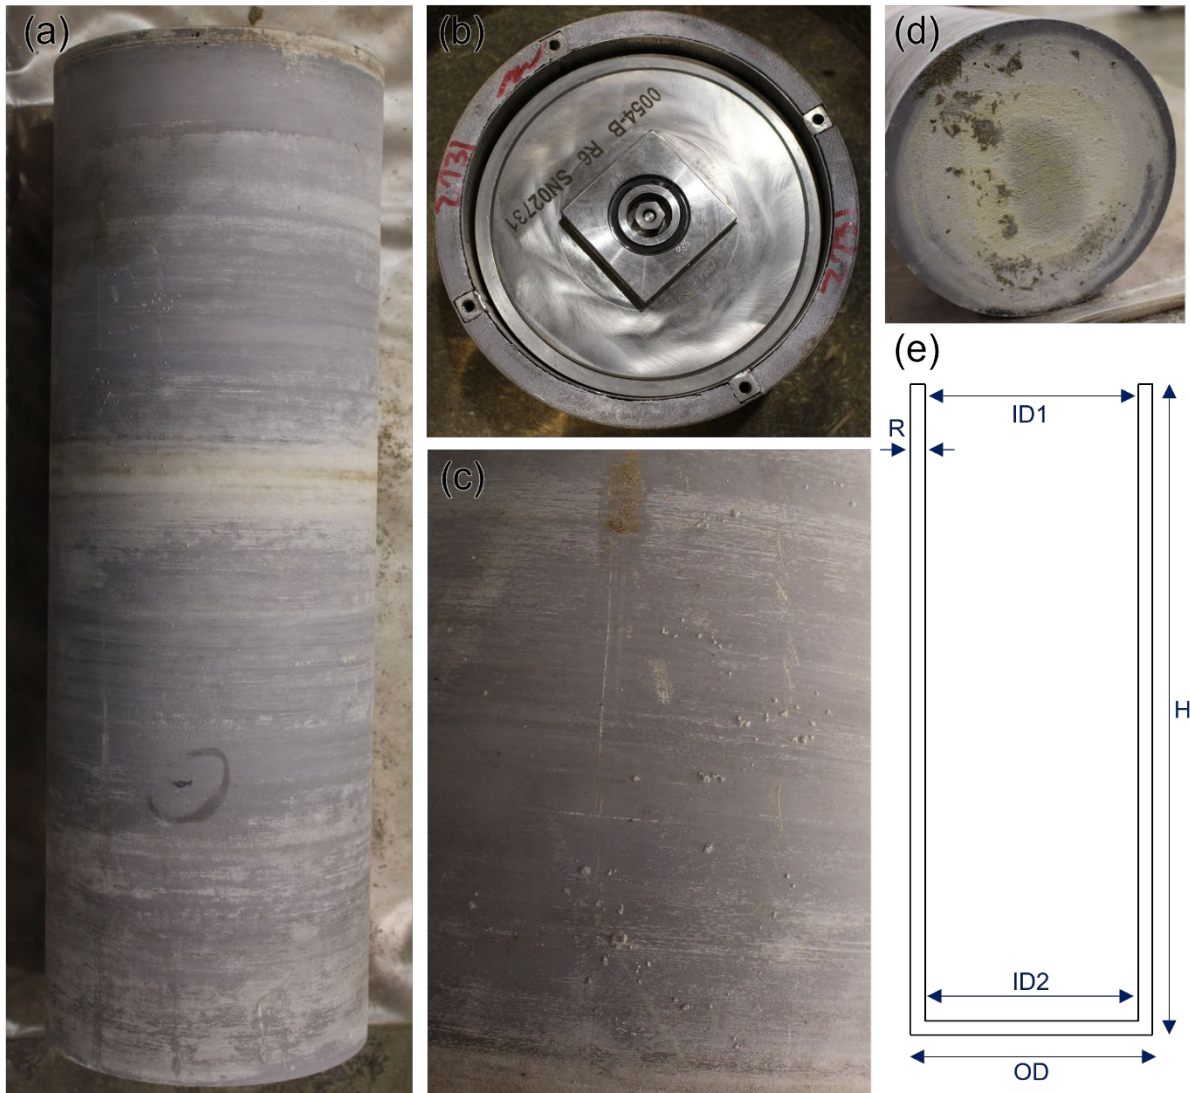
The entire surface of the lead shield was visually examined, and it was found to be free from significant deformation, excessive corrosion (*e.g.*, blistering, flaking) and physical damage. The surface was covered with a layer of white, gray, and tan corrosion products as observed on other packages (Figure 9). The lead shield has one noticeable brown band that appear to correspond to the observed white band on the inside cavity of the lower fiberboard assembly (Figure 5b). There were sporadic clusters of small, raised corrosion

products on the surface. The physical measurements of the lead shield are recorded in Table 1 and the dimension labels are depicted in Figure 9e. All but two dimensions are consistent with drawing requirements; the OD is 0.006 inch greater than the drawing specifications of 8.252-8.35 inch, and the height of the shield is 0.019 inch greater than the drawing specification of 24.7 inch.

Figure 9. Pictures of (a) lead shield, (b) top of shield, (c) close-up of raised corrosion products, and (d) bottom of shield. (e) Drawing of lead shield and dimension labels.

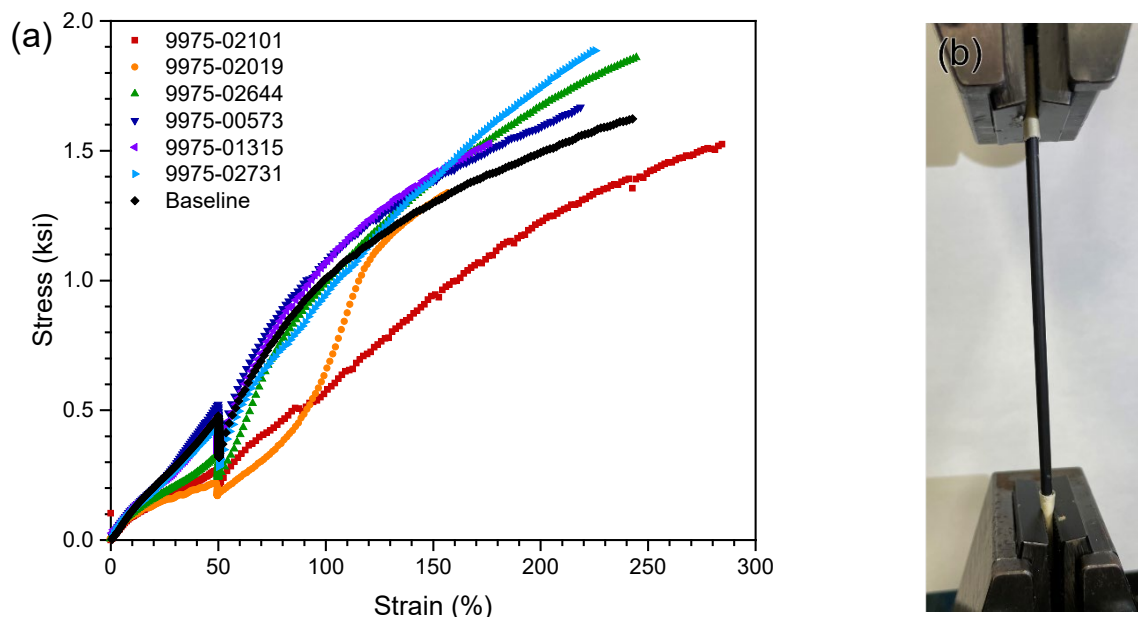
FTIR spectra of the O-rings were indistinguishable from each other and consistent with a Viton® type fluoroelastomer (Figure A-5). Optical and SEM images of the O-ring cross sections identified a distribution of very small particles throughout the outer PCV and SCV O-rings (Figure A-6 and Figure A-7). EDS identified small amounts of aluminum, silicon, and zinc, which are likely from additives in the formulation (e.g., ZnO). Tensile test results are shown in Figure 10, and no cracks or other signs of degradation were observed during elongation to 50% strain. The PCV inner O-ring failed after reaching 225% elongation with a tensile strength of ~1.9 ksi. These values are consistent with the O-rings from other DE packages and comparable with the baseline Viton® GLT mechanical properties.

Figure 10. Tensile (a) stress-strain curves for PCV inner O-rings from DE packages and picture (b) of tensile testing at 50% stretch using flat yarn grips for 9975-02731.

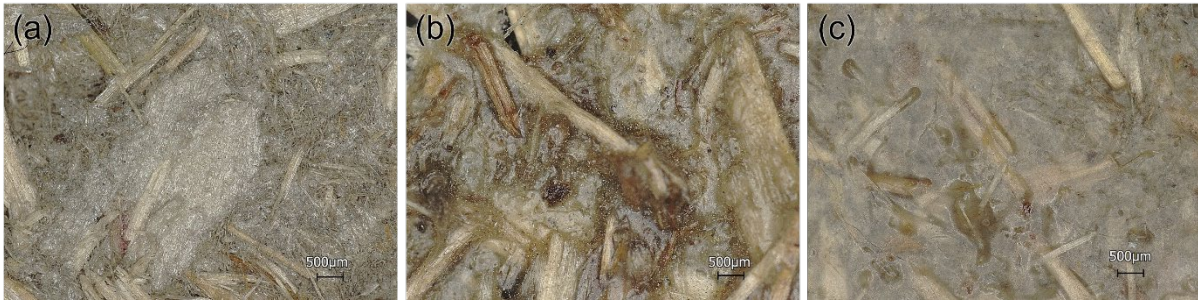
Figure A-1. Optical microscope images of (a) upper fiberboard, (b) discolored fiberboard, and (c) fiberboard with dried Elmer's® wood glue.

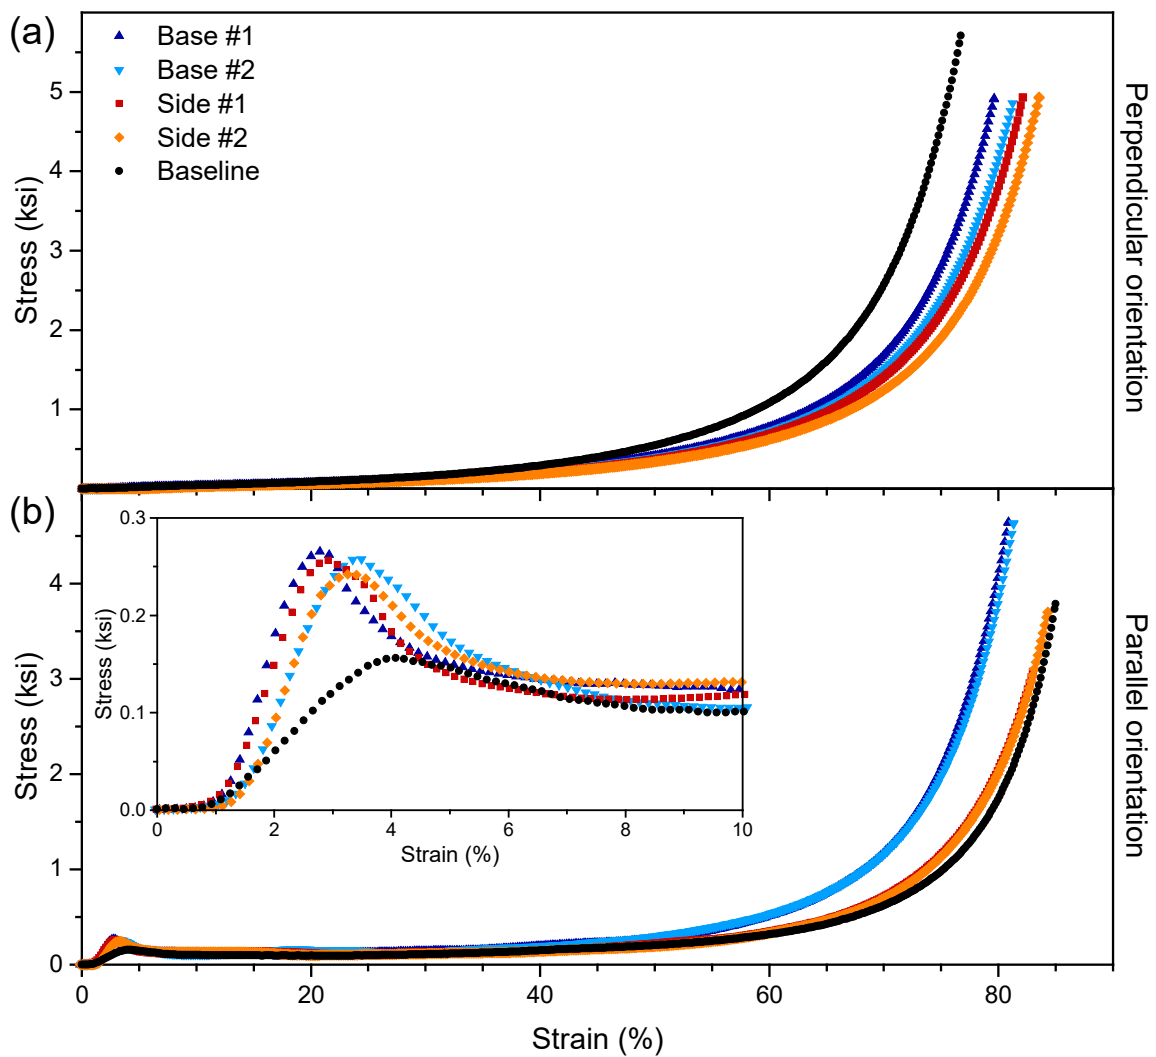
Figure A-2. Stress-strain curves for the compression of 9975-02731 fiberboard samples in the (a) perpendicular and (b) parallel orientations, and baseline data from an unaged fiberboard assembly. The inset graph shows the linear elastic and buckling region for fiberboard samples compressed in parallel orientation.

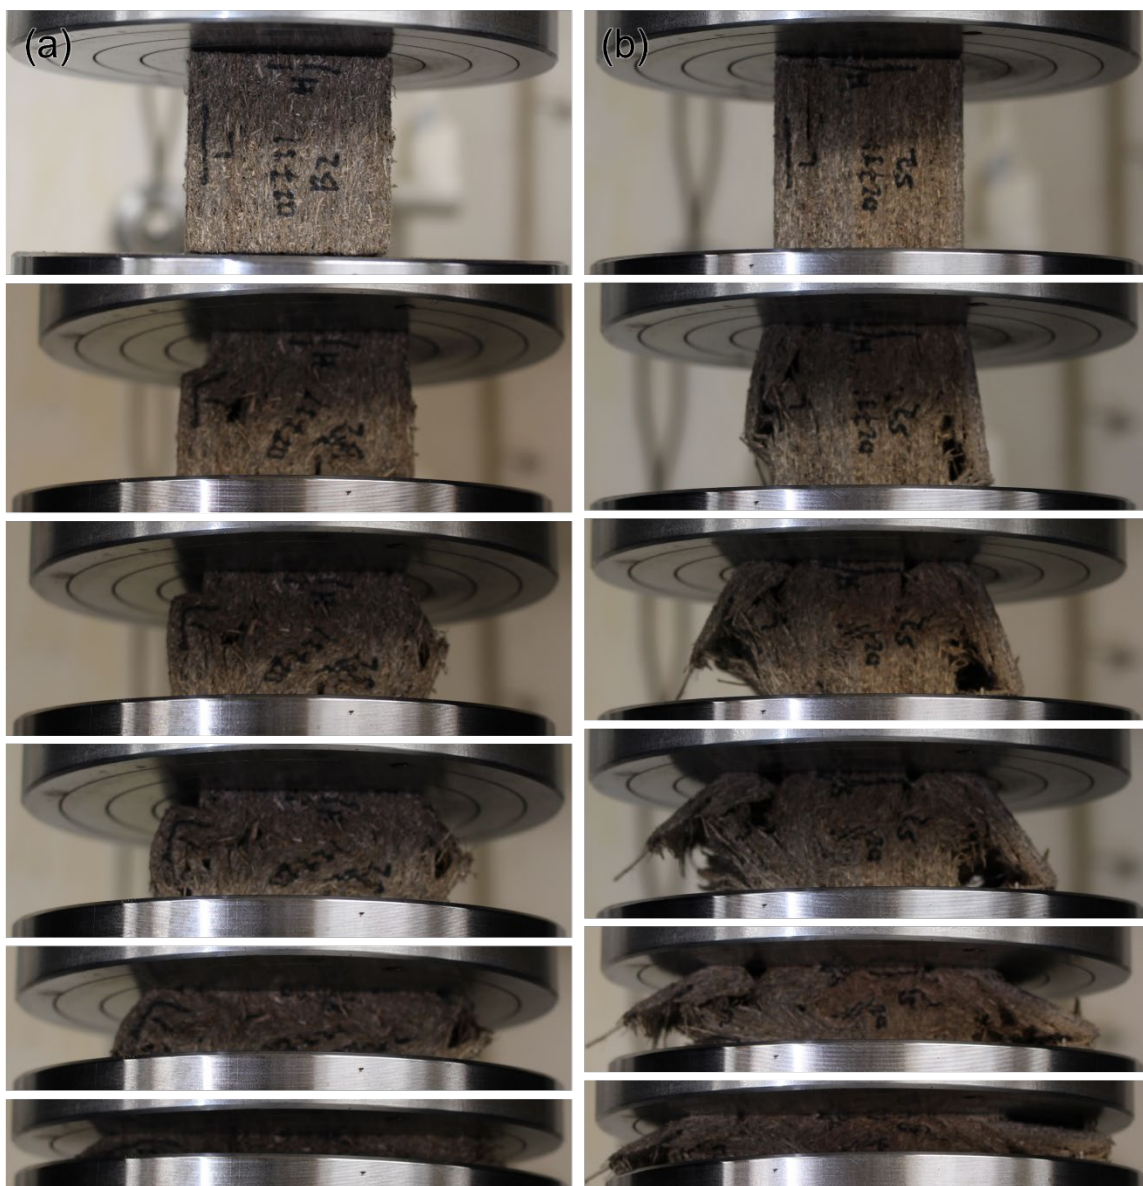
Figure A-3. Pictures of compression testing, in the parallel orientation, of fiberboard samples from the (a) base and (b) side of the lower subassembly.

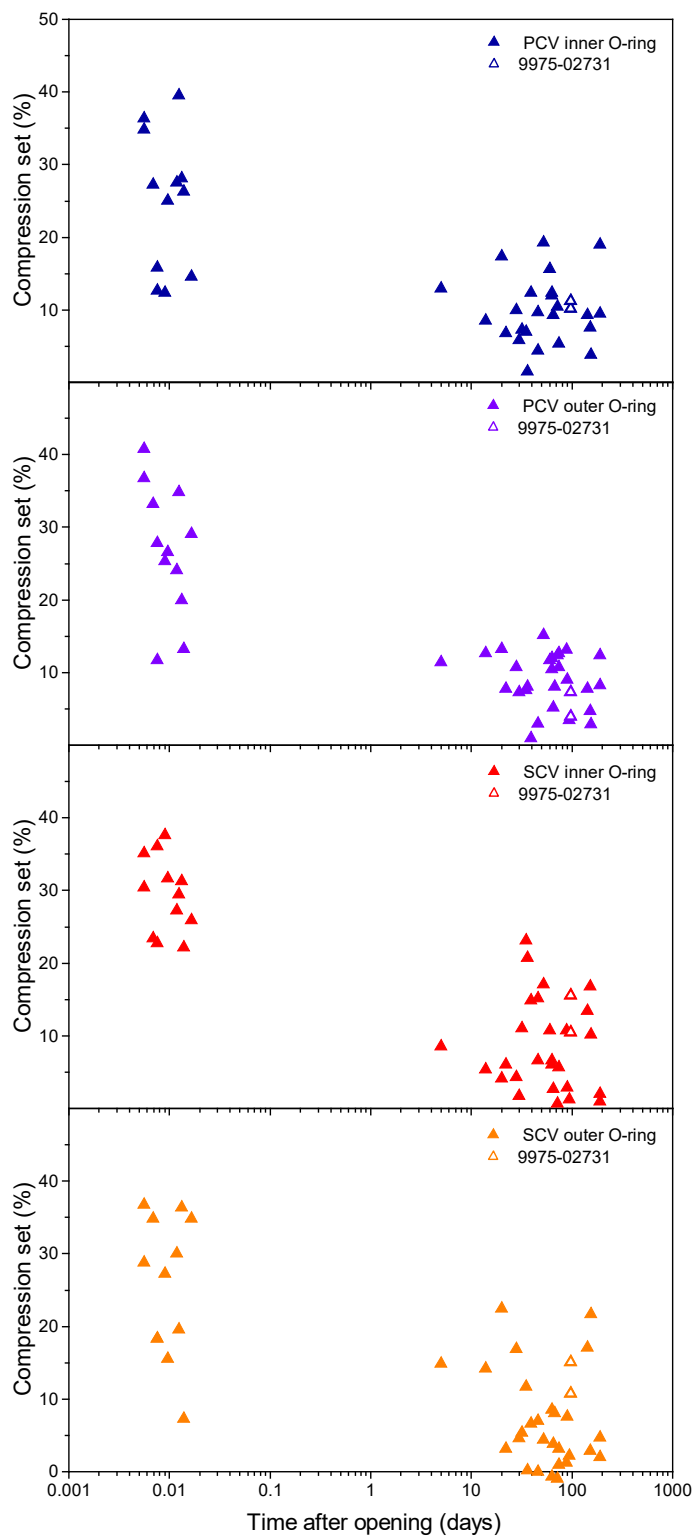
Figure A-4. Compression set of SCV and PCV O-rings from 9975-02731 and other DE packages.

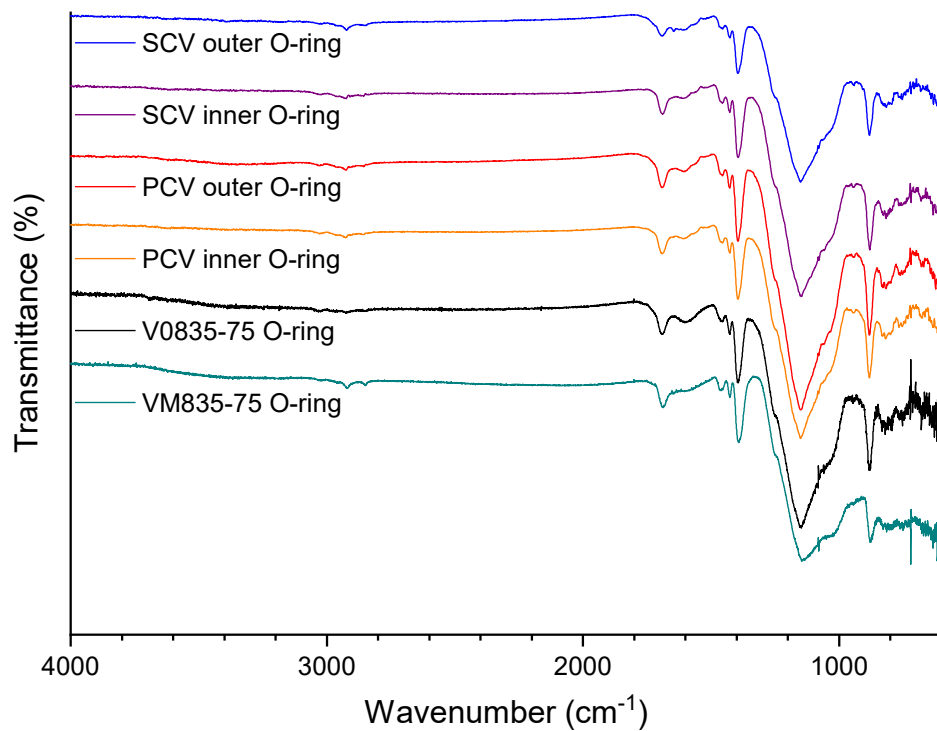
Figure A-5. FTIR spectra of the 9975-02731 SCV and PCV O-rings.

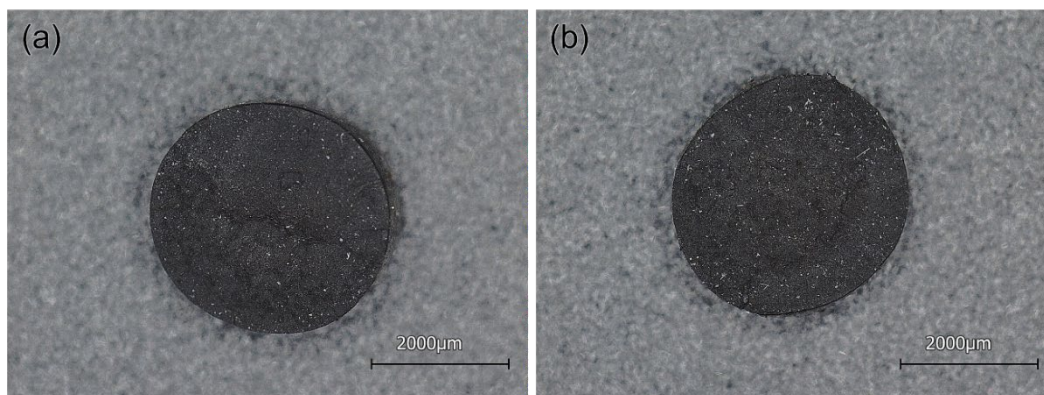
Figure A-6. Optical cross section of the (a) PCV outer and (b) SCV outer O-rings.

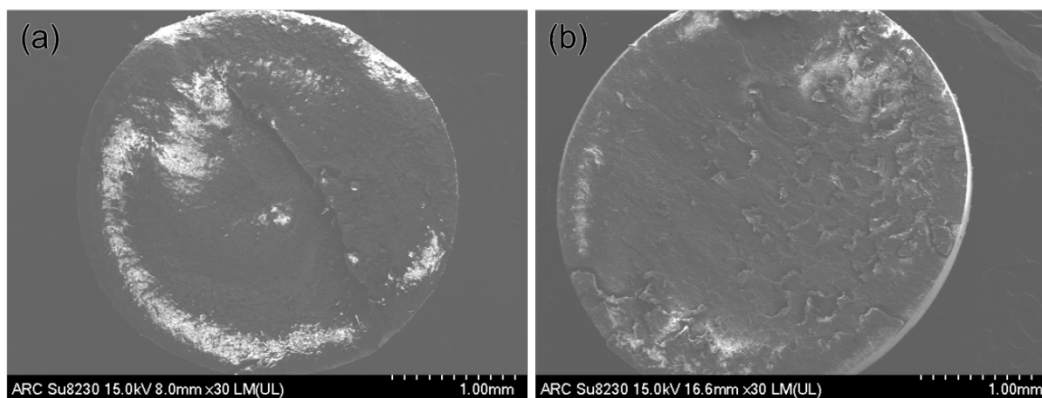
Figure A-7. SEM cross section images of (a) PCV outer and (b) SCV outer O-rings.
