SDU 7 Shotcrete Sample Characterization

C. A. Langton and K. A. Hill

July 2022

SRNL-STI- 2022-00296 Revision 0

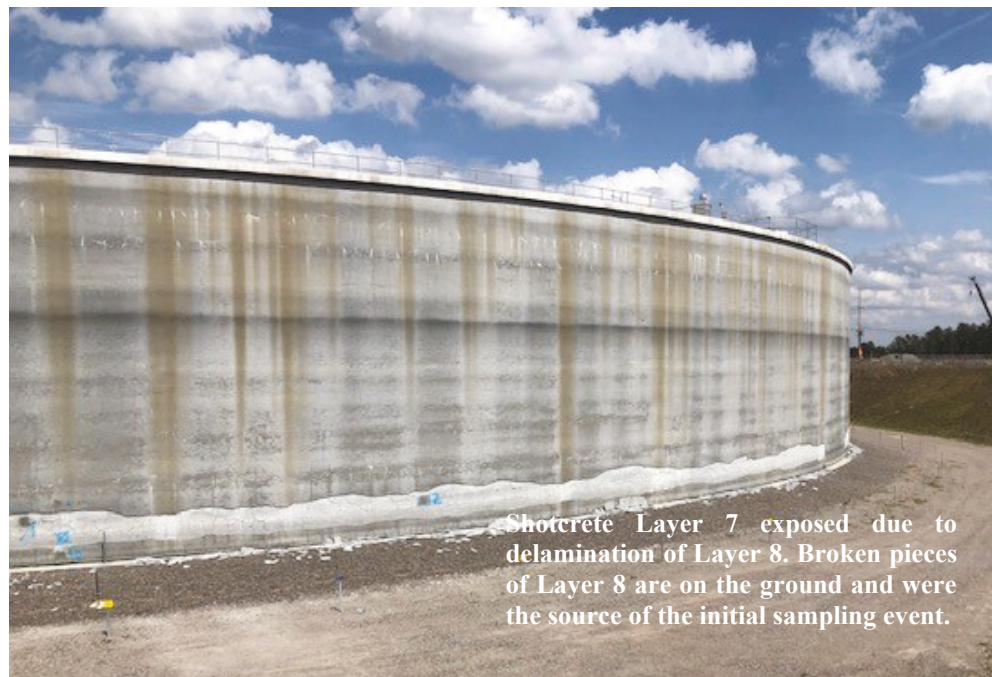
Figure 1-3. SDU 7 March 2022.

At the time of this evaluation, map cracking was observed on the exposed outer surfaces of Tanks 6 and 7. This type of cracking and secondary crack filling (white lines indicating the cracks) was most prevalent on the surface of SDU 7. The condition of SDU 7 at the time this request was made is shown in Figure 1-3. Cracks were visible over most of the exposed surface of SDU 7, and large areas of bulging and loose shotcrete were present above the delaminated regions. Vertical streaks of iron staining are from a steel ring around the top of the tank and do not affect the performance of the shotcrete.

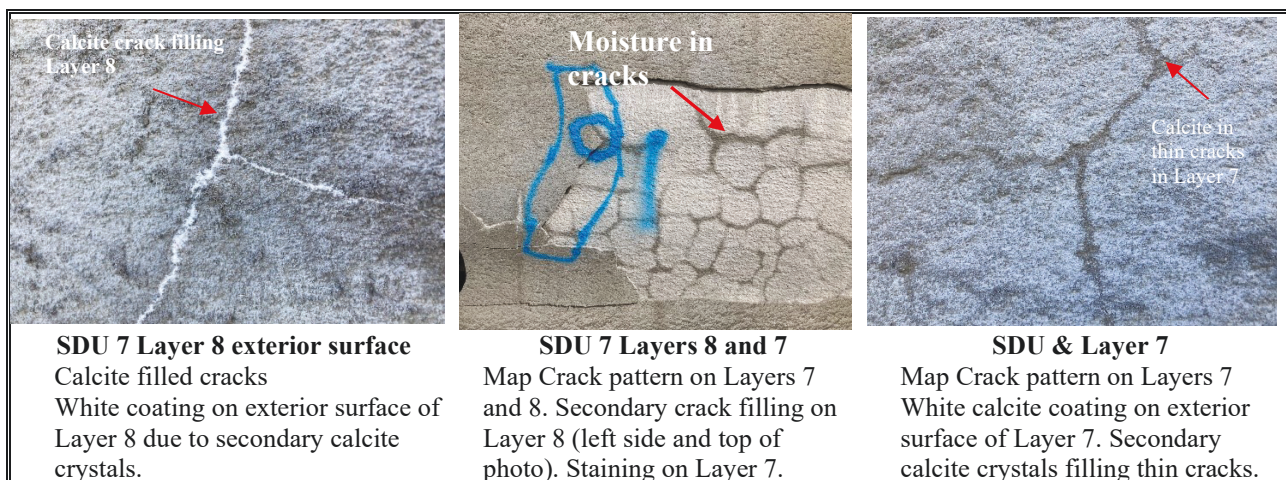
Delamination of Layer 8 shotcrete was observed on the southeast side of SDU 7. The most severely affected area was from the ground up to about 6 feet over a circumferential distance of at least 100 feet. See Figure 1-3. Cracking and bulging of Layer 8 was observed over higher up on this side of SDU 7 over a larger area. A white coating was first observed on the underside of delaminated pieces of Layer 8. Upon close examination, the exposed surface of Layer 8 also had a white coating but because this surface was more irregular than the underside it was less striking. Exposed areas of Layer 7 shotcrete were also coated with a white material.

Map cracks (alligator cracks) were observed on most of the SDU 7 exposed surface (Layers 8 and portions of Layer 7). Secondary crack filling (See Figure 3-1) was also observed on the intact and delaminated surfaces and edges of Layer 8 and on exposed areas of Layer 7. "Staining" was observed on exposed intact areas of Layer 7. Upon close examination, the staining was determined to be the result of higher moisture content regions and the cracks were indicated as white lines. The "staining" pattern disappears in dry weather. On close examination, thin cracks were observed to be at the center of the stained areas. These features are shown in Figure 3-1.

Figure 3-1. Visual Field Observations of SDU 7 (collected in second sampling effort).

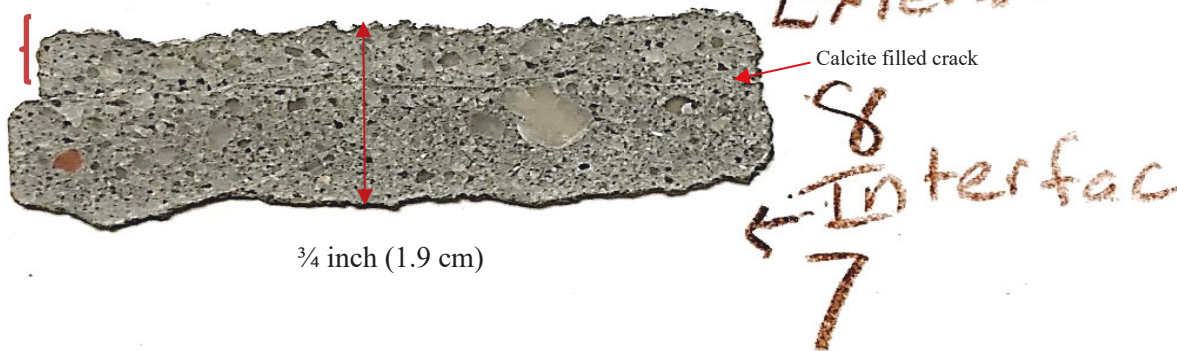
Carbonation was concentrated on the exterior and interior surfaces of Layer 8 but also extended throughout the entire thickness of Layer 8. It was most prevalent to a depth of about 7 mm from the exterior surface in Layer 8. The interface between the outer carbonated region and SDU 7 Layer 8 bulk shotcrete was delineated by a thin white line parallel to the sample surface in several samples. The line was determined to be a crack in a plane parallel to the surface that was filled with secondary calcite. The crack visible in Figure 3-2 is shown in an SEM backscattered electron (BSE) image in Figure 3-3.

Carbonated exterior zone with clearly defined interface

Figure 3-2. Carbonated exterior region of SDU 7 Layer 8. (Visual observation)

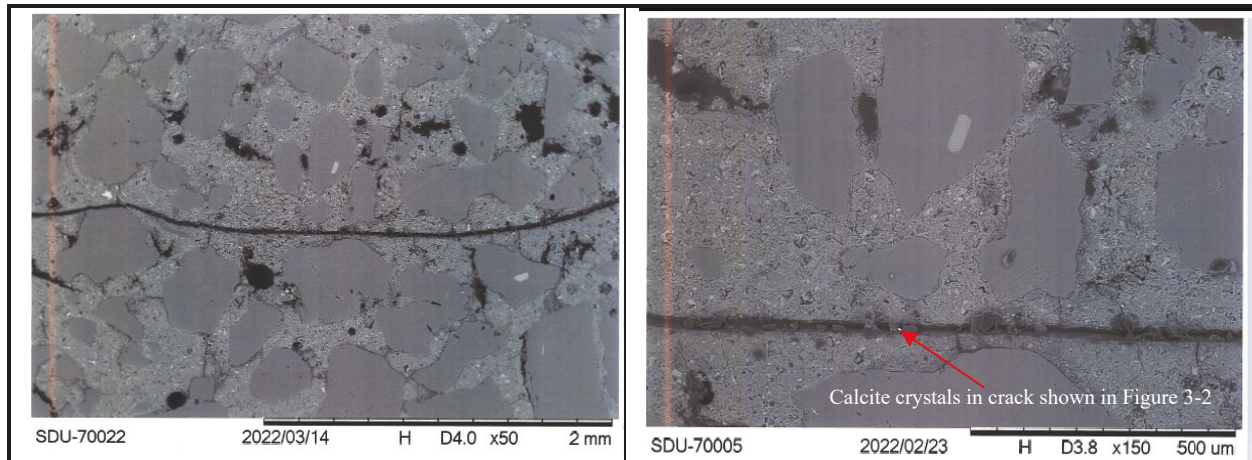
The white materials

Figure 3-3. SEM BSE image of Layer 8 sample shown in Figure 3-2.

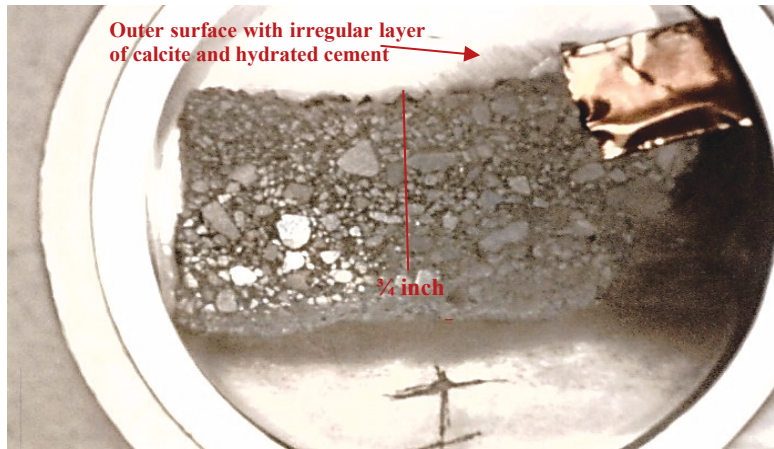
Carbonation was also observed on polished cross sections of Layer 8 shotcrete. An example is shown in Figure 3-4. In reflected light, the most carbonated regions are a lighter gray color on the interior and exterior regions of the layer in Figure 3-4. The white crystals on the exposed surface are calcite crystals. The inner surface is smoother and is coated by a thinner continuous layer of calcite crystals. This layer of discrete calcite crystals was lost during the polishing of this sample and the lighter gray region at the bottom edge of the sample is a mixture of carbonated cement paste, calcite, and calcium silicate hydrate (unhydrated cement paste) based on SEM EDX analysis of this sample.

Figure 3-4. SDU 7 Reflected light image of Layer 8 polished sample illustrating shotcrete texture and surface carbonation on both exposed exterior and underside of Layer 8.

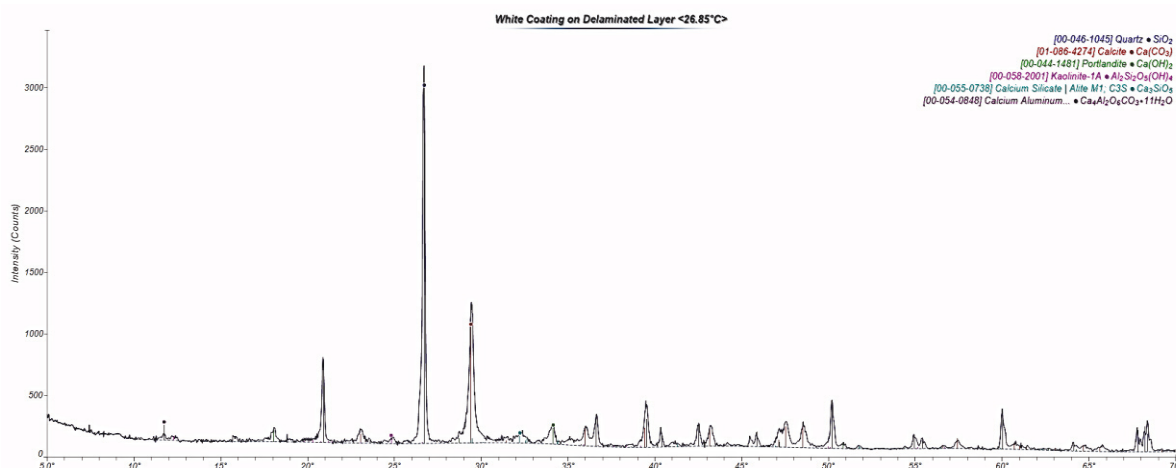
The shotcrete aggregate was identified as quartz. Calcite was identified to be the phase responsible for the white coating on the exposed and inner surfaces of SDU 7 Layer 8, the exposed surface of Layer 7, and as the phase filling cracks. See Figure 3.5. Portland cement matrix phases present in the material scraped from the inner surface of Layer 8 are included: cement hydration products: portlandite, $\text{Ca}(\text{OH})_2$, carbonated calcium aluminate hydrate, and unreacted alite Ca_3SiO_5 . (Most Portland cements contain a small fraction of alite that does not hydrate.) Kaolinite clay was also identified and was determined to be contamination resulting from contact with the ground around SDU 7. The exterior surface had the same phases present except that no portlandite was detected.

The solubility of $\text{Ca}(\text{OH})_2$ in water at 20 °C is about 1.7 g/L. Repeated wetting as the result to exposure to rainwater absorbed into the porous shotcrete dissolved this phase. Upon drying Ca^{2+} ions were transported to surfaces and into pores and cracks where it carbonated by atmospheric CO_2 as shown in Equation 1.

Figure 3-5. Coating scraped off surface of inner surface of SDU 7 Layer 8.

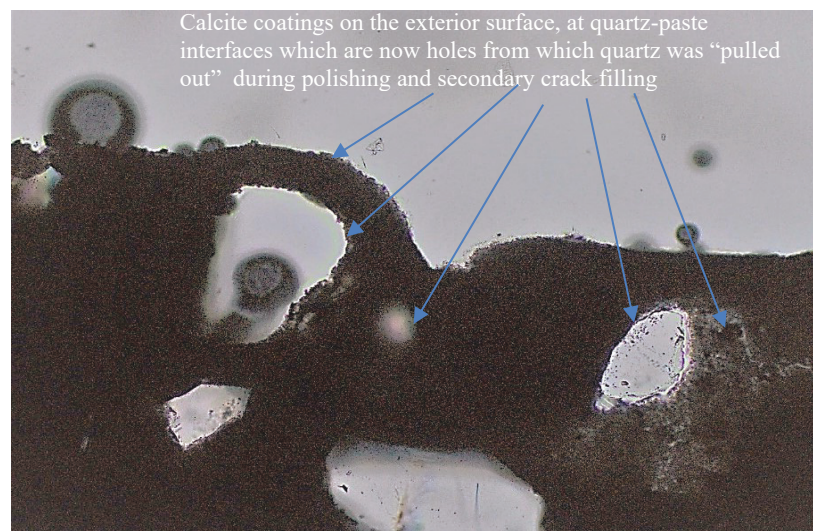
Figure 3-6. Optical microscope image of SDU 7 Layer 8 outer surface.

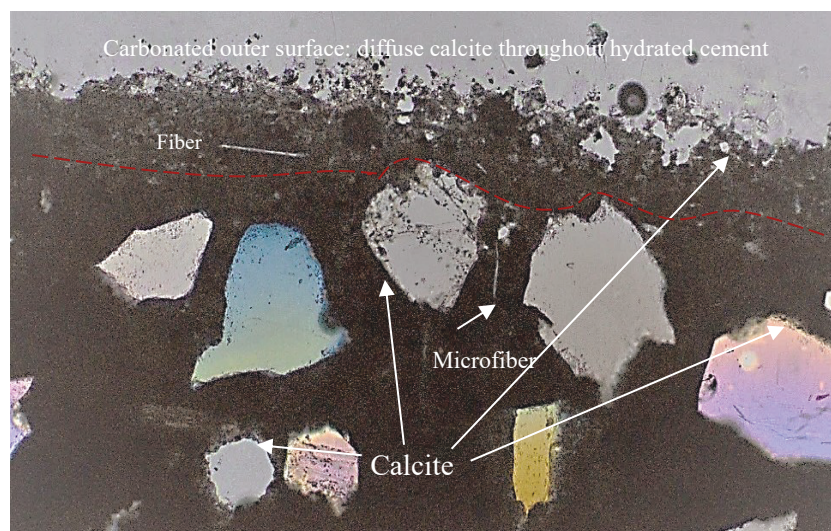
Figure 3-7. Optical microscope polarized light image of SDU 7 Layer 8 outer surface. Multicolored grains are quartz view in polarized light. Irregular shaped “grains” are quartz pull outs.

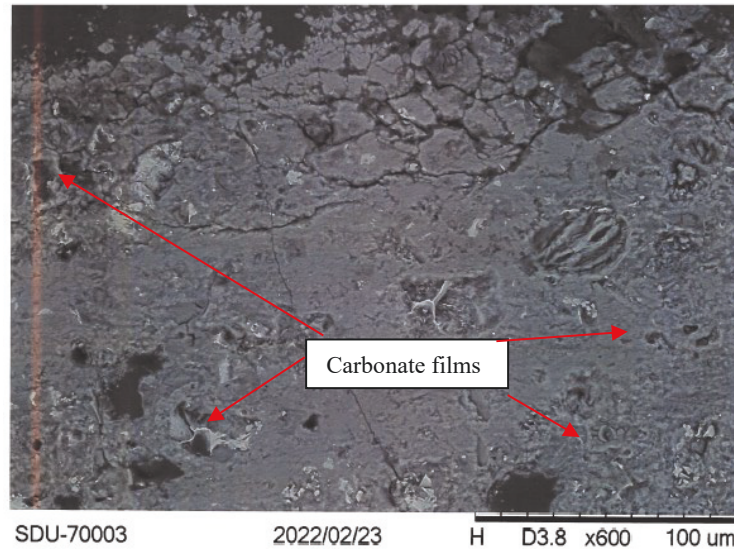
Figure 3-8. SEM BES microscope image of calcium carbonate deposits as partial pore filling and as surface coatings are a common feature of SDU 7 Layer 8 shotcrete.

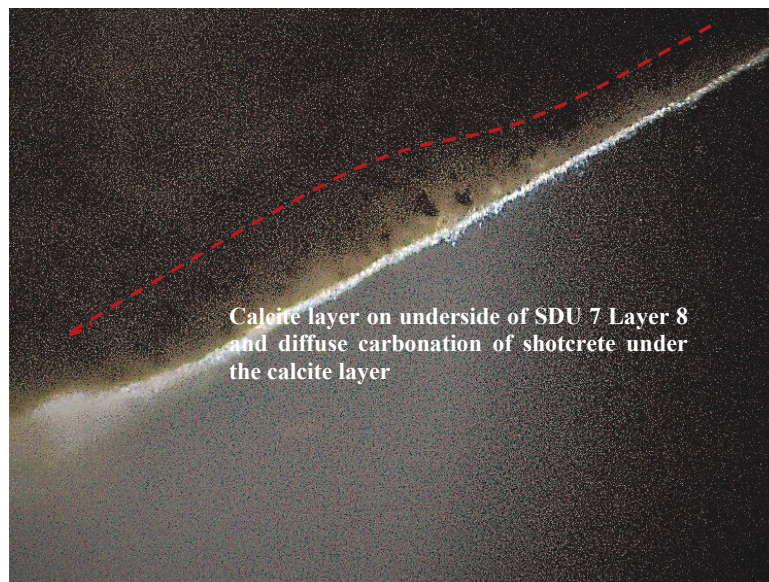
The exposed exterior shotcrete surface of SDU 7 Layer 8 is irregular and is coated with small ($\sim 0.1 \mu\text{m}$) crystals of calcite mixed in with quartz sand and patches of hydrated cement. The exterior coating is shown in Figures 3—1, 3-2, 3-4, 3-6, and 3-7. A layer of calcite was also observed below the underside of Layer 8 which was not directly exposed to the weather. See Figure 3-9. Formation of this coating is attributed to the presence of a crack or “gap” between Layers 7 and 8 that experienced repeated wetting and drying over many cycles.

Figure 3-9. SEM BES microscope image of SDU 7 Layer 8 inner / underlying surface illustrating the calcite coating on the underside of Layer 8.

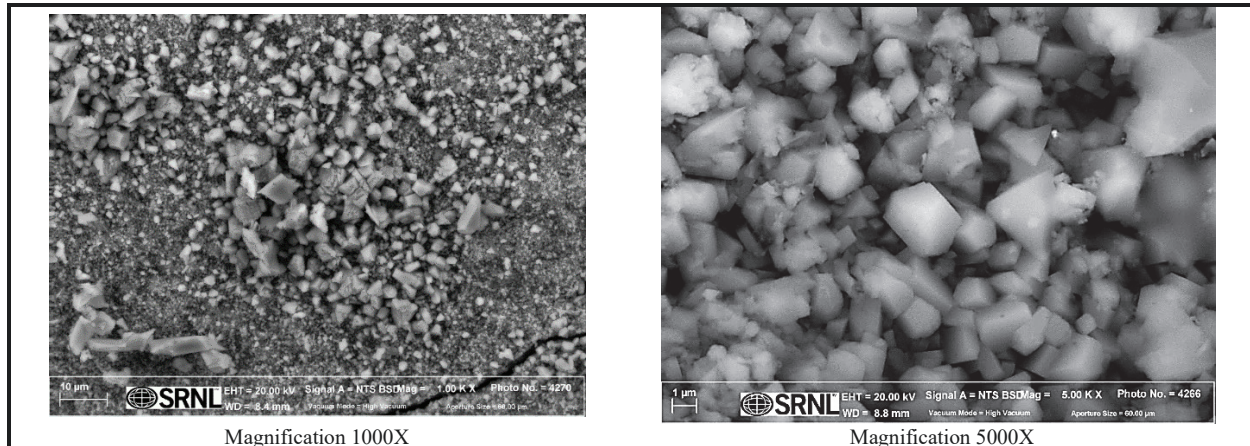
Higher magnification images of the calcite crystals on the backside of Layer 8 are shown in Figure 3-10. The crystals are up to about 1 μm and are larger than those on the exposed exterior surface of Layer 8 which are shown in Figures 3-11.

Figure 3-10. Calcite coating on the smooth underside surface of SDU 7 Layer 8.

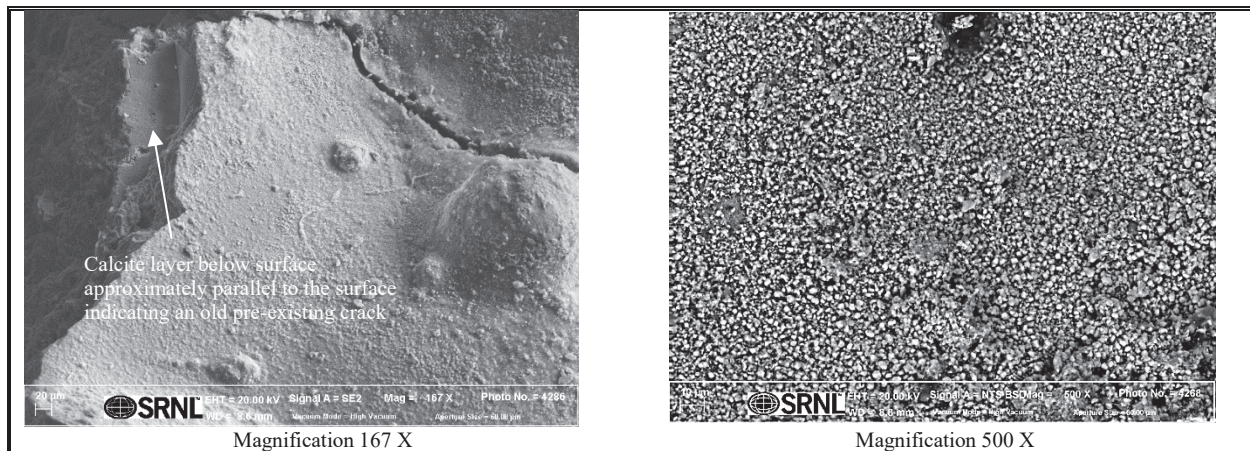
The calcite crystals covering the exposed surface of Layer 8 are mixed with hydrated cement particles both of which can be seen coating a few sand grains in Figure 3-11. The calcite crystals are about one tenth the size as those on the underlying Layer 8 surface. A pre-existing crack parallel to the surface of Layer 8 is shown in Figure 3-11. A corner was broken off the Layer 8 sample exposing a smooth calcite layer below the surface. This type of feature was observed on several samples of Layer 8 and may be associated with the as placed “gun finish”.

Figure 3-11. Calcite coating on rough exterior surface of a delaminated piece of SDU 7 Layer 8.

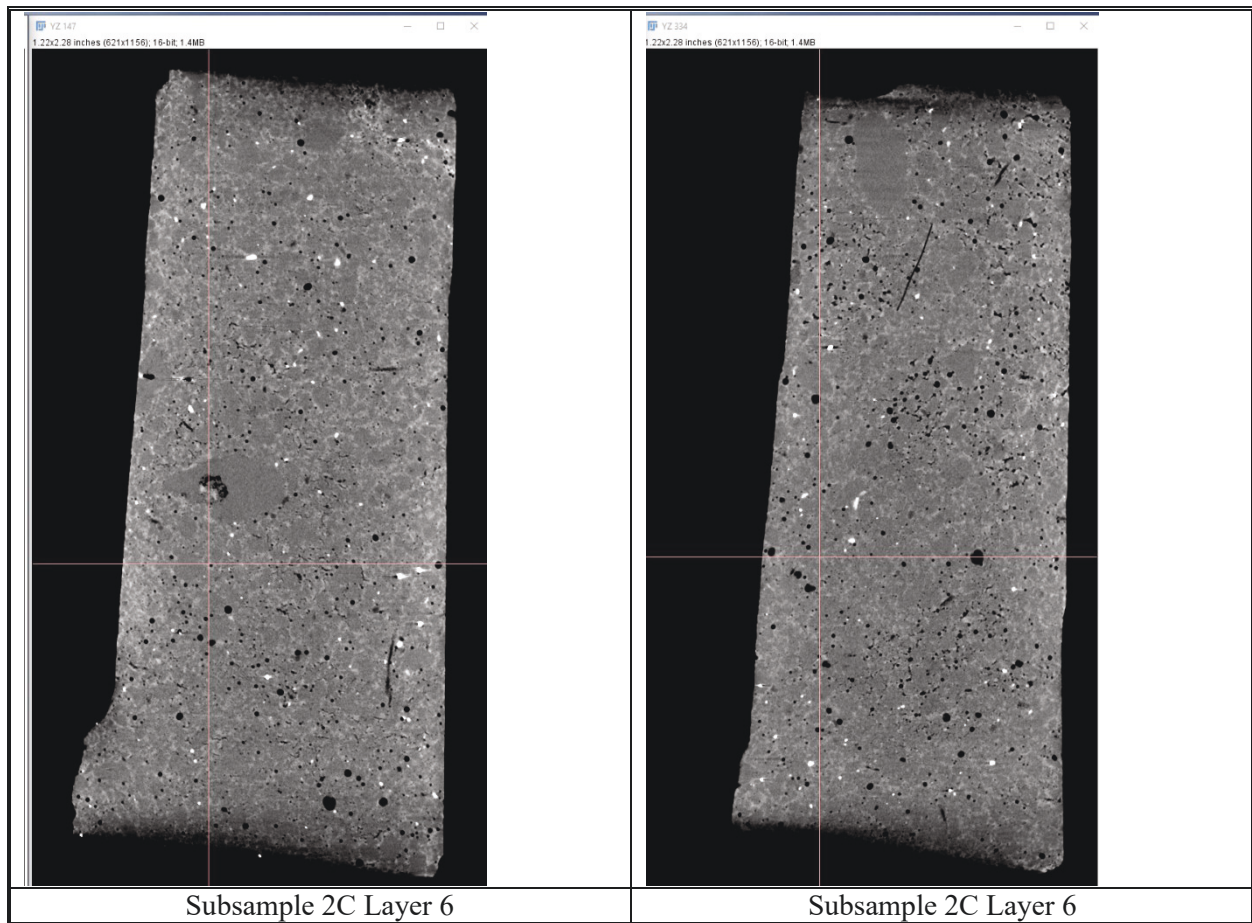
Pores created by an air entrainment admixture are viewed as small uniform voids (black circles) in thin section and polished surface images. See Figures 3-3 and 3-8. The air entrainment pores are well distributed throughout shotcrete Layers 6, 7, and 8. They were best observed in the CT x-ray images of a full thickness layer of shotcrete as shown in Figure 3-12. The volume of air entrainment pores was not quantified. A few fibers are also shown in this figure and appear as black linear features.

Figure 3-12. Subsample 2C CT X-ray images of a plane through Layers 6 (left) and 7 (right). At these locations the shotcrete texture is uniform, air entrainment is present, and a few large fibers are visible.

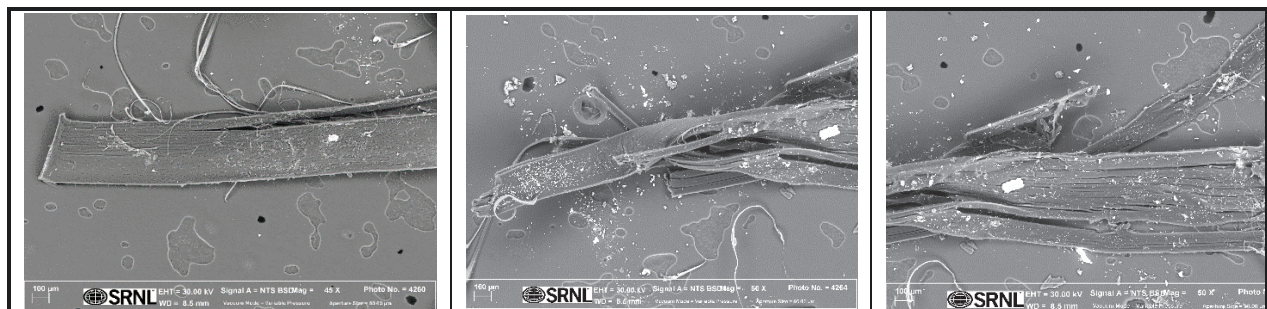
Several microfibers were pulled out of fractured surfaces of SDU 7 Layer 8 shotcrete. They appear to be self-defibrillating microfibers as indicated by “scoring” along the length of the fibers. See Figures 3-13 and 2-14. Overall, the bonding between the fibers and matrix was good. The significance of partial defibrillation may impact the susceptibility of the shotcrete to plastic shrinkage and /or placement properties. The type of fiber, dose, and method of incorporation into the shotcrete mix warrants reviewed to achieve the maximum benefit of the fiber addition.

According to ACI 506.1-21, one reason for adding microfibers to shotcrete mixes is to “minimize plastic shrinkage” [Nitschke and Winterberg 2016]. Macroscopic and microscopic examination of the fibers indicate that many fibers were not defibrillated, i.e., did not separate into smaller fibers or fiber bundles, during the mixing process. This does not appear to have impacted the overall shotcrete porosity and paste-aggregate bonding. However, it may have contributed cracking resulting from plastic shrinkage which occurs in fresh cementitious materials as the result of water loss due to evaporation from the surface after placing and before hardening. However even with a highed addition of microfibers more defibrillation, plastic shrinkage will occur if the evaporation rates is not controlled by dequate wet curing for a sufficient length of time.

Figure 3-14. Examples of reinforcing fibers pulled from SDU 7 Layer 8.

2. Micro self-defibrillating polypropylene fibers were used in the SDU shotcrete mix. Partial defibrillation or no defibrillation was observed in the samples examined. This did not appear to impact the overall quality. However, review of the fiber specification (amount, type, and incorporation) is recommended to optimize the effect of the fiber reinforcement in the “green” and cured shotcrete.

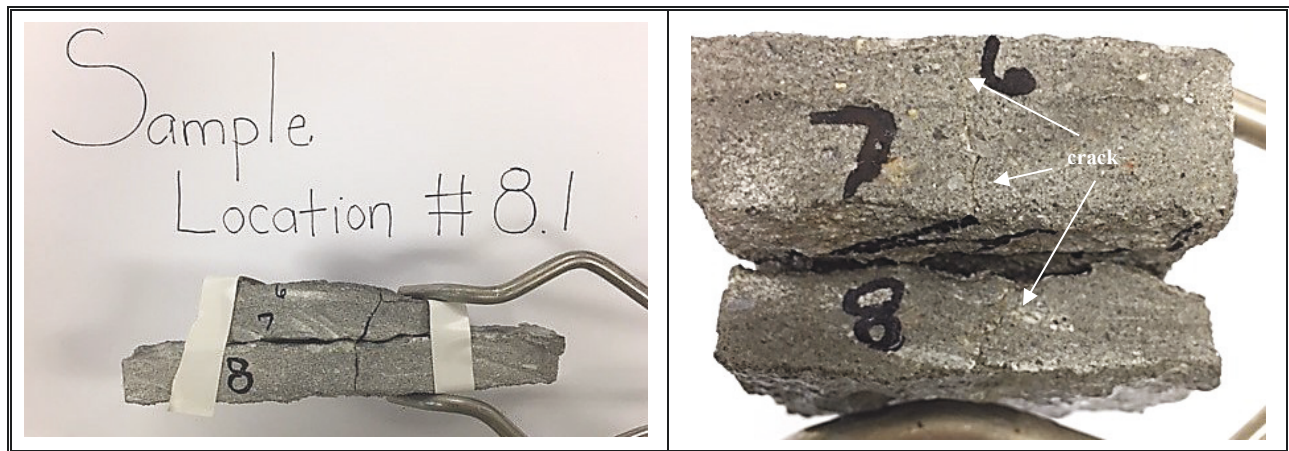
Visual examination was the most useful method for evaluating the presence of reflection cracks because sample collection at cracked locations resulted in layer debonding. Sample 8.1 was the only location where specimens containing reflection cracks were collected. However numerous locations were visually of reflection cracks. These locations had cracks in exposed areas of Layer 7 that were directly aligned with the edges of delaminated sheets of Layer 8 that were still partially attached to the wall. Photographs of two subsample specimens from sample location 8.1 are shown in Figure 3-15. At this location, the reflection cracks transected the interfaces of shotcrete Layers 6, 7, and 8. These cracks are filled with secondary calcite.

Figure 3-15. Examples of reflection cracks in tow samples at SDU 7 Location 8.1. Reflection cracks transect Layers 6, 7, and 8.

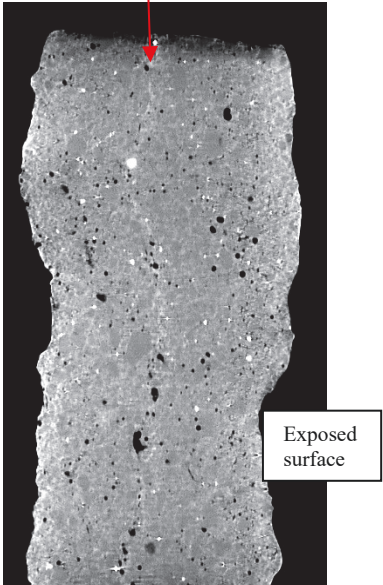
Subsample	Shotcrete Layers	X-ray image
<p>2A-a Layer 7 was exposed to weather as result of Layer 8 delamination</p>	<p>Layers 6 and 7</p> <p>Layer 6 ~ 8 to 10 mm Layer 7 ~ 10 to 13 mm</p> <p>Sand aggregate = dark grains Interface = white indicating implying calcification.</p> <p>Pores concentrated in interfacial region</p> <p>Calcification on Layer 7 exterior surface (brighter strip a few mm thick. Small black areas = air entrainment pores Large black areas = larger pores</p> <p>(Xray data for full thickness)</p>	<p>Layer 6 Interface Layer 7</p>

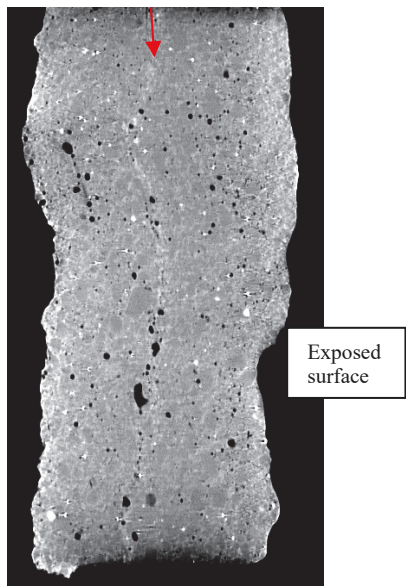
<p>Image = plane at a depth of ~ 5 mm into sample</p>
<p>2A-b Layer 7 was exposed to weather as result of Layer 8 delamination</p>	<p>Same as above</p>	<p>Layer 6 Interface Layer 7</p>

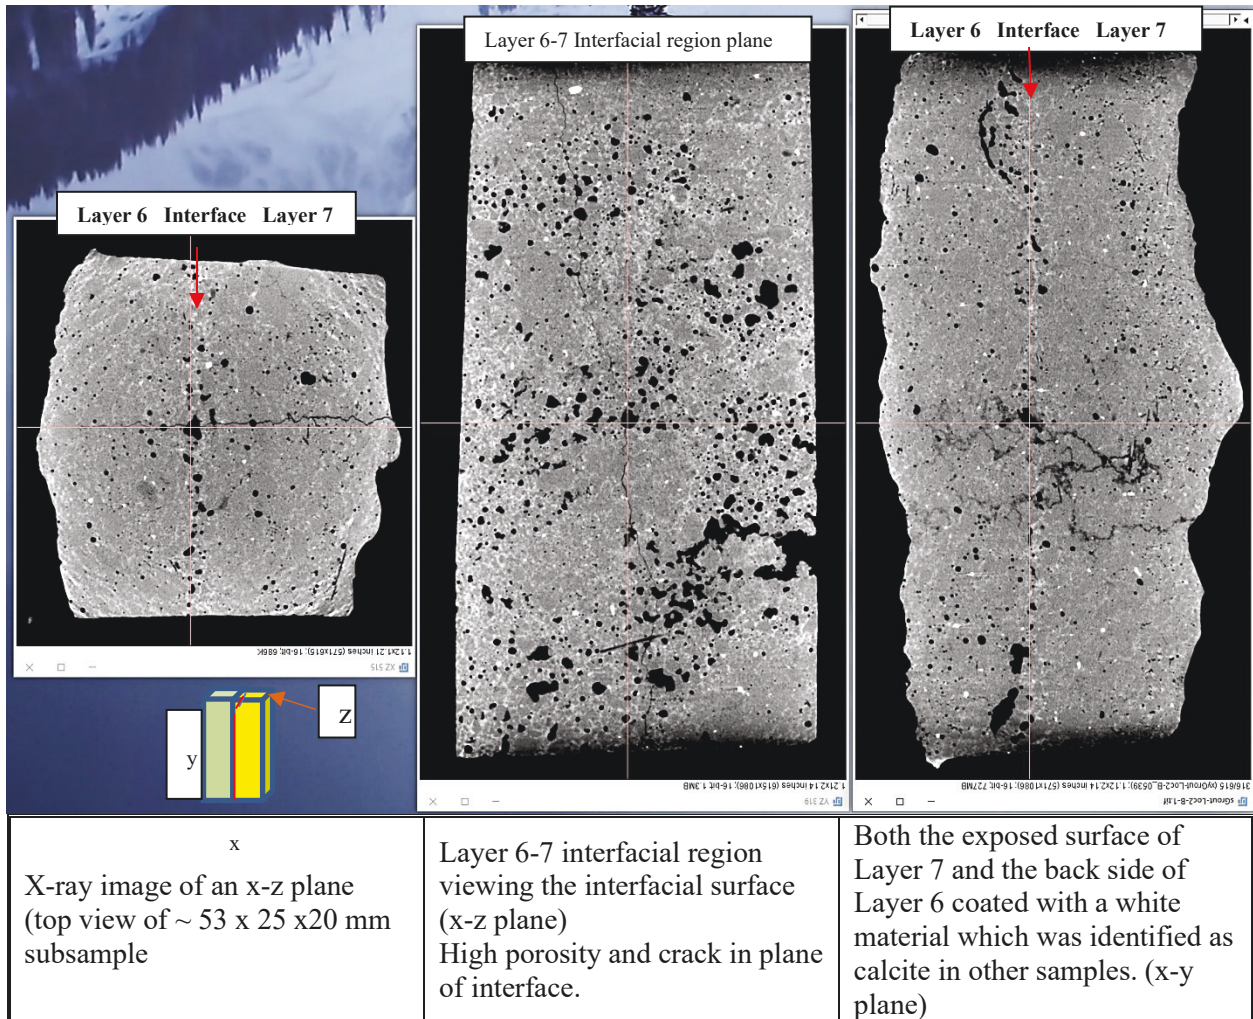
Figure 3-16. X-ray CT images of Subsample 2B (Layers 6 and 7). Layer 7 was exposed due to delamination of Layer 8.

The interface (composite of multiple overlying planes) between Layers 6 and 7 in Subsample 2B is very porous as shown in all views. In addition, the view n the x-y plane suggests a concentration of secondary calcite filling a crack aligned with the porous interface. The crack through the image in the center of Figure 3-15 does not appear to be filled with calcite and therefore may have occurred during sampling or subsampling. Similar views are shown for sample 2C in Figure 3-17. A high porosity interfacial region between Layers 6 and 7 is also observed but is somewhat less obvious because in this sample the multiple

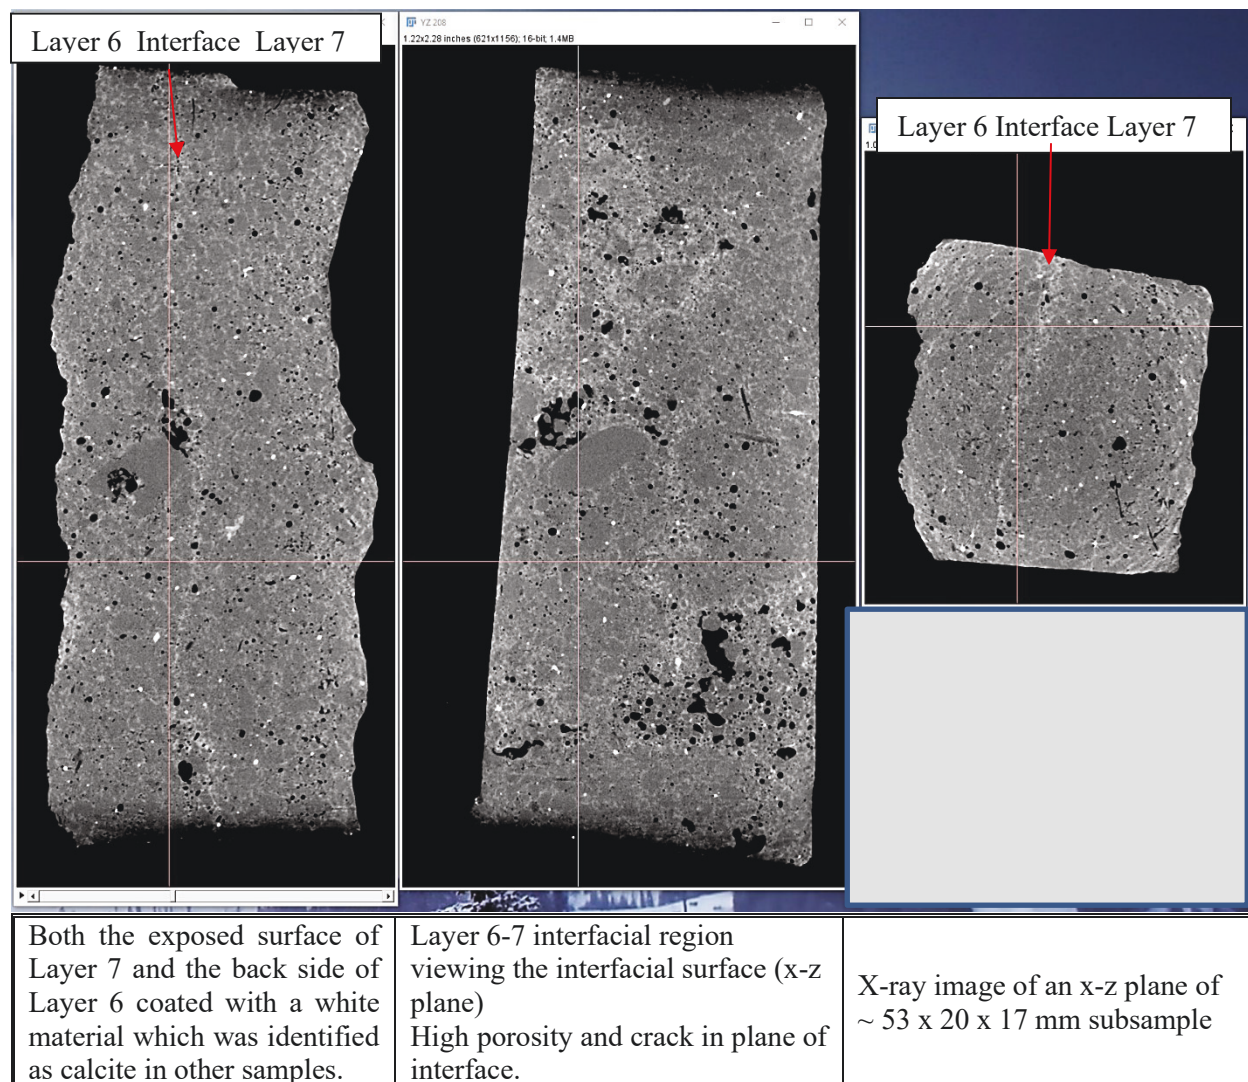
planes that are were used to make the image transect not only the interfacial region but also bulk material due to the uneven nature of the interface.

Figure 3-17. Subsample 2C X-ray images of Layers 6 and 7 (left), Orthogonal view of sample showing features on an interfacial region plane.

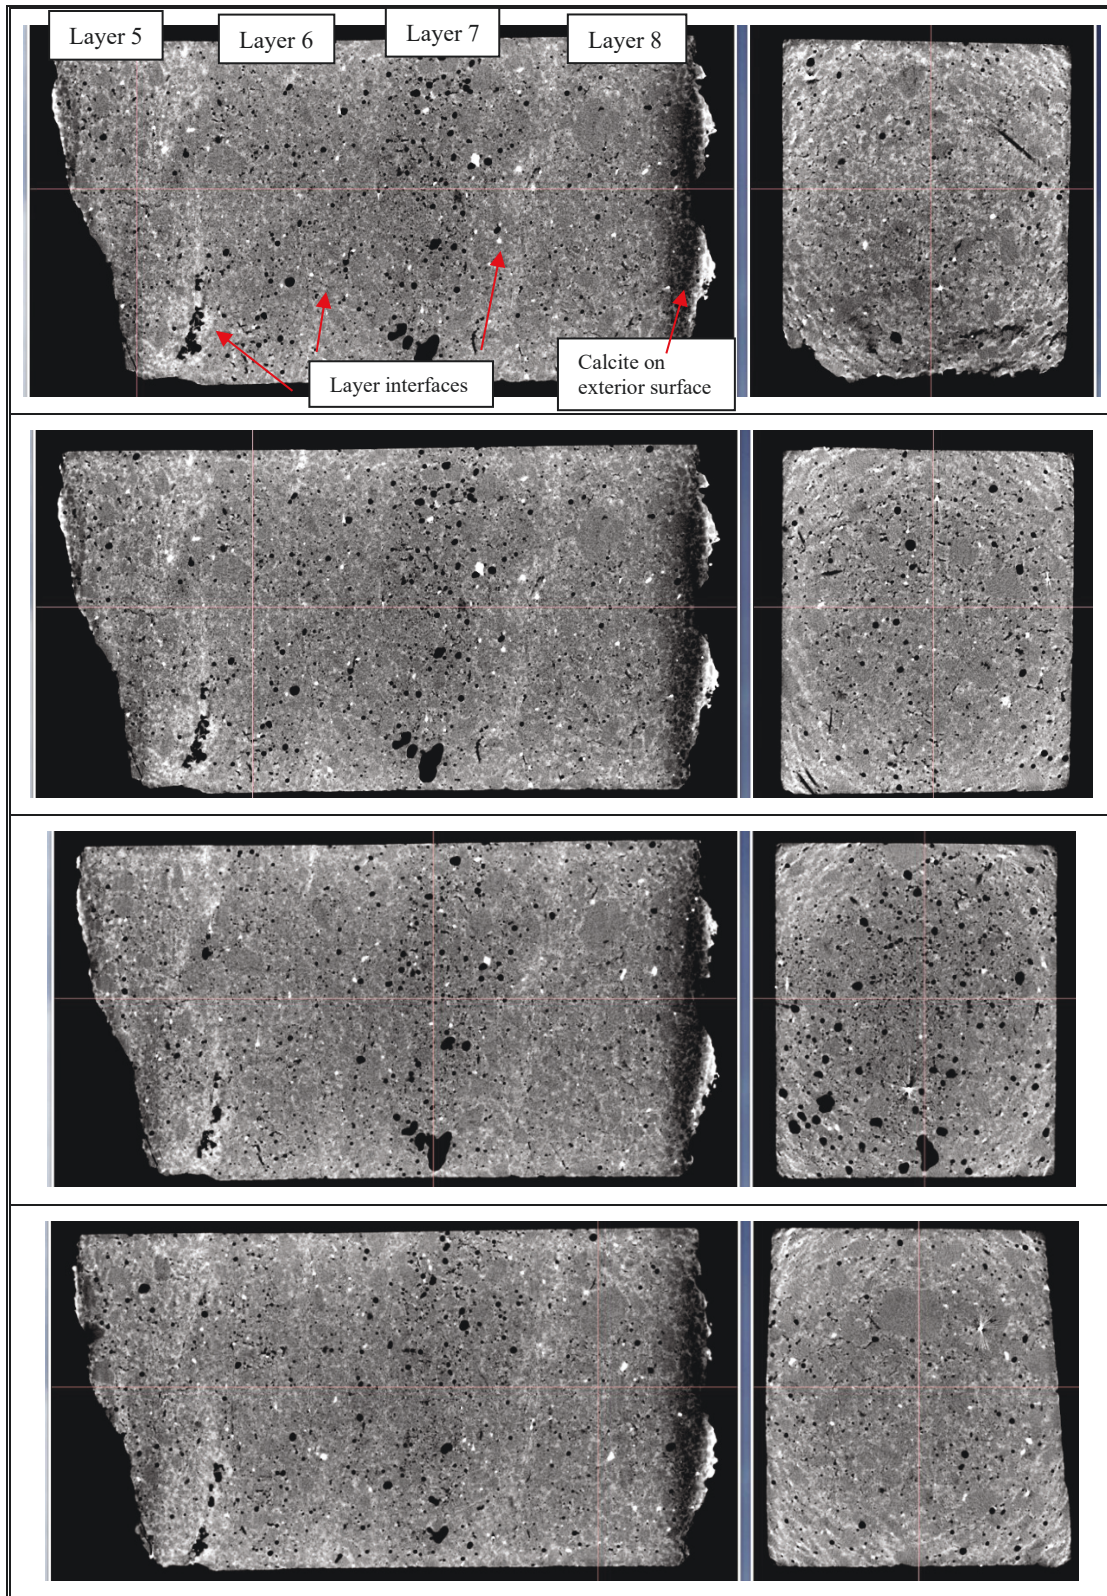
The x-ray CT images in Figure 3-18 of a multilayer subsample collected from location 4B. Shotcrete from all of the protective cover (Layers 5 to 8) is shown but Layer 5 is not complete. The total thickness of this sample is about 50 mm (about 2 inches) and the estimated thickness of the protective shotcrete cover is probably about 2.5 inches. The approximate average thickness of each layer in subsamples 4B, 4Be and 4Bf is listed in Table 3-3.

In subsample 4B, the Layer 7 bulk shotcrete more porosity than was observed in Layers 5, 6, or 8. Additional samples are needed to determine whether this location or any of the locations examined are anomalous or representative of a systemic condition.

Figure 3-18. Sample 4B Subsample D. X-ray images of the outer four layers of SDU 7 shotcrete. Left images are orthogonal to the layers. Right images are cross sections through the layer indicated by the red cross hairs.
