Furniture Rack Corrosion Coupon Surveillance - 2012 Update

October 2012

Savannah River National Laboratory
Savannah River Nuclear Solutions, LLC
Aiken, SC 29808

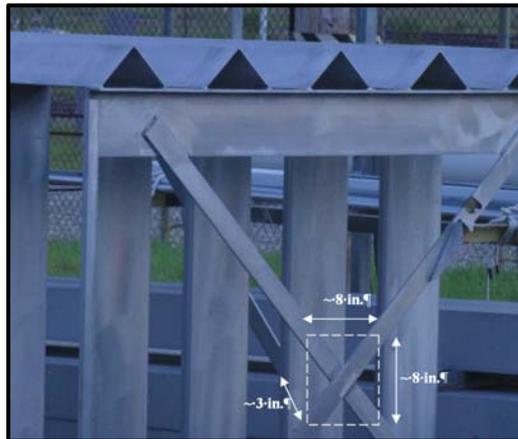
With the 2009 coupons, a welded section from an actual furniture rack assembly pulled from L Basin was also sent to SRNL for analysis. Figure 2-1 shows the location on the furniture rack that the sample was taken. The furniture rack was in the basin for 14 years. The analysis will be used to benchmark the furniture rack coupon data.

Figure 2-1 Location of furniture rack sample sectioned from actual furniture rack assembly (picture shows a spare rack not actual rack that the sample was sectioned from)

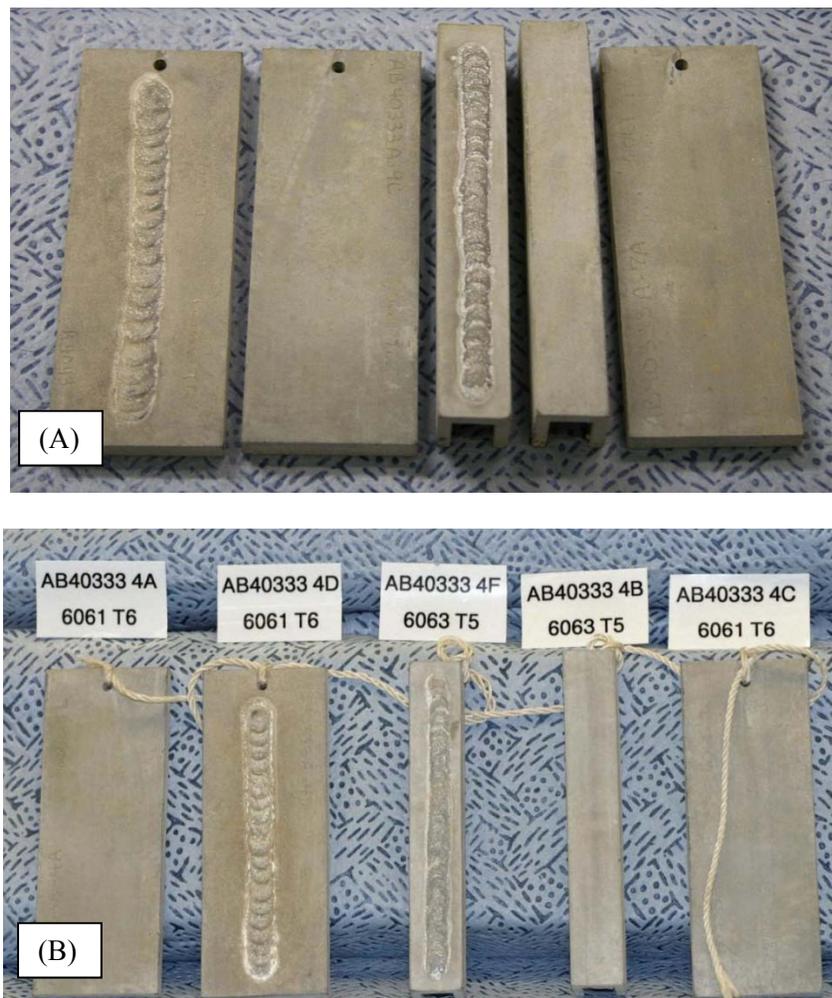
The furniture rack coupons build up a non-uniform aluminum oxide layer on the surface during exposure. The as-received condition is documented in Figure 4-1 for the coupons removed in 2009 and 2011, which is similar to furniture rack coupons from 2002 onward [1-3]. The non-uniform nature of the oxide is noted by variation in the coloring, which gives a mottled gray appearance. A heavy oxide can also be observed in the HAZ of the weld as noted by the whiteness around the weld. Also noted on the coupons were rust-colored spots, which are indicative of ferrous corrosion products or residual particles that settled on the coupons during exposure.

Figure 4-1 As-received condition of the furniture rack coupons removed from L Basin in (A) 2009 and (B) 2011

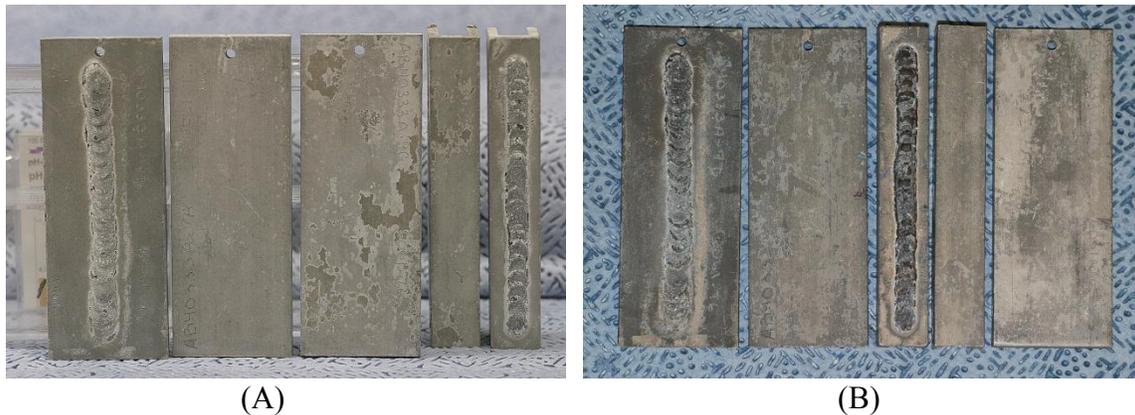
The coupons were cleaned in concentrated nitric acid at room temperature for variable times as noted previously. For 2009 and 2011, the total times of immersion were 120 and 20 minutes, respectively. For 2009 coupons, much of the oxide was removed by the extended time in the nitric acid as shown in Figure 4-2. The photographs in this figure taken after 20 and 120 minutes of cleaning show the patchy removal of the oxide during the cleaning process. At the conclusion of cleaning, oxide still adhered to areas especially at the HAZ and the weld as shown in Figure 4-3 for the welded 6063 U-channel coupon as well as in patches around the remainder of the coupons. The small pits that are present cannot be fully resolved at this magnification.

Figure 4-2 2009 L Basin furniture rack coupons after nitric acid cleaning: (A) after 20 minutes and (B) after 120 minutes

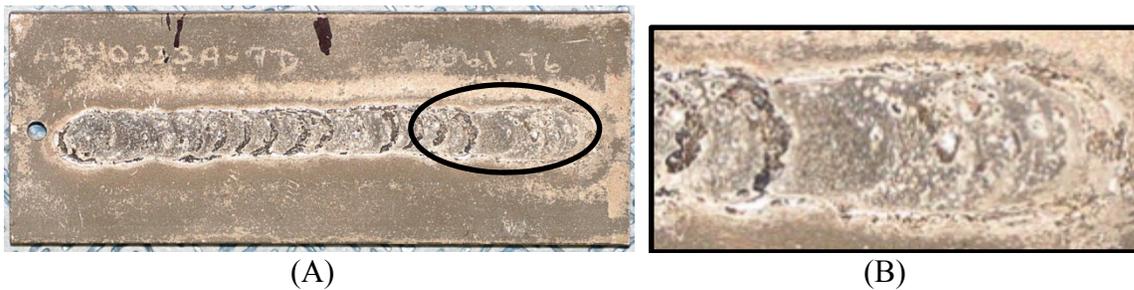
Figure 4-3 2009 L Basin furniture rack coupon – welded 6063 U-channel – (B) is a magnified view of the encircled area in (A) showing residual oxide after nitric acid cleaning

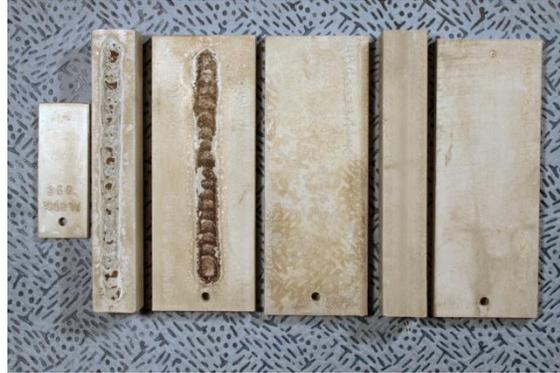
The 2011 coupons are shown in Figure 4-4 after two 10-minute cleaning periods. The coupons appear similar to those from 2009 as shown in Figure 4-2 (B). The oxide appeared to be easier to remove from the 2011 coupons than the 2009 coupons, which is part of the rationale for differences in cleaning times.

Figure 4-4 2011 L Basin furniture rack coupons after 20 minutes in nitric acid; also shown in the figure on the right is the 6063 control coupon for determining weight loss during cleaning

A 6063 control coupon was used during the cleaning in 2011. The appearance of the coupon is shown in Figure 4-4 along with the 2011 furniture rack coupons. The coupon has a degraded or tarnished appearance, especially in contrast to a coupon with a freshly prepared surface that has a shiny metallic appearance. The change in appearance of the control coupon demonstrates the degradation that the coupons experience during cleaning. This degradation or corrosion is minimized for the basin coupons because of the thick oxide layers. However, once this layer is removed the surface of the furniture rack coupon will be degraded. The corrosion rate from weight loss for the fresh surface control coupon was calculated to be equivalent to 66 mpy for the 20-minute cleaning time.

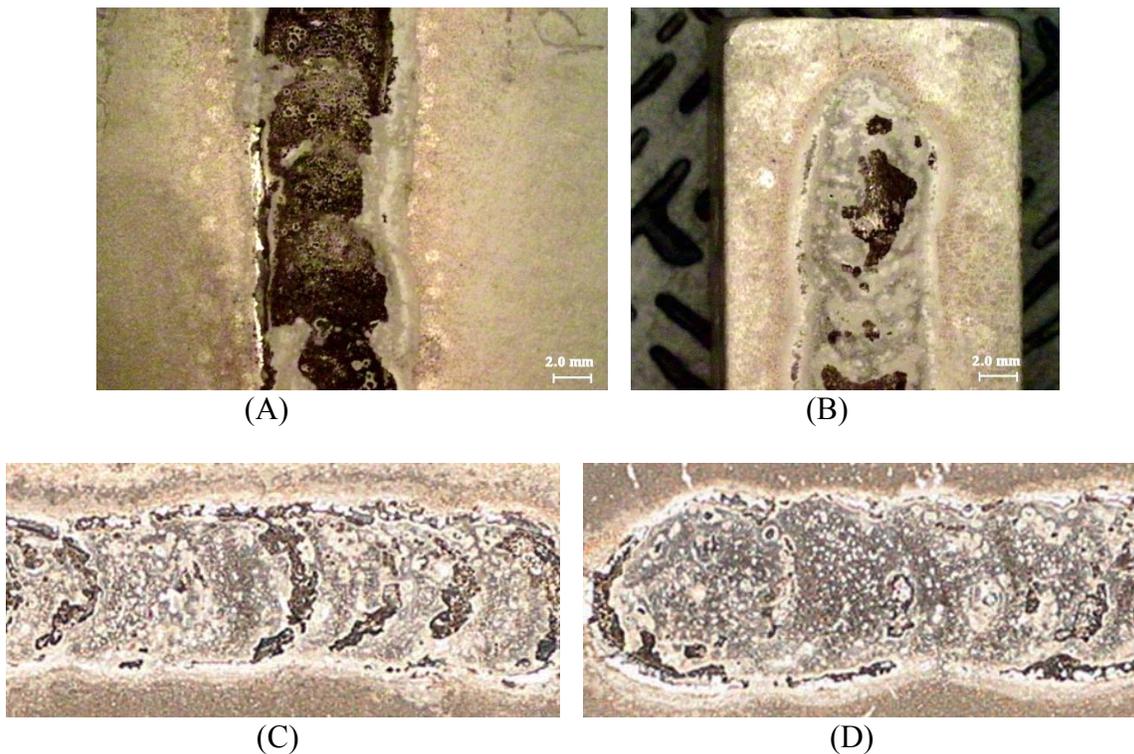
This difference in oxide removal is especially apparent on the welded 6061 plates which are shown in Figure 4-5 (A and C) for 2011 and 2009, respectively. The welded U-channel coupons had similar oxide coverage at the completion of cleaning (Figure 4-5 (B and D)). The different oxidation characteristics could be associated with differences in the individual coupon metallurgy or localized variations in the basin chemistry.

Figure 4-5 L Basin furniture rack coupons after cleaning in nitric acid: (A) 2011 welded 6061 plate, stereo-micrograph (75x), (B) 2011 welded 6063 U-channel, stereo-micrograph (75x), (C) 2009 welded 6061 plate, 35 mm; and (D) 2009 welded 6063 U-channel, 35 mm

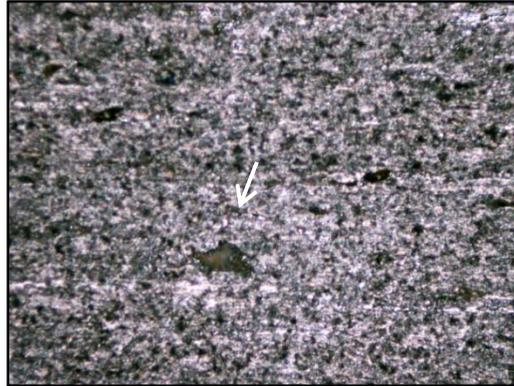
Prior to discussing the pit depths on the furniture rack coupons, pit depths were also evaluated for the 6063 control coupon that was cleaned in nitric acid for 20 minutes. No pits were found when the coupon was examined at 100x magnification. At 200x magnification, 13 measureable pits were found with an average and maximum pit depth of 0.45 and 0.95 mils, respectively. These pits were angular and asymmetric (not

rounded) with the long axis running parallel to the grinding marks in many cases as shown in Figure 5-1.

Figure 5-1 Pitting observed in 6063 control coupon cleaned in nitric acid with 2011 furniture rack coupons (200x, arrow indicates pit)

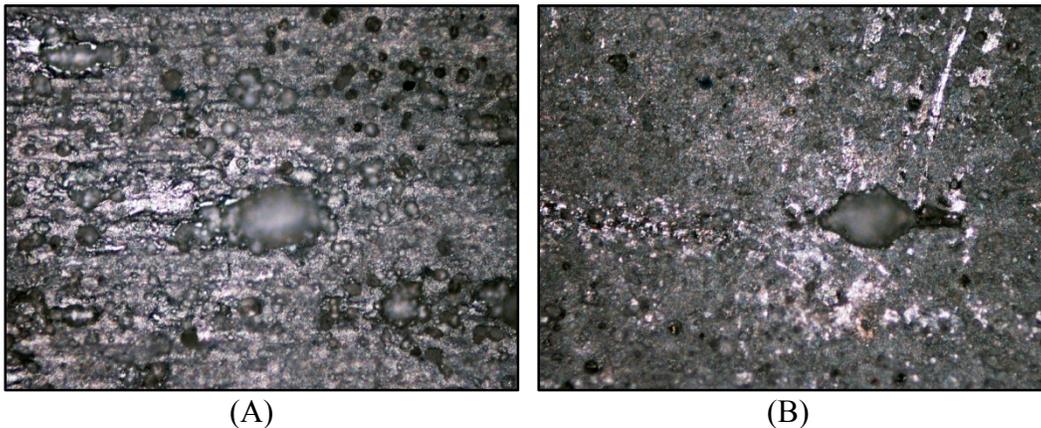
The pitting morphology demonstrated that most pits were not cleaning pits as shown in Figure 5-2. In Figure 5-2 (A), a typical symmetrical, rounded pit was the prevalent pitting observed showing minimal directionality with respect to the grinding marks. Some pits appeared angular and to be growing along the grinding marks as shown in Figure 5-2 (B) and were similar to the control coupon pits (Figure 5-1).

Figure 5-2 Pit morphologies in 2011 furniture rack coupons after cleaning in nitric acid: (A) rounded, symmetrical pit on AB40333A-4A and (B) angular, directional pit on AB40333A-4B (200x)

The furniture rack coupons for 2011 had similar pitting parameters except for coupon AB40333A-4A which had some significantly deeper pits as shown by the P_{\max} and P_{10} values as well as a larger standard deviation. In general for the 2011 coupons, the pit count was very low which is in agreement with a previous pit density of less than 10 pits/m² [3]. The average pit depth, P_N , was approximately 1 mil after approximately 16 years of exposure, which indicates an extremely low average pit growth rate of less than 1 mpy.

Since the furniture rack coupons were strung together in the same location of the basin, pitting differences would be expected to be associated with the plate microstructure (impurities or intermetallics at the surface) and not environmental factors. If coupon 4A was located at the top of the coupon string, however, particulate settling on this coupon might be more prevalent and act as precursor to pitting (this type of corrosion is referred to as underdeposit corrosion). Since the coupons were hung vertically, metallurgical differences are more likely. Further metallurgical investigation of coupon 4A would be required to assess the difference in pitting from the other 2011 coupons.

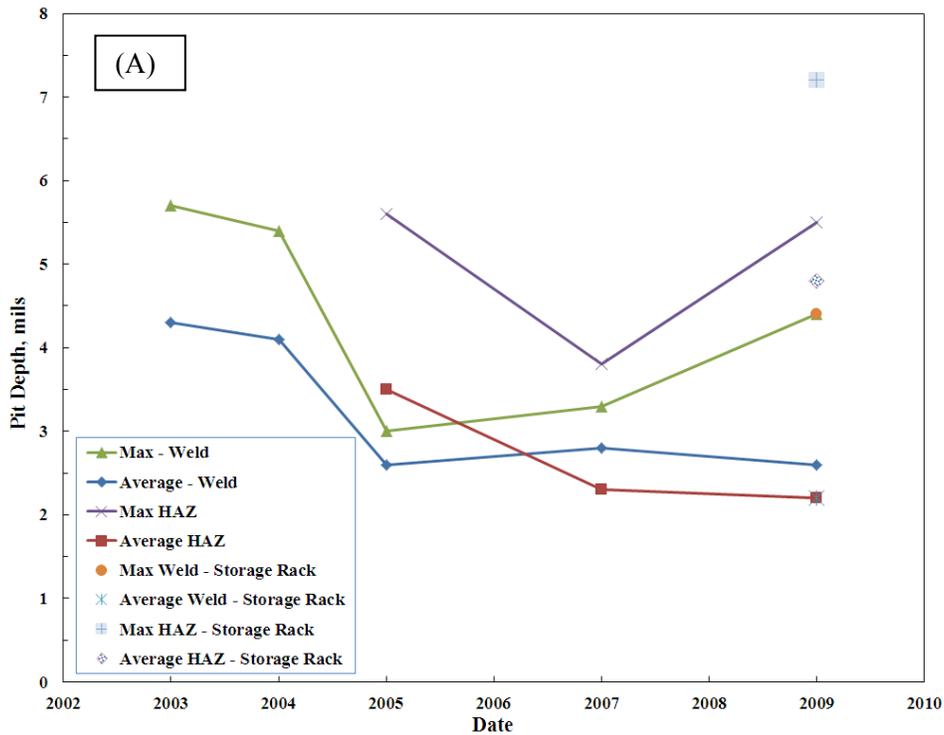
A comparison of pit depths to measurements from previous years for the weld and HAZ of 6061 plate and 6063 U-channels are shown in Figures 5-3 and 5-4, respectively. The data indicated that the pitting corrosion in the weld and HAZ appears to be constant over the exposure period with the average pit depth in the range of 3-4 mils. This value is slightly greater than the average depth measured for the base metal at 1-2 mils.

Figure 5-3 Cumulative average and maximum pit depths from the weld and HAZ measured in 6063 U-channel and storage rack

The maximum pit depth does not appear to be growing, although 2009 data values show an increase. These larger pit depths may be associated with the extended cleaning times. Cleaning times have not been reported previously so the impact on previous data sets cannot be evaluated [1-3].

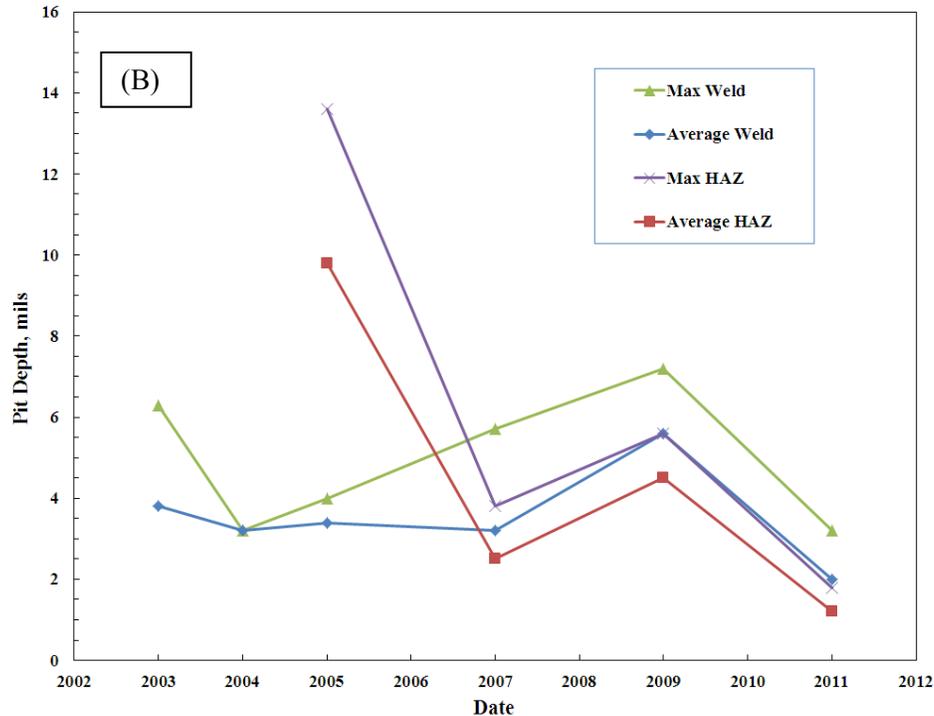
Figure 5-4 Cumulative average and maximum pit depths from the weld and HAZ measured in 6061 plate
