L Basin Corrosion Surveillance Program – Evaluation of 2014 Surveillance Coupons

December 2017

SRNL-TR-2017-00415, Revision 0

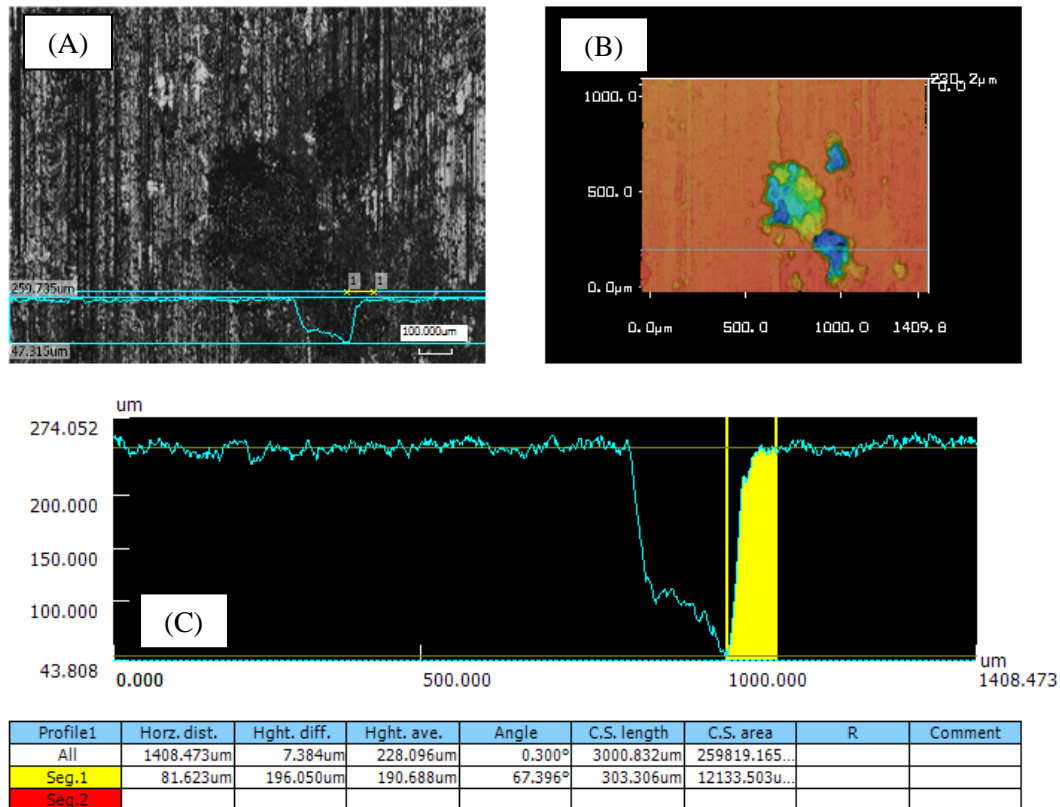
Figure 2-4. Pit measurement for an individual image from single coupon 1100-032, Q1 on the front or numbered side: (A) laser scan image; (B) height scan with profile line through deepest part of pit; and (C) the profile measurement with the pit depth of 196.05 μm shown in the table

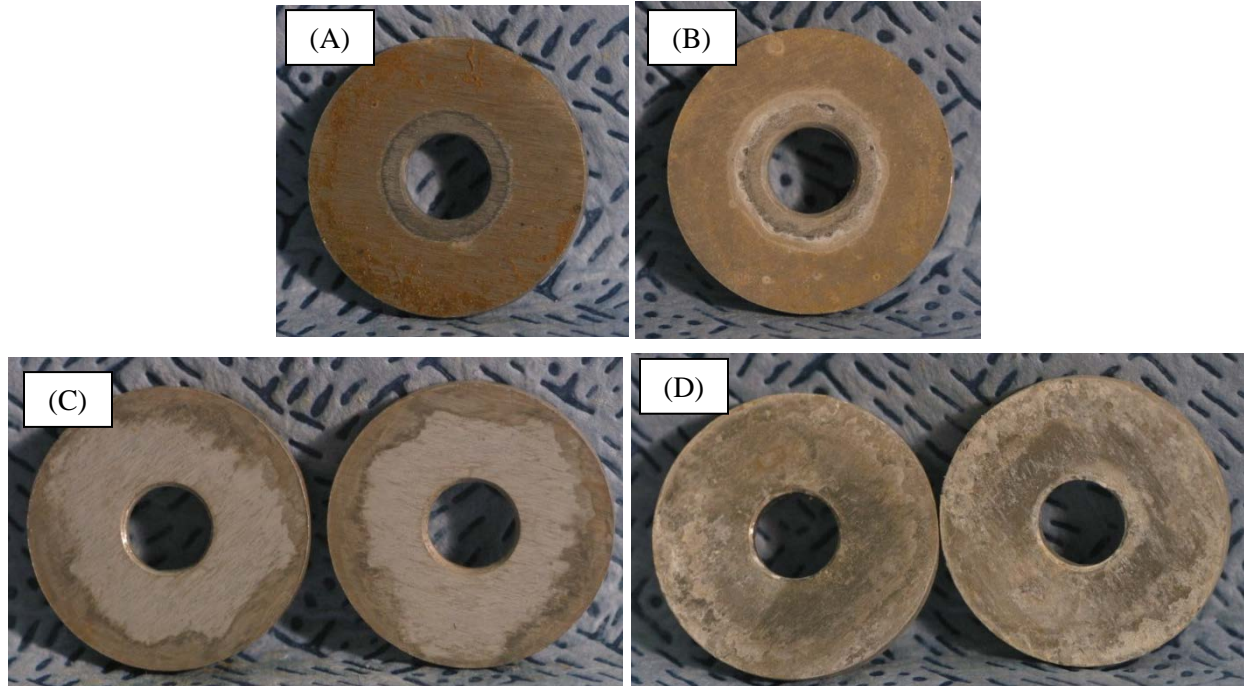
The 2014 surveillance coupons were visually different than the 2010 surveillance coupons. The 2014 coupons had a rust-like patina or particles on many of the coupons, especially on the upward facing surfaces as shown in Figure 4-1(A). This rust-like patina was noted on removal of the coupons from the basin. Previous coupons have not been observed with this feature as shown by the photographs in Appendix C for single configuration coupons and the 1100 galvanic couples. Many coupons removed in 2004 had discrete particles, which is attributed to settling particulate from the basin or spotting from corrosion of impurities or intermetallics anodic to the base metal.

Figure 4-1. Photographs of 2014 L Basin surveillance coupons prior to cleaning: (A) single Al1100 coupon with rust-like patina; (B) single Al6061 coupon without rust patina; (C) mating surfaces from Al 6063 crevice couple; and (D) mating surfaces from Al1100 galvanic couple (304L on left, Al1100 on right).

Very broadly, the 2014 surveillance coupons developed a surface oxide, which led to a change in the surface color as shown in Figure 4-1(B). This oxide was non-uniform due to localized variations, including the formation of pits as well as the galvanic coupling and crevice effects. Within the crevices between the separation washer and the coupon, a buildup of white oxide formed near the washer edge. Mating surfaces of coupon couples showed a large buildup of oxide which had either a mottled appearance (galvanic couples, Figure 4-1(D)) or an irregular ring appearance (crevice couples, Figure 4-1(C)). The observed black oxide occurred mostly in a crevice. As can be seen from the data in Table 4-1, the corrosion morphology of the upward and downward facing surfaces differed visually for both single and couple configurations.

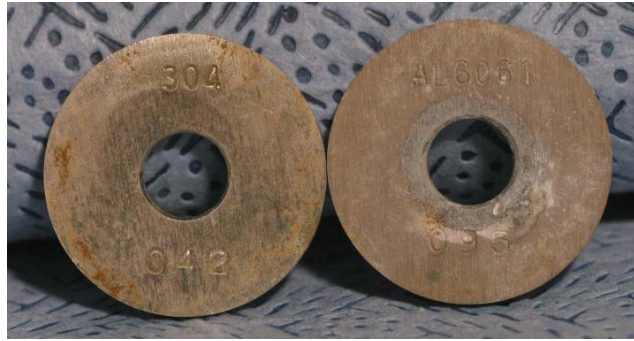
The 304L coupons in the galvanic couples showed minor discoloration with no detectable corrosion attack. Debris was obvious on the upward facing surfaces with rust-colored deposits or corrosion products as shown in Figure 4-2. Pitting corrosion was not apparent on the coupons. Surfaces that mated with an aluminum surface had a mottle appearance with a buildup of oxide from the aluminum coupons as shown in Figure 4-1(D). A thorough pit analysis of these 304L coupons was not performed since no apparent corrosion was observed.

Figure 4-2. Photographs of Al6061 galvanic couple with the 304L coupon surface facing upward and the Al6061 coupon surface facing downward

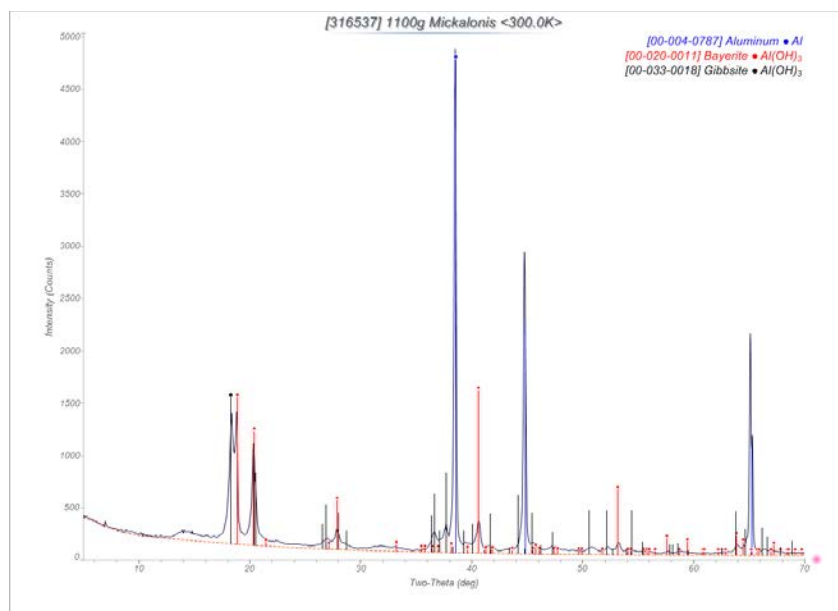
One species expected to be found was iron oxide because of the rust coloring on many of the coupons. Fe and O as dominant peaks were identified a few times. The SEM examination, however was not extensive and the presence of the rust-colored particulate was non-uniform. For the 6061 single coupon that was examined, Ag particulates were identified, although no reason can be given for why Ag was only found on one examined coupon or the source.

Figure 4-3. X-ray diffraction spectra for Al1100 galvanic coupon #026 downward facing coupon after a 15-year exposure in L Basin

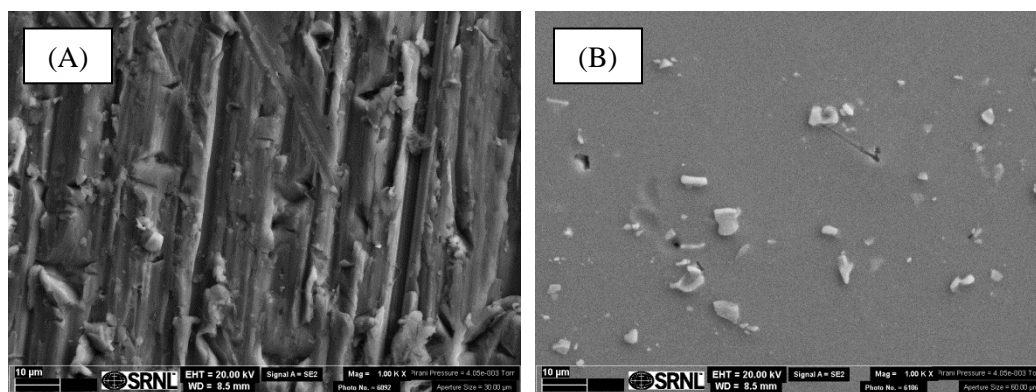
The SEM/EDS analysis of the base metals showed there was a wide population of small intermetallic and impurity particles. Since the sizes were small ($10\text{ }\mu\text{m}$) as shown in Figure 4-4 and Figure 4-5, the chemical analysis data made isolation of specific compositions difficult because of the size of the EDS excitation volume. The elements identified are shown in Table 4-2 and are defined as primary and impurity ($<0.1\text{ wt\%}$). EDS spectra for the coupons exposed to the basin water had similar elements. The additional elements are identified in the table. Some of these additional elements identified on the surfaces of exposed coupons are also known as minor impurities in these alloys. These elements have been italicized in the table. Nearly every element identified on the surfaces of the exposed coupons could be from the alloy.

Figure 4-4. SEM micrographs showing intermetallic and impurity particles in base aluminum alloys: A) Al1100 (sample ground with 600-grit paper); and B) Al6061

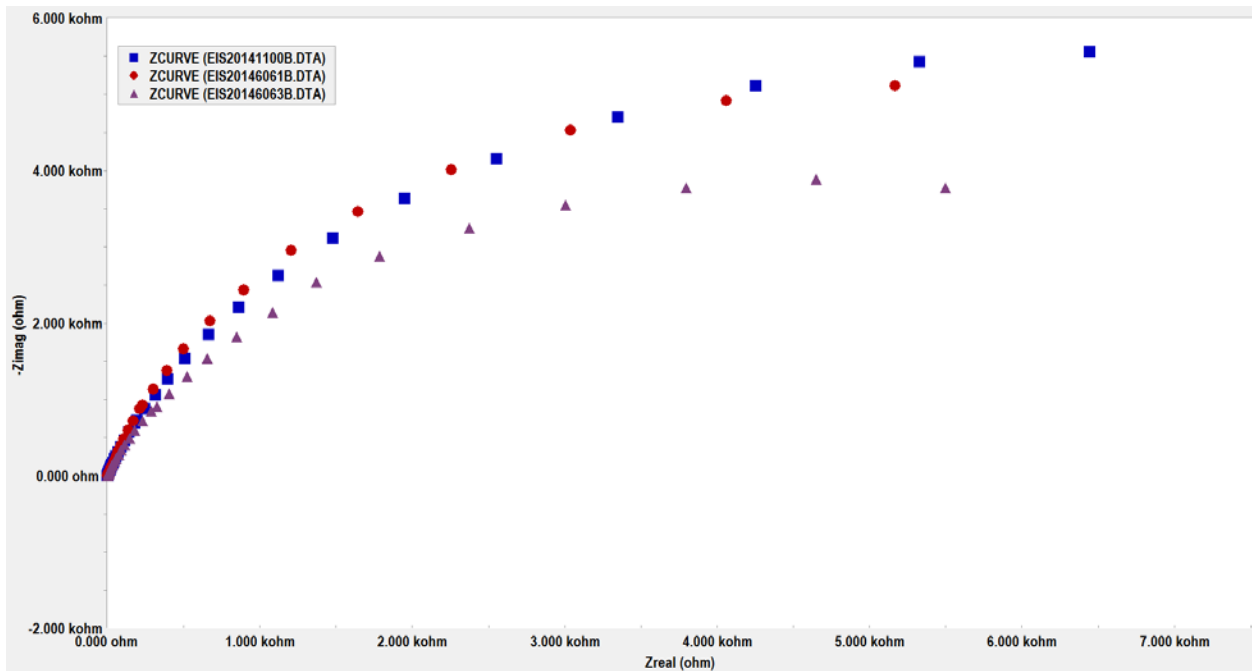
The impedance spectra for the single coupons of the three different alloys are shown in Figure 4-6 as a Nyquist plot, which shows the relationship between the real and imaginary impedance. The three spectra have similar shapes indicating a basic similarity in the oxide. The 6063 coupon does not reach the same imaginary component of the impedance as the 6061 and 1100 coupons so has a lower total impedance or resistance and a possible higher susceptibility to corrosion.

Figure 4-6. Nyquist plots for single coupons of each aluminum alloy, specifically 1100 #032, 6061 #093, and 6063 #123

Electrical circuit models are generally fitted to the impedance data to develop a better understanding of the processes and quantify these differences. Several standard models that are used to fit corrosion processes were tried with these data. In fitting a model, the most significant difference was seen in the resistance elements representing oxide and pore resistance with other elements representing a diffusional component and oxide capacitance being similar. The resistance values for 6063 were both smaller than those for 1100 and 6061, which were similar, and indicate the oxide film may not be as protective as those of 1100 and 6061.

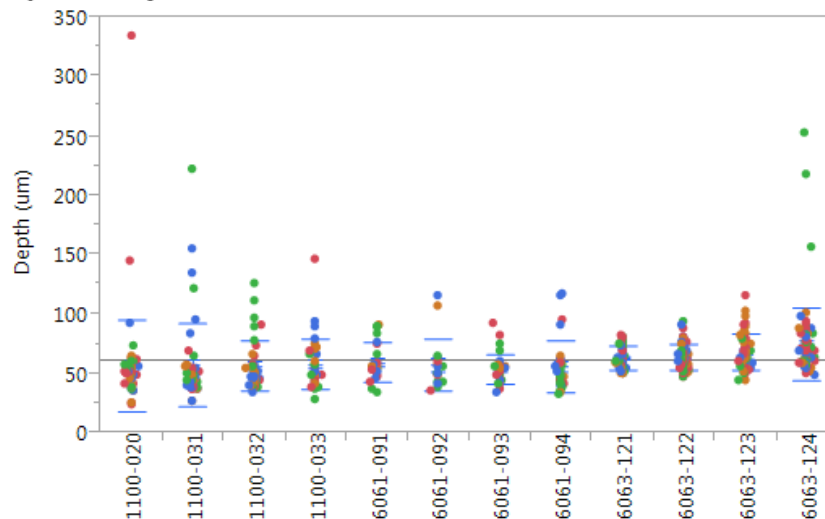
As can be seen by these data, the differences between alloys are minimal and statistically there is no difference among the coupons, which can be seen graphically by the pit depth data presented in Figure 4-7 (units are in μm which is the measuring unit of the LCM). In previous coupon analysis, a comparison between the upward and downward faces have shown that no consistent face had deeper pits [8, 10, 14]. A significant difference was also not seen this year between the upward and downward facing surfaces. Again, similar to results from prior year coupons, the deeper pits were observed on the open face as opposed to the pits formed under the separation washer, i.e. a crevice pit [8, 14].

Figure 4-7. Plot of mean pit depth (>25.4 μm (1 mil)) and standard deviation for each 2014 surveillance coupon (the solid line indicates the overall average mean for this data set; color indicates the different quarter the pit was located)

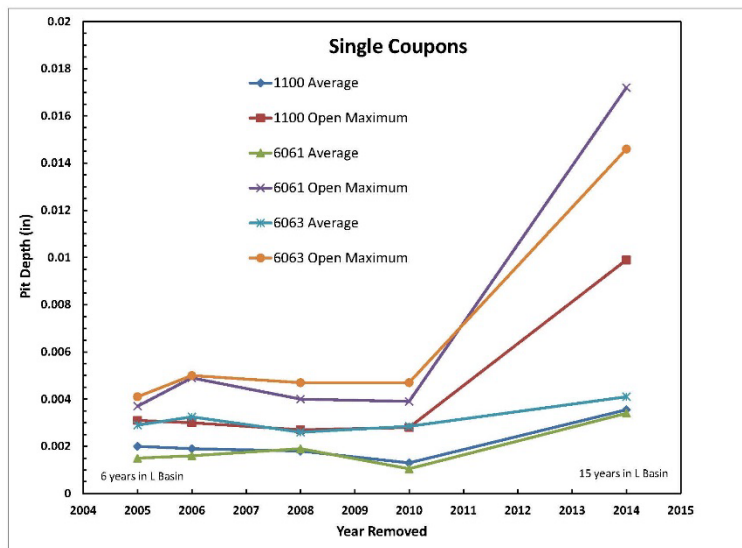
The pit depths measured this year are in general the highest measured thus far for the coupons inserted into the basin in 1999. The trends of pit depth (absolute maximum and the average of the 10 deepest) from 2005 to 2014 are shown in Figure 4-8. These data do not differentiate between the back and front of the coupons, i.e. upward or downward orientation, which have shown similar depths. As can be seen by the data in Figure 4-8, the maximum pit depth measured in 2014 is significantly larger than previous

years. The 2014 maximum pit depths range from 10 to 16 mils for the three alloys. Previous years maxima were in a tight range of 3-5 mils.

The large increase in maximum pit depth was unexpected. Besides the difference in measuring technique, another difference found between the coupons from 2014 and those removed previously is the variation in surface deposits as shown in Appendix C with a pictorial comparison for the three alloys of representative coupons from each removal between 2005 and 2014. Coupons removed in 2005 and 2006 had a layer of sand particulate resulting from the startup of a new sand filter in July 2004 [10]. Coupons from 2008 and 2010 had a minimal amount of debris [8, 14]. For 2014 coupons there is the presence of the rust-colored debris with EDS identified iron particulate. Iron is known to be cathodic to aluminum so aluminum would corrode in preference to the iron. The iron in fact may act as a pit initiator and accelerate pit growth by depolarizing the cathodic reaction of oxygen reduction [15]. The deepest pit however was not always associated with a thick layer of particulate, i.e. A1100 #32 (see Appendix B). The timeframe that these particulates deposited on the aluminum surface is unknown.

Figure 4-8. Trend plot of the maximum and the 10-deepest average pit depths for single surveillance coupon from 2005 to 2014

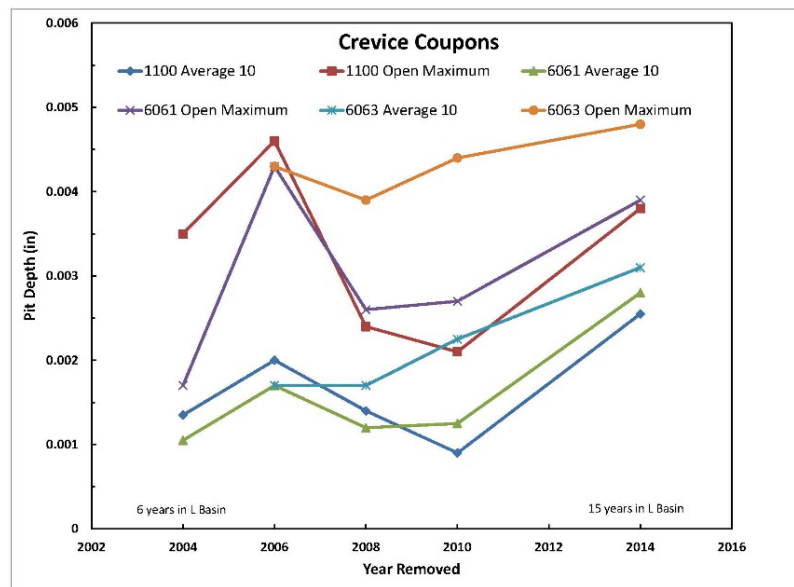
The 2014 crevice coupons generally continued the trend of slightly increasing pit depths with time observed with previous crevice couples as shown by the data in Figure 4-9 for the crevice couples removed between 2005 and 2014. As for the single coupons, the greater depths are observed for the 2006 and 2014 coupons.

Figure 4-9. Trend plot of the maximum and 10-deepest average pit depths for crevice surveillance coupon from 2005 to 2014

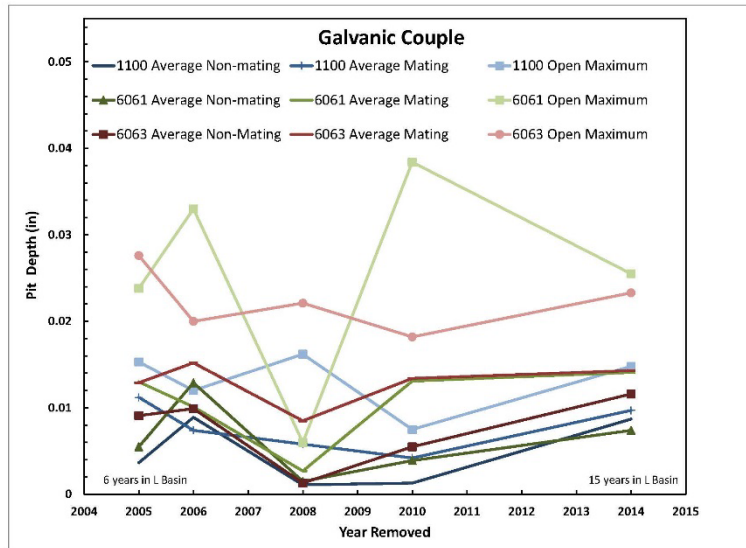
Figure 4-10. Trend plot of the maximum and average pit depth for galvanic surveillance coupon from 2004 to 2014

By comparison of the data in Table 4-9 with that in Table 4-5 and Table 4-8, the pit depths can be seen to be greater along with a higher pit density for the galvanic couples than the other coupon configurations. These greater depths are attributed to the galvanic interaction with the stainless steel coupon and the resulting increased cathodic reaction rate. The back or mating side of the galvanic coupons, similar to the crevice coupons, has a higher average pit depth, which is also similar to coupons removed in previous years (see Figure 4-10). Many of the absolute maxima on the 2014 galvanic coupons were associated with the edge, number or separation washer on the non-mating side.
