# **A Structural Impact Assessment of Flaws Detected During Ultrasonic Examination of Tank 15**

**B. J. Wiersma  
J. B. Elder**

Savannah River National Laboratory  
Materials Science and Technology Directorate

Publication Date: August 2008

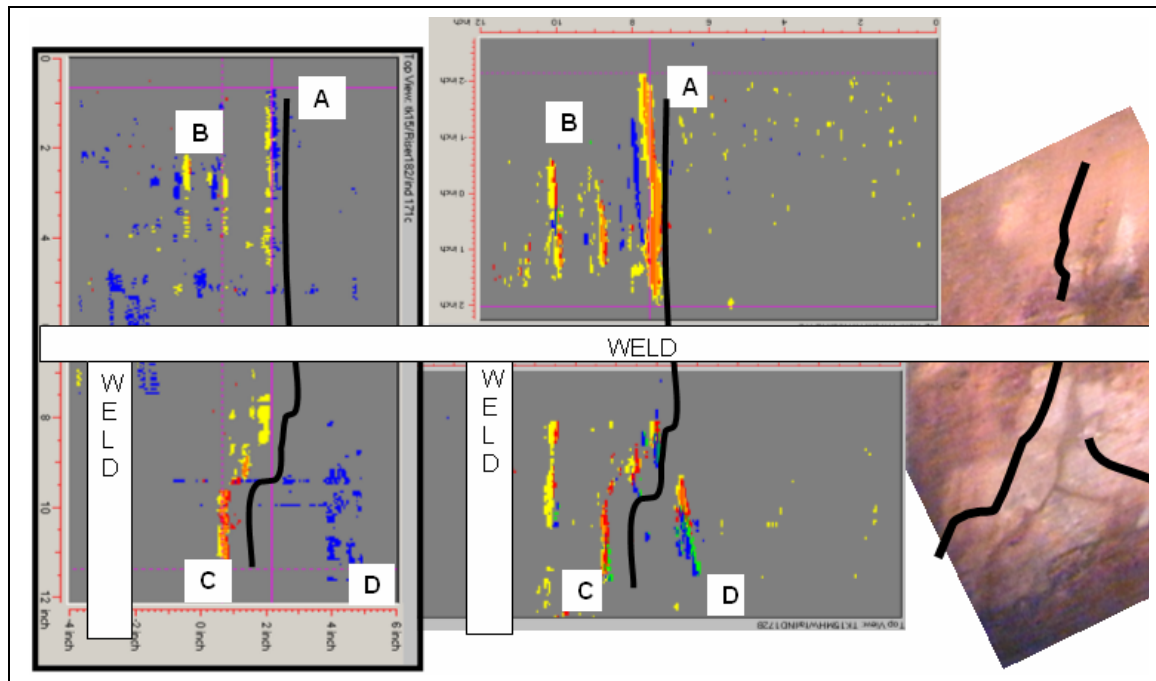
**Figure 17. Images from crack # 3 2002 (left) and 2007 (center and right)**

Although the techniques and the transducers used to size the crack in 2002 and 2007 were the same, there was a significant mechanical improvement to the fixtures that held the probes. This improvement allowed for better contact between the probe and the tank wall surface and a closer approach to the seam weld bead. As a result, better scan resolution, and hence more accurate sizing, was achieved. For example, the difference in resolution, and the effect on sizing, is clearly shown in Figure 17. In 2002, this crack was sized by starting at the tip on the upper plate and driving the crawler over the weld and then locating the crack closest to the vertical weld. In the process of driving over the weld, probe contact was lost approximately 1" from the horizontal weld and therefore you have no signal in this area. As it crossed the weld bead, the wheels on the crawler may have spun a little adding additional length to the crack measurement. Thus, the fact that the length that was reported in 2002 as "may be 10.7 inches combined", while in 2007 it was reported as 10.5" are not inconsistent. In 2007, with the new fixtures, scan was at a much higher resolution. For this scan, the crawler began above the tip of the crack in the upper plate and scanned across the horizontal weld then continued on the other side. The area missed due to the weld geometry was 1.8 to 2 inches. The improved resolution can be observed by comparing the two additional indications that were observed more clearly. In 2007, the scan was able show more clearly an additional indication adjacent to the vertical weld on the bottom plate. This is believed to be a weld bead on the interior surface of the tank wall. Additionally the scan in 2007 shows a crack branch that goes away from the weld. It could not be determined if this branch was present in 2002, or not.

To determine whether growth had occurred in this situation, the edge of the weld bead on the interior surface of the tank was used as a reference point. A comparison was then made between the distance between this reference point and the tip of the crack in 2002 and 2007. From this comparison it was determined that the tip of the crack had extended by 0.25". Crack growth in the other three cases was determined similarly by comparing to reference points that were clearly observed in both 2002 and 2007. All available scan data was utilized to look for landmarks and determine if growth had occurred. Typically there were at least two sets of data for each indication from each examination period.

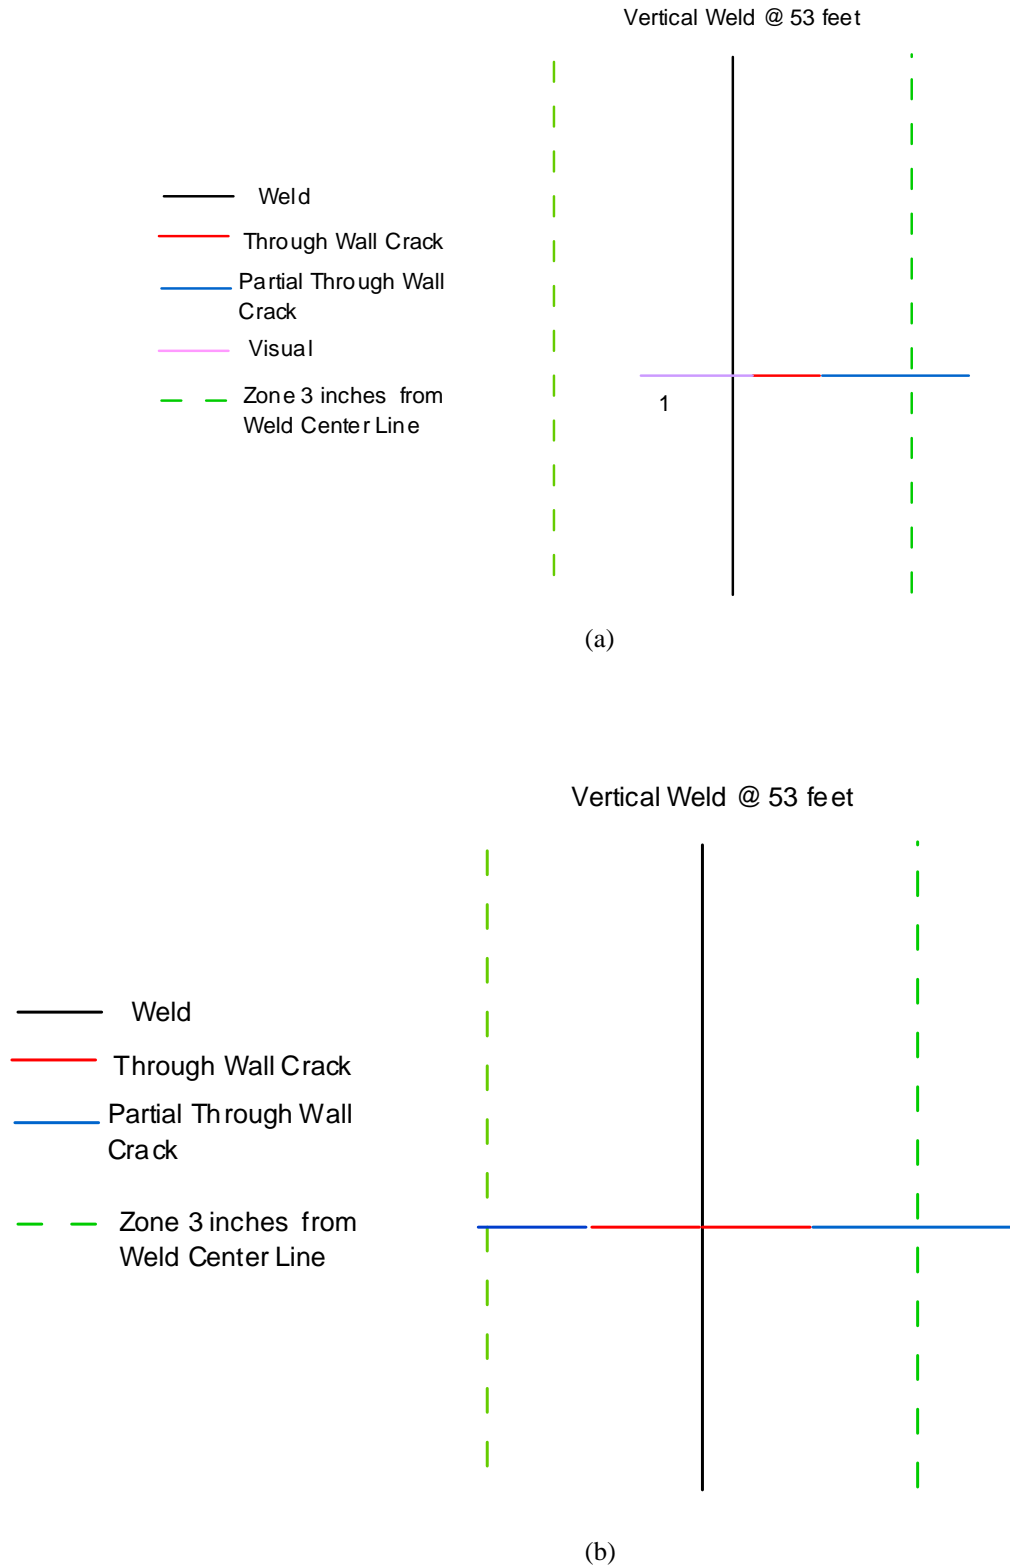
**Figure 18. Rudimentary drawing showing crack # 1 (a) 2002 and (b) 2007.**

The rudimentary drawing of crack #1 is shown in Figure 18. The crack was first visually observed in 1998 due to moisture leaching from the interior to the exterior and had no associated leakage. UT inspections of this crack were performed in 2002 and 2007. During the first 21 years of service the crack was exposed to supernate, while for the past 25 years it has been in the vapor space. Though the exact date is unknown, visual inspection results and the limited amount of leakage appear to indicate that through-wall penetration occurred during the past 25 years of vapor exposure. Initiation of the crack may have occurred during the exposure to supernate.

The UT inspection in 2002 was performed on the portion of the crack to the right of a vertical weld. Visual inspections at the time indicated that the crack extends through the weld to the other side. The through-wall portion of the crack extends approximately 1.4 inches from the weld center-line and is roughly perpendicular to the vertical weld (i.e., horizontal). However, the UT inspection revealed that the crack extends an additional 2.9 inches part through-wall. The crack length of 4.3 inches to the right of the weld extends slightly beyond the assumed 3-inch residual stress zone around the weld. The data from the UT scan are portrayed in Figure 19. In 2002 (top image in Figure 19), only the right side of the crack was scanned. The images in Figure 19 are from the right side of the indication, from 2002 (top) and 2007 (bottom). The images would need to be flipped to coincide with the photograph of the indication. The growth is evident on the left side of the image.

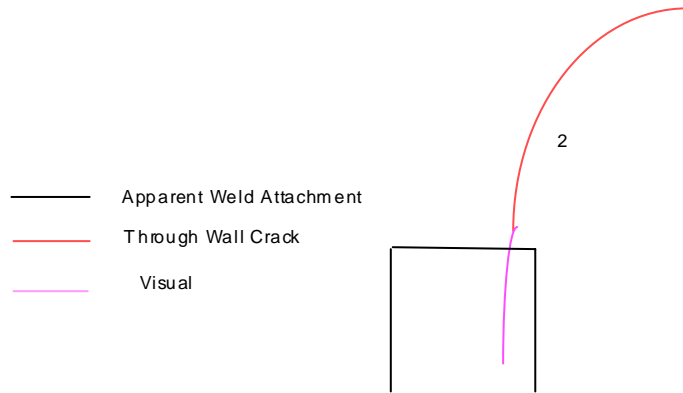
**Figure 20. Rudimentary drawing showing crack #2.**

The crack was located in the center of the lower shell plate far removed from seam welds. There is visual evidence that the crack is associated with a weld attachment. Previously, mid-plate leak sites were also correlated with weld attachments (see Tank 16 and Tank 6). The arc-like nature of the crack is also consistent with results observed during laboratory testing [15]. The visually observed portion of the crack is parallel to a weld fusion line. The portion that was inspected with UT shows the influence of the intersection of two fillet welds on the residual stress distribution. Curvature is generally the result of a region of large compressive stresses that exist at the end of these regions. The total length of the crack could not be measured due to the weld attachment obstruction. In 2002, the portion of the crack that was measured was approximately 3.7 inches in the vertical direction and 2.3 inches in the horizontal direction. No mention was made as to whether the crack was longer on the interior or exterior of the tank. If the visually observed portion of the crack were estimated to be approximately 2 inches longer, the total length of the crack would be approximately 6 inches. The UT examination performed in 2007 indicated no changes in the crack length.

Due to a lack of significant driving forces, either hydrostatic or residual stresses, the crack currently does not impact either the structural stability or the leak tightness of the tank. At this time the level the tank will be at during waste removal is not known, however, this site is close enough to the sludge level that it is very likely that waste will be above the crack during waste removal. The primarily vertical characteristics of the crack would be subject to hydrostatic stresses in the hoop direction. The hydrostatic stresses are potentially higher at this site than for Crack #1, however, it is anticipated that the sludge slurry during waste removal would have a relatively low specific gravity of the sludge slurry. Therefore, from a structural stability perspective the crack is not anticipated to be significant. If the waste is raised above this level, leakage may occur. Procedures to handle the leakage are in place.

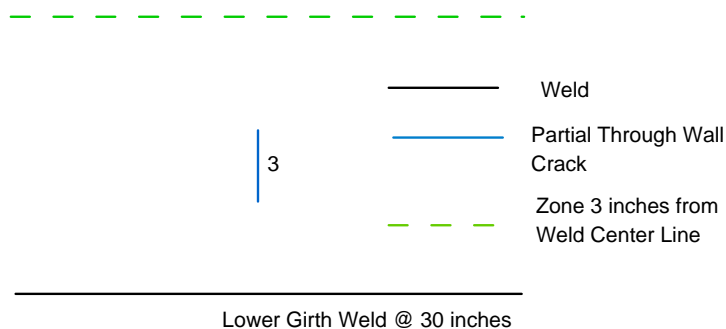
**Figure 21. Rudimentary drawing of crack # 3.**

The rudimentary drawing of crack #3 is shown in Figure 21. Since this crack is part through-wall, there was no previous indication of a crack. Between 1961 to 1965 the site was exposed primarily to supernate. The site has been completely immersed in the sludge since that time. The exact date of crack initiation is unknown, however, it is apparent that it occurred either during exposure to the supernate or the sludge layer.

The crack is vertical and was located approximately 0.8" above the bottom horizontal weld. In 2007, the crack was approximately 25% through-wall and 0.6 inches long. Although, the length was slightly longer than that measured in 2002 (i.e., 0.55 inches), comparison of the two UT scans did not provide sufficient evidence to suggest that any crack growth had occurred. Due to a lack of significant driving forces, either hydrostatic or residual stresses, and the fact that the crack is part through-wall the crack currently does not impact either the structural stability or the leak tightness of the tank. Since the crack is within the 3-inch reference zone around the weld, future crack growth is possible. However, maintaining the waste within the corrosion control limits during any future waste removal operations would minimize this possibility.

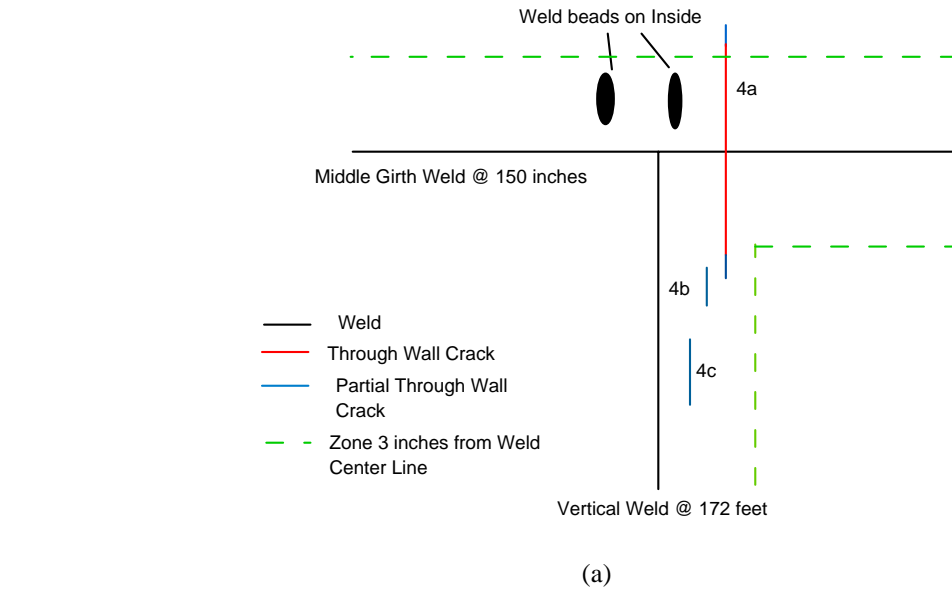
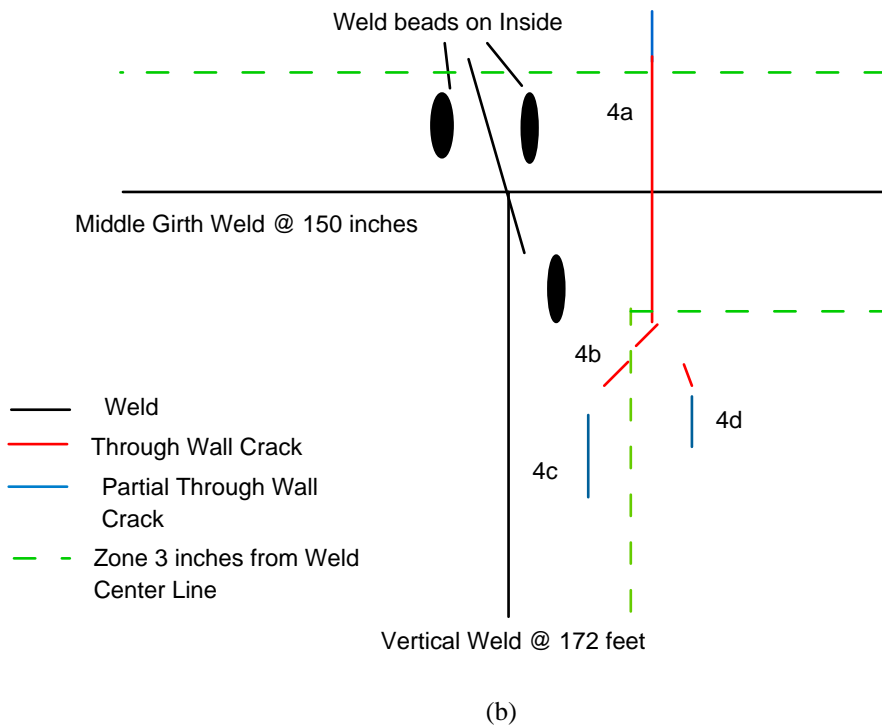
**Figure 22. Rudimentary drawing of crack #4 (a) 2002 and (b) 2007.**

The crack is located near the intersection of a vertical weld and the middle horizontal weld, and is roughly perpendicular to the horizontal weld. In 2007, the UT examination revealed that this vertical crack appears to consist of four segments, one through-wall crack (4a) and three smaller partial through-wall cracks (4b, 4c, and 4d). If segments 4a-4c are considered a single crack, the crack length would be approximately 10.5 inches. This crack is the longest vertical crack ever observed. The through-wall portion of crack 4a was approximately 7 inches, although on the interior the crack was approximately 7.9 inches. In 2007, it was determined that the segment of crack 4a in the upper plate had extended approximately 0.25 inches in the direction away from the weld, and therefore just outside the residual stress zone. The portion of the crack that extended was partial through-wall. The three other sections of the crack were approximately 50% through-wall and were 1.0 (4b) and 1.8 (4c), and 1.4 (4d) inches long. No extension was observed for cracks 4b and 4c. Crack segment 4d was not observed in 2002. Due to the improvements in the probe fixtures it is not known whether this crack segment was actually present in 2002. In addition to the intersection of the vertical and horizontal seam welds, weld beads in the vicinity of the crack may have influenced the residual stress distribution. However, assuming they are cracks, both were outside the 3 inch zone around the horizontal weld, but within the 3 inch zone of the vertical weld. Residual stress modeling of a region near a horizontal and vertical weld indicates that a "pocket" of tensile stress in the direction transverse to the vertical weld is present approximately at the location of Cracks 4b, 4c, and 4d (see Figure 10). Thus, the cracks would tend to grow parallel to the vertical weld rather than perpendicular. The modeling also suggests that this tensile stress has a relatively short range and therefore the crack driving force in that direction decreases. After this short distance, the primary tensile stress becomes longitudinal to the vertical weld.

Due to a lack of significant driving forces, either hydrostatic or residual stresses, the crack currently does not impact either the structural stability or the leak tightness of the tank. At this time the level the tank will be at during waste removal is not known. However, if the waste level were to exceed the middle horizontal weld, the primarily vertical characteristics of the crack would be subject to hydrostatic stresses in the hoop direction. The hydrostatic stresses are potentially higher at this site than for Crack #1, however, it is anticipated that the sludge slurry during waste removal would have a relatively low specific gravity of the sludge slurry. The instability length for a vertical crack at the middle girth weld of a Type I tank, with a solution with specific gravity of 1.1, was estimated to be 111 inches for normal operating conditions and 64 inches for seismic conditions [22]. Although, this is a Type II tank rather than a Type I, there are enough similarities between the two tank styles that one may assume that the instability crack length would be similar. Therefore, from a structural stability perspective the crack is not anticipated to be significant. If the waste is raised above this level, leakage may occur. Procedures to handle the leakage are in place.

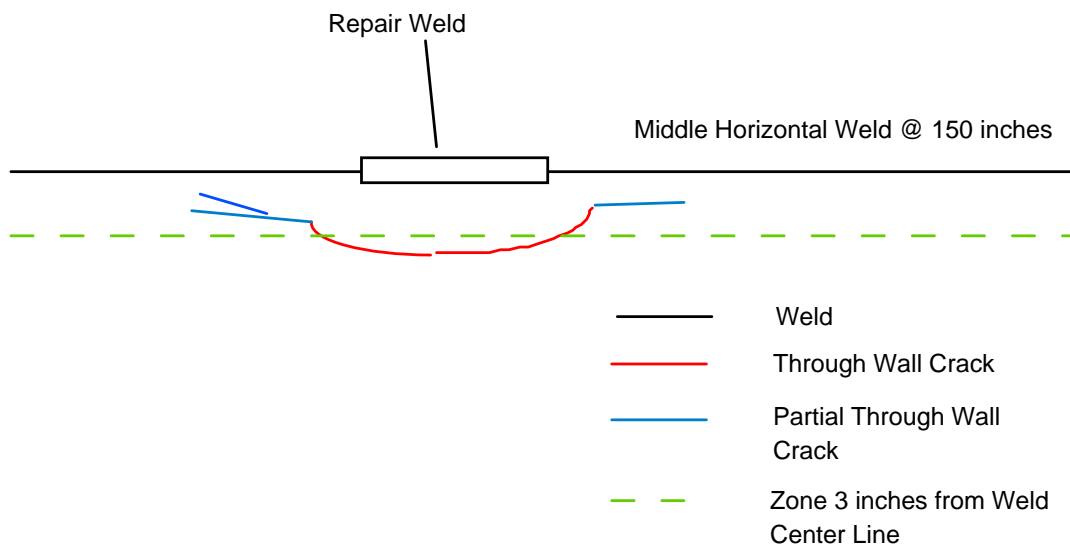
**Figure 23. Rudimentary drawing of Crack #5.**

The crack is located near a repair weld in the middle horizontal weld. The crack arcs slightly around the repair weld, however it is primarily oriented in the horizontal direction. In 2007, the length of the crack was determined to be approximately 20 inches. In 2002, the crack was reported to be approximately 18 inches. However, comparison of the two scans indicated that there was actually no further growth. The through-wall portion of Crack 5 is approximately 10 inches and is in the section of the crack that is adjacent to the repair weld. At each end of the through-wall section of the crack are part through-wall sections. The crack to the left of the repair is approximately 6 inches and appears to branch, while the portion of the crack to the right is approximately 4 inches. The arc-like pattern of the crack adjacent to the weld repair is consistent with laboratory results [15]. The behavior also agrees with the residual stress model for a narrow weld repair in that the crack is located a short distance from the weld repair fusion line. The simulated weld repairs in the laboratory were much wider than this repair in the tank. This crack is the longest ever observed.

Due to a lack of significant driving forces, either hydrostatic or residual stresses, the crack currently does not impact either the structural stability or the leak tightness of the tank. The fact that the crack is oriented primarily in the horizontal direction means that hydrostatic stresses in the hoop direction will not have a significant impact on further growth of this crack. Therefore, from a structural stability perspective the crack is not anticipated to be significant. If the waste is raised above this level, leakage may occur. Procedures to handle the leakage are in place.

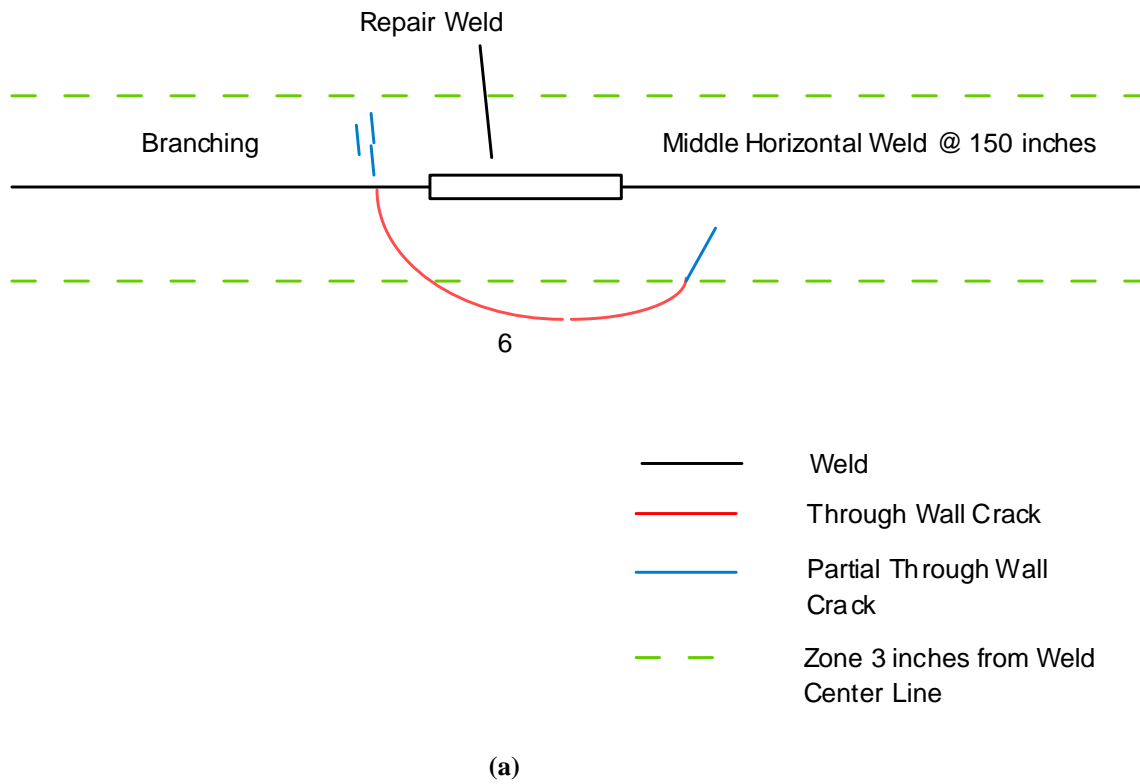
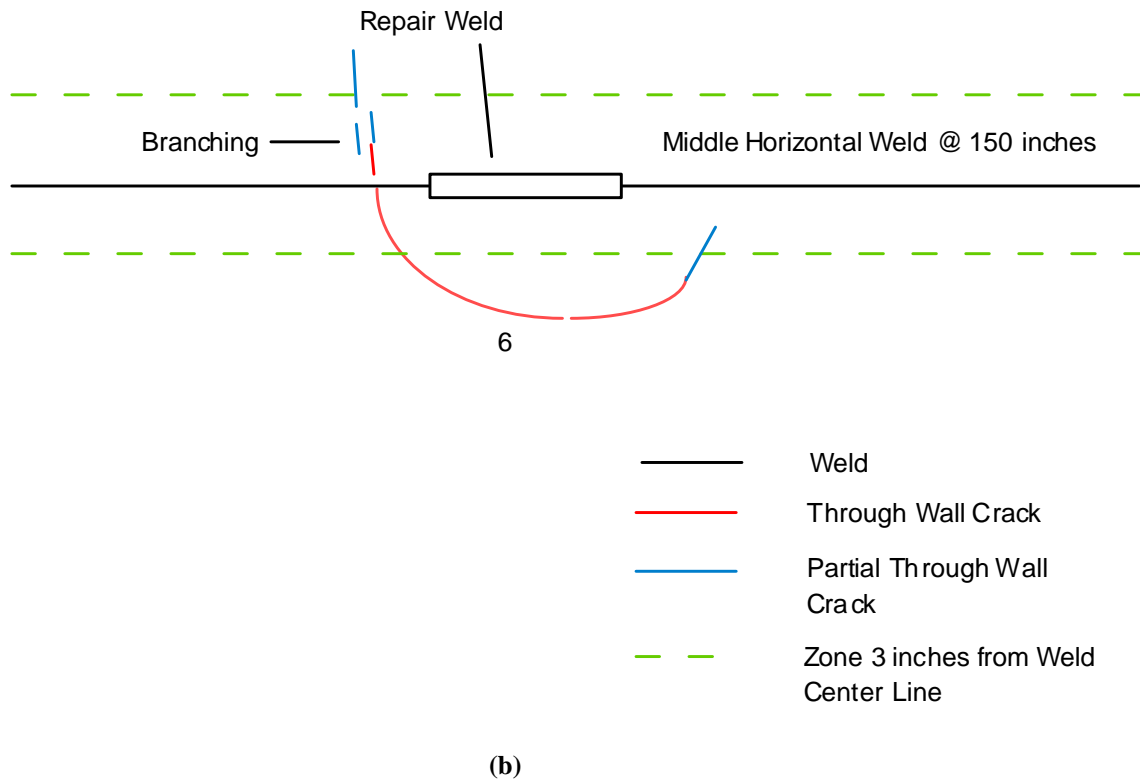
Figure 24. Rudimentary drawing showing crack # 6 (a) 2002 and (b) 2007.

This crack has been the subject of several investigations [5]. The crack is located near a repair weld in the middle horizontal weld (see Figure 25). In 2007, it was determined that the length of the crack was approximately 19 inches. The visible portion of the crack begins at the left edge of the repair weld and then arcs so that it becomes parallel to the horizontal weld. According to the residual stress modeling, the maximum transverse tensile stress occurs at this location. The distance of the parallel portion of the arc is approximately 6 inches from the center of the weld. This distance is further than that observed for Crack #5, however, the effect of a nearby vertical weld may influence the residual stress pattern as well. The through wall portion of the crack is approximately 14.4 inches. At each end of the through-wall section of the crack are part through-wall sections. In the plate above the weld, a primarily vertical branched crack extends tangentially from the repair weld approximately 3.7 inches above the middle horizontal weld. Approximately 1 inch of this segment is through-wall, whereas in 2002, all of this segment was part through-wall. There has been approximately 1.7 inches of crack extension into the base plate since 2002. The segment that has extended is part through-wall. The part through-wall crack in the plate beneath the weld arcs back toward the middle horizontal weld. The arc-like pattern of the crack adjacent to the weld repair is consistent with laboratory results [15]. The behavior also agrees with the residual stress model for a narrow weld repair in that the crack is located a short distance from the weld repair fusion line.

Due to a lack of significant driving forces, either hydrostatic or residual stresses, the crack currently does not impact either the structural stability or the leak tightness of the tank. This statement is confirmed by the finite element fracture analysis previously performed on the crack (assuming that it was 15 inches) [21]. The analysis showed that the hydrostatic stresses were not sufficient to drive the crack to instability. The horizontal orientation of the crack means that hydrostatic stresses in the hoop direction will not have a significant impact on further crack growth. Therefore, from a structural stability perspective the crack is not anticipated to be significant during waste removal. If the waste is raised above this level, leakage may occur. Procedures to handle the leakage are in place.

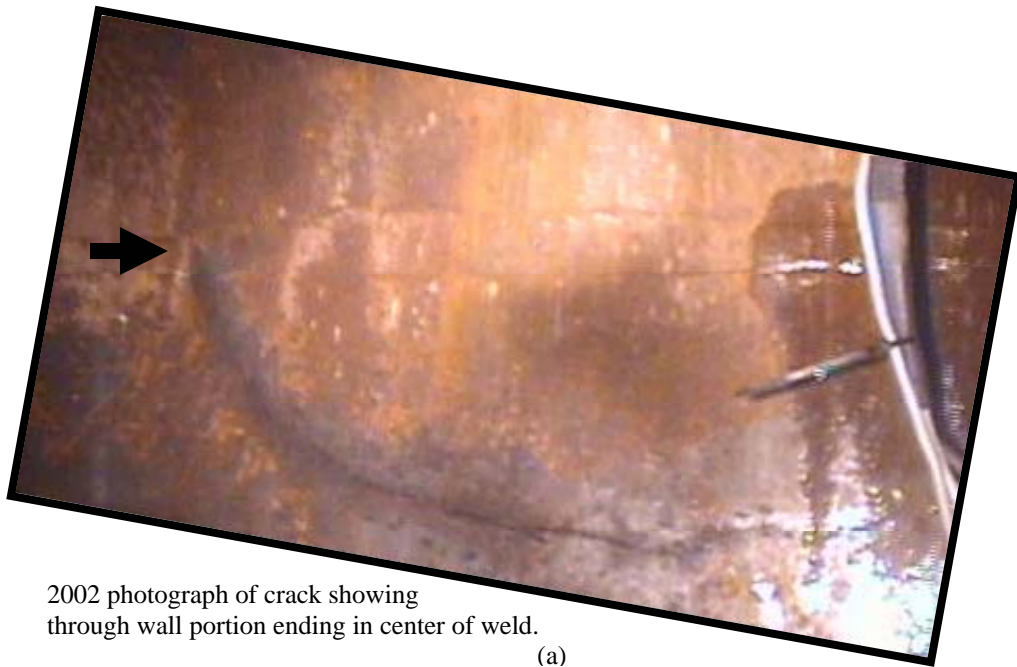
2002 photograph of crack showing  
through wall portion ending in center of weld.

**Figure 25. Bleedout photographs of crack # 6 (a) 2002 and (b) 2007.**

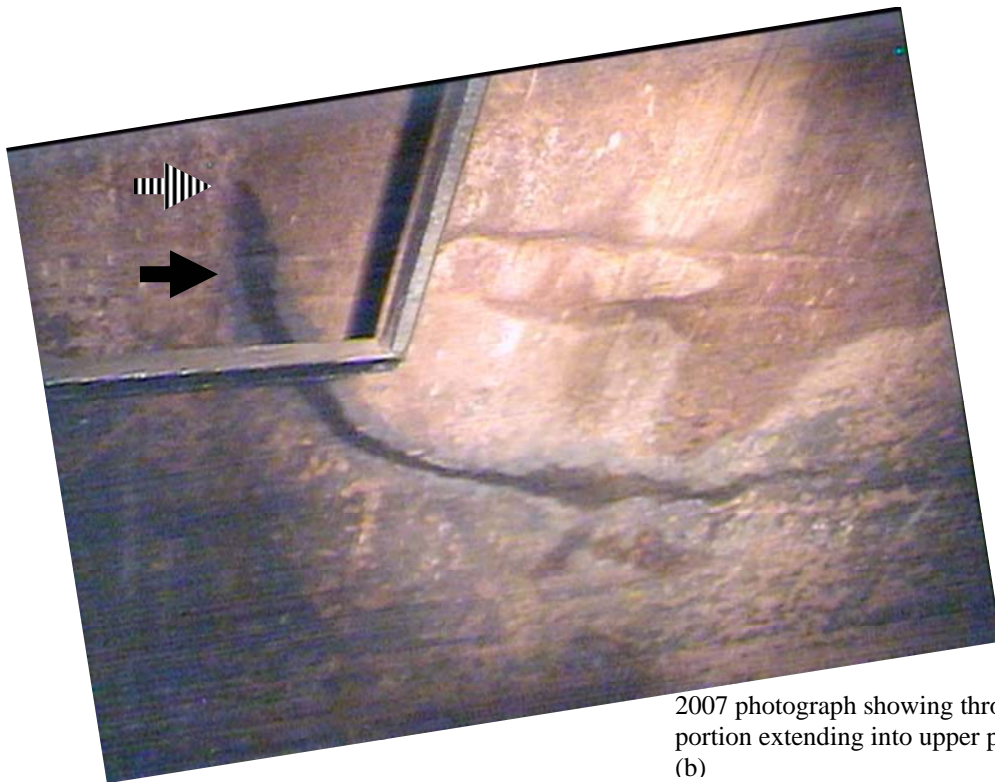
2007 photograph showing through wall  
portion extending into upper plate  
(b)

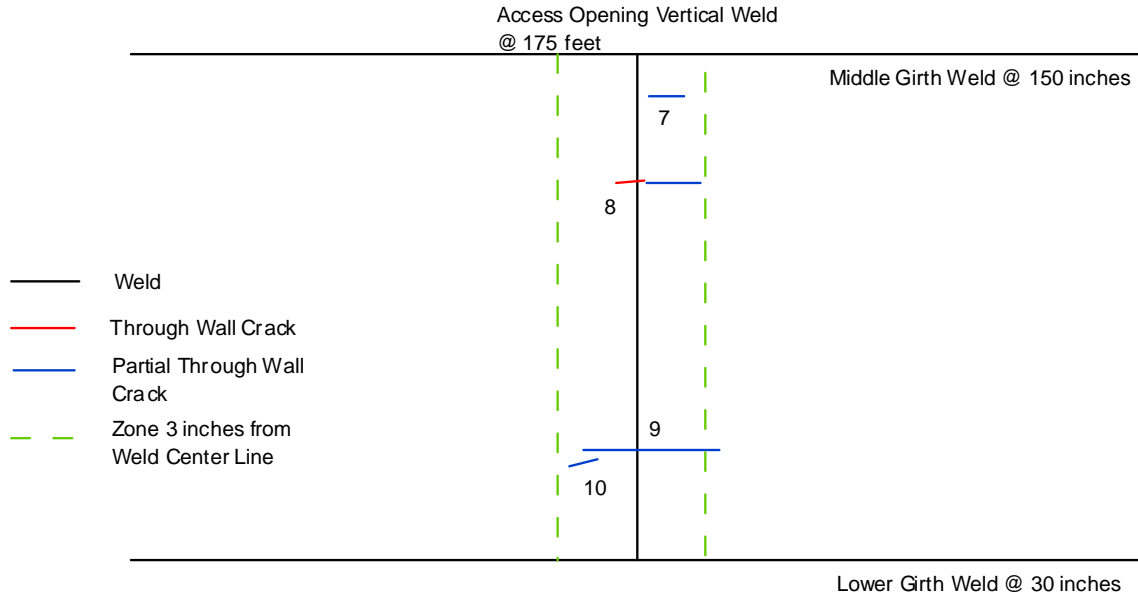
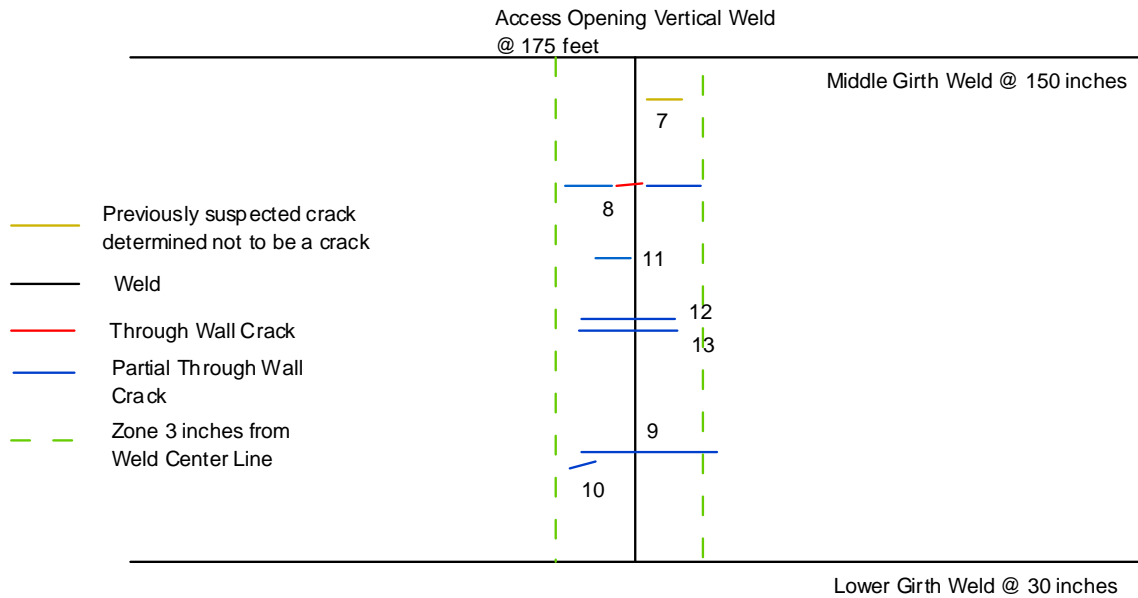
Figure 26. Rudimentary drawing of cracks #7-13 (a) 2002 and (b) 2007.

Due to a lack of significant driving forces, either hydrostatic or residual stresses, the crack currently does not impact either the structural stability or the leak tightness of the tank. The horizontal orientation of the crack means that hydrostatic stresses in the hoop direction will not have a significant impact on further crack growth as well. Therefore, from a structural stability perspective the crack is not anticipated to be significant. If the waste is raised above this level during waste removal, leakage may occur. Procedures to handle the leakage are in place.
