**Failure Evaluation of Savannah River Site High-Level Waste Evaporator
242-25H – Part I
17366**

Author: T. Yamamoto
Savannah River Remediation LLC

ABSTRACT

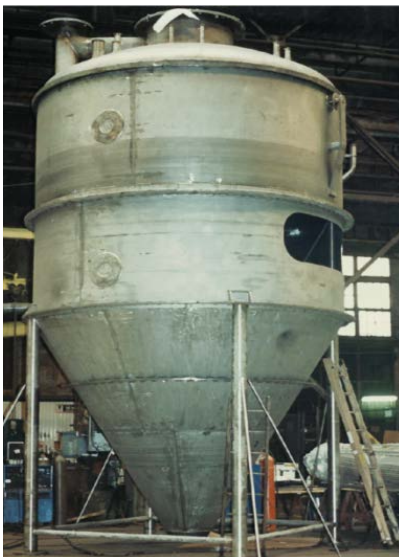
Fig. 3. Construction of 25H Evaporator Vessel

A remote examination of the exterior of the evaporator vessel was conducted to document the construction of the lagging on the evaporator. There are detailed construction drawings of the evaporator vessel, but insulation and lagging was installed when the vessel was installed in the cell. The general requirements for insulation and lagging are documented, but not the specific details of how the lagging was configured on the evaporator. The exterior examinations helped to document and observe additional details of how the lagging was assembled and held to the evaporator vessel. From the drawings, most of the stiffening bands were stitch welded onto the vessel. However, per the fabrication drawings, the support ring is seal welded on the bottom side and stitch welded on the top, Figure 3, separating the cone from the vertical section of the evaporator.

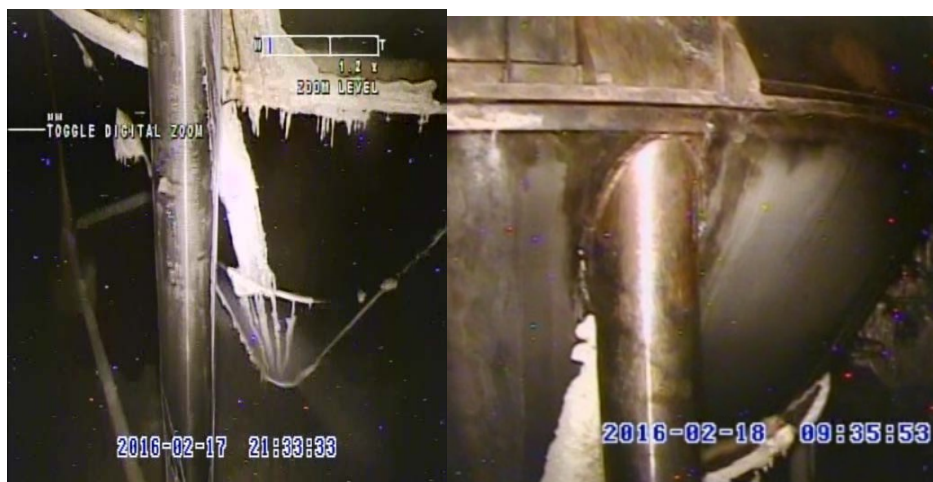
The examination of the exterior walls showed liquid and salt waste coming out of the north-west and north-east leg openings of the evaporator vessel. This location is just below the support ring (see Figure 4.) that segregates the cone from the vertical section of the evaporator. The exterior exam did not indicate any location where the lagging allowed a path to go around the stiffening band. The leak location contradicts where the indicated level stopped during the previous leak test.

Fig. 4. Figure on the left shows visible salt deposits on the lagging of the evaporator vessel. Figure on the right shows one of the location where the leak is coming out of the vessel lagging where the leg penetrates thru.

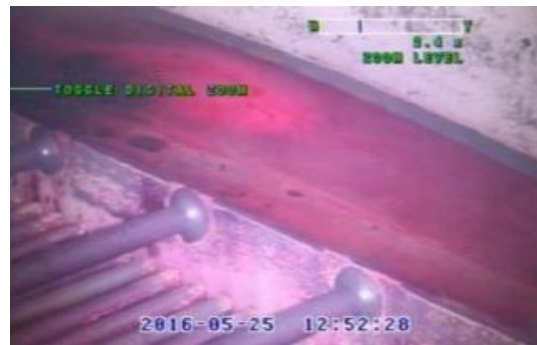
Fig. 5. Figure on the left is the dye penetrant application unit with a dye and flush lance attached to a remote camera. Figure on the right is the top of the steam tube bundle with dye penetrant on the surface before flushing.

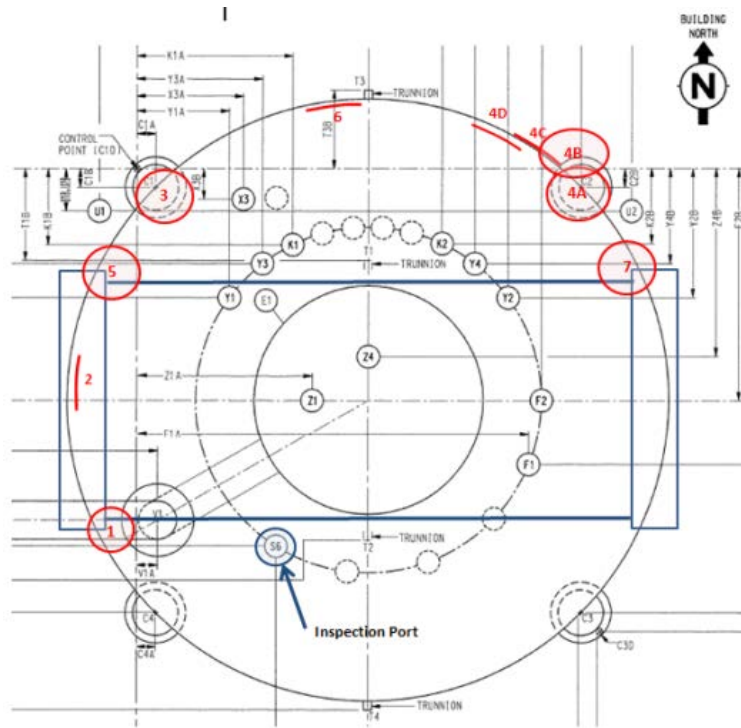
Fig. 6. Dye Penetrant Locations sprayed.

The majority of the north side of the evaporator from the middle of the evaporator down was sprayed with dye and washed. Additional enhanced visual inspections with dye penetrant were performed on the tube bundle looking where the tube sheet was welded to the vessel. There were no specific locations that indicated a leak from the enhanced visual inspection with the dye penetrant. Figure 6 shows all of the areas of interest where dye was applied and the chart gives a description of the individual locations.

1. Tube Bundle Inlet
2. Seam below the weld line where the body is welded to the cone.
3. Northwest corner, Leg connection
4. Northeast corner
 - A. Leg connection
 - B. Rough patch above leg connection
 - C. Weld line near leg connection
 - D. Seam just below the weld line where the body is welded to the cone.

5. Tube Bundle Inlet
6. Steam Lift Supports
7. Tube Bundle Outlet

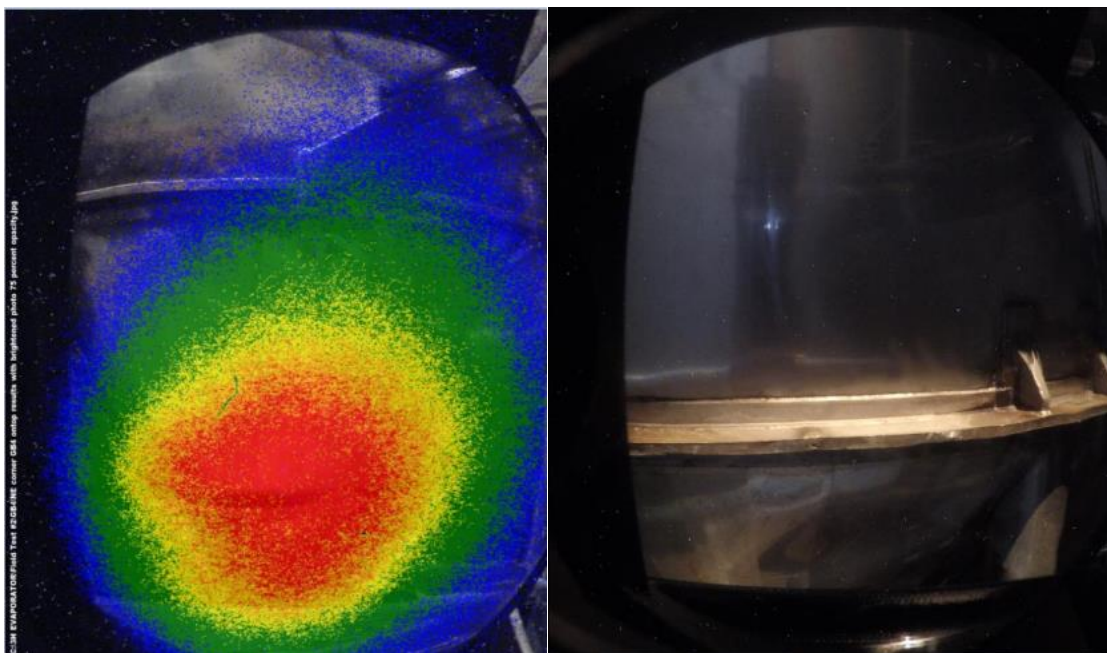
Fig. 8. Figure on the left shows the activity spot in the lower cone section of the evaporator. Figure on the right shows an adjusted image that is scaled to the hot spot on the left image, which resulted in intensity level of the image on the right to have a background value with no values reaching the colored portion of the image.

The results from the Grey QB indicated that there was a very intense concentration of radioactive material in the lower section of the evaporator pot, and background radiation levels in the upper portion (See Fig. 8.). If a leak were to occur in the upper section of the evaporator near the tube bundle, one would anticipate an area with higher radiation levels that would indicate more intensely near the stiffening band that segregates the upper vertical section from the lower coned section. However, that was not observed in the image.

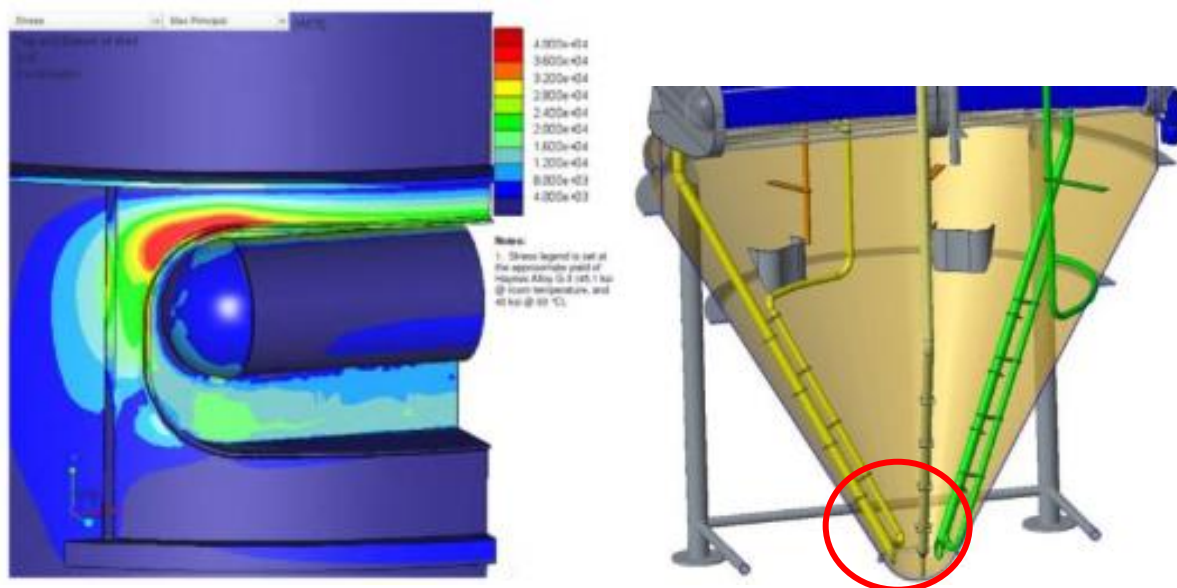
In parallel with the physical investigation, another team was tasked with analyzing the vessel to determine any potential locations where the leak could occur. A Finite Element Analysis (FEA) identified areas with large temperature gradients over small distances where the shell joins the tubesheets and the evaporator vessel. The calculated stresses exceed yield during tube-bundle descaling operations. Additionally an investigation considered the lower section of the evaporator pot. The steam lift lines and the warming coil guide plates could rub against the vessel and wear a hole in the vessel from rubbing [3]. Part II will provide more detail of the analysis.

Fig. 9. Figure on the left indicates in red the high stress point where the tight radius of the tube sheet is welded to the evaporator vessel. Figure on the left shows where the lift has the opportunity, when thermally growing, to interfere with the body of the vessel and could cause wearing and eventually a leak. Developed by AECOM.
