Failure Evaluation of Savannah River Site High-Level Waste Evaporator 242-25H – Part II – 17353

Charles Keilers *, Bruce Wiersma **, John Schwenker *, Thomas Yamamoto *

* Savannah River Remediation, LLC

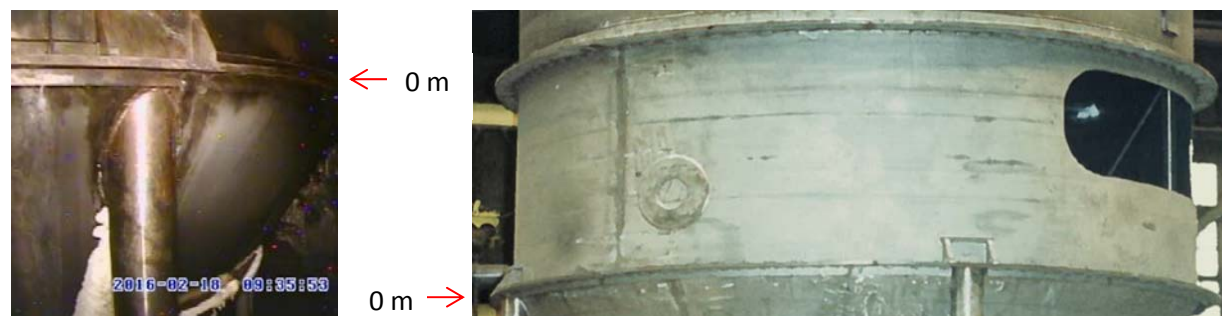
Fig.3. Figure on the left shows visible salt deposits, emanating from where the legs penetrate the vessel insulation. Salt deposits are not visible on or above the support ring (0 m level). Figure on right shows the leg support ring during fabrication before installing vessel interior components, shipping to the site, and installing insulation.

After the leak's discovery, remote inspections of the vessel exterior showed salt deposits where the leg supports penetrate the vessel's insulation and insulation sheathing (Figure 3). Salt was not observed on the upper cylindrical portion of the vessel, supporting that the leak-site is in the cone below the support ring and not at the tube bundle elevation.

For the cone failure scenario, an equivalent hole diameter of 2 mm to 4 mm would be consistent with the maximum leak-rate (which occurred on February 28, 2016) and assuming the leak is located in the cone, fills the insulation annulus, and exits out the leg penetrations.

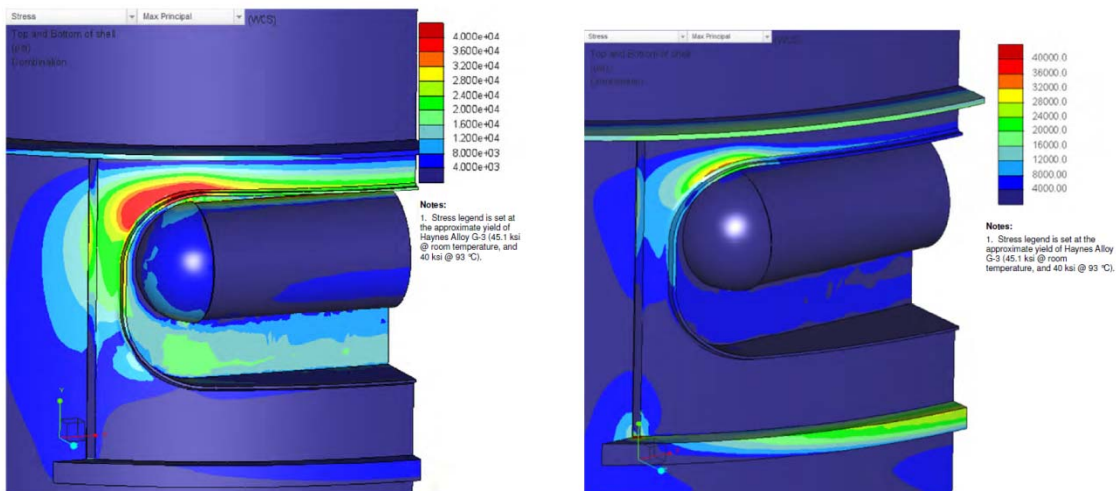
- The highest calculated stresses are at the interfaces of the shell, the tube-sheets, and the sleeves for both the steam and the condensate chests (Figures 4 and 5). In these locations, calculated stresses during descaling operations exceeded yield, driven by a 135°C temperature gradient between the steam and the shell over a short distance. The temperature gradient is lower (40°C) during normal operations, leading to calculated stresses of about half of yield.

- For these stresses, calculated fatigue life ranged from about 300 to 4,000 cycles for welds and 900 to 14,000 cycles for base metal. For comparison, the 25H Evaporator has experienced about 500 to 700 thermal cycles, assuming about 20 descaling operations and 10 to 20 normal thermal transients per year.

Fig 4. Maximum principal stresses for descaling and normal operations [3].

Given these results, thermally induced fatigue of the shell where it joins the tube-sheets is possibly but not conclusively the cause for the leak. Fatigue could be enhanced by environmental factors (e.g., mercury), an initial defect, or both. However, a fatigue failure at this location is contradicted by the lack of visible waste externally above the cone.

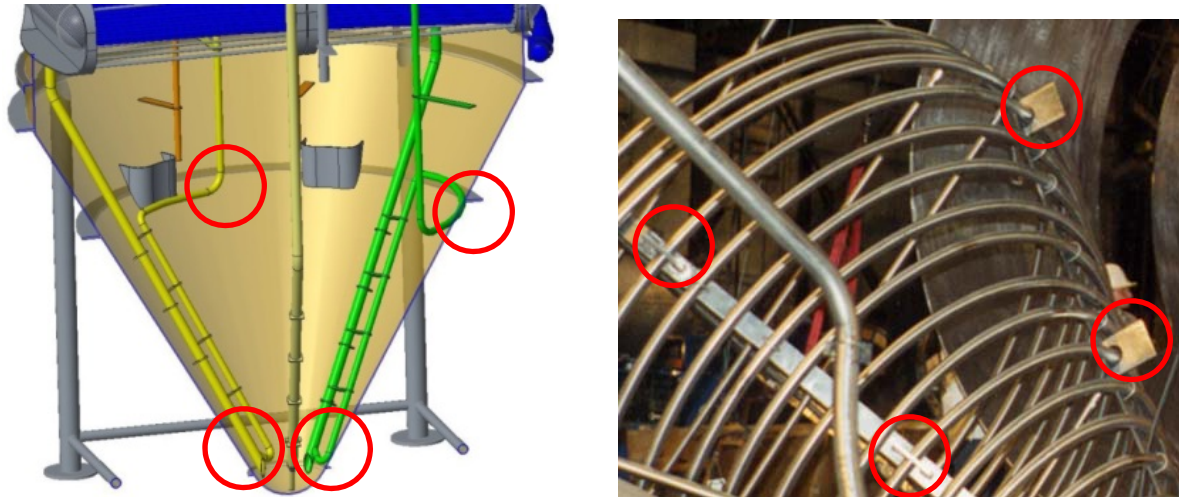
Fig. 6. Potential rubbing locations in the vessel cone: (1) possible steam line interferences; (2) warming coil support plates.

For the 25H Evaporator, two possible sources of metal-to-metal contact and relative motion in the cone are shown in Figure 6:

- There are two steam lines that run to the bottom of the vessel. These create a vacuum in the lift lines, causing the motive force to remove concentrated waste from the vessel. Drawing dimensions indicate the potential for these steam lines to interfere with the vessel at four locations. The steam lines would fit in the vessel, provided there is a small twist of the steam lines by a fraction of a degree. The resulting torsion could cause a high contact force between the steam lines and the vessel. Daily repetitive motions, perhaps caused by daily temperature swings or random building vibrations could cause relative motion.

- The warming coil frame has eight guide plates that may touch the vessel with a low contact force. The guides prevent excessive lateral motion in the event of an earthquake. The guide plates were not needed in earlier SRS evaporators because they used smaller warming coils. The warming coil has low natural frequencies and is susceptible to amplified motion, possibly caused by random vibrations or cross flows.

The parametric study found, for the warming coil guides, the required contact force to fail the vessel would be low, ranging from about 1 N at 10 Hz under abrasion to 4 N at 200 Hz under adhesion with good lubrication. It is possible that cross flow or other disturbances could cause the warming coil to vibrate in this frequency range. For the steam lines, assuming a high contact force and low contact area indicated that a repetitive motion every twenty minutes to thirty hours would be sufficient to wear through the vessel.

Overall, a wear failure in the cone seems possible and intuitively more likely than erosion; however, the sources of motion are speculative, making wear failure not conclusively the cause.
