Failure Evaluation of Savannah River Site High-Level Waste Evaporator 242-25H – Part II – 17353

Charles Keilers *, Bruce Wiersma **, John Schwenker *, Thomas Yamamoto *

* Savannah River Remediation, LLC

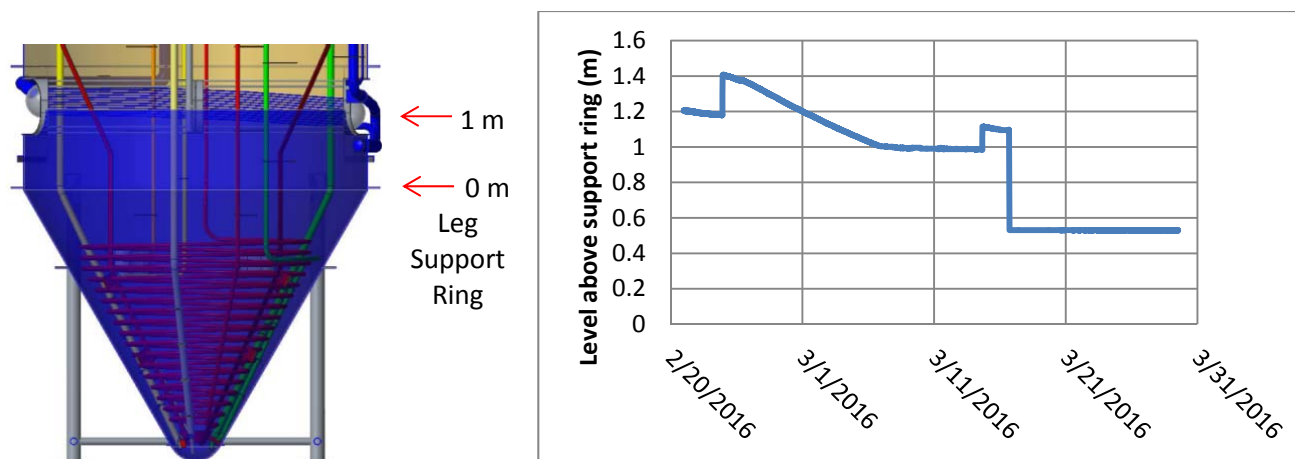
Fig.2. Leak rate data (evaporator figure is from [3]). Level dimensions are relative to the support ring where the legs are attached and where the shell transitions from a cone below to a cylinder above (i.e., 0 m).

In early March 2016, to help find the leak-site, the leak was permitted to flow unimpeded until level stabilized, which occurred at about mid-elevation of the tube-bundle, 1.0 m above the support ring for the leg attachments (Figure 2). Level was raised and allowed again to fall unimpeded, this time falling more slowly and stabilizing at 1.1 m above the support ring, still within the height of the tube-bundle. Level was then lowered below the tube-sheets but above the support ring; it remained steady for the next two weeks, supporting a scenario that the leak-site was within the tube-bundle elevation.

The leak-rate data during this period was analyzed and is consistent with a crack about 25 mm long by 0.5 mm wide at the tube bundle elevation.¹ An attempt to re-activate the leak in early May 2016 was unsuccessful, indicating that the leak has somehow sealed.

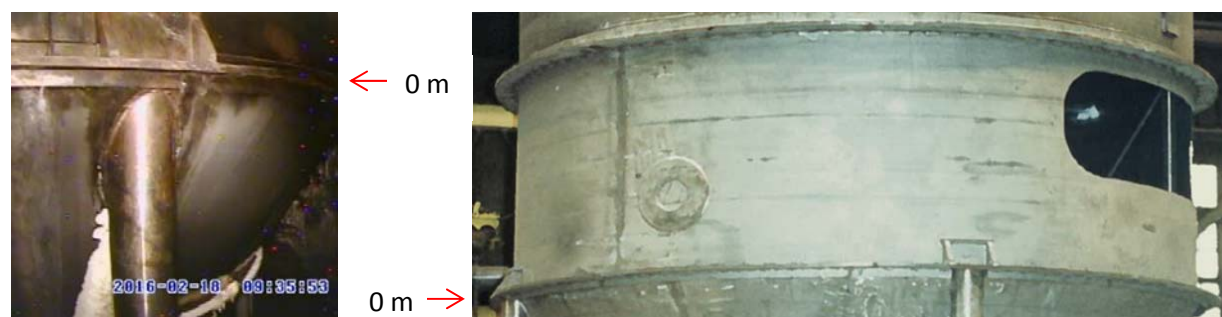
Fig.3. Figure on the left shows visible salt deposits, emanating from where the legs penetrate the vessel insulation. Salt deposits are not visible on or above the support ring (0 m level). Figure on right shows the leg support ring during fabrication before installing vessel interior components, shipping to the site, and installing insulation.

After the leak's discovery, remote inspections of the vessel exterior showed salt deposits where the leg supports penetrate the vessel's insulation and insulation sheathing (Figure 3). Salt was not observed on the upper cylindrical portion of the vessel, supporting that the leak-site is in the cone below the support ring and not at the tube bundle elevation.

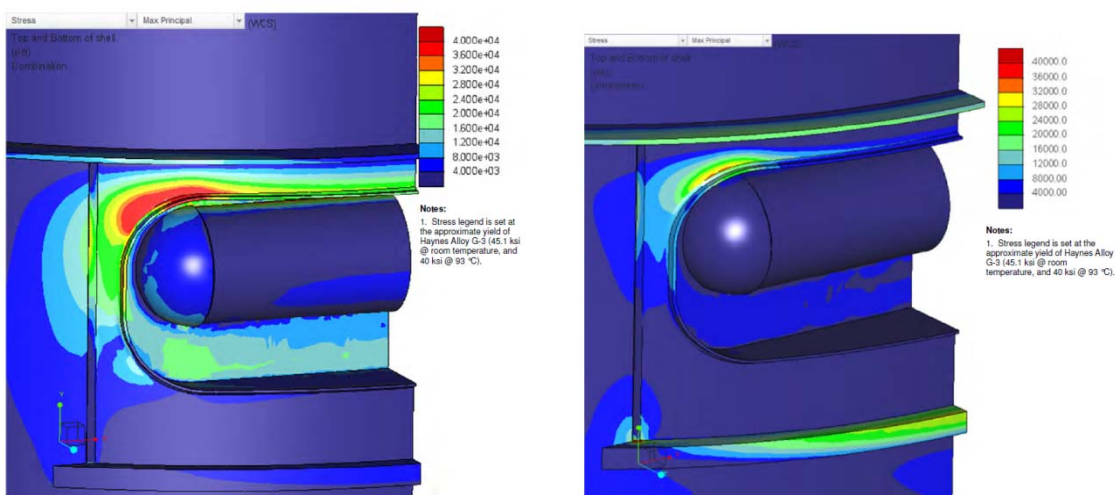
- The highest calculated stresses are at the interfaces of the shell, the tube-sheets, and the sleeves for both the steam and the condensate chests (Figures 4 and 5). In these locations, calculated stresses during descaling operations exceeded yield, driven by a 135°C temperature gradient between the steam and the shell over a short distance. The temperature gradient is lower (40°C) during normal operations, leading to calculated stresses of about half of yield.

- For these stresses, calculated fatigue life ranged from about 300 to 4,000 cycles for welds and 900 to 14,000 cycles for base metal. For comparison, the 25H Evaporator has experienced about 500 to 700 thermal cycles, assuming about 20 descaling operations and 10 to 20 normal thermal transients per year.

Fig 4. Maximum principal stresses for descaling and normal operations [3].

Given these results, thermally induced fatigue of the shell where it joins the tube-sheets is possibly but not conclusively the cause for the leak. Fatigue could be enhanced by environmental factors (e.g., mercury), an initial defect, or both. However, a fatigue failure at this location is contradicted by the lack of visible waste externally above the cone.

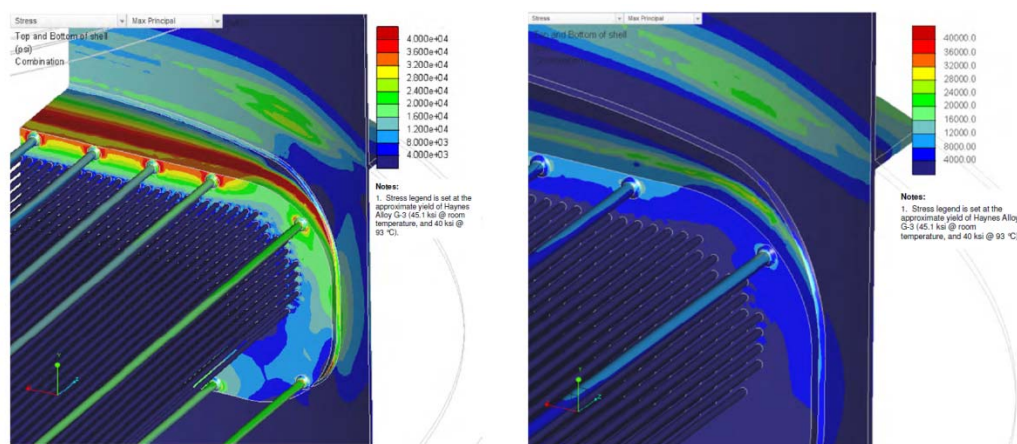
Fig 5. Maximum principal stresses for descaling and normal operations [3].

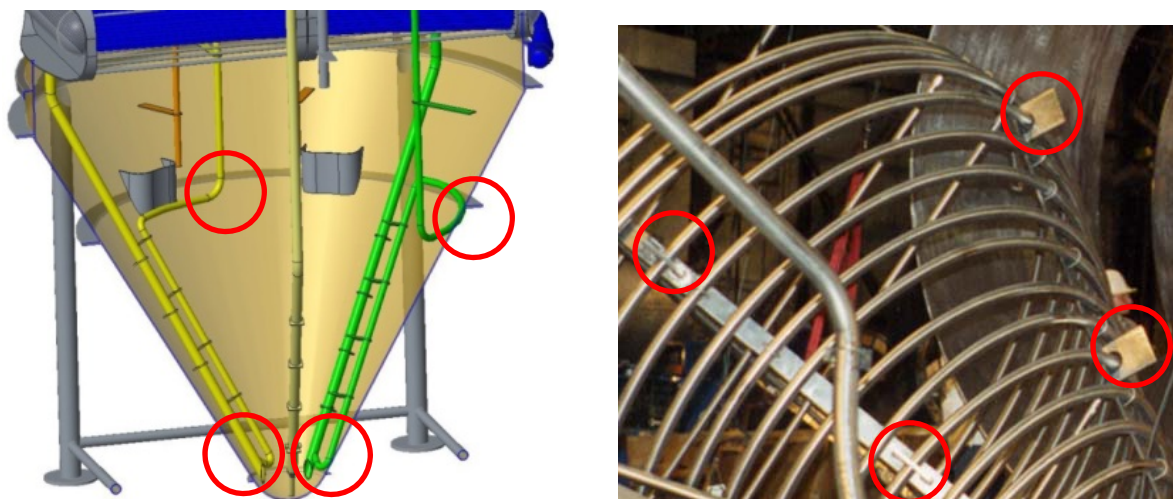
Fig. 6. Potential rubbing locations in the vessel cone: (1) possible steam line interferences; (2) warming coil support plates.

For the 25H Evaporator, two possible sources of metal-to-metal contact and relative motion in the cone are shown in Figure 6:

- There are two steam lines that run to the bottom of the vessel. These create a vacuum in the lift lines, causing the motive force to remove concentrated waste from the vessel. Drawing dimensions indicate the potential for these steam lines to interfere with the vessel at four locations. The steam lines would fit in the vessel, provided there is a small twist of the steam lines by a fraction of a degree. The resulting torsion could cause a high contact force between the steam lines and the vessel. Daily repetitive motions, perhaps caused by daily temperature swings or random building vibrations could cause relative motion.

- The warming coil frame has eight guide plates that may touch the vessel with a low contact force. The guides prevent excessive lateral motion in the event of an earthquake. The guide plates were not needed in earlier SRS evaporators because they used smaller warming coils. The warming coil has low natural frequencies and is susceptible to amplified motion, possibly caused by random vibrations or cross flows.

The parametric study found, for the warming coil guides, the required contact force to fail the vessel would be low, ranging from about 1 N at 10 Hz under abrasion to 4 N at 200 Hz under adhesion with good lubrication. It is possible that cross flow or other disturbances could cause the warming coil to vibrate in this frequency range. For the steam lines, assuming a high contact force and low contact area indicated that a repetitive motion every twenty minutes to thirty hours would be sufficient to wear through the vessel.

Overall, a wear failure in the cone seems possible and intuitively more likely than erosion; however, the sources of motion are speculative, making wear failure not conclusively the cause.
