Achieving Leak Tightness in New Savannah River Site Saltstone Disposal Units – 17454

Charles Keilers, Savannah River Remediation, LLC

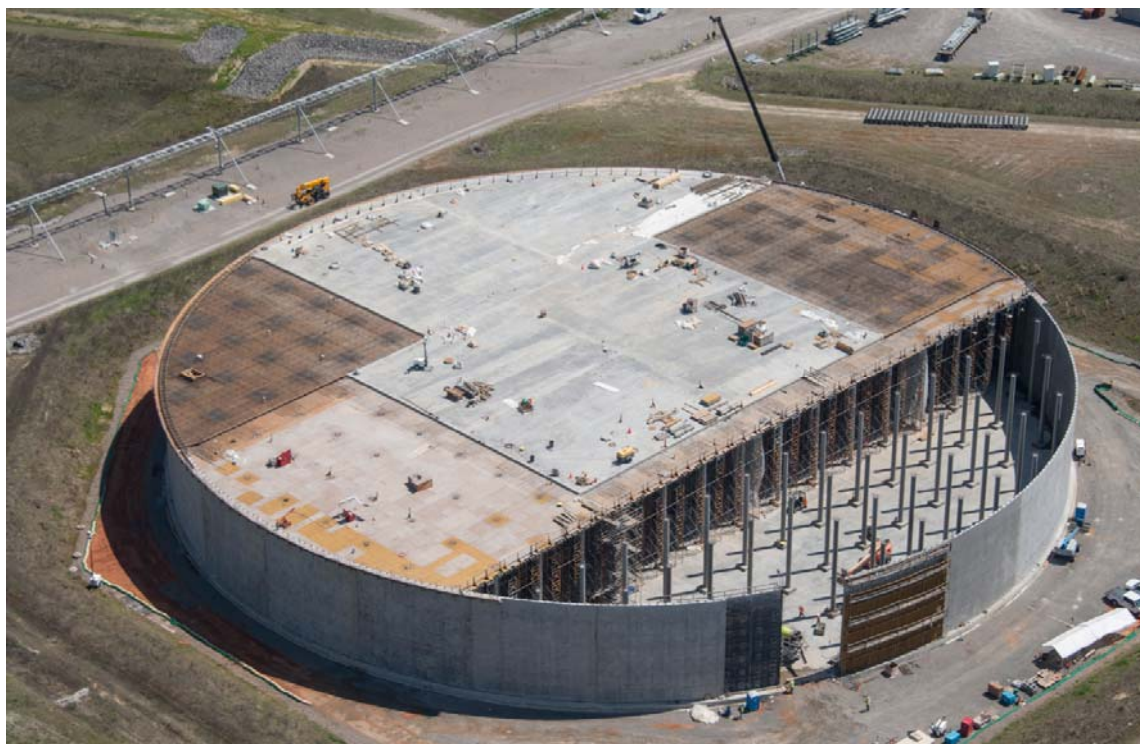
Fig. 2. SDU-6 during construction.

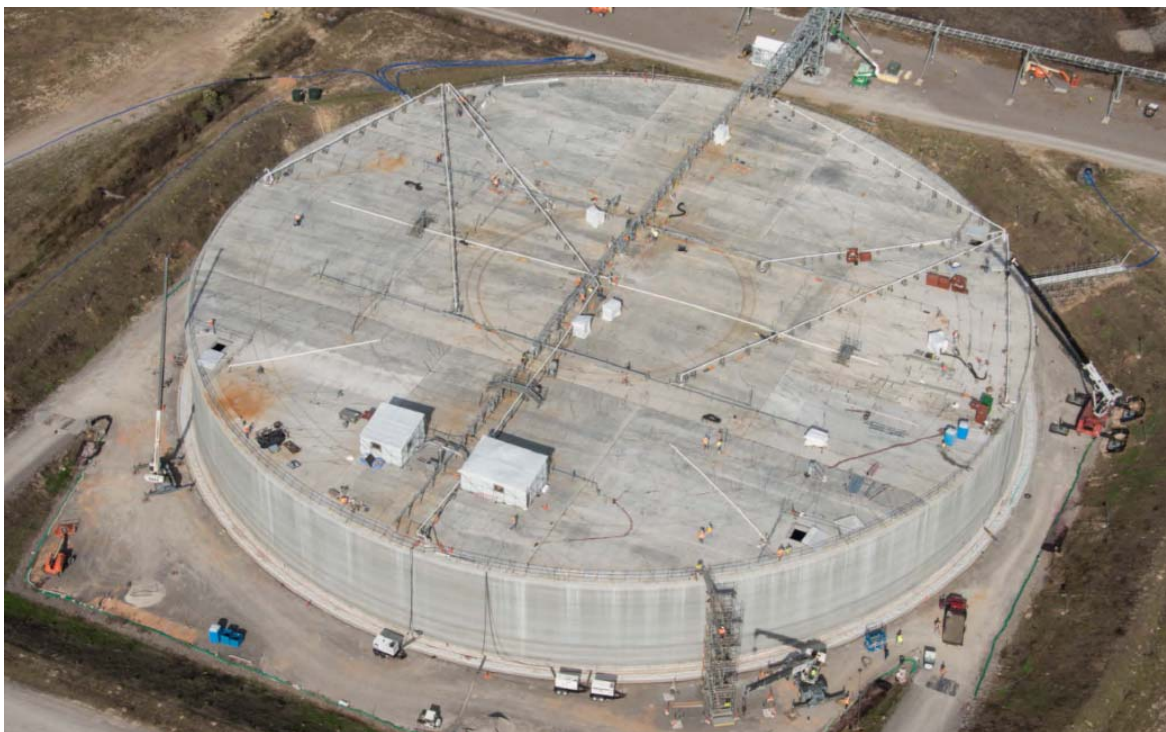
Fig. 3. SDU-6 near completion.

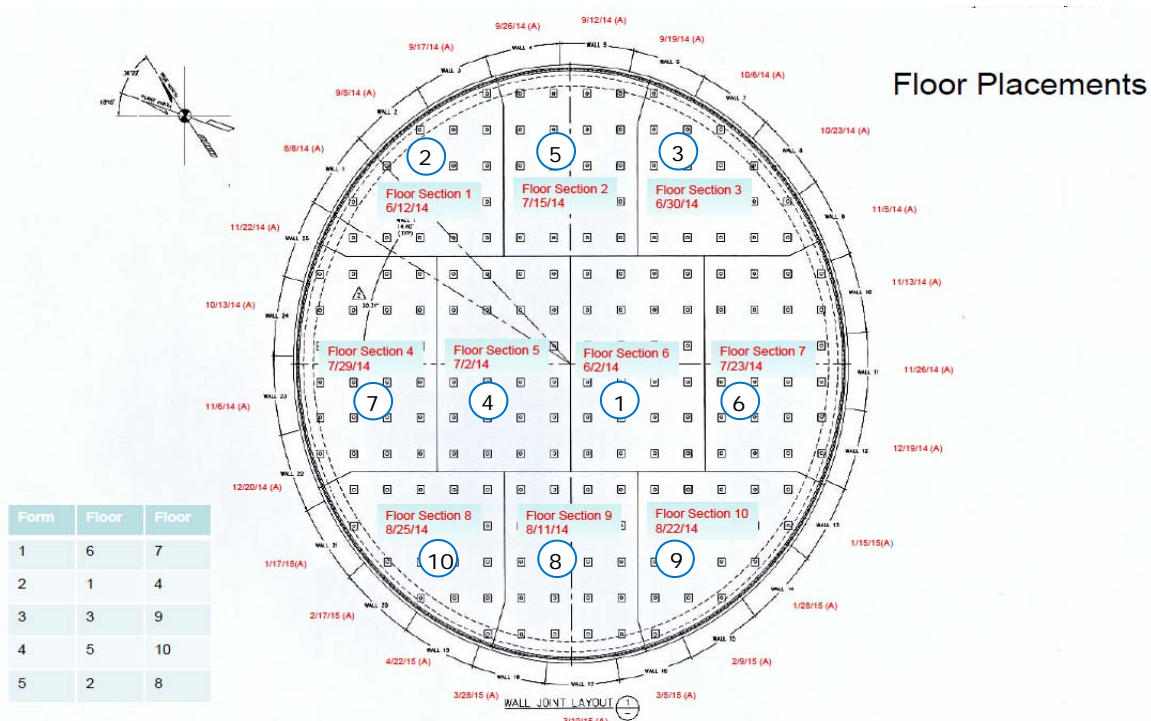
- Construction joints should be avoided or, at least, minimized for a water-tight structure. Because of its large size, SDU-6's base slab was placed in ten sections, as shown in Figure 5, with water-stops across the construction joints. The "checkerboard" installation sequence created conditions conducive to shrinkage cracking due to restrained edges at construction joints. The thicker wall footing may also have restrained concrete shrinkage, causing cracking near the wall.

Fig 4. SDU-6 floor sections, showing the “checkerboard” placement order that likely restrained shrinkage and enabled concrete shrinkage cracking.

The SDU-6 experiences identified improvements that can be made in design and construction of these large environmental engineering containment structures. The most likely cause of the base slab cracking is restrained drying shrinkage due to the checkerboard placement shown in Figure 4, possibly exacerbated by the concrete mix design. Even so, standard concrete design practices will lead to distributed tight cracks that still may not achieve the zero leakage criteria specified for SDU-6. SDU-6 needs an elastomer coating or liner for chemical protection of the concrete. The project baseline was to install a coating system to chemically protect the concrete from the high-pH, high-sulfate Saltstone solutions. The coating was not installed during the hydrostatic test. An adhered elastomeric liner system was later determined to provide higher assurance of bridging floor cracks and preventing leakage. A liner has been selected and is being installed in a manner that meets the zero leakage criteria.

The base slab was cast in 10 placements with water-stops between each section at the construction joints, as shown in Figure 4. The base slab is 0.305 m (12 inches) thick and has steel reinforcement bars running in each direction near the top and bottom surfaces for crack control (i.e., #5 @ 6 inches, top, and #6 @ 12 inches bottom, each way; minimum reinforcement ratio of 0.6 percent). At the outer wall, the foundation slab thickness increases to 0.610 m (24 inches), primarily to provide space for the wall reinforcement system. For external surfaces, concrete crack control followed ACI 350 for normal environmental exposure [3]. Internally, reinforcing at the top surface of the base slab is designed for severe environmental exposure (e.g., sulfate solutions exceeding 10,000 ppm).

- Increase batch plant capacity, allowing placement of larger floor segments.
- Develop a concrete placement strategy and plan that addresses key attributes, including minimizing construction joints and restrained edges.
- Consider thermal protection to achieve gradual cooling during curing and minimize the potential for cracking.
- Better control moisture and curing practices to avoid rapid surface drying.
- Reevaluate the reinforcement detailing, considering anticipated construction loads, thermal and temperature loads, and construction sequence.
- Determine by test the actual shrinkage characteristics and the time-temperature and strength-gain characteristics of the mix design and reevaluate the mix design.

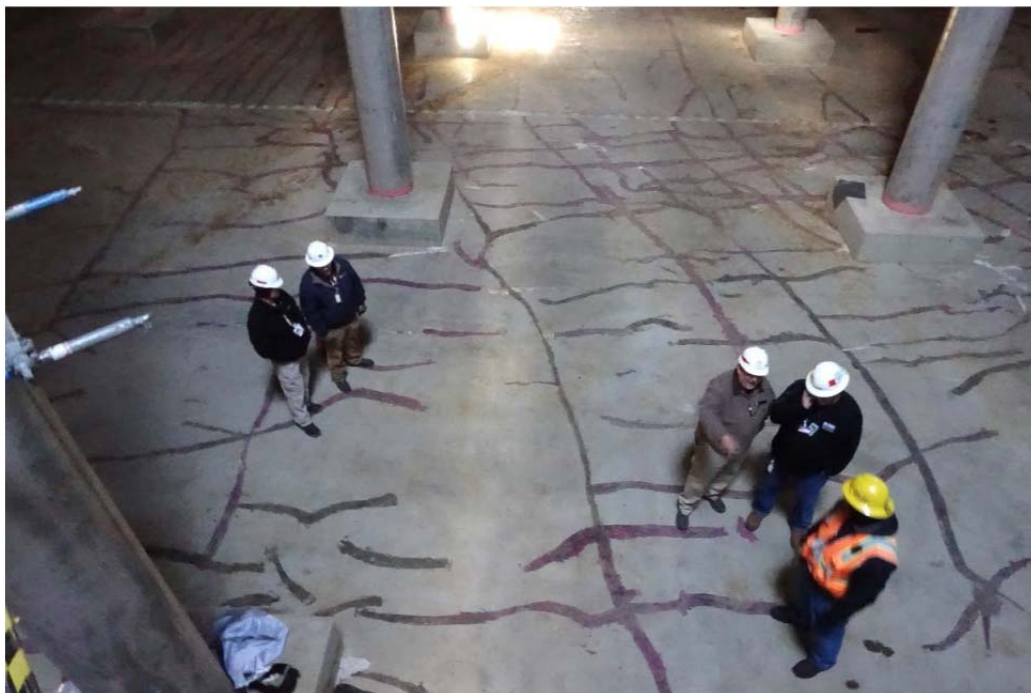
- The SDU-6 base slab has extensive tight visible cracks with widths of 0.07 to 0.5 mm (3 to 20 mils). Visible surface cracks were repaired with a flowable, gravity-fed epoxy, as shown in Figure 4. Early on, several cracks were ground down, and the cracking disappeared within 6 to 10 mm depth. However, concrete core samples taken in January 2016 in areas susceptible to shrinkage found cracks extending through the slab thickness [7].

Fig. 5. Slab cracking, highlighted in purple from epoxy that was gravity-fed into cracks as a repair (photograph from [7]).

In January of 2016, five cores were taken from the SDU-6 floor slab. Four cores were taken at locations with visible shrinkage cracking, while one core was taken in an area free of visible cracks. The core samples revealed cracks extending below the upper rebar layer, which was new information. The cracking went through the cementitious paste and, in some instances, through the aggregate without vertical displacement. This would be consistent with cracking due to shrinkage and not a thermal or structural over-load condition. A petrographic analysis concluded that the concrete appears to be high quality, it contains the desired constituents, and it was mixed at correct proportions per the project's specifications [7].

For SDU-6, the observed crack widths were 0.07 - 0.5 mm (3 - 20 mils). ACI 350 design practices are intended to ensure that any cracking that occurs within an environmental structure is appropriately distributed and has limited width. The SDU 6 crack sizes are within the regime deemed reasonable by ACI reports that formed the basis for ACI 350 and other ACI structural codes (e.g., [9], Table 4.1). For example, ACI 349.3 [10] defines the crack acceptance criteria in an existing structure as less than 1 mm (40 mils). Settlement survey data also indicates the expected structural response during construction and the subsequent liquid tightness test.

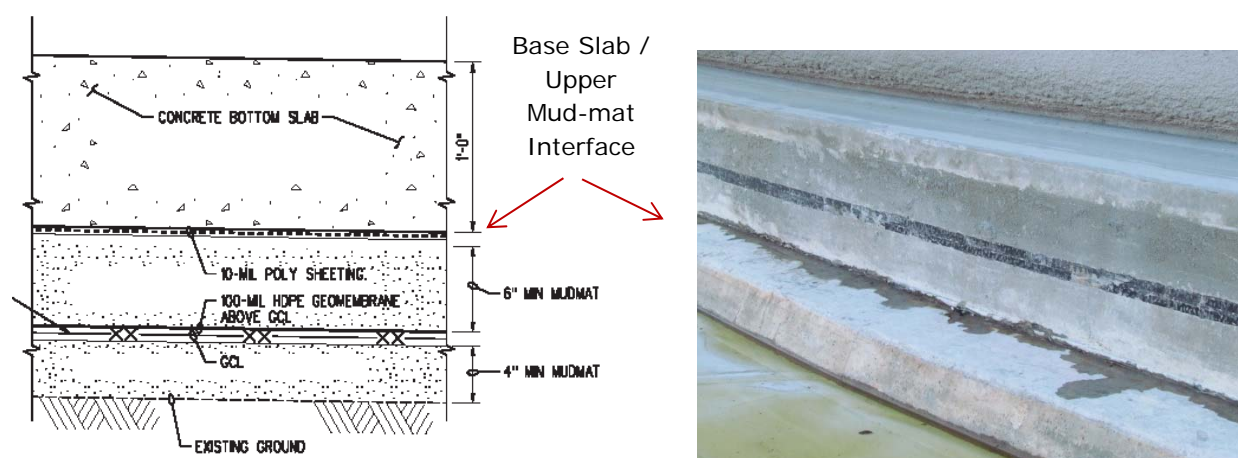
- SDU-6 is required to pass a hydrostatic test with a dye tracer and with zero apparent leakage. When tested in late 2015, without a liner or coating, flow and dye were observed between the upper and lower basemats and the slabs. Estimated leak rate is less than 4 L/min (1 gpm) (Figure 6). There was no measurable change in water level over the three days of the test.

Fig. 6. Representative leakage between the SDU-6 base slab and upper mud mat. There was no dampness on the walls and no measurable drop in level over 72 hours, but there was visible dye and flow at the basemat. Estimated leak rate is less than 4 liters per minute with tank at capacity (114 ML).

Figure 6 shows the base slab and the upper and lower mud mats, which are separated by a polyethylene sheet and geomembrane, respectively.

In late 2015, SDU-6 was hydrostatically tested without a coating or liner. Measured drop in level over 72 hours was less than the 1.6 mm (1/16 inch) detection threshold and the 3.2 mm acceptance criteria in [4]. The walls were dry. However, flow and dye were observed at the base slab and mud mats (Figure 6). SDU 6 was suspected to be leaking through either cracks in the base slab or via pathways around the construction joint water-stops. Visible floor cracks had been repaired with flowable epoxy before testing. After leak testing, additional cracks were identified in the base slab; however, these appear most likely due to pre-existing but undiscovered cracks

Since there was no measurable change in level, the leak rate was estimated as a maximum of 4 L/min (1 gpm). An adhered elastomer liner is being installed to chemically protect the concrete and achieve leak tightness.
