PVP2007-26362

EVALUATION OF THE FAILURE OF A RADIOACTIVE WASTE TRANSFER LINE JACKET

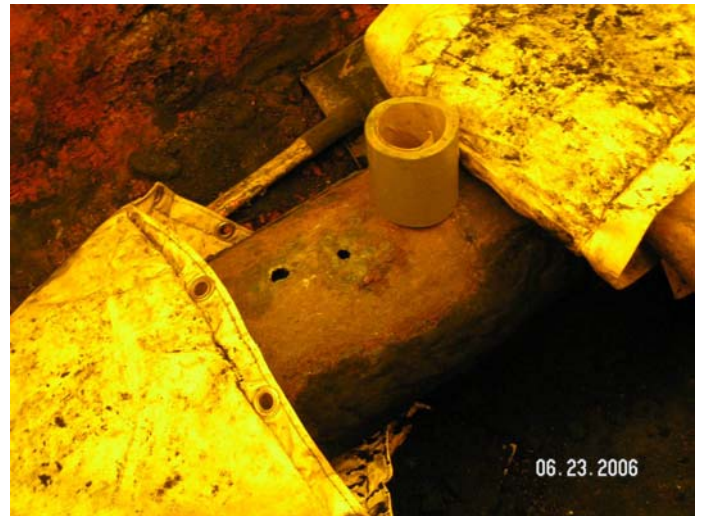
thermal insulation. Two other leak sites were found directly on the jacket. Figure 2 shows two approximately 1 inch diameter holes on the top side of the pipe near the 12 o'clock position. The corrosion appeared to be primarily between the 10 o'clock and 2 o'clock positions on the pipe. The remainder of the pipe appeared to be in good condition, with little or no corrosion. The fourth leak site occurred near a weld joining a 10" to 8" reducer pipe to the 8" jacket. The flaw appeared to be linear probably due to improper welding and inspection during the original installation rather than corrosion. In fact, a linear defect is not likely to have developed from corrosion at this particular location.

Figure 2. Leak site on transfer line jacket.

The failure of the vent pipe likely occurred due to galvanic corrosion. As was noted previously, the jacket pipe was buried in the thermal insulation, while the vent appeared to be in the clay soil. Dissimilarity in the electrical resistance between the thermal insulation and the soil backfill can create a corrosion macro-cell that can accelerate corrosion in the less resistant soil. In this case, the soil has a lower electrical resistance than the insulation and the vent pipe corroded preferentially. Defects in the coating on the vent pipe would also contribute to the problem.

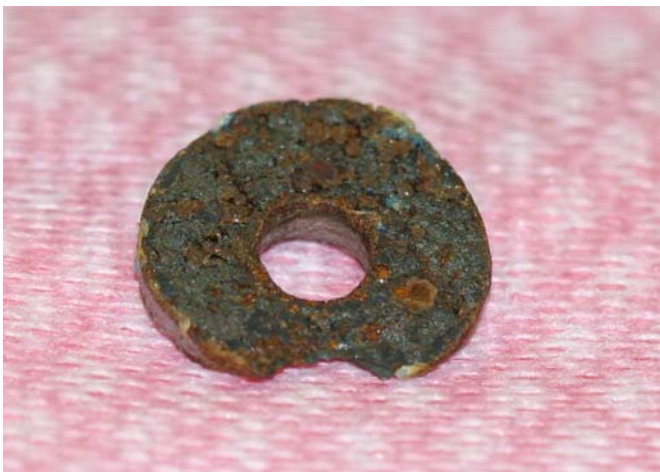
A sample of the jacket was core drilled from near one of the leak sites shown in Figure 2. A visual examination of the sample was performed. The disk sample was approximately 0.75 inches in diameter and had been cut such that a through-wall pit was on the outer edge. Figure 3 shows the area near the pit exhibited gradual thinning to the edge, which gave the surface a convex or "dished" shaped appearance. In addition to this pit, there was also evidence of broad, shallow pitting on the exterior surface of the pipe. Some pits had coalesced to yield a rough surface appearance. The depth of these partial through-wall pits was not measured. Neither the coating nor thermal insulation adhered to the sample.

Figure 3. Exterior of cored sample of pipe.

Properly applied coal tar and coal tar epoxy coatings provide excellent corrosion protection. However, small defects (i.e., holidays) occasionally remain in the coating after application is complete. Defects in coatings may also occur during backfilling as rocks and equipment may scrape the pipe surface. These defects provide an ideal site for corrosion to occur should water penetrate to the surface. The thermal insulation is hydrophobic and if it has been properly placed will effectively prevent water intrusion. However, this particular thermal insulation has been known to sinter and crack if it is exposed to temperatures greater than 325 °F. The cracks allow water to penetrate through the insulation to the steel surface. The thermal insulation also contains organic compounds that break-down at the higher temperatures. The result is that the acidity of the liquid that eventually becomes trapped between the insulation and the pipe may be as low as pH 2. Accelerated corrosion in this acidic environment will likely occur at any coating defect.

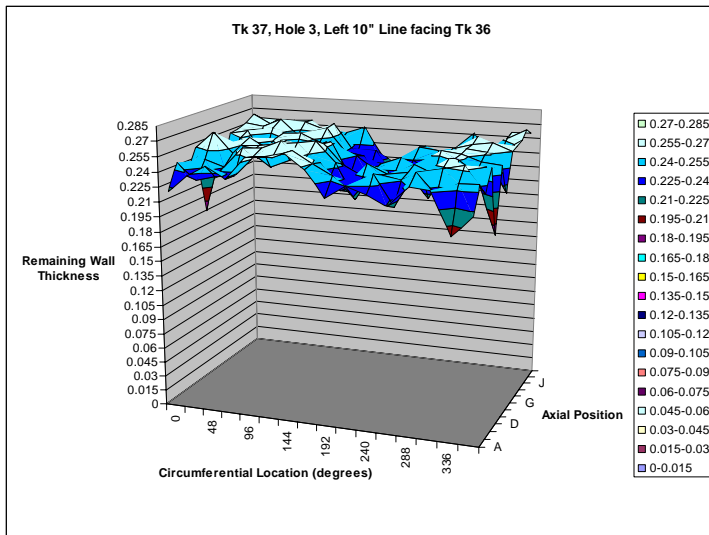
Data analysis is facilitated if the UT data is presented in the form of a wall thickness map showing the location and depth of the pits (see Figure 4). It is desirable to minimize the distance between UT wall thickness measurements in order to characterize the morphology of the pit as well as possible. An example is presented to illustrate the determination of a pit depth and the average depth of penetration due to general corrosion. To determine the maximum pit depth in a given area, the minimum wall thickness is located. Figure 5 shows a 3 X 3 square inch grid with the minimum wall thickness located in the center. The average of the eight other wall thicknesses measurements is determined next. The pit depth is then calculated by subtracting the minimum wall thickness from this average wall thickness. The ASTM guidelines for pit evaluation recommend that a minimum of 10 pits be utilized to describe the metal penetration due to pitting [1].

Figure 4: Wall Thickness Map Showing the Location and Depth of Pits

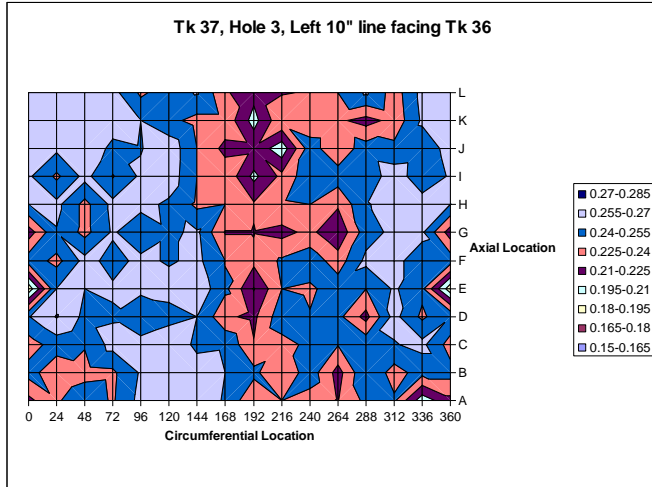
The location of the deepest penetration in relation to the circumference of the pipe is summarized in Table 1. Figure 6 also shows a wall thickness contour plot that illustrates where corrosion is occurring on the pipe. The areas within $\pm 40^\circ$ of top dead center (TDC) and bottom dead center (BDC) underwent the most significant corrosion (i.e., deepest penetration). In the situations where the deepest pits were not located near TDC or BDC, no UT data was collected due to heavy scale and deposits at BDC. Both TDC and BDC are located at horizontal tangents to the pipe, which is the most likely place for water to accumulate beneath the thermal insulation. Thus, it is not surprising that the most aggressive corrosion occurs in these regions.

The general corrosion and pitting data shown in Table 1 also indicates that all three locations experienced a similar degree of corrosion. For example, each location had a maximum pit depth greater than 60 mils. The amount of general corrosion appeared to be slightly higher on the pipe that was coming

from an adjacent waste tank. However, this could be an indication of a high pit density, where many smaller pits have coalesced together to give a roughly uniform corrosion appearance. The total penetration due to general corrosion and pitting ranged between 52 to 65 mils for the three locations. The consistency between these values is probably the best indicator that the degree of corrosion was similar.

Figure 6: Contour Map Showing Areas of Most Prevalent Corrosion

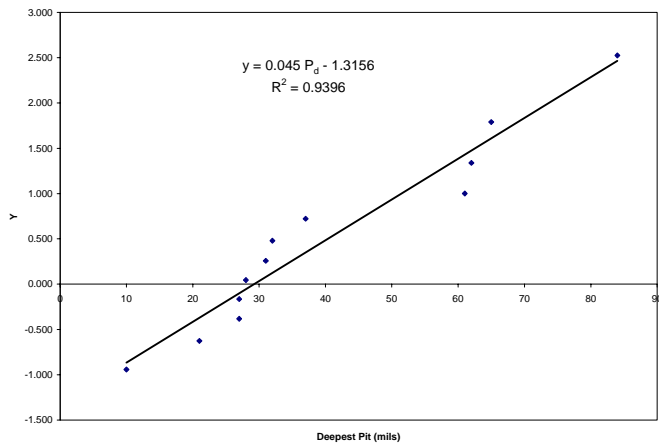
The deepest pit on a pipe segment (P_d), the cumulative frequency and the transformed cumulative frequency are shown in Table 2. The plot of the deepest pit vs. the transformed cumulative frequency is shown in Figure 7. The slope of the line is 0.045 and the intercept is -1.3156. Substitution of these

values and the return period calculated previously into Equation 5 give and expected maximum pit depth of 168.3 mils.

The maximum total penetration is the sum of the average wall thinning and the expected maximum pit depth. Table 3 indicates that the average wall thinning was 19.6 mils less than nominal. Therefore, the total penetration is approximately 187.9 mils. Thus based on these UT measurements it is estimated that corrosion has penetrated approximately 75% through-wall.

Figure 7: Plot of Deepest Pit vs. Variate 'y'
