The Use of Digital Radiography in the Evaluation of Radioactive Materials Packaging Performance Testing

Cecil G. May
Savannah River National Laboratory
Aiken, SC 29808

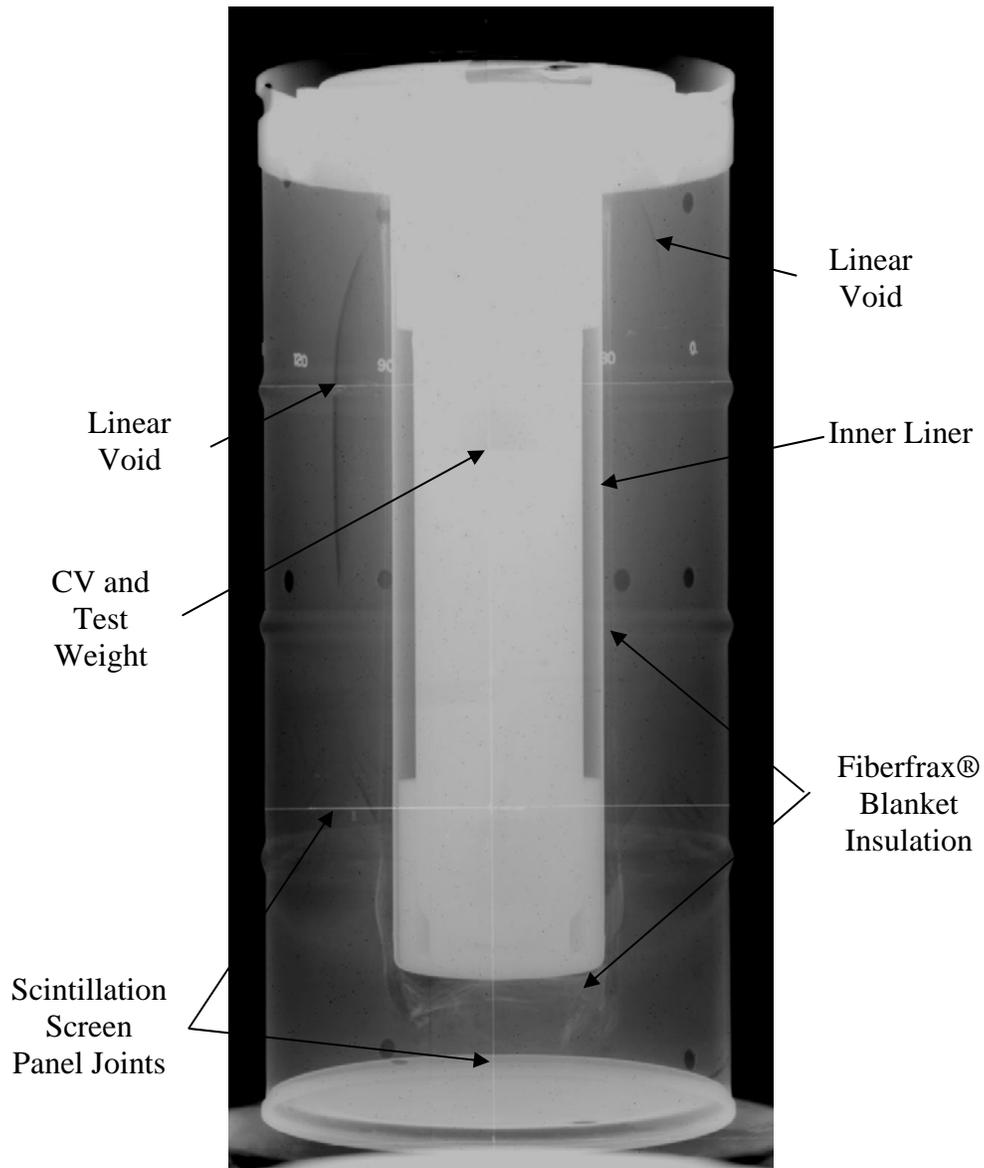
Figure 6. Typical baseline radiograph showing internal components and imperfections

Figure 6 shows a typical baseline radiograph and the internal parts of the package. The baseline radiographs shows the internal condition of the packaging before testing begins. Two linear voids are present in the polyurethane foam that fills the internal cavity. The Fiberfrax[®] insulation blanket around the inner liner and at the bottom of the inner liner shows as a light line. At the bottom of the inner liner, the blanket appears to have separated from the liner. The top and bottom load distribution fixtures are located at the top and bottom of the containment vessel. The test weight is shown inside the CV.

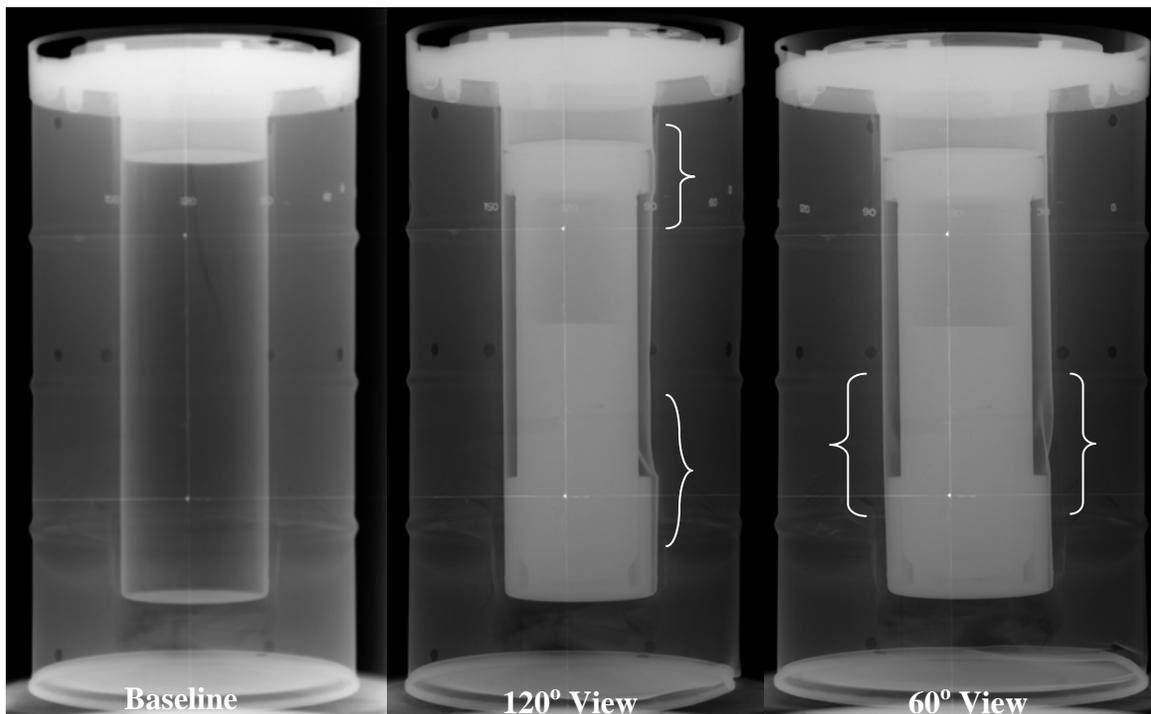
Figure 7. Comparison of baseline radiograph to 120° and 60° views after 30-ft drop

In the 30-ft drop test, the package was dropped onto an unyielding steel plate set in concrete from a height of 30-ft. The package was dropped in the horizontal position and struck the plate horizontally at approximately the 330 degree area on the drum circumference. Figure 7 compares the baseline radiograph to radiographs taken after the

drop. The areas at the bottom load distribution fixture of the inner liner show a buckling of the inner liner that holds the CV. The liner section at the top load distribution fixture is distorted from by the impact of the fixture against the liner during the drop. Based on a point of impact at approximately 330 degrees, the 120 degree view should show the most severe damage to the liner. Figure 8 gives a clearer view of the distortion of the inner liner at the top load distribution fixture.

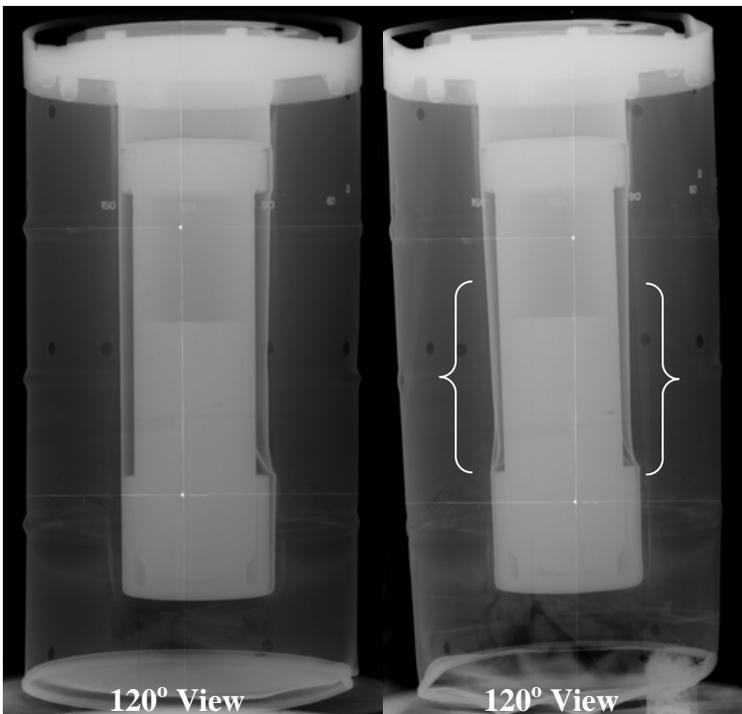
Figure 9. Left: Pre-crush radiograph 120° view. Right: Post-crush 120° view

As seen in Figure 9, the inner liner is distorted even more by the crush test. The indications under the bottom of the inner liner in pre-crush radiograph are much more pronounced after the crush test. This indicates damage to the polyurethane foam in this area. Damage to the bottom of the outer drum is obvious.

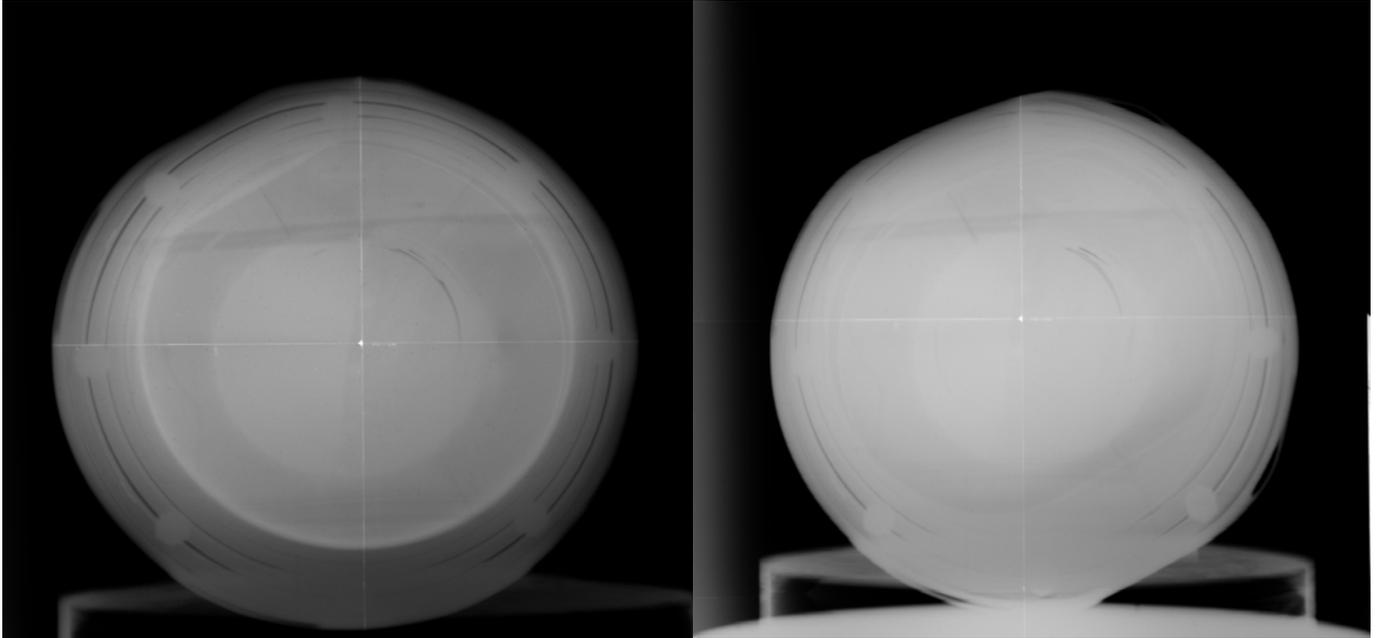
Figure 10. Left: End-to-end view after 30-ft drop. Right: End-to-end view after crush test. Both views indicate radial cracks in the foam.

Figure 15 is an example of the heat and flames of the thermal test attacking a defect in the foam that resulted localized charring of the foam. The areas where the foam is charred to the Fiberfrax® insulation were where defects in the foam existed. The radiographs in Figure 10 have indications of radial cracks at the 150° and 330° locations.

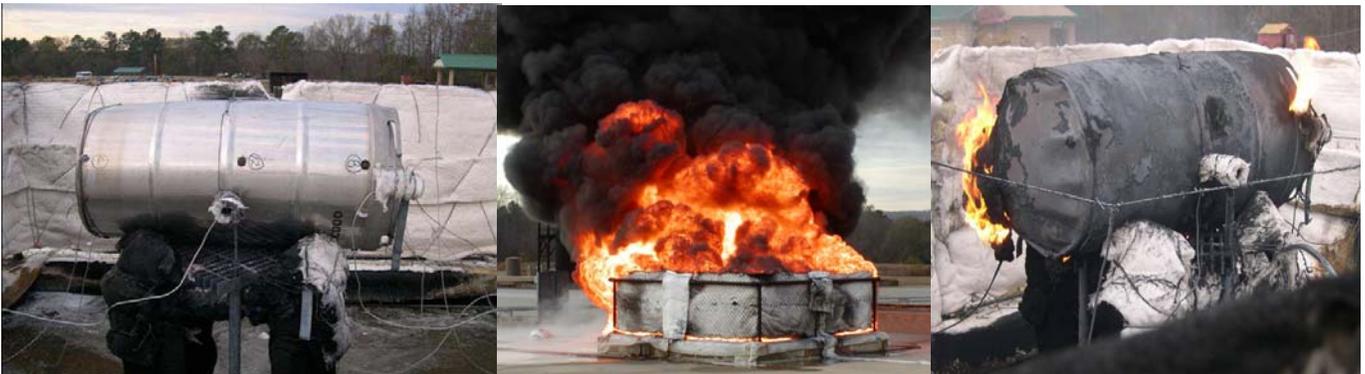
Figure 11. SN-3 before, during, and after the thermal test

temperature of 1475° F (800°). The package was fully engulfed by the flame. Photos in Figure 11 show the package before, during the engulfing flame, and afterwards. The heat from the flames degraded the foam as can be seen in the radiographs in Figure 12. The radiographs indicate greatly deteriorated foam near the outer drum. In the end-to-end view, the foam is separated into two lobes. The areas where the foam is completely deteriorated to the Fiberfrax[®] insulation align with the radial cracks seen after the drop

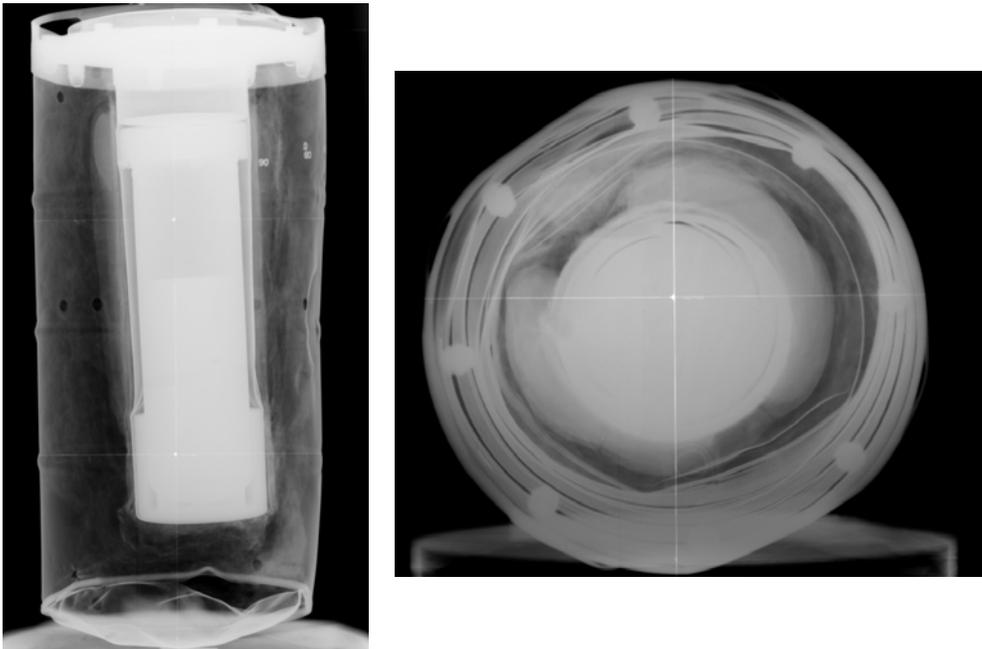
Figure 12. SN-3, Radiographs after thermal tests.

and crush tests (Figure 10). The two lobes still attached to the inner liner appear to be undamaged. The areas where the foam degraded vary in density indicating varying

degrees of deterioration. The whole package radiograph shows an opening at the drum bottom that allowed the flames to come in direct contact with foam.

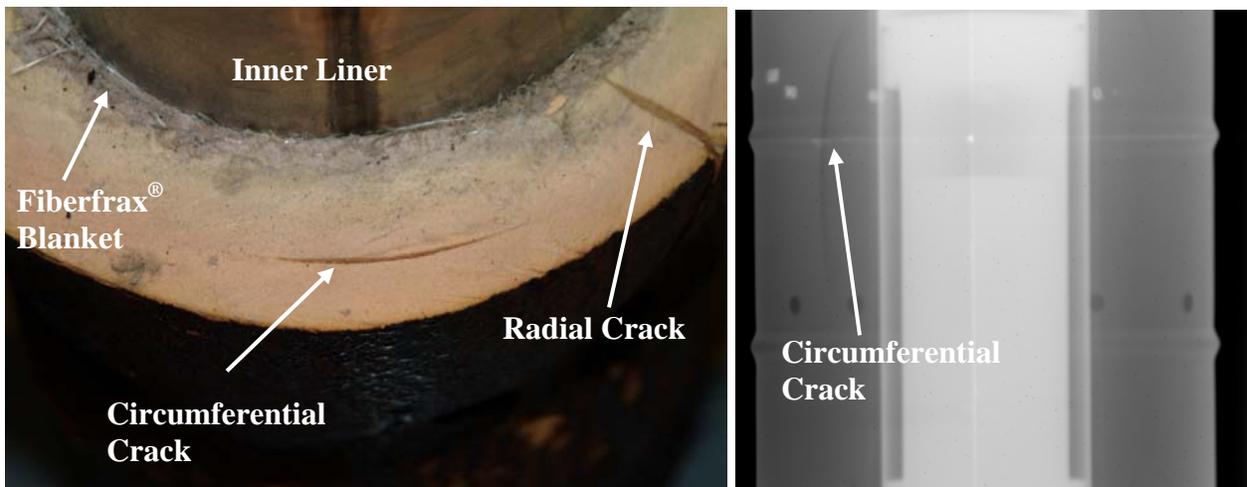
Digital radiography images taken between each of the HAC tests show the effects each test had on the package. The radiographs were able to show the effect of each test and the cumulative effects of all the tests on the package design. At the end of the tests, each package was cut apart to remove the containment vessel for leak testing. In doing so, the interior of the packages were examined and the results substantiated indications seen in the radiographs. The thermal tests for all the packages degraded the foam to great extent. Some packages had a complete cocoon of undamaged foam around the inner liner. When the undamaged foam was sectioned, voids, both circumferential and radial, were found. These voids could be traced back to indications in the baseline and in-test radiographs. Examples of the voids and radiographic indications are shown in Figure 13.

Figure 13. Comparison of actual cracks in the foam with radiographic indications

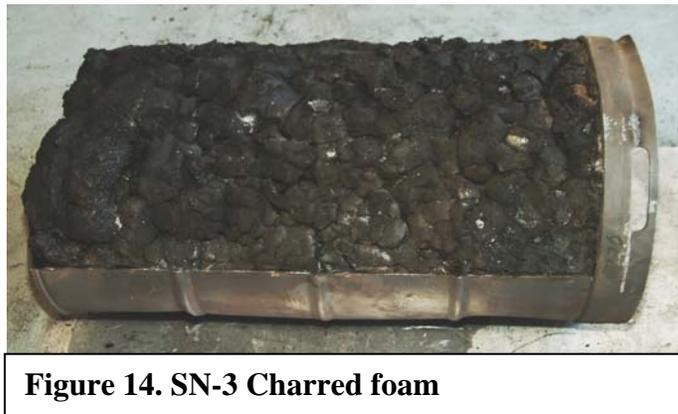
Figure 14. SN-3 Charred foam

Figure 14 is a photograph of SN-3 after the outer drum shell was cut away. The foam is a nodular shaped with varying degrees of charring. The nodular shape and varying densities resulted in the different densities in the radiographs.

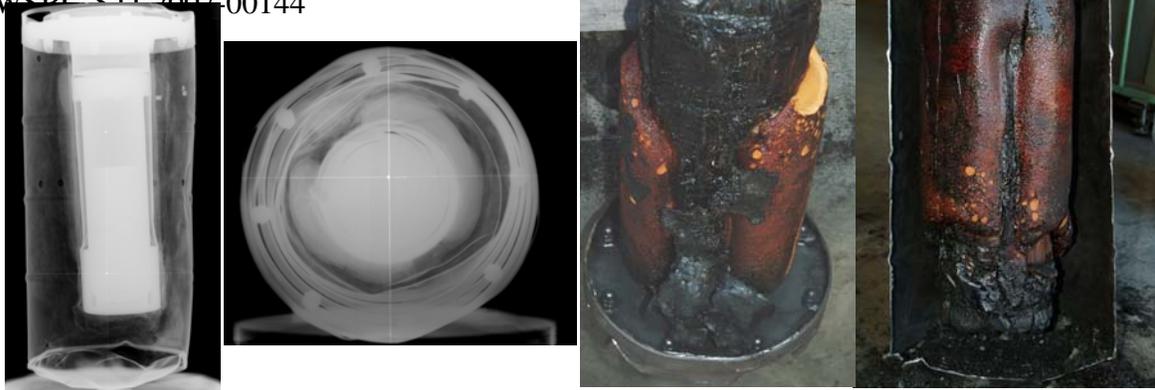
Figure 15. SN-3. Photographs showing deteriorated foam at the 150 degree and 330 degree locations. Same locations that radial cracks were indicated after the drop and crush tests.

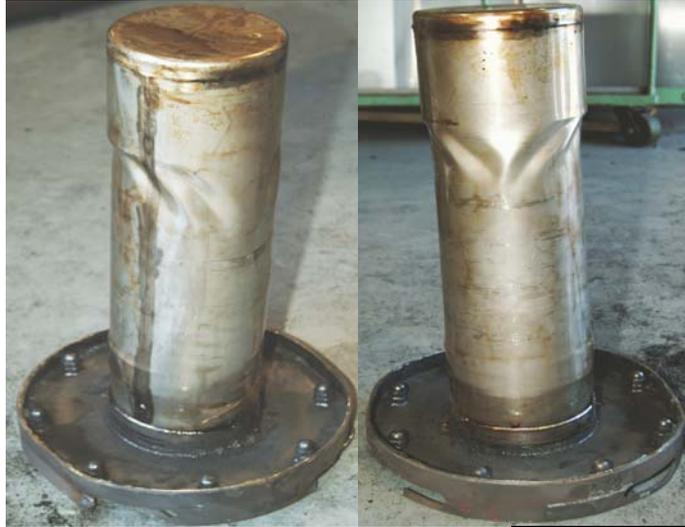
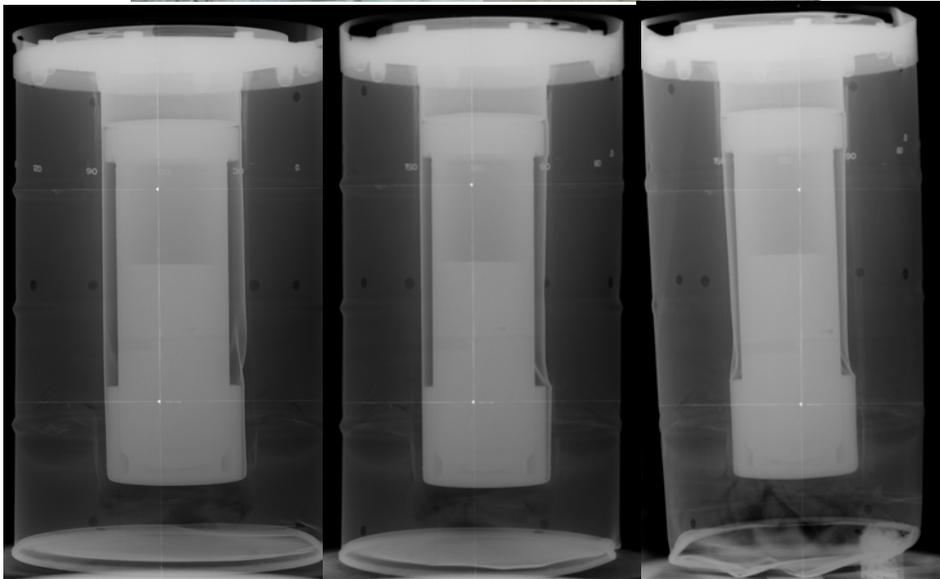
Figure 16. SN-3 inner liner deformation photographs and radiographs after drop and crush tests.

Figure 16 compares the deformation in the inner liner with the radiographs taken after the drop and crush tests. The outlines of both bottom and top load distribution fixtures are seen in the photographs. Both, including the buckled area, are seen in the radiographs.
