# FY2005 and FY2006 Corrosion Surveillance Results for L-Basin

Savannah River National Laboratory  
Materials Science and Technology

Publication Date: September 2007

**DOCUMENT: WSRC-STI-2007-00692****Title: FY2005-2006 Corrosion Surveillance Results for L-Basin (U)****MS&T APPROVALS**

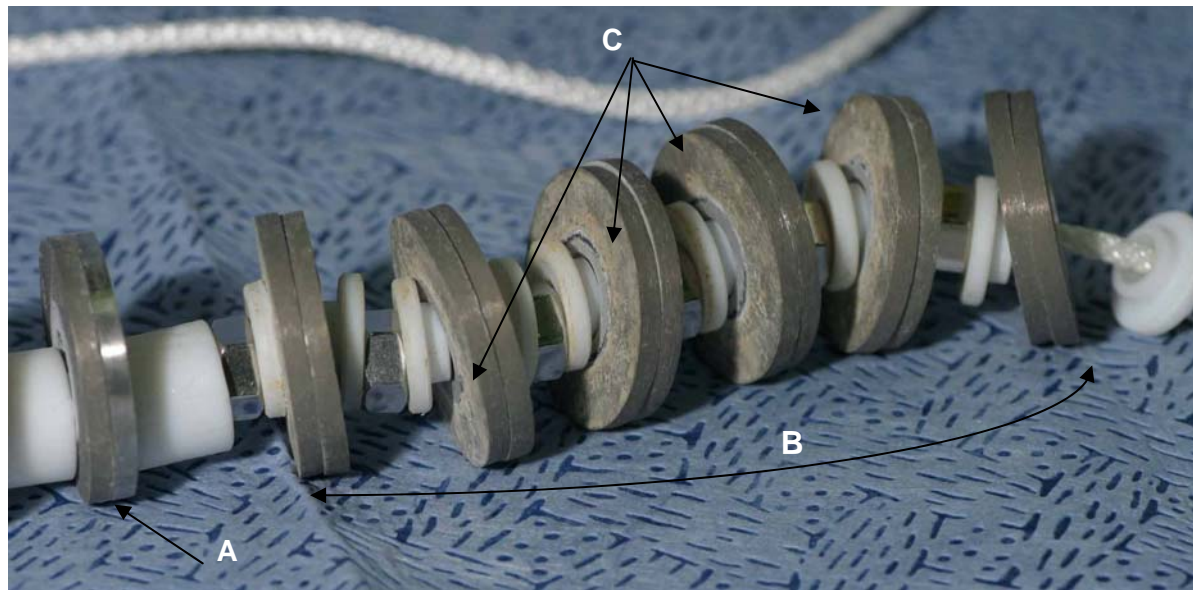
The set of 2005 galvanic coupons is shown in Figure A.3. Figure A.4 is a close-up that reveals the position of the Teflon PTFE (Polytetrafluoroethylene) washers (spacers) and the upward facing surface of a few coupons. The Face-Up side pointed up towards the water surface while hanging in L-Basin. A surface coating (yellow color) appears on the Face-Up side of most coupons. The colored surface is also visible in most of the as-received photos of the 30 aluminum coupons in the junior ray gun sets removed in 2005 (Figure A.5 through Figure A.20) and 2006 (Figure B.4 through Figure B.19). Distinguishing between the Face-Up versus the

Figure A.4 Close-up view of the surveillance coupons showing coupled coupons with Teflon insulating washers (spacers) that were removed from the rod used during immersion and placed on a string for transport to SRNL. A galvanic couple (stainless/aluminum) is visible at A and the remainder of the coupled coupons in the photograph at B are crevice type. Yellow/tan coloring is visible on the face-up surface of the coupons (C).

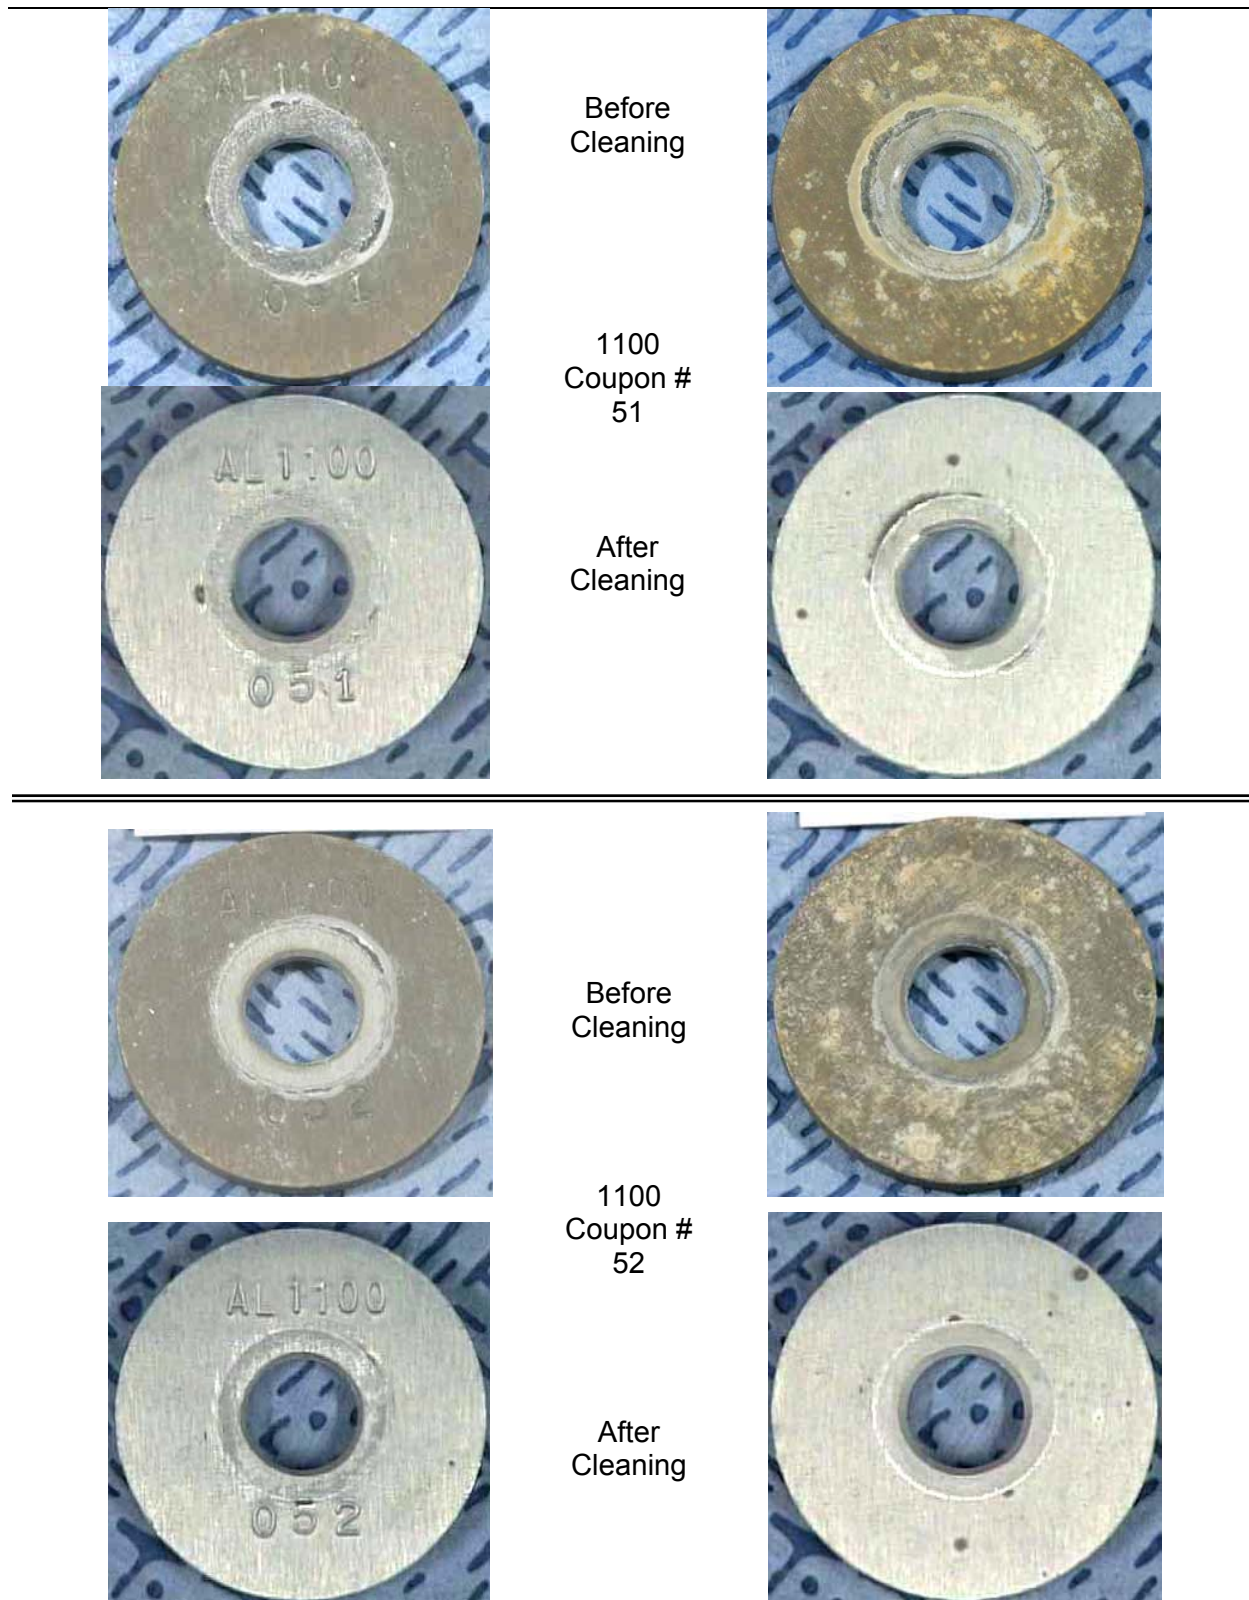
Figure A.5    Photos taken before and after cleaning of single 1100 coupons, #'s 51 and 52. The yellow/tan coloring is visible on the Face-Up side (w/o #) of the two 1100 coupons.

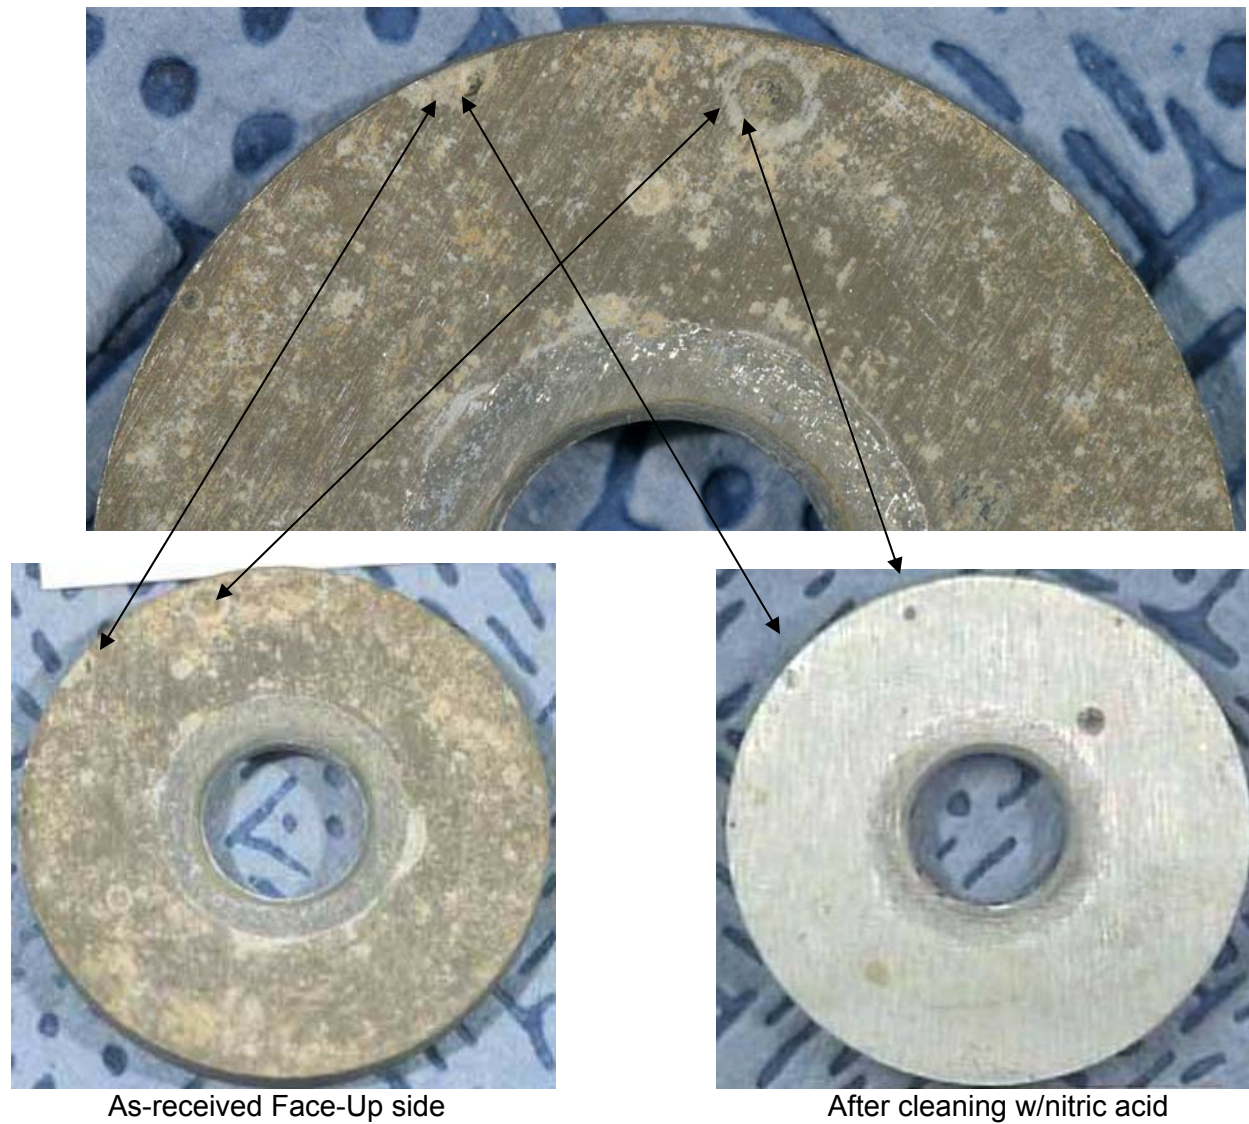
Before and after cleaning photos of single coupons are shown in Figure A.5 through Figure A.20 for the 2005 coupon set and Figure B.4 through Figure B.19 for the 2006 coupons. For the 2005 and the 2006 coupons sets, the Face-Up side of each single coupon reveals the yellow-tan color on the surface. Pits are visible in the as-received surface of the Al 1100 #54 coupon (Figure A.7) and confirmed in the cleaned coupon.

Figure A.7 Comparison of individual coupon 1100 # 54 with a few deep pits shown after cleaning with the same pits visible in as-received coupon.

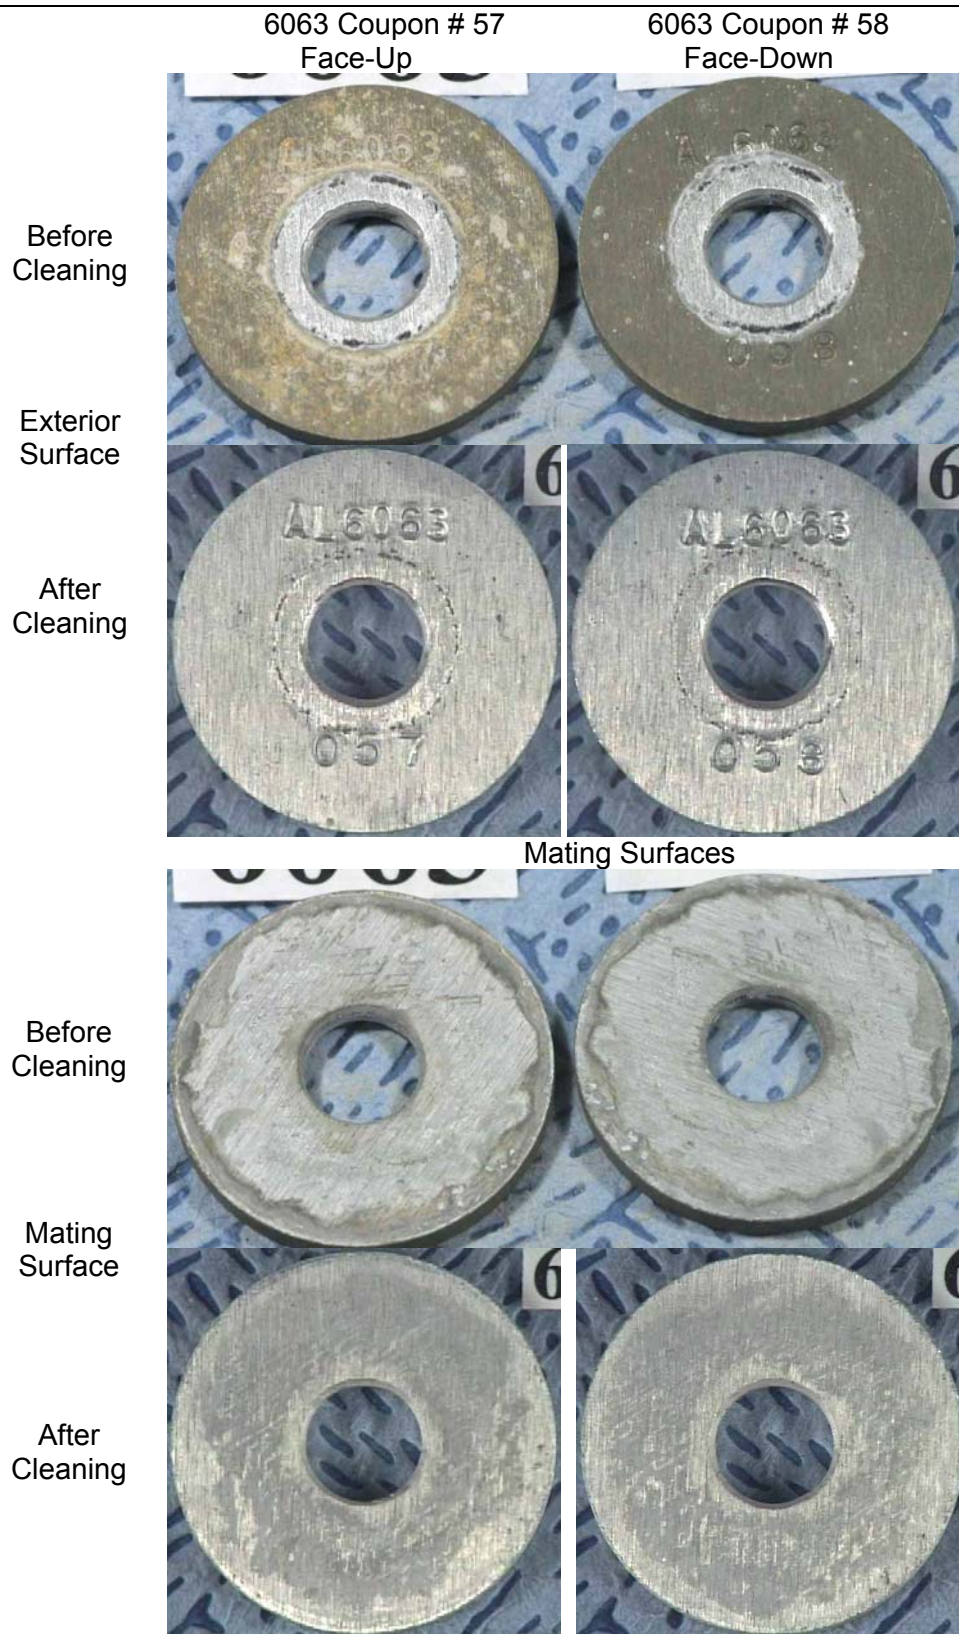
**Crevice Coupon Specimen Sets:** Crevice coupon surfaces (two of the same alloy mated together) are shown in Figure A.15 through Figure A.20 (2005) and Figure B.10 through Figure B.15 (2006). All of the crevice coupon non-mating surfaces that faced up reveal the yellow-tan coloring on the surface. In Figure A.20, surface pitting is visible before and after cleaning on the Al 6063 #59 coupon.

Figure A.19 Photos taken before and after cleaning of crevice (two of the same alloy mated together) coupons (Al 6063 #'s 57 and 58).

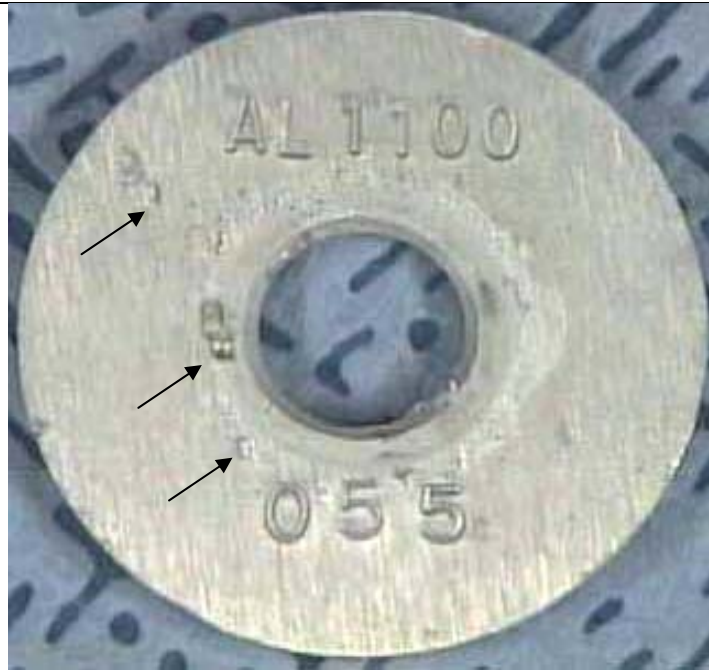
**Single Coupons:** Examples of the 2005 coupons are shown in Figure A.21 through Figure A.23. The Al 1100 #055 coupon (Figure A.21) shows a few individual pits on the surface facing up in the basin. Figure A.22 shows 2-3 pits that formed below the PTFE washer on the Face-Up side of the coupon. Figure A.23 shows numerous pits on the Face-Up side of the Al 6063 #053 coupon. The higher number of pits shown on the 6063 coupon compared with the 1100 and 6061 coupons is attributed to end grain attack of the 6063 alloy.

Figure A.21 Pits shown in Face-Down orientation of Al 1100 #055 coupon

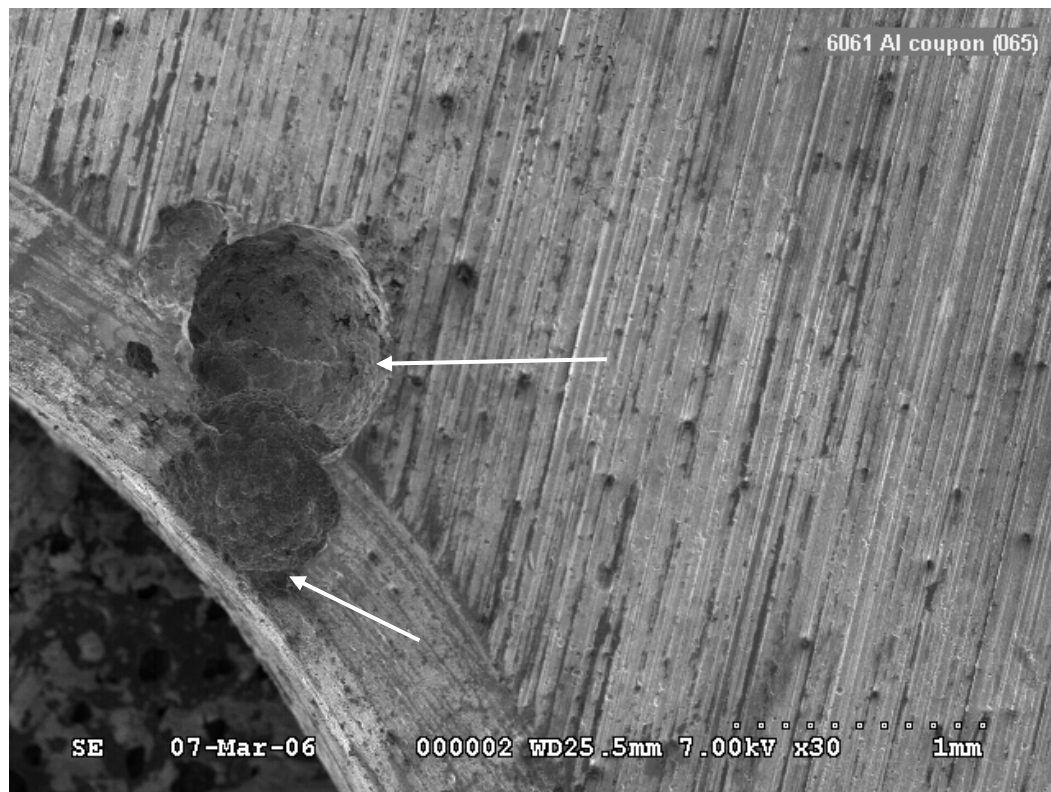
Figure A.22 Pits shown in crevice area beneath PTFE washer on Face-Up side of Al 6061 #065 coupon. The surface of this coupon is shown in Figure A.13.

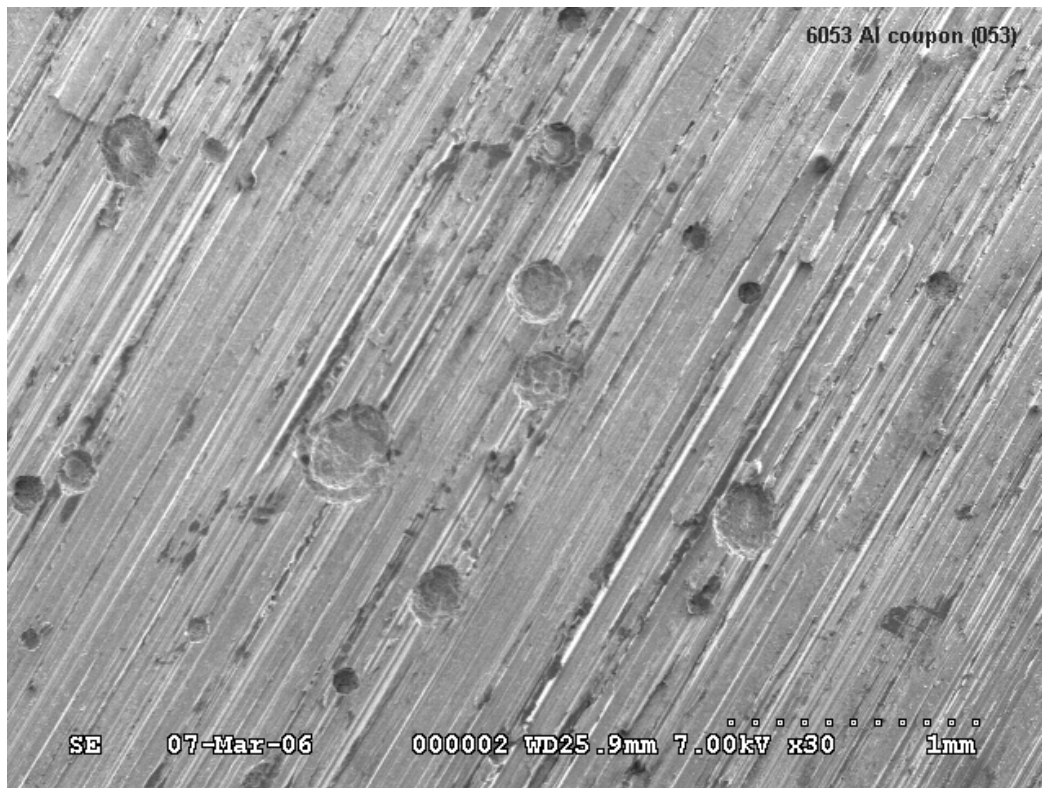
Figure A.23 Pits shown on open surface of a single Al 6063 #053 coupon. This surface was in the Face-Up position and is shown in Figure A.6.

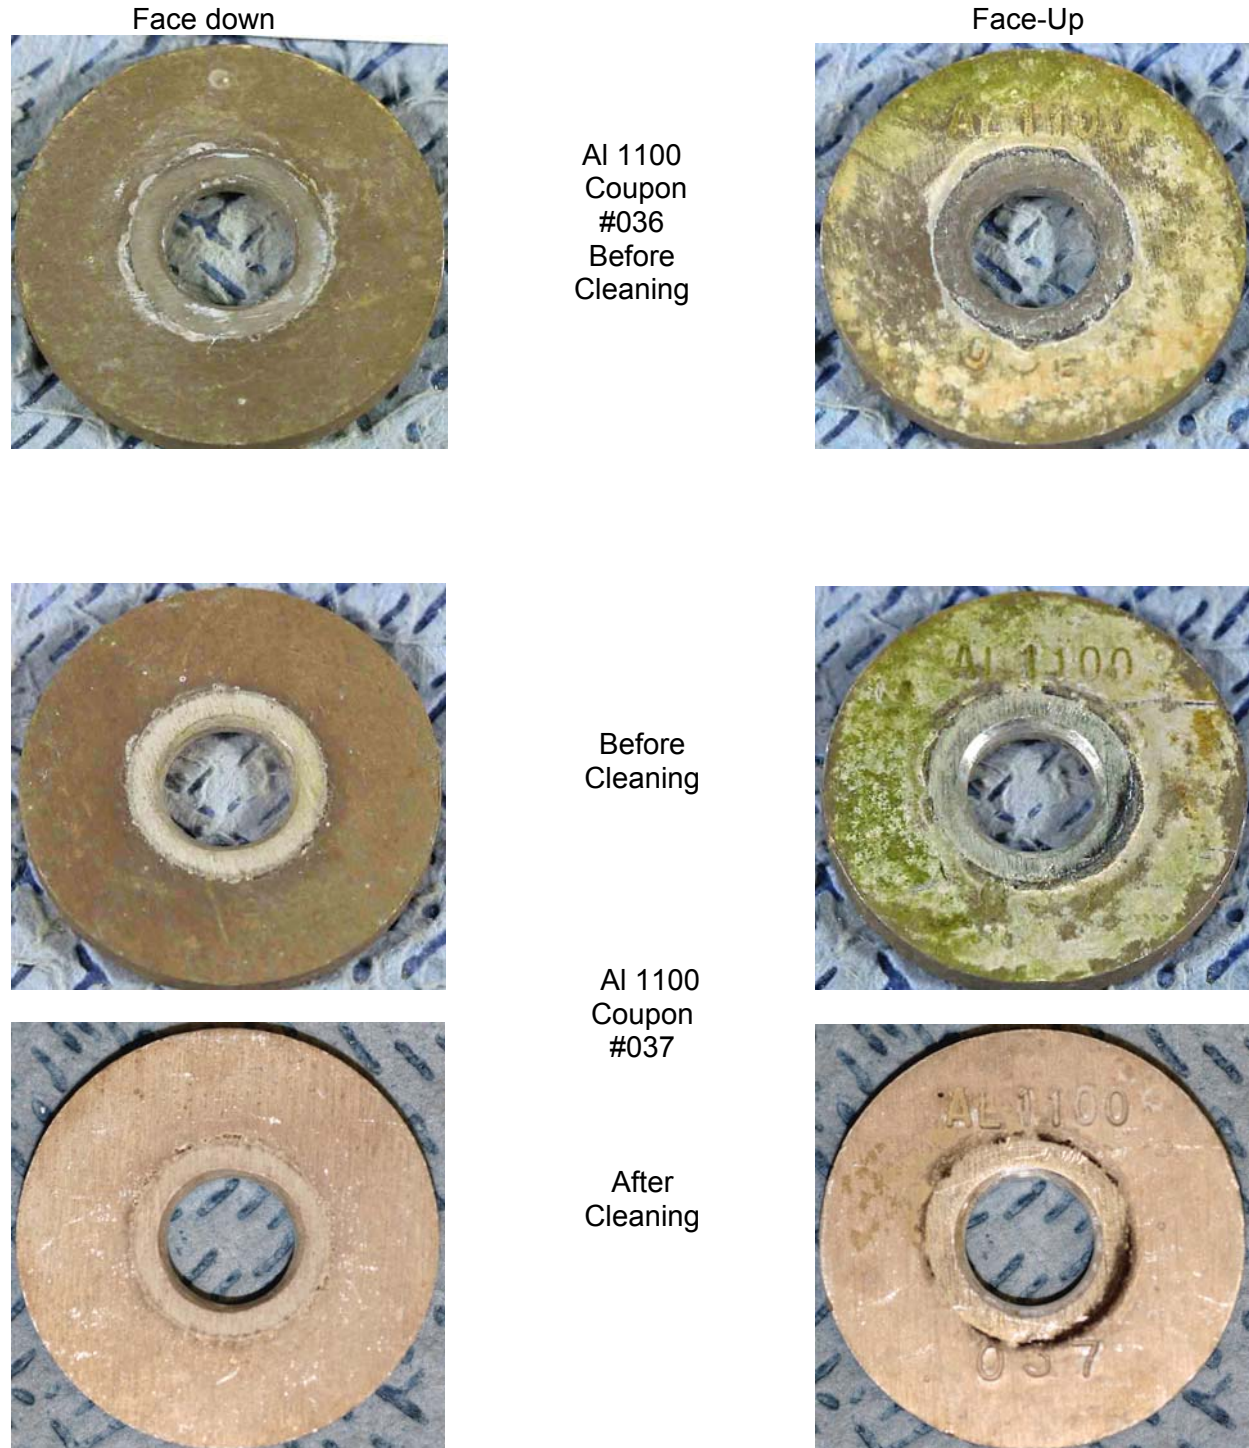
Figure B.5 Photos taken before and after cleaning of single 1100 coupons, #'s 036 and 037. Coupon #036 was sectioned for surface analysis in the SEM and never cleaned.

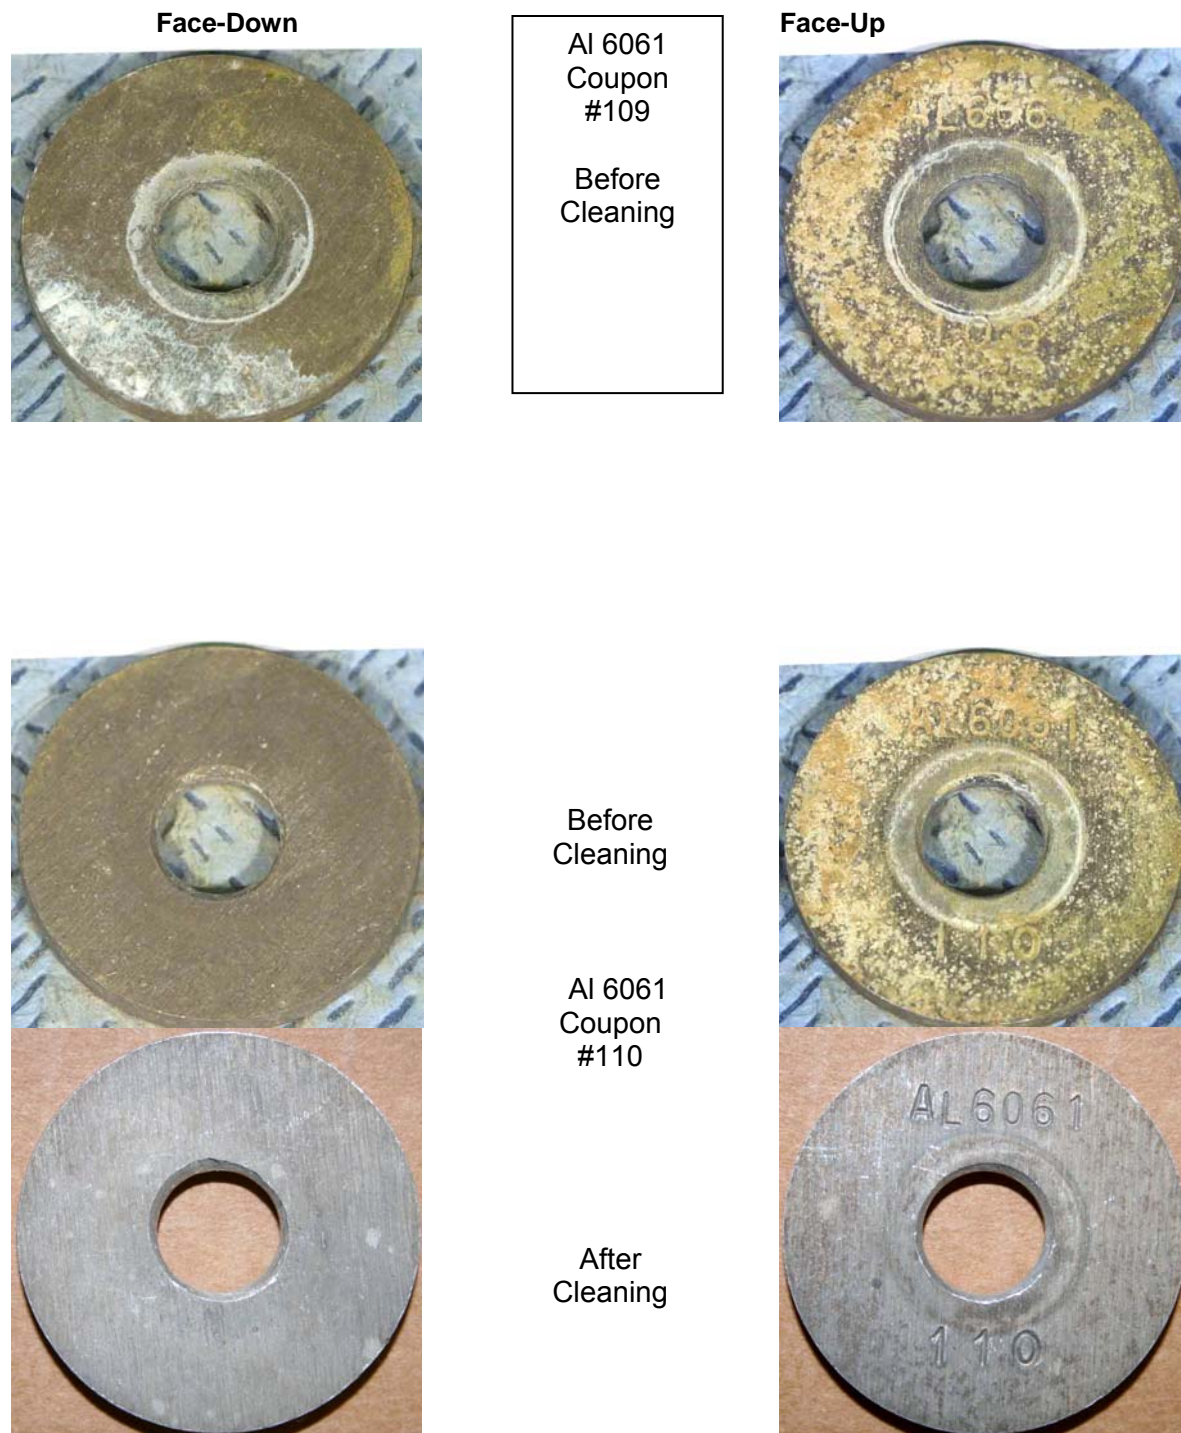
Figure B.7 Photos taken before and after cleaning of single 6061 coupons, #'s 109 and 110. Coupon #109 was contaminated during surface analysis in the SEM and never cleaned.

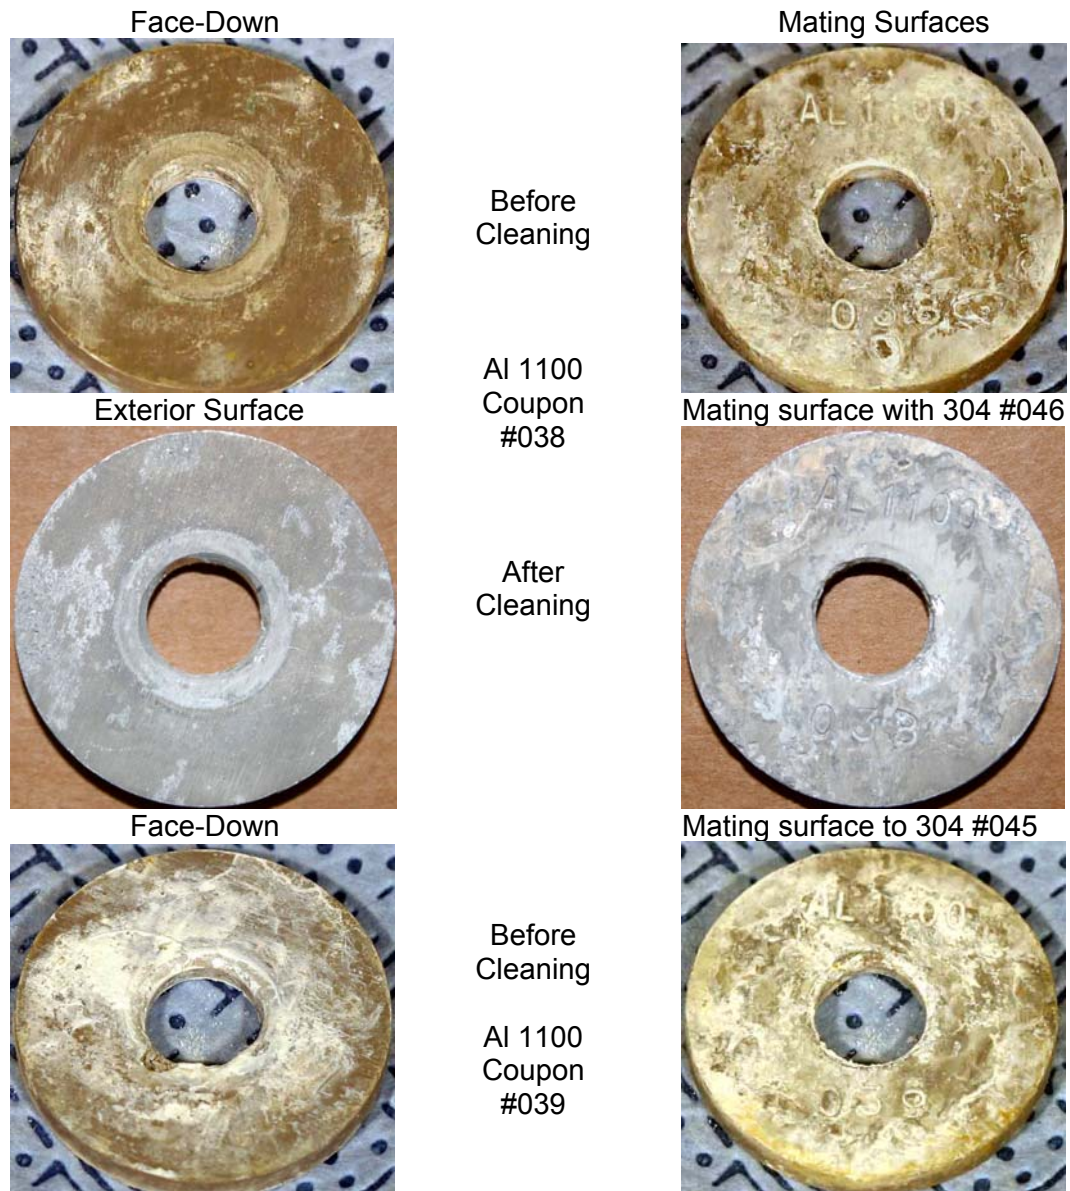
Figure B.16 Photos taken before and after cleaning of galvanic 1100 coupons, #'s 38 and 39  
Coupon #39 was contaminated during surface analysis in the SEM and never cleaned.

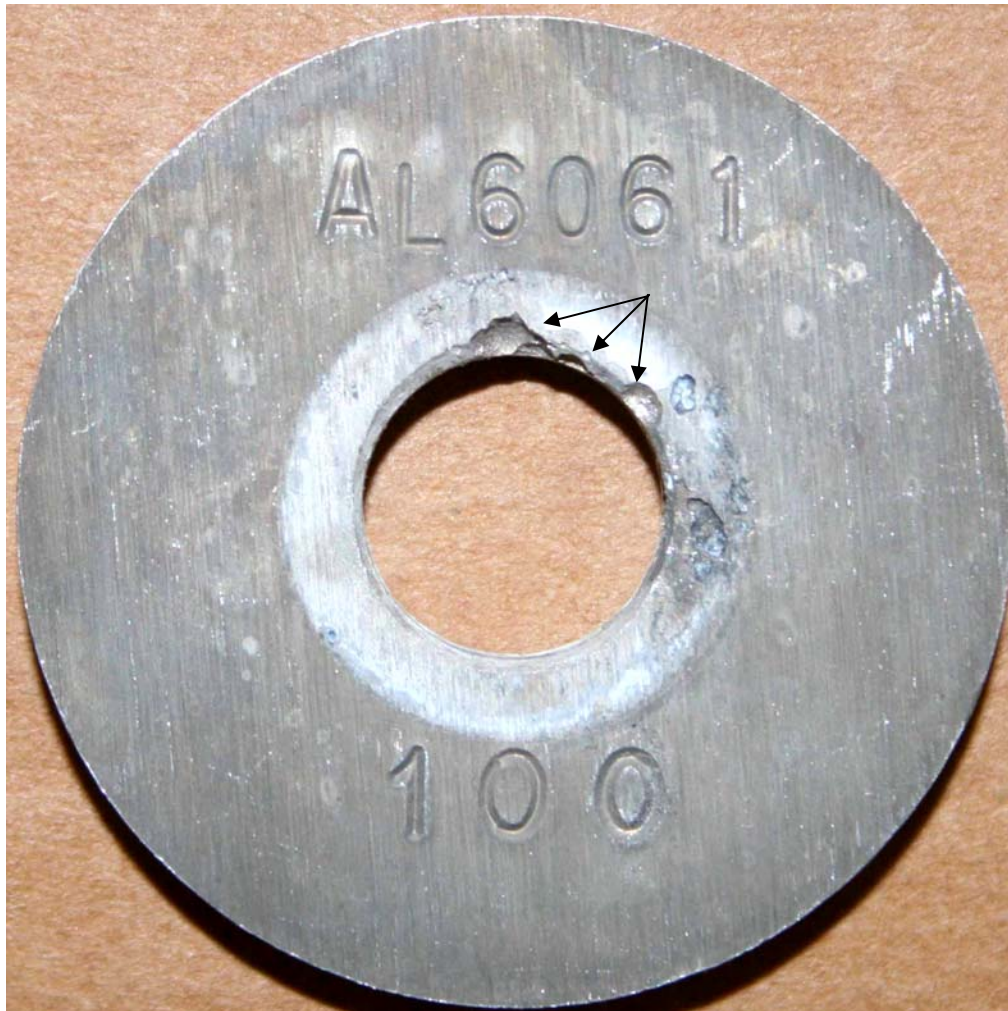
**Galvanic Coupon Specimen Sets:** Galvanic coupon surfaces (mated with 304 stainless steel) are shown in Figure A.12 through Figure A.14 (2005) and Figure B.16 through Figure B.19 (2006). For the non-mating surface side, four out of the six aluminum coupons were facing up in the 2005 galvanic coupon set and coloring was not visible on these surfaces. In the 2006 galvanic coupon set, all non-mating surfaces of the aluminum coupons faced down. Large pits are visible below the Teflon washer area on an Al 6061 coupon (2006) on the side opposite to that mated to 304 stainless steel (Figure B.18).

Figure B.18 Magnified surface of Al 6061 Coupon # 100 revealing deep pitting in crevice area below Teflon washer.

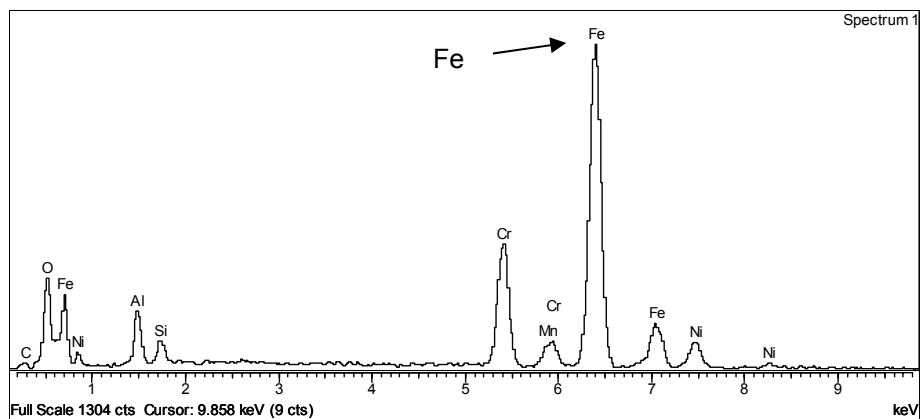
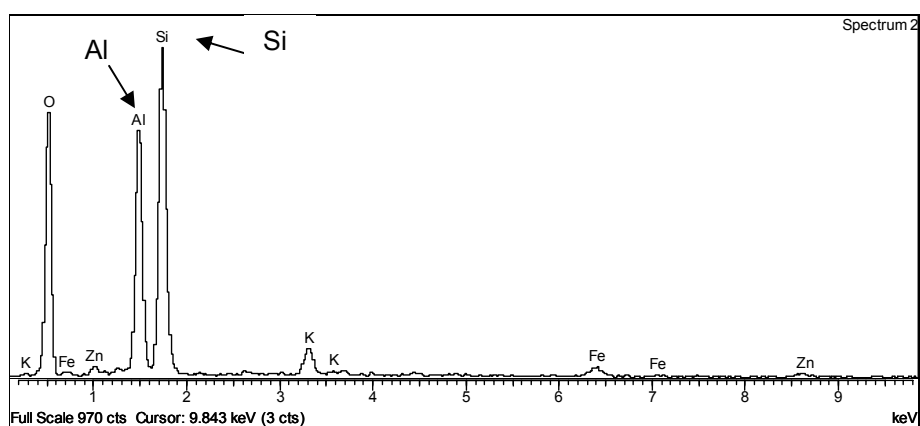
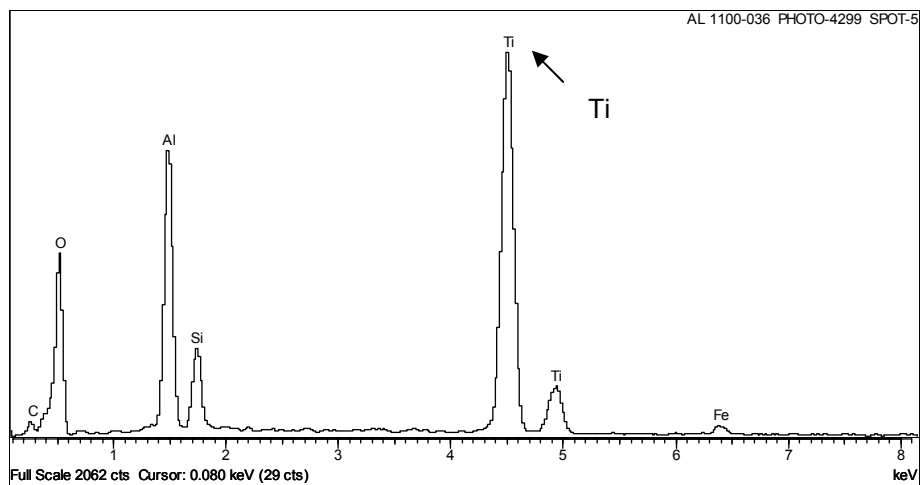
Literature reports of effects of debris on aluminum [3] have indicated increased corrosion rates due to foreign particle deposition on the surface of water immersed aluminum coupons. The particles act as cathodes on the surface and the surrounding metal (anode) corrodes. This type of attack was observed in the L-Basin coupons. Energy dispersive spectroscopic (EDS) analysis was performed on selected 2006 corrosion coupons prior to cleaning to confirm the existence of foreign particles. EDS confirmed that sand particles containing Si, Ti, and Fe from

the sand filter release were present on a Al 1100 coupon surfaces as shown in Figure B.20. White areas on some coupons (Al1100 #039 and Al6061 #109) were analyzed by X-Ray diffraction (XRD) and contain elemental aluminum, Bayerite ( $\text{Al}(\text{OH})_3$ ), Quartz ( $\text{SiO}_2$ ), and Moscovite ( $\text{H}_2\text{KAl}_3(\text{SiO}_4)_3$ ) on both sides of the coupons. In addition, XRD analysis was performed on surface deposits from a sand filter media trap which contained Quartz ( $\text{SiO}_2$ ), Hematite ( $\text{Fe}_2\text{O}_3$ ), Fluorapatite ( $\text{Ca}_5(\text{PO}_4)_3\text{F}$ ), Rutile ( $\text{TiO}_2$ ), and Hematite ( $\text{Fe}_2\text{O}_3$ ) [4] which were found in the sand deposits on the Al 1100 coupon.

(A) EDS displays high Fe contents

(B) EDS displays Si content higher than Al

(C) EDS displays high Ti contents

Figure B.20 Spot analysis of an Al 1100 #036 coupon surface by energy dispersive spectroscopy (EDS) revealed areas containing Si, Ti, and Fe in addition to the expected Al and O.
