L-Area Wastewater Storage Drum Evaluation

P. R. Vormelker, D. Z. Nelson, C. N. Foreman, D. J. Hathcock, and D. W. Vinson
Savannah River National Laboratory
Materials Science and Technology

Publication Date: November 2007

DOCUMENT: WSRC-STI-2008-00228

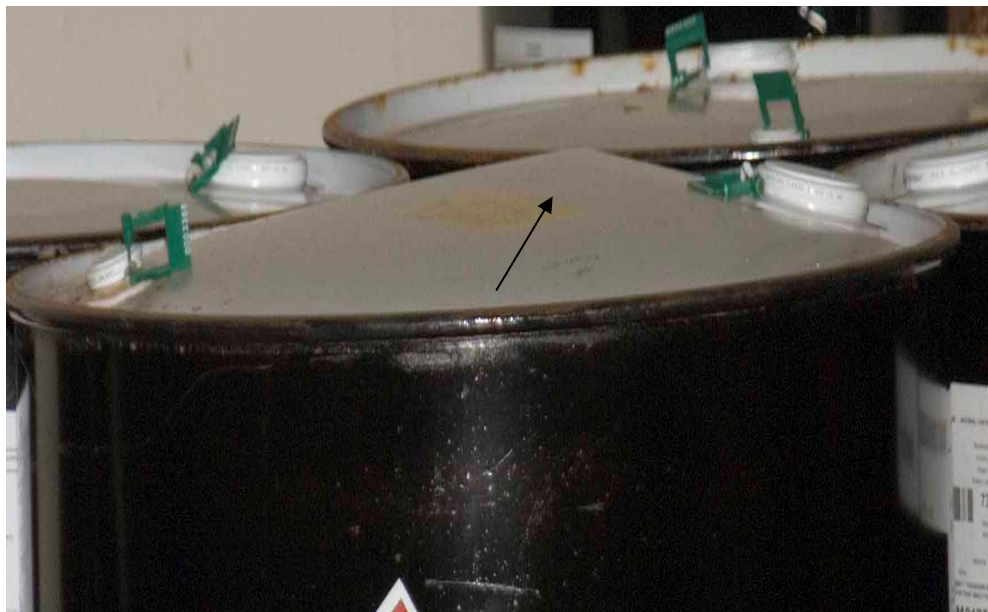
**Figure 1.** Bulged lid of 55 gallon wastewater drum stored in L-Area.

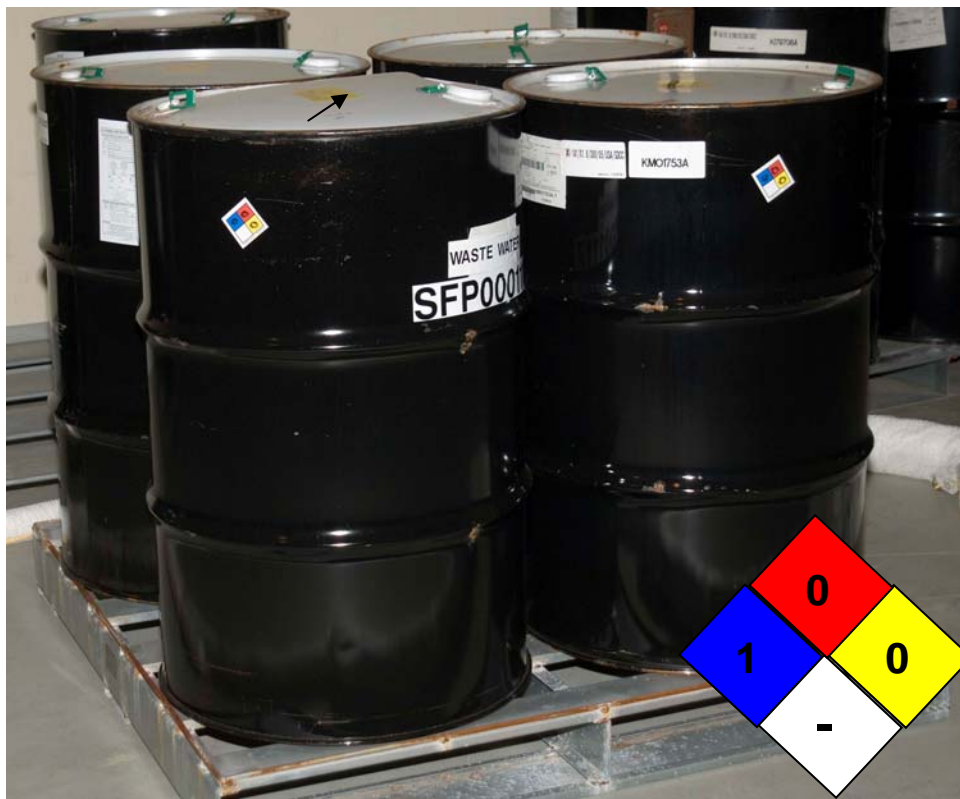
Figure 2. Bulged drum (A) on pallet along with three additional drums containing wastewater. The NFPA hazard label is reproduced in lower right corner.

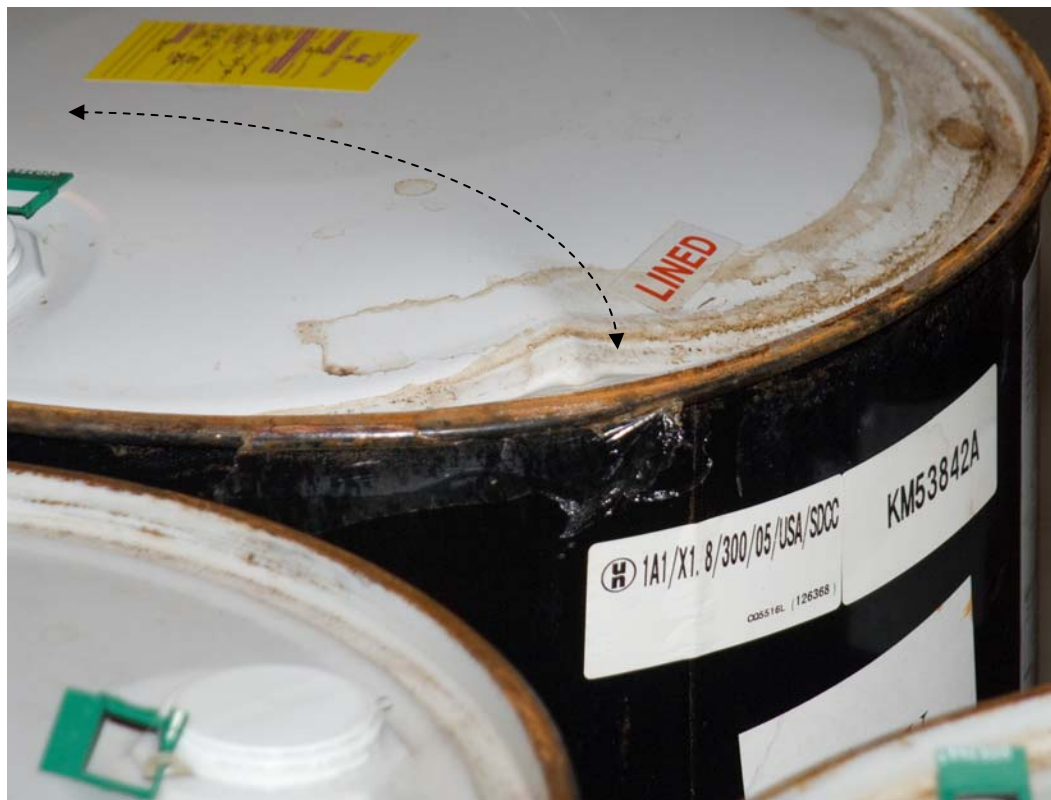
Figure 4. The drum lid crease is shown below dotted line. Drum Label reveals PO No. KM53842A" with the United Nations uniform drum designation "1A1/X1.8/300/05/USA/SDCC." The designation "SDCC" identifies Skolnik Industries as the manufacturer.

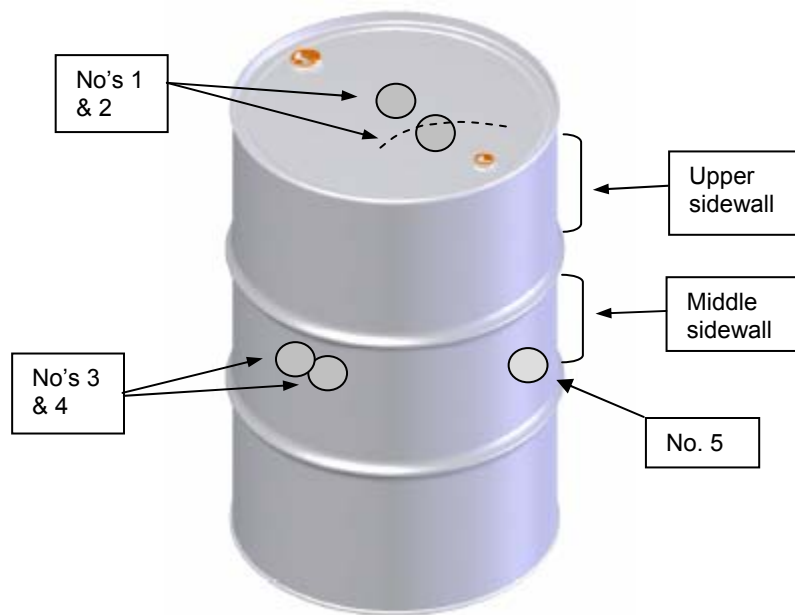
Figure 6. Location of five disks cut from bulged drum (SFP0001117).

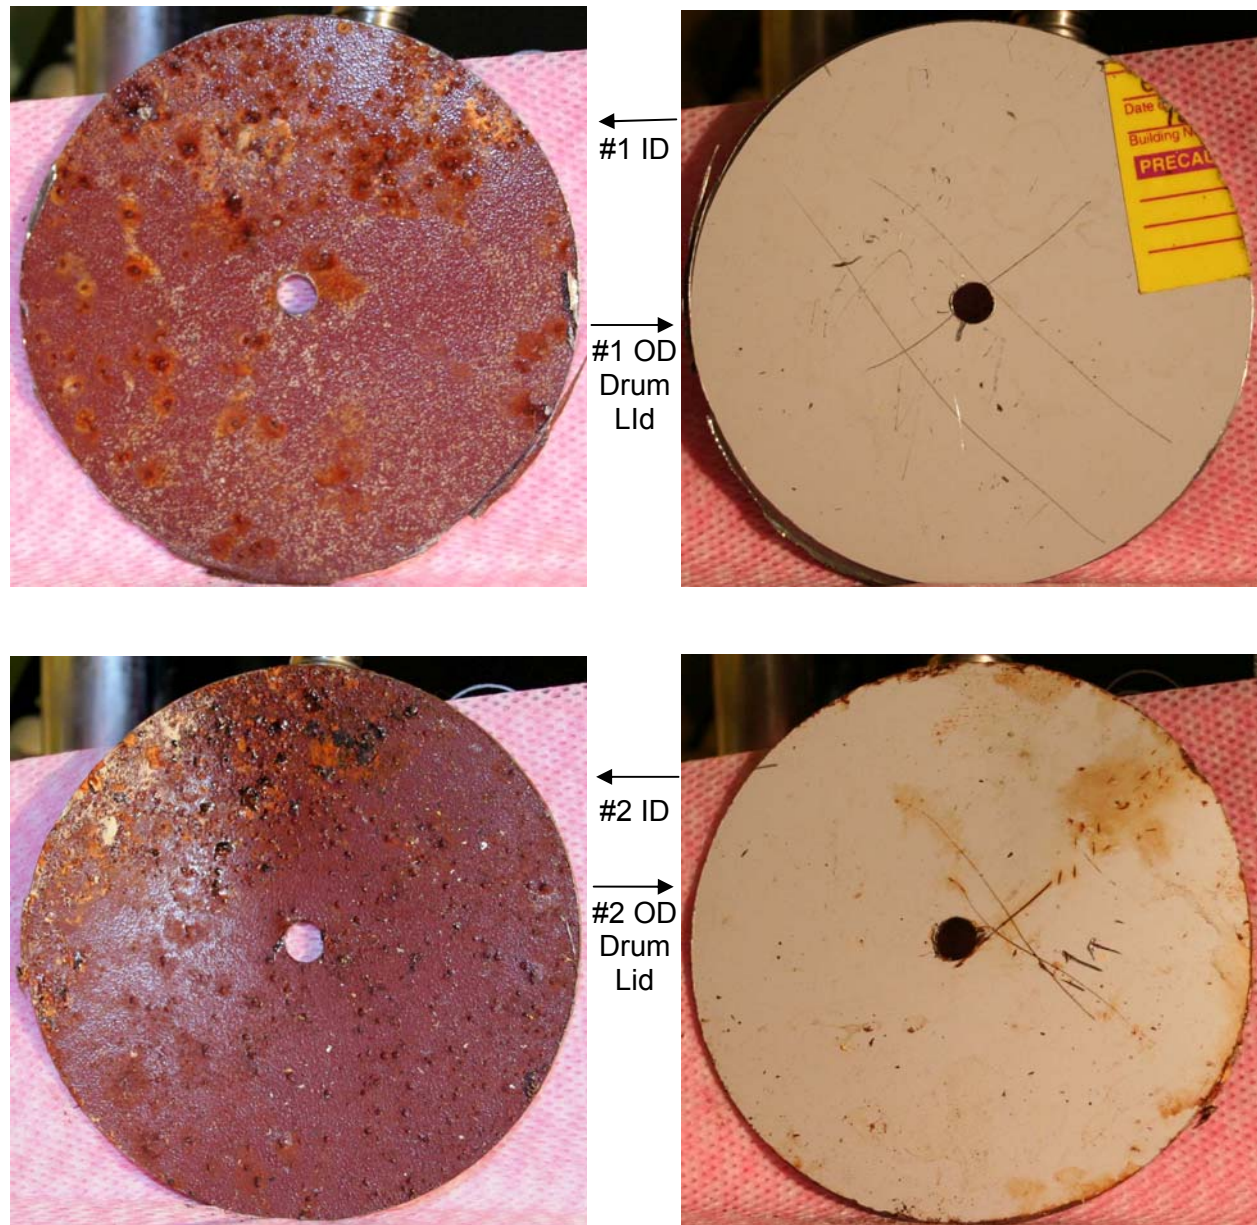
The approximately 4 ½ inch diameter disks were cut from the bulged drum in positions indicated in Figure 6. The outside and inside surfaces of these disks are shown in Figure 7. Corrosion is very evident on the interior surface of the two lid samples. Corrosion was preceded by blistering which is shown on the sidewall sample shown in Figure 8. Additional samples were cut from the sample in Figure 8 where the cut lines are indicated. These samples were used for close-up metallography and XRD (X-ray diffraction) analysis (Figure 9). XRD analysis revealed the presence of hematite (Fe_2O_3), magnetite (Fe_3O_4), talc, $\text{Fe}(\text{OH})_2$ and the carbon steel base metal. Hematite is visible in sample 1 and 2 (Figure 7) with the normal rust color while magnetite is black and is visible in sample 2. Talc is probably from the gloves used to handle the samples. Close-up photos are shown in Figure 10 where the black oxide is clearly visible in the center of a burst blister.

Figure 7. ID and OD of two disks cut from drum head revealing visible corrosion in ID surface of both samples. Minor corrosion was visible on the OD of the number 2 sample, from Figure 6.

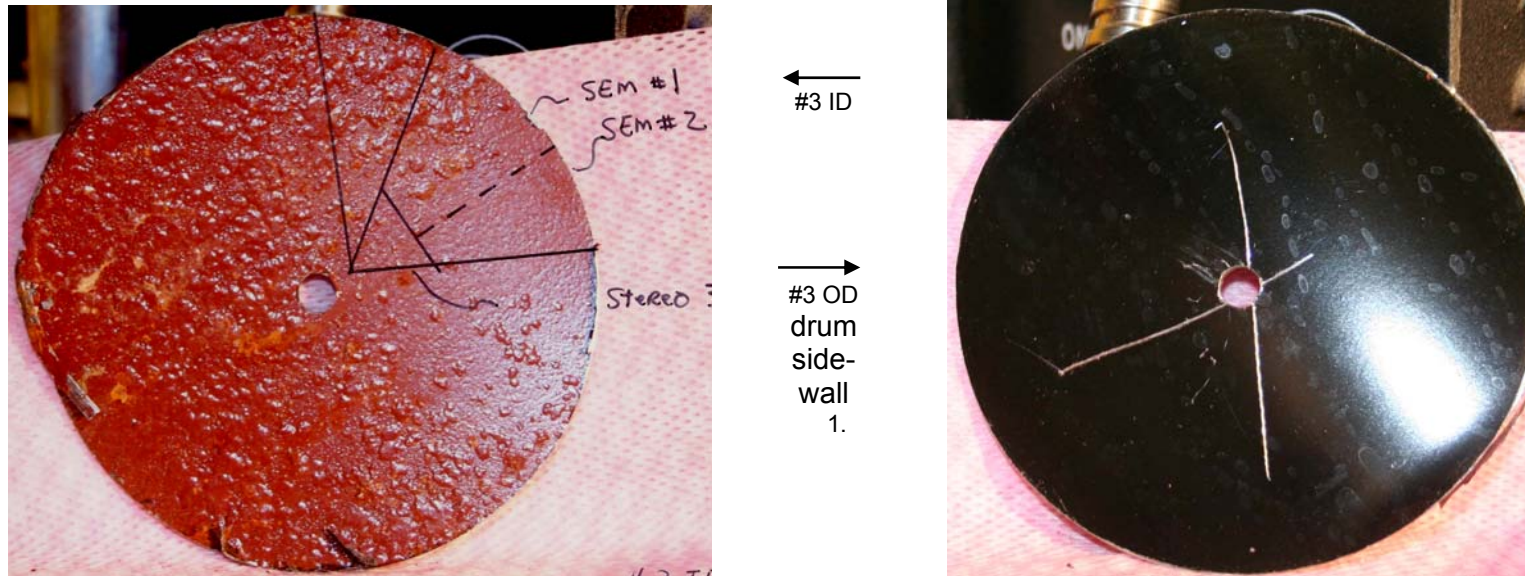
Figure 8. ID and OD surfaces of the number 3 disk (See Figure 6) cut from the drum sidewall. The ID surface also reveals the areas cut from the disk for SEM evaluation.

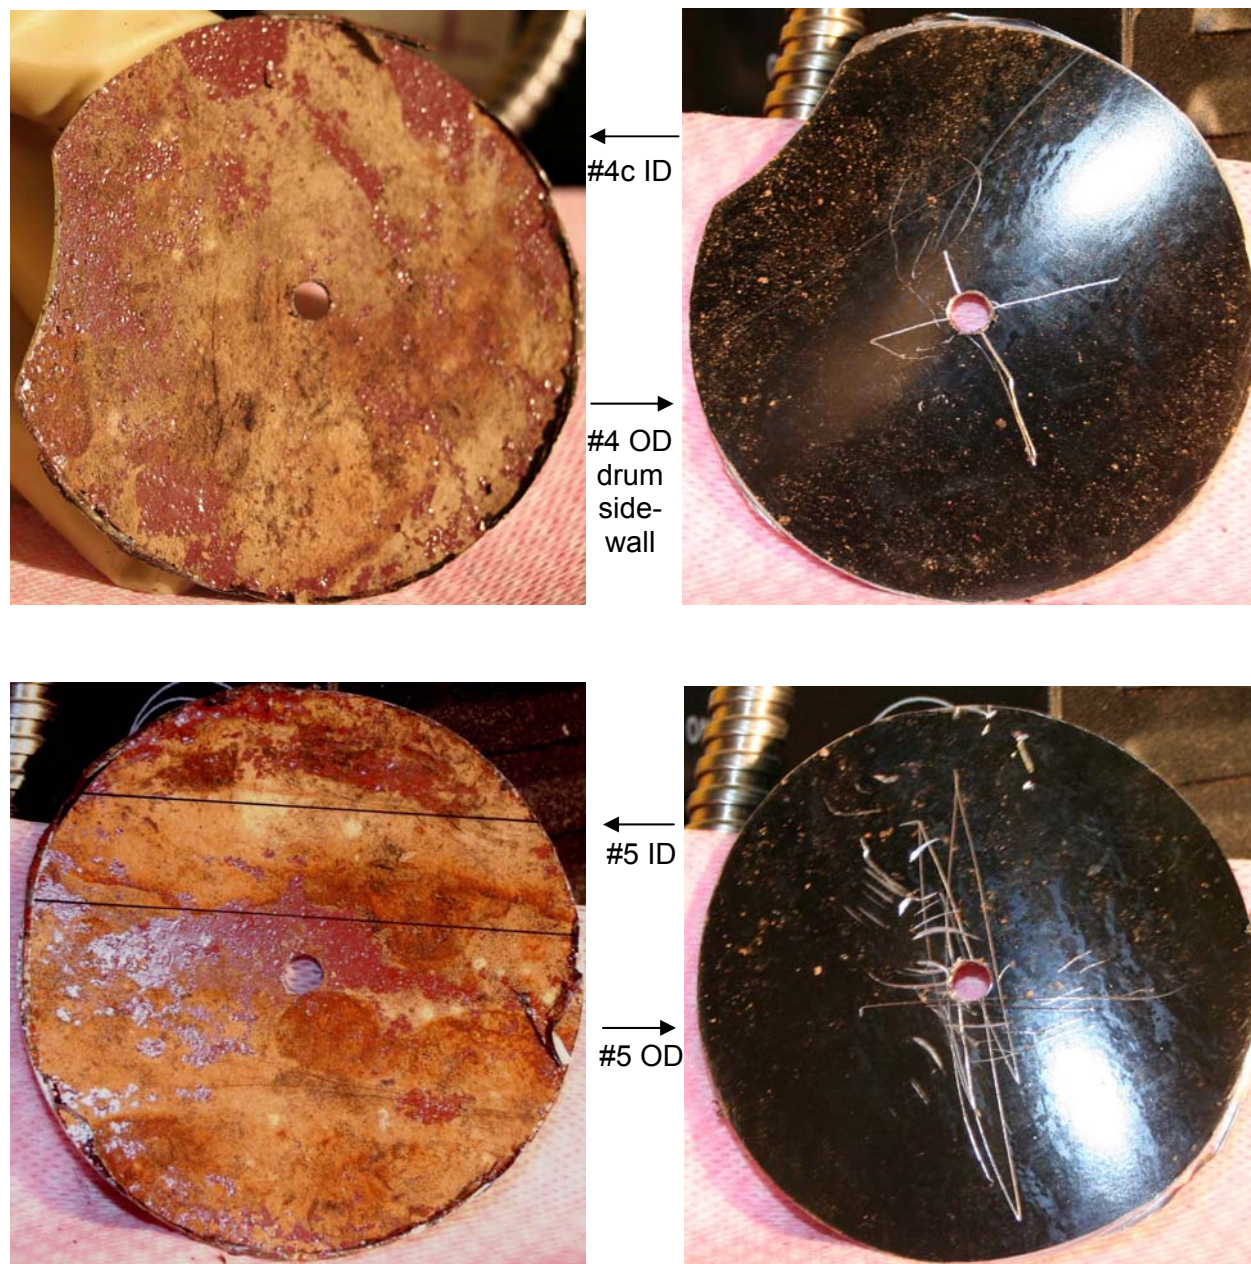
Material was scraped from the surface of disk 5 (Figure 11) and analyzed by gas chromatograph mass spectroscopy (GC/MS). The results, shown in Table 4, reveal significant surface deposits from oil with smaller amounts from branched alkyl benzenes and tributyl phosphate. Oil in the original Tuff Tank was known to exist, the alkyl benzenes are probably from a scintillation cocktail, and the TBP (tributylphosphate) may be from the oil or from other contaminants from sampling of the water during analytical procedures. TBP is used to enhance oil film strength in lubricants.

Figure 11. ID and OD surfaces of the number disk numbers 4 and 5 (see Figure 6) which were also cut from the drum sidewalls. Disk number 5 has two parallel lines within which the surface was scraped for analysis. The ID surface on both disks is blistered but is not as visible in these photographs (compared to previous photos) due to surface deposits.

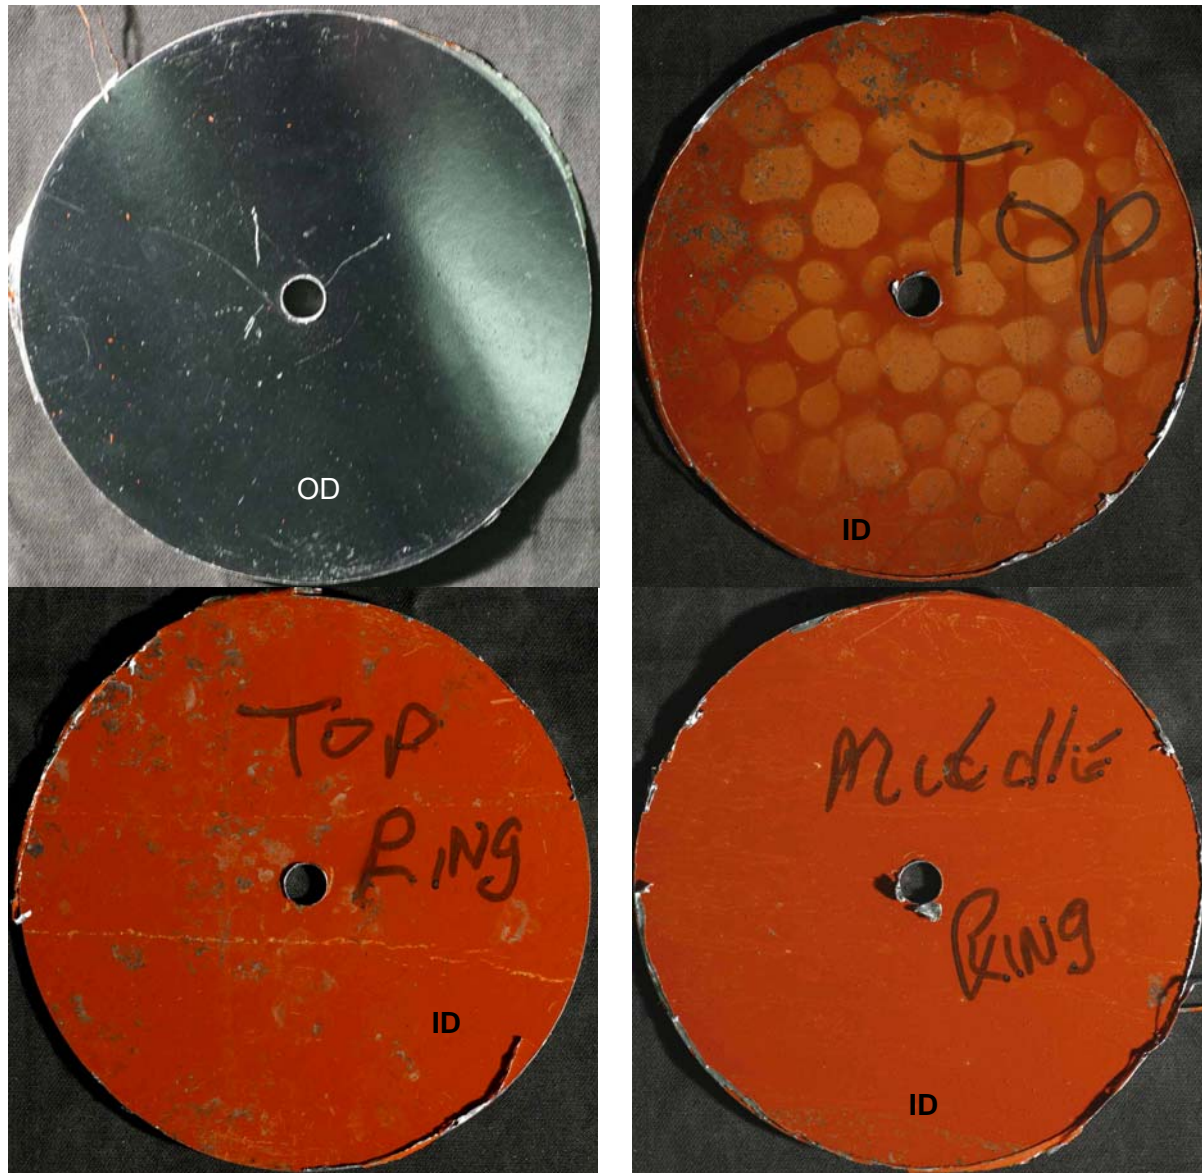
Samples were cut from a clean spare drum (same design and manufacturer as the bulged drum) and are shown in Figure 12. The top ring and middle ring samples were cut from the upper sidewall and middle sidewall section, respectively, as shown in Figure 6. Both sides of the lid are shown in the upper photos in Figure 12. The top ID surface shows surface stains that may be the result of condensation. The sidewall samples appear to be clean. Coating thickness measurements were performed with an Elcometer (model No. 246F) dry film thickness gauge and are shown in Table 7. Exterior coating thicknesses on the three samples averaged 0.37 mil while the interior coating thickness averaged 1.2 mils. Skolnik's interior coating process calls for a 1 mil nominal coating thickness. Coating vendors such as Carboline, Heresite Protective Coatings, International Protective Coatings, and Sherwin Williams prescribe a minimum of a 2 mil primer coat with a 2- 4 mil final coat for two coat coverage or 5 mils for single coat coverage per an internet search for epoxy phenolic type coatings. Based on vendor guidelines, Skolnik's interior drum coating nominal thickness of 1 mil may be insufficient for corrosion protection of carbon steel immersed in an acidic wastewater. This thin coating may contain too many holidays (coating defects) to be protective in immersion service.

Figure 12. Photos of samples cut from a spare drum of same type as bulged drum and was unused prior to sample cutting. Some cutting debris are visible on the surface of the Top Ring sample.

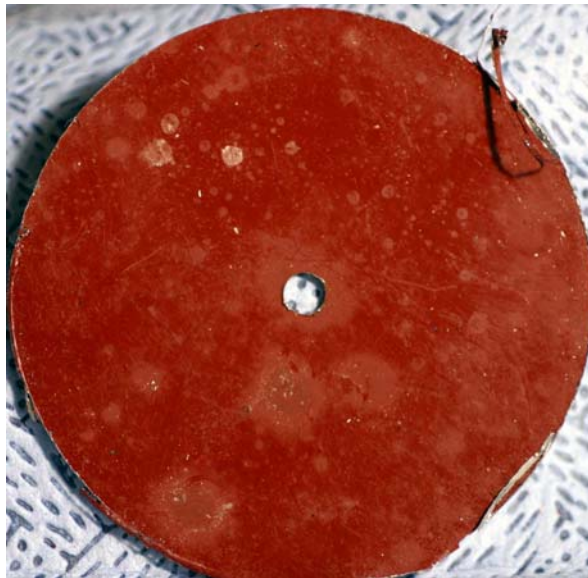
Figure 13. ID of Lid sample from drum 1114. This is also typical of lid samples from drums 1115, 1116, and 1117-2. Some staining is visible.

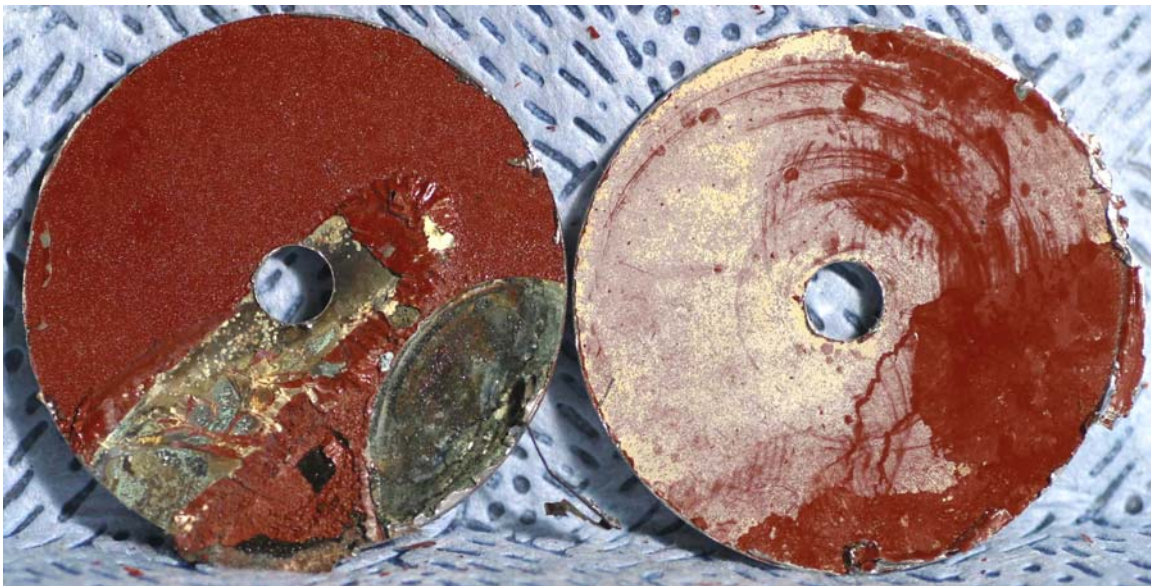
Figure 14. Drumwall ID samples from drum 1114.

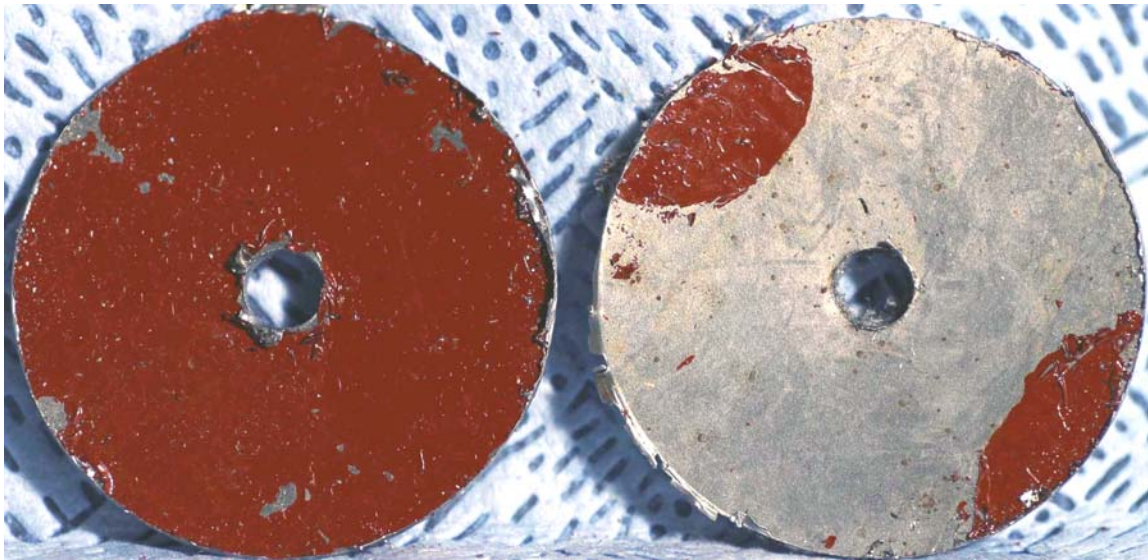
Figure 15. Drumwall ID samples from drum 1115.

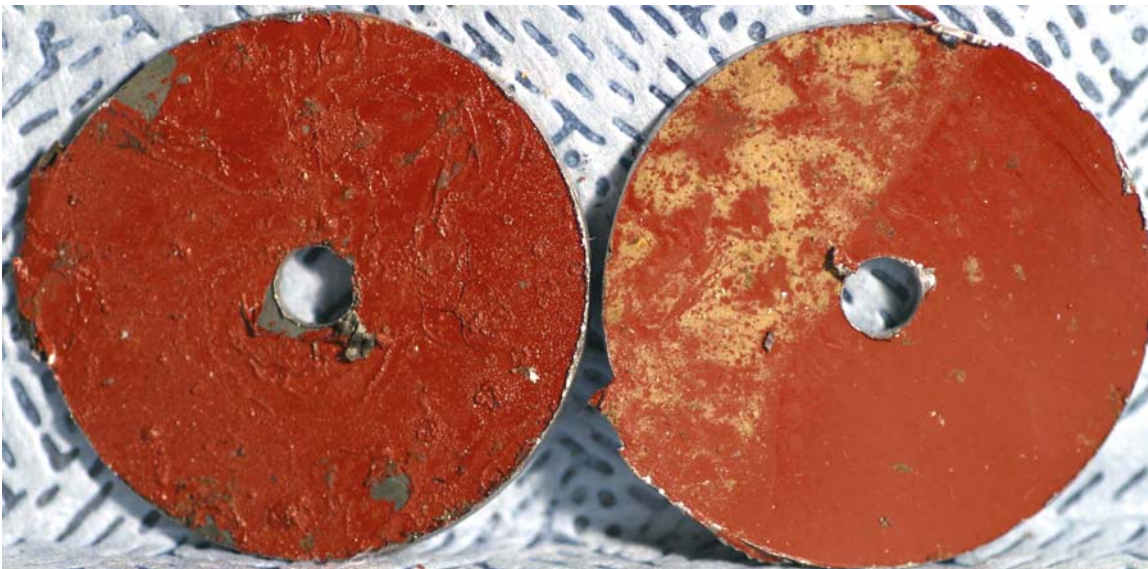
Figure 16. Drumwall ID samples from drum 1116.
