## **F-Canyon 8.5 Evaporator Vessel Repair Patch Recommendation (U)**

Savannah River Technology Center  
Strategic Materials Technology Department  
Materials Technology Section

Publication Date: August 2003

**DOCUMENT:** WSRC-TR-2003-00394

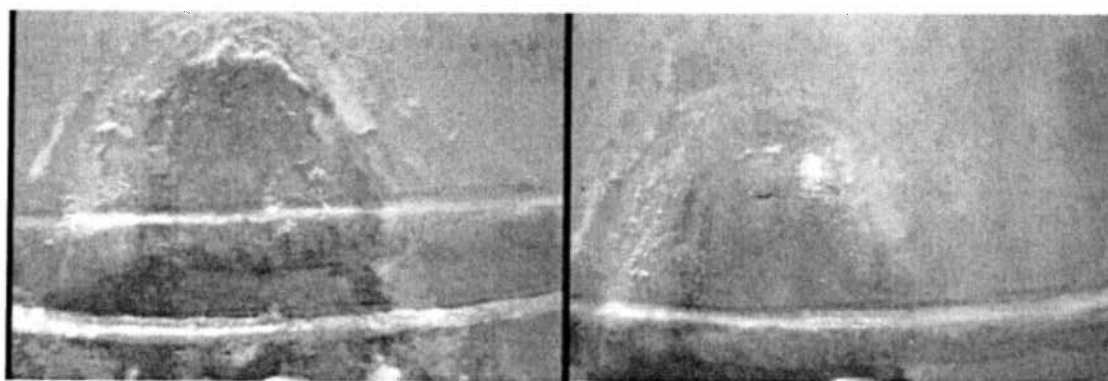
**Figure 2: Leaksite Before (2a) and After Cleaning (2b)**

The initial view of the leak appeared to show two small holes (shown in Figure 2a) in the shell of the evaporator. The perforations are estimated to be no larger than 3/32" in diameter and no more than 1/4" apart, located approximately 1-1/2" above, and oriented parallel to the bottom head-to-shell weld. This weld is estimated to be 3/4" in width and still has a weld crown though the weld ripples and any undercut were obviously removed with a grinder during fabrication. The perforations are located at the boundary or slightly beyond the heat affected zone (HAZ) of the bottom head-to-shell weld. The design drawing indicates several internal attachments welded on the interior of the shell in this immediate area. Such internal attachments are typically made using oversized fillet welds that can create an additional HAZ in the shell that are not readily discernable from the exterior. It is suspected that the holes may well be in just such a HAZ, which is more susceptible to corrosion.

After additional cleaning with a power wire brush, the area between the holes was opened up to reveal a single crescent shaped perforation (shown in Figure 2b) approximately 1/4" in length. Bare metal was attained all around the hole without any residual deposits. It is unclear whether this change was caused by removing a very thin layer of material between the initial holes or by removal of deposits. Additional cleaning was again performed and while the crescent shaped perforation did not appear to increase in size, it did begin to show some "denting" or displacement of the area immediately surrounding the hole. This change indicated that the shell wall in this localized area is thinned.

This portion of the evaporator pot is expected to have the microstructure most susceptible to corrosion due to the numerous weldments on the interior of the tank wall with the attachment of the overflow weir. A through-wall penetration of the 3/8" thick wall could develop in approximately 19 years under the following conservative assumptions: (1) corrosion rate of 60 mils/year, as observed in sensitized type 304L coupons in simulated solution, (2) 33%  $\text{HNO}_3$  exposure at boiling temperatures, and (3) uniform exposure at this region. It is possible that the extensive weldments in this area could lead to a buildup of impurities, leading to a high corrosion rate. However, it is expected that the remainder of the tank will be microstructurally less susceptible to corrosion.

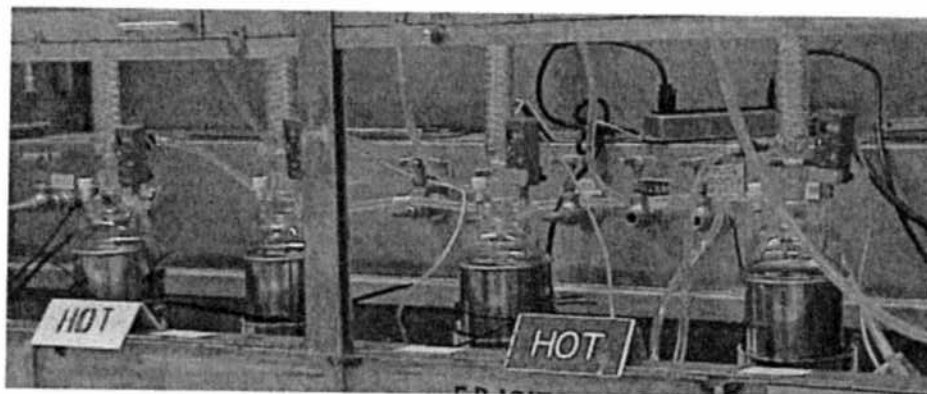
**Figure 6: Exposure testing of candidate materials**

Lead surveillance testing was performed to determine functionality of several combinations of materials and exposures. The testing was performed by machining a through-wall notch into a 1L stainless steel beaker and applying various repair patch combinations (as shown in Figure 6) in 'Cells 1-4' respectively. Each cell has 2 machined leaksites (A and B) that have been patched.

Cell	Patch	Solution	Comments
1A	Viton <sup>®</sup> B Foam + Viton <sup>®</sup> Sealant + RTV Sealant	12 hours NaOH >48 hours HNO <sub>3</sub>	No leaks. NaOH solution discolored slightly. Black flakes in bottom of beaker
1B	Viton <sup>®</sup> B Foam + Viton <sup>®</sup> Sealant + Liquid Metal Paste	12 hours NaOH >48 hours HNO <sub>3</sub>	No leaks. NaOH solution discolored slightly. Black flakes in bottom of beaker
2A	Viton <sup>®</sup> Sealant	12 hours NaOH >48 hours HNO <sub>3</sub>	No leaks. NaOH solution discolored.
2B	Viton <sup>®</sup> A Foam + Viton <sup>®</sup> Sealant	12 hours NaOH >48 hours HNO <sub>3</sub>	No leaks. NaOH solution discolored.
3A	Viton <sup>®</sup> B Foam + Viton <sup>®</sup> Sealant + RTV Sealant	12 hours NaOH 12 hours NaOH 14 hours HNO <sub>3</sub> 4 hours HNO <sub>3</sub>	No leaks. NaOH solution discolored slightly. Black flakes in bottom after NaOH exposures, not seen during HNO <sub>3</sub> exposure. Temperature remained at 70°C.

3B	Viton <sup>®</sup> B Foam + Viton <sup>®</sup> Sealant + Liquid Metal Paste	12 hours NaOH 12 hours NaOH 14 hours HNO <sub>3</sub> 4 hours HNO <sub>3</sub>	No leaks. NaOH solution discolored slightly. Black flakes in bottom after NaOH exposures, not seen during HNO <sub>3</sub> exposure. Temperature remained at 70°.
4A	Viton <sup>®</sup> Sealant	12 hours NaOH 12 hours NaOH 14 hours HNO <sub>3</sub> 4 hours HNO <sub>3</sub>	No leaks. NaOH solution discolored. Black flakes in bottom. Loss of adhesion of sealant on interior surface.
4B	Viton <sup>®</sup> A Foam + Viton <sup>®</sup> Sealant	12 hours NaOH 12 hours NaOH 14 hours HNO <sub>3</sub> 4 hours HNO <sub>3</sub>	No leaks. NaOH solution discolored. Black flakes in bottom. Loss of adhesion on interior surface.
