A Structural Integrity Evaluation of the Tank Farm Waste Transfer System

WSRC-TR-2005-00532 Rev. 1

Keywords: Corrosion, Structural Integrity, Transfer Lines

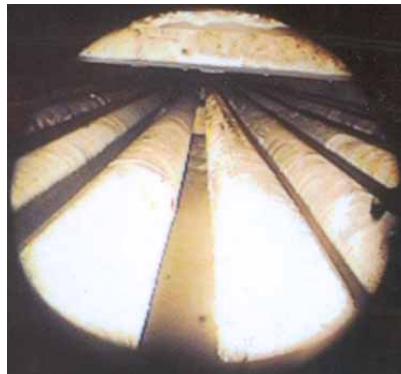
Figure 1. View of Type I Transfer Lines in Concrete Encasement between Tanks 1 to 8 in F-area

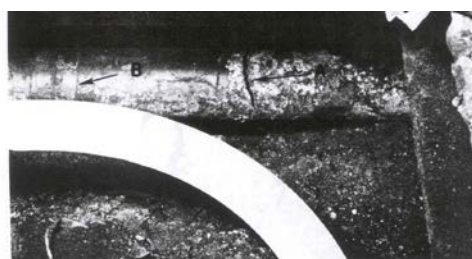
CRACKED SERVICE PIPE (NOZZLE 9) OUTSIDE EAST WALL OF F-AREA CTS PIT.

etc) that were also embedded in the concrete. As mentioned earlier, the pit wall was repaired by replacing the embedded sections of pipe with new stainless steel pipe enclosed in modular jackets. The jackets provided an enclosed air space around the stainless steel piping, eliminating any contact with chloride bearing materials.

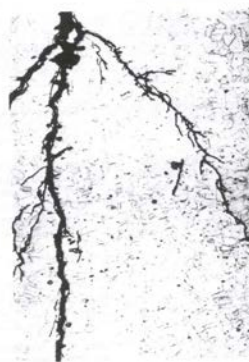
TRANSVERSE SECTION OF SERVICE PIPE (NOZZLE 9) SHOWING BRANCHING TRANSGRANULAR STRESS CORROSION CRACKS.

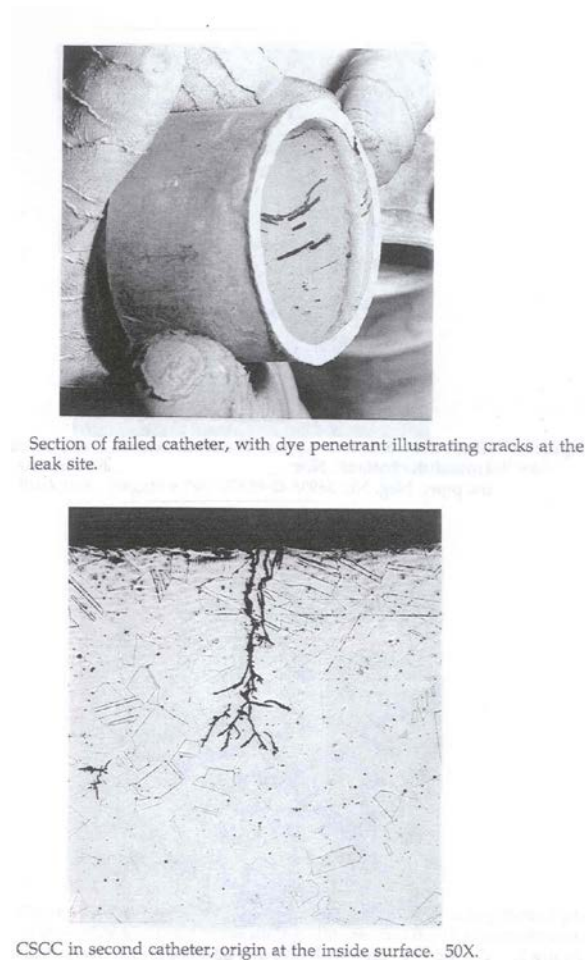
heated soil in the area was observed to be unusual. The steam leakage was postulated as a heat source which would produce the elevated temperatures necessary to enhance stress corrosion cracking. A time/temperature combination is also required for cracks to initiate and propagate. It was observed that both the extended period of steam leakage and the extended period before the line was placed in service were likely contributors to the failure. It was therefore recommended that the repair time for leaks in buried steam lines be minimized and that new pipe lines should not be held out of service for extended periods of time [60].

Figure 10. Section of core pipe from clean-out-port #3: (a) Dye penetrant test showing cracks on the interior of the pipe, (b) Micrograph showing transgranular chloride SCC [61].

Due to this failure, it was also recommended that the time for which the transfer lines are exposed to stagnant well water at elevated temperatures be minimized. Administrative controls, such as the Corrosion Control Program Description Document, are in place to minimize the potential for well water to be left in the lines for extended periods of time [61]. In fact, placing the lines in service with the waste supernate, which has relatively high nitrate and hydroxide concentrations, will protect the stainless steel.

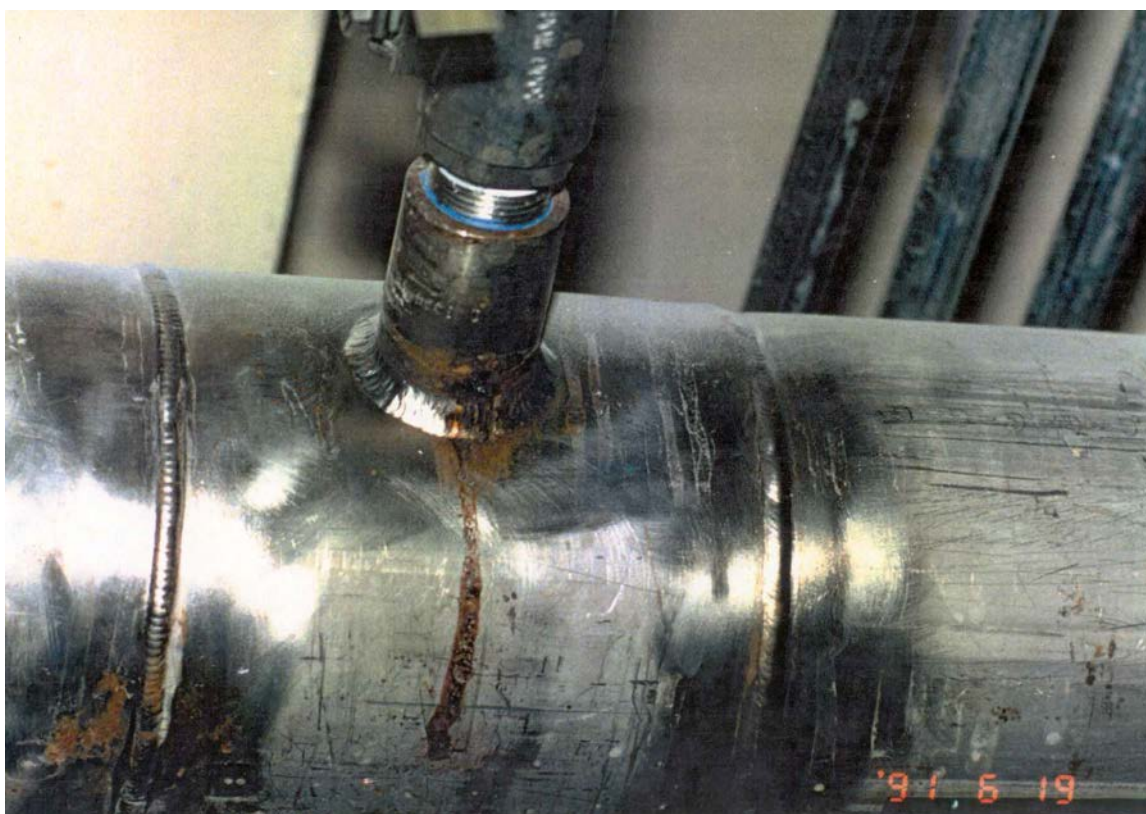
There have been three documented cases of MIC of stainless steel piping at SRS. One case was confirmed, while MIC likely played a role in the corrosion mechanism in the other two cases based on the appearance of the corrosion and the environmental circumstances. The confirmed case of MIC occurred in the Defense Waste Processing Facility (DWPF) in 1991 [68]. During a routine walk-through inspection of the Melter Cooling Water System (MCWS), rust colored “bleed-through” was observed on the exterior of the piping near the welds (See Figure 13). Approximately 1/3 of the welds in the piping showed evidence of leakage. The MIC presumably occurred because the MCWS was originally tested and flushed with neutral water that was not chlorinated or treated with any biocide. When water quality problems were noted, the system was drained and flushed with de-ionized water that was not treated. The water was left stagnant in the line for several months.

Figure 13. Evidence of MIC on the exterior of the cooling water pipe in the DWPF [68].

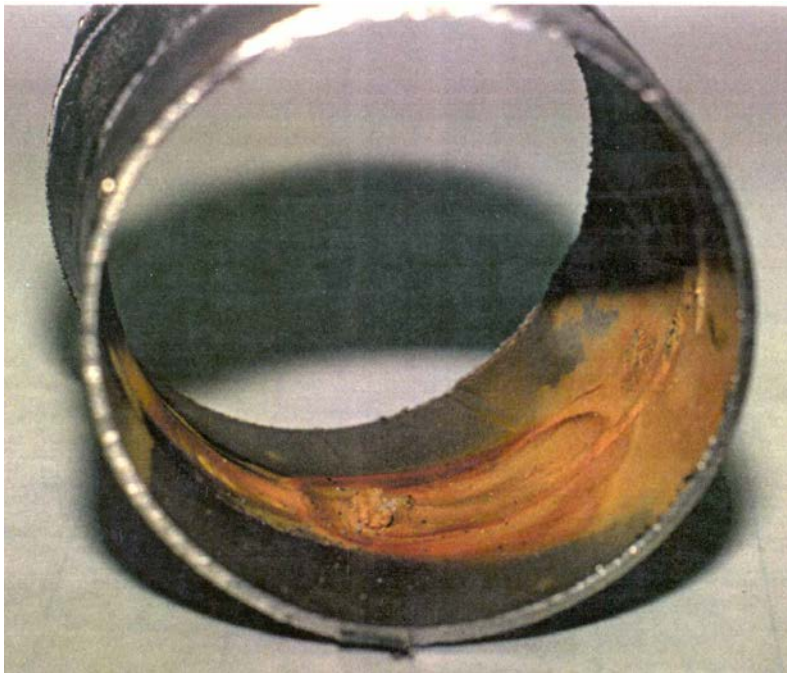
Evidence of tubercles was observed on the interior of the pipe near the welds (see Figure 14). The MIC colonies were tested and it was determined that the attack was due to iron and manganese oxidizing bacteria. Metallographic observations of the failed pipe showed that pitting corrosion occurred with the development of large sub-surface voids near welds (see Figure 15). From Figure 16 it can also be seen that preferential corrosion occurred along the interfaces of the two phase dendritic structure of the weld filler metal.

Figure 14. Dry tubercle and ring stains on pipe weld associated with MIC [68].

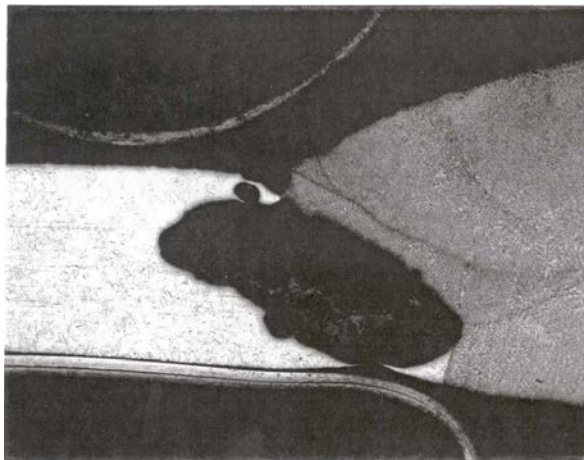
Figure 15. Macroview of pipe wall section at weld that shows evidence of MIC. Void caused by corrosion traverses entire cross-section [68].

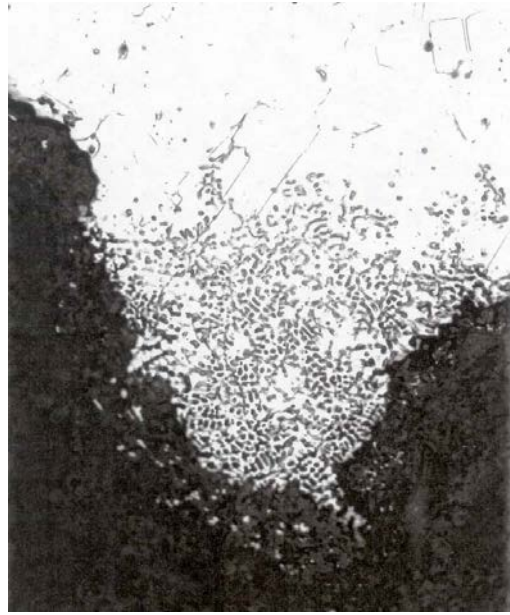
Figure 16. Preferential corrosion of weld filler material in the vicinity of the MIC attack [68].

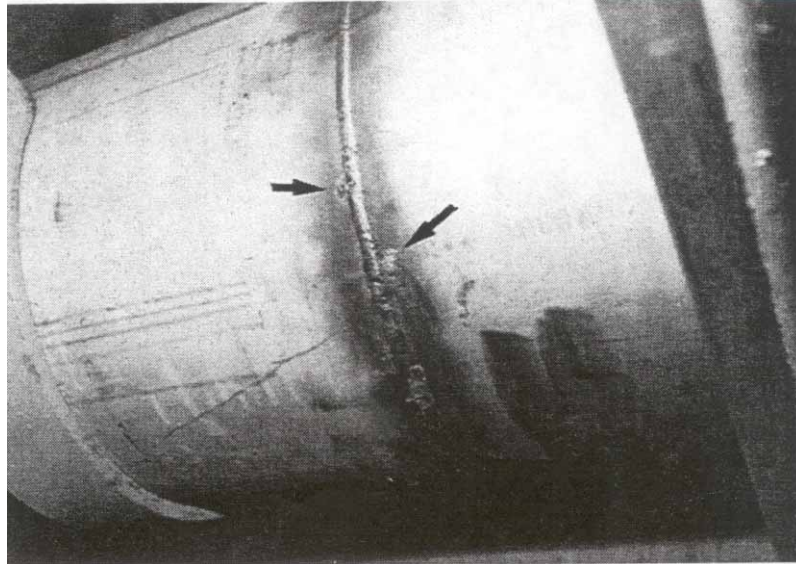
MIC is also suspected as the primary cause of leakage from a cooling water header inside the 221-H canyon facility [69]. The sections of the header affected were the farthest from the supply, and the flow was essentially non-existent between 1986 and 1991. The leaks occurred on, and near, several welds on the header. A total of 13 welds were observed to contain pitting. A brown deposit and staining was observed on the exterior of the pipe at the leak site. Radiographic examination of the pipe wall revealed the presence of voids primarily at the bottom of the pipe where mud had deposited. The pipe was sectioned in these areas where voids were discovered and destructive metallography was performed. Preferential attack of the weld zone similar to that discovered in the MCWS was evident (see Figure 17) and the attack initiated at the toe of the weld. The void itself indicated that corrosion proceeded along grain boundaries and resulted in grain dropping of the austenitic phase (see Figure 18). During internal inspections of the pipe, samples of mud were collected and analyzed for microbes. Tests for anaerobic, sulfate reducing, and acid-producing types of microbes were positive. No tubercle formations were observed at the location of the voids. However, it remains possible that less-rigid masses of organisms and corrosion products had existed and were disturbed by the mud.

Figure 17. Leaks were located near circumferential welds [69].

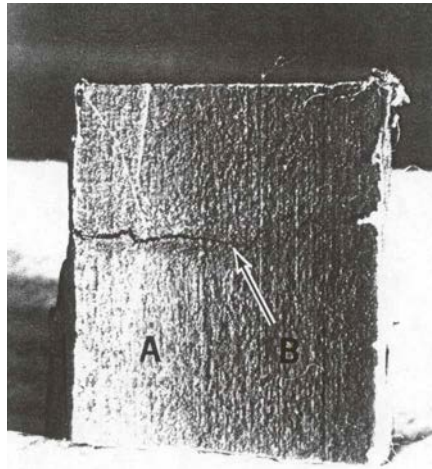
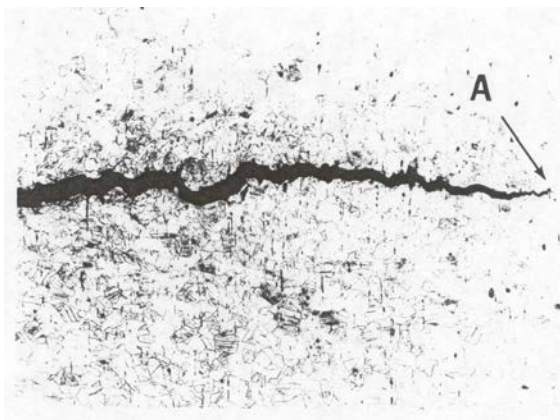
Figure 20. Fatigue crack of 501 transfer line (near 1-H Evaporator): (a) View of interior surface of pipe, (b) Micrograph showing the fatigue crack [9].

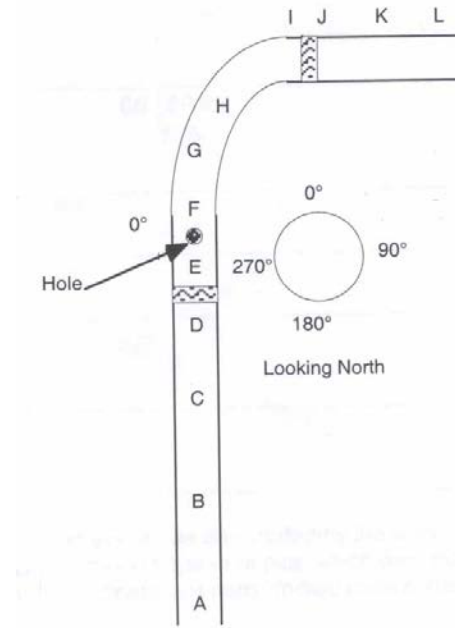
Figure 22. Diagram showing the location of the through-wall penetration and area of UT data collection on Line #106 (near FDB-2) [98].

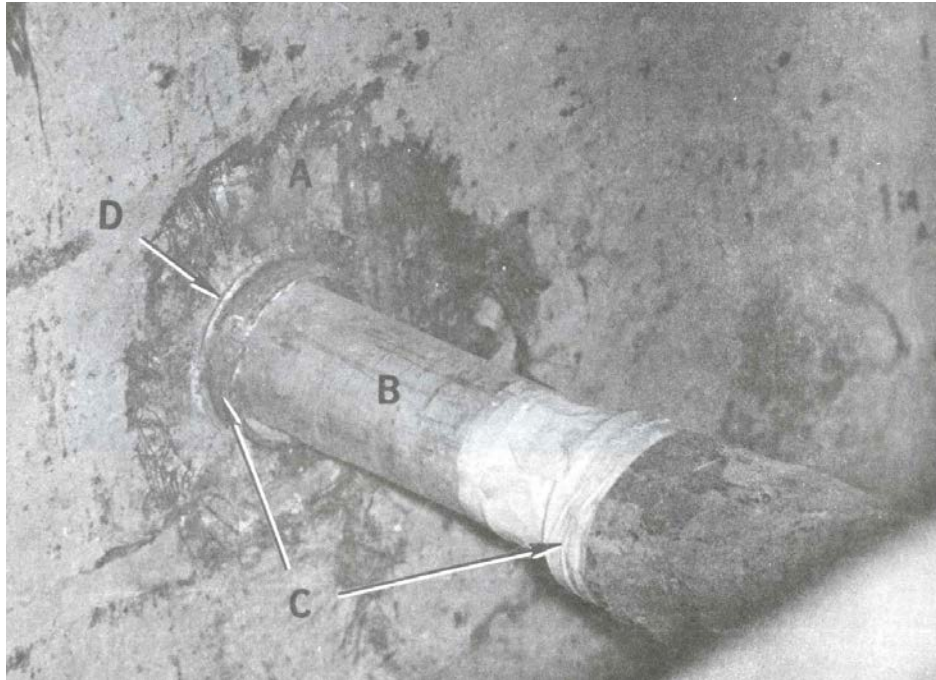
Several other process lines near line #106 also had jackets with a wall thickness of 0.156". In 1980, a failure of the jacket on transfer line #108 was discovered near the concrete wall of FDB-2 [99]. The dimensions of the jacket were the same as those for line #106. Visual inspection revealed a crack in the weld that attaches line #108 to the wall of FDB-2. The failure was likely due to a poor weld in combination with surface loading (e.g., heavy cranes). The jacket showed little or no evidence of wall thinning or pitting (see Figure 23). This observation provides further evidence that properly coated lines do not suffer general corrosion and excessive thinning. However, local damage or small flaws in coatings lead to local attack and the formation of small through-wall penetrations.

Figure 23. View of FDB-2, Line #108 with 9-inch section of jacket removed: (A) FDB-2 concrete wall, (B) core pipe, (C) jacket, (D) cracked weld [99].

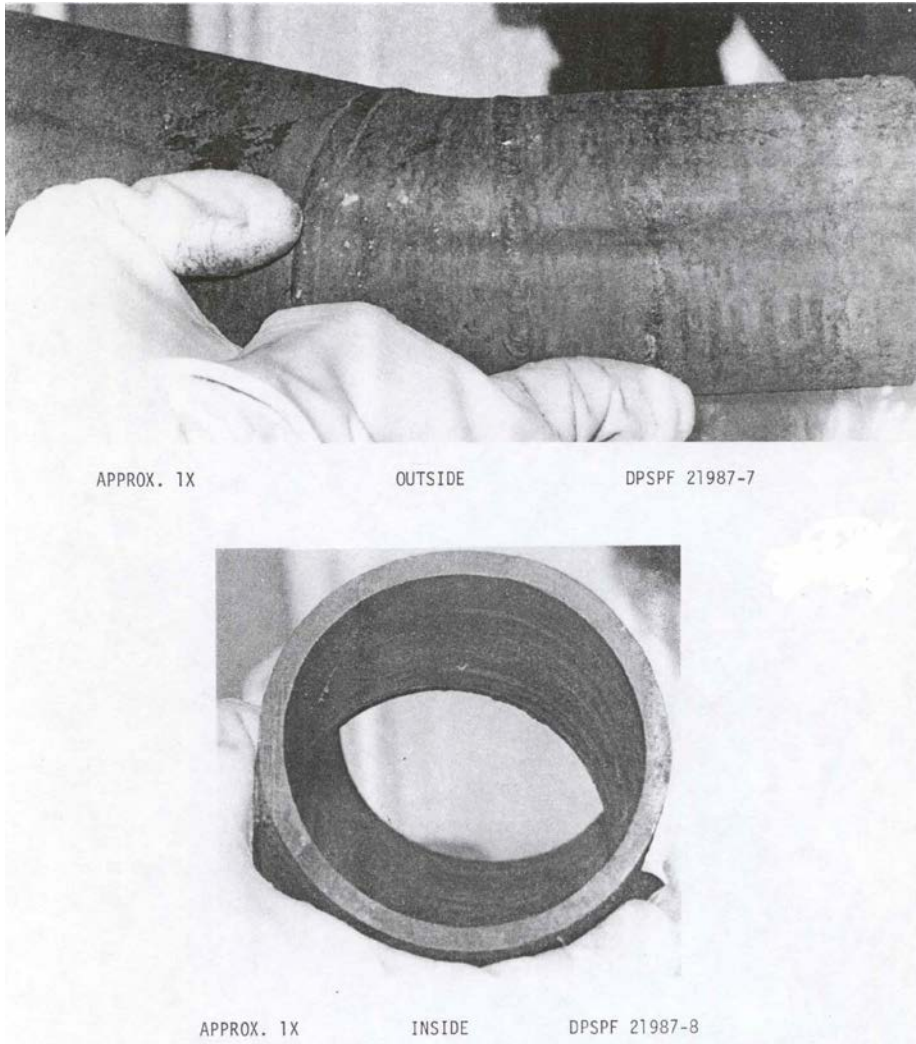
Figure 24. Carbon steel elbow from core pipe between Tanks 1 and 7: (a) exterior and (b) interior [100].

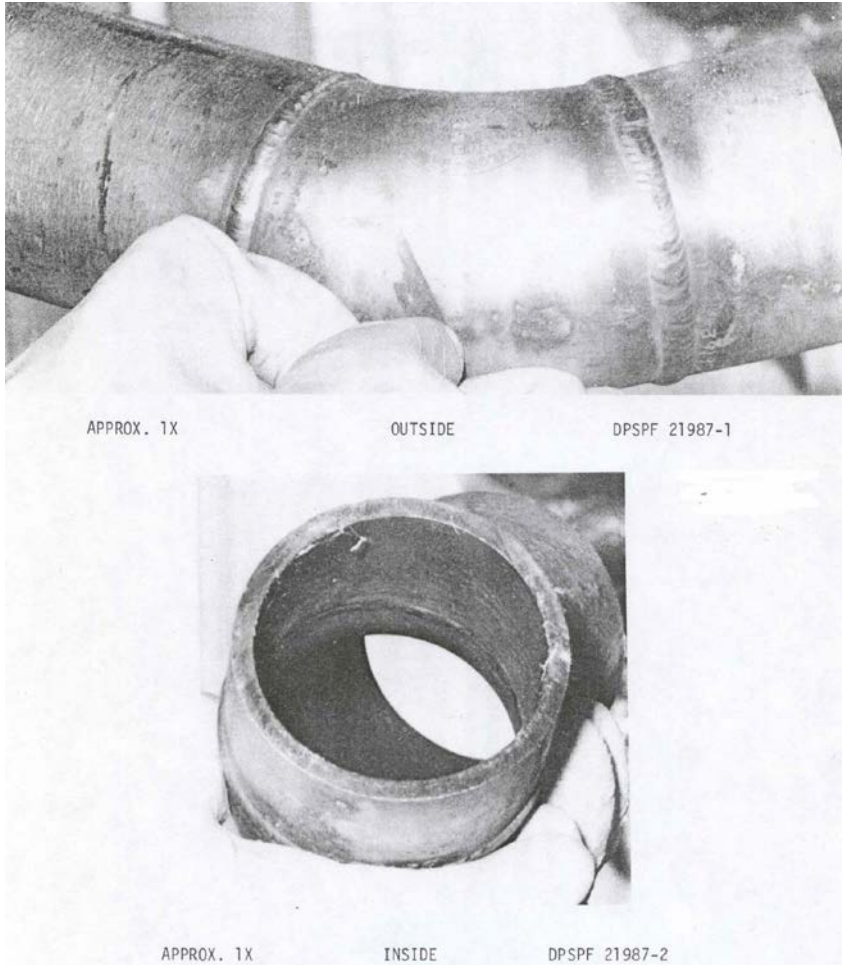
Figure 25. Stainless steel elbow from core pipe between Tanks 6 and 7: (a) exterior and (b) interior [100].

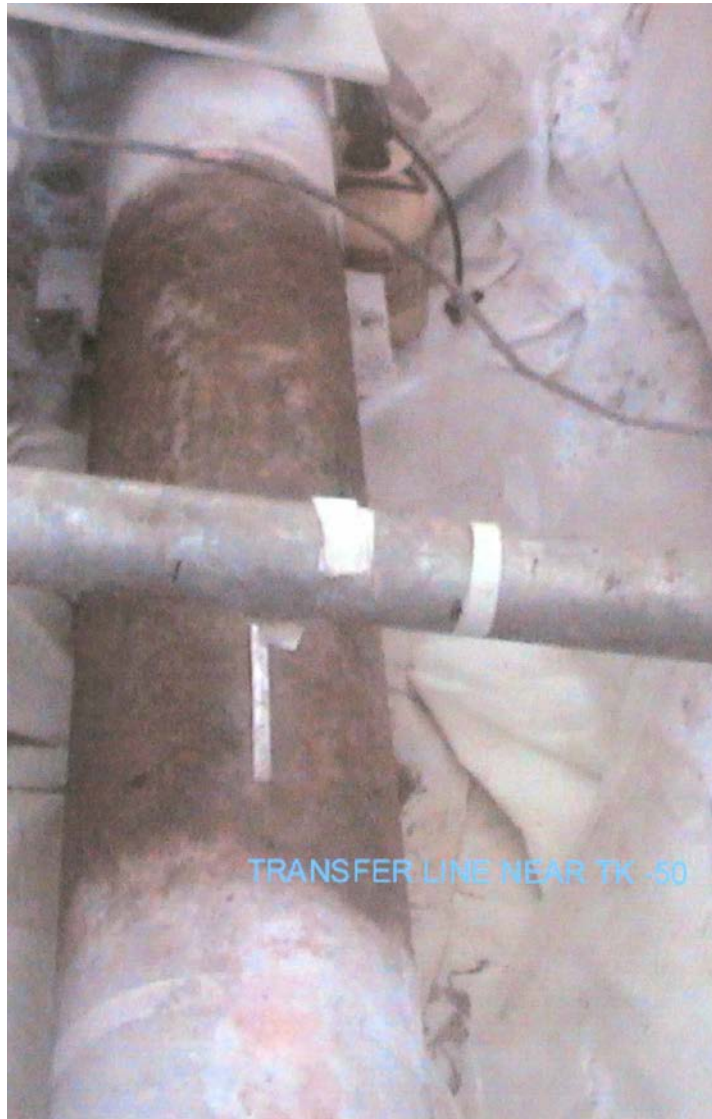
Figure 26). Generally, the wall loss was greater (more frequent and deeper pitting) along the bottom half of the jacket.

Figure 26. View of Line #1663 (near Tank 50) that shows corrosion of the exterior of the jacket [102].

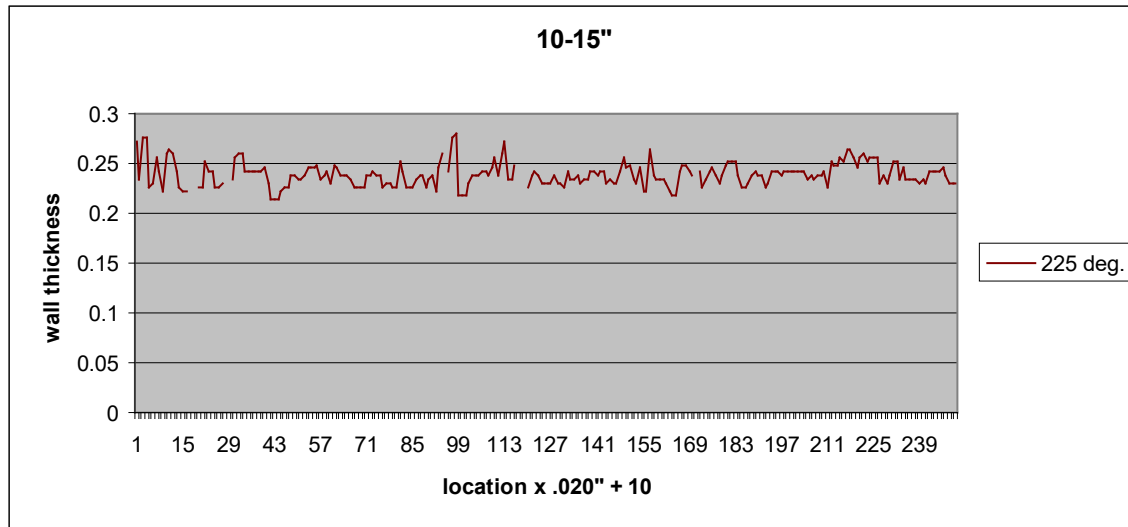
Ultrasonic line scans were performed every 45 degrees around the jacket circumference to determine the wall thickness profile. Approximately 12,000 data points were recorded (see Figure 27 for an example of the thickness profile). Examination of all the profile data showed that the average thickness (approximately 0.24") is near the nominal thickness. However, significant pitting was identified and the minimum wall thickness at the deepest pit was 0.127".

Figure 27. Thickness profile of Line #1663 (near Tank 50). The location is approximately 10-15" along the corroded area at approximately 225° from the top of the pipe [102].

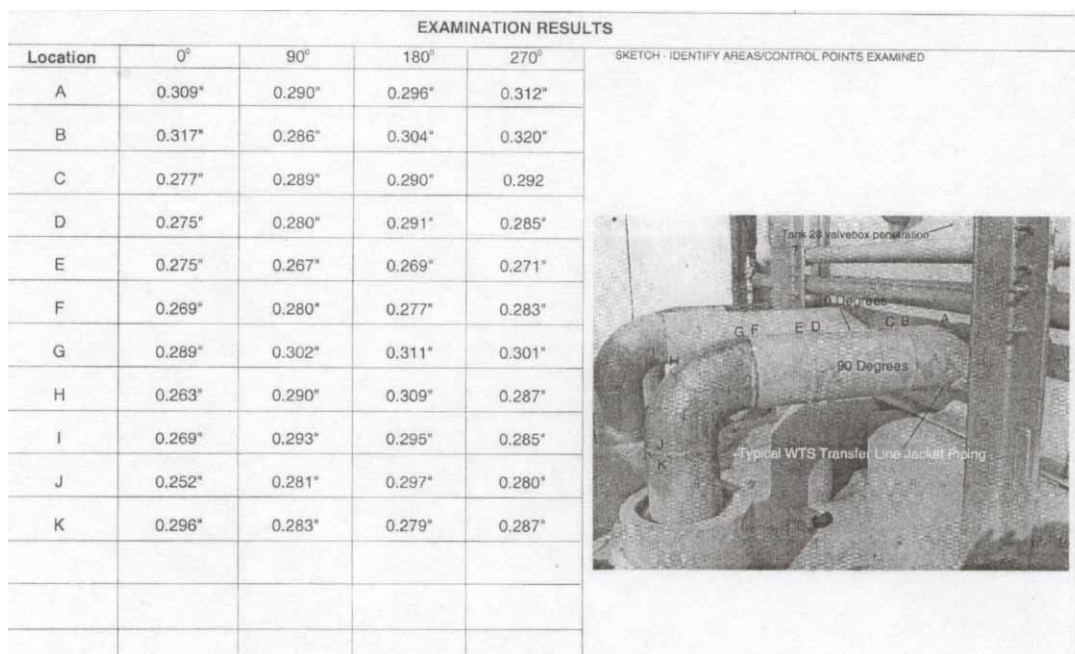
Figure 28. UT data for Line #1211 jacket (near Tank 28) [103].

These jackets were shielded with lead and covered with insulation. Installation of the exterior insulation under current quality control practices will ensure that little or no further degradation of the carbon steel occurs during service. The ambient environment is expected to be less aggressive than the soil. Therefore, no additional actions are recommended for this situation.

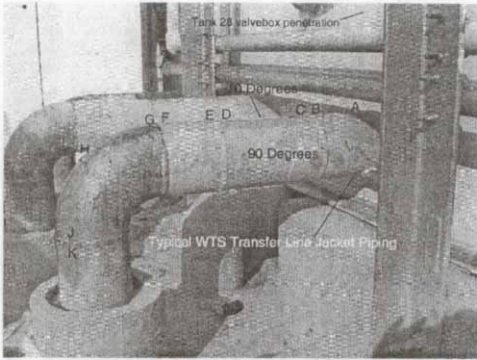
Figure 30. UT data for Line # 1216 jacket (near Tank 28) [103].

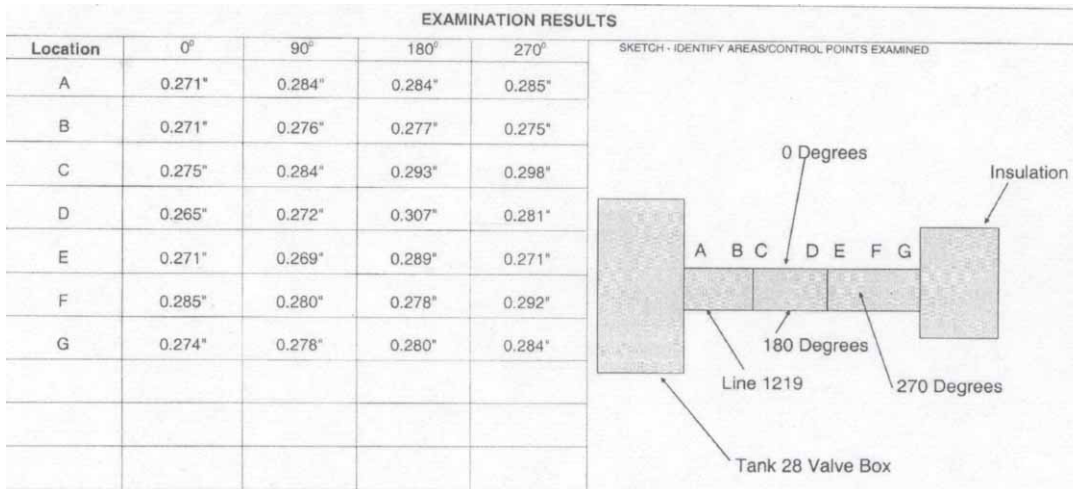
Figure 31. UT data for Line #1209 jacket (near Tank 28) [103].
