Analyses of HAZEN Corrosion Coupons, Rev. 1 (U)

Savannah River National Laboratory
Strategic Materials Technology Department
Materials Technology Section

Publication Date: April 2006

DOCUMENT: WSRC-TR-2006-00142, Rev. 1

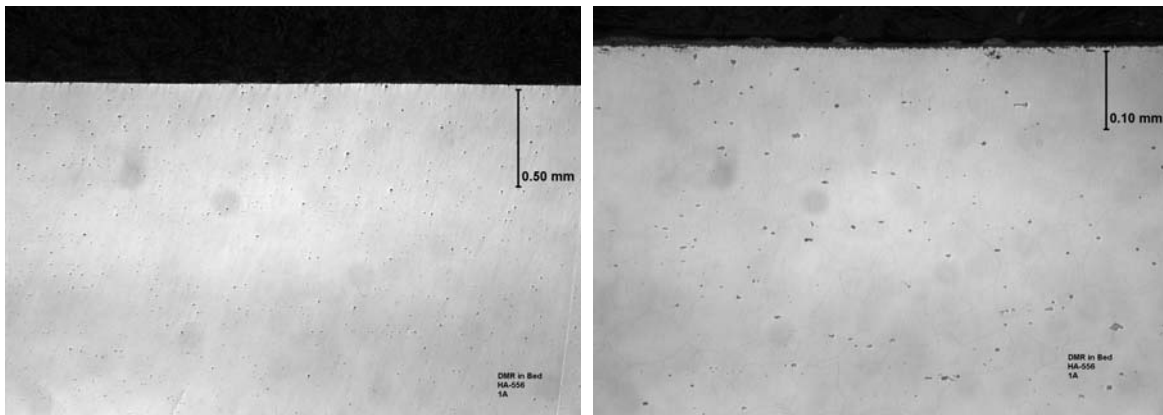
Figure 2: Metallographic Cross Section of Coupon 1A - Haynes 556 Alloy Exposed to DMR Bed

The micrographs of the coupons exposed to the DMR bed are shown in Figure 2 - 5. The Haynes 556 and 230 alloys appear to have a relatively straight corrosion front, while the HR-160 alloy exhibited intergranular attack. The Haynes 230 alloys appeared to have diffusion related effects as the grain boundaries were explicitly visible.

The Haynes 556 appeared to have a uniform corrosion front with a continuous protective oxide scale. The Haynes 230 showed evidence of non-uniform attack, i.e. pitting and a slightly thicker oxide scale. The Haynes HR-160 exhibited uniform and shallow intergranular attack (IGA). The 316L stainless steel exhibited a thick oxide scale.

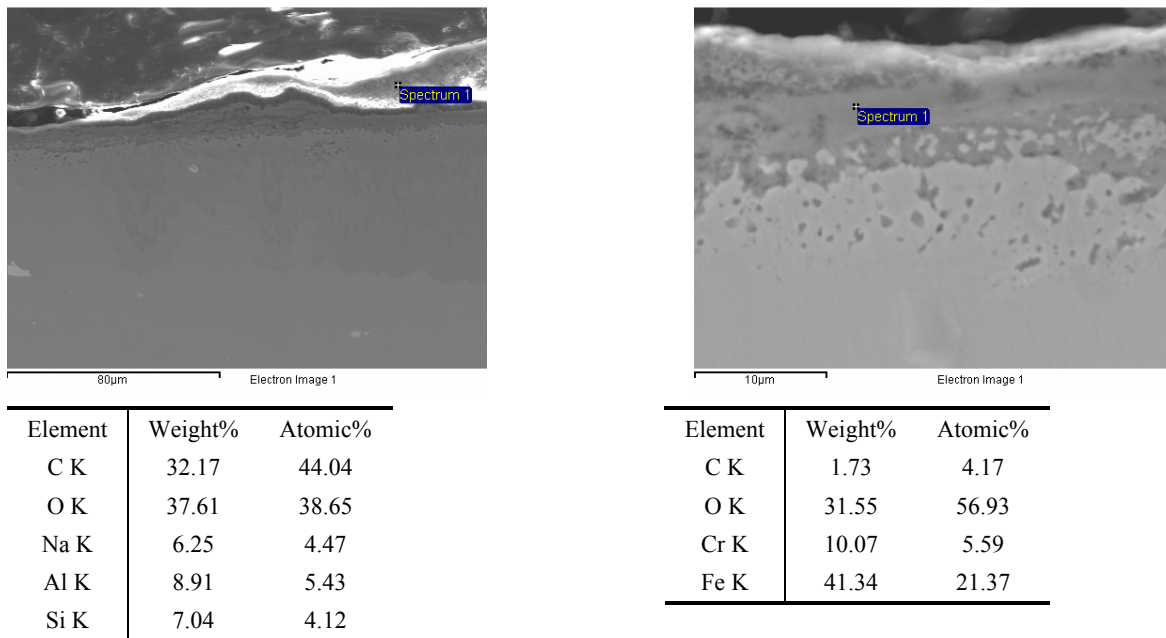
In the HA-556 alloy, the underlying oxide is primarily iron oxide, and there was no evidence of sulfide phase forming within the matrix. The HR-160 alloy had an oxide layer of a combination of chromium, cobalt, and nickel. However, there was evidence of chromium-rich sulfide formation within the matrix. The HA-230 alloy had an oxide layer of a combination of chromium, and nickel. However, there was evidence of chromium-rich sulfide formation within the matrix. The SEM/EDX analyses confirmed the formation of sulfide rich eutectics in the HR-160 and the HA-230 alloys, whereas the HA-556 alloys did not. As such, the HA-556 alloys is expected to have performed better than the other alloys in this application.

Figure 6: SEM/EDX of HA-556 Alloy Exposed to DMR Bed Indicating Ash-Type Deposit and Underlying Iron Oxide.

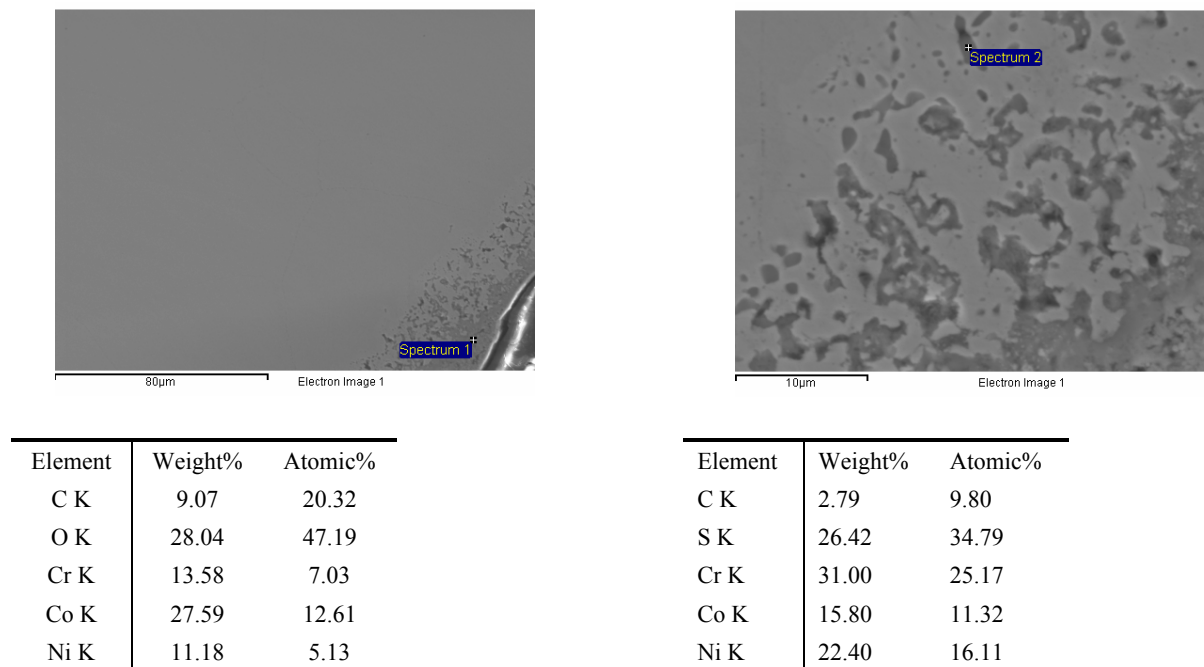
Figure 7: SEM/EDX of HR-160 Alloy Exposed to DMR Bed Indicating Ash-Type Deposit and Sulfide Formation Within Matrix

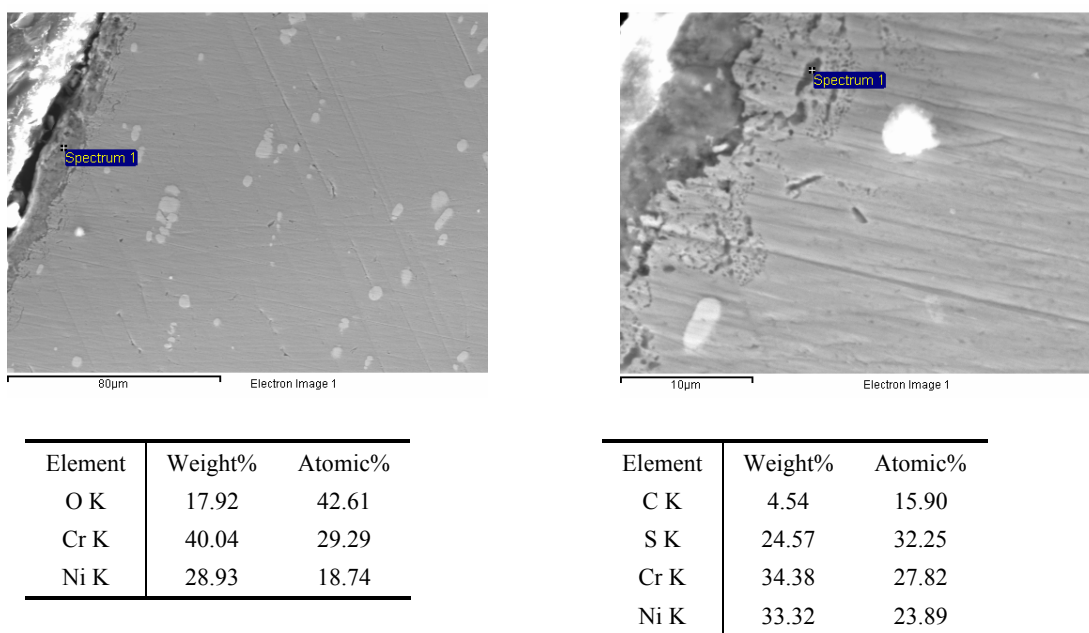
Figure 8: SEM/EDX of HA-230 Alloy Exposed to DMR Bed Indicating Ash-Type Deposit and Sulfide Formation Within Matrix

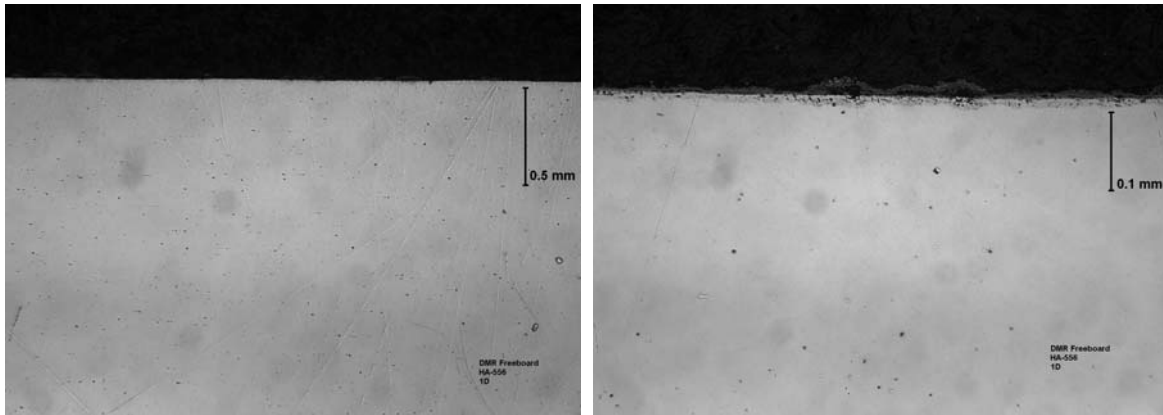
Figure 10: Metallographic Cross Section of Coupon 1D - Haynes 556 Alloy Exposed to DMR Freeboard

The micrographs of the coupons exposed to the DMR freeboard are shown in Figure 10 - 13. The Haynes 556 and 230 alloys appear to have a relatively uniform corrosion front, while the HR-160 alloy exhibited intergranular attack on the surface. The 316L stainless steel showed an extensive oxide layer and IGA.

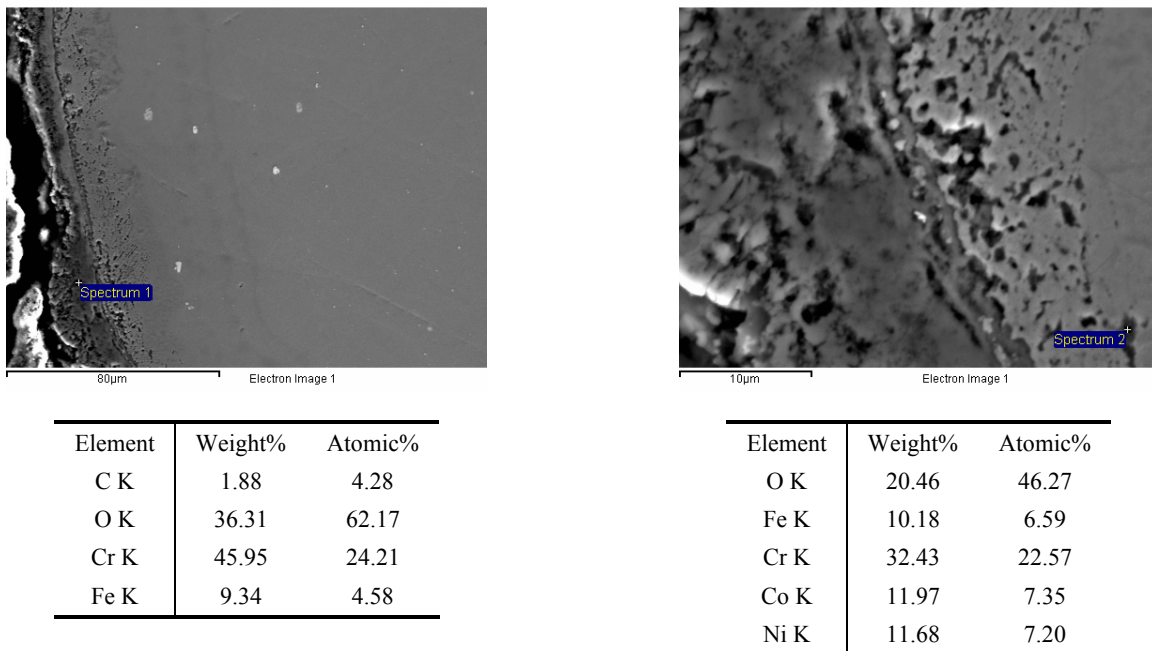
The coupons exposed to the DMR freeboard were expected to be subject to the same corrosion as in the DMR bed. Once again, SEM/EDX analysis, shown in Figure 14 - 16 was completed to determine the presence of sulfides in the matrix. As with the coupons exposed to the DMR bed, the HA-556 alloys did not exhibit the formation of the sulfides, while the HR-160 and the HA-230 alloys exhibited sulfide formation. As with the coupons exposed to the DMR bed, the HA-556 is expected to perform better than the alloys given the formation of the sulfides.

Figure 14: SEM/EDX of HA-556 Alloy Exposed to DMR Bed Indicating Ash-Type Deposit and Underlying Oxide.

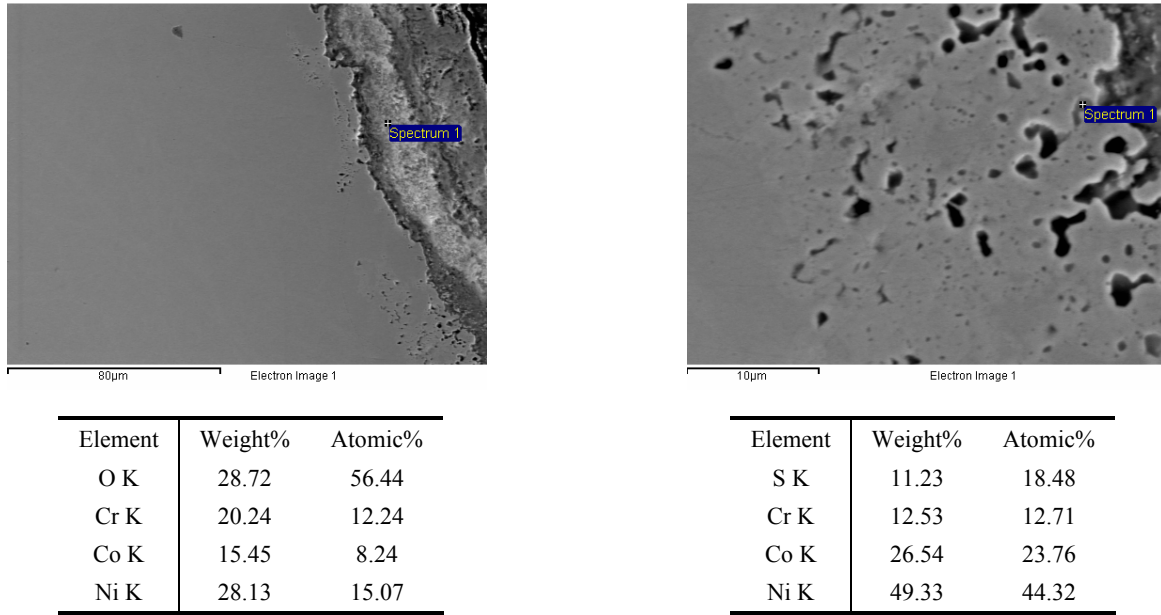
Figure 15: SEM/EDX of HR-160 Alloy Exposed to DMR Bed Indicating Ash-Type Deposit and Sulfide Formation Within Matrix

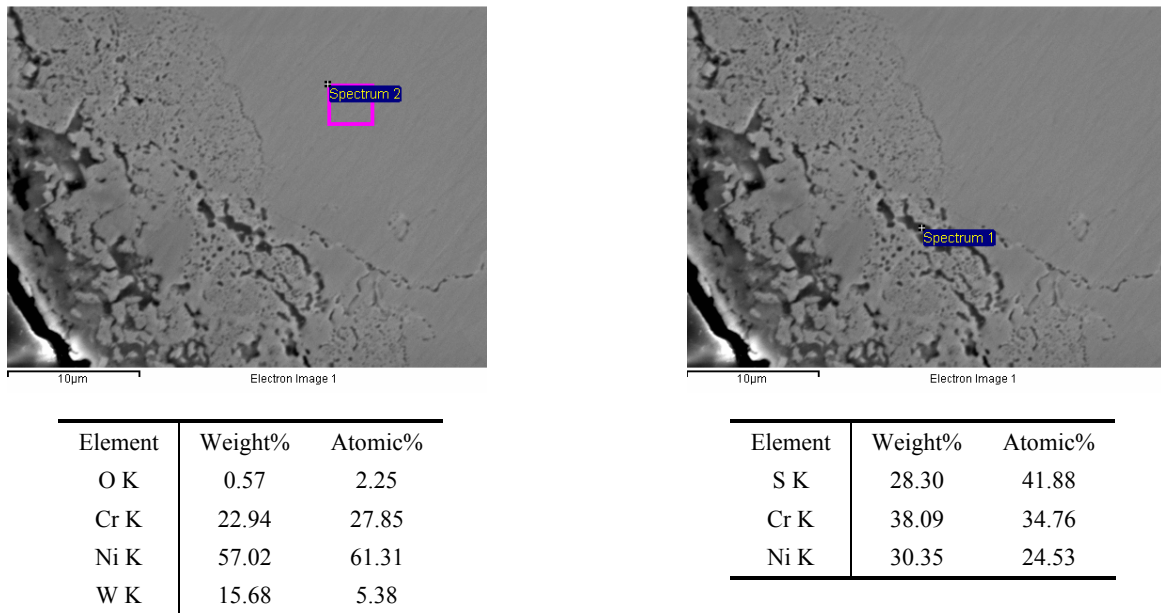
Figure 16: SEM/EDX of HA-230 Alloy Exposed to DMR Bed Indicating Ash-Type Deposit and Sulfide Formation Within Matrix

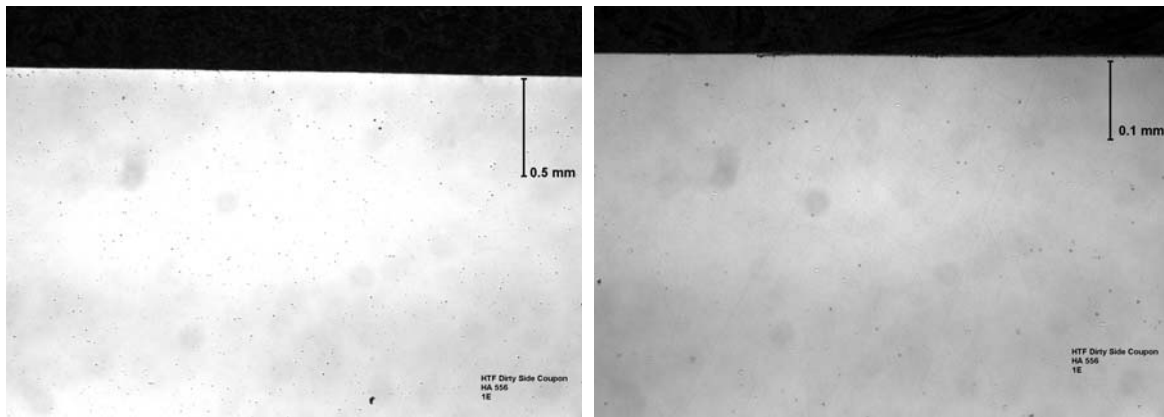
Figure 18: Metallographic Cross Section of Coupon 1E - Haynes 556 Alloy Exposed to HTF Dirty Side

The micrographs of the coupons exposed to the dirty side of the HTF are shown in Figure 18 - 21. The Haynes 556 and HR-160 alloys exhibited relatively uniform corrosion fronts without evidence of IGA. The HR-160 and 230 alloys showed evidence of pitting attack.

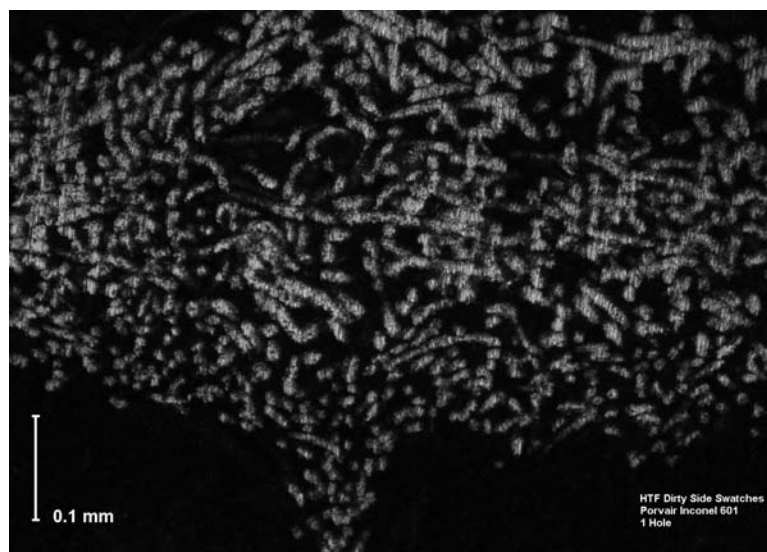
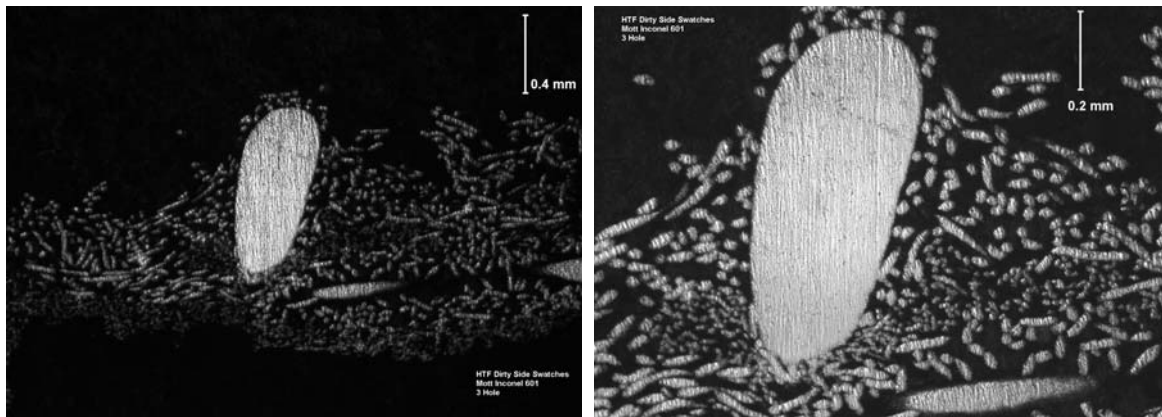
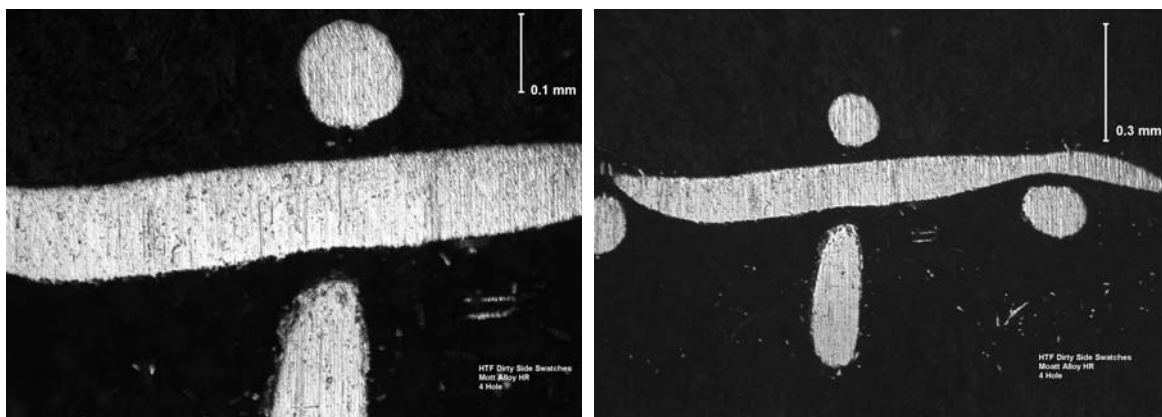
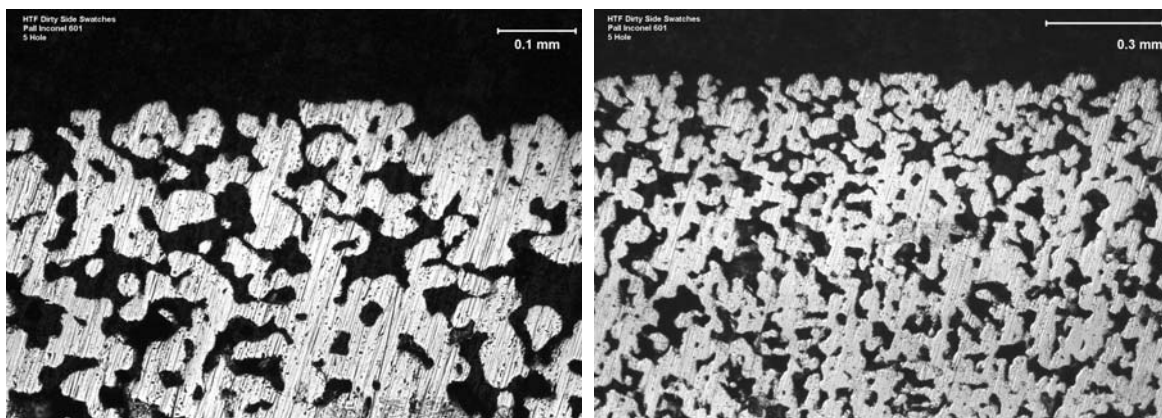
The micrographs and photographs showing overall condition of the swatches were used to rank these coupons. The Pall Inconel 601 Alloy appeared to have superior performance in this environment. However, it was clear the swatches did not retain sufficient integrity to maintain filter functionality. The orientation of the coupons played a key role in the degradation of the filters, as the process deposits were minimal on the Pall Inconel swatch while extensive on several of the other swatches.

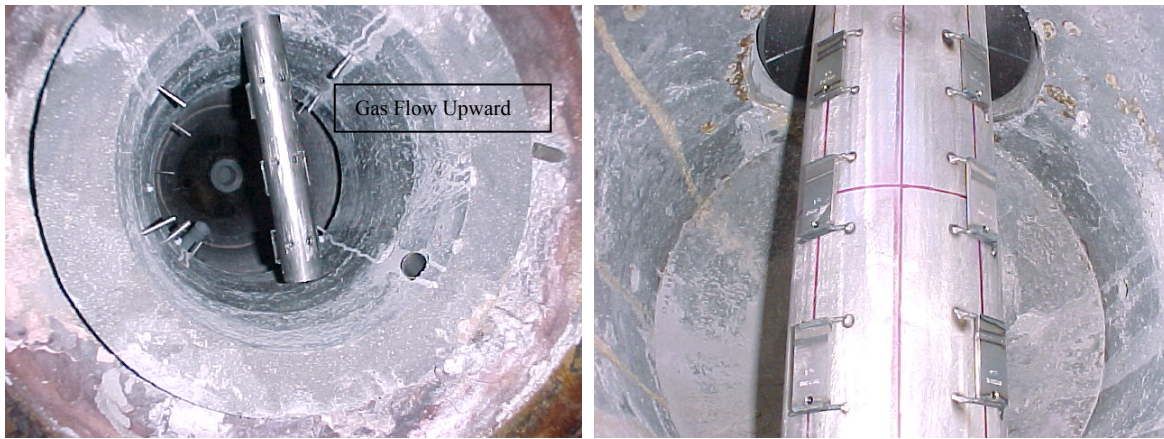
Figure 27: Coupons Exposed to CRR Bed

The pictures of the coupons are shown in Table 9. The coupons showed pervasive corrosion with significant erosion on the coupons, indicated by the smoothness on the edges. There was evidence of process deposits on the coupon, including silicates, sulfates, and phosphates.

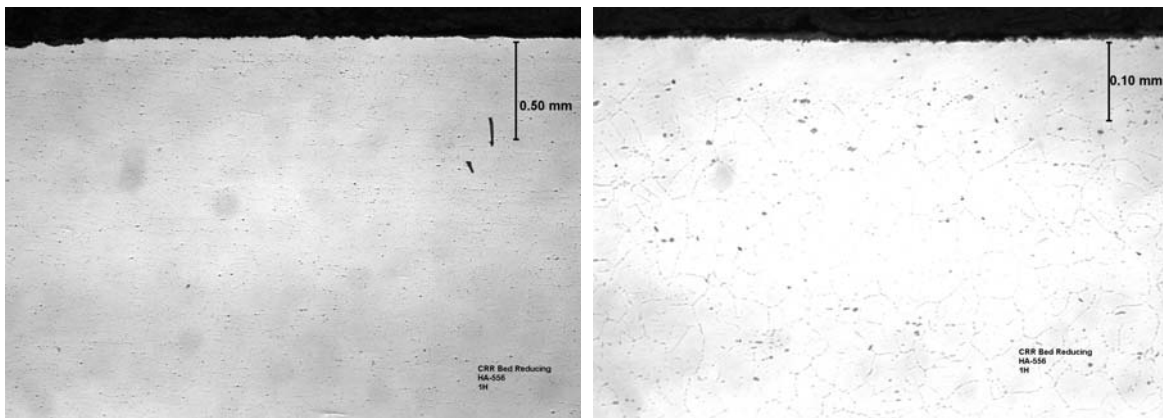
Figure 28: Metallographic Cross Section of Coupon 1H - Haynes 556 Alloy Exposed to CRR Reducing

The placement of the coupon in the process stream plays a significant role in the erosion of the coupon. The erosion resistance of these alloys is expected to be similar; however, it appears that the HR-160 eroded less than the other alloys. The micrographs of the coupons exposed to the CRR bed reducing are shown in Figure 28 - 30. All the alloys exhibited relatively straight corrosion fronts, with evidence of intergranular attack and dealloying at the surface.

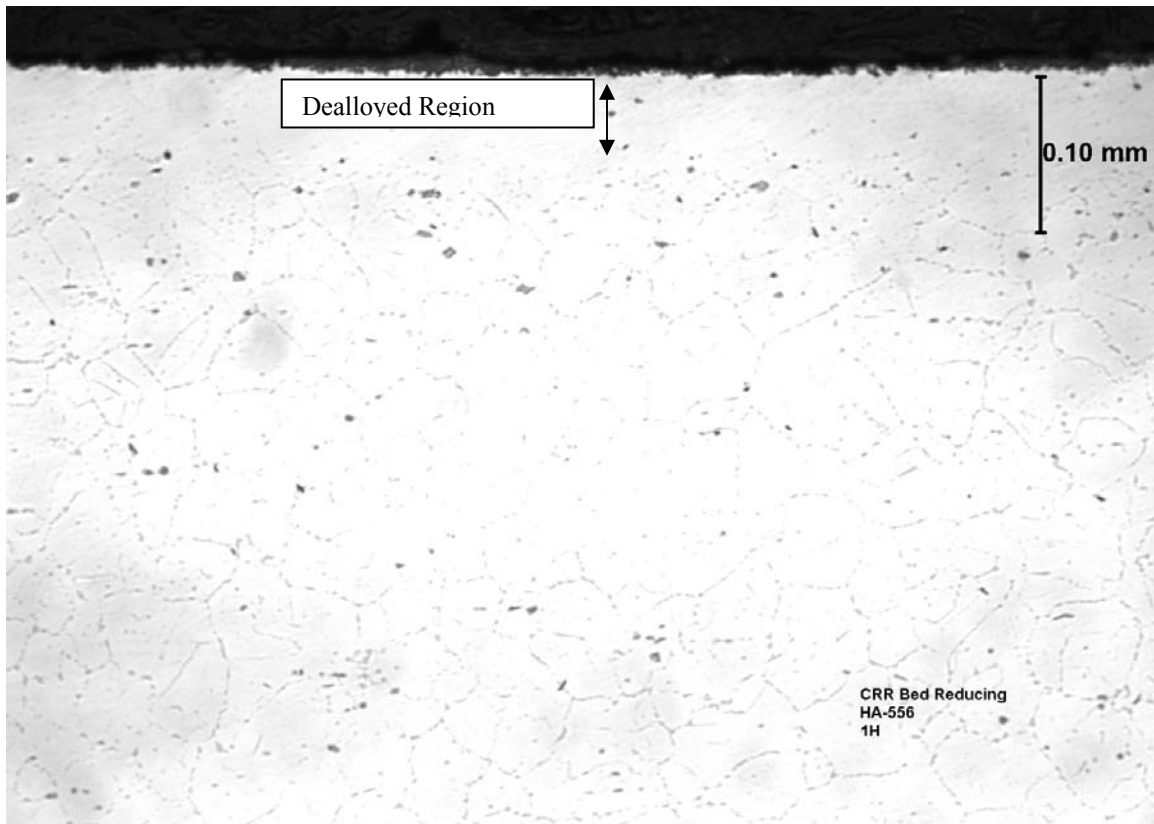
The “dealloyed” region is shown in Figure 31. The region is near surface and a region denuded of distinguishable grain boundaries is seen in the micrograph. This phenomenon is most likely due to diffusion related process at these temperatures, but can be considered a corrosion process. The phenomenon could also be due to a combination of erosion/corrosion mechanisms.

Figure 31: Metallographic Cross Section of Coupon 1H - Haynes 556 Alloy Exposed to CRR Reducing Showing Dealloying at the Surface

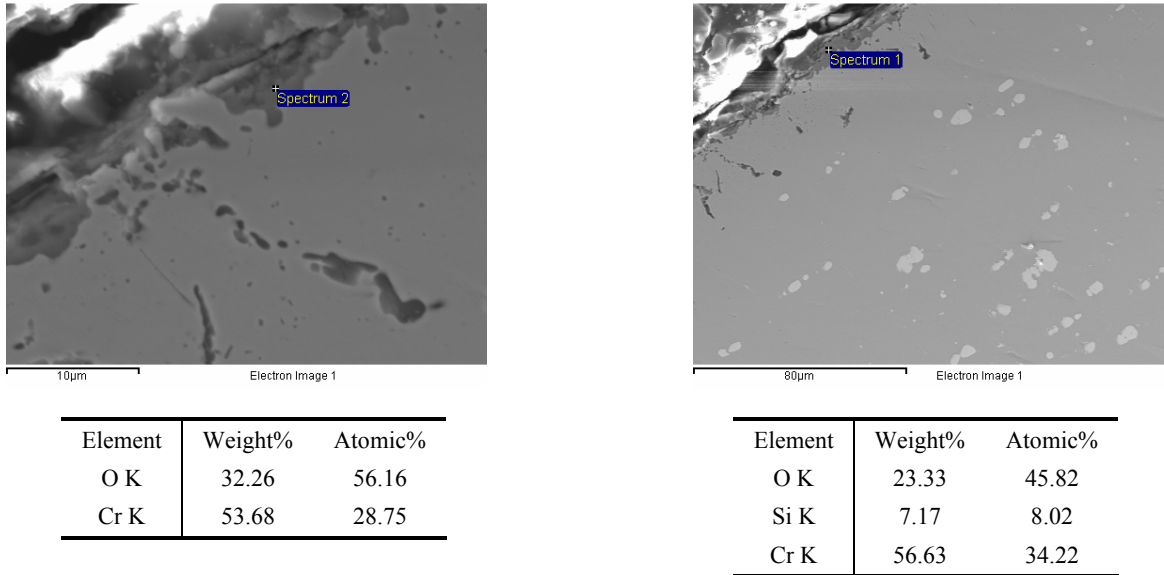
The SEM/EDX of the coupons exposed to the reducing portion of the CRR bed are shown in Figure 32 - 34. The analyses indicated the lack of an oxide on the surface of the Haynes 556 alloy, with iron as the primary chemical constituent. The HR-160 alloy and the Haynes 230 alloy had a chromia surface oxide with underlying silica. Even though the HR-160 alloy has significantly higher silicon content than Haynes 230, silica formed on both surfaces. The silicon additions are known to provide superior oxidation resistance at relatively high temperatures where the silica can form. The enhanced resistance has been attributed to the formation of a protective and tenacious silica layer.[11] It has also been proposed that the silica layer enhances the formation of stable chromia layers and may act as a diffusion barrier.[12]

Figure 34: SEM/EDX of Haynes 230 Alloy Exposed to DMR Bed Indicating Stable Oxide on Surface
