Analyses of THOR Treatment Technologies CP-2 Corrosion Coupons (U)

Savannah River National Laboratory
Strategic Materials Technology Department
Materials Technology Section

Publication Date: July 2006

DOCUMENT: WSRC-TR-2006-00268

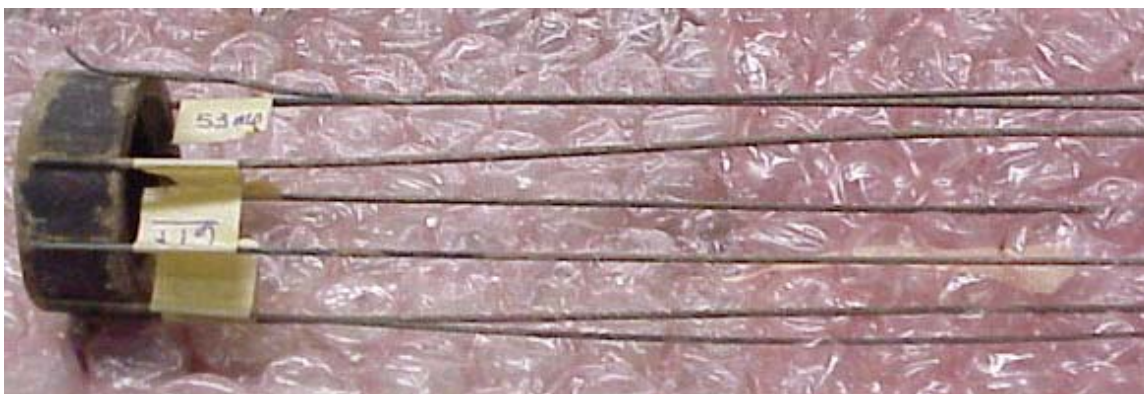
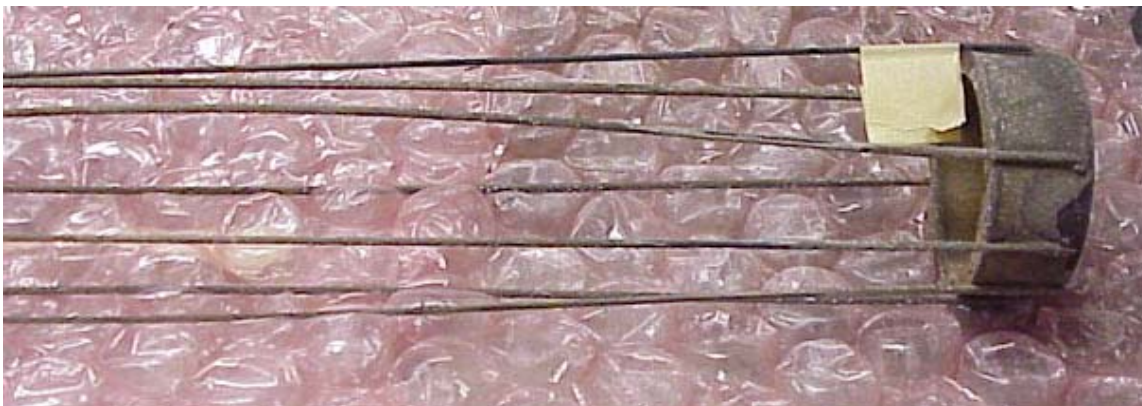
Figure 1: Wires Exposed to the DMR Freeboard

The DMR coupons were exposed for a total time of 180 hours nominally at 600°C, in addition to several days at elevated temperatures, i.e 100°C to 225°C. The thickness of the wires was measured to determine the general corrosion of the coupons. The thickness measurements do not reveal any differences in corrosion performance.

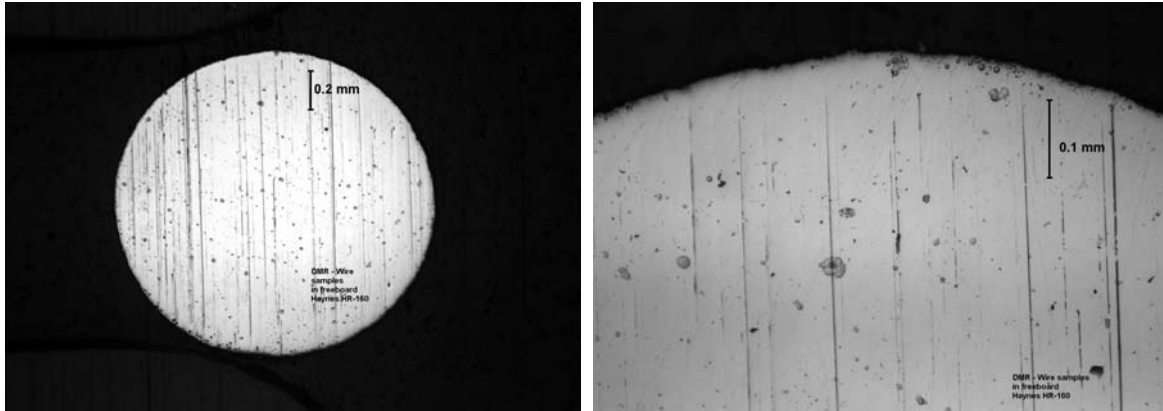
Figure 6: Metallographic Cross Section of HR-160 Wire

It is difficult to draw quantitative conclusions from these exposures because of the short duration and the relatively low temperature of the test. However, it appears that the HR-160 alloy has performed the best on the surface, but the 53MD has the least void formation within the matrix.

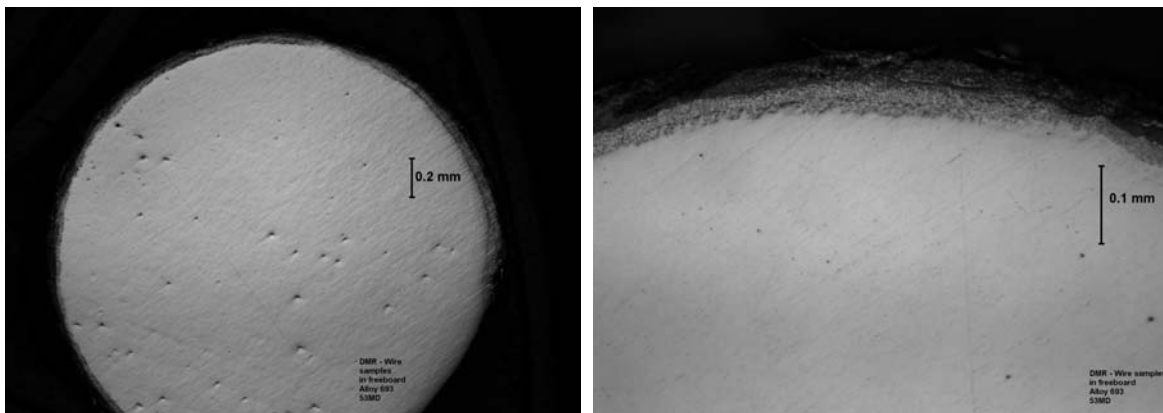
Figure 8: Metallographic Cross Section of 53MD (693) Wire

The metallographic analysis indicates that the 53MD wire has a stable oxide film on the surface and also indicates the least amount of void formation within the matrix. The 53MD wire also had the thickest oxide layer, but this may also be due to the exposed surface area being larger than the other wires, that were thinner. The oxide layer depth was estimated using the calibrated micrographs and are shown in Table 4. All of the alloys performed similarly with the exception of the 53MD alloy having the largest oxide layer.

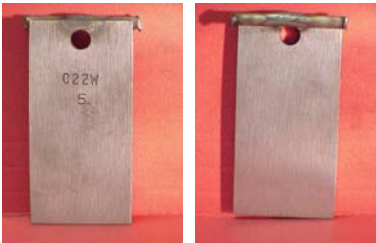
COUPON	MATERIAL	AS-RECEIVED	XRD DEPOSIT ANALYSIS
5A	Hastelloy C-22

Graphite Hg_2SO_4 (mercury sulfate)
6C	Hastelloy C-2000

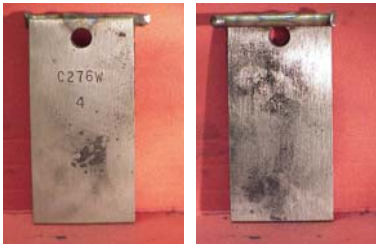
7E	Hastelloy C-276

Al ₂ O ₃ Aluminum Oxide Graphite Hg ₂ SO ₄ (mercury sulfate) Potassium aluminosilicate
8J	Al6XN

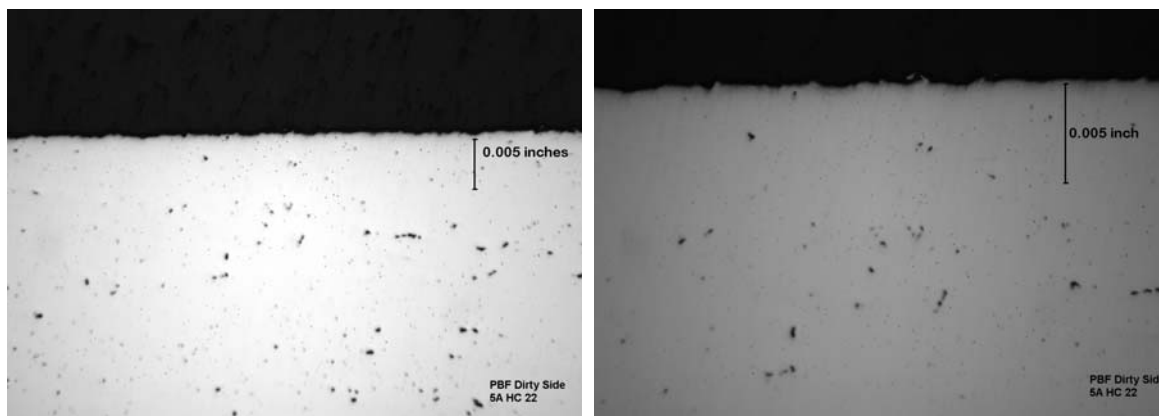
Figure 9: Metallographic Cross Section of Coupon 5A- Hastelloy C-22 Exposed to PBF Dirty Side

Metallographic analyses of these coupons were completed and are shown in Figure 9 - 13. The metallographic analysis indicates pervasive pitting with little intergranular attack beyond the pitting front.

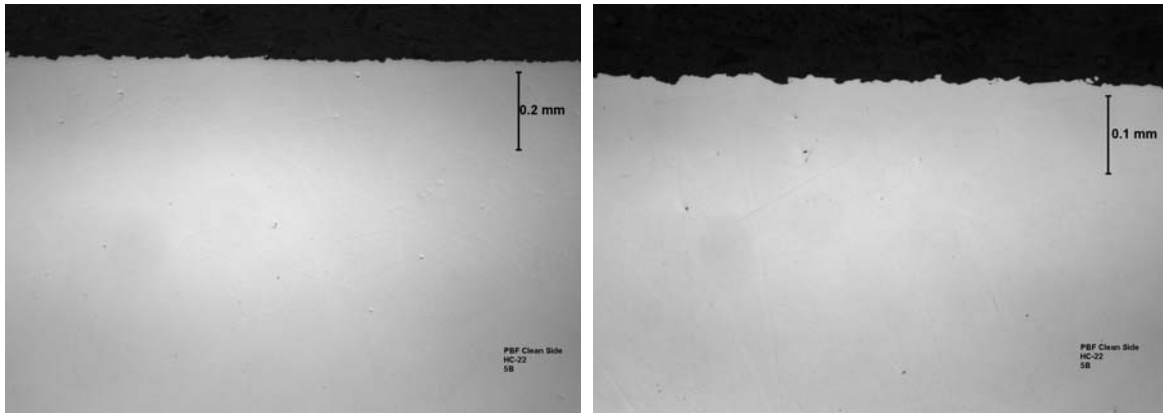
Figure 14: Metallographic Cross Section of Coupon 5B- Hastelloy C-22 Exposed to PBF Clean Side

None of the coupons exposed to the PBF clean side exhibited intergranular attack or internal void formation. Preliminary analysis of the microstructures indicates that performance of alloys was similar with the nickel based alloys performing slightly better than the stainless steels. The depth of penetration was estimated using the calibrated micrographs and are shown in Table 6. The temperatures in the PBF remained below 160°C and many of the high temperature corrosion mechanisms are not significant in this range. As such, the down-time corrosion or ash-related corrosion is potentially more significant for these coupons.

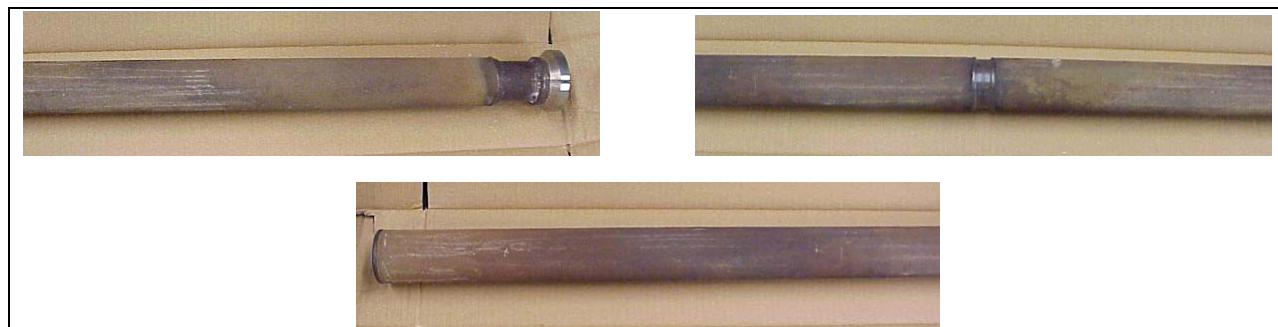
**Figure 20: Pall M5 Filter with 316L Stainless Steel Filter and Media**

The filters were visually examined. The Pall M5 filters had significant oxide growth on the filter surface attributed to corrosion of the 316L stainless steel. The P3 filter had corroded but to a significantly lesser extent. The 465 filter exhibited essentially no change in the test period. Typically, the M5 filters are recommended for temperatures less than 420°C, while the P3 filters are recommended materials for slightly higher temperatures. The 465 filters exhibit the widest range of corrosion resistance and are typically used for much higher temperature service or at critical temperatures of volatile halogens, i.e. near 600°C. In this case, the P3 filter appears to be sufficient for the process. However, further analysis will be done with scanning electron microscopy (SEM) to determine the integrity of the fibers within the matrix.

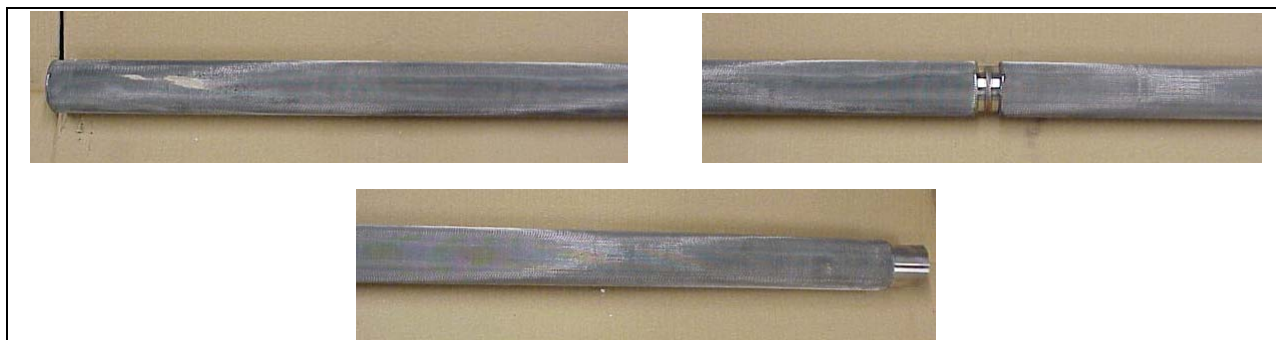
Figure 23: Porvair Stainless Steel Microfiltrex

The filter media did not appear to have any corrosion upon visual observation. The short exposure times may not have provided sufficient exposure to the corrosive gas stream. However, SEM can be done to determine the integrity of the mesh.
