# Tank Inspection NDE Results for Fiscal Year 2007 Including Waste Tanks 35, 36, 37, 38 and 15

**Savannah River National Laboratory**

**DOCUMENT:**      **WSRC-TR-2007-00064**

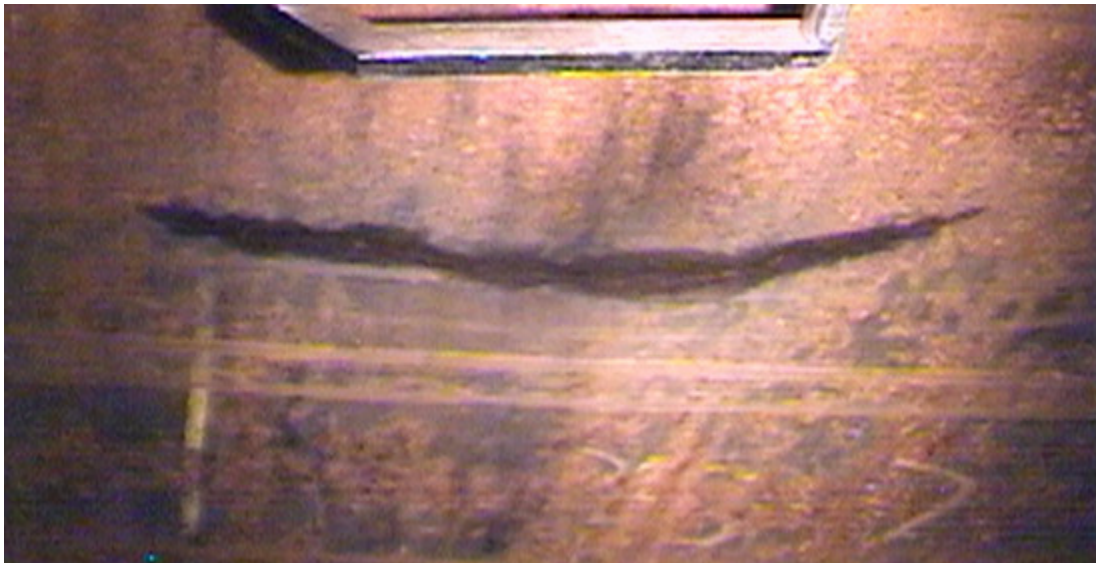
**Figure 8: Example of Through-Wall Bleed-Out**

Through-wall bleed-out is the term being used to describe the field implemented variation of a liquid penetrant surface inspection technique. It was noted that the water being used for UT couplant, would penetrate (through capillary action) surface cracks. Due to the elevated temperature of the tank wall (~120 degrees F), the wetted surface would dry after a few minutes. Where there was a crack open to the exterior surface, the water drawn into the crack would then bleed out providing a high contrast image of the open crack. Video cameras were utilized to view these indications and make crude measurements of length as the crawler was driven along the indication(s). Figure 8 provides an example of this technique on the crack in the middle horizontal weld at 192 feet.

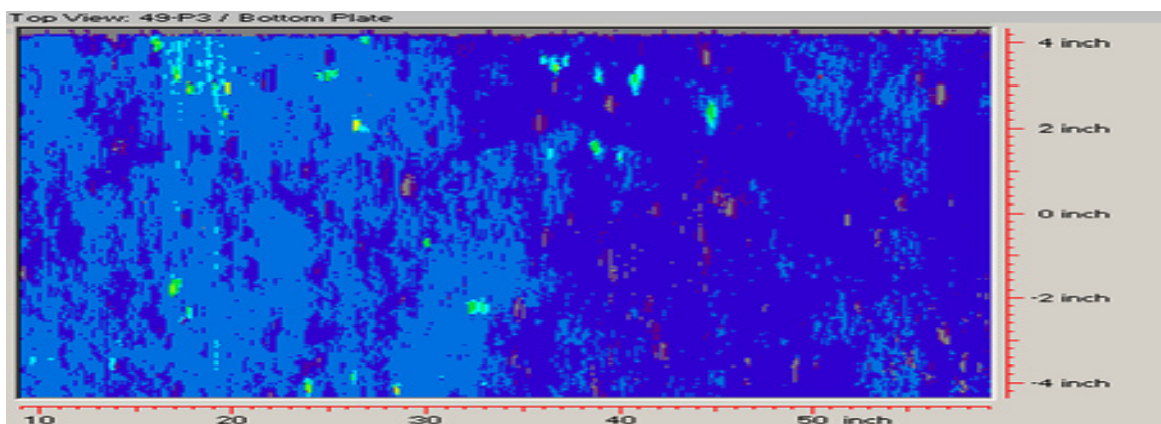
**Figure 15: Incipient Pitting FY2005 Data from Tank 49**

Service induced indications are those indications that developed after the tank was put into service. The In-service Inspection program is focused on detecting these types of indications. Service induced indications include general thinning, corrosion, pitting, interface attack and stress corrosion cracking in all regions of the tank walls including the vapor space. In an effort to provide leading data, conditions may be noted which are not reportable by the acceptance criteria. An example of this type of condition is incipient pitting.

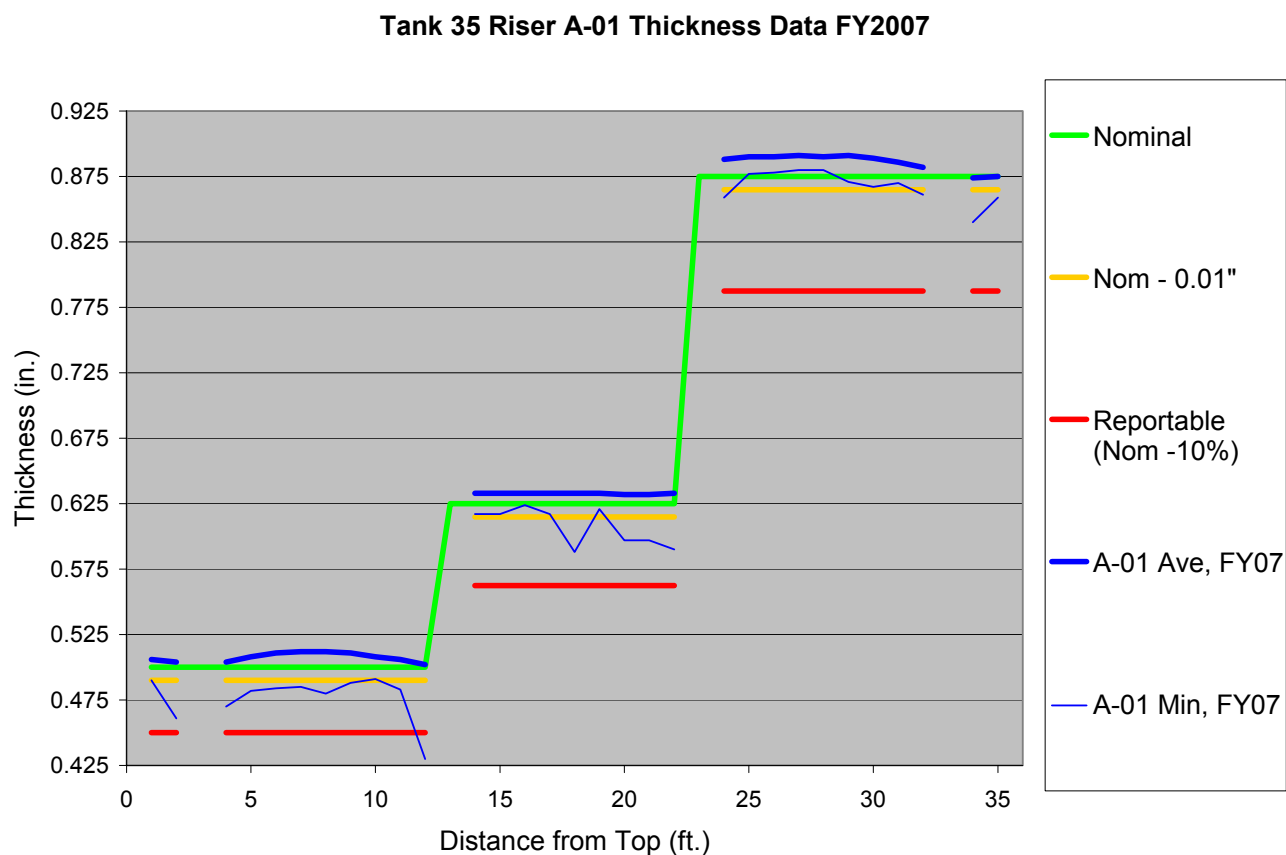
Figure 17: Thickness Mapping Data Summary Tank 35 Riser A-01

Tank 35 was scheduled for an augmented inspection which included one vertical strip for the entire accessible height under riser A-01. No service induced reportable areas were detected in the primary wall, but one grinding area was below the 10% reporting level. One of the Secondary wall plates and the secondary floor had reportable areas.

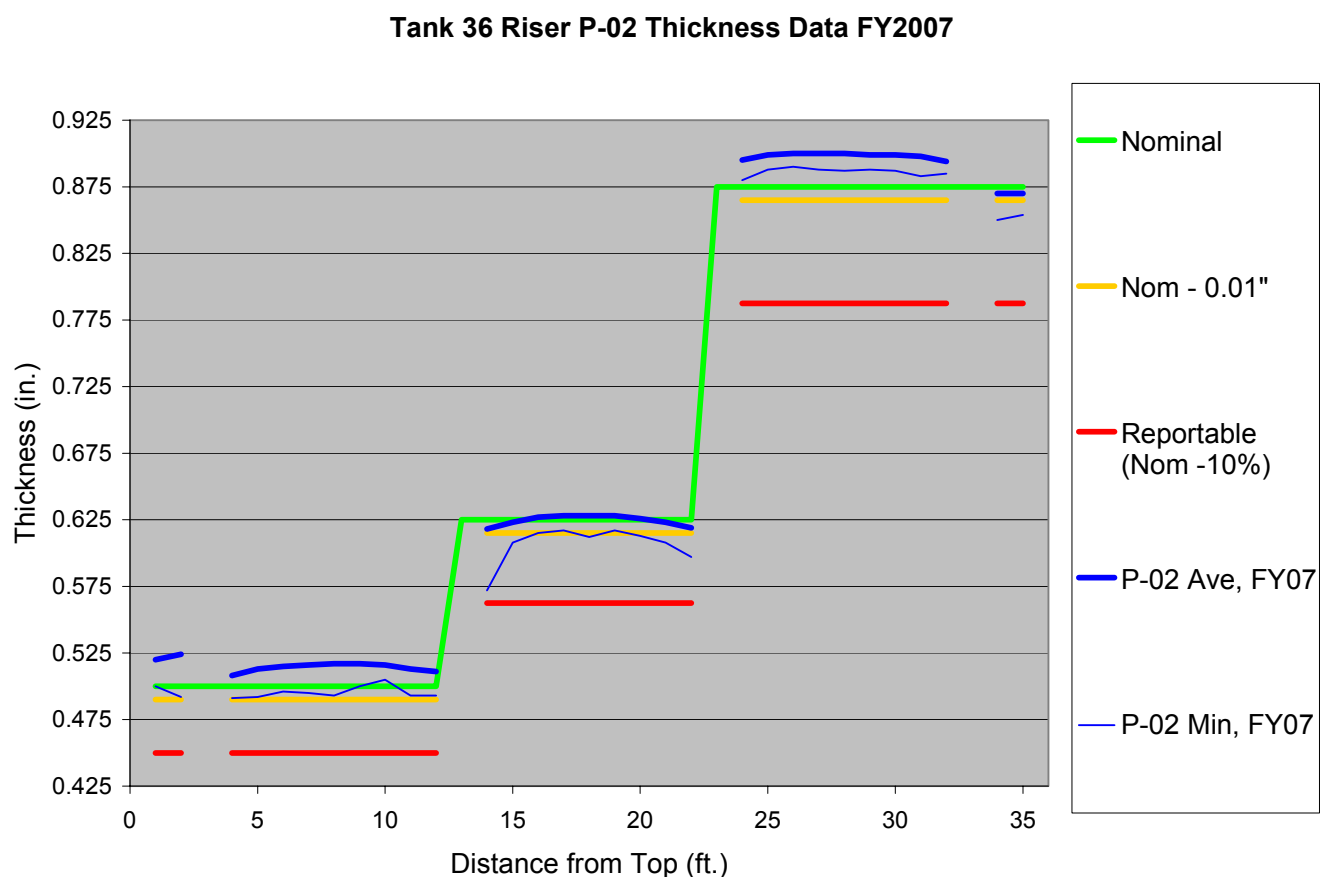
Figure 19: Thickness Mapping Data Summary Tank 36 Riser P-02

Tank 36 was scheduled for an augmented inspection which included one vertical strip for the entire accessible height under riser P-02. No reportable areas were detected in the primary wall. The secondary floor had reportable areas.

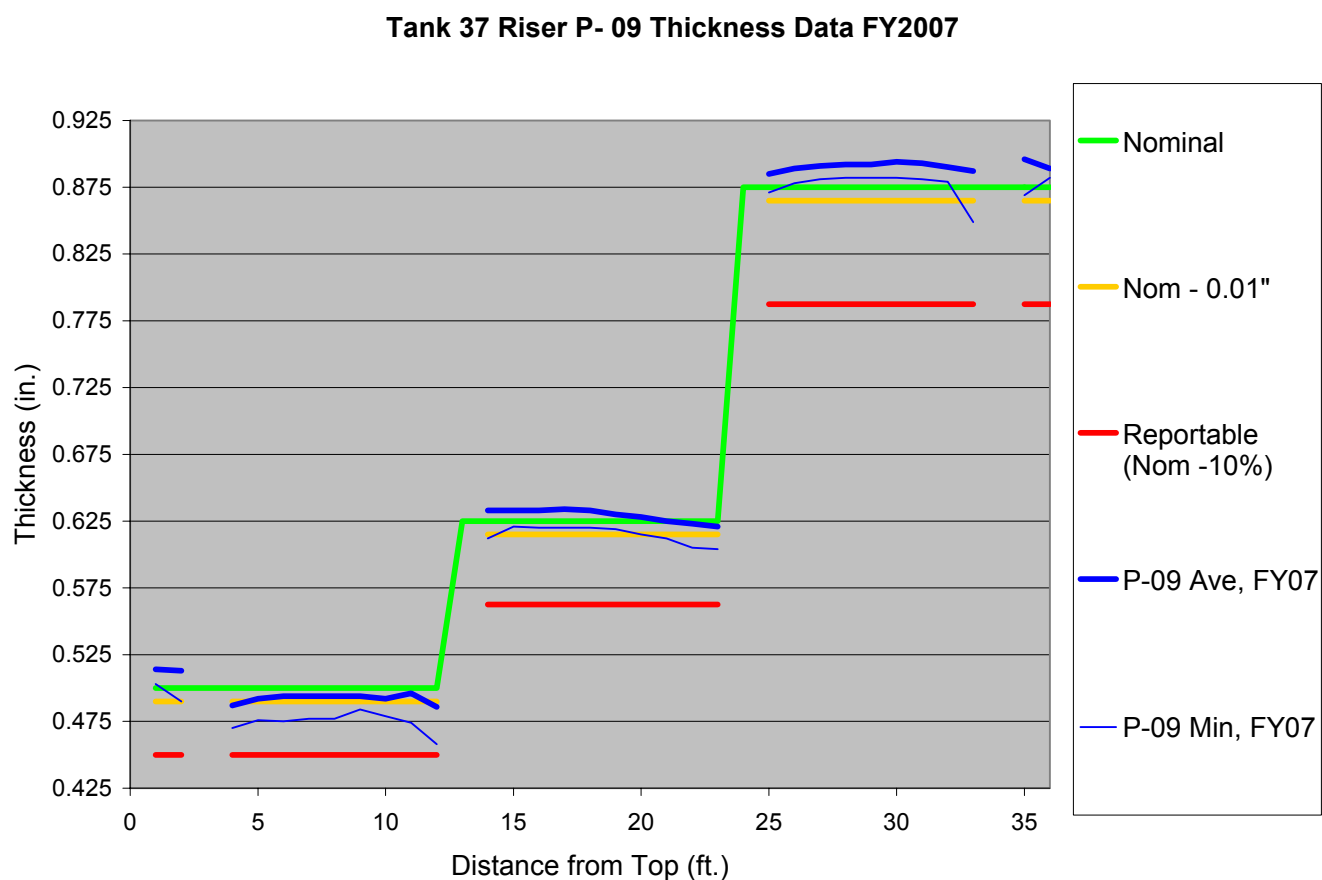
Figure 21: Thickness Mapping Data Summary Tank 37 Riser P-09

Tank 37 was scheduled for an augmented inspection which included one vertical strip for the entire accessible height under riser P-09. No reportable areas were detected in the primary or secondary walls, but the secondary floor had reportable areas.

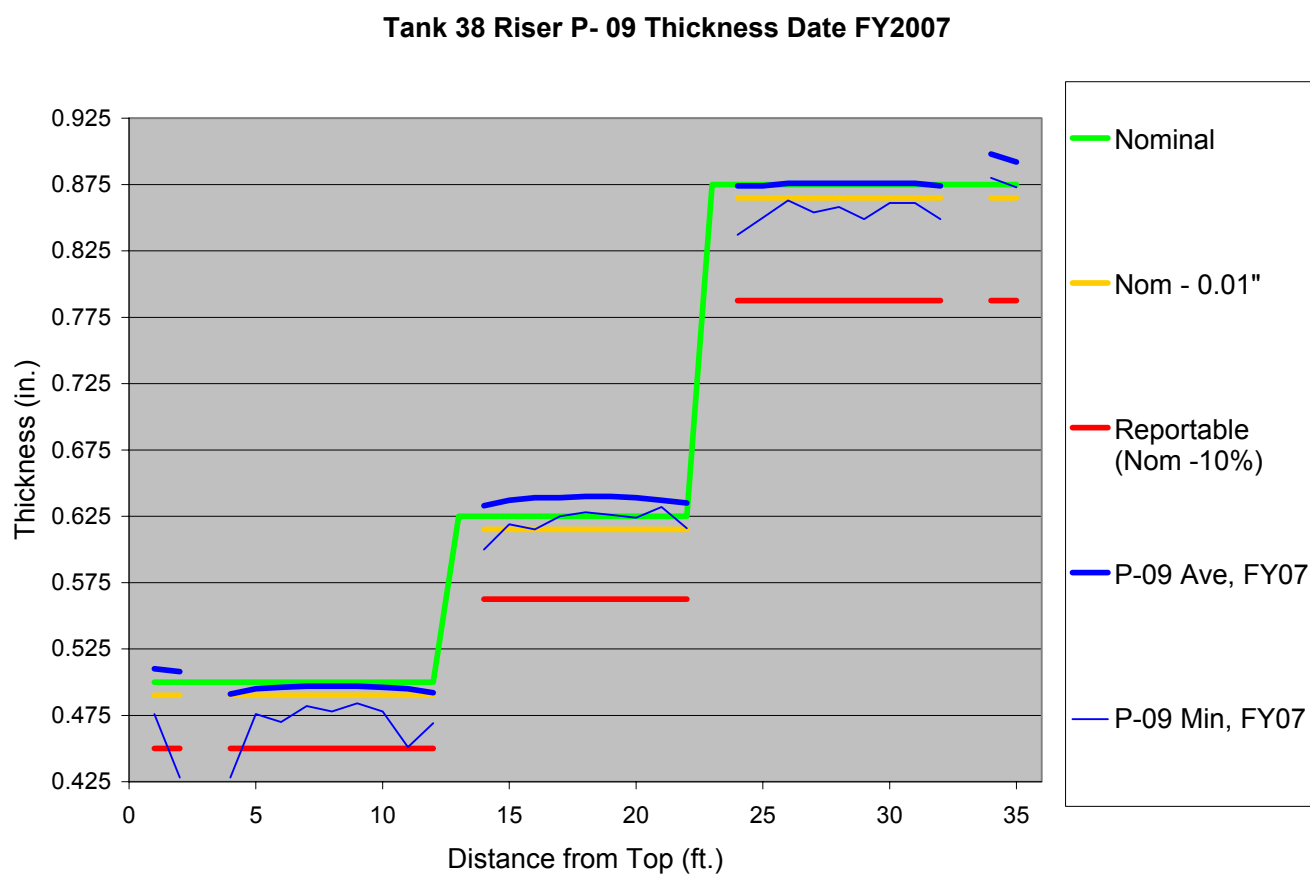
Figure 23: Thickness Mapping Data Summary Tank 38 Riser P-09

Tank 38 was scheduled for an augmented inspection which included one vertical strip for the entire accessible height under riser P-09. No service induced reportable areas were detected in the primary wall. The secondary wall and floor had reportable areas.

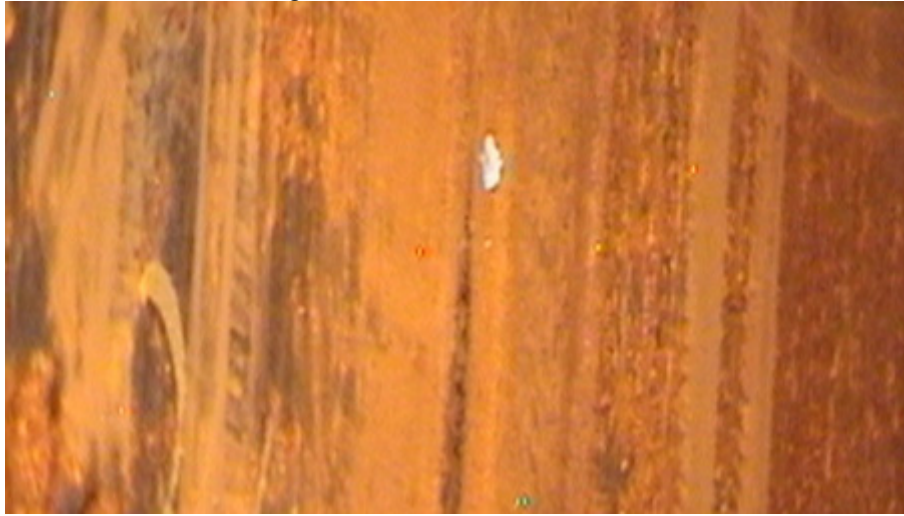
New salt nodule on right side of weld from indication first detected in 2002.

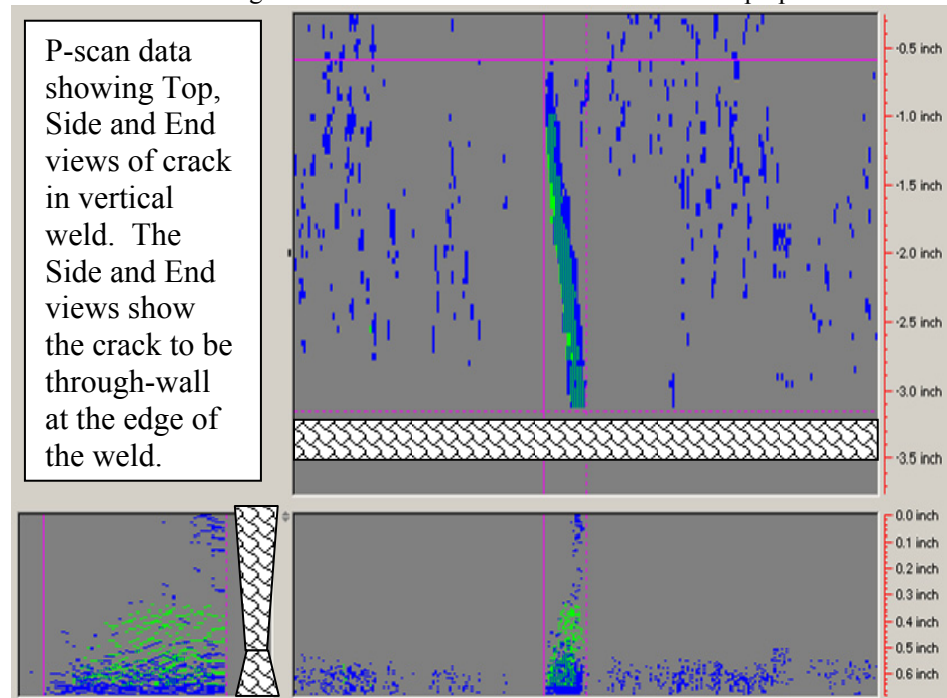
**Figure 32: IP182 Vertical Weld P-scan Data from Crack under the Salt Nodule**

UT Data rotated 90 degrees. The weld is vertical and the crack runs perpendicular to the weld.

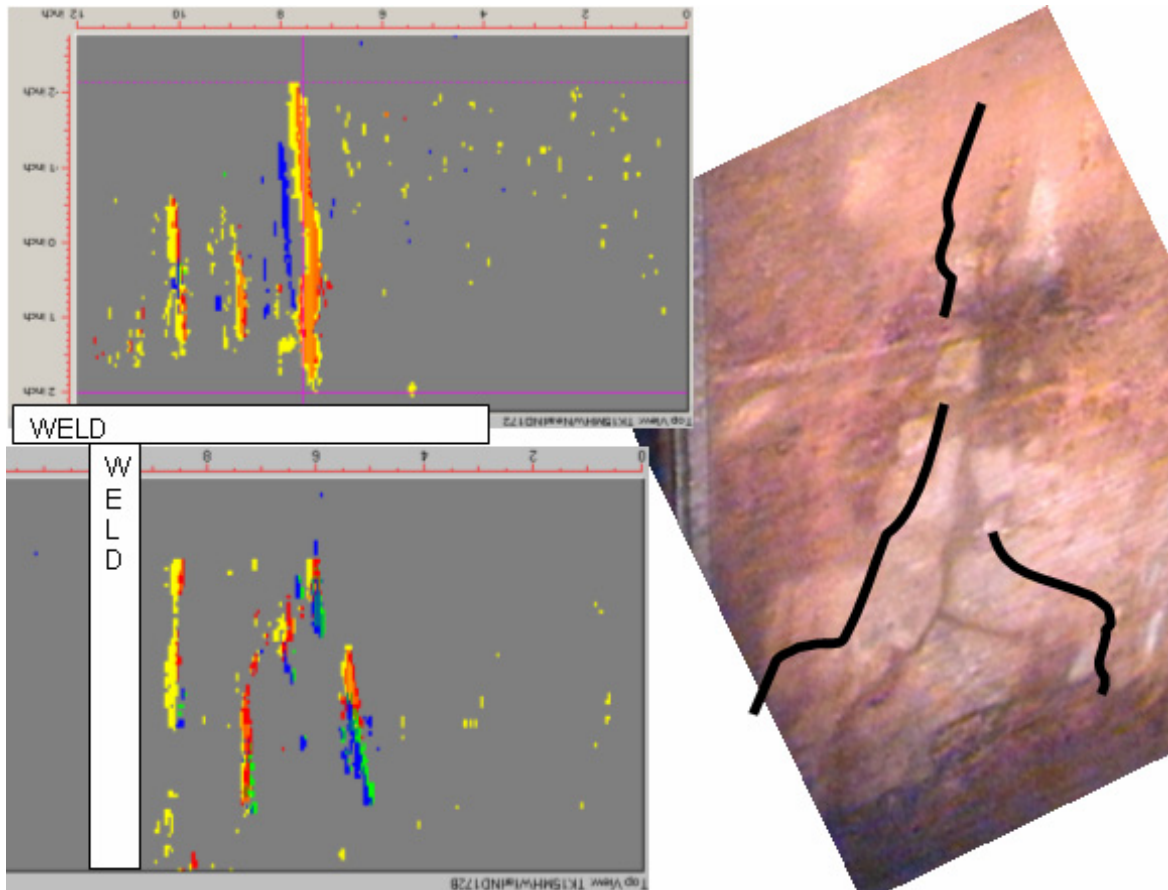
Figure 34: Images of Crack at 172 from 2007

The crack length was evaluated and compared with the lengths reported in 2002. It was determined that the vertical crack in the top plate grew 0.25 inch. The total measured length of the crack is 10.5 inches. The images in the following figure show a bleed-out photograph of the crack and P-scan data from the top and bottom plate scans.

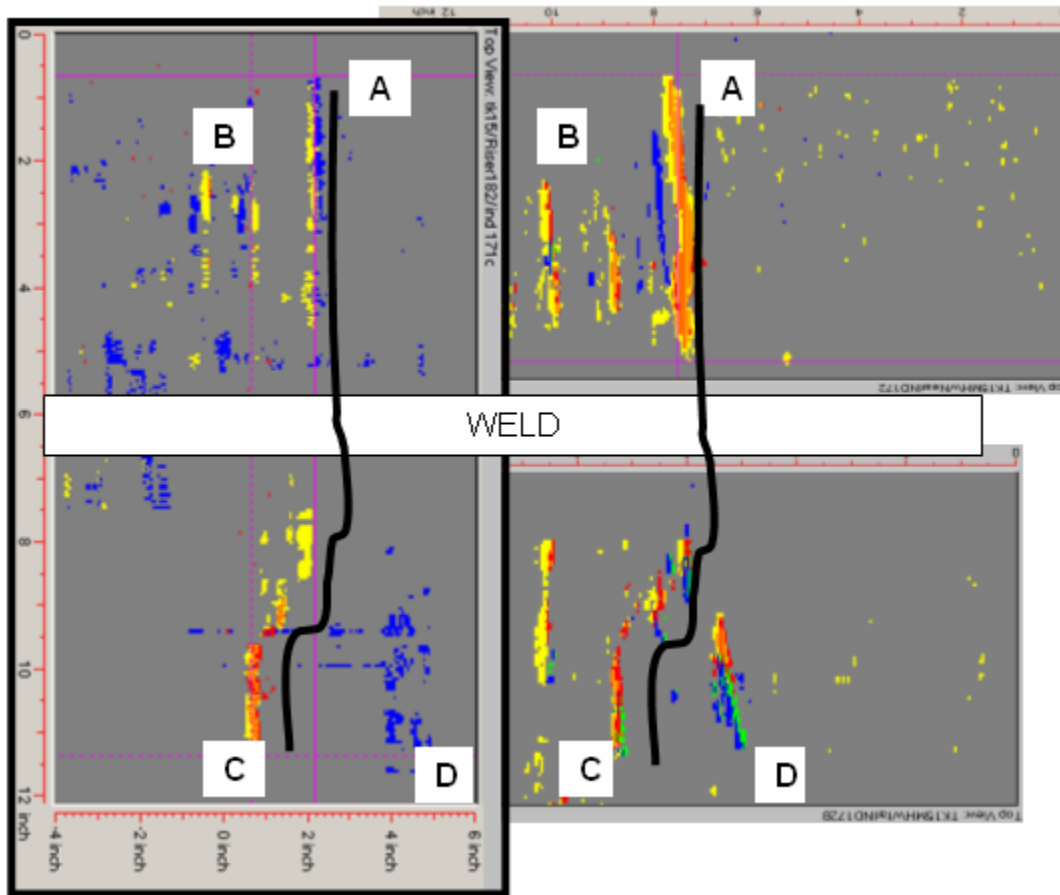
**Figure 35: Images of Crack at 172 From 2002 Compared to 2007**

In the following figure, the left section is P-scan data collected in 2002 from the crack at 172 feet. The images on the right are from scans of the same area in 2007. Letters “A” through “D” are added as landmarks to note the same indications in both sets of data.

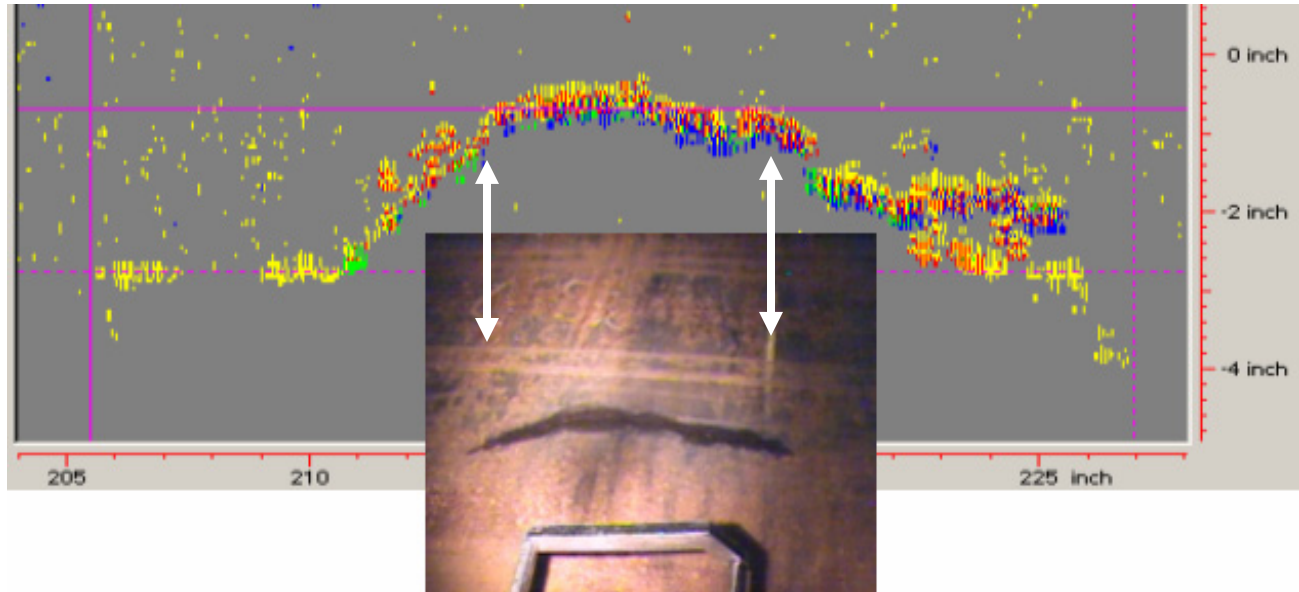
**Figure 36: Images of Crack at 192 Feet**

The crack at 192 was a previously identified leak site in 2002. The crack was determined to be at a weld repair. The crack length was evaluated and compared with the lengths reported in 2002 and determined to have increased do to improved scanning techniques. Total length measured to be 20.4 inches. This change is not attributed to growth. Figure 36 shows the bleed out image from the through wall portion of the crack and the P-scan data from 2007.

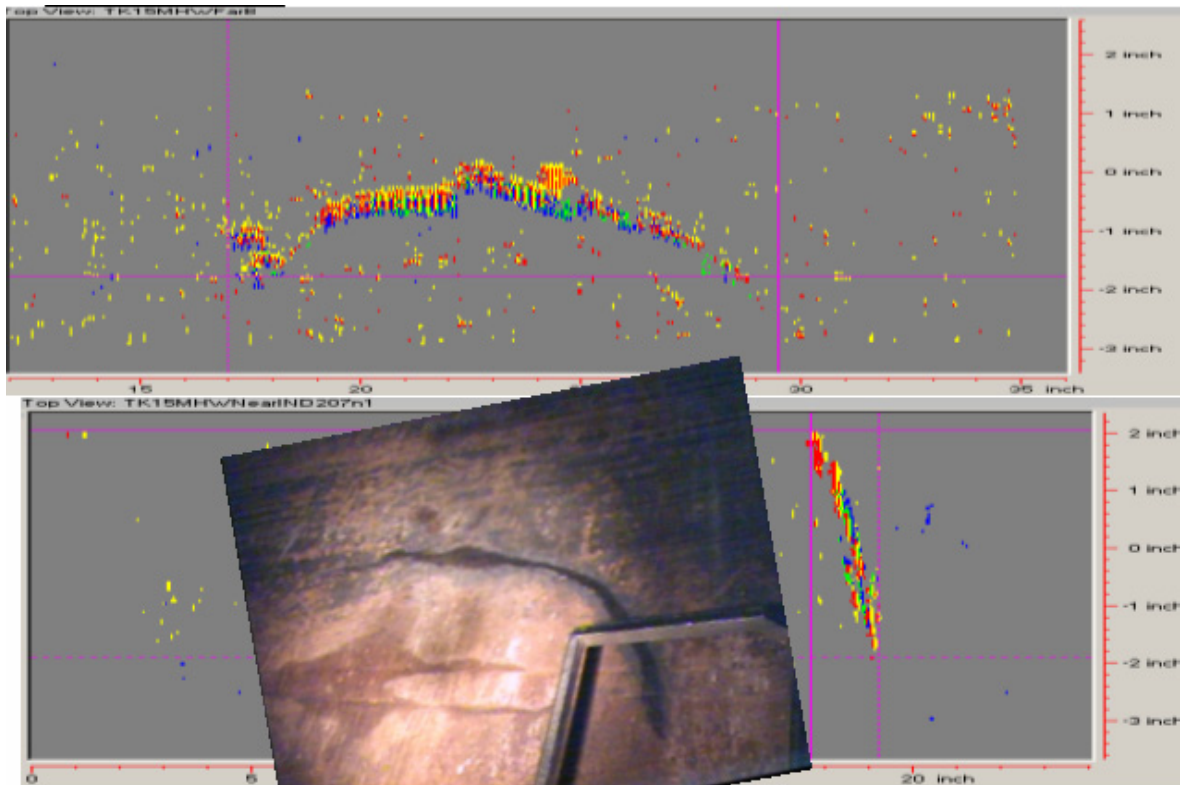
**Figure 37: Images of Crack at 207**

The crack at 207 was a previously identified leak site in 2002. The crack was determined to be at a weld repair. The crack length was evaluated and compared with the lengths reported in 2002 and determined to have increased on the top plate perpendicular to the weld. The total length was measured to be 19 inches long with 1.7 inches attributed to growth. Figure 37 shows the bleed out image from the through wall portion of the crack and the P-scan data from 2007.

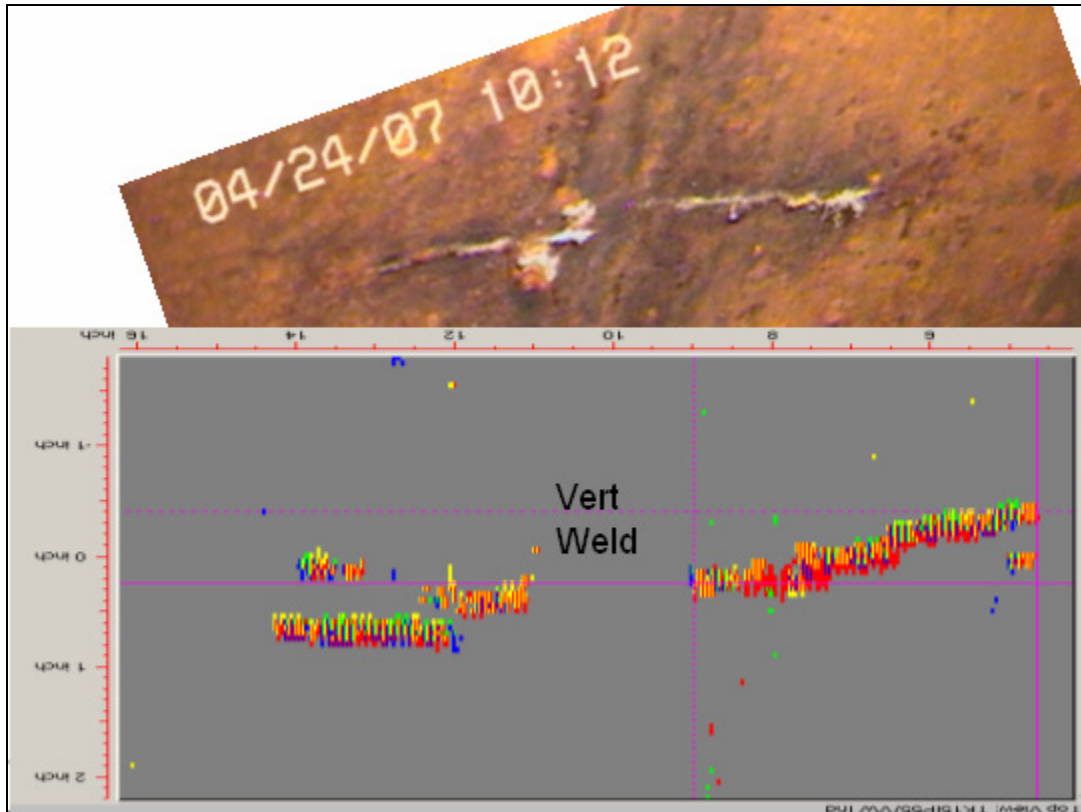
**Figure 38: Images of Crack in Vertical Weld at IP55**

The crack in the top plate vertical weld at 53'' was a previously identified leak site. In 2002 only the portion on the right side of the weld was examined. Due to improvements in probe holders and scanning techniques, the entire area was examined in 2007. The crack grew 0.46 inches on the right side. The total length of the crack was measured to be 9.54 inches. There is no previous data from the other side of the weld.

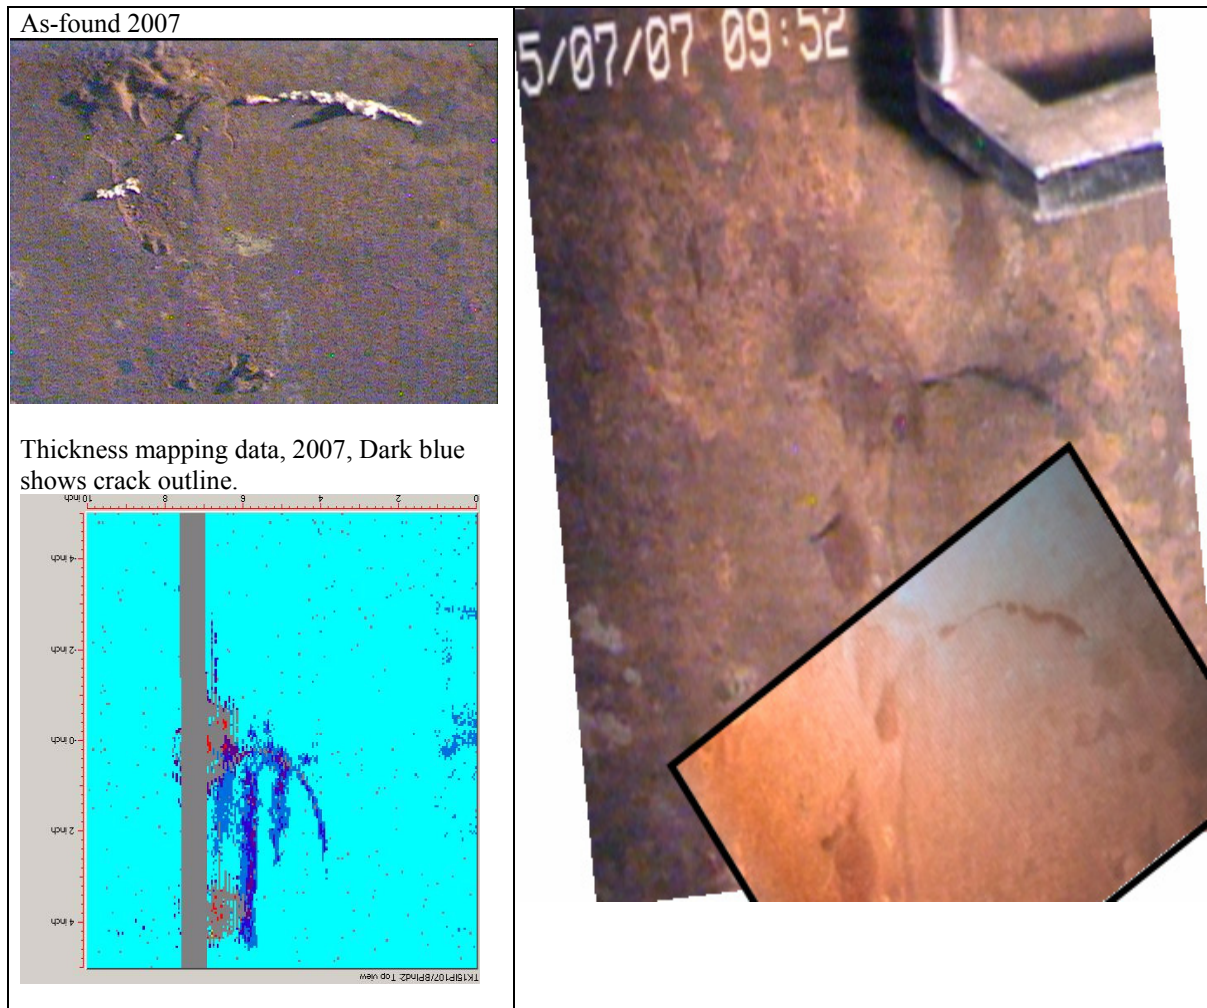
**Figure 39: Images of Crack at Attachment Weld Near IP107**

The crack at the attachment weld in the lower plate at 115 feet is pictured in figure 39. The images below include the “as-found” condition in 2007, the thickness mapping data from the 2007 horizontal scan and the bleed-out images from 2002 and 2007. Note the salt buildup showing the through-wall portion of the crack. The crack appears to have remained the same size at 2.3 inches x 3.7 inches.
