Corrosion Evaluation of Tank 40 Leak Detection Box

WSRC-TR-99-00200 (U)

Publication Date: June 1999

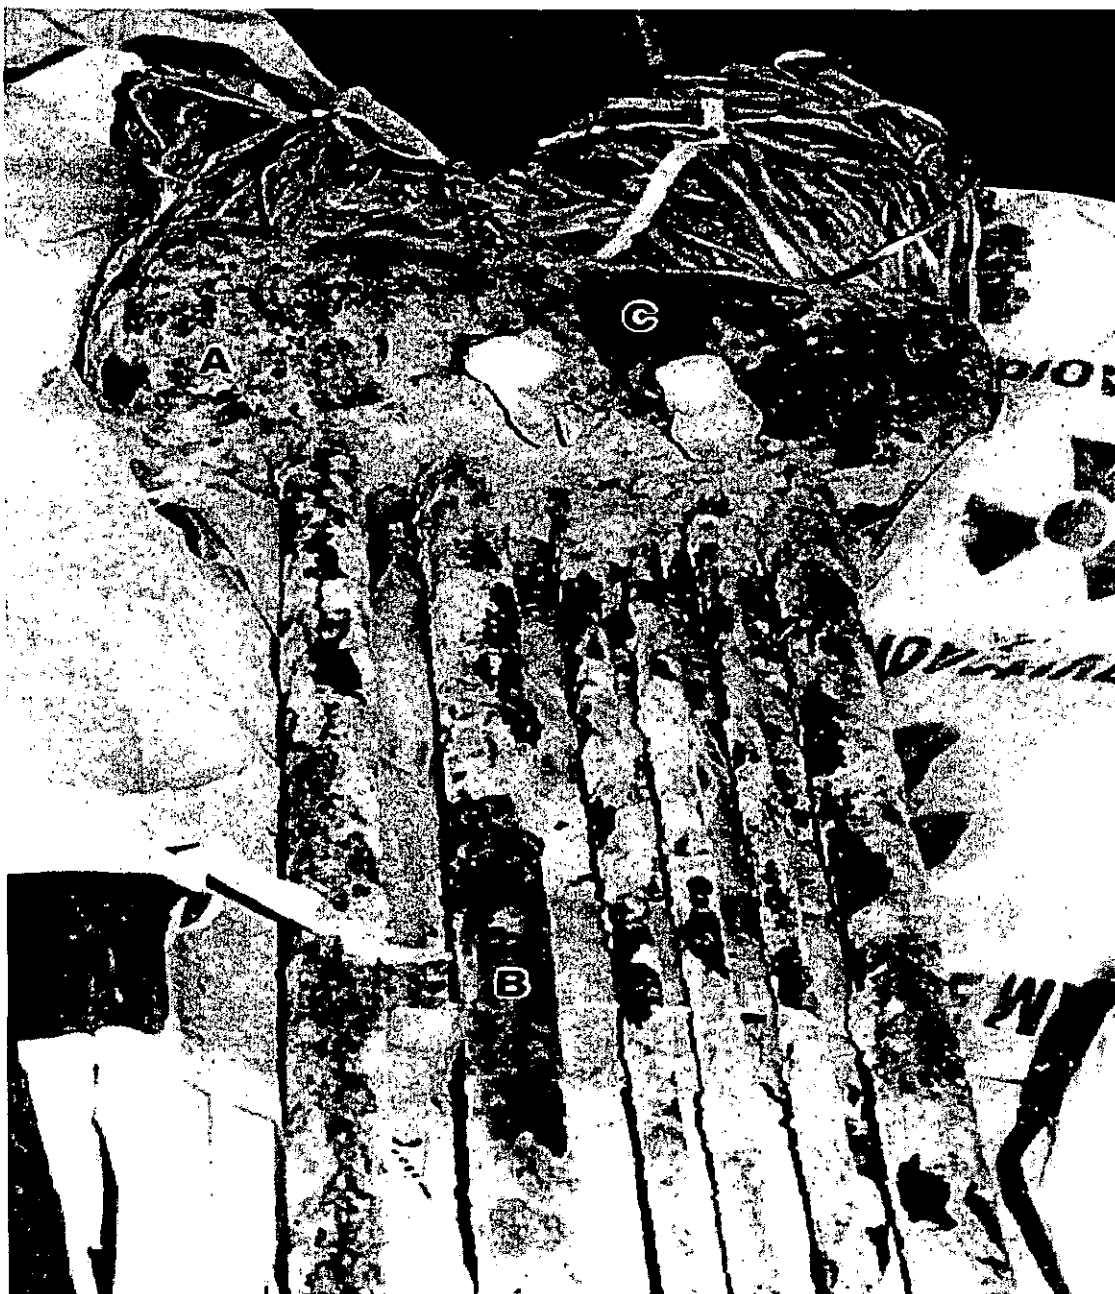
Figure 2. View of Tank 40 LDB and support piping

The exterior surface of the LDB is shown in Figures 2 and 3. Figure 2 shows the LDB and lower sections of the dip tubes and other lines. The surface morphology is variable. The area marked 'A' had a residual layer of the backfill material, which is Gilsulate 500™, adhering to the steel. The steel surface itself had regions of either a uniform black oxide, which is marked 'B', or non uniform general corrosion with the formation of reddish brown oxides, which is marked 'C'. The general corrosion probably resulted from the excursion of water through the backfill to the steel surface. The upper pipe sections shown in Figure 3 passed through the concrete pad and into the atmosphere. The section through the concrete, which is marked 'A', has a black oxide film with minimal surface corrosion. The above ground sections were painted. The visual assessment did not reveal any significant area of corrosion where the LDB integrity was impaired.

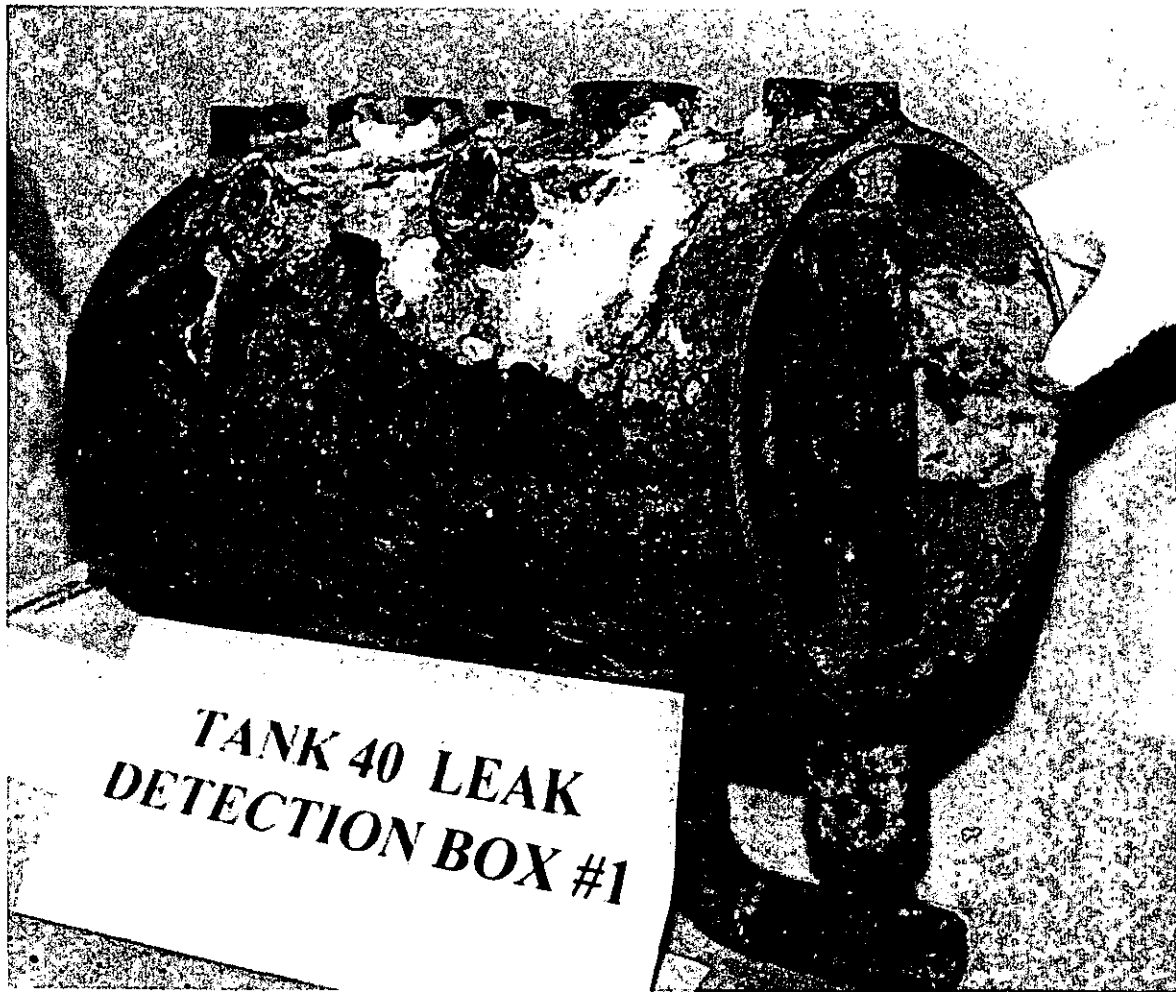
Figure 5. View of Tank 40 LDB with end caps removed

The interior surface had a variable morphology, indicating different environmental exposures. However, aggressive or severe degradation was not observed. Figure 5 shows a picture from the conductivity probe end of the pipe. Figure 6 is a picture of a weld region after sectioning. The arrow in the figure indicates the weld. Three regions were identified based on the morphology of the corrosion products and are shown schematically in Figure 7. These three regions had well defined lines of demarcation. Region 1 had a light flaky corrosion product which was a light reddish brown in color. Region 2 had a heavy crusty layer of black/brown corrosion products. Region 3 had a thin adherent layer of rust and surface oxide. If the lines of demarcation are taken as previous water lines, their orientation indicated that the LDB was not vertically in place, but slightly skewed.

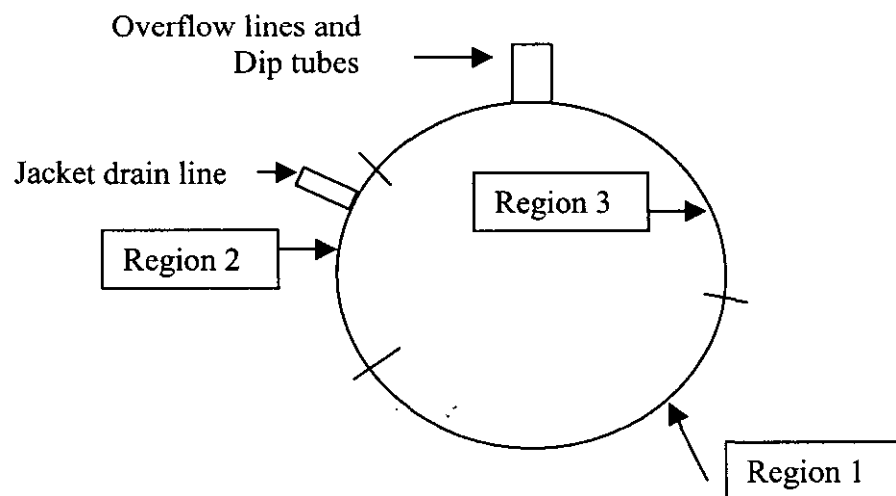
Figure 7. Schematic drawing of regions of different corrosion morphology

Region 3 is typical of a normal atmospheric exposure of carbon steel. The light layer of surface rust probably formed due to atmospheric moisture at points where the mill oxide was either thin or damaged. Regions 1 and 2 had more exposure to water. Region 1 was probably where stagnant water collected in the LDB. The surface appeared as if a sediment layer remained intact. Region 2 may have had a condensate or a water film resulting from run down out of the drain lines. The coloring of the corrosion products indicated a higher oxygen concentration than found in Region 1. Chemical analysis of the surface was not performed to verify corrosion products and oxides or surface contaminants.
