Proceedings of PVP:  
PVP 2001  
22-26 July 2001

## Digital Radiography of a Drop Tested 9975 Radioactive Materials Packaging

Glenn Abramczyk  
Westinghouse Savannah River Co.  
Aiken, South Carolina, 29808  
(803) 725-8701, glenn.abramczyk@srs.gov

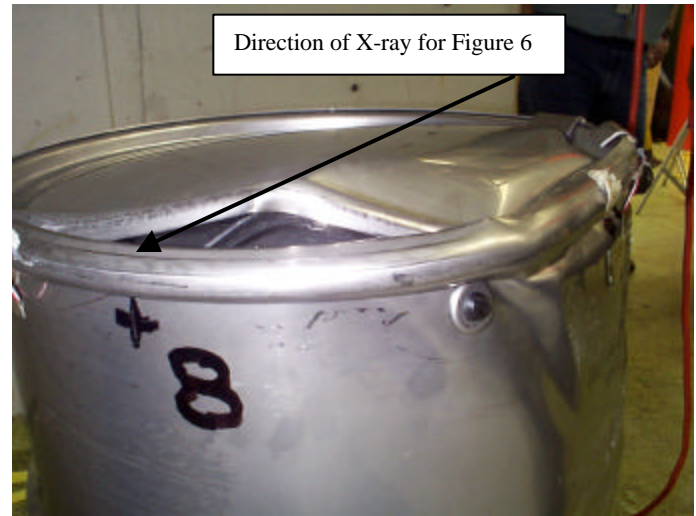
Figure 3. 9975 Package Drop Damage

The 9975 package design as depicted in Figure 1 was dropped from a NCT drop height of 4-feet followed by the HAC 30-foot drop and 40-inch puncture pin drop, Reference 2. The purpose of the preconditioning NCT drop was to maximize weakening of the closure system so that the effects of the subsequent HAC drops would be maximized. In each drop the axis of the package was oriented 17.5° from horizontal. The shallow drop angle and impact positions were selected to maximize damage to the drum closure. The test sequence, the dual 17.5° drops, resulted in a partial separation of the lid from the drum rim, as shown in Figure 3. The puncture drop did not appreciably increase drum damage, rather the opening between the drum lid and drum wall were found to close slightly.

After examining the damage to the package closure it was determined that the pass/fail criteria that had been established for the test had been exceeded. Though the physical gap criteria established for the test was exceeded, evidence existed that indicated the package would survive the regulatory thermal test. With this information and the strategy that a CoC could most easily be obtained by completing the regulatory HAC test sequence, the damaged package shown in Figure 3 was prepared for a regulatory thermal test.

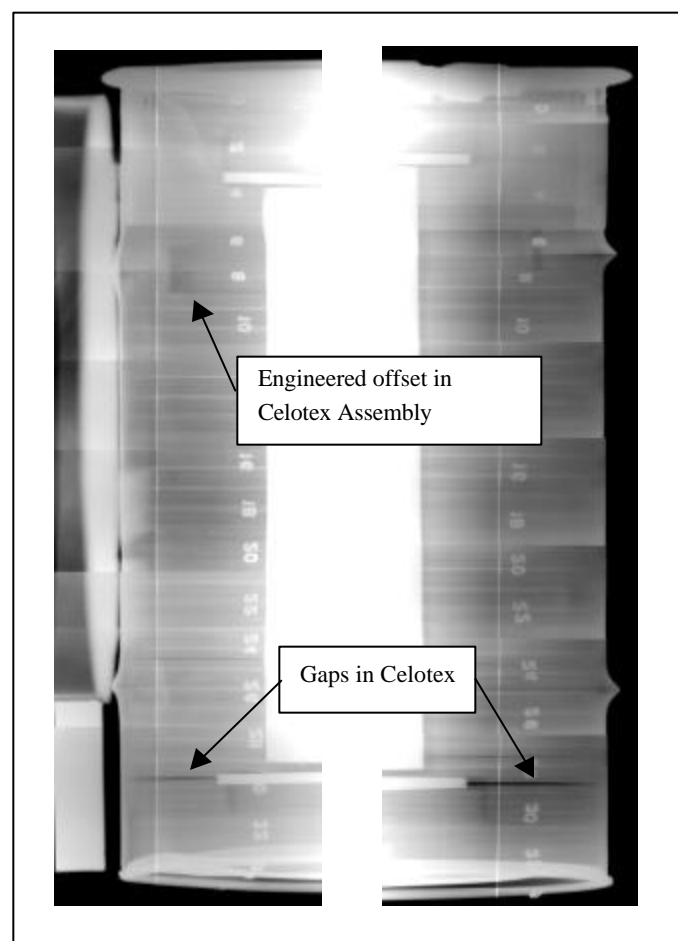
**Figure 6. Digital Composite of 9975 Package**

Figure 6 depicts a composite image of the 9975 package. It is composed of 8 digital images taken along each half of the package. The axial positions in which the images were acquired do not permit a 1 to 1 match up of the drum. All images were taken when the drum was resting horizontally, down is the left side of this image.

Indications of gaps in the Celotex (black lines in Figure 6 and 10 and light colored lines in Figures 8 and 9) that were discovered in the radiographic examinations of the damaged package resulted in package thermal analysis. Thermal analyses were performed for the 9975 with the assumption of a bounding 1.38 inch circumferential radial gap through the Celotex insulation to determine the effect of such a large gap in the hypothetical fire test, Reference 4. Results from the analysis showed that the 9975 package safety basis was not effected.

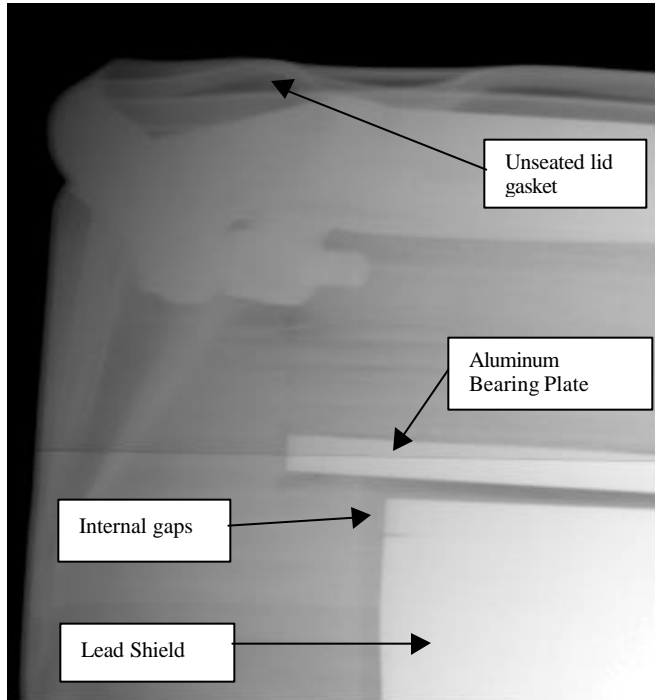
**Figure 7. Drum Lid Closure**

Figure 7 depicts a digital shot of the 9975 lid closure. The X-ray was shot looking from the rear of the drum and pointed to the “#8” as shown in Figure 3. The drum was in an upright position. From the X-ray the dislodged lid gasket that serpentine across the gapped lid can be readily distinguished. The engineered gap between the lead shield

and top bearing plate is also observable and is seen as a light shaded area which is representative of the gap. This gap also extends along the lead shielding. This gap beside the lead shield is a result of the Celotex being crushed during the side drop. A slight bulge in the lead shield due to the impact of SCV can be evident.

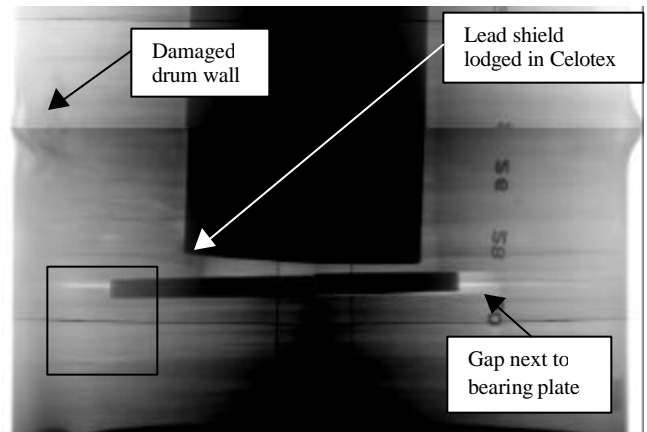
**Figure 8. Bottom Radiograph of 9975 Drum**

Figure 8 illustrates a bottom view of the drum radiographed in an upright position. The left side of the lead shield is imbedded in the Celotex and is preventing it from contacting the bottom bearing plate which would be its nominal position during normal transport. Drum damage in the form of small ripples can be seen on the left side of the radiograph, indicating the direction of the side impact. Since this drum was dropped in a slight top down orientation the shield was probably positioned fully forward in the package before the drop as evidenced by the position of the lead shield after the drop. Celotex gapping can also be seen in this view. Note the position of the bottom bearing plate appears to have shifted towards the impact side. Because the mass of the aluminum bearing plate is small, it seems likely that the body of the lead shield must have been in contact with the plate at some time during the impact and forced the shield sideways through the Celotex.

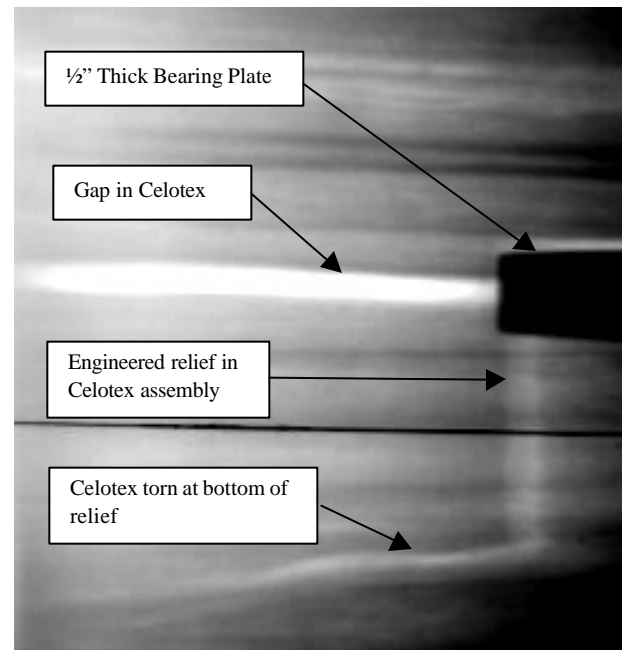
**Figure 9. Damaged Celotex Adjacent to the Bottom Bearing Plate**

Figures 9 and 10 illustrate specific package damage from the drop test. Figure 9 blows up a section of Figure 8 slightly rotated that shows a fairly large gap just adjacent to the bearing plate and a what appears to be a tear in the Celotex extending from the engineered relief below the bearing plate. When Figure 9 is viewed dynamically, the gap extends radially from the plate's edge for the most part the full circumference of the drum. However, the gap does not stay as nearly as pronounced (wide or long) as observed in the Figure. The tear at the bottom of the designed relief demonstrates that the relief performs as expected by translating damage away from the edge of the bearing plate thereby reducing Celotex separation adjacent to the bearing plate.

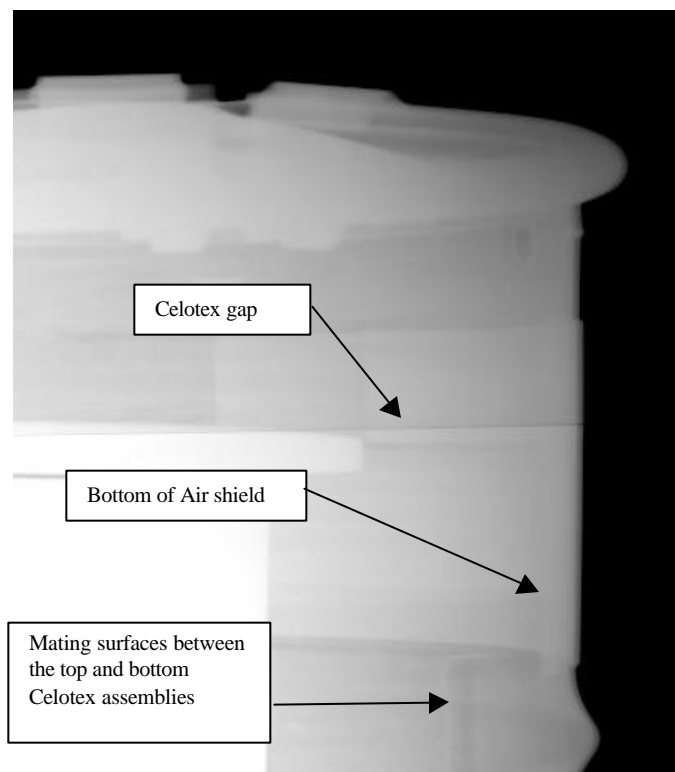
**Figure 10. Top Section of Drum**

Figure 10 illustrates an additional separation area in the Celotex. There is a slight gap in the Celotex adjacent to the top bearing plate, similar to the one shown in Figure 9. The gaps appear to form along the glue plane. Figure 10 is interesting in that the gap formed by the mating top and bottom Celotex assemblies is evident. The combination of the offset between the Celotex assemblies, the design relief above the bearing plate and the top Celotex assembly air shield minimizes Celotex damage at the top of the package.
