# Laser Engineered Net Shaping® for Repair and Hydrogen Compatibility

*LENS technology seems well suited for repair of overbored reclamation-type materials, but additional process development is required for other types of repairs*

BY P. S. KORINKO, T. M. ADAMS, S. H. MALENE, D. GILL, AND J. SMUGERESKY

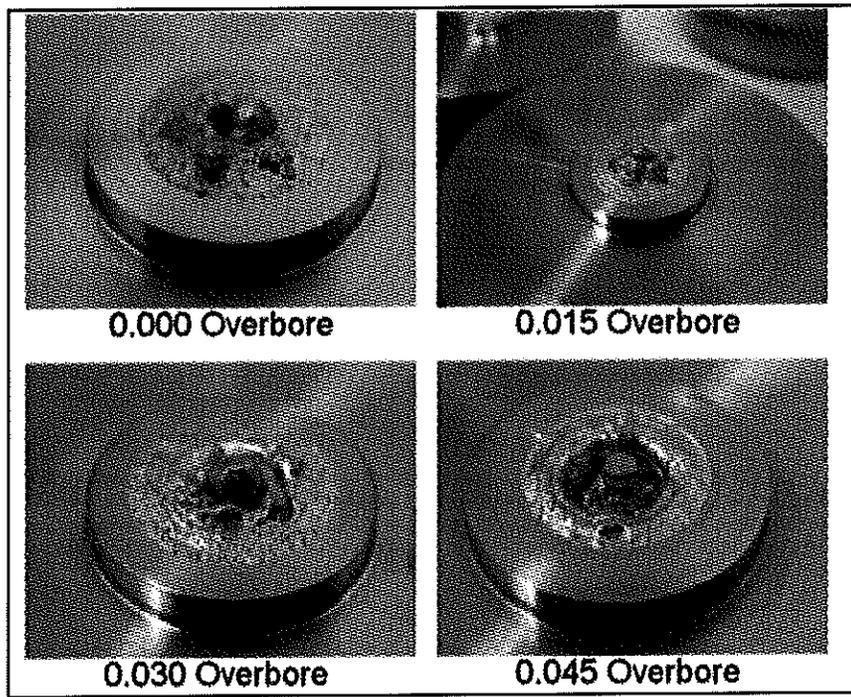
Fig. 5 — The repaired bores had excellent adhesion to the walls and bottom of the bore, but the material was not high quality at the center.

Figure 5 shows the as-repaired condition of the deposit from a macro standpoint. It is important to note that differences in the appearance and the apparent density and crowning of the fill are not due to the diameter of the oversize bore, but are instead due to process improvements made throughout the repair of these components. The 0.045-in. (1.14-mm) overbore bases were done first and have the least desirable center bump. The 0.030-in. (0.76-mm) overbore bases had the improvement of higher rotational speed near the center of the deposit, and the 0.000- and 0.015-in. (0.38-mm) overbore bases had further improvements in that the center of the bore did not have additive material for the first layers. The zero overbore sample has a slightly improved definition of where the final radius should be for each layer. A difficulty for the process development was that the LENS

material deposition team only had two process setup pieces which was insufficient for optimizing the deposition approach. As shown by Fig. 5, considerable improvement in the appearance of the samples is evident from the 0.045-in. (1.14-mm) overbore to the 0.015-in. (0.38-mm) overbore, or from the first to the seventh component (the first of the 0.015-in. overbore repairs). Additionally, as the amount of overbore changed, the diameters of the deposited rings changed, which added another variable to the process development challenges.

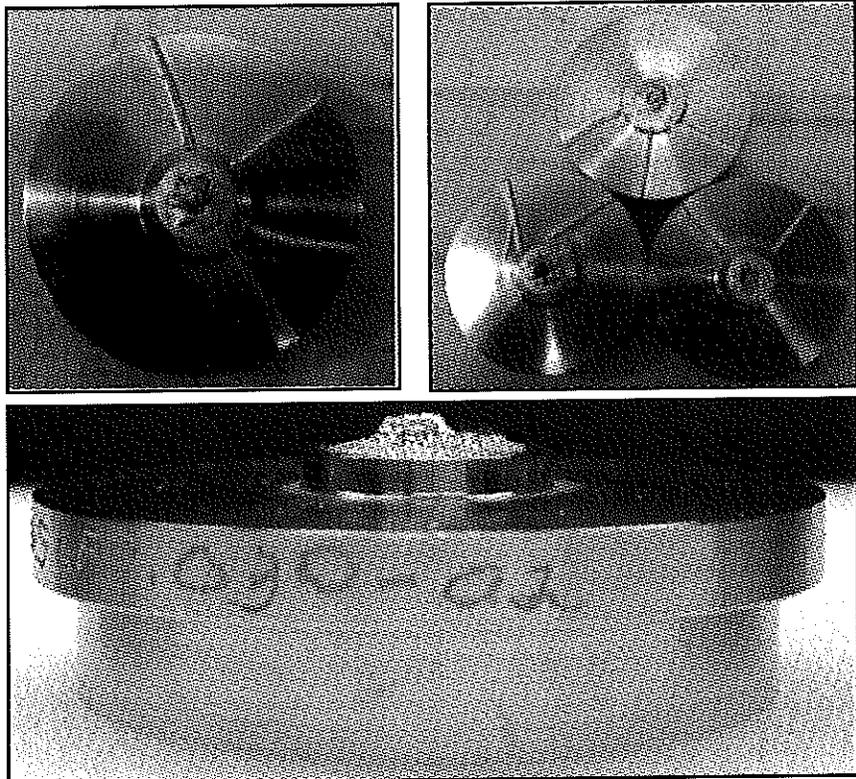
Fig. 6 — Bore and radial repaired scratches on the surface of the weld bases.

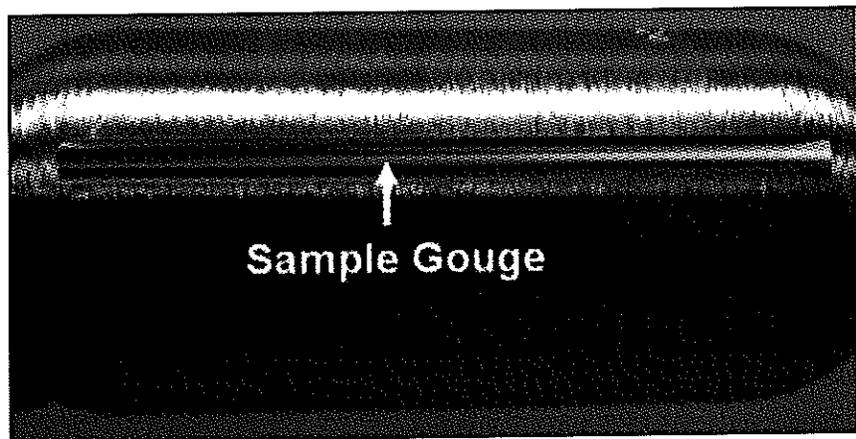
Fig. 7 — Sample gouge in sample gas bottle. Gouges were 0.125 in. wide and either 0.010 or 0.020 in. deep.

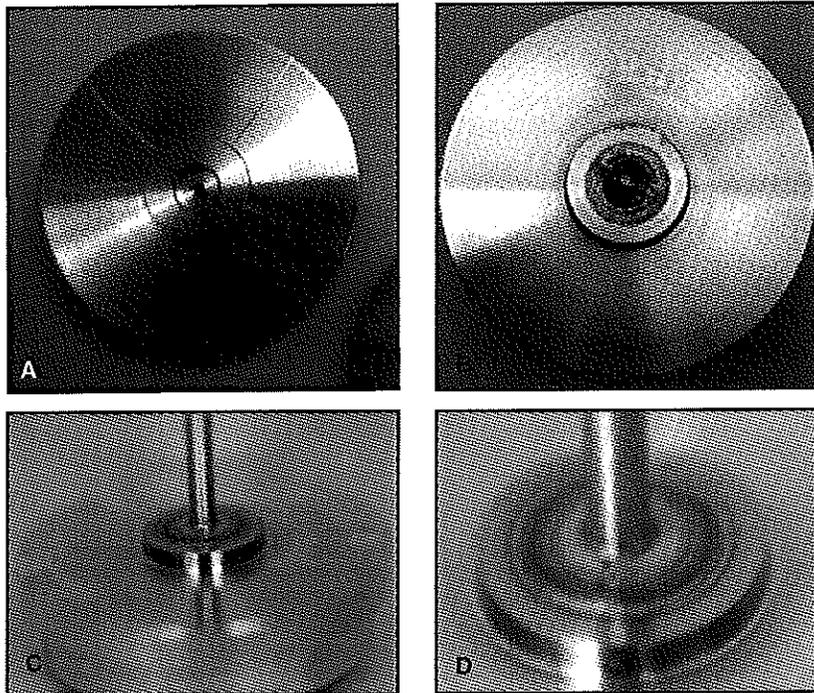
Fig. 13 — LF-7 test base in the following conditions: A — As machined; B — as LENS repaired; C and D — as welded.

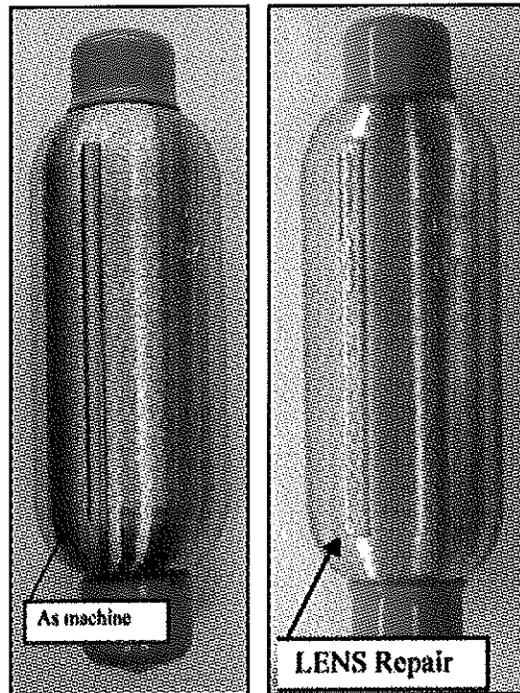
Fig. 14 — As-machined (notched), as-LENS-repaired, and as-final-machined gas sample bottles.

The LENS repairs for the sample gas bottles were generally successful with the repaired gouges having an acceptable appearance as shown in Fig. 14. Upon hydrogen charging and burst testing, the bottles all passed the required pressure before bursting, but the bottles did burst along one edge of the gouge. Further analysis and sectioning showed that the LENS material did not quite fill the bottom corner of the gouge in some cases. This bottom corner of the gouge acted as a stress riser causing failure to initiate at the site. To achieve better results in the future, it is suggested that a ball end mill or angled mill be used to make the bot-

tom corner easier to fully fill with LENS material and to reduce the stress riser. It is expected that this modification would make the failure much less likely to occur at the gouge location.

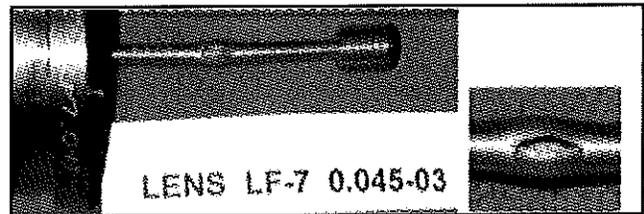
Fig. 18 — Burst tested 0.045-in. overbore and LENS-repaired and reclamation-welded sample.

All of the reclamation test welds failed in the fill stem tube wall at a pressure of approximately 58 to 62 ksi, which is consistent with the expected material properties of these stems. A graph of the data is shown in Fig. 17 and a photograph of a typical burst tested reclamation test stem is shown in Fig. 18. It can be seen that the tube split and formed a fingernail-type breach. The test results for the reclamation test base samples

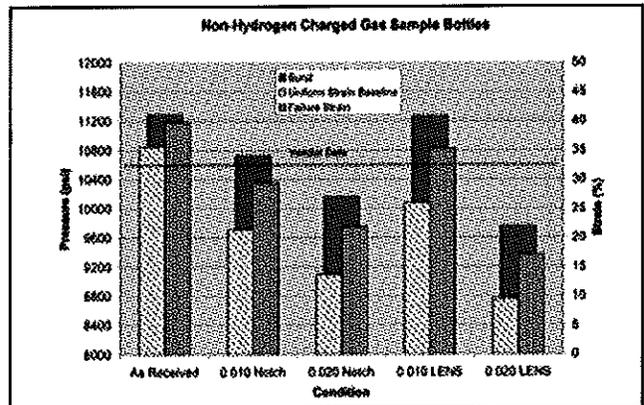
Fig. 19 — Effect of notches and LENS repair on burst properties of gas sample bottles.

with water using a hypodermic needle. The bottles were then attached to the system piping and were pressurized to failure in approximately 1 min. The vessels all exhibited a longitudinal tear that apparently initiated near the center of the vessel, which would be at the location of the highest strain. The data for the as-received sample bottle are comparable to the vendor certification data for these vessels (Table 5). The as-notched samples in the uncharged condition exhibited a reduction in both burst pressure and failure ductility. LENS repair for a 0.010-in.-deep notch is able to restore the burst pressure; however, the uniform strain (ductility) is not fully restored — Fig. 19.

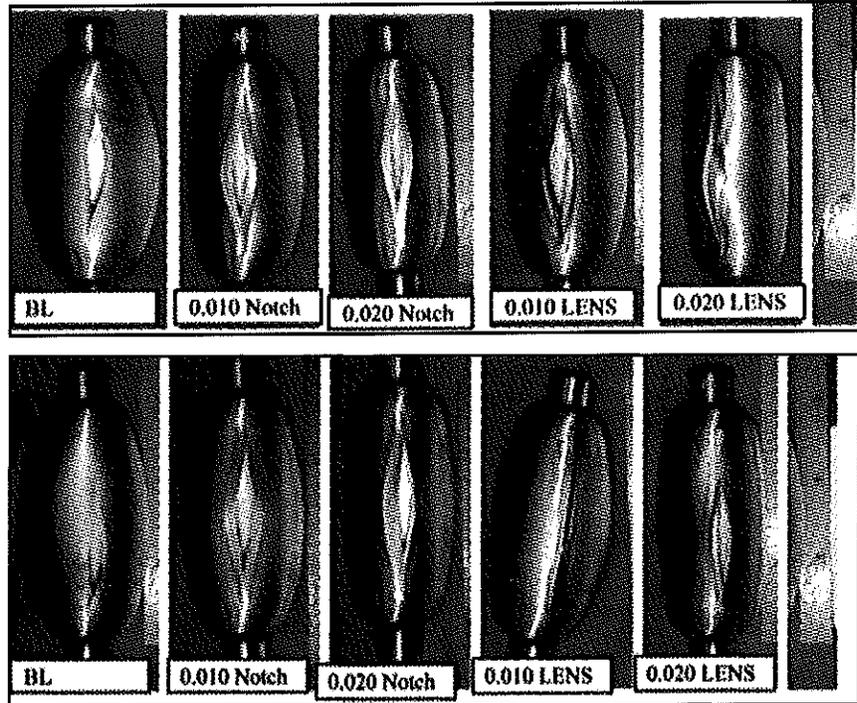
Fig. 21 — Burst test gas sample bottles: A — As received; B — hydrogen charged.

The appearance of the burst tested gas sample bottles exhibited the expected failure with the bottle opening up axially; in addition, all of the samples with notches failed in the notch. There was one exception for the LENS-repaired samples: Sample 0.010 LENS-repaired 1, which failed in the vessel body away from the LENS repair, suggesting an excellent repair and no adverse impact on strength. Macro photographs of the burst-tested vessels are presented in Fig. 21. The baseline samples are presented in Fig. 21A and the hydrogen-charged samples are presented in Fig. 21B. The change in sample diameter growth, i.e., direct indication of strain, is apparently lower as the extent of the defect increases.

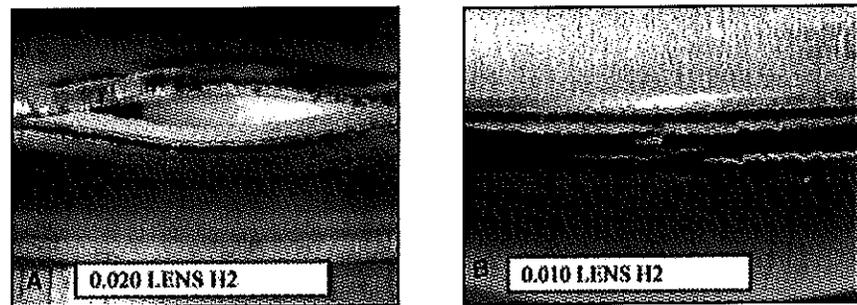
Fig. 22 — Expanded view of hydrogen-charged and tested samples: A — Repaired over a 0.02-in. notch; B — repaired over 0.010-in. notch that failed in the body, not the repair.

The fracture surfaces of the LENS repaired surfaces were also examined. The LENS material appears to have cracked axially and some of the samples exhibit a possible delamination. This failure mode may be indicative of the deposition method and deposition direction. The cracking and onset of delamination of sample 0.010 LENS H<sub>2</sub> that did not fail in the LENS repair area is shown in Fig. 22.

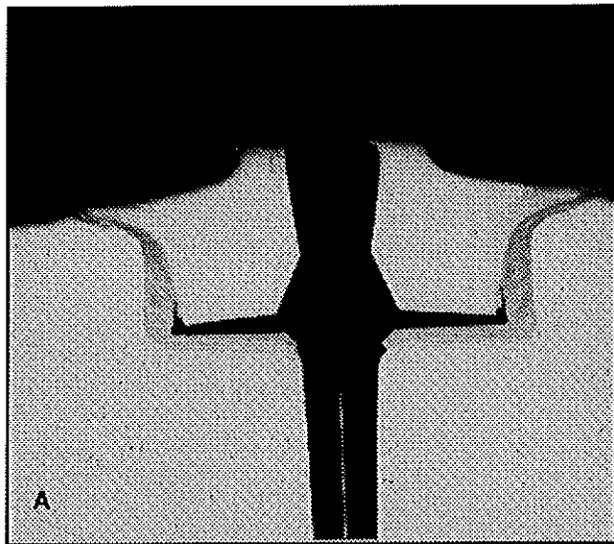
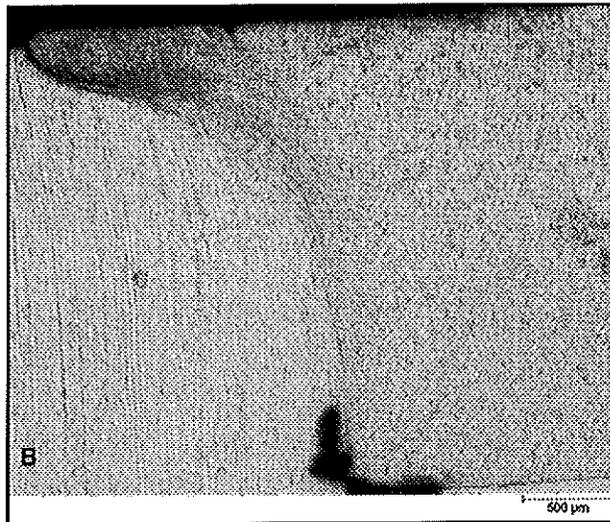
Fig. 23 — A — Metallographic cross section of a burst tested, LENS-repaired 0.045-in. overbore reclamation weld; B — typical Type 304 SS reclamation weld in the as-welded condition (note parallel nature of foot base and reclamation base).

A comparison of the microstructure from a typical Type 304L SS reclamation weld reveals similarities and differences. The flow lines for both the stem foot as well as the base material are apparent. There are perceived differences in the relative amount and location of the material for the LENS-repaired sample compared to the standard base. The presence of flow lines in the LENS material is less apparent than for the fill stem bare stock. Note also the presence of fine porosity in the "corner" of the reclamation test base/LENS material. The LENS material seems to

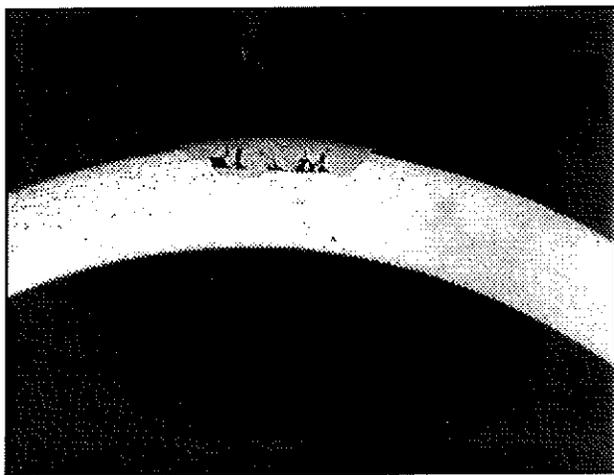
Fig. 24 — Typical area of a LENS-repaired sample that had a 0.020-in.-deep notch machined into it.

The sample bottles were also examined metallographically. A typical LENS repaired and machined sample is shown in Fig. 24. This sample exhibits some voids and porosity in the repair area. At least two different sample elevations were examined to verify the presence of these anomalies. The voids appear to be due to incomplete fusion of the laser-sintered powder to the bottle substrate. Higher magnification images clearly indicate that the bond is intermittent. The shape of the voids also indicate incomplete fusion as opposed to gas formation voids. It is surmised that a change in the bottle slot geometry to make the defect more weld repairable would have improved the nature of this repair. It is further expected that radiographic examination of the bottles prior to testing would have revealed these defects and perhaps have enabled a secondary fusion cycle to "heal" the voids. An optimized process certainly would have enabled higher-quality LENS repair techniques and material application to be implemented.
