## Radiation Effects on Epoxy/Carbon-Fiber Composite

E.N. Hoffman, T.E. Skidmore

*Savannah River National Laboratory: SRS Road 1, Aiken, SC 29808, and hoffman@srnl.doe.gov*

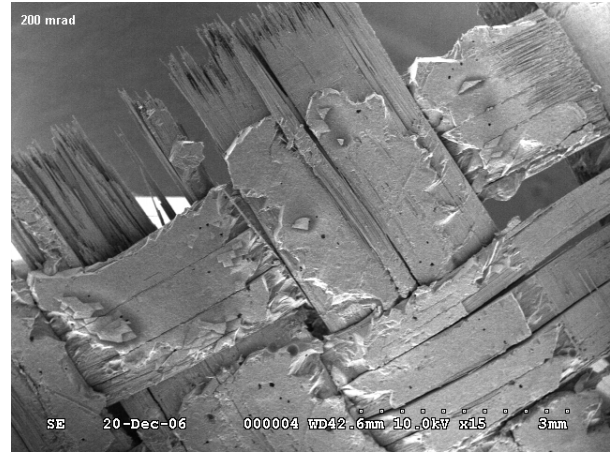
At the higher dose of 200 Mrad, the resin undergoes a significant color change with a visible dark yellow color. Damage extends along the length of the tensile bar and is not contained to the fracture site. In addition to color changes, pockets of resin are missing at the interface between carbon fiber woven points. This damage extends several inches from the fracture site down the length of the tensile sample. Noticeable volume of resin is also absent from the interior of the tensile bars. Weight measurements were taken for a bar from each radiation dose. While baseline, 50 Mrad, and 100 Mrad samples weighed between 7.7 and 7.9 g, the 200 Mrad weighed 7.5 g, which is a more significant weight loss.

At radiation doses of 200 Mrad (a typical nuclear qualification dose), the integrity of the composite is diminished. Significant epoxy debris remains on carbon fibers and numerous cracks run through the epoxy core.

Several budes covered in cracks have formed on the irradiated sample. These are most likely due to the release of gases from the epoxy upon radiation decomposition. Offgassing of polymers during radiation exposure is expected. Heavy microcracking is present throughout the resin and the macroscopic disconnect between sections of epoxy on the carbon fiber weave, see Figure 1. Laden with cracks, the epoxy appears to have lost much of its reinforcing strength. Might want to say that although significant changes are observed in the composite/interfacial regions, the impact upon specific properties is unknown and requires further investigation. Depending on service conditions, the degradation observed may be acceptable. Alternative epoxy resins with superior radiation resistance could also be incorporated, if other properties are suitable.

Fig. 1: Epoxy surface on tensile bar subjected to 200 Mrad gamma radiation. Macrocracks form at the interface of carbon fiber bundles as well as along the length of the carbon fiber bundles. The crack formation suggests the epoxy has lost significant reinforcing properties.

Also should note that the composite should be irradiated at varying dose rates to determine the potential for dose rate effects and for life prediction purposes. High dose rate irradiation does not accurately predict service life, particularly if operating at significantly different dose rates.
