# HEAVY WATER MODERATED POWER REACTORS

PROGRESS REPORT  
JANUARY-FEBRUARY 1965

HEAVY WATER MODERATED POWER REACTORS  
PROGRESS REPORT  
January-February 1965

E. I. DU PONT DE NEMOURS & COMPANY  
SAVANNAH RIVER LABORATORY  
AIKEN, SOUTH CAROLINA

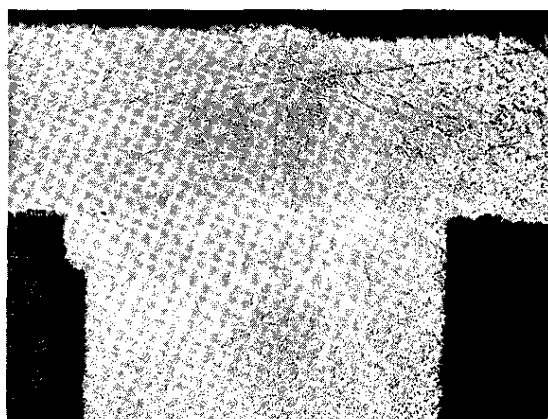
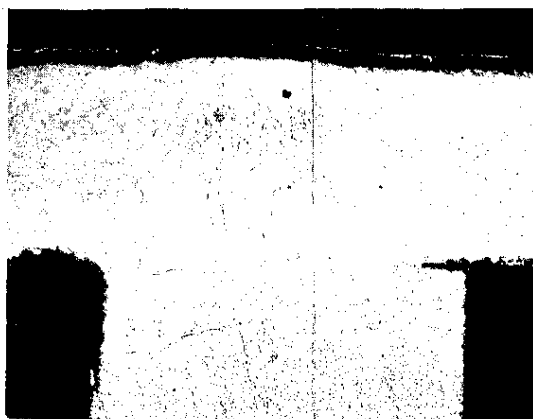
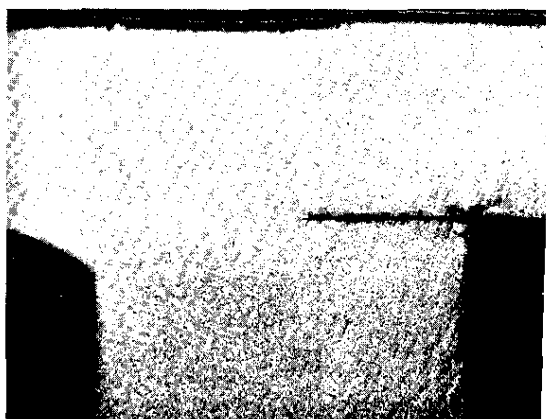
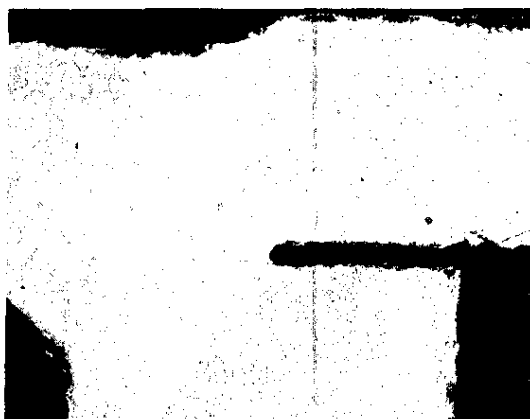
FIG. 1 CROSS SECTION OF WELD BETWEEN RIB AND HOUSING TUBE

Deviation of the centerline of the weld from the centerline of the rib along the full 10-foot length was determined by examination of 9 metallurgical samples cut at 1-foot intervals plus 2 samples taken 6 inches from each end. The results from 44 samples, all from the same tube, are shown below:

The offset between the centerline of the weld and the center of the 60-mil-wide rib is probably due to an accumulation of mechanical factors during electron beam welding, including (1) the radial motion of the rear support truck passing over the uneven table surface, (2) lateral motion of the rib in the mandrel slot, (3) inability of the guide rolls to exert enough pressure to fully compress the tube against the mandrel and thus center it, and (4) possible deviation in the weld beam deflection. Excessive bow of the Zircaloy tube increases the offset to the extent that the guide rolls and mandrel are not able to remove the bow. The tube that was sectioned had a bow of 0.160 inch.

Although the tubes with welded ribs were acceptable for irradiation as housing tubes, the welds would not be satisfactory for swaged  $\text{UO}_2$  fuel tubes. To avoid possible disturbance of the fuel core, it is desirable that ribs be attached to fuel sheaths before the oxide is loaded and compacted. The welds must have sufficient penetration to withstand the rigors of the swaging operation and must have no crevices between rib and sheath due to an off-center weld. Crevices such as those shown in Figure 1b, 1c, and 1d would have to be eliminated over the full length of the tube. Possible methods of eliminating them are (1) increase the weld width, (2) increase the accuracy of rib positioning as the rib passes under the electron beam, and (3) improve the dimensional control of the sheath tubing. Additional work, not now planned, would be required to verify a process for welding long ribs on fuel element cladding.

a. No weld offset

b. 0.004-inch weld offset

c. 0.020-inch weld offset

d. 0.036-inch weld offset

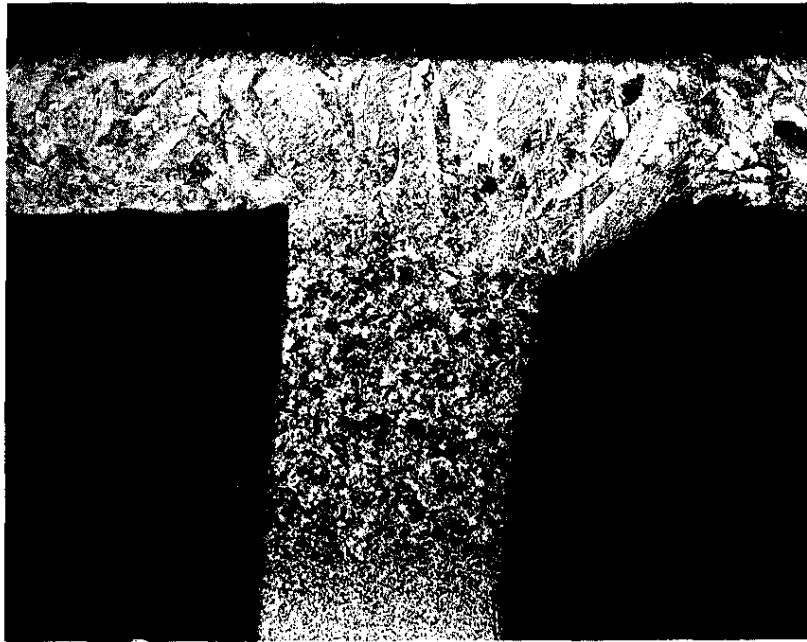
FIG. 3 ZIRCALLOY SHEATH WITH FULLY WELDED RIB AFTER SWAGING

A photomicrograph of a fully welded portion of a rib after swaging is shown in Figure 3. It is apparent from this figure that the 2.5% elongation of the sheath and rib during swaging did not adversely affect the rib, which was machined so that it did not touch the bottom of the groove in the mandrel during swaging.

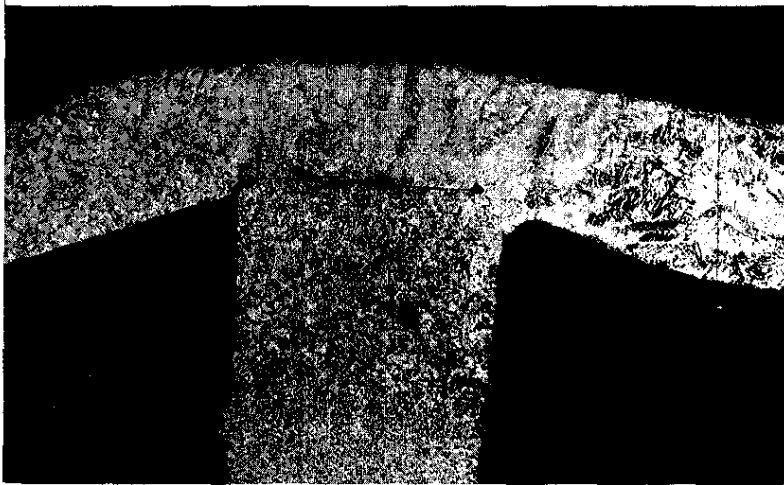
FIG. 4 ZIRCALOY SHEATH WITH INCOMPLETE WELD AFTER SWAGING

Figure 4 illustrates two effects of poorly welded ribs. In this sample, only the right hand corner of the rib was welded to the sheath. The partial weld was not strong enough to prevent separation of the rib from the sheath during swaging. Also, the excessively high rib contacted the bottom of the mandrel groove and caused folds to develop in the sheath tube during swaging.
