# DEVELOPMENT OF LASER ENGINEERED NET SHAPE (LENS) ADDITIVE MANUFACTURING FOR REPAIR

**PVP2015-46001**

## **DEVELOPMENT OF LASER ENGINEERED NET SHAPE (LENS) ADDITIVE MANUFACTURING FOR REPAIR**

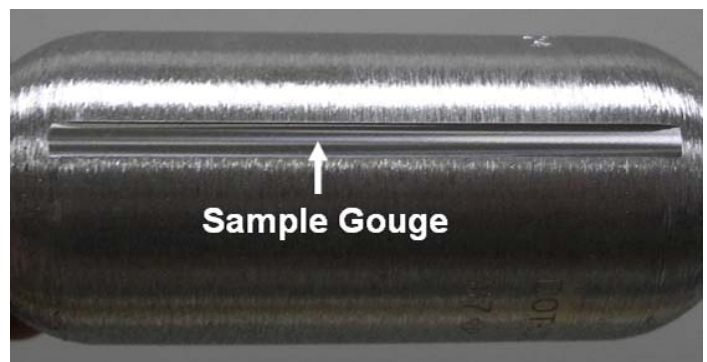
**Figure 2. Defect simulating a deep scratch on a gas bottle, the gouge was created by milling 0.25 mm or 0.51 mm deep gouges 1.1 mm wide.**

Type 304 stainless steel gas sample bottles were milled to have defects that were 0.25 mm deep and 2.5 mm wide and 0.51 mm deep and 2.5 mm deep. The defects had parallel sides and ran the length of the 500 ml bottles. A typical bottle “defect” is shown in Figure 2. The defect was LENS repaired and then excess material was removed using conventional

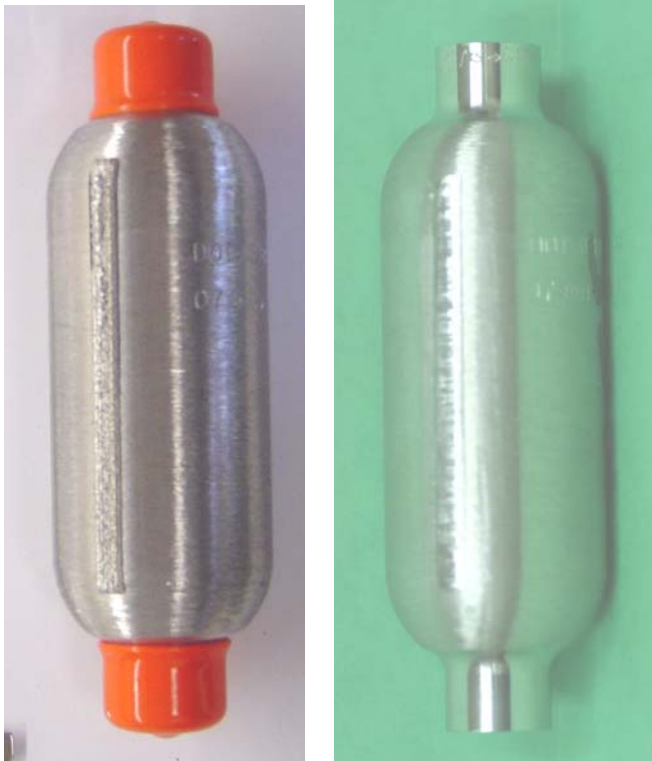
The LENS repaired gas sample bottle in as repaired and as machined conditions are shown in Figure 4. The LENS repair was nearly the same diameter as the original bottle diameter, although there was some shrinkage around the LENS repair. A cross-section of the LENS repair is shown in Figure 5. This image shows that the LENS repair did not completely fill the original notch. There was inadequate heat applied to the fuse all of the powder to the bottle. It is surmised that altering the shape of the defect would improve the ability to repair notch type defects. Some potential process improvements include using a 30 to 45 degree angle on the edges of the “scratch” would reduce the interaction of the particles with the sidewalls and help direct the heat into the base of the notch and rastering at 90° to the defect. Unfortunately due to programmatic and

**Figure 4.** As LENS repaired gas sample bottle and after machining. The repair is visible but appears to be cleaned up.

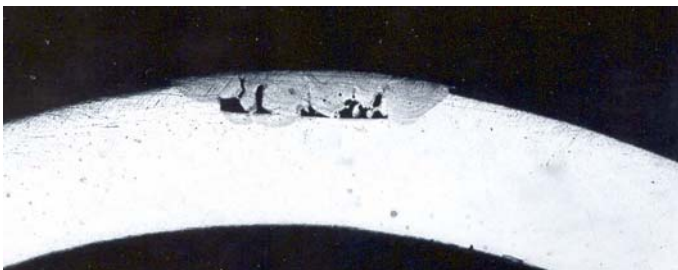
**Figure 5.** LENS repair on gas sample bottle that had a 0.5 mm deep gouge.

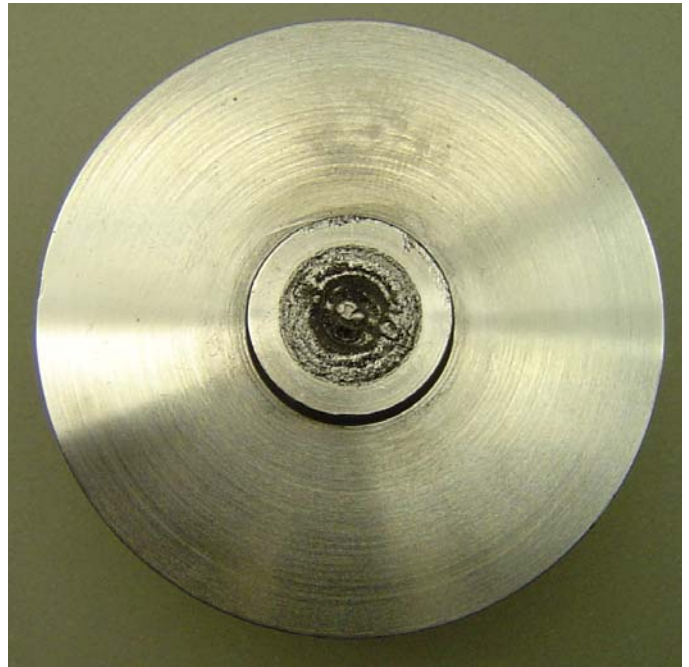
The as-repaired condition of the reclamation test bases is shown in Figure 6 for various levels of overbore. The center of the sample exhibits a protrusion, as indicated in the experimental section. The visual appearance of this material suggests less than ideal particle melting and bonding. The material machined nicely and all the poor quality material at the center of the reclamation bases was removed prior to welding fill stems, a fully repaired, machined, and welded sample is shown in Figure 7. The heat band and slight extrusion of material around the weld are consistent with typical production welds. The fill stem foot diameter is oversized by 0.63 mm.

**Figure 6.** LENS repaired reclamation base with an initial bore that was 1.14 mm oversized.

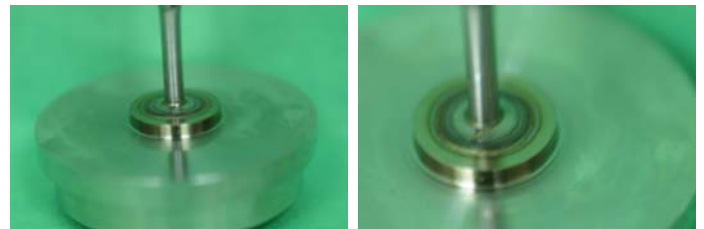
**Figure 7.** LENS repaired, machined and welded test base.

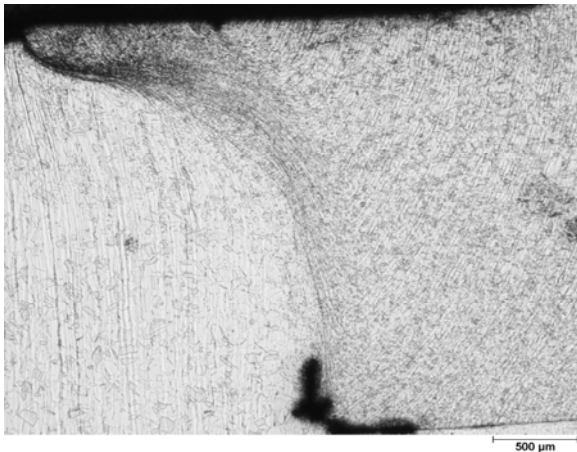
This amount of interference has been successfully used for welding gas bottles. The bond characteristics for a typical reclamation weld are shown in Figure 8. The stem foot undergoes shear displacement and exhibits a slight protrusion. The entire length of the insert is not necessarily bonded and depending on the alloy, the production limits range from 50 to 70% minimum bond. For the LENS repaired test articles, no weld acceptance testing was done due to insufficient assets, however, select samples were examined after burst testing.

**Figure 8.** Typical test base to fill stem weld showing displacement of foot stem material, some near melting of the stem and deformation of material.

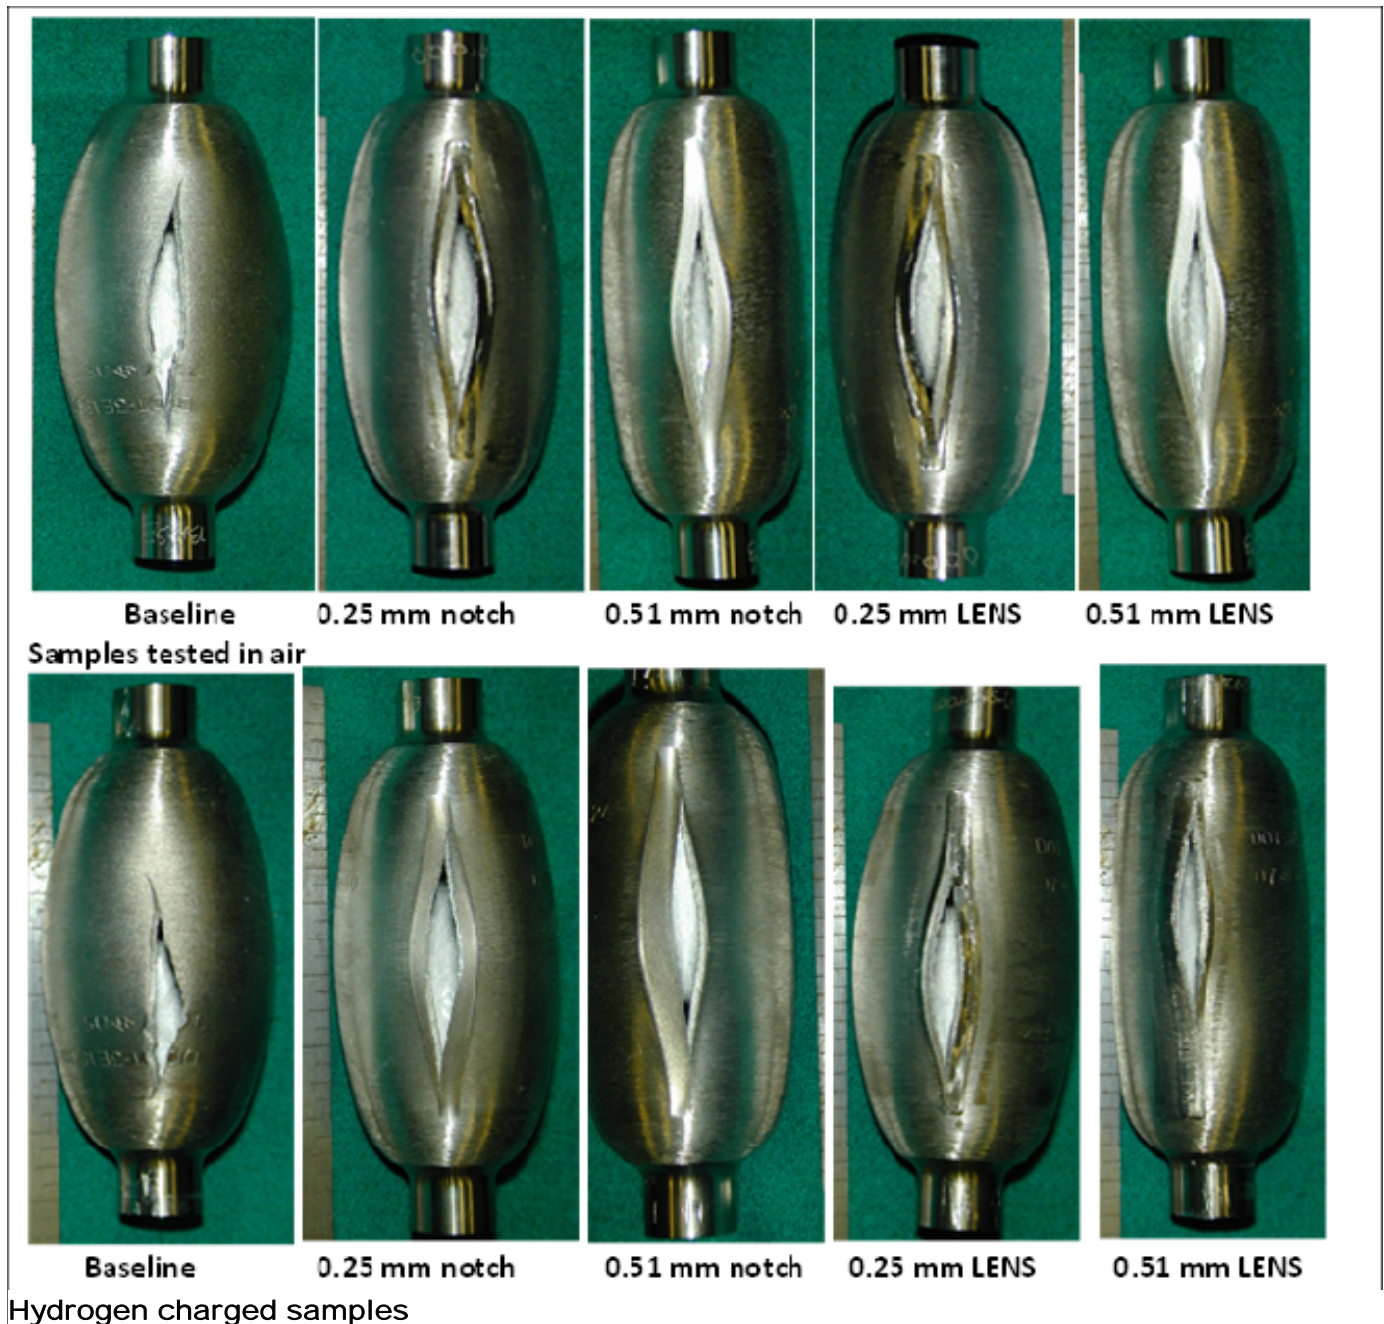
**Figure 13. Appearance of baseline and hydrogen charged gas sample bottles in the as fabricated, damaged and LENS repaired condition.**

The appearance of the burst tested gas sample bottles exhibited the expected failure with the bottle tearing axially, in addition all of the samples with notches failed in the notch. There was one exception for the LENS repaired samples with one of the 0.25 mm LENS repaired samples failing in the vessel body away from the repair, indicating that the repair was excellent and that it had no adverse impact on strength. Photographs of selected burst tested vessels for both baseline and hydrogen charged conditions are shown in Figure 13. The change in sample diameter growth, i.e., direct indication of strain, appears lower as the extent of the defect increases, this feature is apparent in Figure 12 as well.

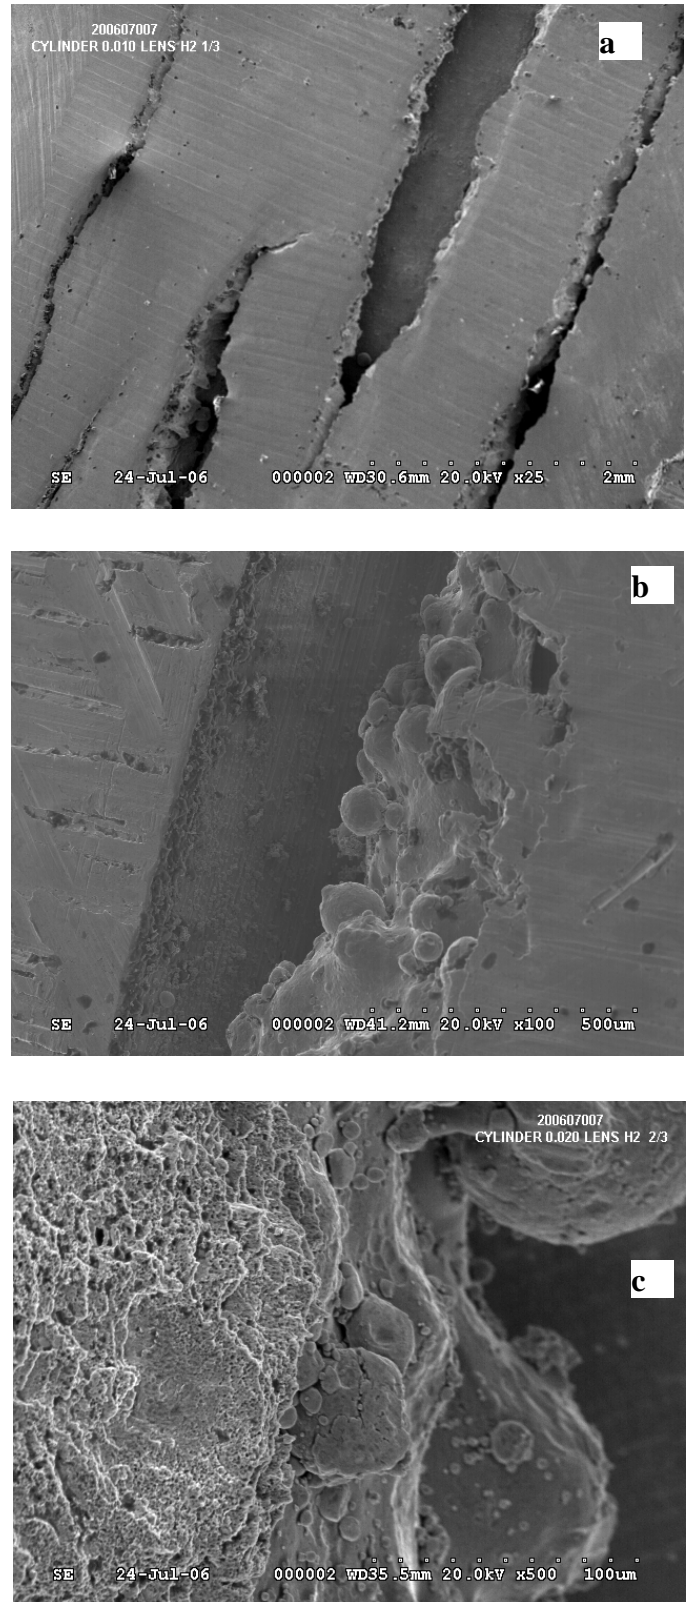
The fracture surfaces of the LENS repaired surfaces were also examined. The LENS material appears to have cracked axially with a width that is consistent with the hatch width (Figure 1) of the LENS build-up. Some of the samples exhibit a possible delamination from the gas sample bottle as well as between the interlayers of the LENS repair. This failure mode is likely indicative of the non-optimized deposition method and deposition conditions, including the axially deposit into a blind defect. The cracking and onset of delamination of sample 0.010 LENS H<sub>2</sub> that did not fail in the LENS repair area is shown in Figure 14. Some unmelted particles are also visible in the SEM fractograph. These unmelted particles are symptomatic of the rush to repair to meet schedule. Sample preparation to improve the repair methodology would have included development of an angled groove rather than a sharp edge, 90° angle, to avoid particle entrapment near the molten pool, multiple raster directions and higher laser energy to improve the interlayer melting may also improve the LENS repair.

**Figure 14. Burst test fractography for a) 0.25 mm gouge LENS repair H<sub>2</sub>, b) 0.51 mm gouge LENS repair c) 0.51 mm gouge LENS repair H<sub>2</sub> charged.**

Sample gas bottles with machined defects were successfully LENS repaired for dimensional purposes. Gas bottles were burst tested to failure in the as-machined, as repaired, and hydrogen charged conditions. All of the notched and LENS repaired bottles failed in the notch, except one bottle with a 0.25 mm deep LENS repaired notch. Inadequate fusion between the LENS repair and base metal is likely the cause of the failure mode.

The sample gas bottle repair would have benefitted by being optimized for the defect type and geometry. Additional heat was needed to improve the repair tie-in with the gas bottle. Burst testing of the gas bottles indicated that there was a stress riser at the corner of the groove. This may have contributed to the reduced ductility of the machined as well as the repaired bottles.
