## Drop Tests of the Redesigned 9975 Package

RECORDS ADMINISTRATION

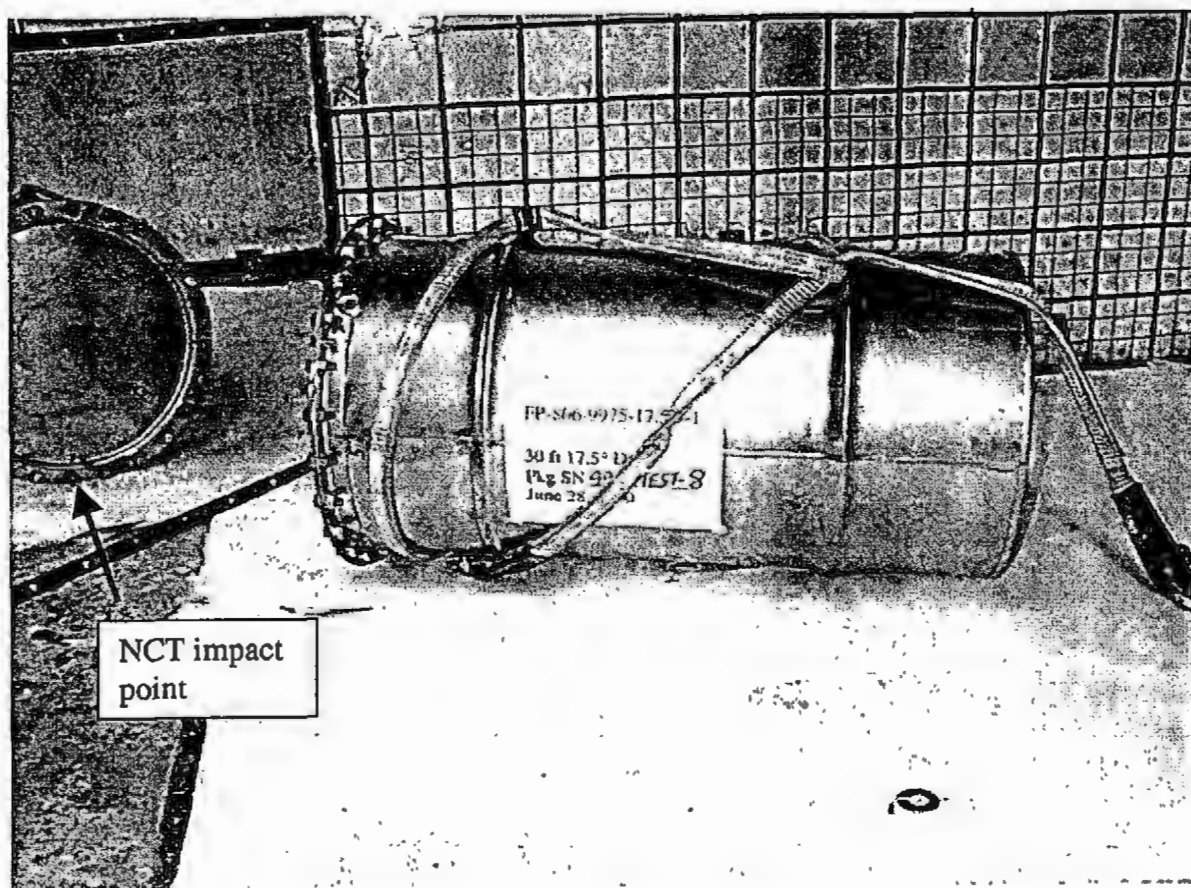
Figure 2. Test 1: Package 9975-TEST-8 after the preconditioning drop. The impact bent the flange downward a small amount ( $\sim 3/16$  in.) and caused some minor, local buckling of the wall of the drum.

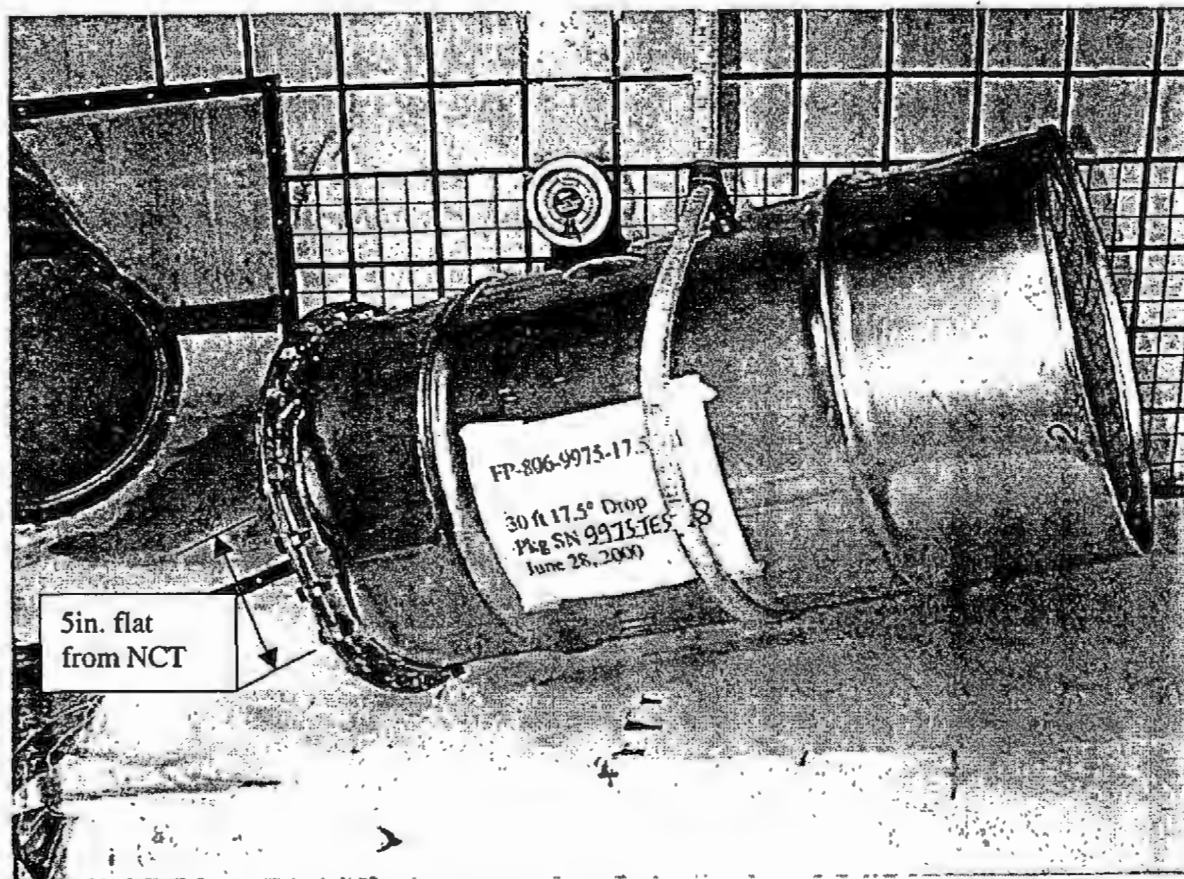
Figure 3. Test 1: Package 9975-TEST-8 rigged for the 17.5°, 30 ft HAC drop.

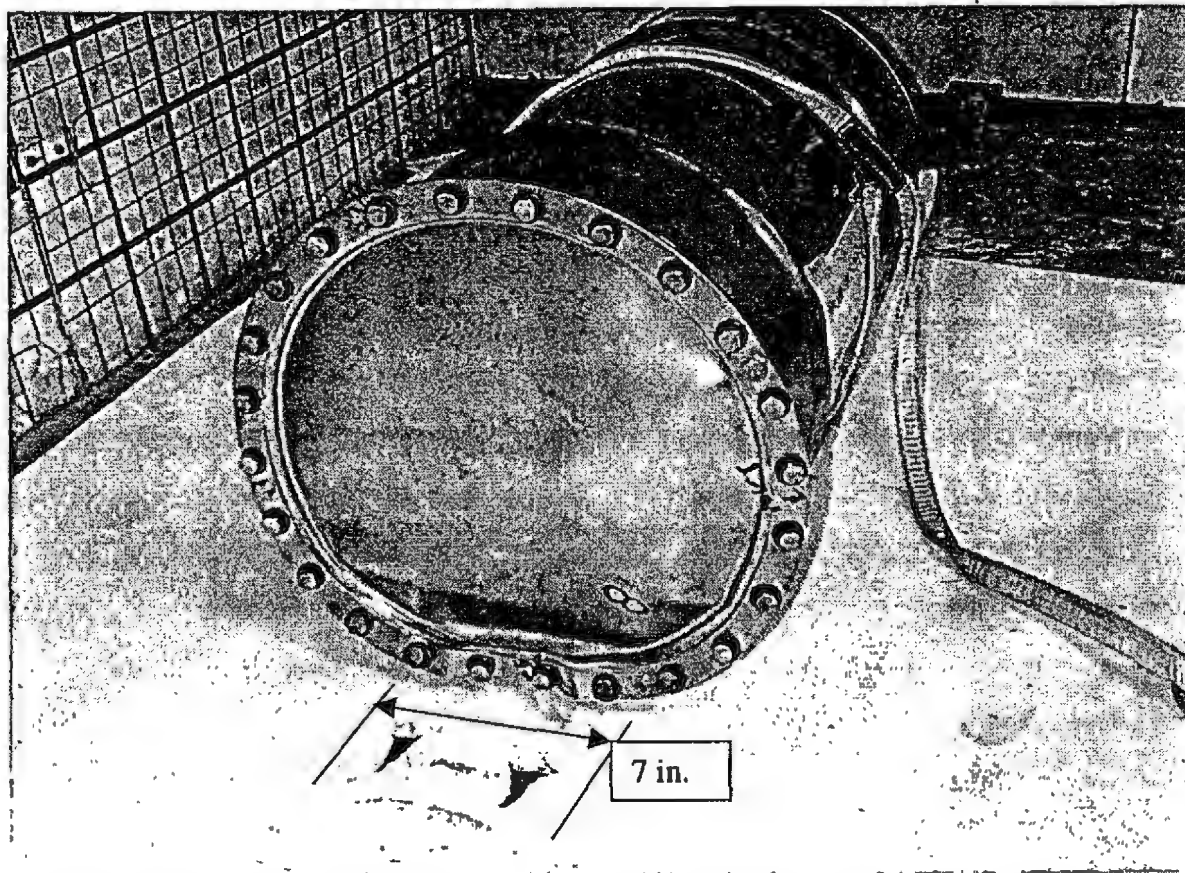
Figure 5. Test 1: Damage to 9975-TEST-8 caused by the 30 ft drop. The flange closure was flattened in the region of the point of impact, with associated buckling of the flange and the top of the package.

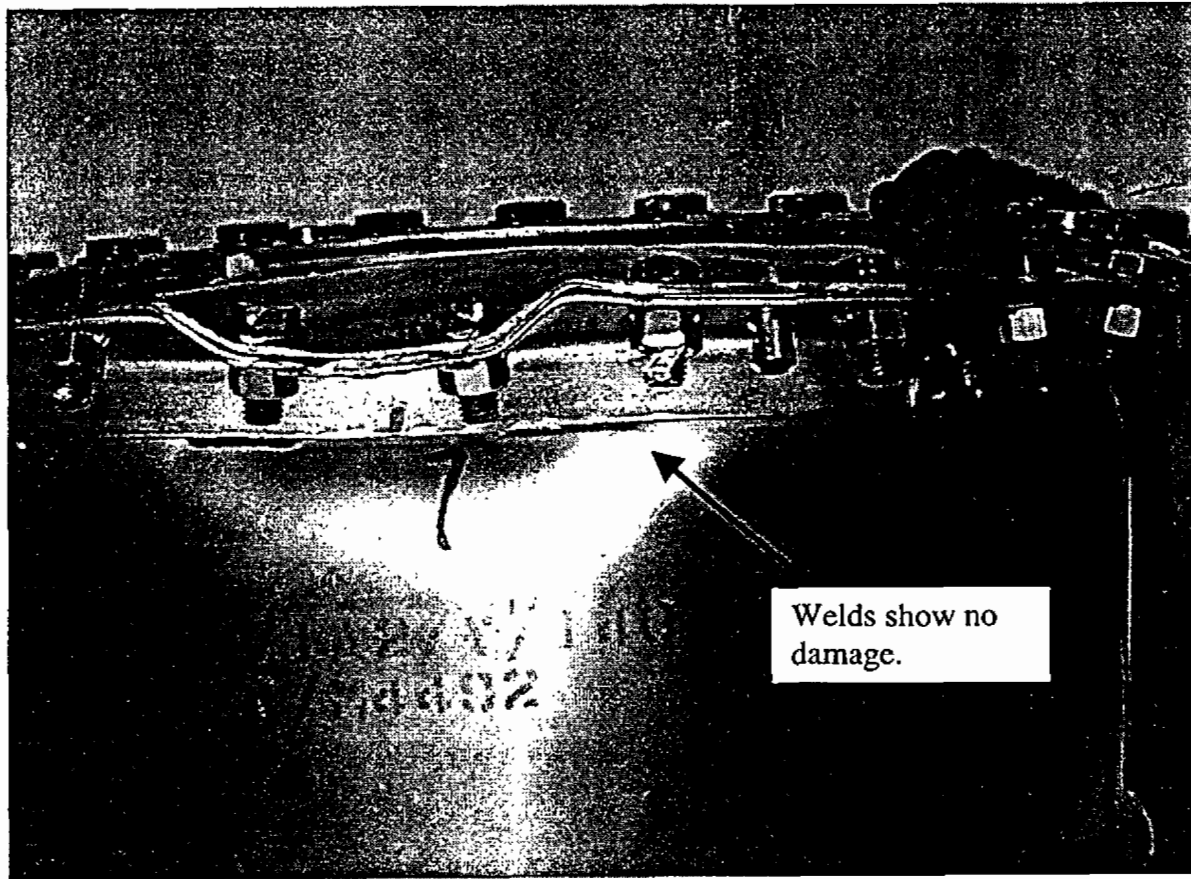
Figure 6. Test 1: Damage to 9975-TEST-8 caused by the 30 ft drop. This view shows buckling of the flange assembly and adjacent sides of the drum.

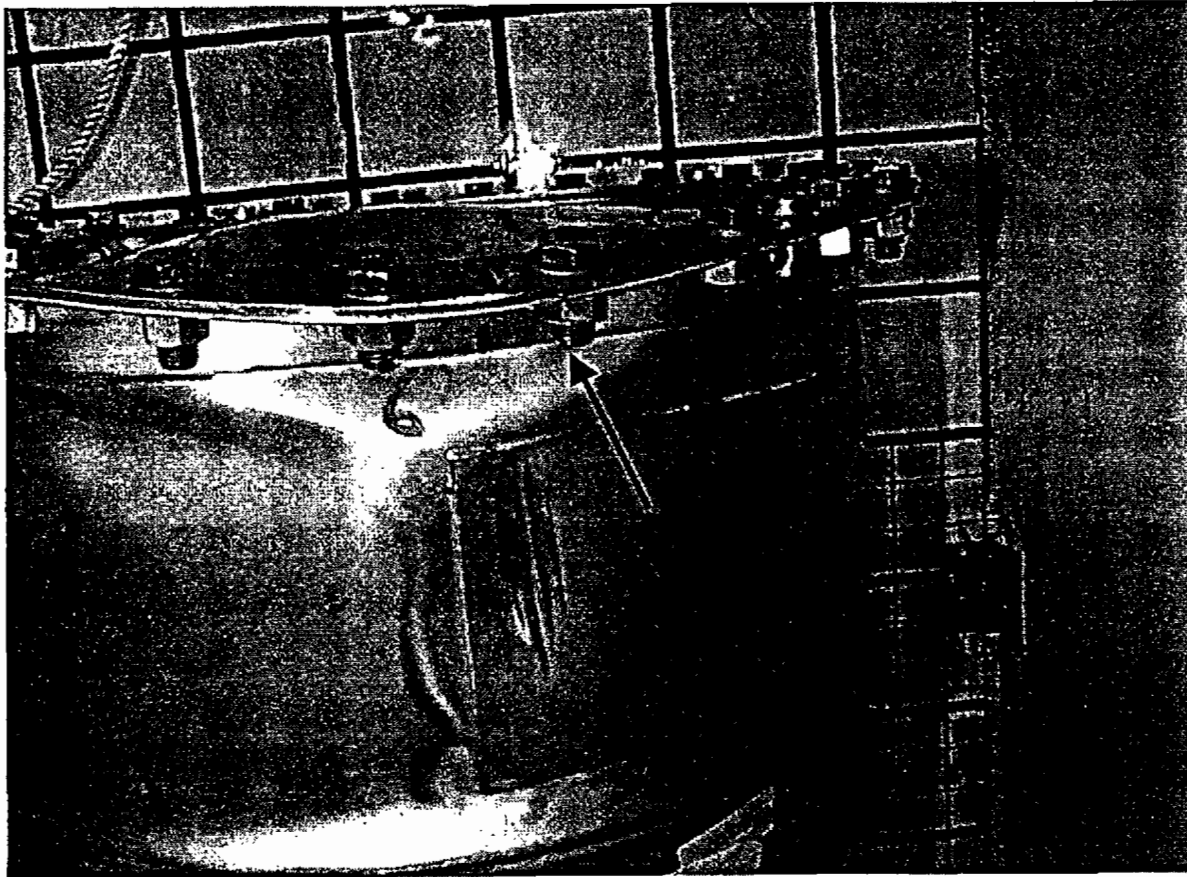
Figure 7. Test 1: Results of the Puncture Pin Test of 9975-TEST-8. The pin scraped the side of the package and glanced off of the bolt to the right of reference mark 6. The arrow indicates the paint mark left on the bolt by the puncture pin.

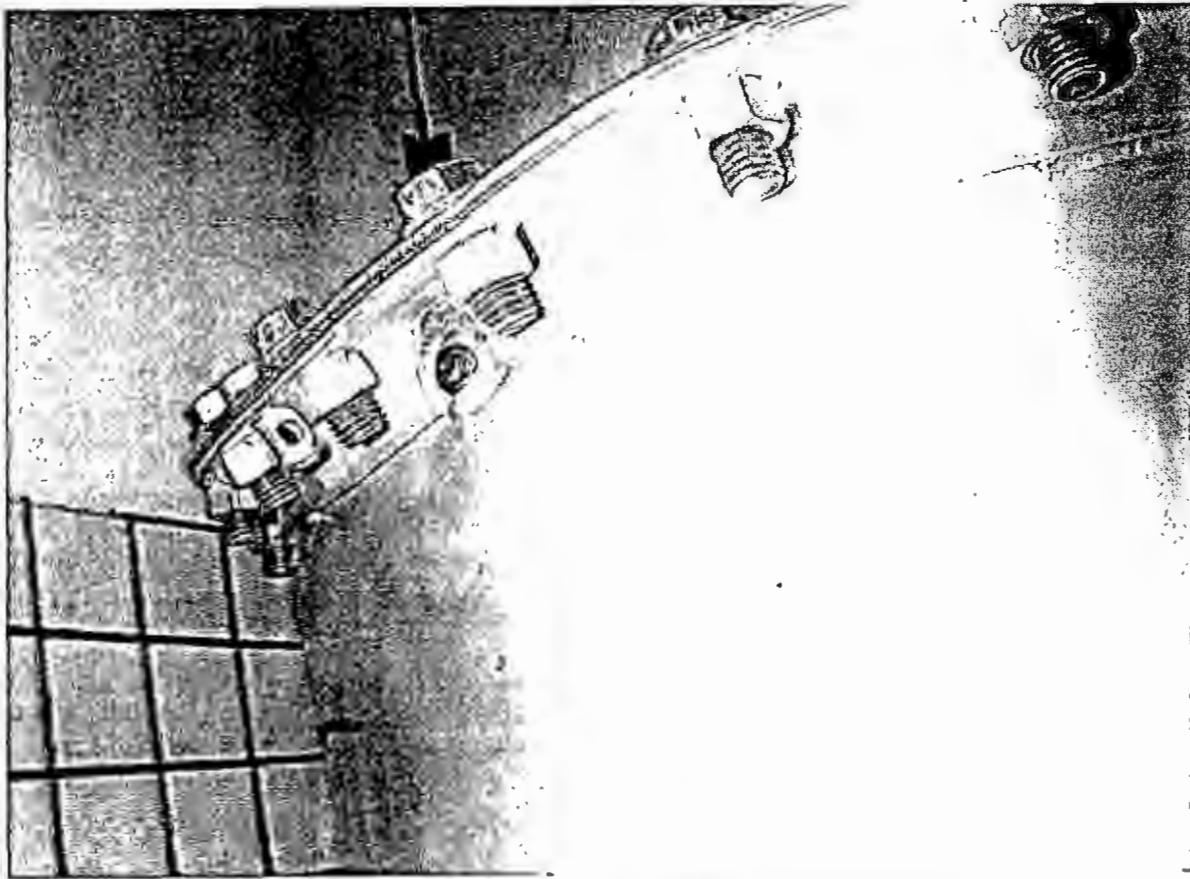
Figure 10. Test 2: Deformation of flange of 9975-TEST-9 caused by NCT preconditioning drop. Impact was directly at vent hole.

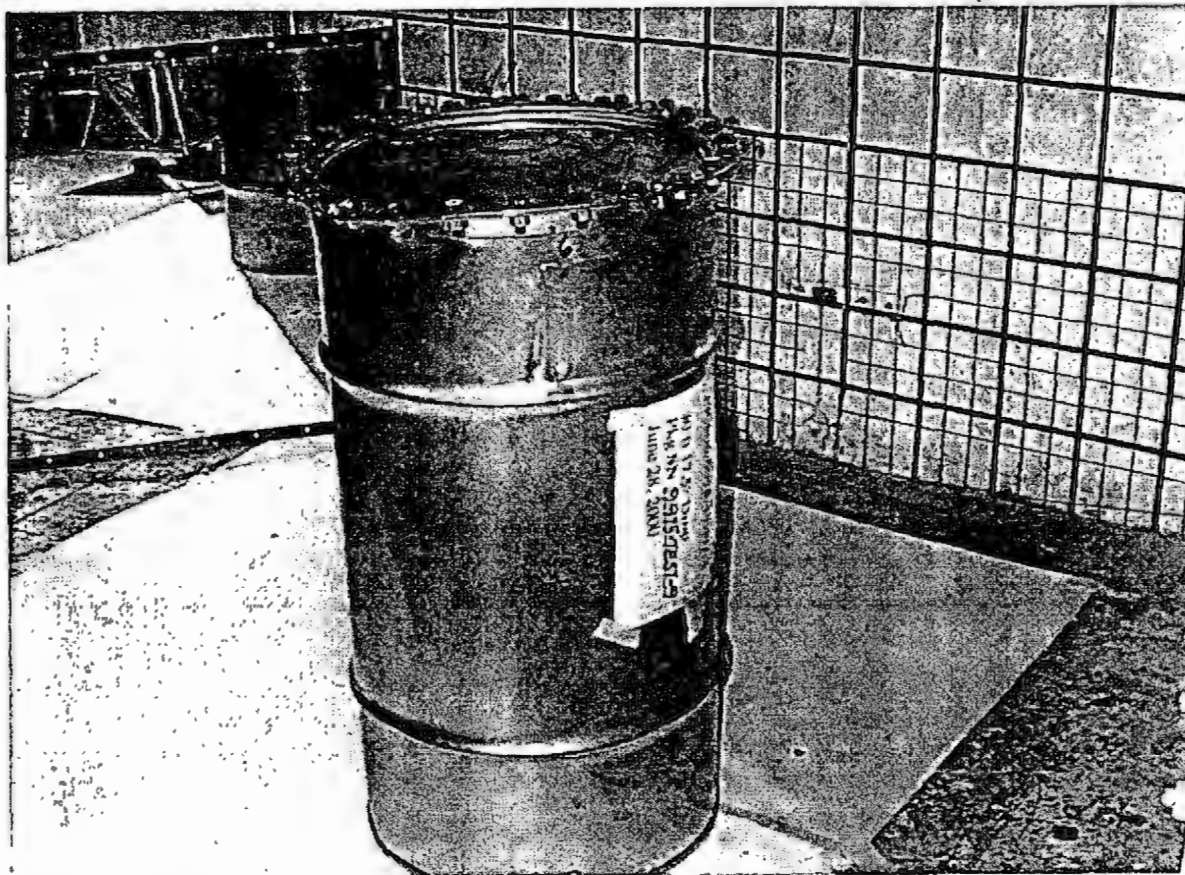
Figure 11. Test 2: Overall view of 9975-TEST-9 following NCT preconditioning drop.

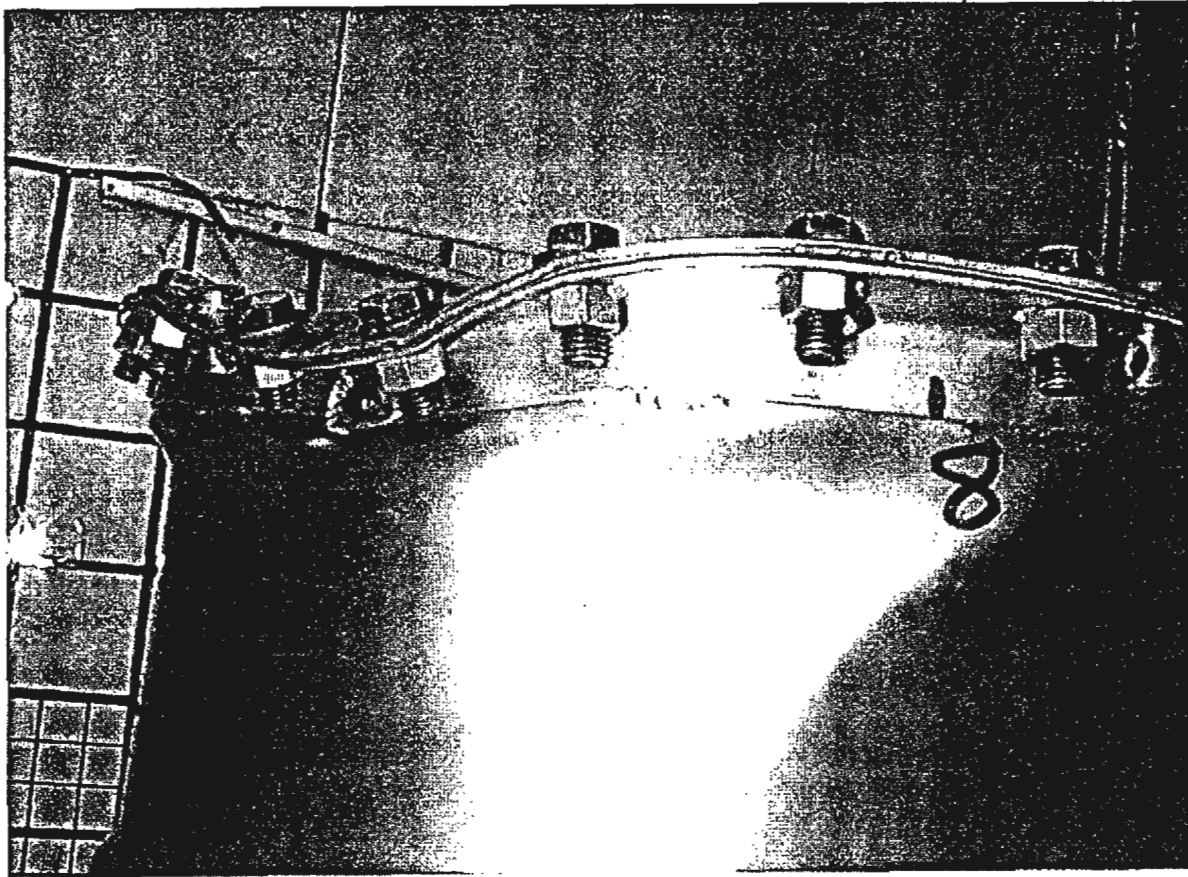
Figure 14. Test 2: Buckled flange and deformation of drum wall caused by 30 ft drop of 9975-TEST-9.

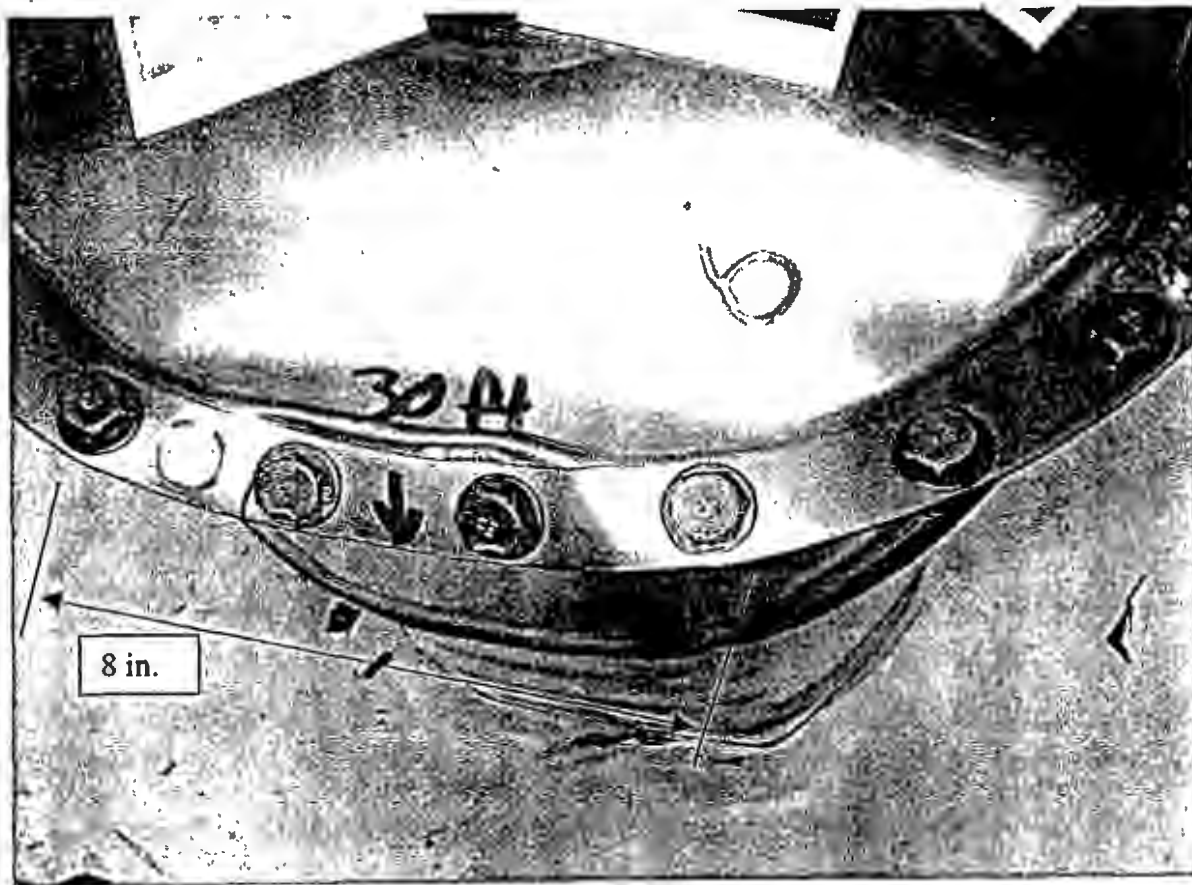
Figure 15. Test 2: Top view of 9975-TEST-9 following 30 ft drop, showing buckled flange and buckling of top.

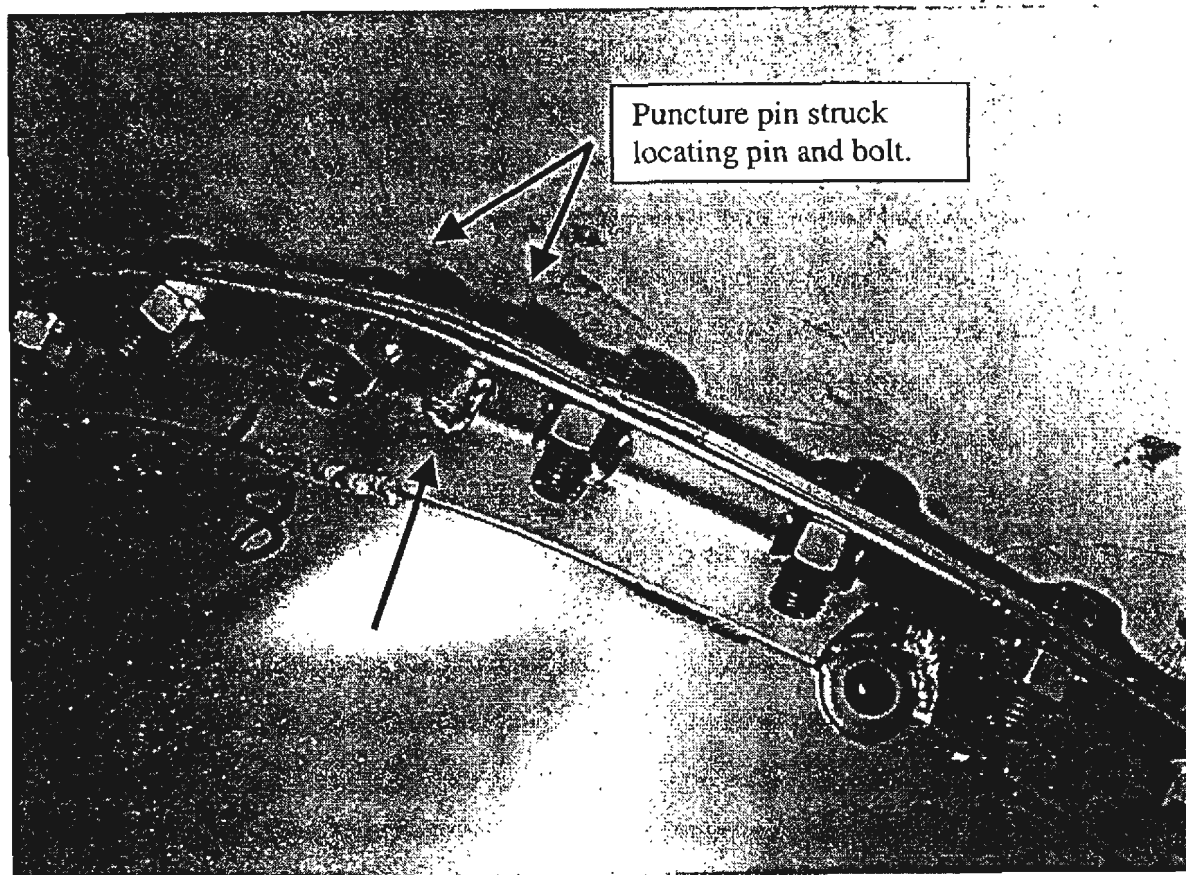
Figure 17. Test 2: Impact point for pin drop of 9975-TEST-9. The arrow indicates the paint mark on the flange locating pin caused by impact with the painted top of the puncture pin.

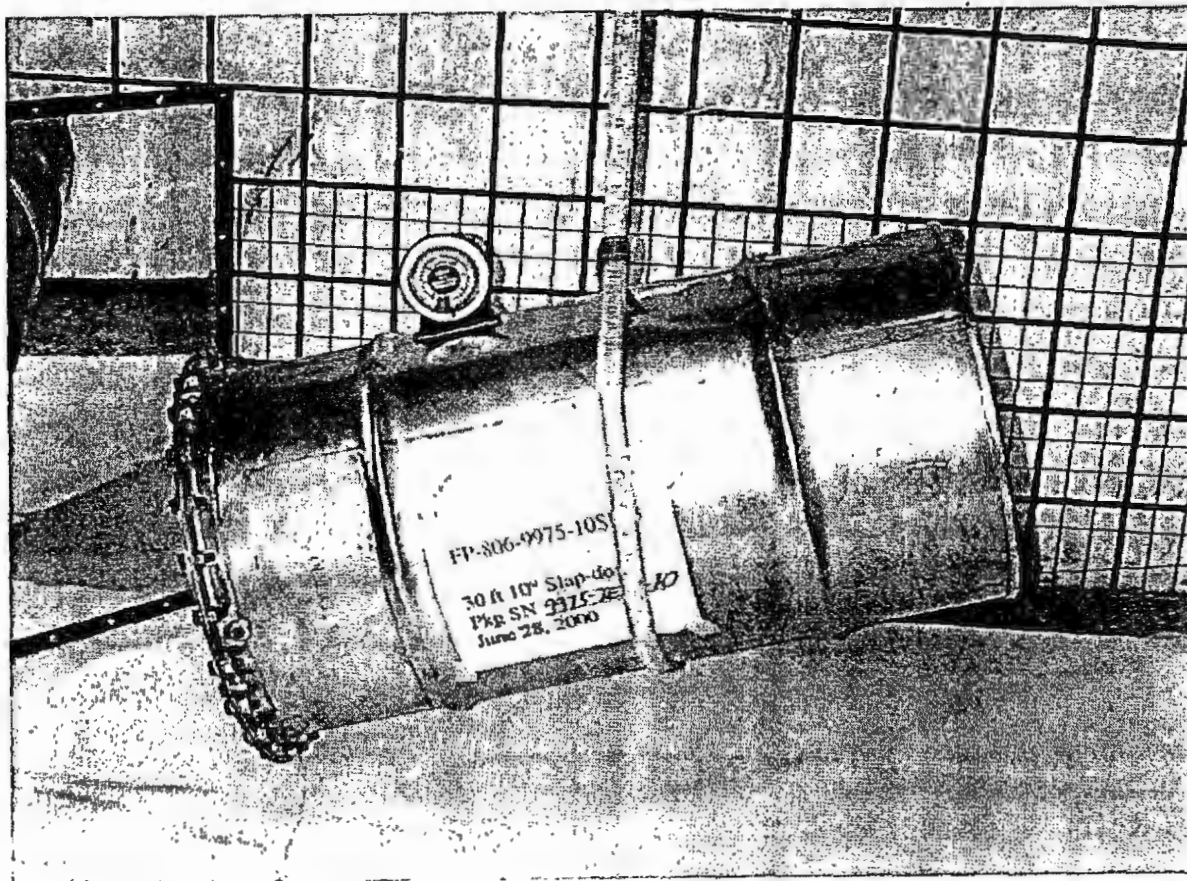
Figure 18. Test 3: Package 9975-TEST-10 rigged for the 17.5°, top down NCT preconditioning test.

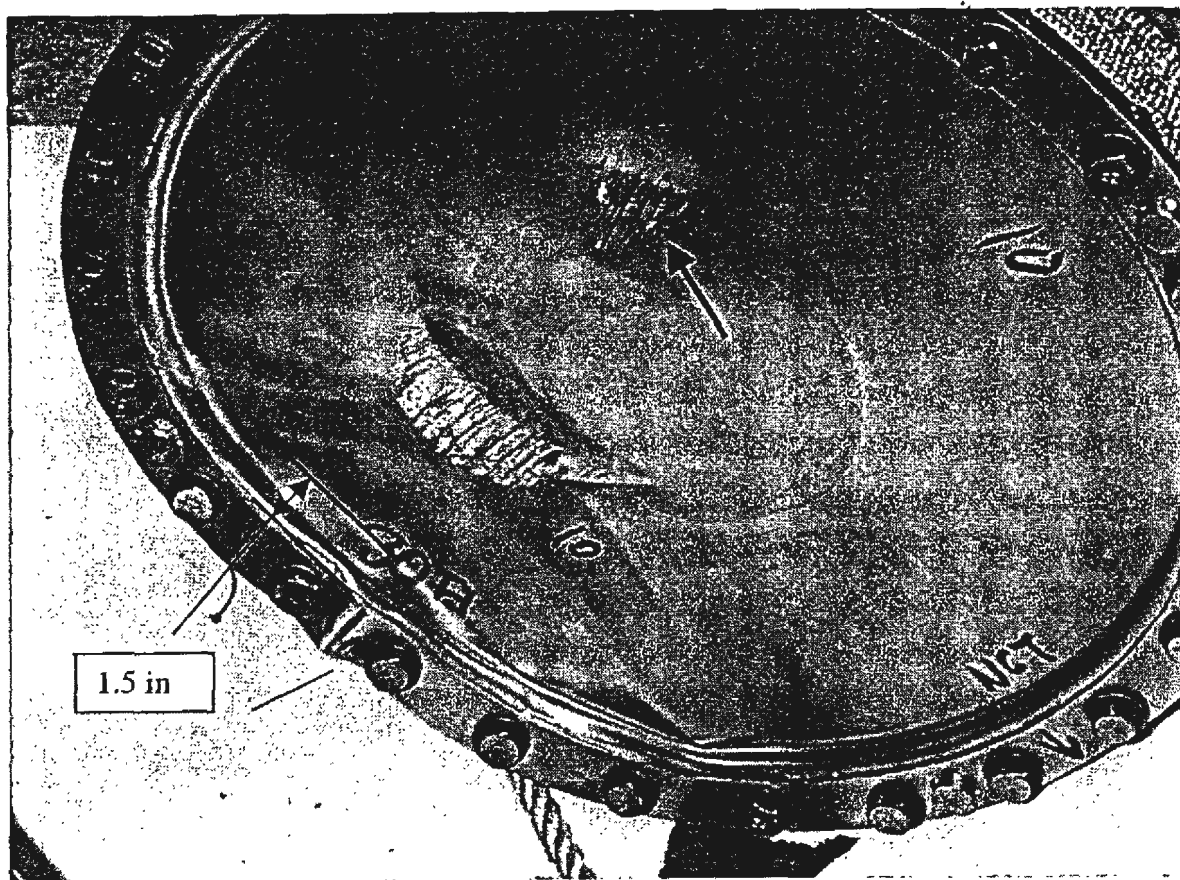
Figure 25. Test 3: Deformation of top of 9975-TEST-10 caused by impact on the puncture pin. The arrow indicates damage caused by the second impact of the package with the pin. The 1.5 in. dimension is the distance from the top of the buckled section of the flange ring to the bottom of the buckled section of the package top, measured parallel to the axis of the package.
