## **Savannah River Site**

### **Tank 18 and Tank 19 Wall Sampler Performance**

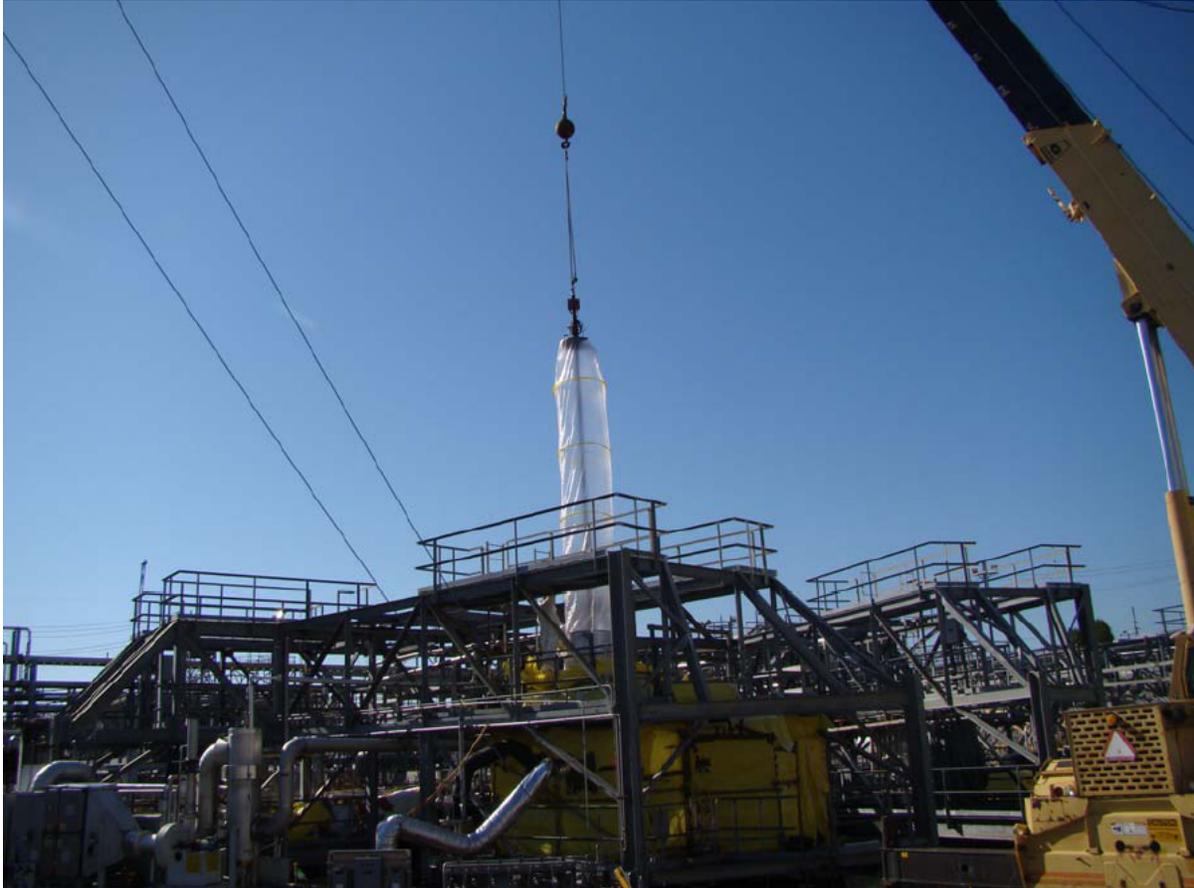
**Figure 1: Installation of Sampler and Mast Assembly in an SRS Waste Tank**

Wall samples were successfully machined from Tanks 18 and 19 in FTF (F-Area Tank Farm), SRS (Savannah River Site) to establish the residual activity ( $\mu$ Curies) prior to permanent closure of these two 85 feet diameter, 1.3 million gallon, steel lined, radioactive waste storage tanks (Figure 1). SRNL (Savannah River National Laboratory) was authorized by SRR (Savannah River Remediation, LLC) to fabricate and test a sampling device to obtain these samples. The sampling device to be utilized was based upon a sampler originally designed by ORNL (Oak Ridge National Laboratory [1 and 2]) to sample concrete tanks, and a sampler design that was used at West Valley [3] to sample steel line tanks. SRNL modified the ORNL sampler design to ensure success in SRS waste tanks (Figure 2). The modifications included an innovative identification and correction of equipment resonance problems which would have caused failure of the sampler in SRS tanks. This paper was condensed from an SRNL report (Leishear and Fowley [4] that was issued to describe the development, fabrication, testing, and deployment of the sampling device.

The mast assembly was lowered by crane into the two tanks until the desired sampling elevations were reached in each tank. Sampler operations were similar to those performed during full scale testing, but an additional video camera was installed in another tank riser to provide an overall view of the mast and sampler.

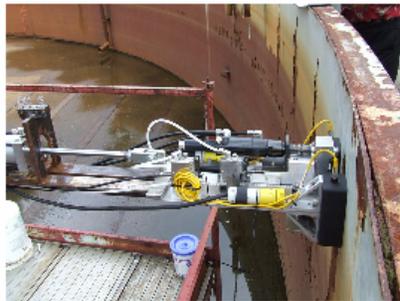
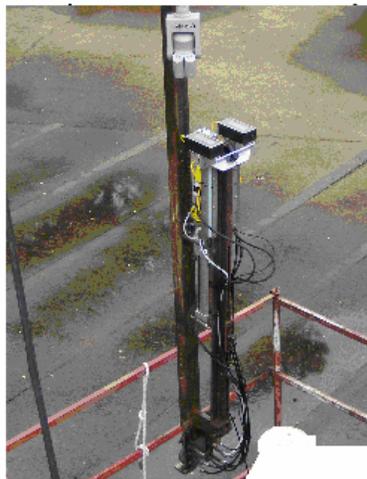
**Figure 3: Mast Assembly Design and Full Scale Testing**

To reduce costs, a simplified sampler and mast assembly was designed, tested, and installed in the waste tanks (Figure 3). In comparison, West Valley deployed the sampler using a reported 50 million dollar robotic arm. Based on their work, SRS developed a simplified and improved design. Total costs were less than five million dollars to obtain wall samples, where the cost of the sampler fabrication and evaluation was approximately \$400,000 and estimated costs for sample analyses are \$300,000 to \$400,000. A 45 million dollar cost savings was realized by SRS from the novel design.

Full scale testing

Sampler and mast assembly

Sampler and mast assembly layout

The mast design used supplied sampler and sampler heads, and the completed assembly consisted of several major components. The mast assembly was encased in a flexible plastic sleeve to maintain radioactive contamination control. Although not used in full scale testing, the sleeve connected to a yellow plastic hut built for working with the sampler, and as the mast was lowered into a tank, the sampler was accessed in the hut. The base of the sampler was a 3 inch thick plate designed to cover 23 inch riser openings at the tank tops. The vertical mast was raised, or lowered through this plate and fixed in position to obtain required heights for wall samples. The cantilevered arm was hinged at the bottom of the mast, and the controls were connected at the top of the mast. The sampler was positioned near the end of the arm, and was lowered into position using a cable connected to a manually operated winch, which was located above the tank. When the arm was lowered, a level was observed on the arm with a remote camera to level the arm to the correct elevation in the tank at either FTF or during full scale testing. Once the arm was leveled, an air actuated cylinder then guided the sampler along the arm until the electromagnets touched the wall. A mast mounted camera was then used to ensure that the electromagnets were properly aligned before energizing the electromagnets. The level was re-checked, and sampling was performed. To obtain samples, the sampler control system was operated to collect a sample from the wall. A mast mounted camera and a fixed focal length camera mounted to the bottom of the sampler were used to determine that the sample was complete. Although a recommended time to machine a sample was used to direct the sampling

To ensure sampling success in the waste tanks, the completed mast and sampler were evaluated during full scale testing. Evaluation at the mockup facility consisted of installing the mast by crane through a full scale riser opening, lowering the mast into position, operating the sampler, removing the mast assembly by crane, and removing and packaging a sample. These steps were performed using the same mast mounted camera equipment available to FTF. Other than the huts at the tank tops and contamination concerns, full scale testing conditions were comparable to FTF. A few minor changes were made to the mast, but it functioned as designed, and workers learned to operate the equipment efficiently before working in FTF. The first holes were drilled in a clean ground surface on the Full Tank wall. The initial attempts to drill rusted surfaces were ineffective ineffective.
