Effect of Scratches on Pinch Welds

P.S. Korinko

October 2005

WSRC-RP-2005-00435

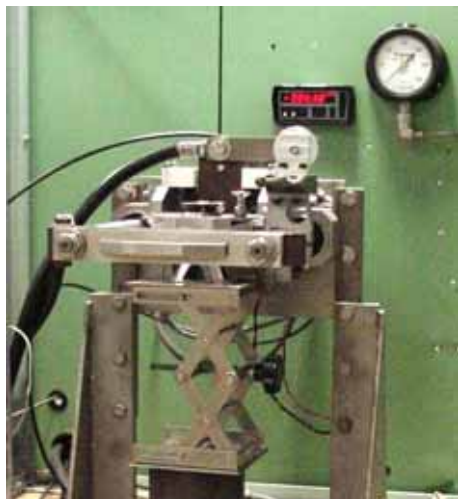
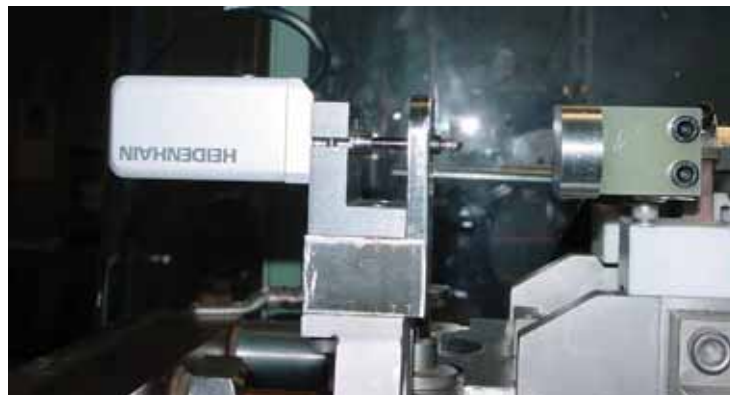
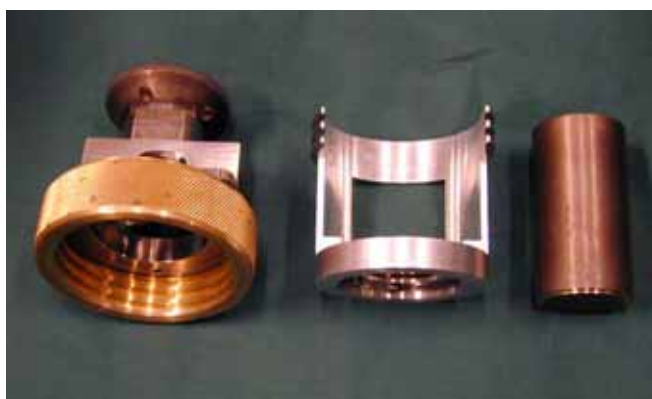
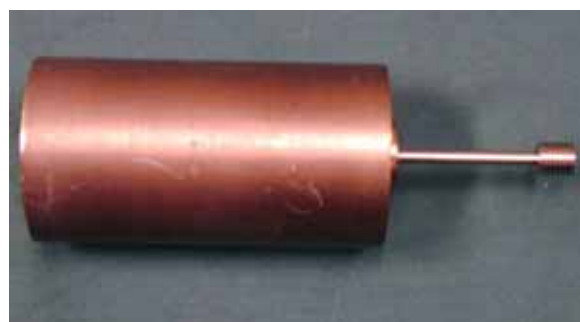
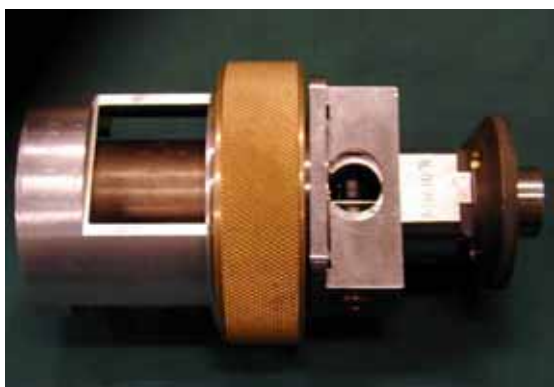
Figure 1. Weld equipment used (a) Weld head (b) displacement sensor and placement (c) assembly for welding (d) simulated LF-7 mass (e) fully assembled fixture including confining dies, "reservoir" and basket.

Welds were made using the SRNL pinch welder using nominal weld conditions at a force of 1250 lbs, a target current of 3700 A, in voltage control mode, and 12 cycles. The welds were made in the vertical orientation with a simulated LF-7 mass and LF-7 fixturing. The weld head and fixturing are shown in Figure 1. The welds were made using an atmosphere of 2 ATM deuterium after evacuating the system to about -28 inches of water.

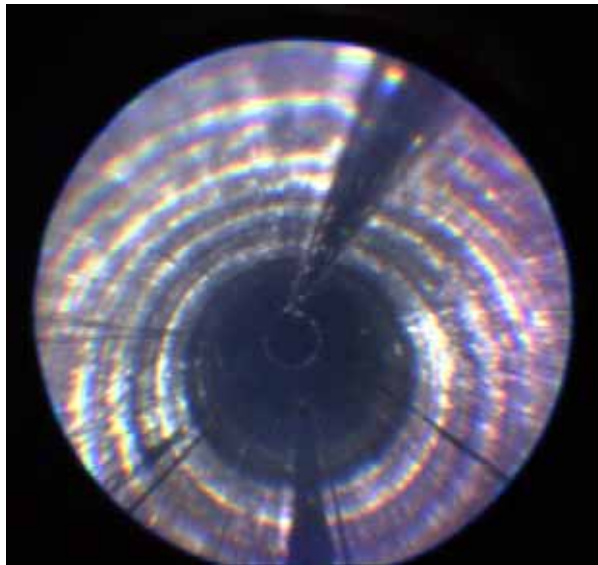
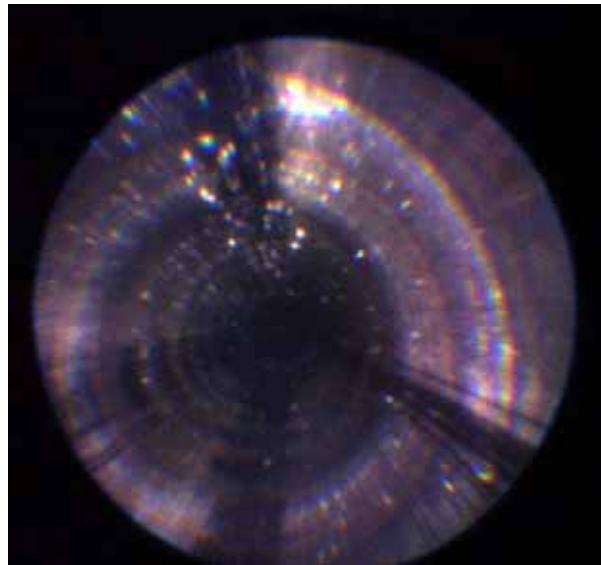
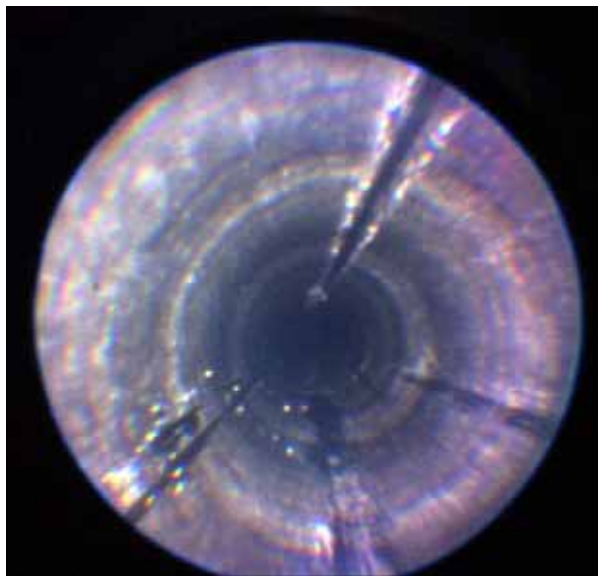
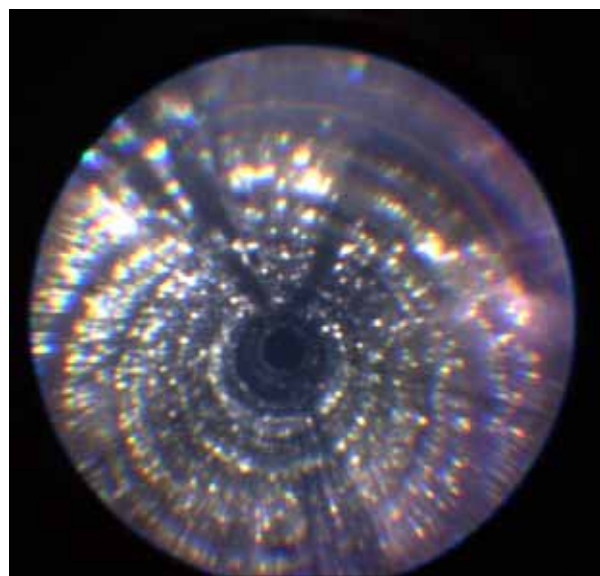
Figure 2. Forward looking borescope images (a) X0034 (b) X0039 (c) X0042 and (d) X0047

The internal bore condition of the four stems is shown in Figures 2 and 3 for forward looking and side-looking borescope images, respectively. The scratches are located towards the top of the page and these images are about ¼ inch from the weld zone; the scratches were uniform the length of the fill stem. Two of each sample were Oakite cleaned and the other two were Nitradd cleaned and exhibited the expected lightly etched appearance. Note the raised metal on the side of the furrow and the burnish mark opposite the scratch. The linearity of the scratch and the presence of raised metal are apparent in the images from the True Color Tube Borescope Inspection System (TCTBIS) shown in Figure 4. The scratch was oriented at about 90° from vertical and the burnish mark opposite the scratch is apparent. The scratches seem more prominent in stems X0039 and X0047 than in stems X0033 and X0042. The scratch depth and width were determined by KCP to be between 0.0014 and 0.0019 inch and .0025 to .004 inch, respectively.

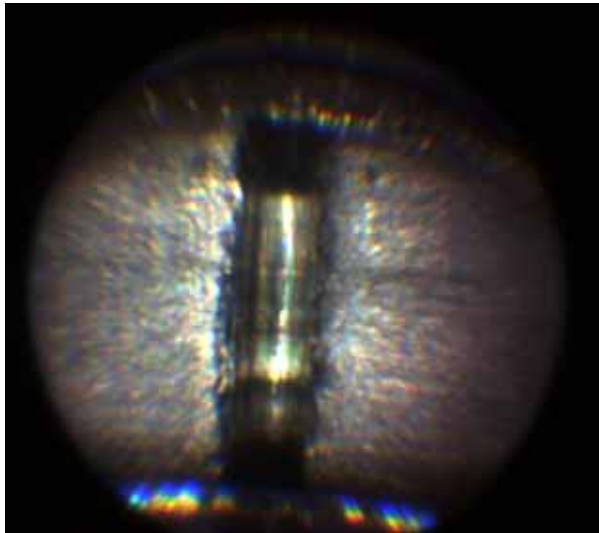
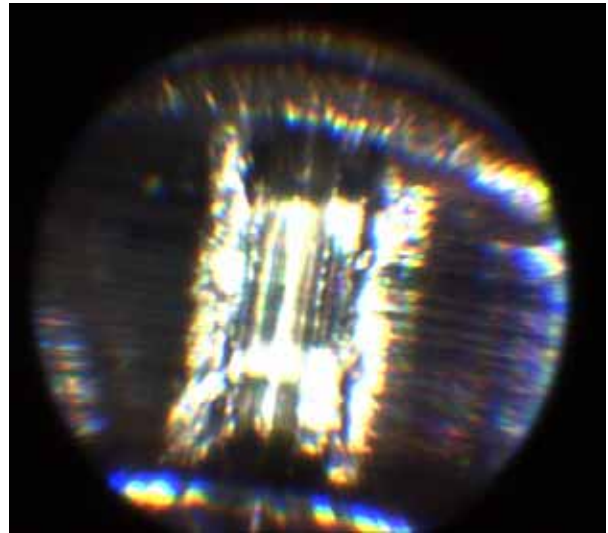
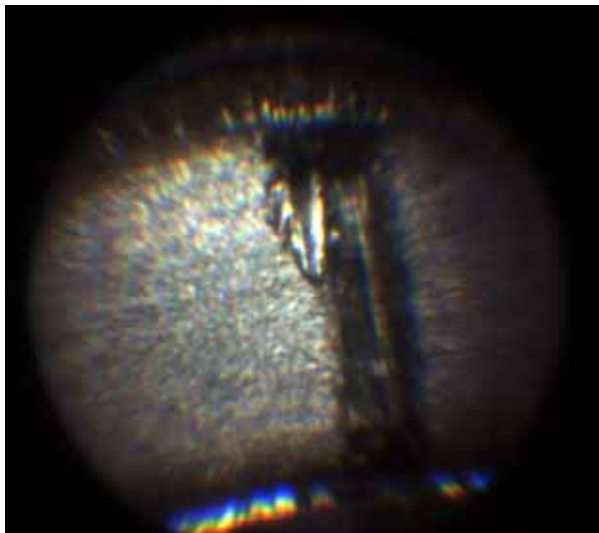
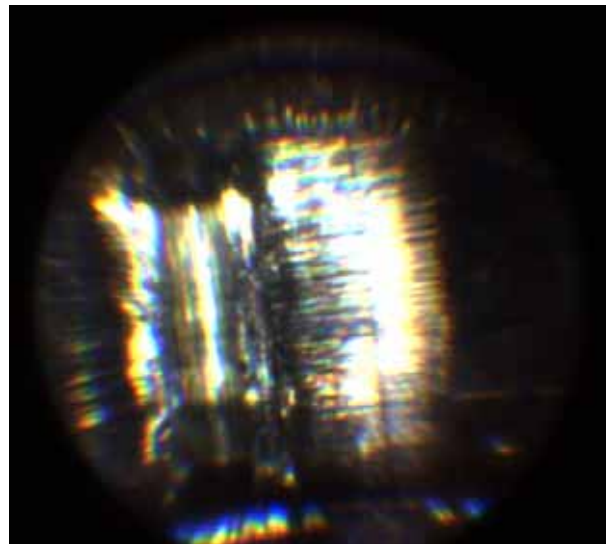
Figure 3. Side looking borescope images (a) X0034 (b) X0039 (c) X0042 and (d) X0047

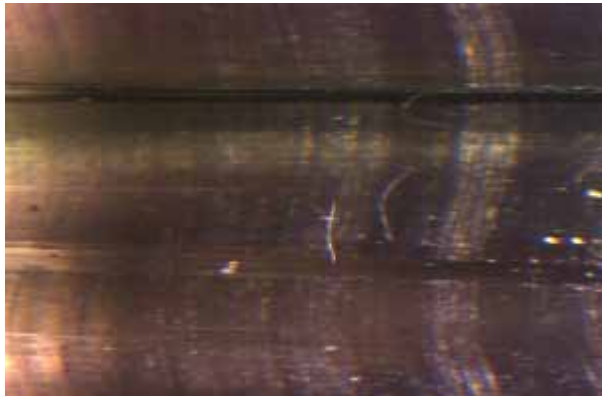
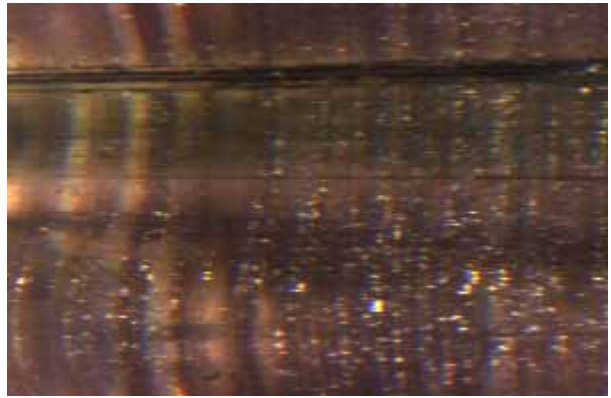
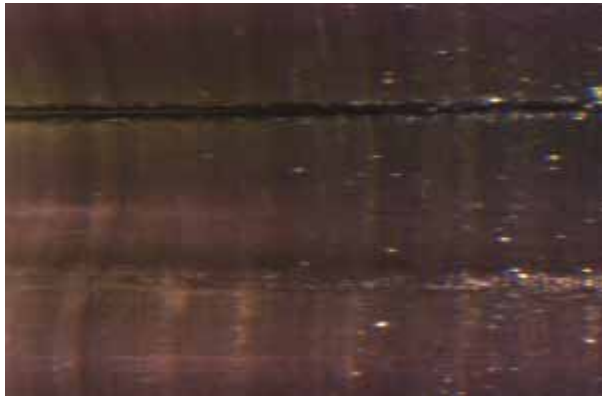
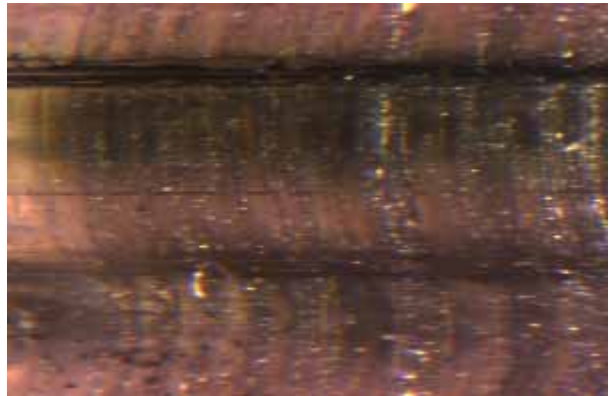
Figure 4. Unwrapped images using the True Color Tube Borescope Inspection System (TCTBIS) for (a) X0034 (b) X0039 (c) X0042 and (d) X0047.

Samples X0034 and X0039 were examined in the tube bore section to show the extent of raised metal and the depth of the scratch, Figure 11. These two samples were selected based on the apparent difference in scratch depth observed in the borescope images in Figure 4. The depth of the scratches was measured from these images to be approximately 0.0016 and 0.002", for X0034 and X0039, respectively. The height of the raised metal for each sample was approximately 0.0009 and 0.0005, respectively. The depth of the burnish mark opposite the scratch was not measurable.

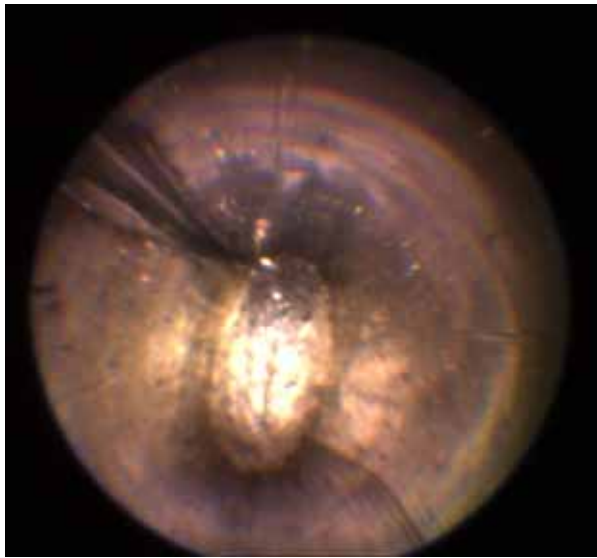
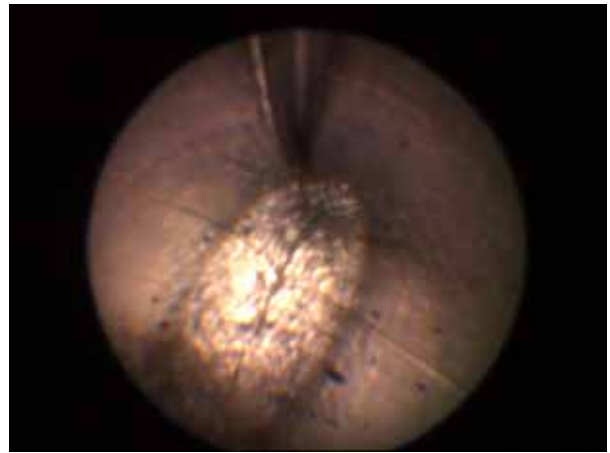
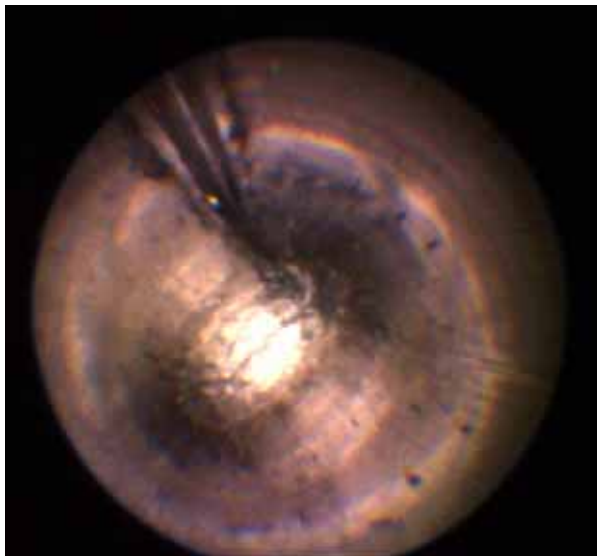
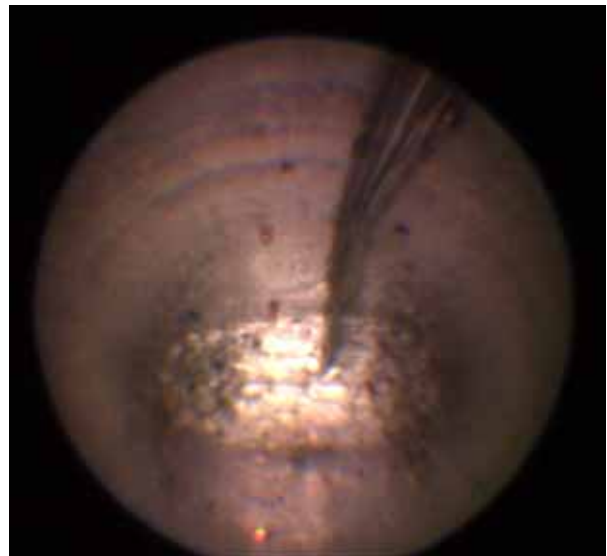
Figure 5. Forward looking borescope image after welding of (a) X0047 0° (b) X0034 45° (c) X0039 45° and (d) X0042 90°. Note target values are reported, not actual.

The actual scratch orientation for the welds is shown in the forward looking borescope images shown in Figure 5. It is apparent that the target and actual weld orientation are not coincident due to the difficulty in precisely orienting the scratch relative to the axial serial number and maintaining this orientation while assembling the simulated reservoir into the weld fixture. The end of the welds have a consistent appearance, with no obvious defects, such as splits or voids, visible where the weld intersects the scratch.

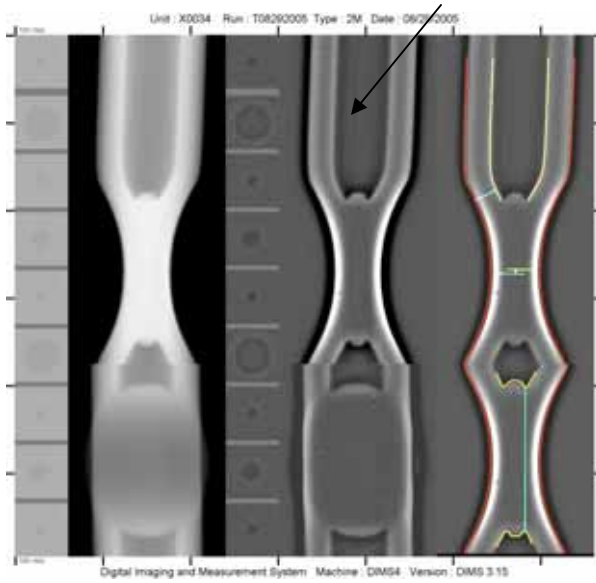
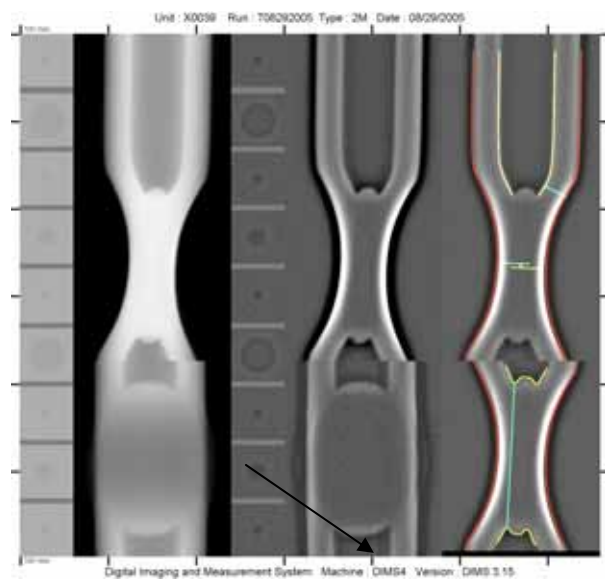
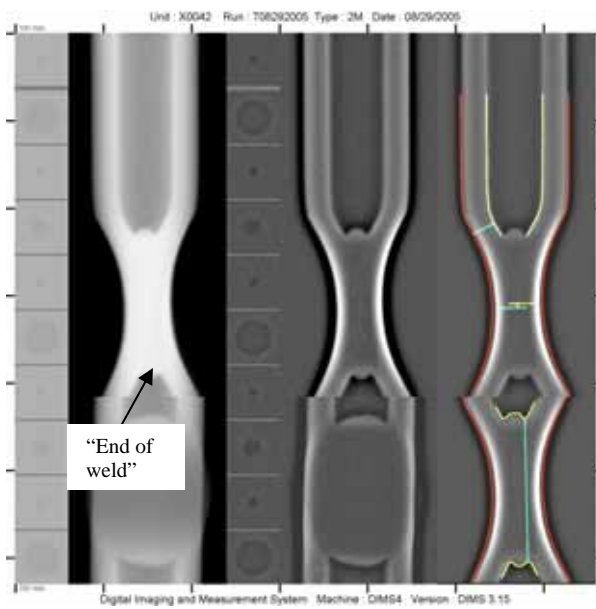
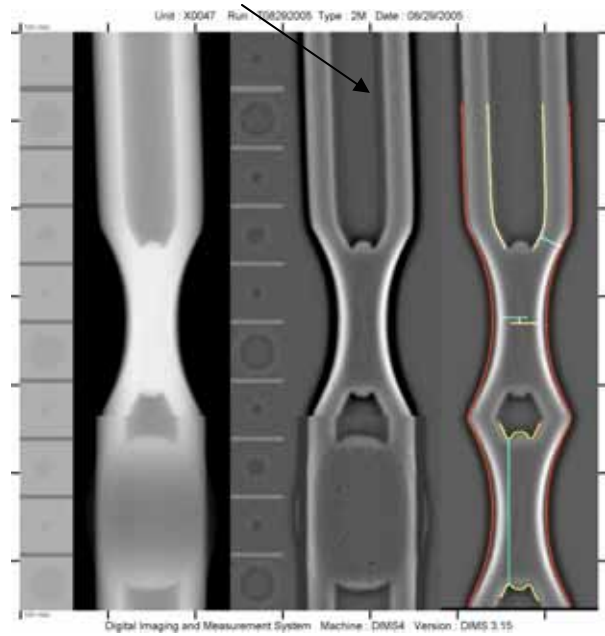
Figure 6. Face and side view radiographs of scratched and welded stems (a) X0034 (b) X0039 (c) X0042 (d) X0047. Note the presence of fiduciary marks in image on lower right side of all these images. These are used to determine closure length, wall thickness, alignment, etc.

Digital radiographs of the face and side view for each of the welds are shown in Figure 6. The scratches, indicated by the arrows, are visible in the side views of samples X0034 and X0047. The scratch is partially visible in the face view of X0039. The scratches are obvious in these images and appear as linear indications. The radiographs were interpreted in DP and samples X0039 and X0047 were reported to have split extrusions.

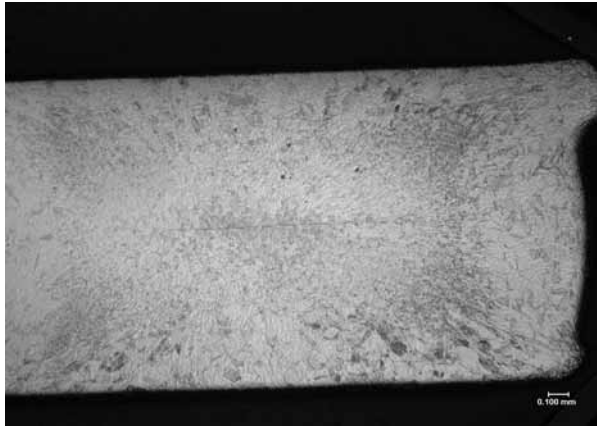
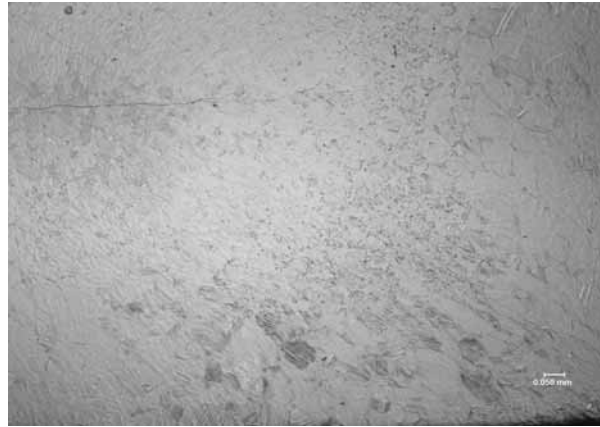
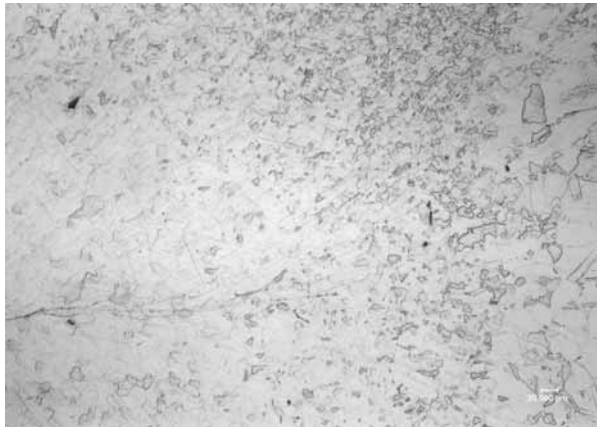
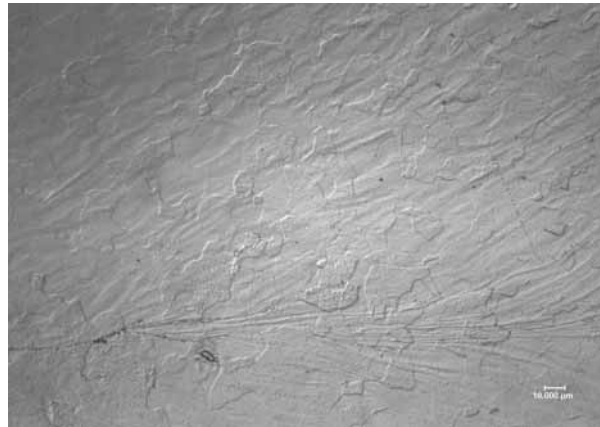
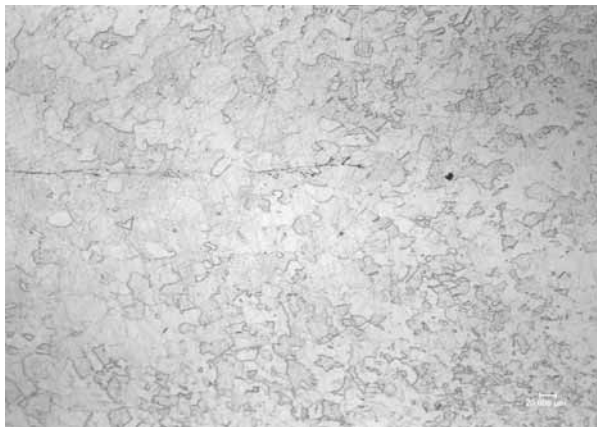
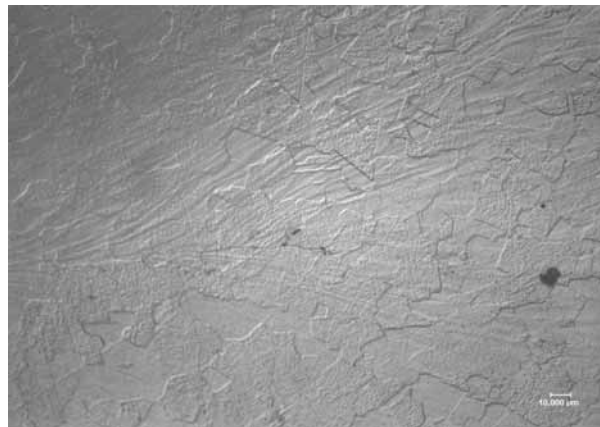
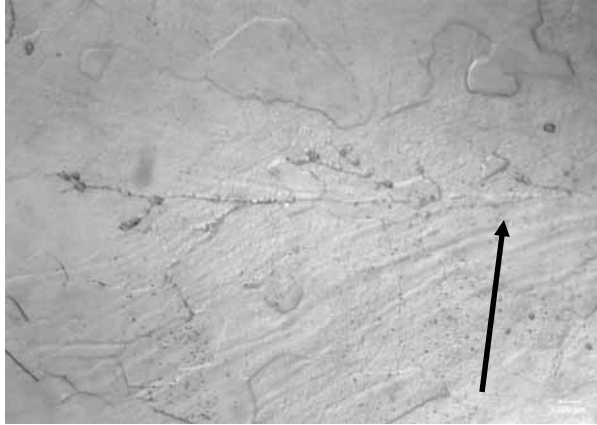
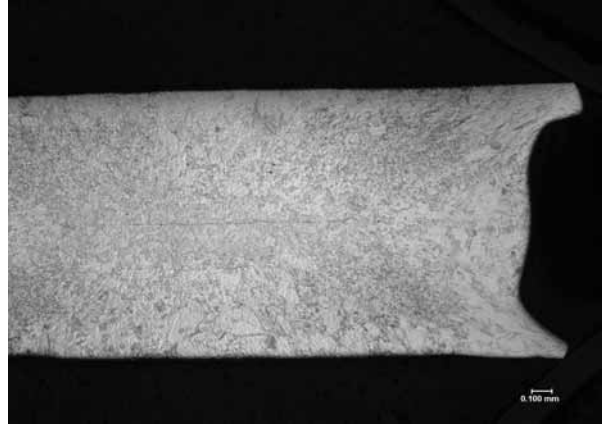
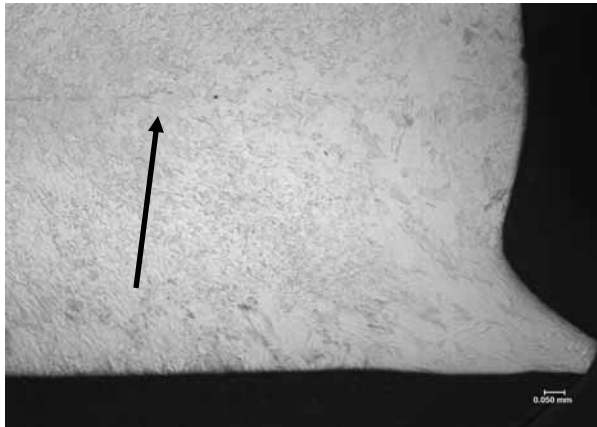
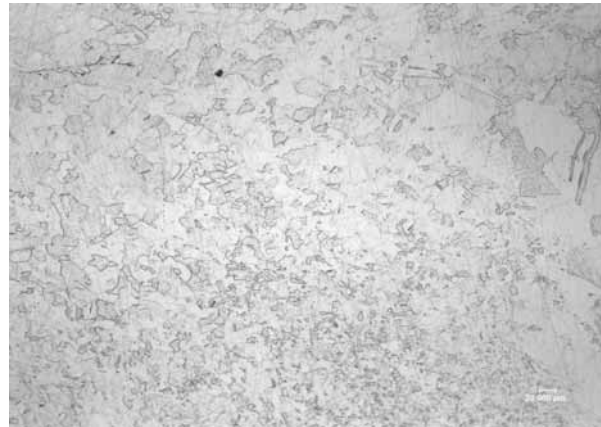
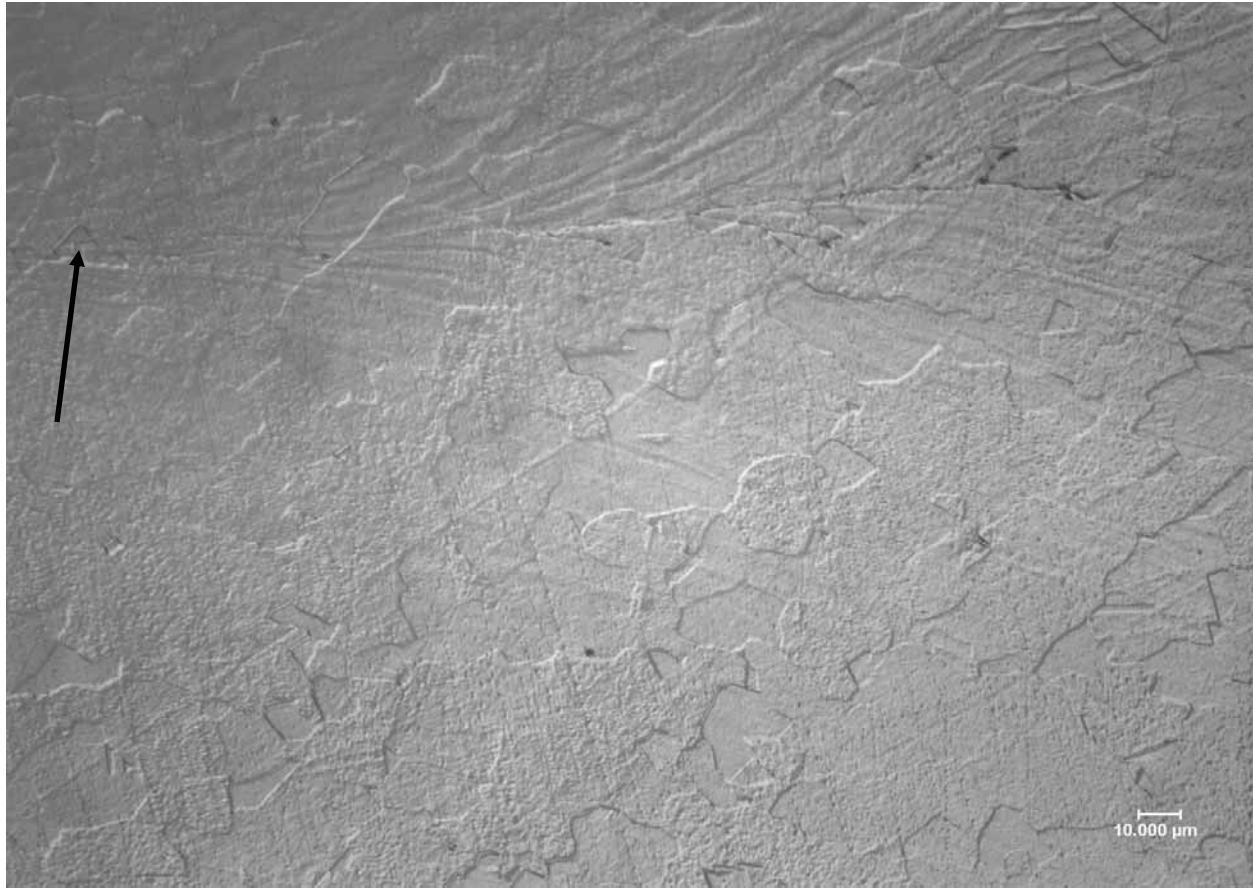
Figure 7. Transverse cross sections in the crow's foot of weld in stem X0034 at (a) 50X (b) 100X (c) 200X and (d) 500X magnifications, scratch at 45° from axis, at 0.02" from end of weld, (e) 200X, (f) 500X and (g) 1000X at a distance about 0.06 from end of weld, (h) 50X (i) 100X and (j) 200X and (k) 500X at the weld center. See Figure 5 for nominal end of weld and note that the bond line does not exhibit any gross disruption, however, there is evidence of the prior scratch in two of the three axial locations as indicated by the arrows.

The metallographic examinations were conducted about 0.02 inch from the end of the weld, about 0.06 inch from the end, and near the center of the pinch weld. Cross sections of the fill stems were also examined to characterize the scratch depth and amount of raised metal. The weld quality was determined from the cross sections, special attention was devoted to looking for laps and other weld anomalies. The micrographs for each weld cross section at the three axial locations are shown in Figures 7-10; not all the magnifications are include in these micrograph series since there was indistinct evidence of the scratches in many of the micrographs. The arrows on the micrographs indicate suspected evidence of the scratches. Figures 7g and 7i show possible bond line disruptions at both axial locations of 0.06 inch and the center for sample

X0034. Apparent bond line disruptions are visible in Figures 8d, 8g, and 8i for stem X0039, Figures 9d, 9e, and 9j for stem X0042, and in Figures 10e, 10g, and 10i for stem X0047 at all three axial locations. These indications are visible in large part because the bond line is not linear in these areas. The bond quality does not appear to be compromised though. Since these scratches were clean and since there is a significant amount of material flow, the scratches filled with metal and bonded adequately.

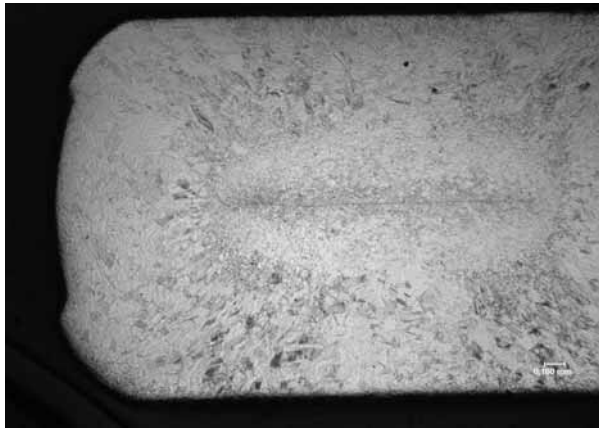
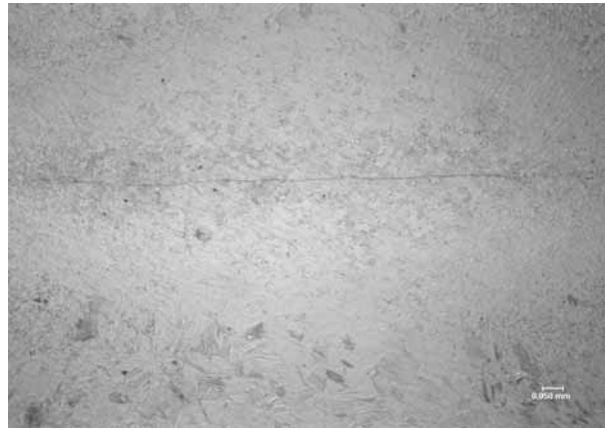
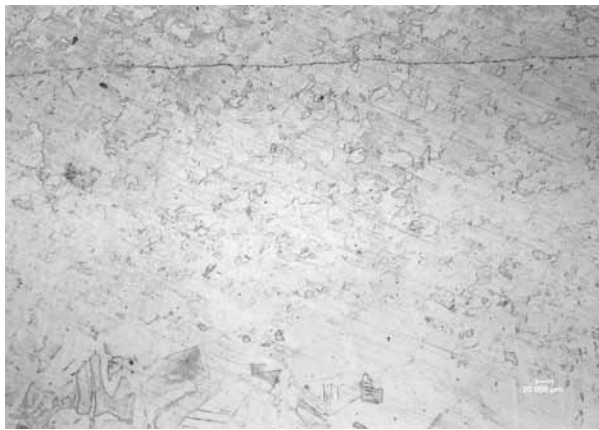
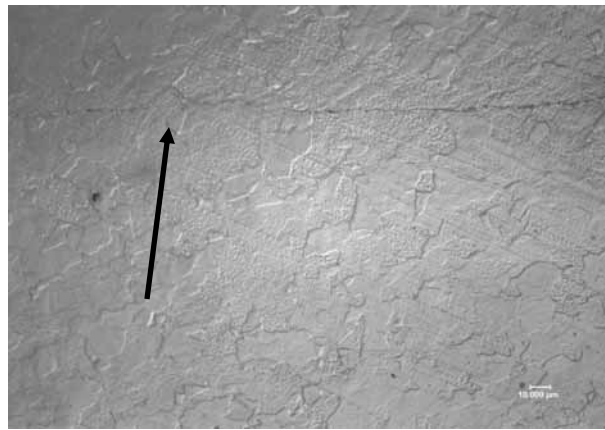
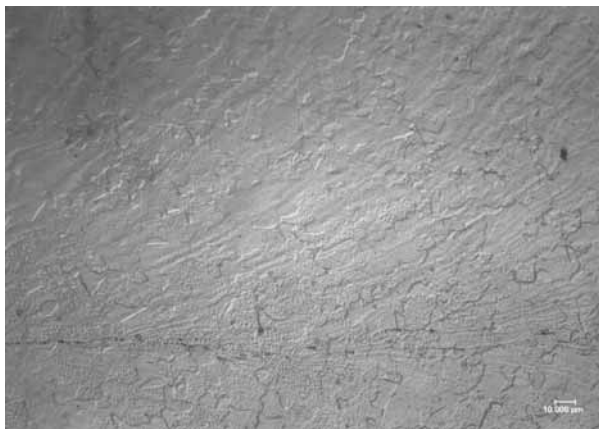
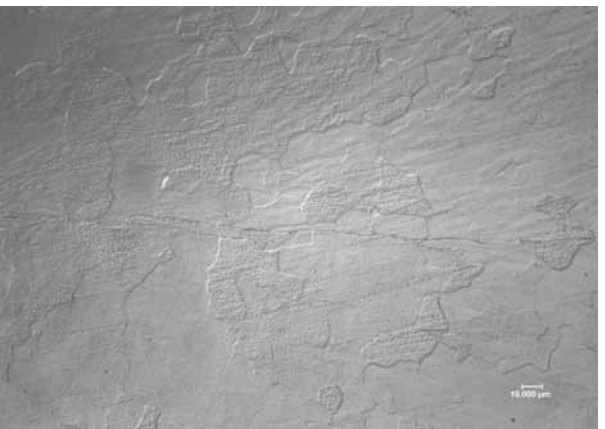
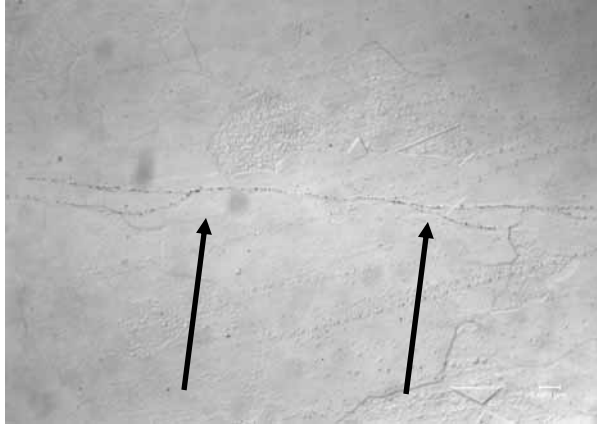
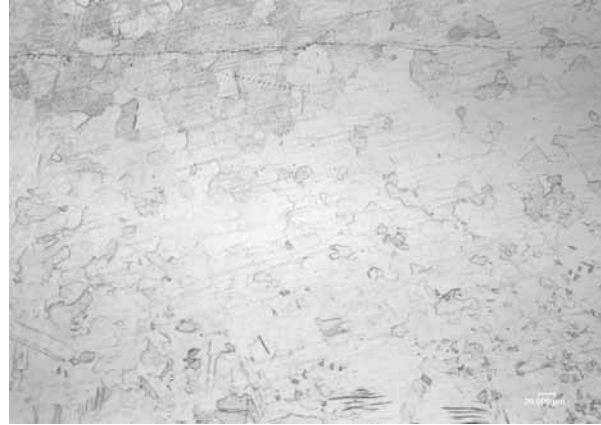
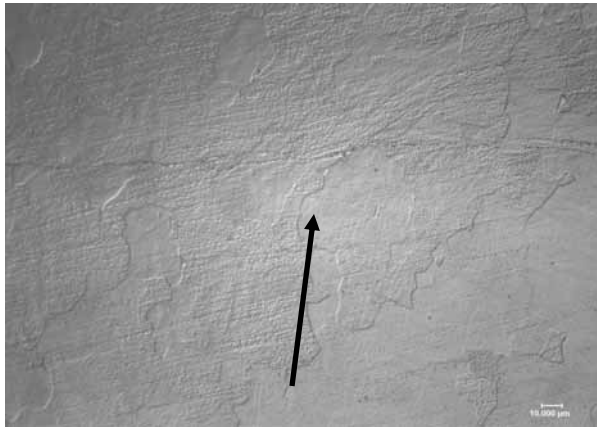
Figure 8. Transverse cross sections of welds at magnifications of (a) 50X (b) 100X (c) 200X (d) 500X (e) 500X at 0.02 inch from end of weld and at (f) 500X and (g) 1000X at 0.06 from end of weld and at (h) 200X and (i) 500X at the center of the weld of sample X0039. The arrow in (d) highlights nonlinear indication attributed to scratch.

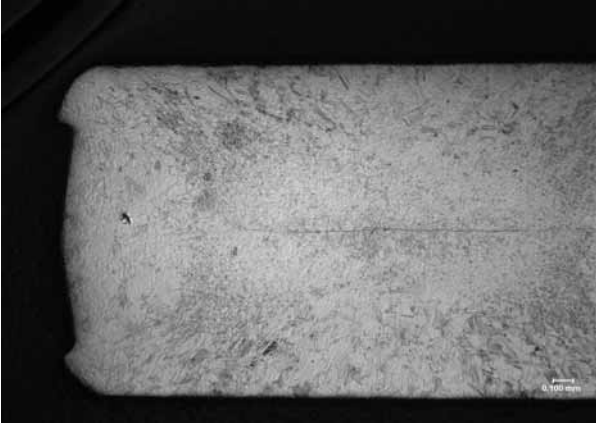
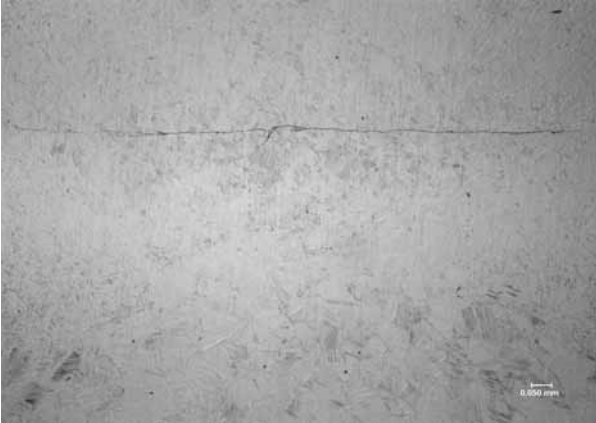
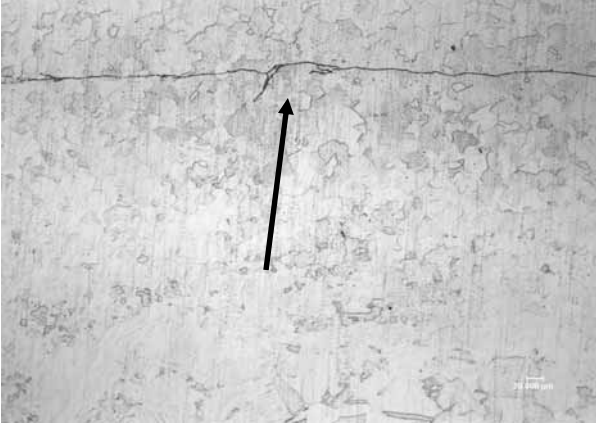
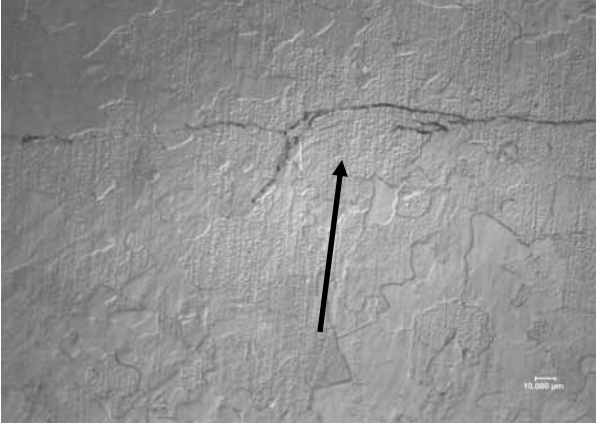
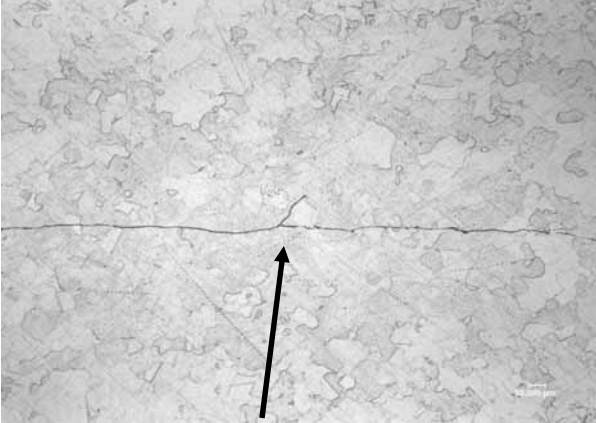
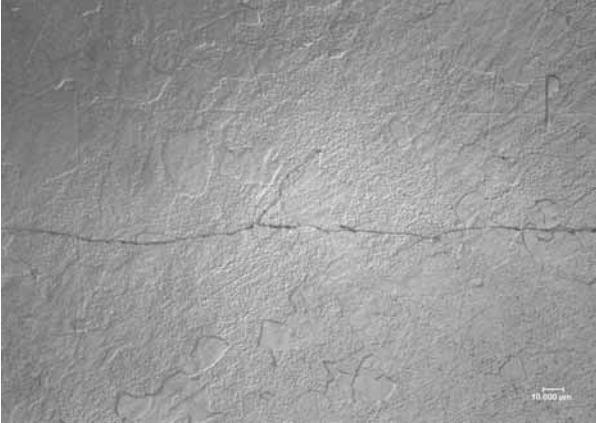
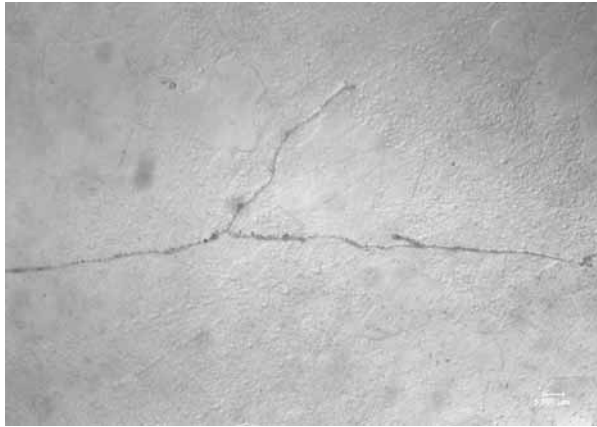
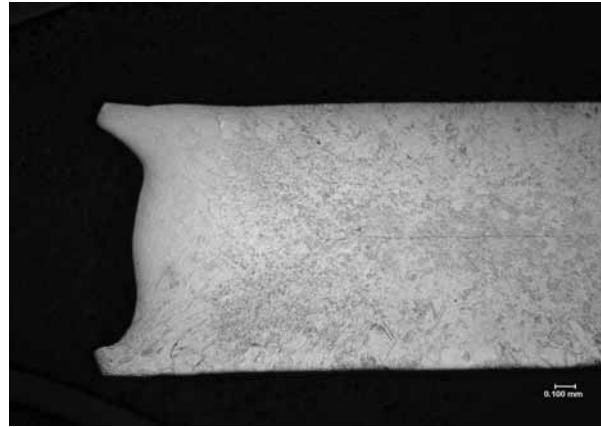
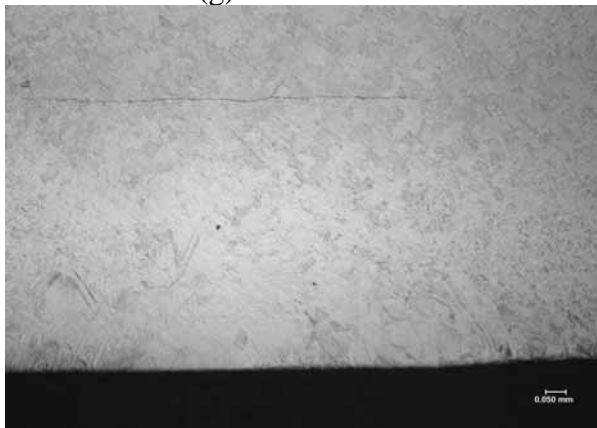
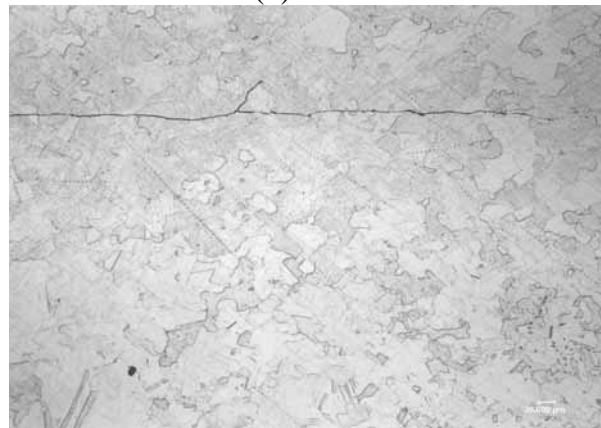
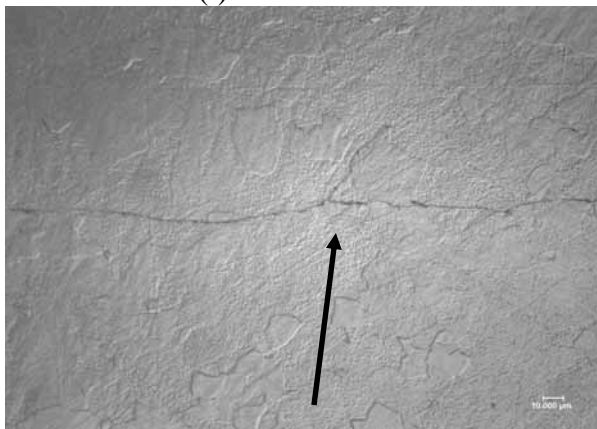
Figure 9. Transverse cross sections of welds at magnification of (a) 50X (b) 100X (c) 200X and (d) 500X at 0.02 from end of weld and (e) 200X (f) 500X and (g) 1000X at 0.06 inch from the end of the weld and at (h) 50X (i) 100X (j) 200X and (k) 500X in the center of the weld for sample X0042. Note the there is a detectable disruption in the bond line in all three axial locations, as highlighted by arrows, however it does not appear to adversely affect the weld.

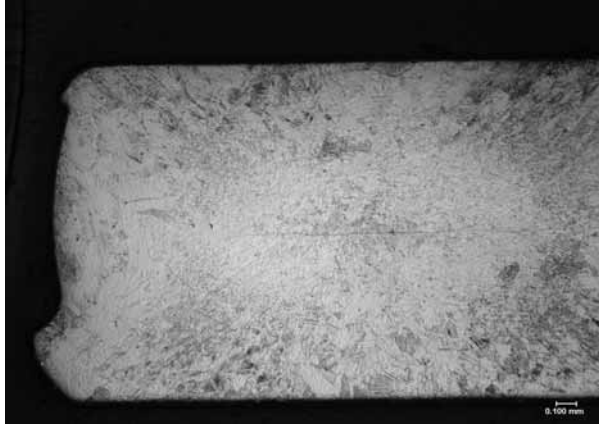
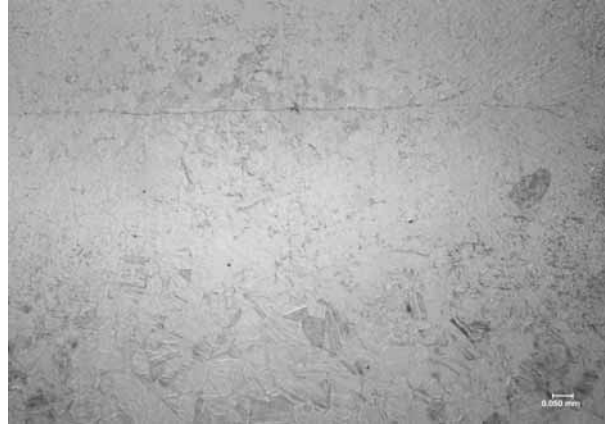
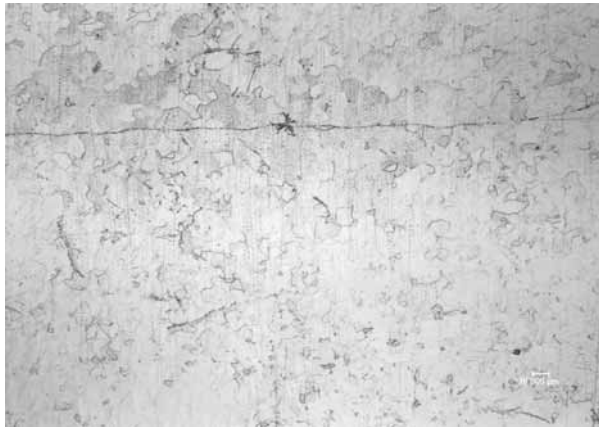
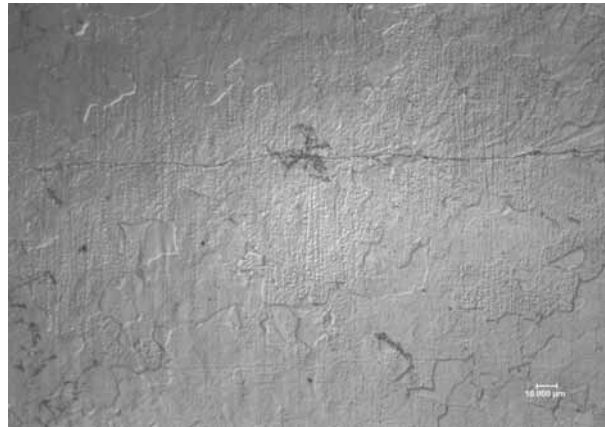
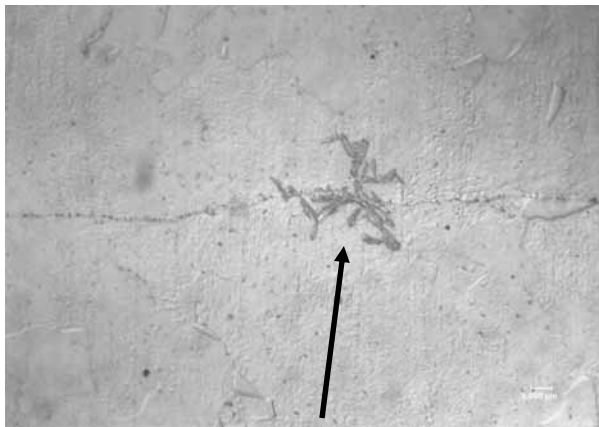
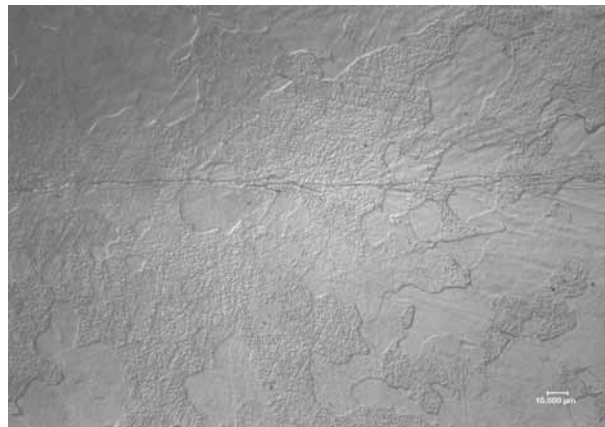
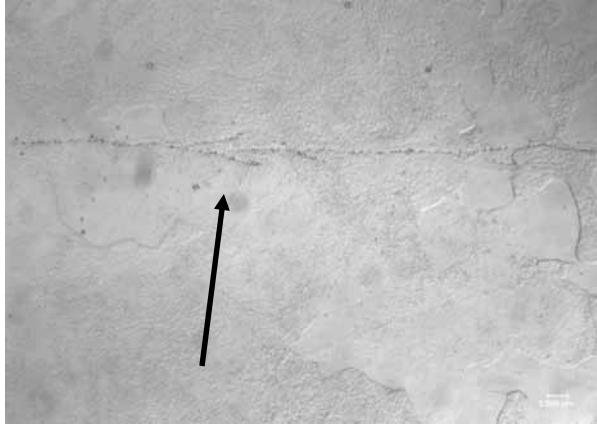
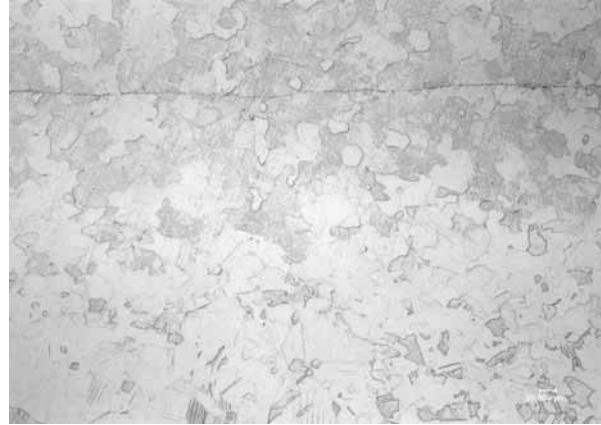
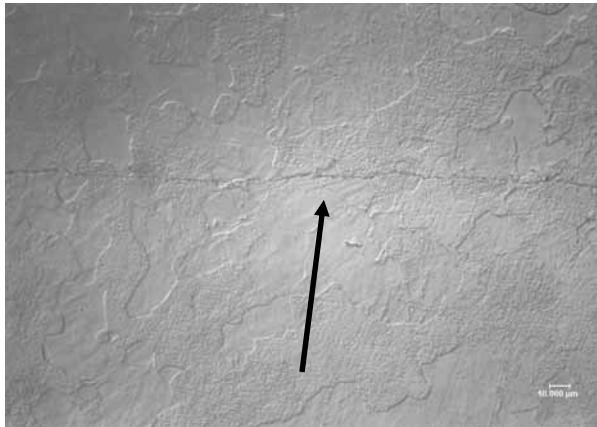
Figure 10. Transverse cross sections at magnifications of (a) 50X (b) 100X (c) 200X (d) 500X and (e) 1000X at 0.02 from end of weld (f) 500X (g) 1000X at 0.06 from end of weld and (h) 200X (i) 500X at the weld center of sample X0047. Note that some disruption, highlighted by the arrows, of the bond line is evident in all three axial locations but little effect on the weld is apparent.

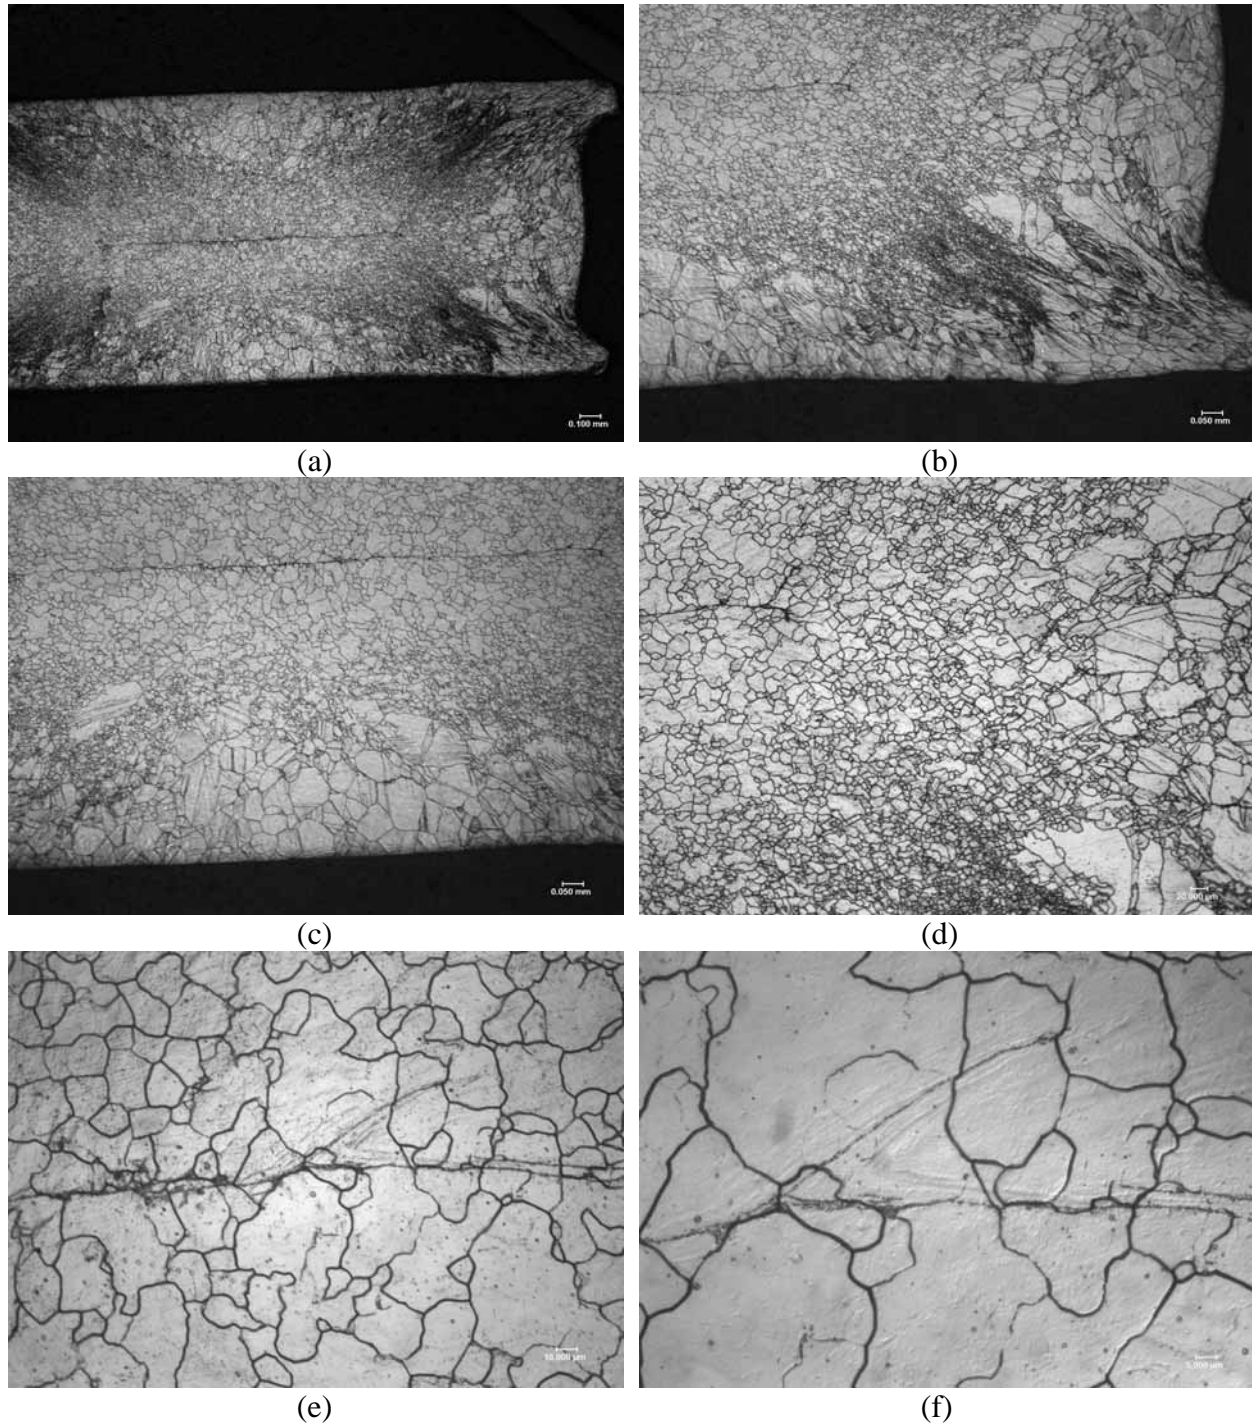
Figure 11. Sample X0039, nitric acid etchant showing recrystallization and grain growth. The evidence of the scratch is visible at 100X and higher magnifications. (a) 50X (b) 100X (c) 100X (d) 200X (e) 500X and (f) 1000X magnifications.

Weld sample X0039 was etched using nitric acid etchant over the oxalic acid to determine if the scratch may have impeded grain growth. The images are shown in Figure 11. The scratch is apparent near the center of the sample in Figure 11c, the nominal 100X magnification image. This area was further examined at higher magnifications, and while the disruption due to the scratch is visible, it does not appear to have adversely impacted grain growth across the interface. The grain structure is more clearly delineated with the nitric acid etchant. The grain size and distribution is consistent with that described in a weld evolution study that was recently completed, Ref. 1.
