Effect of Scratches on Pinch Welds

P.S. Korinko

October 2005

WSRC-RP-2005-00435

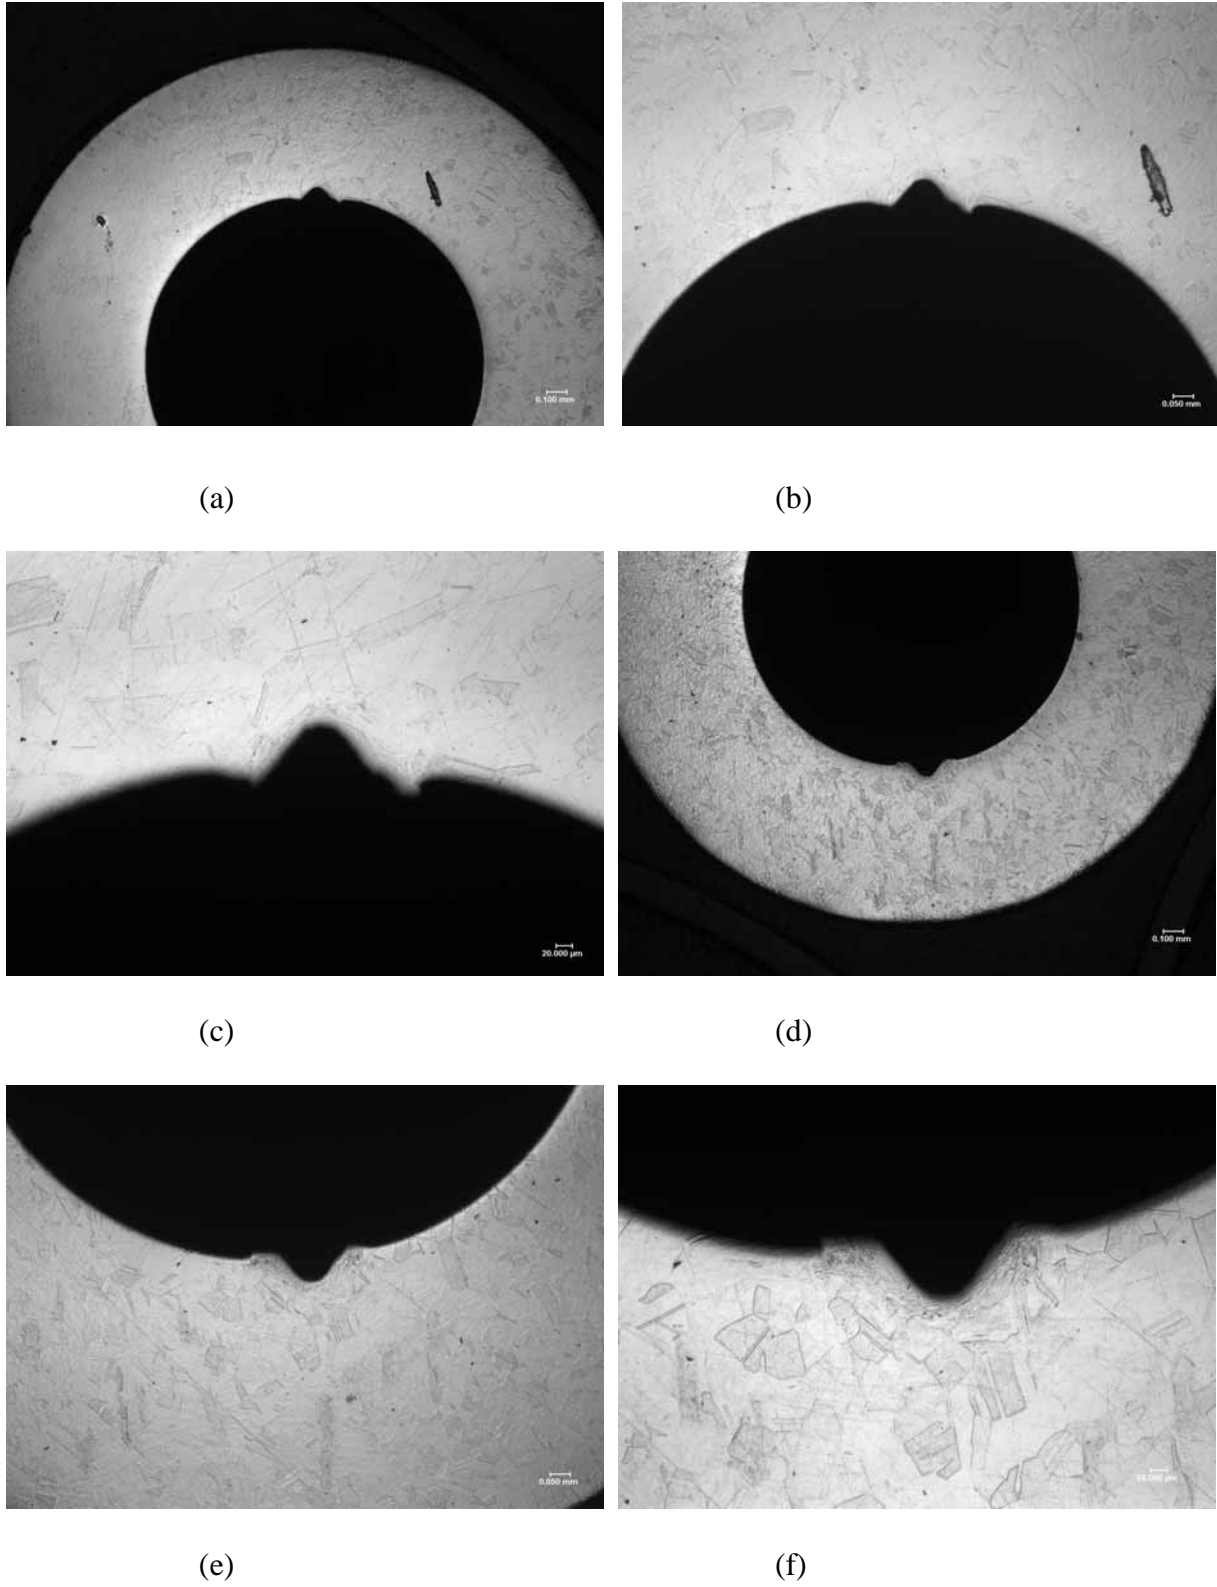
Figure 12. Transverse cross-sections of the tubes showing the amount of raised metal and the depth of the scratch (a) X0034 50X (b) X0034 100X (c) X0034 500X (d) X0039 50X (e) X0039 100X, and (f) X0039 500X.

Samples X0034 and X0039 were examined in the tube bore section to show the extent of raised metal and the depth of the scratch, Figure 11. These two samples were selected based on the apparent difference in scratch depth observed in the borescope images in Figure 4. The depth of the scratches was measured from these images to be approximately 0.0016 and 0.002", for X0034 and X0039, respectively. The height of the raised metal for each sample was approximately 0.0009 and 0.0005, respectively. The depth of the burnish mark opposite the scratch was not measurable.
