Vapor Corrosion Response of Low Carbon Steel Exposed to Simulated High Level Radioactive Waste

K. H. Subramanian

Savannah River National Laboratory
Materials Science and Technology Directorate

DOCUMENT: WSRC-TR-2005-00508

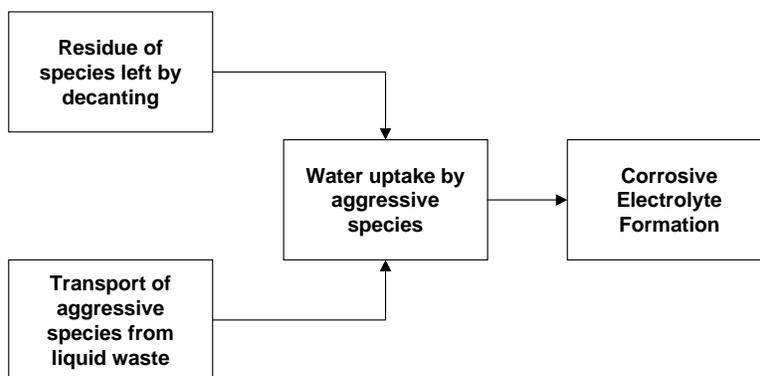
Figure 1: Schematic of Hypothesized VSC Mechanisms

It was hypothesized that general or localized corrosion may occur in the vapor space due to conditions created by relative humidity and the deliquescence behavior of aggressive species. Several mechanisms have been proposed for the deposition of aggressive species on the tank wall within the vapor space. In dry environments the salt may exist as a solid residue on the steel tank, left by evaporation or decanting of supernate. Alternatively, species may have been deposited on the tank wall by evaporation from the supernate, transport as an aerosol, and then condensation on the tank wall. In sufficiently humid conditions the residue can adsorb atmospheric moisture and dissolve, forming a corrosive electrolyte. A schematic of these mechanisms is shown in Figure 1

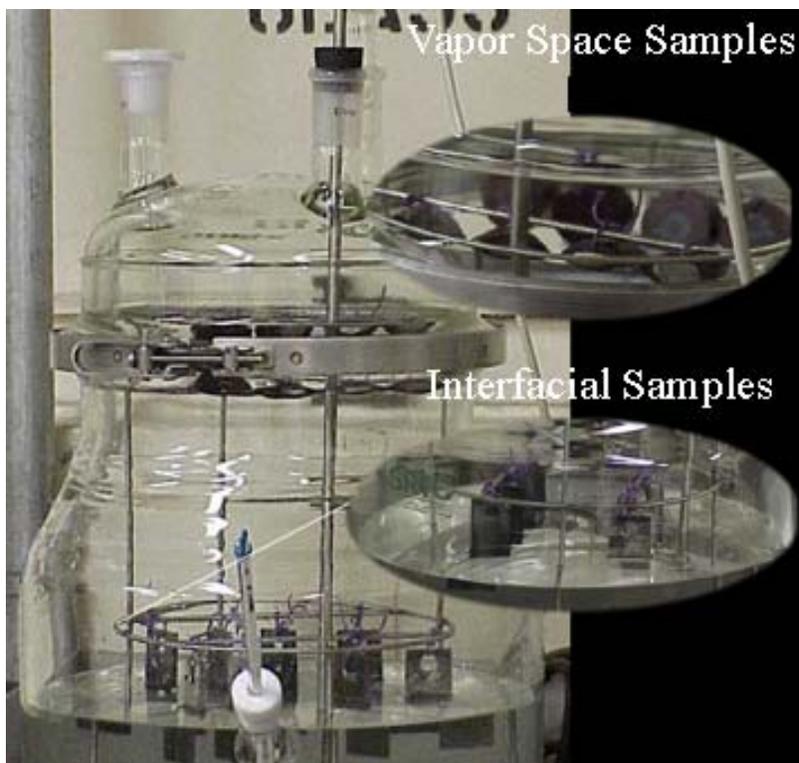
Figure 2: Experimental Test Setup

The testing in the vapor space was done on ¼-in. thick round disk samples mounted in epoxy resin. All heat treatments were done prior to mounting. Polishing, indenting, and deposition of bulk salts were performed after mounting. The liquid air interfacial testing was done on 2-in x 1-in x 0.125 in. standard pitting coupons. A photograph of the experimental test setup is shown in Figure 2. The insets give higher magnification of the coupons exposed to the vapor space and the coupons exposed to the liquid/air interface.

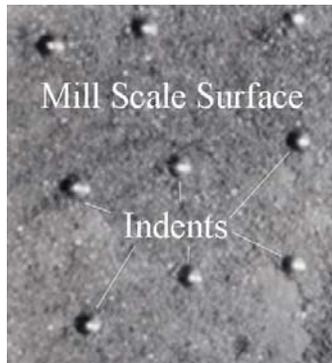
Figure 3: Representative Array of Microindents

defects in the mill scale were introduced utilizing a diamond tip glass drill bit. A representative array of indents is shown in Figure 3. The indents exposed the underlying bare metal, but may have crushed the oxidized layer into the indent. The surface area of the exposed bare metal was not quantified. Deposits of the bulk solution were made on the sample surface to simulate the mechanism of salt deposition through decanting.

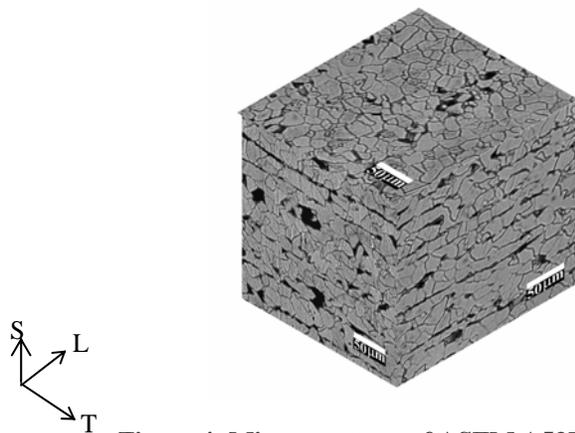
Figure 4: Microstructure of ASTM A537 C1.1 Steel.

The tanks were fabricated with semi-killed, hot-rolled A537-C1.1 plate, with nominal composition shown in Table 2. The A537 steel is a ferritic/pearlitic steel with the microstructure shown in Figure 4. A representative coupon is shown in

The tanks were made from hot-rolled plate and tend to have manganese sulfide and aluminum oxide inclusions that are oriented parallel to the rolling direction. Previous experiments have shown that pitting on polished coupons above simple waste simulant has initiated in rows suspected to be in line with these inclusions. Other studies revealed that nitrate-induced pitting in these steels typically initiates around manganese sulfide or aluminum oxide inclusions.⁷

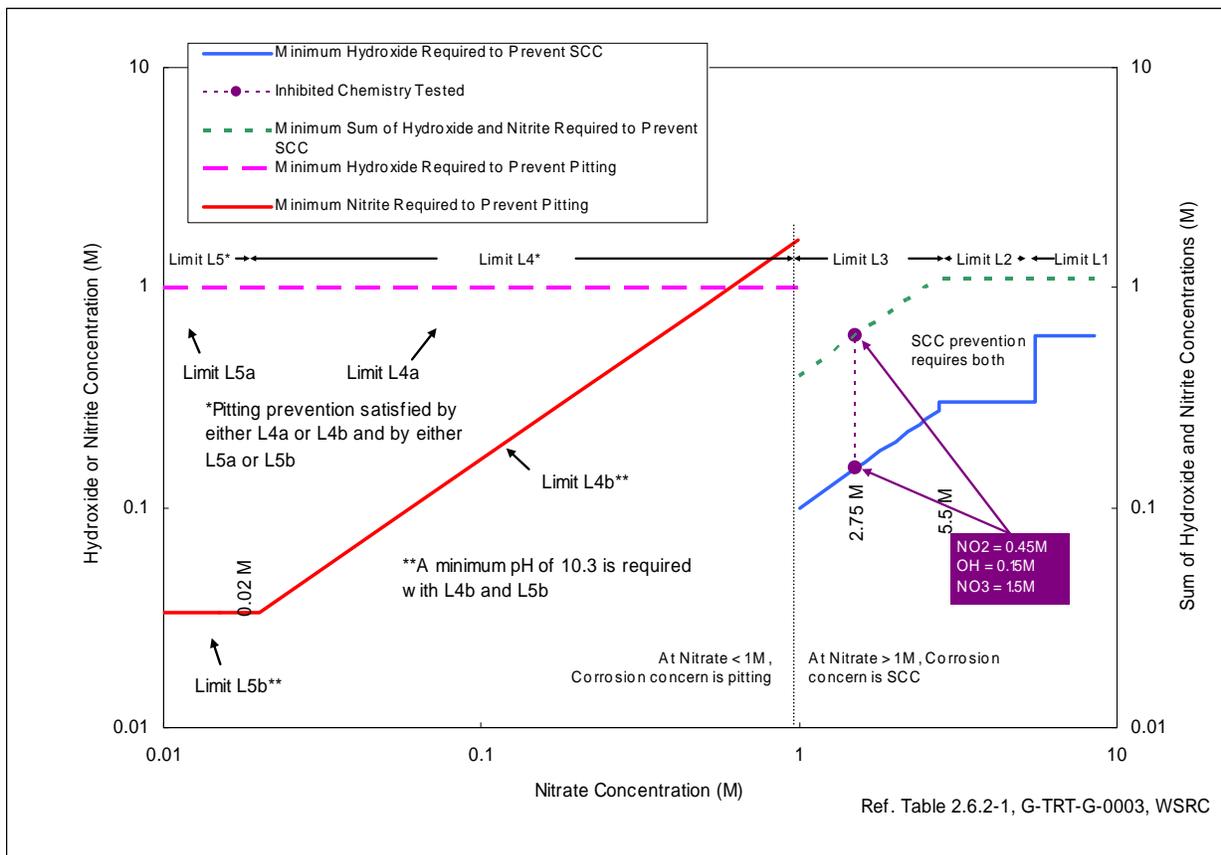
Figure 5: Summary of Chemistry Control Program and Tested Solution Chemistry (as reproduced from Reference 3)

A graphical representation of the chemistry control program is shown in Figure 5.³ The summary indicates the hydroxide and nitrite levels that are to be maintained as a function of nitrate concentration. The inhibited chemistry tested is indicated on the graph. Limit L3, the regime within which the pitting studies were done, addresses the nitrate range that is typical of fresh waste. The limit is specified to prevent nitrate-induced stress corrosion cracking, as SCC is the primary concern at nitrate concentrations above 1M. The limit was based upon a combination of operational experience and the knowledge of the corrosion mechanisms. A minimum hydroxide concentration of 0.1 M was conservatively selected to maintain inhibiting conditions in 1M nitrate waste solutions. The minimum hydroxide concentration and the minimum sum of hydroxide and nitrite in L3 over the range 1 M nitrate to 2.75 M nitrate were selected to transition smoothly to the L2 limit at 2.75 M nitrate. Limit L3 carries a maximum temperature of 70°C, or 105°C if the sum of hydroxide and nitrite concentrations exceeds twice the nitrate concentration.

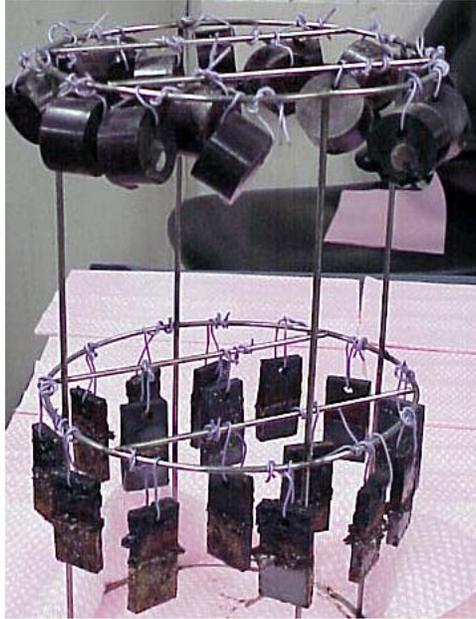
Figure 6: Solution 1 Solution Rack as Removed.

The solution rack as removed from exposure is shown in Figure 6.

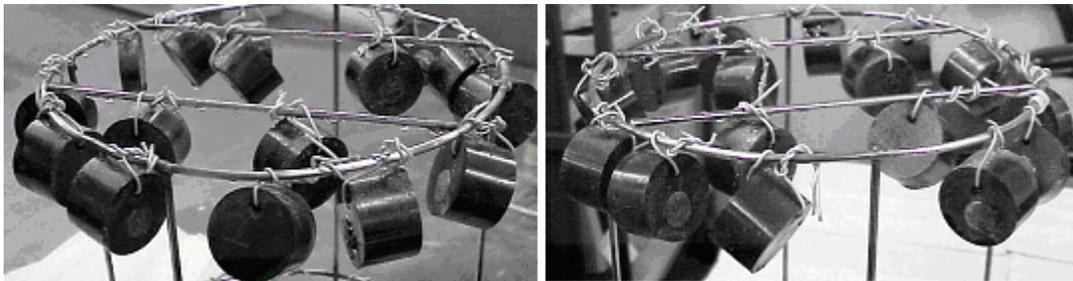
Figure 7: Vapor Space Coupons as Removed from Exposure to Solution 1.

The visual analysis of the vapor space coupons, shown in Figure 7 revealed severe corrosion on the polished specimens with the initial deposits, but only spotty corrosion on polished specimens without the initial deposits. The heat treated coupons exhibited severe corrosion only when deposits and indents were both present. The other coupons exhibited spotty corrosion, but were largely protected. It is important to note that the indented sample without the deposit did not exhibit corrosion.

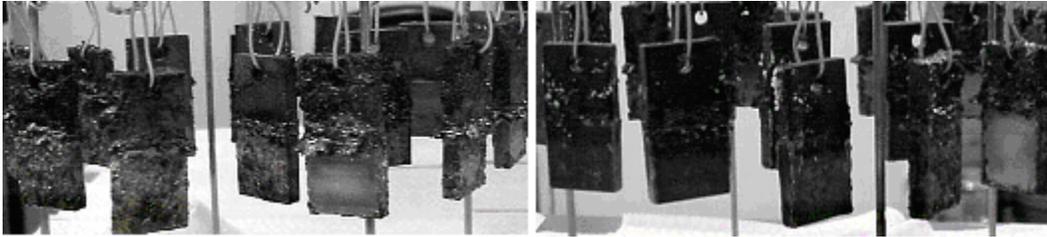
Figure 8: Liquid/Air Interface Coupons as Removed from Exposure to Solution 1.

The polished specimens of the liquid air coupons were severely corroded above the line and moderately corroded below the line. The below the line corrosion was limited to the “outer surface” of the sample, while the “inner surface” of the coupons was uncorroded. This may be due to liquid level stagnancy on the outer surface, since the stirring motion within the cell was limited to the center of the cell.

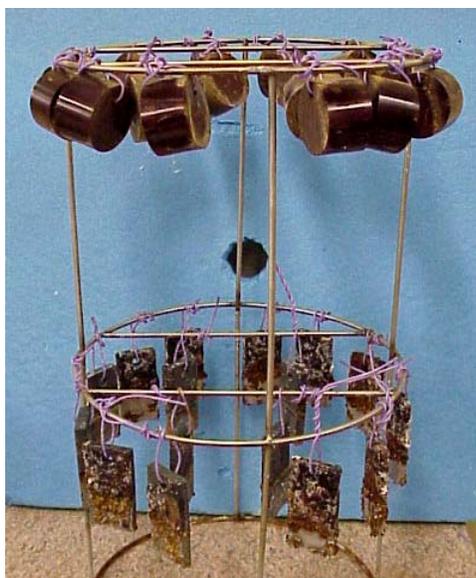
Figure 9: Solution 2 Rack as Removed.

The solution rack as removed from exposure is shown in Figure 9.

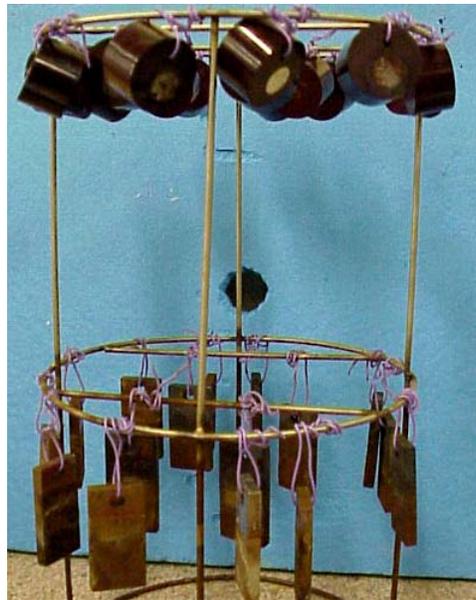
Figure 11: Tank 34 Solution Rack as Removed.

The solution rack as removed from exposure is shown in Figure 11.

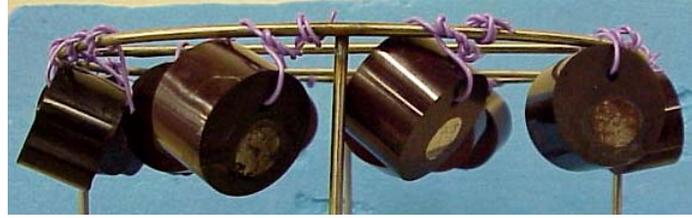
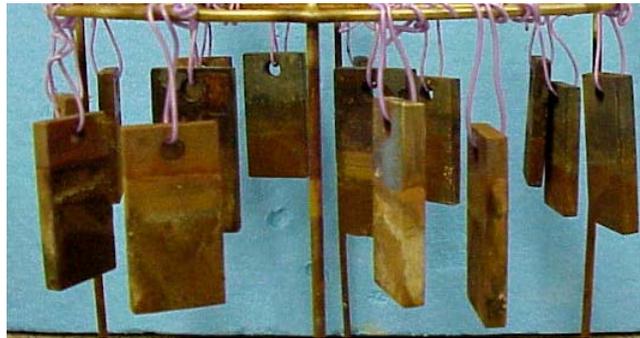
The vapor space coupons and liquid/air interfacial coupons are shown in Figure 12 and Figure 13 respectively. The coupons exhibit only minor staining and there is no evidence of localized or general corrosion. It is clear that the chemistries within these tanks are sufficiently protecting against vapor space and liquid/air interfacial corrosion.

Figure 12: Vapor Space Coupons as Removed from Exposure to Tank 34 Solution.

Figure 13: Liquid/Air Interface Coupons as Removed from Exposure to Solution 1.

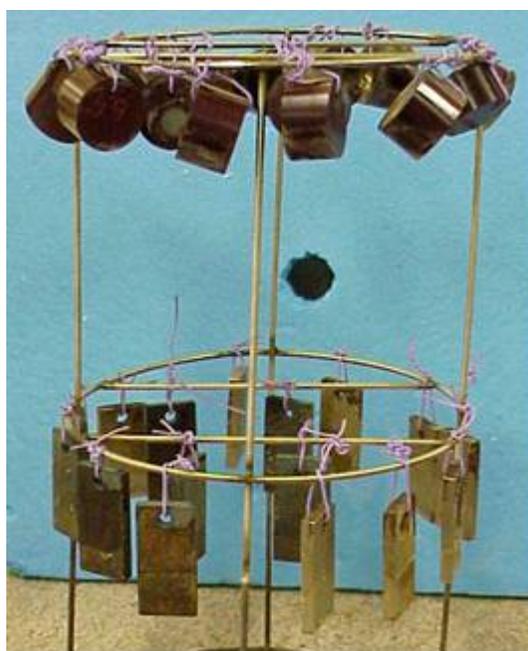
Figure 14: Tank 39 Solution Rack as Removed.

The solution rack as removed from exposure is shown in Figure 14.

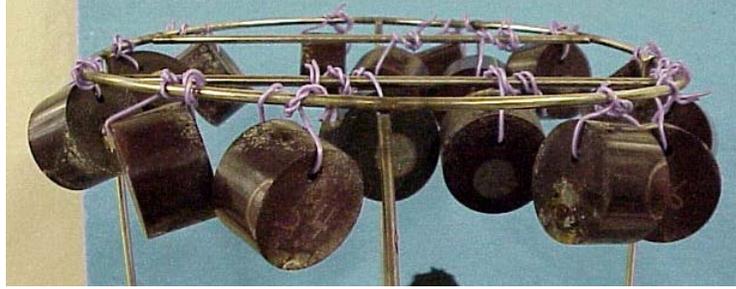
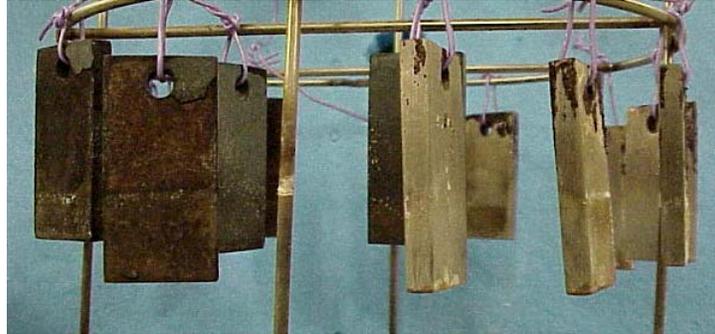
The vapor space coupons and liquid/air interfacial coupons are shown in Figure 15 and Figure 16 respectively. Consistent with coupons exposed to Tank 34 solution, the coupons exhibit only minor staining and there is no evidence of localized or general corrosion. The results indicate that the chemistries within these tanks are sufficiently protecting against vapor space and liquid/air interfacial corrosion.

Figure 15: Vapor Space Coupons as Removed from Exposure to Tank 39 Solution.

Figure 16: Liquid/Air Interface Coupons as Removed from Exposure to Tank 39 Solution.

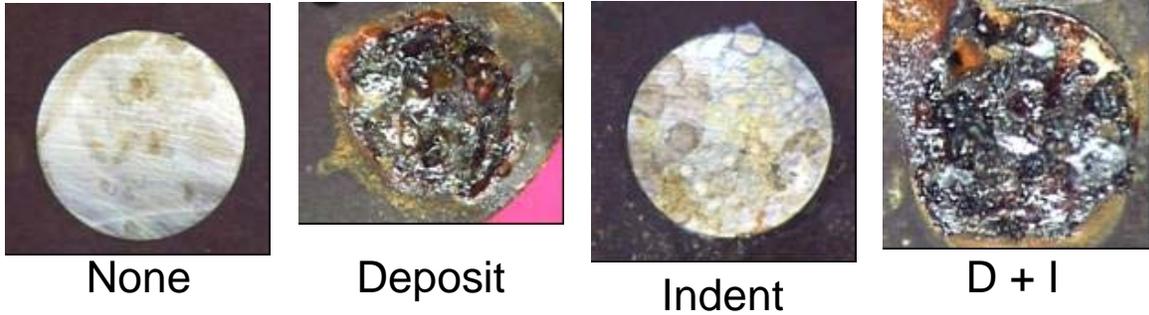
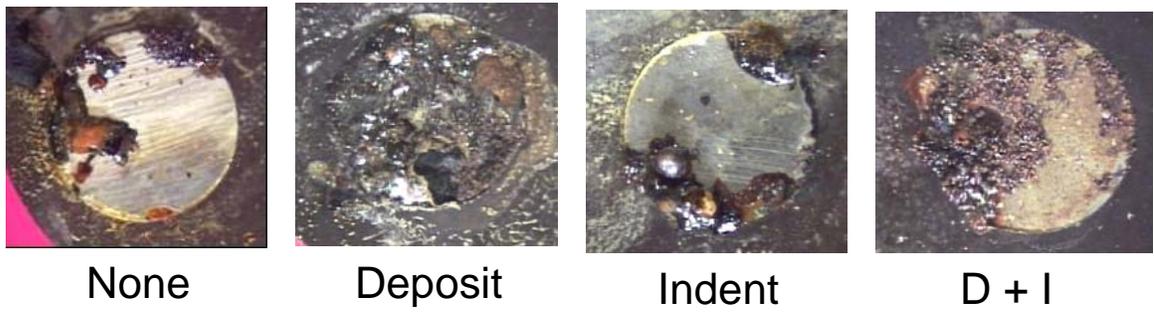
Some general observations were made on the coupons exposed to solutions 1 and 2. The polished vapor space coupons exposed to solution 1 and solution 2 are shown in Figure 17 and Figure 18 respectively. These figures show the coupons with no surface modifications, the coupon with a surface deposit, the coupon with indents, and the coupons with the deposit and the indent ('D + I'). It is seen that the coupons with the deposits exhibited extensive corrosion, but there didn't appear to be any significant transport of the salts from the bulk solution to the vapor space during the test period. These results were similar to those of solution 2. The results suggest that decanting of the solution and the consequent residual species may be the primary parameter mechanism by which aggressive species may be available for corrosion in the vapor space. As such, the extent to which the initial solution is inhibited prior to decanting of the solution plays a key role in the corrosion in the vapor space. This is further corroborated by the fact that even a drop in the final solution pH to 9.8 and 9.9 for solution 1 and solution 2 respectively, did not lead to corrosion in the vapor space which would indicate transport of the species into the vapor space. The indented coupons were broadly corroded and the indents did not provide any specific location for extensive corrosion for the polished specimens.

Figure 17: Polished Vapor Space Coupons Exposed to Solution 1.

Figure 18: Polished Vapor Space Coupons Exposed to Solution 2

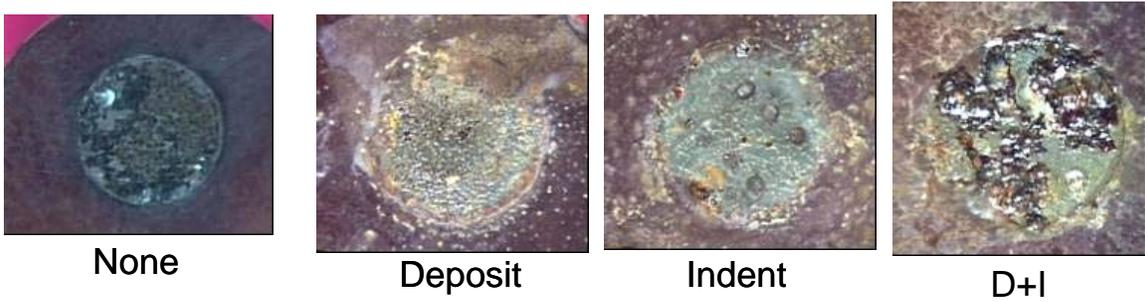
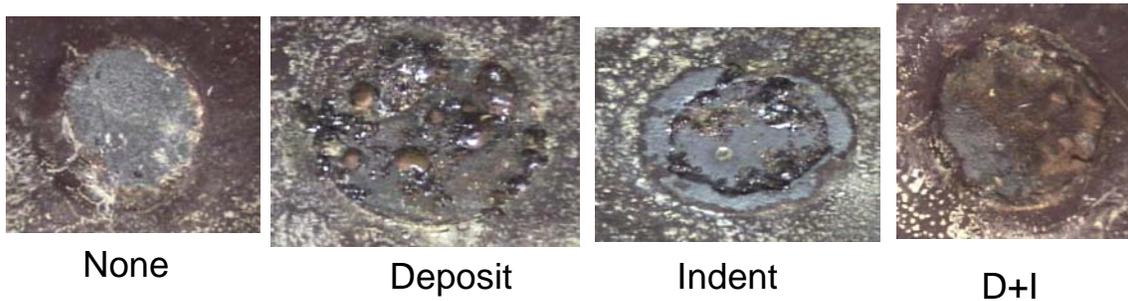
The heat treated coupons for vapor space coupons exposed to solutions 1 and 2 exhibited minor corrosion only in the indented specimens and specifically when surface deposits were present. These results are shown in Figure 19 and Figure 20 for solution 1 and solution 2 respectively.

Figure 19: Heat Treated Vapor Space Coupons Exposed to Solution 1.

Figure 20: Heat Treated Vapor Space Coupons Exposed to Solution 2.

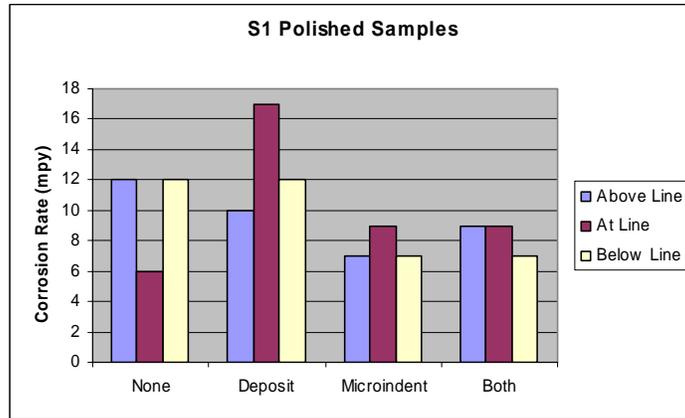
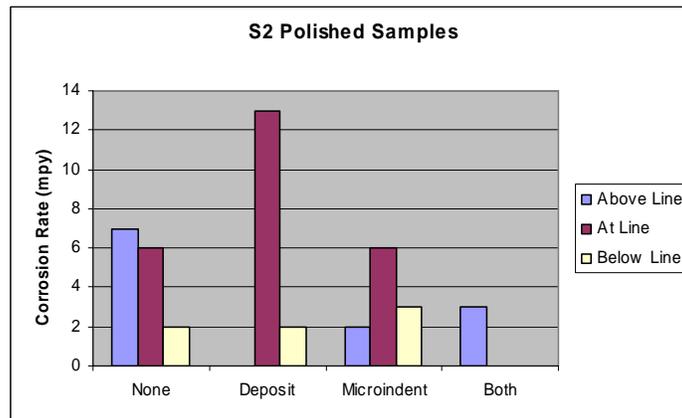
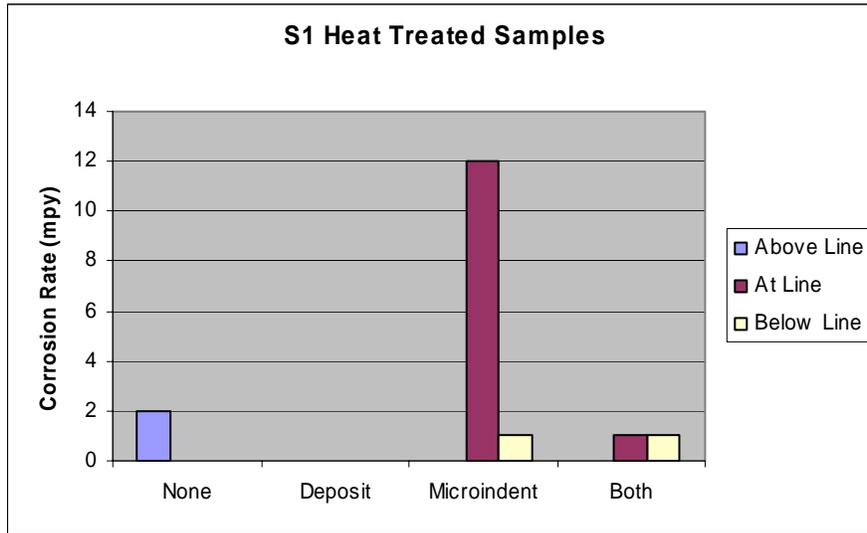
The pits in the liquid/air interface coupons exposed to solutions 1 and 2 were measured and corresponding corrosion rates were determined. The pitting rates were calculated below the liquid line, at the liquid line, and just above the liquid line. The results for the polished coupons are shown in Figure 21 and Figure 22 for solutions 1 and 2 respectively. The results indicate that the pitting rates are between 6-16 mpy for solution 1, while 2-13 mpy for solution 2. The pitting rates were higher and sometimes only measurable above the line for solution 2. These results suggest that even small quantities of minor waste constituents known to be corrosion inhibitors, such as chromate and phosphate, reduce the corrosion rate. This is further corroborated by the fact that the heat treated coupons exposed to solution 2 remained protected, while those exposed to solution 1 exhibited pitting as shown in Figure 23.

Figure 21: Pitting Rates for Liquid/Air Interface Coupons Polished Exposed to Solution 1.

Figure 22: Pitting Rates for Liquid/Air Interface Polished Coupons Exposed to Solution 2.

Figure 23: Pitting Rates for Liquid/Air Interface Heat Treated Coupons Exposed to Solution 1.

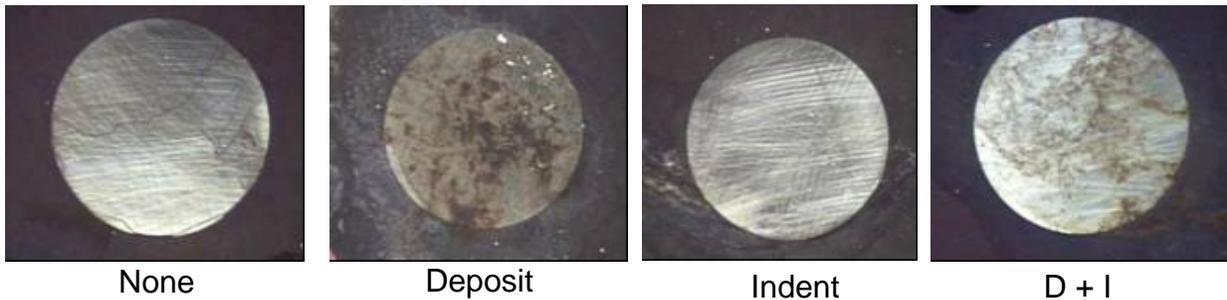
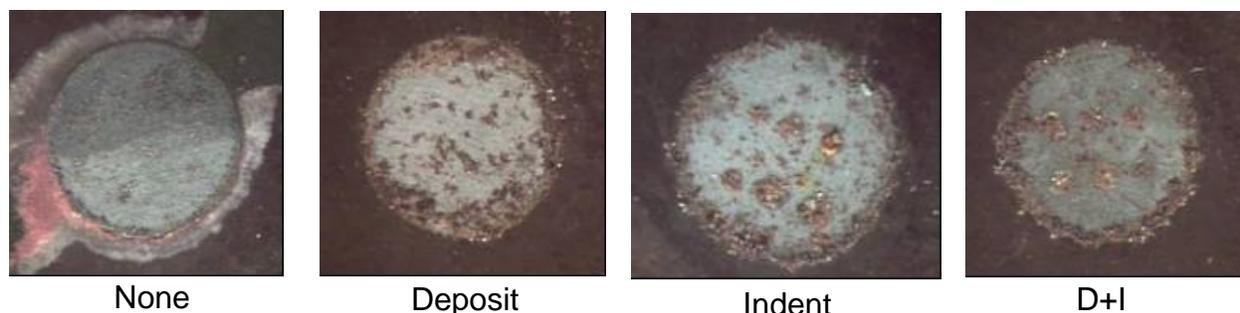
The vapor space coupons exposed to solutions typical of Tank 34 and Tank 39 revealed no measurable corrosion on either the polished or heat-treated specimens. In fact, only the coupons with initial deposits in the vapor space showed any staining, as shown in Figure 24. The heat treated coupons exposed to the vapor space above the Tank 34 solution, shown in Figure 25, were also well protected. The coupons exposed to the liquid/air interface showed staining but no corrosion.

Figure 24: Vapor Space Coupons Exposed to Tank 34 Solution

Figure 25: Heat Treated Vapor Space Coupons Exposed to Tank 34 Solution

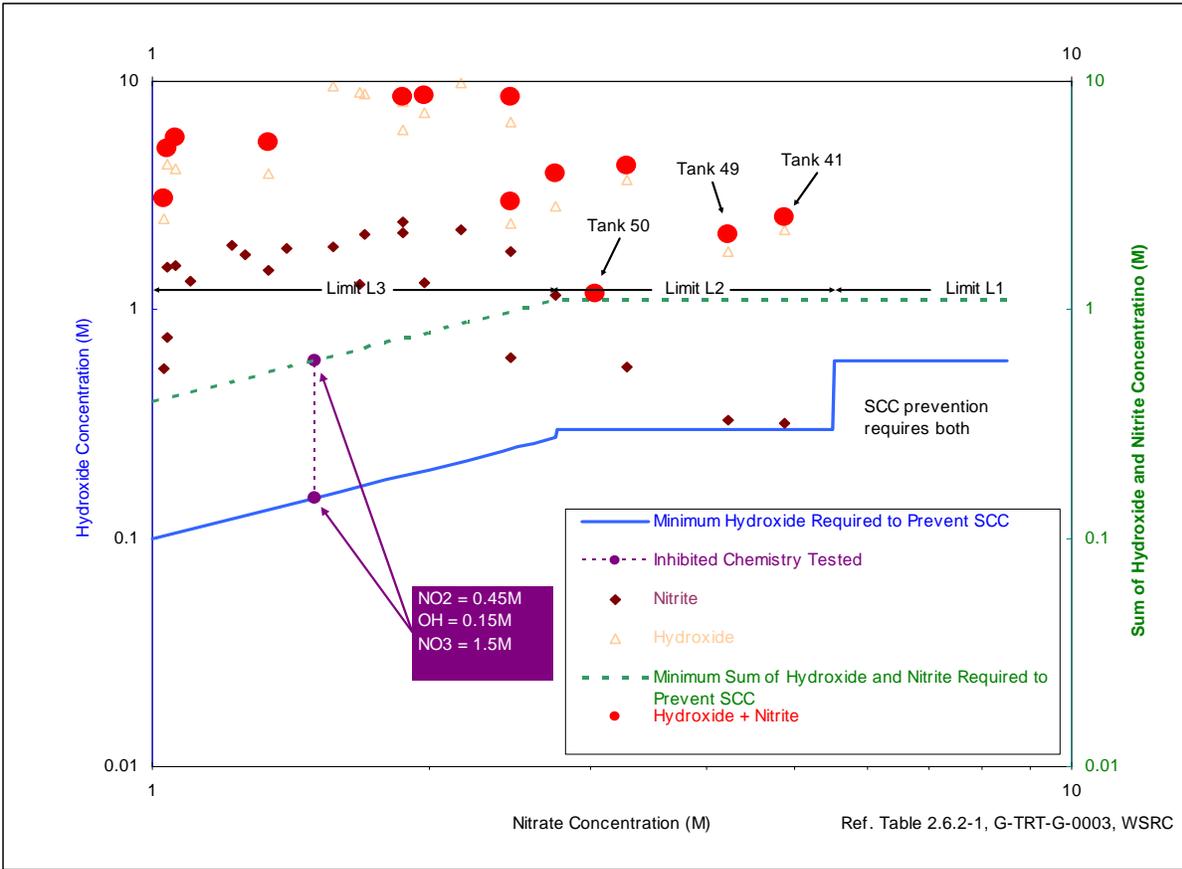
Figure 26: Chemistry of Type III Tanks from Recent Samples

The chemistry analyses from samples taken from the Type III tanks were plotted against the current chemistry control program, as shown in Figure 26, to determine potential vulnerabilities in the tank chemistries in their current state. It is important to note that ultrasonic and visual inspection of the Type III tanks has not found consequential evidence of vapor space or liquid/air interfacial corrosion. The analysis performed here is intended to determine if any tanks are near the boundary conditions of the chemistry control program in which VSC/LAIC may be an issue.

The chemistry of the Type III tanks with greater than 1M $[\text{NO}_3^-]$ concentration as taken from recent samples is shown in Figure 26. The chemistry control program is presented in the graph for nitrate concentrations greater than 1M. The chemistry tested in the experiments was 1.5M NaNO_3 , 0.45M NaNO_2 , and 0.15M NaOH , which is the boundary condition for the chemistry control program. The red dots on the graph indicate the current nitrite + hydroxide concentrations for the Type III tanks. The analyses showed that the chemistry only in Tank 50 near the boundary conditions for the sum of hydroxide/nitrite in the L2 limit. Tanks 41 and 49 are the only other tanks that are near similar boundary conditions.

However, none of these tanks are currently considered at risk since their hydroxide concentrations are well above the boundary conditions (i.e. 1.18M for Tank 50, 1.8M for Tank 49, and 2.23M for Tank 41) tested in the experiments. Ultrasonic inspection of Tanks 49 and 50 have revealed no reportable pitting in either tank.¹⁶

The specific tank chemistries are shown in Table 14, with Tanks 41, 49, and 50 highlighted. Tank 41 and Tank 49 are used as salt dissolution tanks, while Tank 50 is used as an ETF/Saltstone feed tank. The experimental results indicate that Tank 50 would be most susceptible to the potential for liquid/air interfacial corrosion or vapor space corrosion. It is important to note that the salt dissolution tanks have had a recent change in chemistry and Tank 50 has historically had significantly higher concentrations of inhibitor.
