GLASS MACROCRACKING DETERMINATION IN PROTOTYPIC CANISTERS CONTAINING LANTHANIDE BOROSILICATE GLASS

Timothy Jones
James Marra
David Immel
Ben Meers

January 2006

Savannah River National Laboratory
Aiken, SC 29808

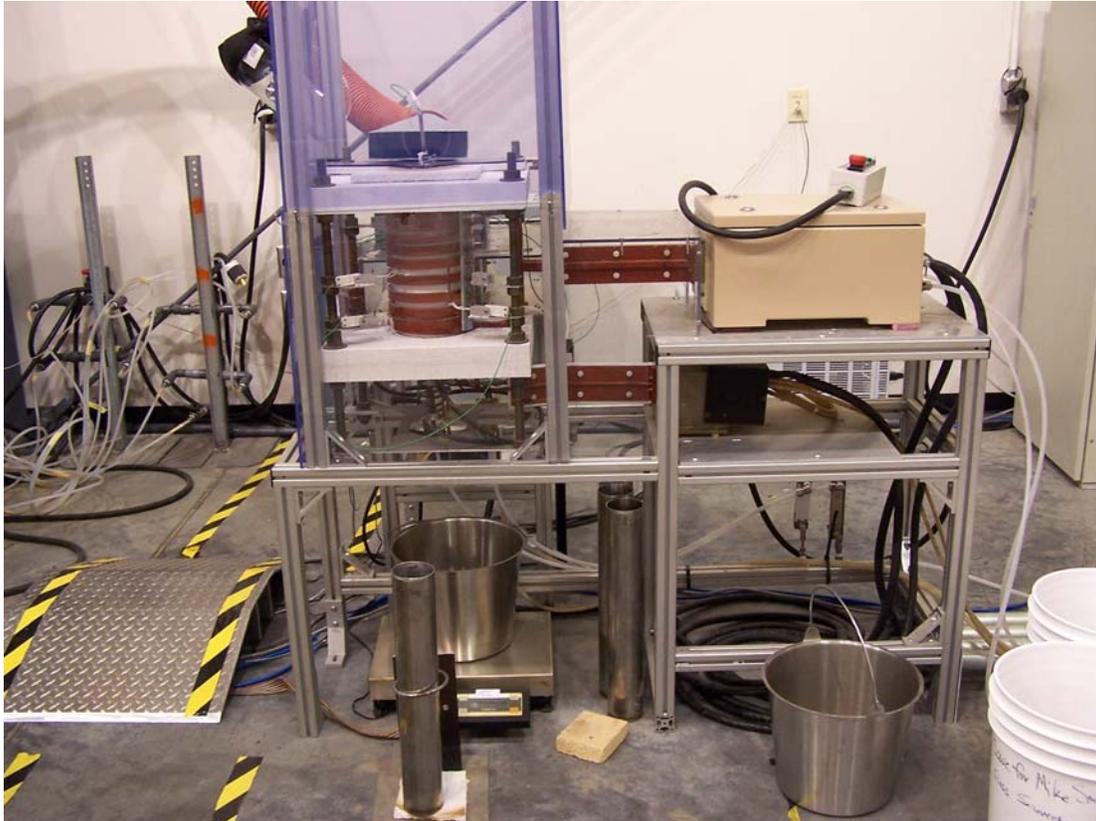
Figure 1. Cylindrical Induction Melter System

The Cylindrical Induction Melter (CIM) system installed at the Aiken County Technology Laboratory (ACTL) is a robust and remotely operable system to be used to produce experimental data through vitrification testing. The CIM system is located in the ACTL High Bay. It consists of an inductively heated platinum/rhodium (Pt/Rh) containment vessel and drain tube, three induction heating systems and power supplies, a Modicon® control system, a chiller, and a simple off-gas venting system (See Figure 1).

The melter containment vessel is constructed from 80% platinum / 20% rhodium alloy, cylindrically shaped, and heats as a result of exposure to changing electro-magnetic fields generated by the heat stations (induction heating). The Pt/Rh melter vessel is 14" high overall, consisting of a 13" tall by 5" diameter cylinder, with the lower 1" tapered to produce a conical transition to the 6" long by 0.20" I.D. 80% Pt / 20% Rh drain tube welded to the bottom (See Appendix 7.1). The vessel wall thickness is 0.080", and the drain tube wall thickness is 0.030". Four R-type thermocouples are welded to the vessel wall, and a "spring-loaded" contact R-type thermocouple is located to contact the drain tube. A "bed" thermocouple is suspended within the batch bed/glass melt pool from above. The "bed" thermocouple, designated as T6, was Materials & Test Equipment (M&TE) calibrated to +/-10°C at 1150°C. Primary temperature indication for the vessel may be provided by any of the five welded vessel T/Cs, however the T6 bed thermocouple provided the temperature data for the glass product. The vessel is surrounded by a Zircar® insulating cylinder and water-cooled copper coils through which the electric current is passed to produce the electro-magnetic field (see Figure 1).

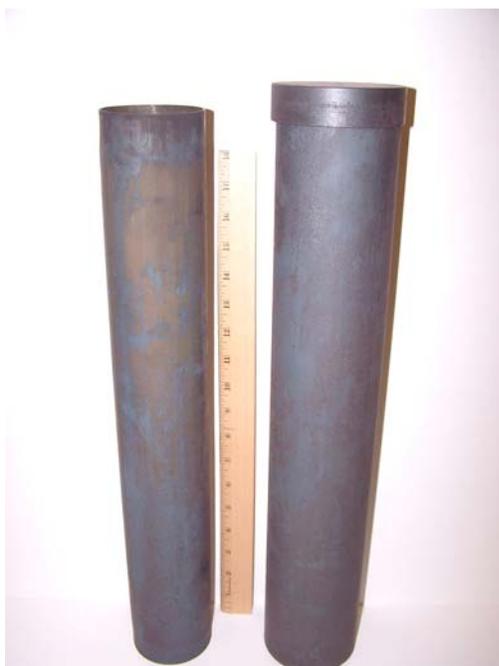
Figure 2. Inner and Outer Cans

The prototypic canisters that were used for these tests were constructed of 304L stainless steel. Cans of two dimensions were fabricated: the “inner” canister into which the molten glass was poured, and the “outer” canister that represents an enclosure into which the glass-filled “inner” canister is placed for transfer. The “inner” canisters measured 19.25” tall by 2.87” inside diameter with 0.065” wall thickness (see Figure 2). The “inner” canisters were filled to within 2” of the top of the can with LaBS glass during the melter draining operation (see Figure 3). The “outer” canisters were constructed of 304L stainless steel, and measured 20.0” tall by 3.25” inside diameter with 0.125” wall thickness. The “outer” canisters also had stainless steel caps that loosely fit over the tops of the cans. Liquid penetrant tests were performed per ANSI B31.3 method on the welds of all prototypic “inner” canisters to assure the weld integrity. The design dimensions of the inner and outer canisters are shown in Appendix 7.2.

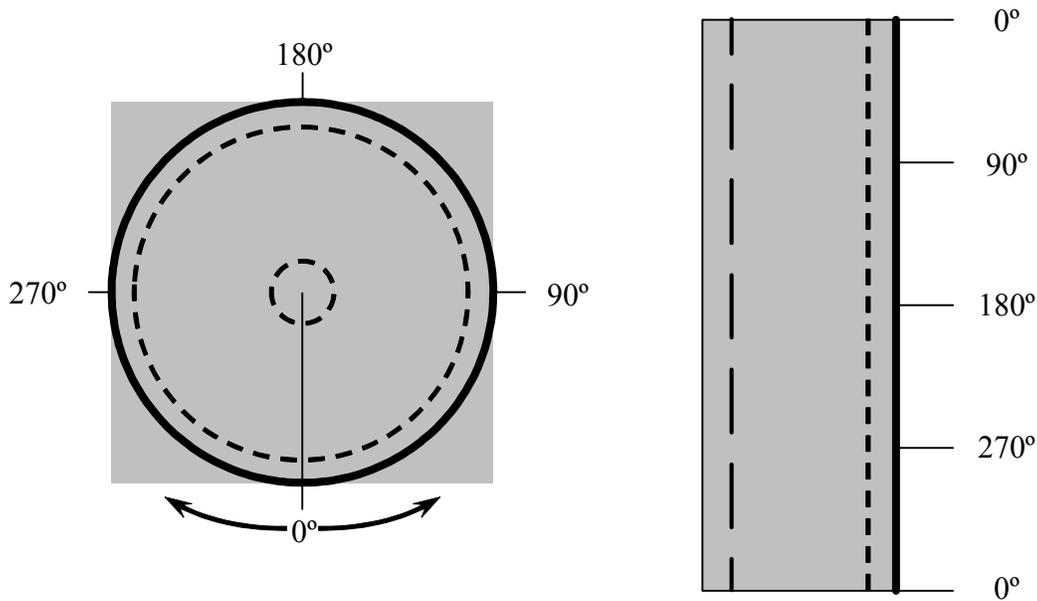
Figure 4. Radial Slice Construction

The digital radiographs were processed to horizontal slices using the Feldkamp cone-beam reconstruction algorithm as implemented by Lawrence Livermore National Laboratory software code. The CT slices in their raw form were processed using a 3-dimensional smooth filter to increase feature distinction. Individual slices were processed by a high pass-filter to attenuate the bulk material and amplify the appearance of any inconsistencies and discontinuities in the materials (e.g. porosity, voids, or cracking). The slices were then assembled into a 3-d data set using in-house software. To allow for detailed observation of the can distortion experienced during annealing, a data set was generated by geometrically “unwrapping” each slice from around its center point as diagrammed (see Figure 4).

While distorting the central region, it allows for better display and understanding of the edge region geometry. These radial slices can also be stacked together and displayed as a vertical slice image.

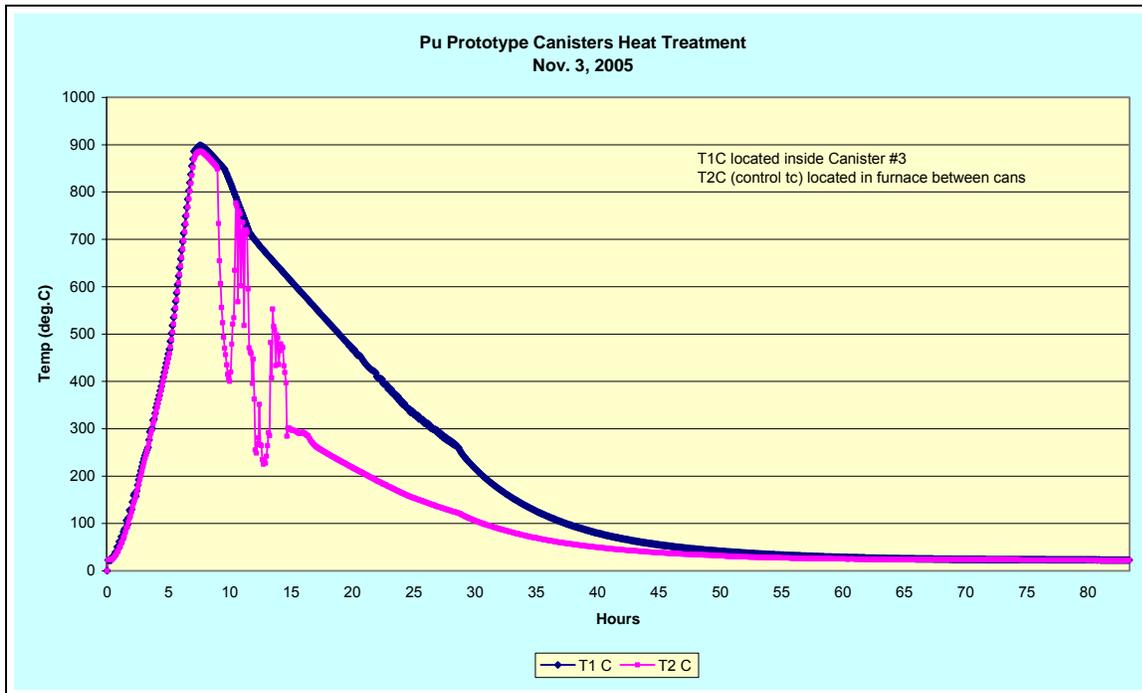
Figure 5. Prototype Canisters Heat Treatment

The entire glass filling (heating) and cool down of the cans in the DWPF test required 42+ hours (See Figure 5). The heat treatment schedule for this test was reduced by eliminating the time taken for the glass to reach the T7.3 thermocouple at the 84" height in the DWPF canister, i.e. 42+ hours for can-in-canister test reduced to 28.5 hours for this heat treatment cycle.

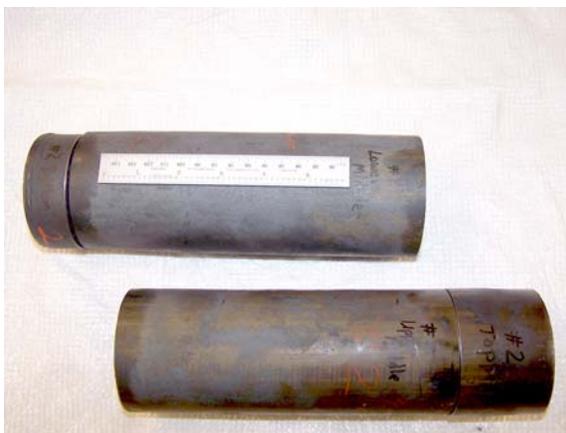
Figure 8. Sectioned Canister #2

Canister #2 was sectioned by three cuts (see **Figure 8**), yielding the top surface section (33 mm glass thickness), the upper cut section (194 mm glass thickness), the mid-section (212 mm glass thickness), and the bottom section (26 mm glass thickness). See Appendix 7.3 for illustration of sectioned canister dimensions. Canister #3 was sectioned by four cuts (See **Figure 9**), yielding the top surface section (32 mm glass thickness), the upper cut section (201 mm glass thickness), the mid-section (180 mm glass thickness), the lower section (22 mm glass thickness), and the bottom section (25 mm glass thickness). The lower section of canister #3 was not used in determining surface area increase due to cracking, so that only four sectioned samples were considered for each canister.

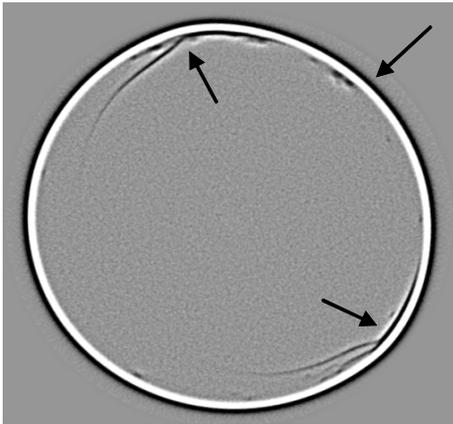
Figure 18. Post-Heat Treated CT slice from Canister #2 Middle Section

Figure shows:

- typical can deformation of two outward and one inward distortions
- arc cracking emanating from the outward nodes
- wall porosity location and size
- glass separation from the can at outward deformation nodes.

Post heat treated inspections show three types of cracks in the material (arc, chaotic, and horizontal). Both samples have vertical arc shaped cracks emanating from the two deformation nodes running the length of the material. The magnitude of the arc cracks is proportional to the magnitude of the can deformation, appearing and intensifying through the bottom section, large and constant in the middle section, and abating through the top section.

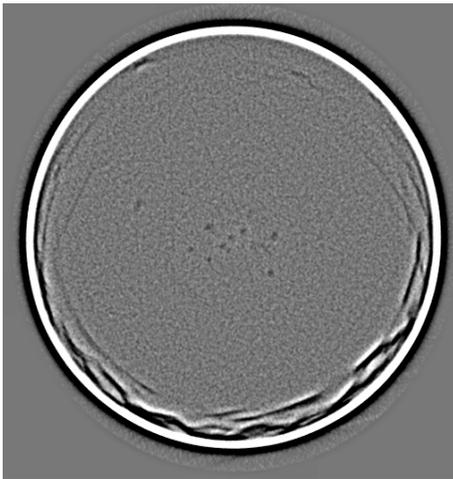
Figure shows:

- chaotic cracking in the outer edge of glass
- central porosity location and size
- reduced deformation at extremities of the can

Observable in both samples in the top section is a chaotic fracturing of the glass in the arc corresponding to the inward deformation. The extent of chaotic fracturing is larger in Canister #2. Canister #3 shows a large horizontal crack in the lower middle section.

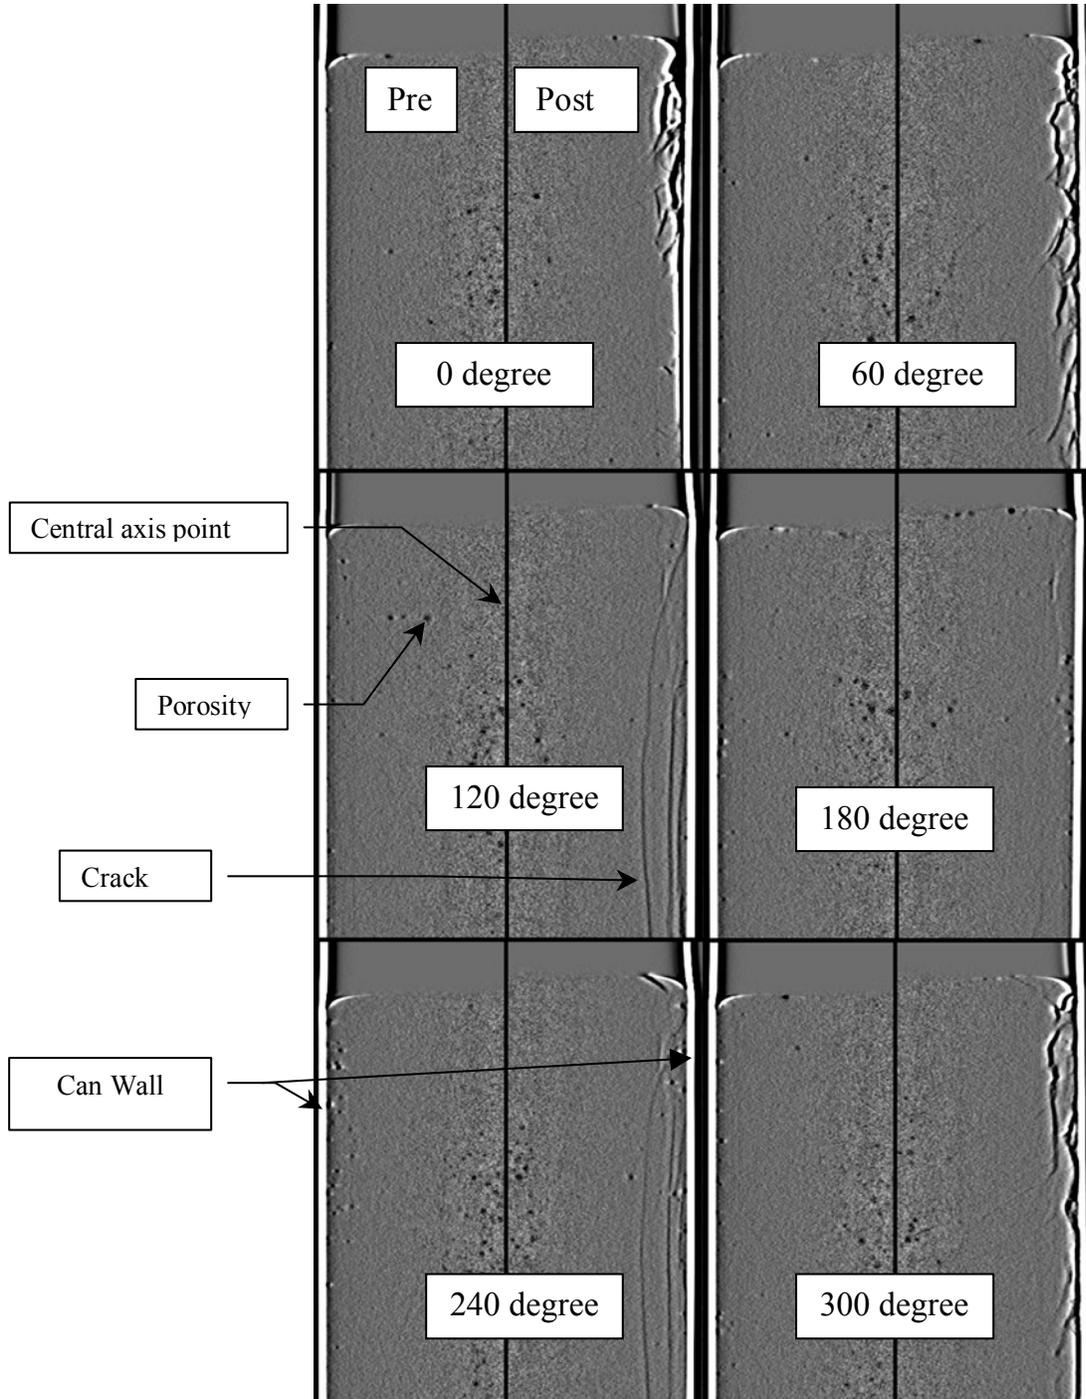
Figure 21. Pre-heat treated and Post-heat treated Canister CT Scans

A vertical slice created by assembling data points at a constant angle (0, 60, 120, 180, 240, and 300) radiating from the center point from horizontal slices. The pre-anneal scan is flipped horizontally and abutted to the post-anneal scan. Each side (Pre and Post) displays the same view from each scan and can be directly compared.

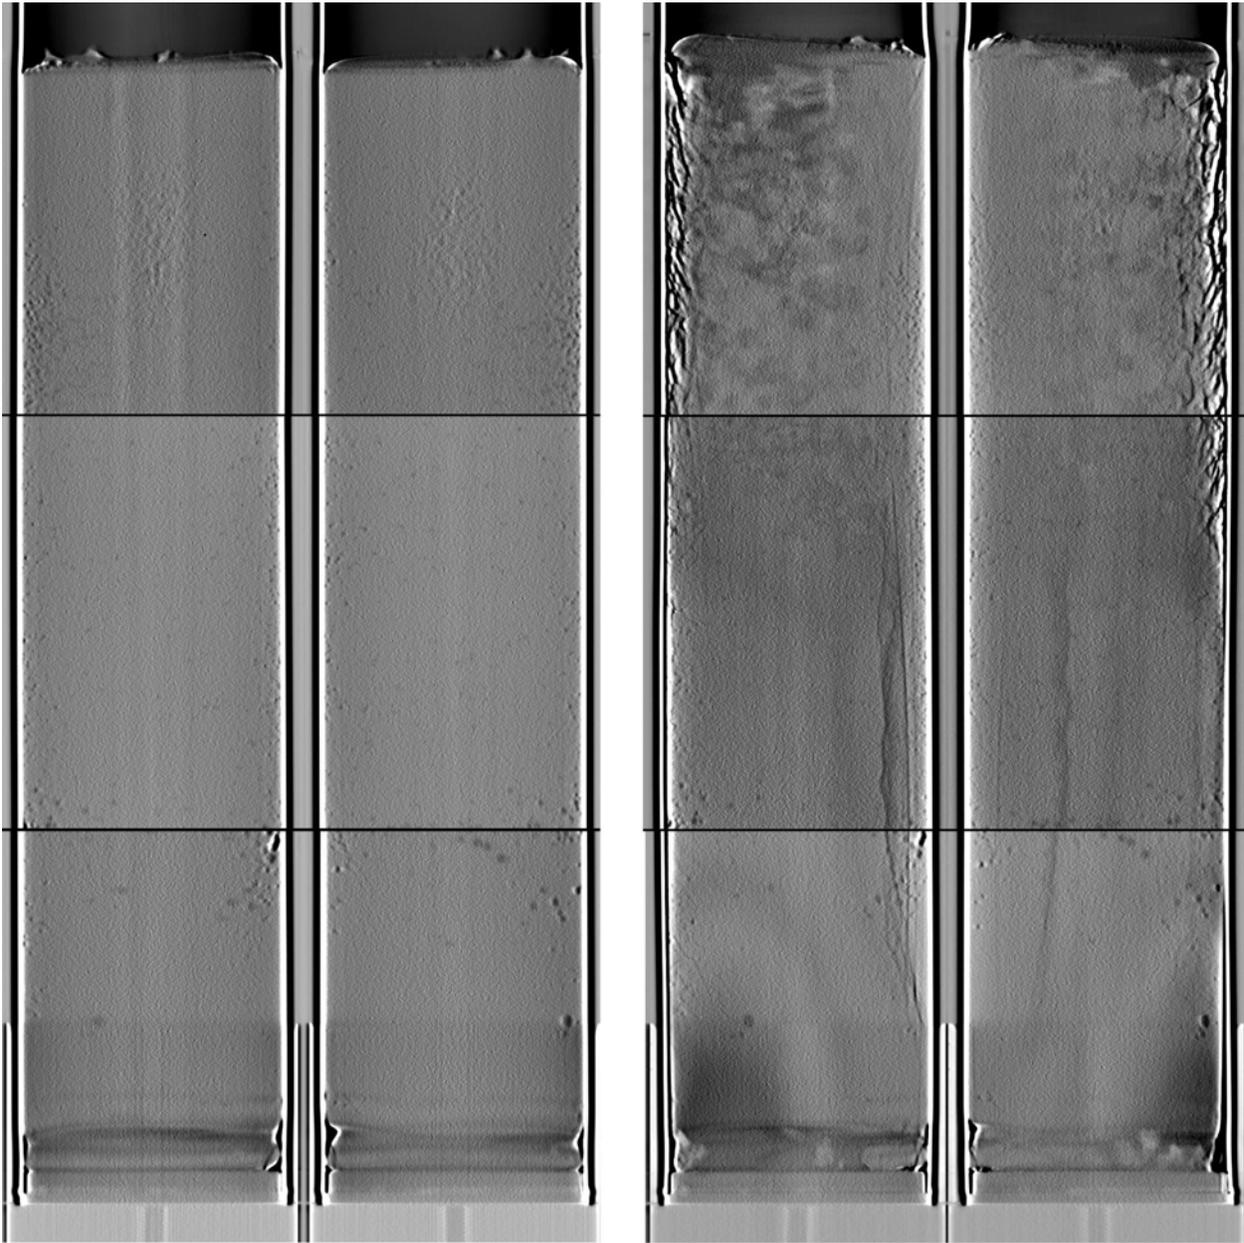
Figure 22. Canister #2 Composite CT Generated Radiographs

Can 2 composite CT generated radiographs 0 and 90 degrees views of pre-annealed (left) and post-annealed (right) top, middle and bottom sections.

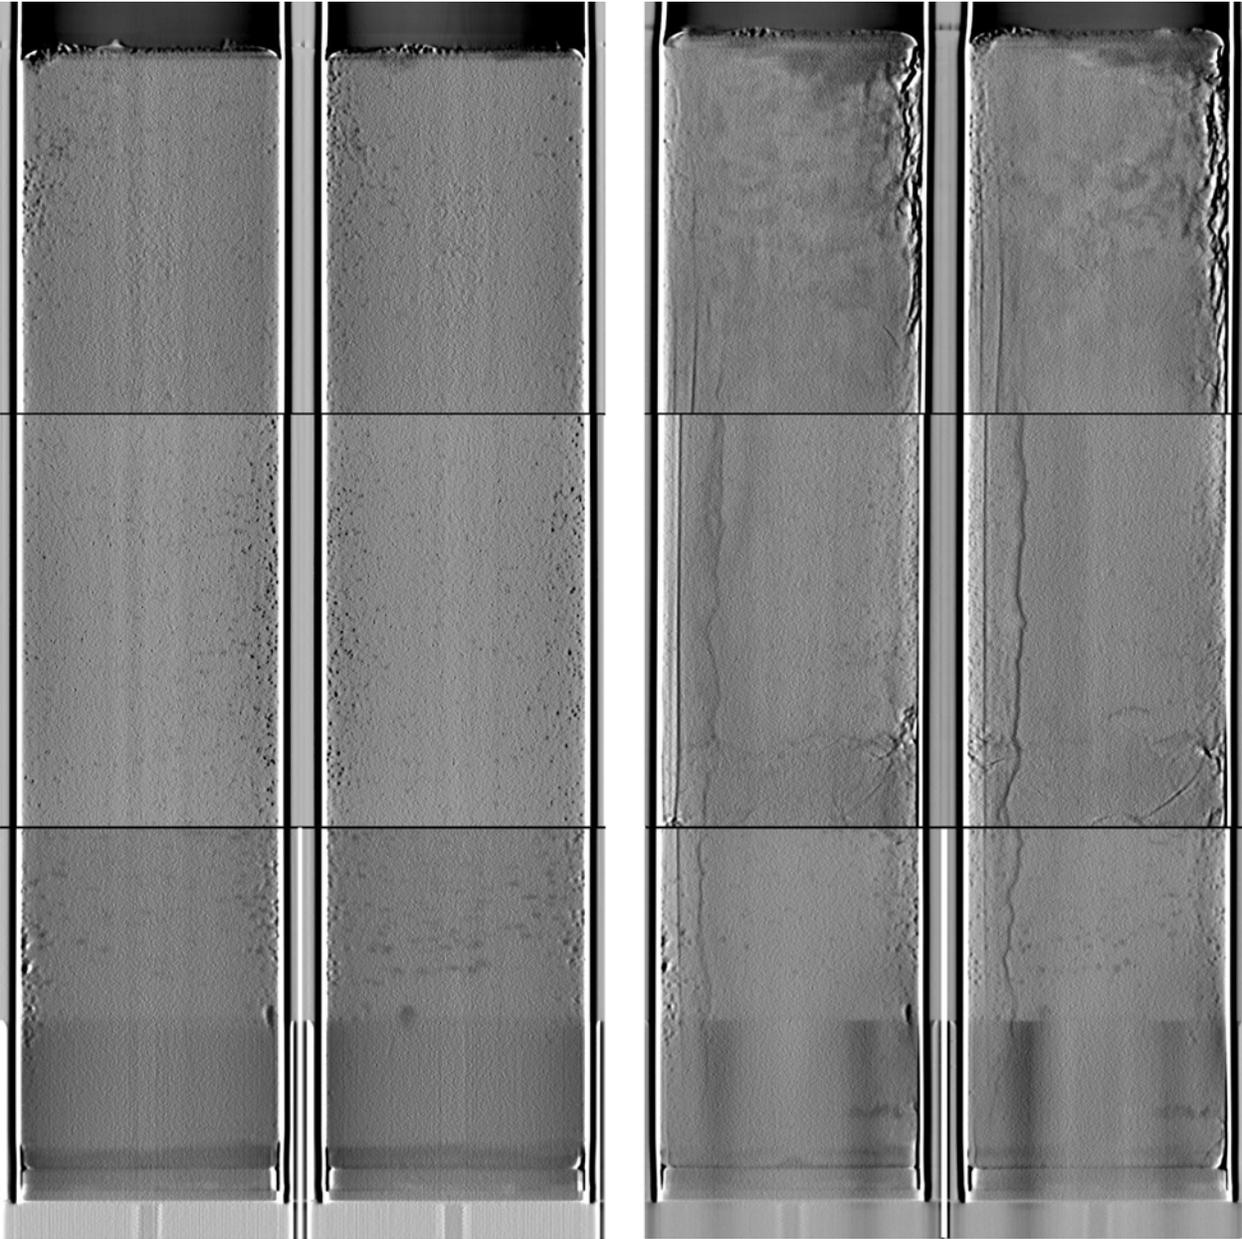
Figure 29. Canister #3 Composite CT Generated Radiographs

Can 3 composite CT generated radiographs 0 and 90 degrees views of pre-annealed (left) and post-annealed (right) top, middle and bottom sections.

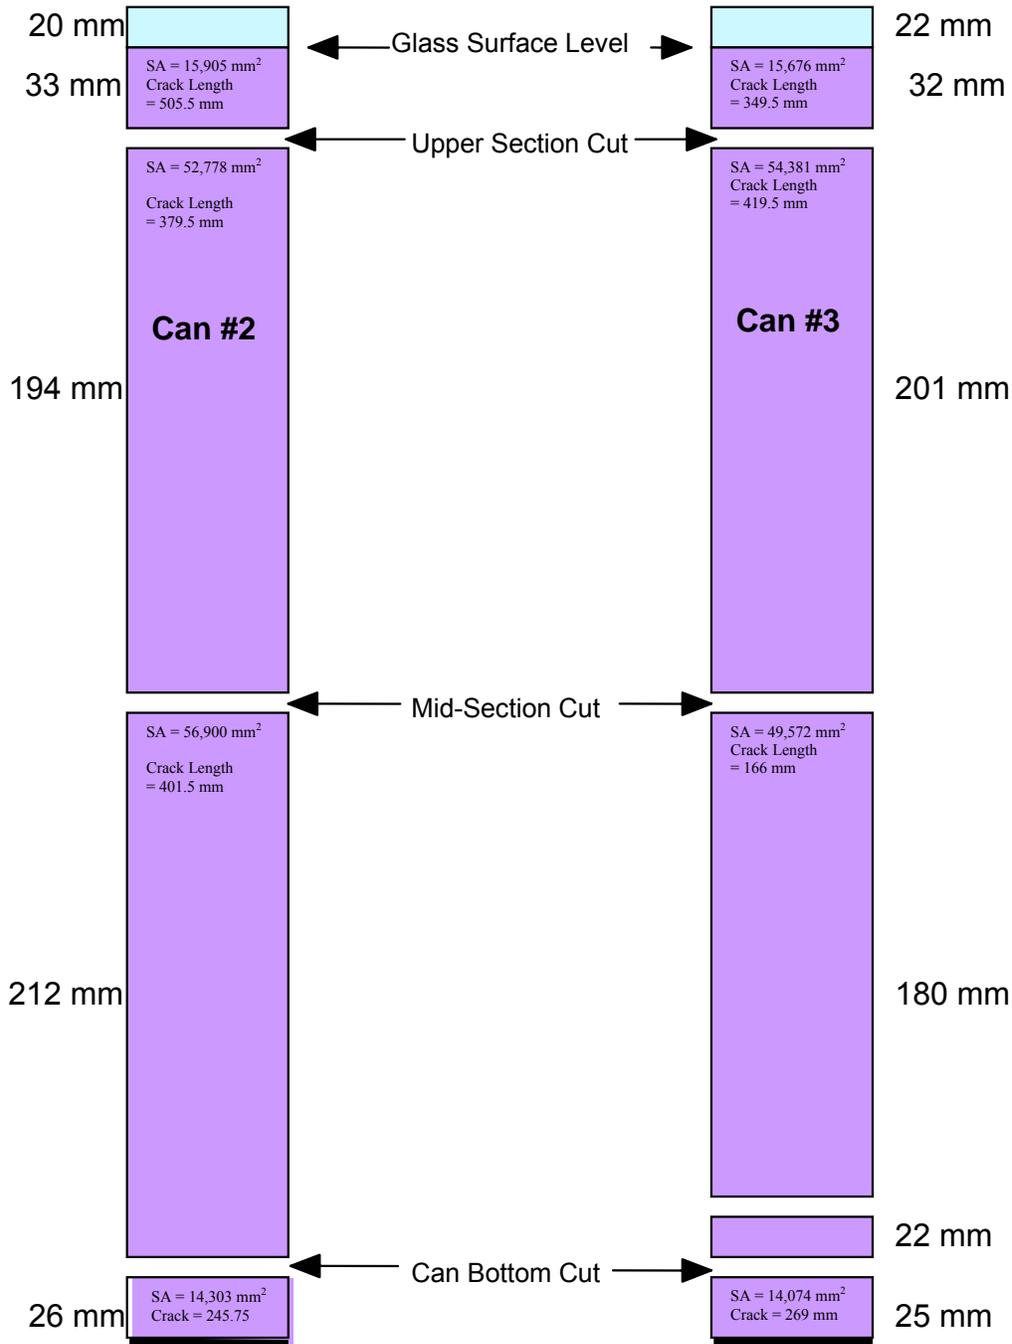
7.3 Prototypic Pu Vitrification Canisters Sectioned Dimensions

$D = \text{can inside diameter} = 72.9 \text{ mm}$
 $Ht. = \text{can section height (mm)}$
 $r = \text{can inside radius} = 36.45 \text{ mm}$
 $A = \text{x-sectional area} = \pi r^2 = \pi (36.45\text{mm})^2 = 4,173.9 \text{ mm}^2$
 $C = \text{circumference} = 2\pi r = 2\pi (36.45\text{mm}) = 229.02 \text{ mm}$
 $SA = \text{surface area} = (C \times Ht.) + 2A$
 $CSA = \text{crack surface area} = 2L \times Ht.$

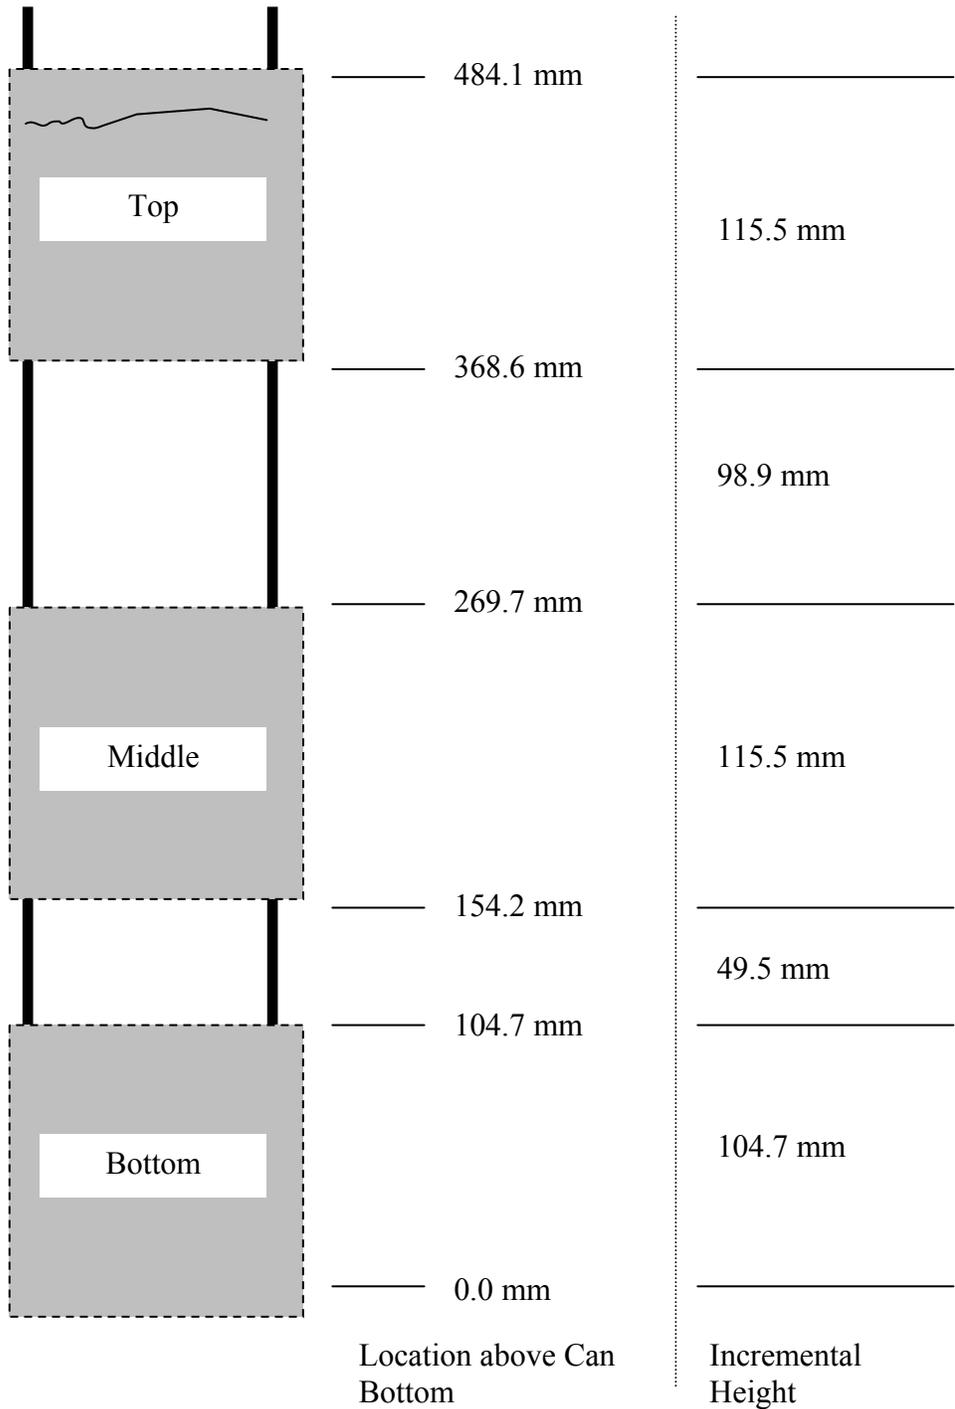
7.4 Prototypic Canisters Radiography Section Dimensions

Region	Lower Bound	Upper Bound	Height
Bottom	0.00"	4.12"	4.12"
Middle	6.07"	10.62"	4.55"
Top	14.51"	19.06"	4.55"
