AEC RESEARCH AND DEVELOPMENT REPORT

**STRESS CORROSION CRACKING OF
AUSTENITIC STAINLESS STEEL**

STATUS REPORT - SEPTEMBER 1, 1964

Savannah River Laboratory
Aiken, South Carolina

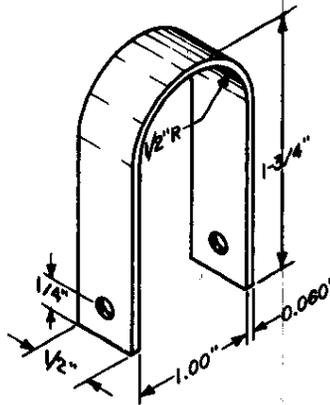
FIG. 1 DIMENSIONS OF U-BEND SPECIMEN

- Square sheet samples approximately $1/2 \times 1/2 \times 0.06$ inch with various heat treatments, degrees of cold work, and surface preparations.
- U-bend samples with the general design shown in Figure 1.
- Thin foils (approximately 1000 \AA thick) prepared by wet grinding, mechanical polishing, and electrochemical thinning to the required thickness.

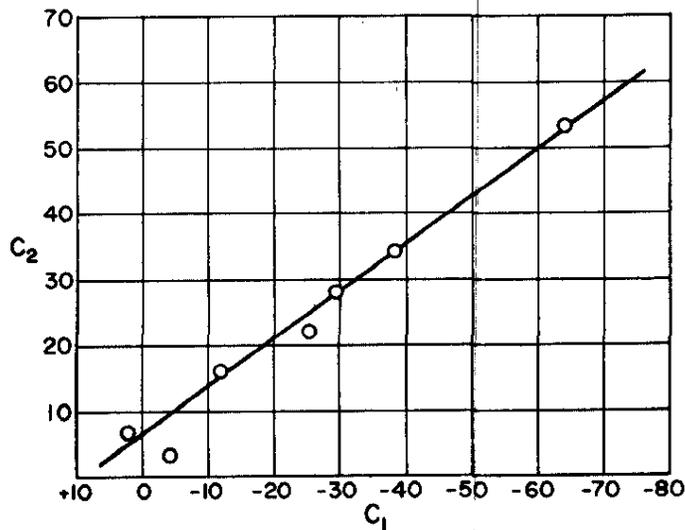
FIG. 2 CORRELATION OF EMPIRICAL CONSTANTS DETERMINED FOR DIFFERENT HEATS OF STAINLESS STEEL

shown in Table II. The values of C_1 and C_2 were different for each heat of steel, but appeared to be related to each other in a linear fashion (Figure 2).

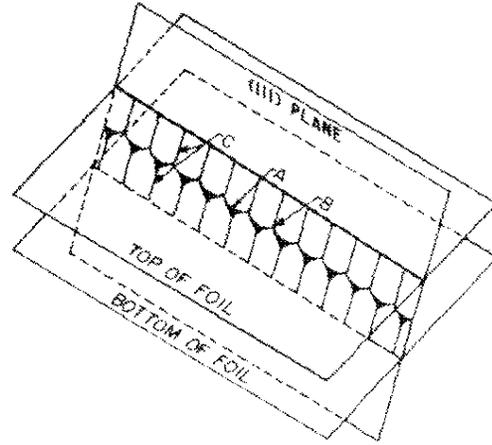
NEG. 1759C

a. Dislocation network containing alternate extended and contracted dislocation nodes.

b. Sketch showing region circled in Figure 5a. Arrow A points to an extended dislocation node, B to a contracted node, and C to dislocations.

FIG. 5 EXTENDED DISLOCATION NODES IN TYPE 304 STAINLESS STEEL

All six heats of steel contained coplanar arrays of dislocations (Figure 3), and stacking faults were frequently observed in the 304 and 304L steels (Figure 4) and occasionally observed in the 316L steel; extended dislocation nodes were also seen in several of the 304 and 304L steels (Figure 5). These types of dislocation arrangements are indicative of low stacking fault energy.⁽⁸⁾

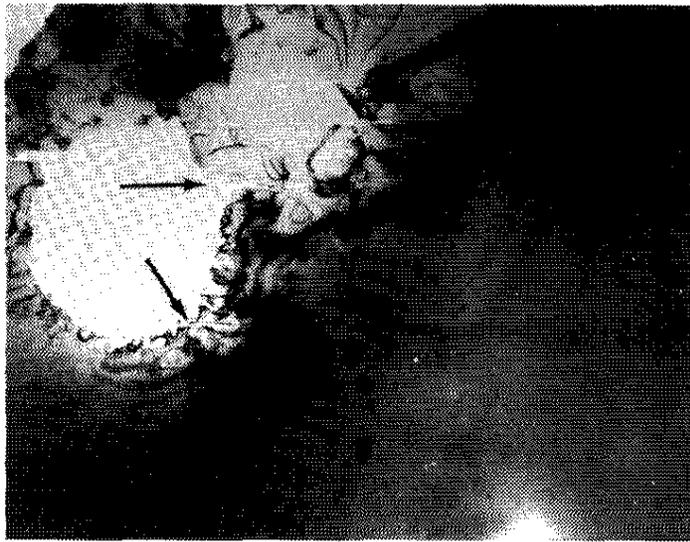
NEG. 1862

FIG. 8 LIMITED PREFERENTIAL ATTACK IN FOIL EXPOSED 30 MINUTES IN DILUTE CHLORIDE SOLUTION AT 100°C (Heat 11880)

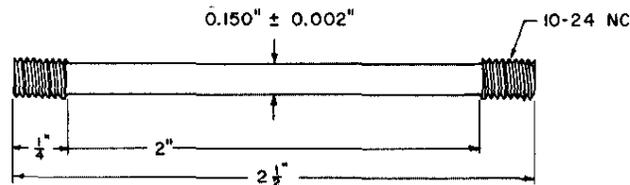
FIG. 9 DIMENSIONS OF TENSILE SPECIMEN

Stress-aging tests were performed using annealed and quenched tensile specimens (Figure 9) machined from 304 stainless steel heat 31614. Tests were conducted at room temperature, 100, 125, 150, 175, and 200°C. The specimens were strained several percent before straining

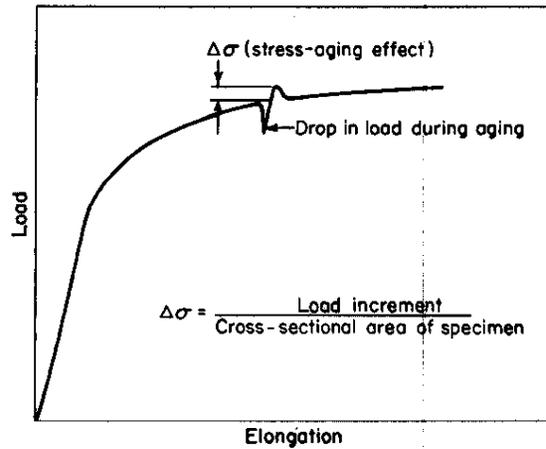
FIG. 10 SHAPE OF TYPICAL LOAD-ELONGATION CURVE SHOWING STRESS-AGING PEAK

was discontinued, and the specimen was held at load (stress-aged) for 10 minutes. After aging, the specimens were strained several percent more. This procedure produced a stress-aging peak in the load-elongation curve (Figure 10). This peak was due to the increase in stress (load) required to re-initiate plastic flow. The height of this peak was a function of test temperature (Figure 11). Similar specimens were tested immediately after a cathodic charging treatment of 2 hours in a 5% H₂SO₄ solution at a current density of 0.25 amp/cm². No stress aging effect was observed in four of the five cathodic-charged specimens, and the magnitude of the effect in the remaining sample was less than in uncharged samples tested at the same temperature.

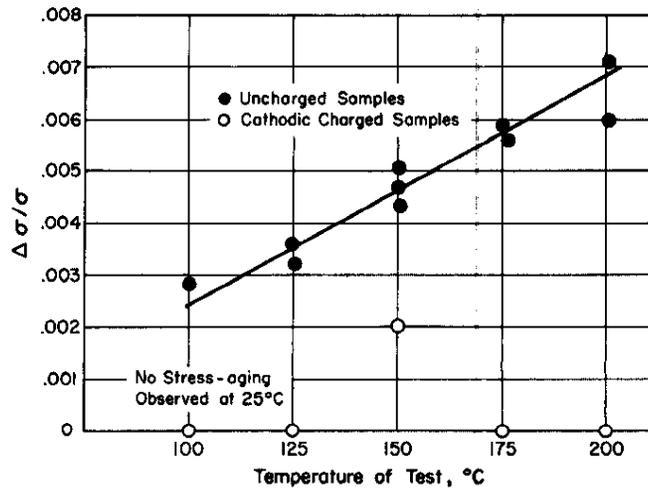
FIG. 11 RELATIONSHIP BETWEEN STRESS-AGING EFFECT AND TEST TEMPERATURE

These results indicate that the introduction of hydrogen decreased the response to stress aging in much the same way as Swann and Pickering⁽¹¹⁾ had observed for nitrogen. Nitrogen has also been shown to increase the susceptibility to stress corrosion cracking,⁽¹²⁾ however, this increase in susceptibility has been rationalized as being caused by the effect of nitrogen on the degree of local order,⁽⁹⁾ not because of nitrogen segregation to dislocations. Additional experiments are necessary to clarify the role of hydrogen and nitrogen in the stress-aging and stress corrosion processes.
