Microbiological and Chemical Test Results on an Unknown Material from the L-Area Spent Fuel Basin

5/18/2012

Author: C. J. Berry, SRNL, Biotechnology

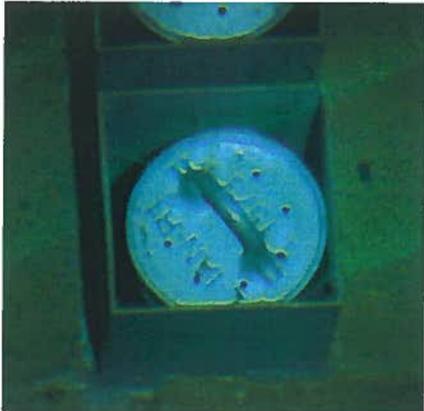
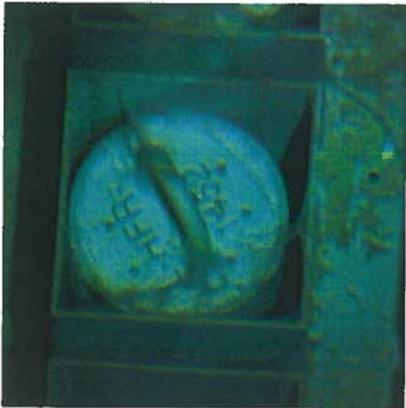
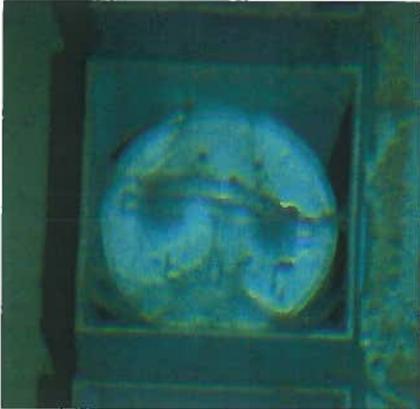
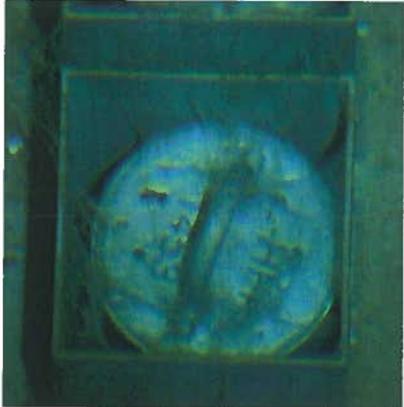
Figure 1. Severity Classifications of the unknown material on a 0 to 5 Scale

The unknown material was noted by operations personnel in October 2011. The material was described as “cobwebs” due to its physical similarity to these structures, see Figure 1. An initial sampling was performed using brushes and cloth wipes to sample the material. During sampling a small amount of material was obtained and initial test results indicated the material could contain microbiological components. A visual inventory of the basin was also conducted in 2011 and this inventory indicated that the cobweb like material was observed in 7% of the basin and on 40% of the fuel (Jesee, 2011). Figure 1 shows five levels of severity used during the basin inventory. The levels were assigned to basin storage locations based on a visual comparison to the pictures shown in Figure 1. The report concluded that there were no clear correlations between the material and the type of fuel stored, the amount of material and the amount of light, or the radioactivity of the fuel where the material was observed.

Severity Level 1

Severity Level 2

Severity Level 3

Severity Level 4

Severity Level 5

- Material removal – the current options include vacuuming the material and using chemical treatment. pH adjustment is probably not an option due to aluminum solubility

issues but the use of hydrogen peroxide has been demonstrated (Hofstetter and Ausmus, 1989). Both methods may need to be repeated periodically and pretesting may be required for peroxide dosing.
