**TESTING OF A FULL-SCALE ROTARY MICROFILTER FOR THE
ENHANCED PROCESS FOR RADIONUCLIDES REMOVAL**

D.T. Herman
D.B. Stefanko
M.R. Poirier
S.D. Fink

JANUARY 2009

Savannah River National Laboratory
Savannah River Nuclear Solutions
Aiken, SC 29808

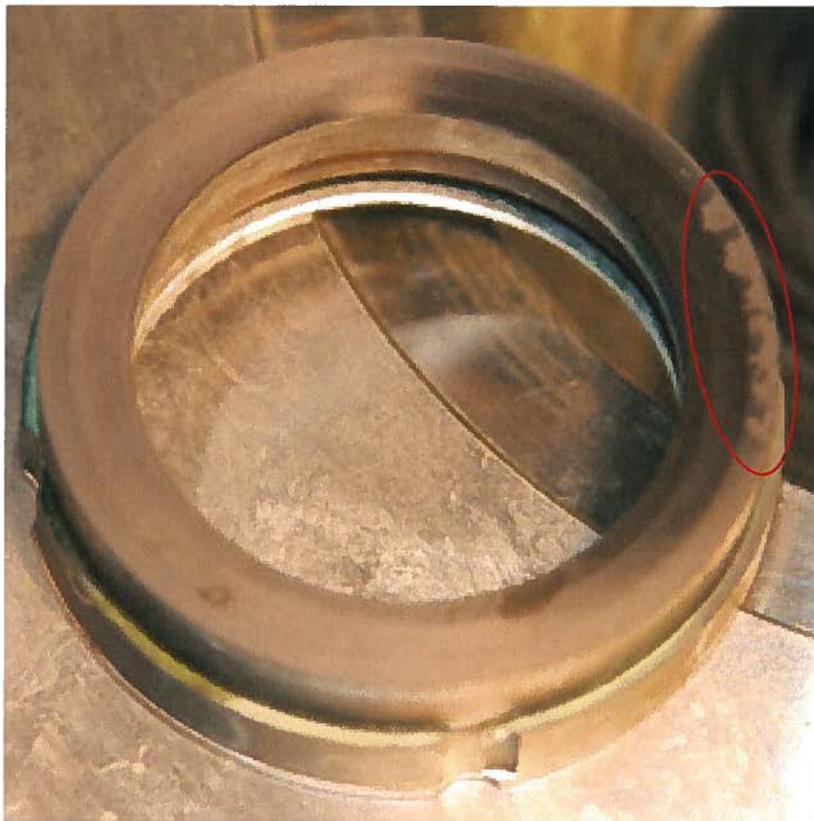
Figure 2. Shaft Seal Carbon Face with Chipped Section Highlighted

Neither method slowed the leak rate. The leak continued after applying approximately 15 psi on the system with the rotor either stopped or turning. Finally, with no improvement seen in the leak, the filter was disassembled and inspected by SRNL and a representative from John Crane International. Figure 2 shows a picture of the carbon face of the mechanical seal. The carbon face of the seal and the supporting assembly are mounted to the rotating shaft during operation. The chipped portion of the seal that is circled in the figure is the root cause of the seal leakage.

The chipped features, shown enlarged in Figure 3, are commonly referred to as blisters and occur in much the same manner as galling of metal. According to the John Crane representative, this type of damage is typically caused when something of a viscous nature gets between the seal faces causing an adhesion that leads to the pullout of surface particles. However, damage is typically not localized. If the general process fluid had caused this we would expect the damage to be random in multiple quadrants rather than confined and excessive at just one point. In fact, none of the John Crane personnel who inspected the seal and have observed this type of damage have seen this effect as localized before. Inspection of the Carbon substructure shows that the material appears consistent with the original fabrication, and the nature of the damage makes the possibility of a defect in the material unlikely.

Inspection and analysis of the seal components leads to the conclusion that the seal failure is an anomaly due to some foreign substance contaminating the seal faces. Within the first 1 or 2 seconds of startup, a momentary hotspot was created on the carbon face. The carbon expanded rapidly as it was not able to locally dissipate the heat. These high spots weakened the carbon locally and were sheared off, causing the blisters.

Three potential contamination methods are theorized. The first potential cause of the material between the seal faces is the previous disassembly of the seal. The seal faces were cleaned but not lapped to assure smoothness. During startup and shutdown, the seal faces come in contact and experience wear. Corresponding wear grooves are formed on the mating faces. These wear grooves typically are not aligned during reassembly. The offset caused by the wear grooves could allow enough space for material to be drawn between the faces by capillary action. By not disassembling the seal or by re-lapping the seal faces after a disassembly, the contact seal will be maintained and dramatically reduce the possibility of material being drawn between the seal faces.

The second method involves a contaminant contacting the seal face during assembly. Any such material would have to have not caused an issue in the initial startup and one-hour run of the filter. The contaminant viscosity may have increased due to heating during operation of the filter or decomposition by nitric acid or acid vapors that may have wicked between the seal faces during the cleaning, with the viscous material leading to the damage of the carbon face upon the subsequent startup.

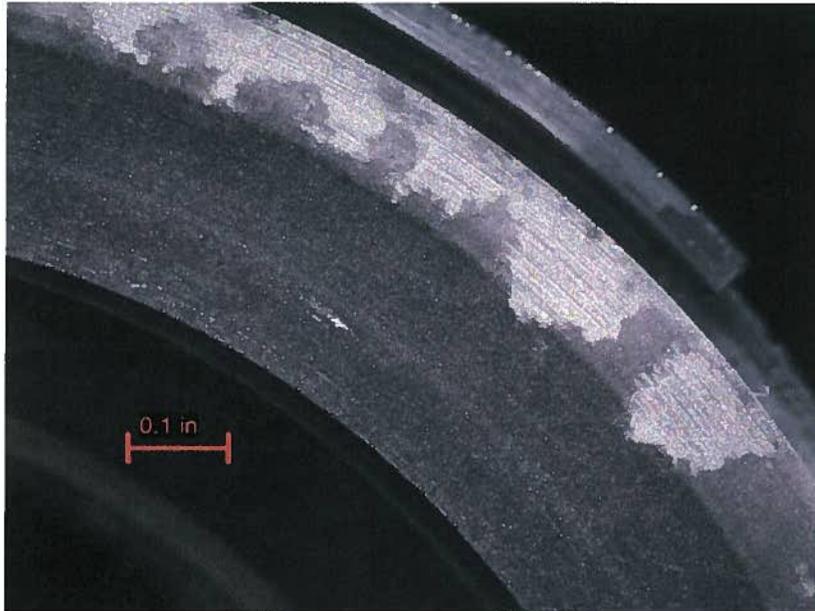
Figure 3. Photo of Blisters on Carbon Seal Face

Prior to the leak, this air seal had seen service in a 150 hour test campaign. After that testing the seal was removed and inspected. No blisters were observed. The seal faces were wiped clean using a lint free towel with acetone and reassembled with the rest of the filter system. The seal was then operated without any signs of damage for approximately one hour. The filter system was then cleaned, in-situ, using nitric acid. During the cleaning, the seal remained assembled and static. Upon restarting the filter system after cleaning, the leak of feed slurry was observed.

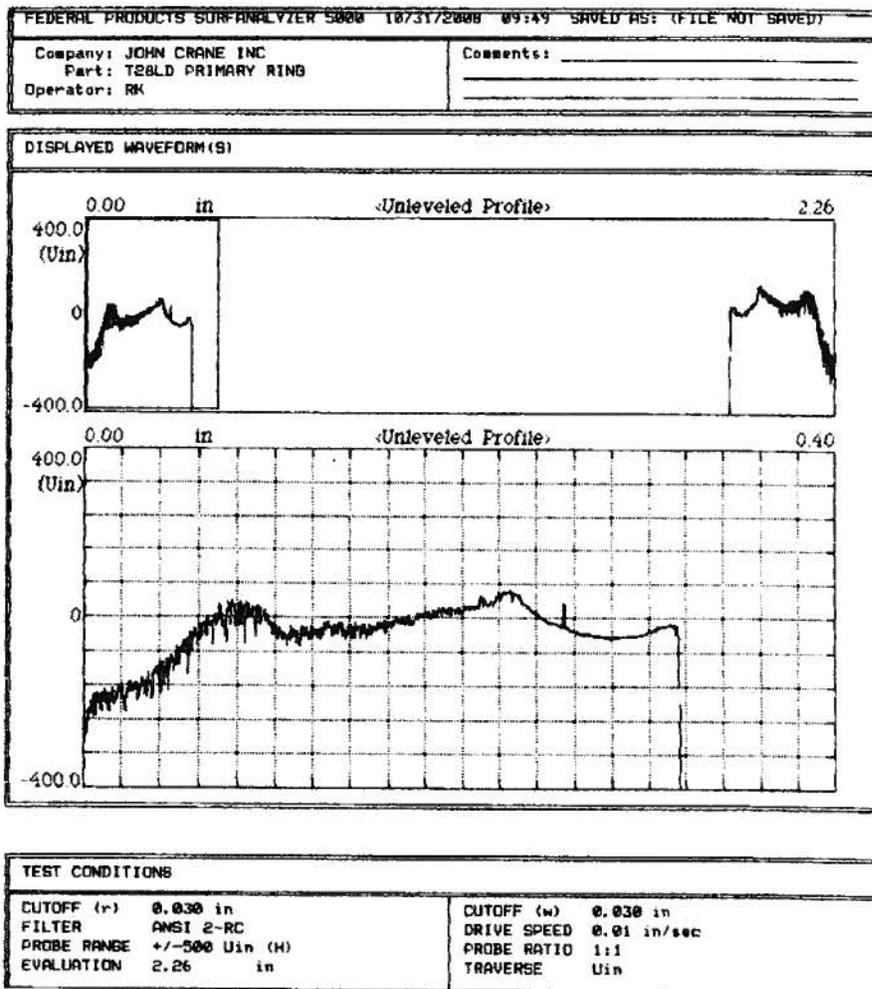
Figure 4. Radial Trace of Carbon Face of Failed Seal

John Crane International representatives performed finite element tracings of the seal faces using a radio profilometer and the tracing is shown in Figure 4. The tracing shows the surface profile of the carbon face taken in an area outside of the blisters. John Crane reported that the wear on these portions of the seal face are within their expectations and the mean deviation across the face is considered good. In the figure, the top portion shows the trace across a single diameter of the seal. The bottom portion shows an expanded version of one radial trace.

of this pattern is in line with a harmonic vibration causing increased wear at the 12 and 6 o'clock positions.

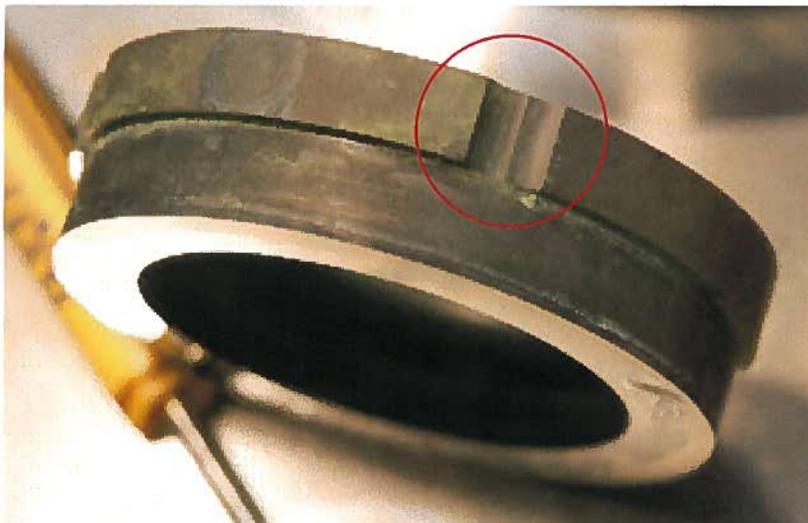
Figure 6. Wear in Drive Tang of the Air Seal Carbon Face

There are four drive tangs on the seal; two of these become the primary drivers during operation. The seal will essentially rock on those positions due to the vibration and wear those grooves. Figure 6 shows the wear in one of the drive tangs. It is believed that the seal reached stability of wear, meaning that the saddle pattern had essentially maximized and would not ultimately cause the failure of the seal. The wear on the drive tangs would have continued, ultimately increasing wear on the carbon until the drive tangs would no longer

drive (rotate) the seal face. All four drive tangs showed similar wear though two did not have the distinct scallop shown in the picture.

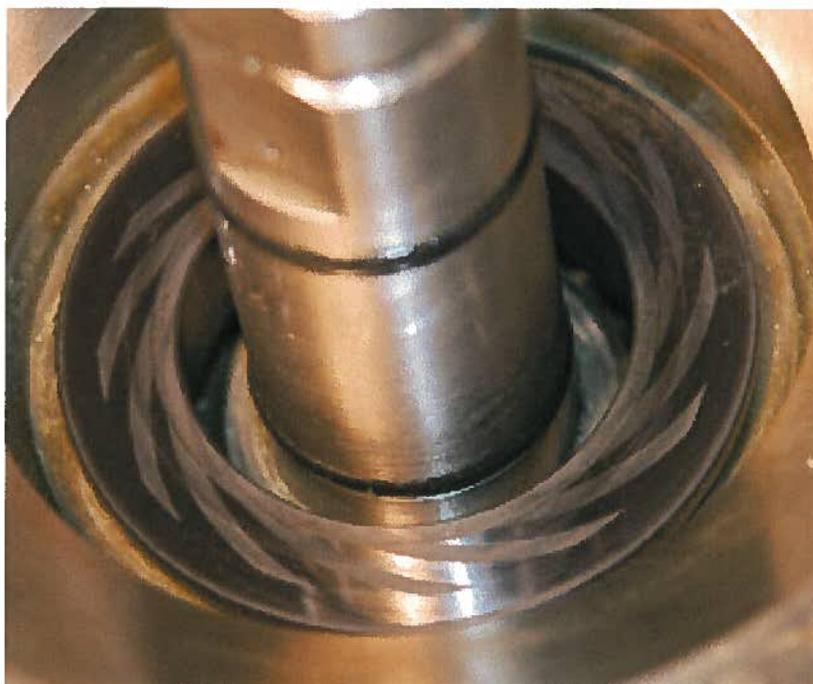
Figure 7. Shaft Seal Silicon-Carbide Face

The stationary silicon-carbide face of the seal is shown in Figure 7. Inspection of this seal indicates that the seal face wore as expected with minor abrasion observed. Visual observation determined that the grooves appeared intact.

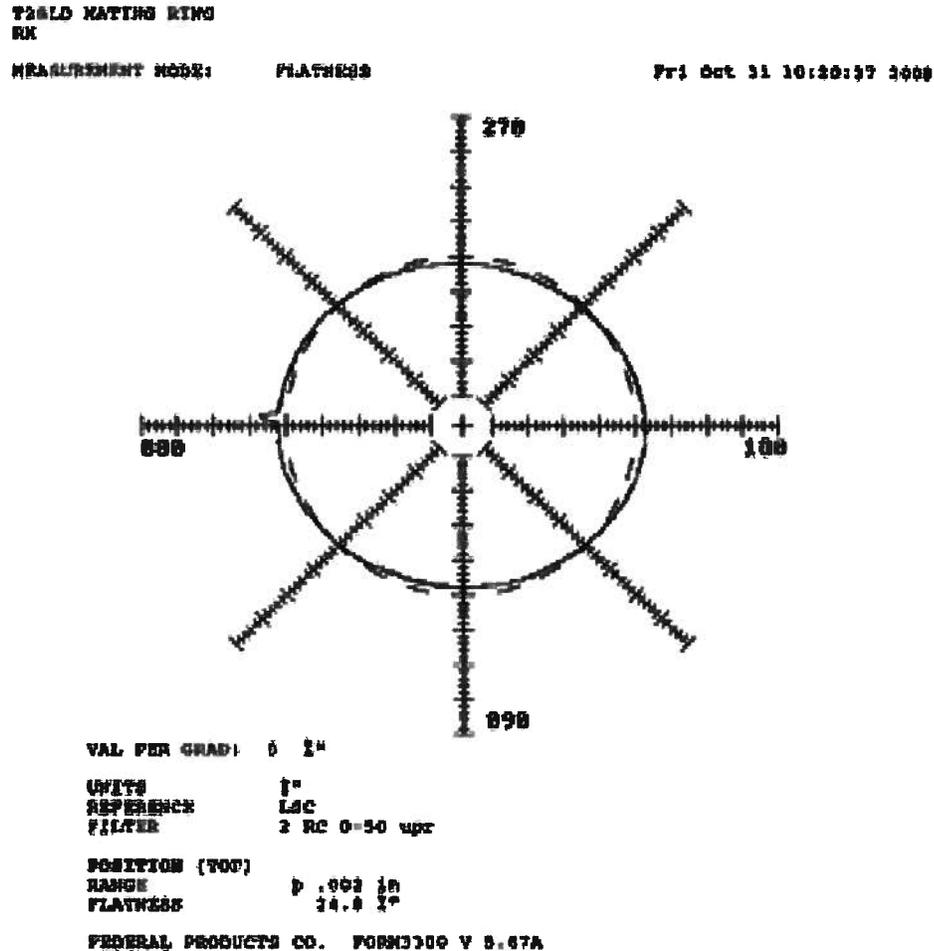
Figure 8. Surface Trace of Silicon Carbide Air Seal Face at the Seal Dam

Figure 8 shows a surface trace of the silicon-carbide face on the seal dam (not including the grooves). This trace indicates the seal face is in good condition and shows no unusual signs of wear. The total indicated run-out measured 24 micro-inches. The original specification of the seal calls for the seal face to be within 22 micro-inches. A small amount of wear is indicated and is judged to be less than 5 micro-inches by the John Crane representative based on his experience.

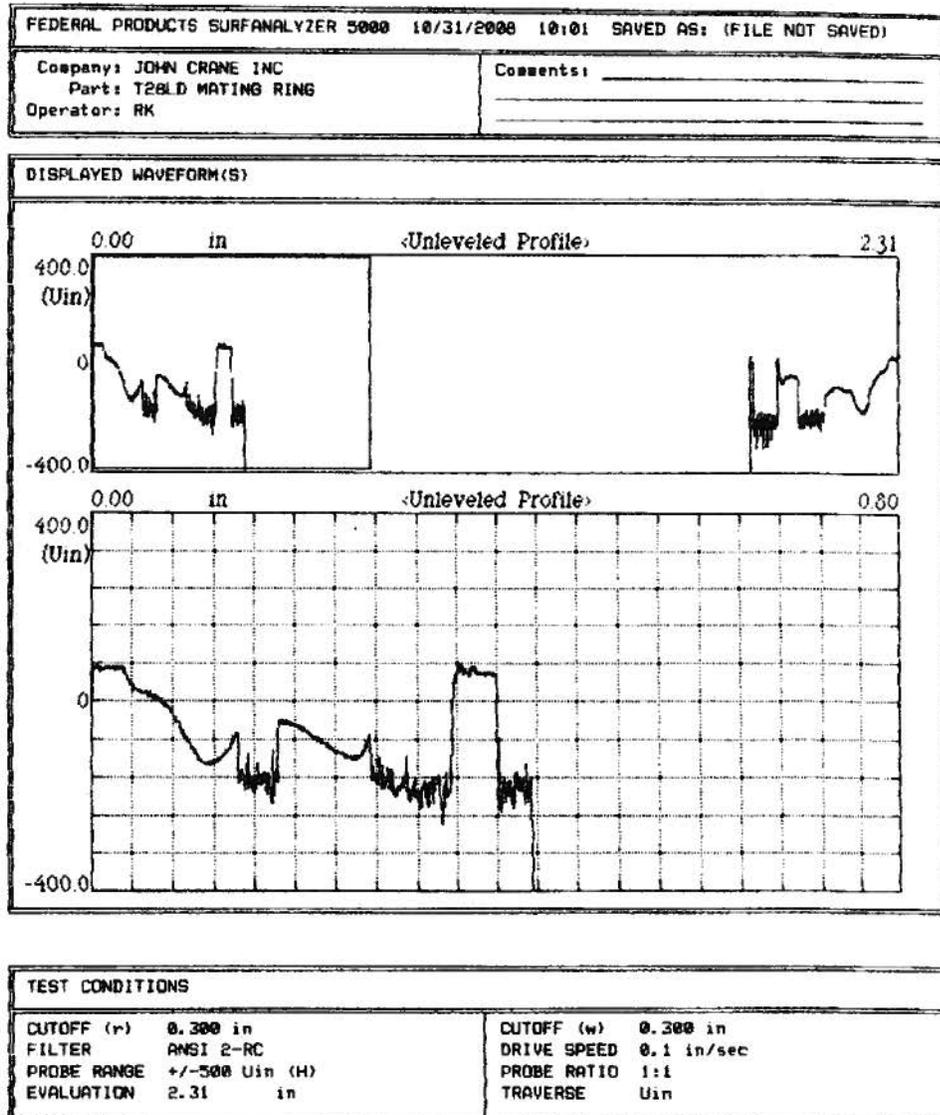
Figure 9 is a surface trace of the silicon carbide face. Similar to Figure 4, the graph shows the measurement across the seal face diameter in the top portion of the figure and an enlarged radial trace in the lower portion of the figure. During the measurement, the grooves were crossed three times on each radius of the seal face. The trace shows that the groove depth is acceptable and shows no accelerated wear.

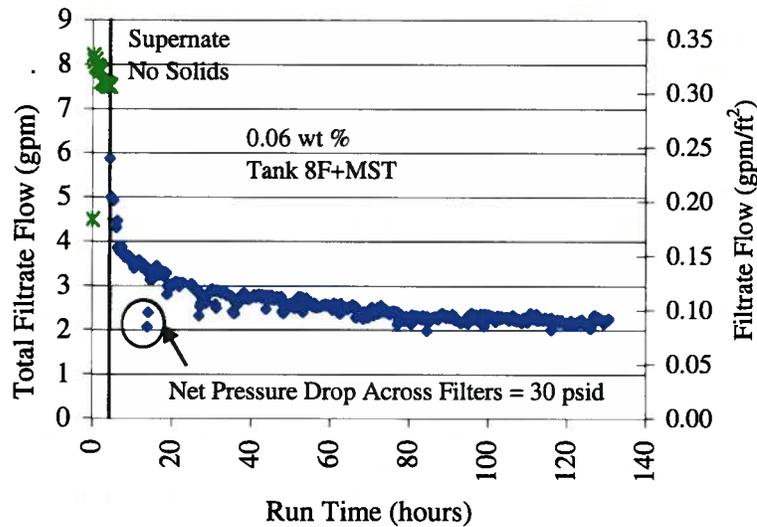
Figure 11. Total Filter Flux with 0.06 wt % Insoluble Solids Simulated Tank 8F Sludge + MST

The solids were added to the feed tank and mixed using the pump since the feed tank was too narrow to accommodate an external mixer. Feed flow was tested between 25 and 35 gpm, feed pressures ranged between 70 and 102 psi and the net pressure drop across the filters was held at 40 psid except for a brief test period at 30 psid. The filter operated for over 126 hours at the 0.06 wt % insoluble solids loading and the resulting flux is shown in Figure 11.

As can be seen from the graph, flux dropped rapidly with the introduction of the solids. In the previous testing using only the Tank 8F simulant, after 34 hours of filtration the flux was still approximately 5.25 gpm¹. For the sludge + MST, flux had dropped to 2.7 gpm in 34 hours and by the end of testing at this solids loading, flux decayed to approximately 2.2 gpm.

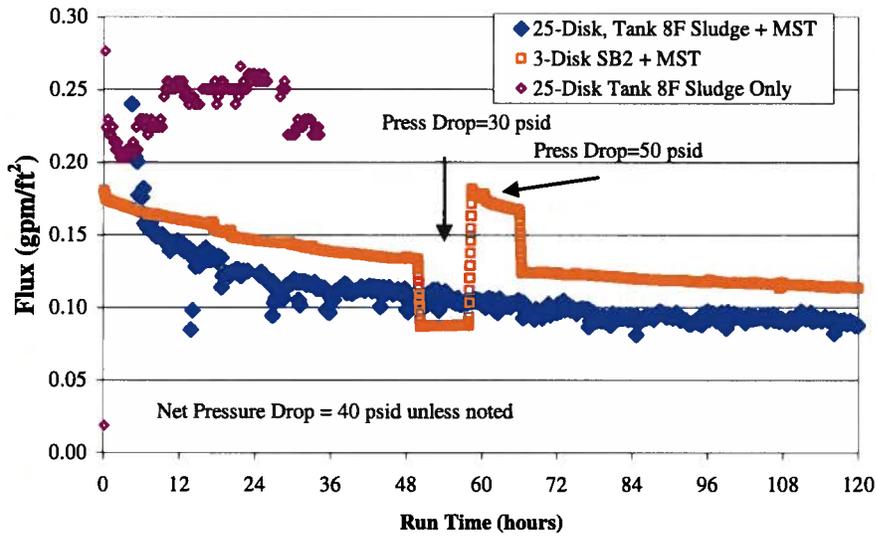
Figure 13. Comparison of 25-Disk Rotary Filter Testing with Sludge and Sludge + MST and 3-Disk Rotary Filter Testing with Sludge + MST at 0.06 wt % Insoluble Solids

Figure 13 shows a comparison of the flux for tests with sludge only and sludge + MST with 0.5 micron filter membrane for the 25-disk unit, and sludge + MST using a 0.1 micron filter membrane for the 3-disk unit at 0.06 wt % insoluble solids¹⁰. It should also be noted that the sludge compositions were slightly different as well.

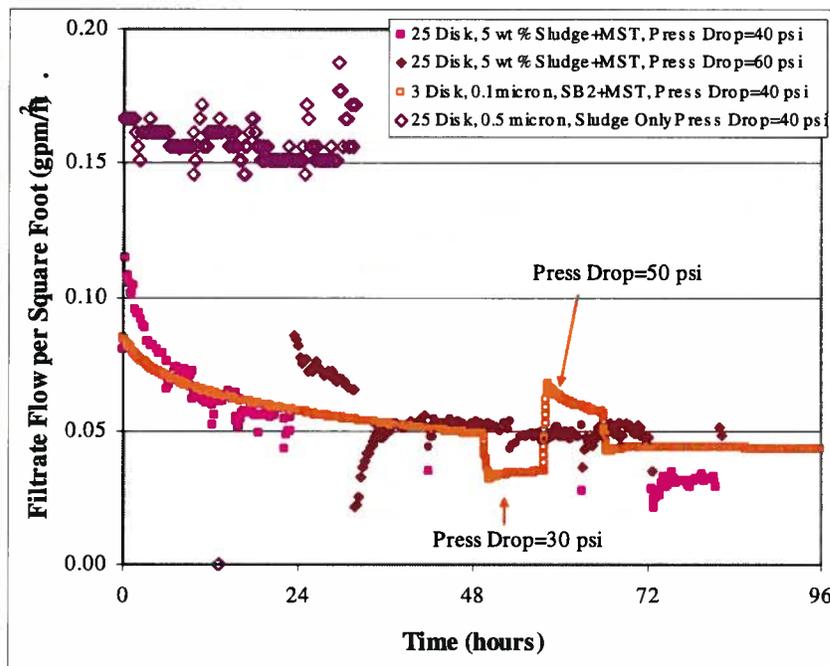
Figure 14. Comparison of 25-Disk Rotary Filter Testing with Sludge and Sludge + MST and 3-Disk Rotary Filter Testing with Sludge + MST at 4.5-5 wt % Insoluble Solids

Figure 14 shows the same information but at the 4.5-5 wt % insoluble solids for all tests. Data in both figures is primarily for a net pressure drop of 40 psid except where noted.

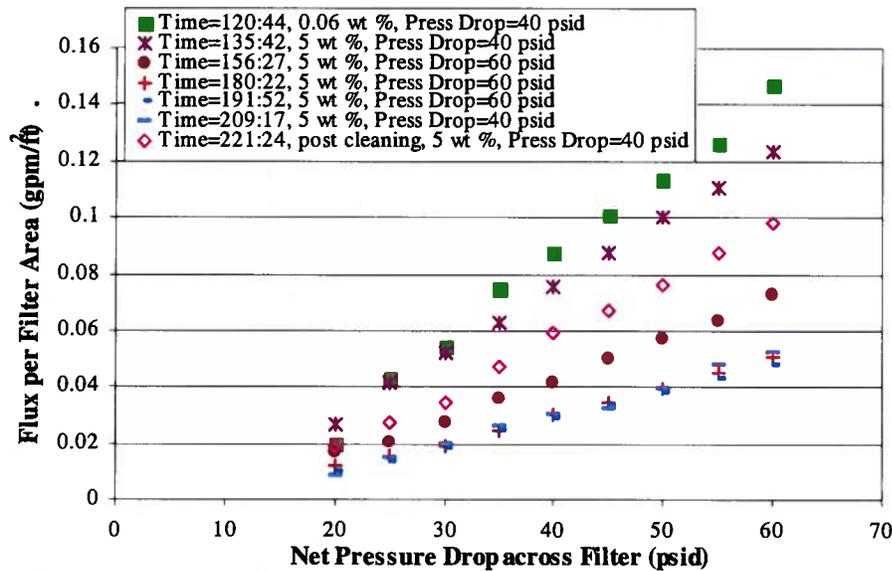
Figure 15. Relationship of Filtrate Flow per Square Foot of Filter Media vs. Net Pressure Drop across the Filter System

Note that if a line is drawn through the data in Figure 15, the points would intersect at approximately 11 psi for 0 filtrate flow. A pressure difference above 11 psi is necessary with the rotor turning at 1170 rpm to produce a net positive flow. A net pressure below 11 psi will result in a net reverse flow of filtrate through the disks. The rotation of the disks results in a centrifugal force that pushes permeate towards the outer edge of the filter disks. This force increases as the radius of the disk increases. The inner radius of the disk may have a net positive pressure resulting in filtration; while the outer radius can have a net negative pressure resulting in permeate being pushed back out of the disk. At the rotor speed used throughout testing (1170 rpm) the pressure drop at the outer edge of the disks is approximately 20 psi. A net pressure below 20 psi will result in a net reverse flow at the outer edge of the disk. A chart showing the relationship between pressure and rpm for the standard size rotary filter disk can be found in Reference 11.

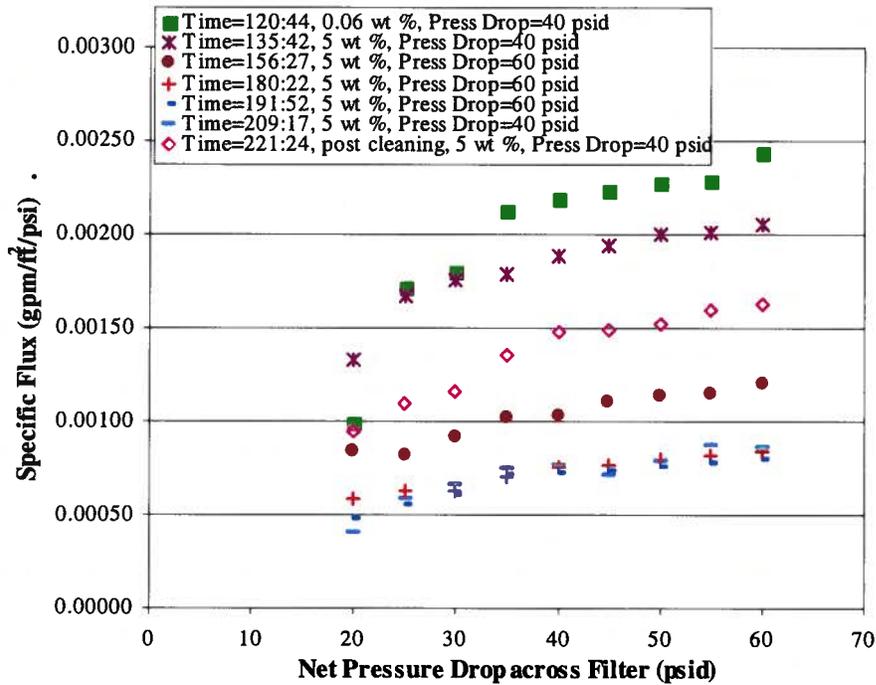
Figure 16. Specific Flux versus Net Pressure Drop

To obtain a comparison on an equal basis, specific flux is used. The specific flux is the filter flux per unit filter area divided by the net pressure drop across the filter system. The specific flux normalizes the productivity based on the applied pressure drop. Increasing the pressure drop across the filters causes absolute increases in the production of filtrate. But as the filtration rate increases, the slurry in the near proximity of the feed side of the membrane becomes more viscous thereby increasing its contribution to the hydrodynamic resistance of filtrate flow through the membrane. The higher the net pressure drop, the greater the filtrate flow. The more concentrated the slurry the more viscous the slurry becomes. This dissipates more of the hydrodynamic pressure available to push permeate through the membrane into “pushing” filtrate through the viscous slurry.¹¹ Therefore, there may be a net increase in permeate by increasing the pressure drop, but it may come at the expense of efficiency and premature fouling of the membrane. Additionally, the increased pressure drop may cause particles to be pushed deeper into the pores of the membrane and making less likely that the particles can be transported from the membrane thereby increasing fouling. The resulting fouling will be shown as a decrease in specific flux.

The rate of filtration through the membrane will decrease as the membrane fouls. By comparing the specific flux at different pressure drops for this slurry, it has been determined that for the solids loading tested, increasing the net pressure drop continued to increase the rate of filtration per applied pressure differential. This is illustrated in Figure 16. As the net pressure drop was increased, the specific flux also continued to increase. The greatest improvement in specific flux is gained by increasing net pressure drop up to approximately 35 psid. At 35 psid and above, the specific flux begins to steady. For this simulant, the specific flux continued to increase as the pressure differential increased. Therefore, the most efficient net pressure drop tested is 60 psid.

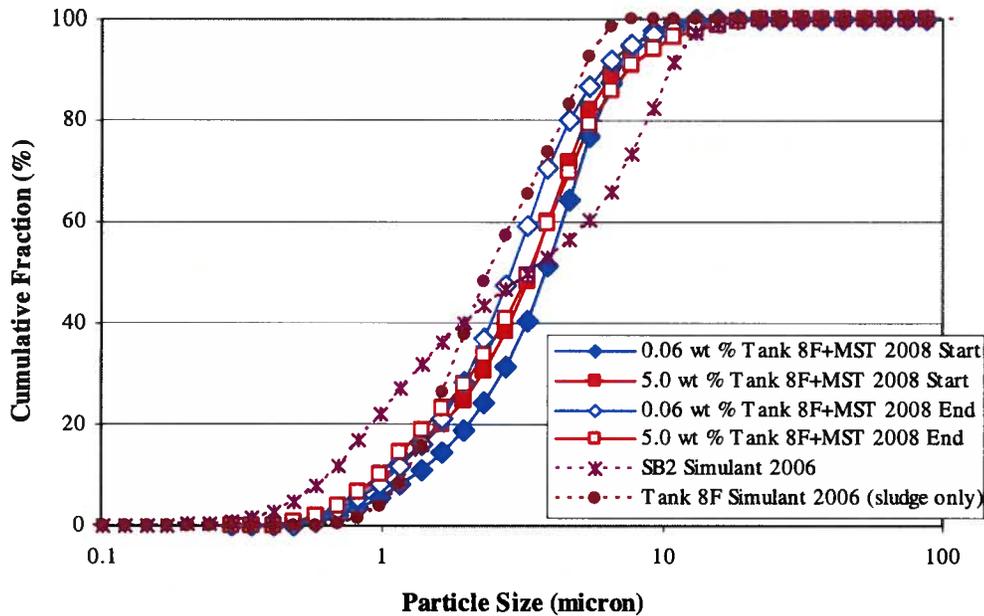
Figure 18. Comparison of Rotary Filter Feed Particle Size Analysis

The SRNL Analytical Development organization measured particle size for feed samples from the start and end of both solids loadings with a Microtrac S3000 using a carrier fluid containing 1.91M NaOH, 2.14 M NaNO₃ and 0.52 M NaNO₂. Results for the 0.06 wt % and 5 wt % testing as well as the Tank 8F sludge-only and the SB2 sludge-only simulant testing¹ are shown in Figure 18. All tests used the 25-disk rotary filter.

The results displayed for the current testing are for samples at the start and end of testing. Results show that the particle size decreased from the start to the end of testing as expected. No trend is observed between particle size and flux from the current full scale rotary filter testing compared to previous slurry testing¹. A slightly higher concentration of fines was measured in the Tank 8 Sludge with MST than the Tank 8 sludge-only testing from 2006 but, a significantly higher amount of fines were measured in the SB2 testing also from 2006. The SB2 and the Tank 8 sludge-only testing from 2006 both had significantly higher flux (approximately 3X) than the Tank 8 Sludge + MST. It is concluded that particle size did not have a significant influence of flux and that the addition of MST affected the rheological properties of the feed and that had the greatest influence on the filtration rates.

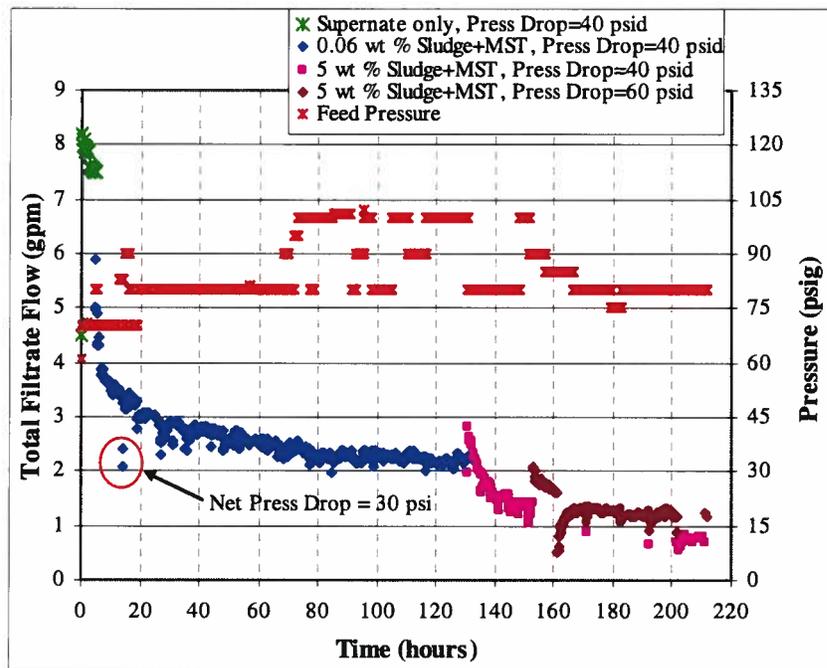
Figure 19. Filtrate Flow Relative to Feed Pressure at all Insoluble Solids Loadings with Tank 8F Simulant + MST

Feed pressure and flow rate was varied to determine the effect on filtration rate. Figure 19 shows feed pressure and filtration rate throughout testing. Though not varied significantly (~25%), no noticeable trend is observed between the feed pressure and the filtration rate.

This is consistent with results from previous testing at similar solids loadings.¹ Filtration rate is dominated by the pressure drop across the membrane.

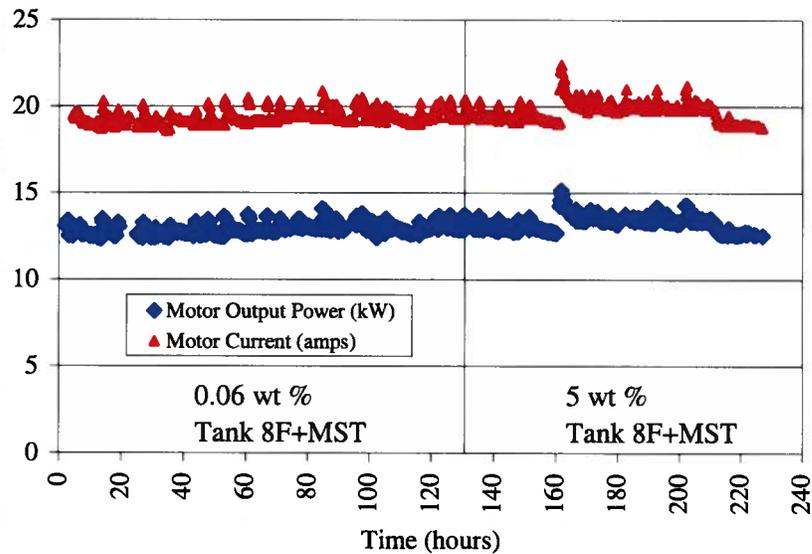
Figure 21. Filter Motor Power and Current Draw

The power and current drawn by the filter drive motor are shown in Figure 21. The vertical line marks the change in solids loading from 0.6 wt % to 5 wt % insoluble solids.

Typically, power/current requirements were greatest at the start of daily testing with a gradual drop throughout the day. The sudden increase in power and current at approximately 162 hours into testing coincides with the sudden drop in flux noted in Figure 12. This occurred at startup after an overnight shutdown. All other parameters including solids loading, feed flow, feed pressure and net pressure drop were essentially the same compared to the previous day’s testing. It is expected that the rotor speed was also constant though it was not directly measured at the time.

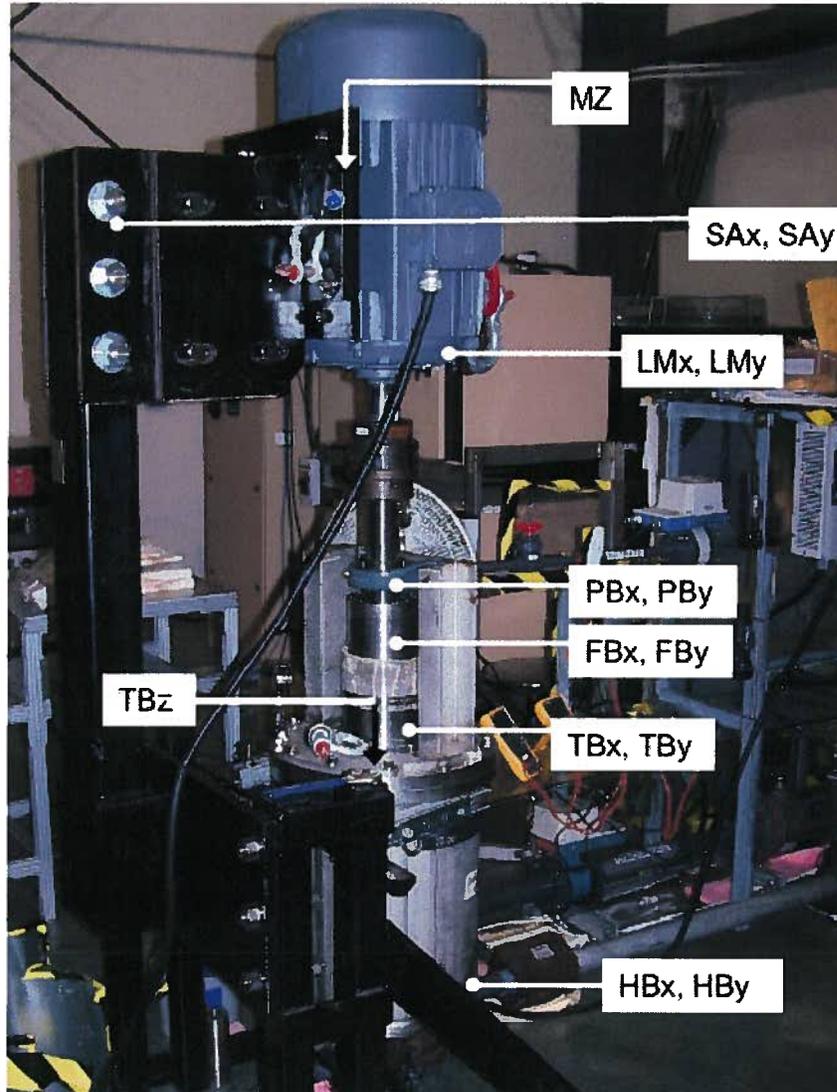
Figure 23. Locations of Accelerometers for Vibration Measurements

included the mounting of the filter, which was accomplished using straps which are susceptible to vibration. Due to the relatively short expected test durations, it was believed that excessive vibrations would give a better indication of the effects on filter components that would be expected with extended operation in field applications.

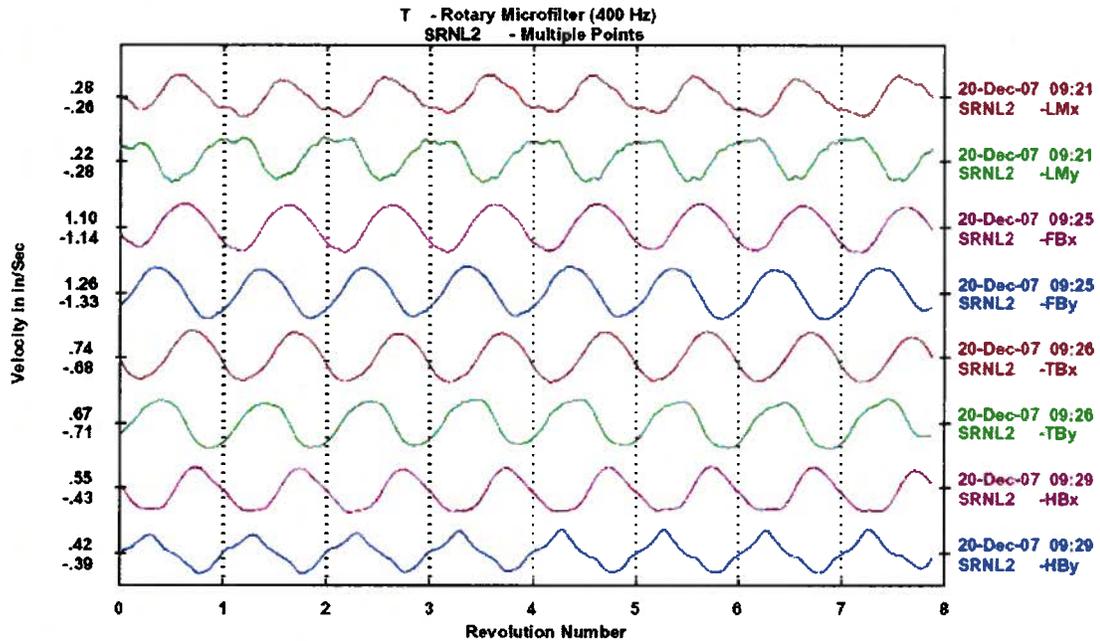
Figure 24. Baseline Vibration Measurements of the Rotary Filter

Figure 24 shows a summary velocity plot from several locations on the filter and motor. The location of the readings is shown in Figure 23. The highest velocities were measured at the rotary joint (FBx, FBy).

Attachment 4 shows the initial time domain and frequency domain plots for the rotary microfilter. The final plots in Attachment 4 show orbits. The velocity amplitudes in the plots are 5 to 10 times greater than normally observed by the analyst. The rotor frequency of 1xRPM dominates the vibration in both the radial and axial planes. The first order peak in the radial plane suggests imbalance, or a bent shaft. The high 1xRPM peak in the axial plane is suggestive of an alignment problem. The 2nd order peak from the support arm data narrows the problem to angular.

The clearance between the filter disks and shaft is over 0.040". The first attempt to improve the balance of the disks was to place 0.018" shims on each flat of the shaft. A support arm was added to the motor mount, a support strap was added to the lower part of the filter tank and shims were also added to the bottom of the filter stack to decrease the gap between the bottom of the filter stack and the mating point in the filter tank. The incorporation of the shims showed an improvement in the vibration signature, though the amplitudes are still high. Figure 25 shows the same summary plot after the incorporation of the support arm, tank strap and shims.

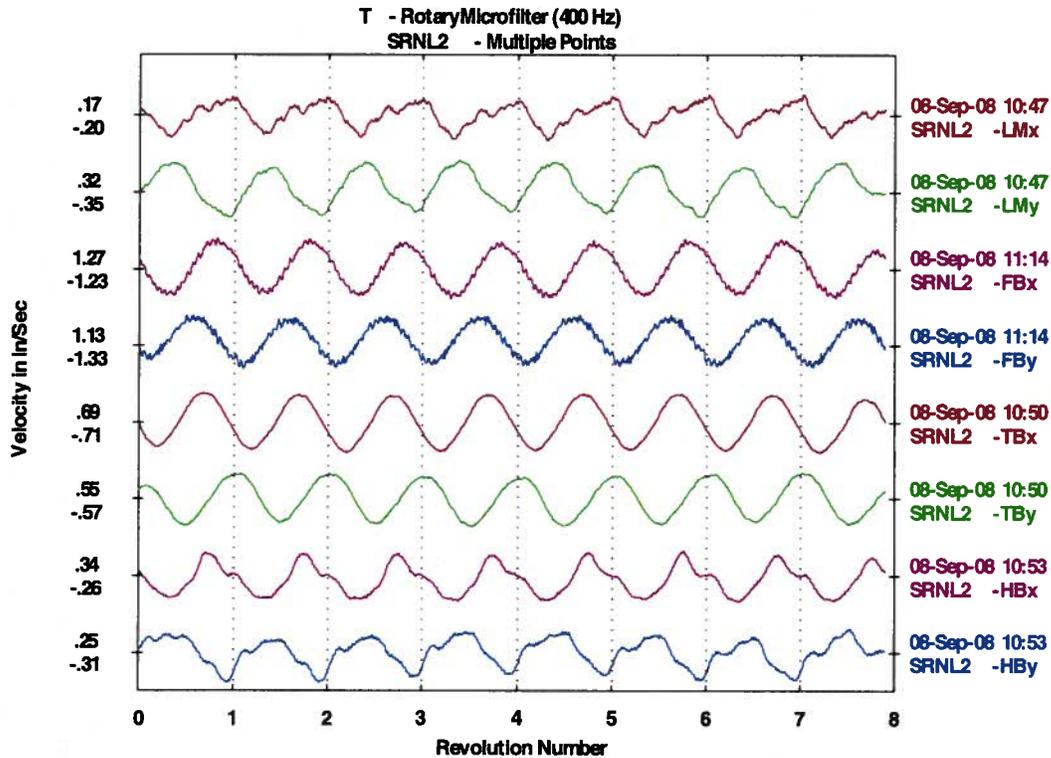
Figure 25. Summary Velocity Plot after the Incorporation of Shims and Support Arm

Improvements were seen in the vibration signature at the lower bushing (HBx, HBy) and slight improvements at the main filter shaft and bearing (TBy). Improvements were also recorded at the drive motor (LMx, LMy). Also of note is a higher frequency overlay at the rotary joint as well as repeated impacts in acceleration indicating wear on the rolling element bearings. Attachment 5 shows the second set of time domain and frequency domain plots for the rotary microfilter.

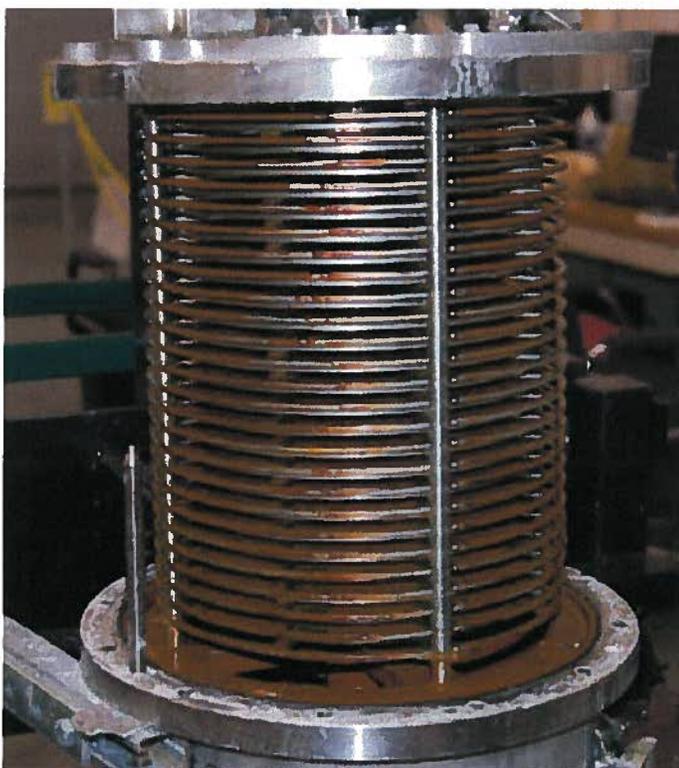
Figure 26. Filter Stack after Rinsing with Inhibited Water

After completion of the filter operation, the system was emptied of slurry and rinsed with ~ 60 gallons of inhibited water (IW) (approximately 6 filter volumes). The rinsing was accomplished by loading the IW into the feed tank and operating the filter while circulating the filtrate into the feed tank. After draining the system, the filter stack was removed and inspected. Figure 26 shows the filter stack as it was removed from the system.

The researcher noted that, based on visual observation, the stack had a greater amount of residual sludge material than in past testing. Several of the bottom filter disks were removed and Figure 27 shows the top and bottom of disk #24 (second from the bottom). This disk was typical of those inspected.

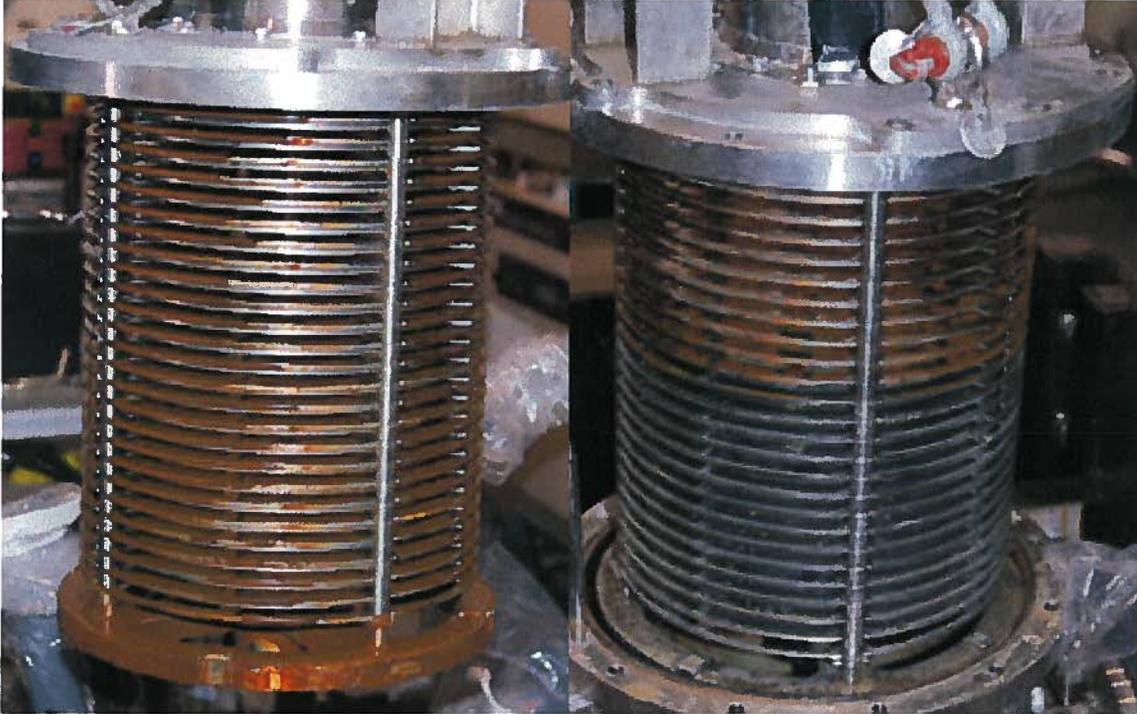
Figure 28. Filter Stack Comparison of IW Rinsed Filter (left photo) and Bottom Half Acid Washed (right photo)

The acid was then drained from the system and the filter was rinsed using 26 L of inhibited water. Water was added through the standpipe and drawn from the filtrate line using the Randolph pump. The water was then drained and the filter opened for inspection. During the inspection it was observed that air was not purged from the upper half of the filter housing. Disks 13 through 25 were submerged in acid while the remaining disks were not. Figure 28 shows a comparison of the filter stack after water rinsing with the first attempt at acid cleaning.

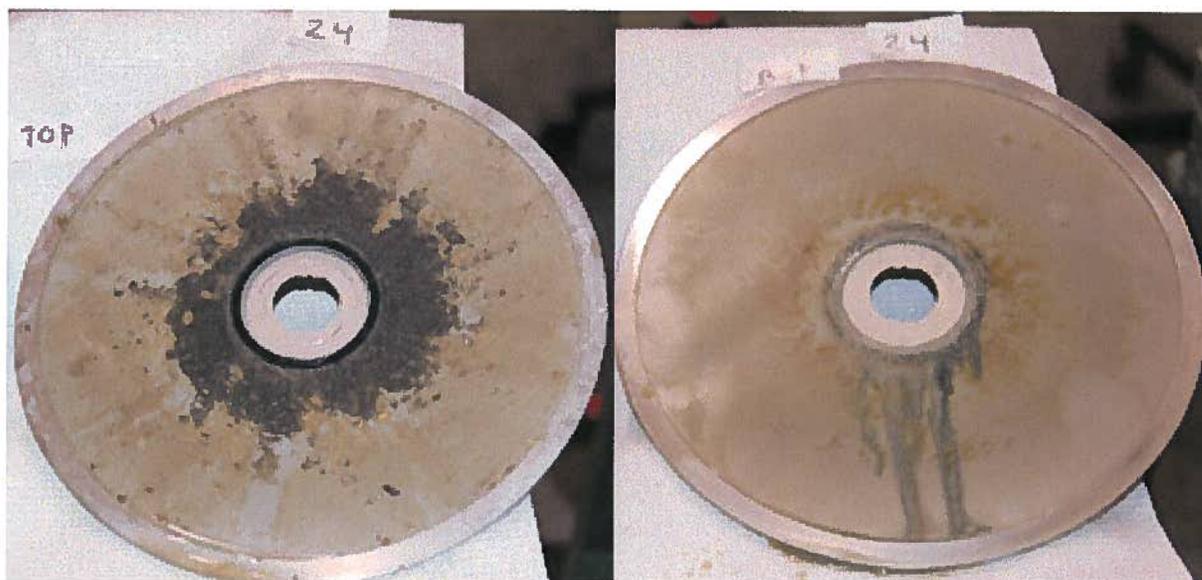
Several of the bottom disks were removed and inspected, all of which had been submerged in acid. Figure 29 shows pictures of the top and bottom of disk #24 (second from the bottom of the stack). Both sides of the disk showed significant cleaning. The top side of the disk still had solids residue especially in the inner radius. The bottom side of the disk had some discoloration due to solids residue.

Figure 29. Disk #24 Top (left photo) and Bottom (right photo) after First Acid Cleaning

After the water rinse was drained from the filter tank, the filter stack was removed and inspected. An additional reduction in the amount of solids was observed on the disks, primarily on the top side.

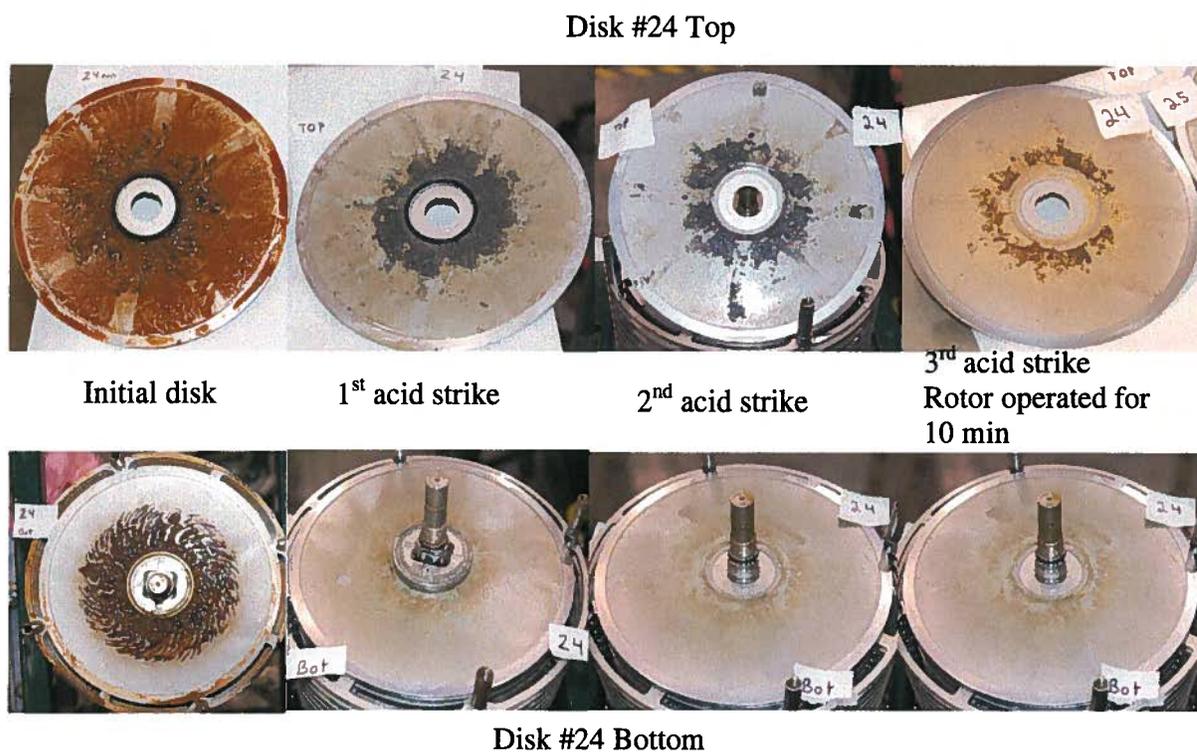
Figure 30. Comparison of Disk #24 after Acid Cleaning Steps

The system was then rinsed with inhibited water. The rinse was performed by connecting the Jabsco pump discharge to the filter inlet; the pump suction was placed into a carboy containing the inhibited water. The filter discharge was choked by throttling the discharge valve. The filtrate line was plumbed to the inhibited water feed tank. During the circulation of the rinse, the rotor was engaged for 10 minutes at similar pressures and rotor speeds used in the acid cleaning. The filter tank was then drained and opened for inspection. Additional improvement was observed when the disks were removed and inspected. Figure 30 shows filter disk #24 in each stage of the acid cleaning. Note that the most dramatic cleaning occurred in the initial soaking and after the rotor was operated during the cleaning cycle.

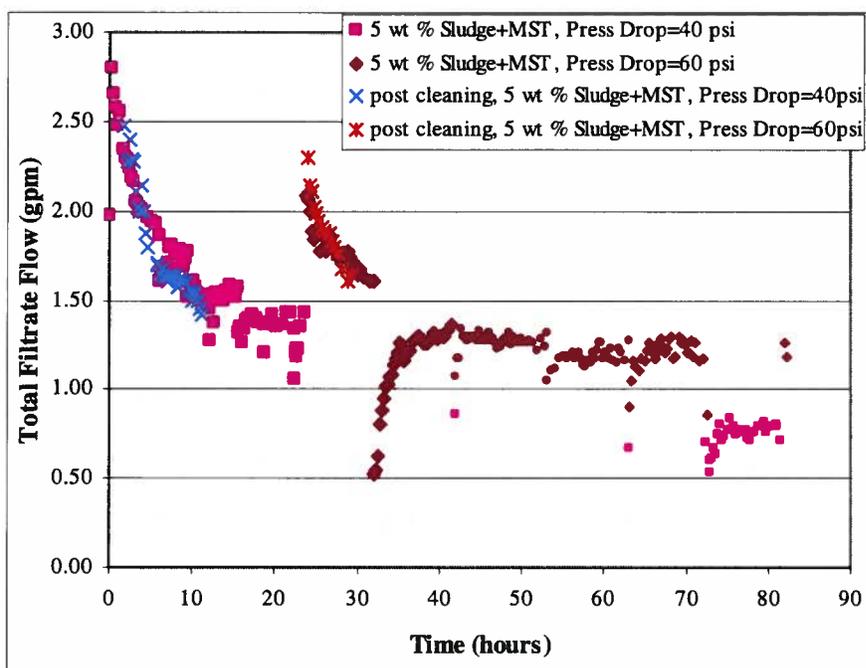
Figure 31. Comparison of Flux from Post Acid Cleaning to Original Data with 5 wt % Insoluble Solids (Time scale aligned for “post acid cleaning” data for comparison)

previous transition from 40 to 60 psid. The decline in flux was similar, though slightly faster for the post-acid-cleaning testing.

Overall, the acid cleaning appeared to be very successful in restoring the filtration rate of the membranes while using a minimal amount of acid. Additional benefit can be obtained by extending the soak of the filter disks or increasing the circulation time of the acid during the cleaning cycle. The testing parameters were limited by the ability of the available pump to apply pressure to the system. It should be noted that SpinTek recommends a minimum of 20 psi be applied across the filter disk to overcome the centrifugal force due to rotating the disks at 1200 rpm pushing permeate to the periphery of the disks.

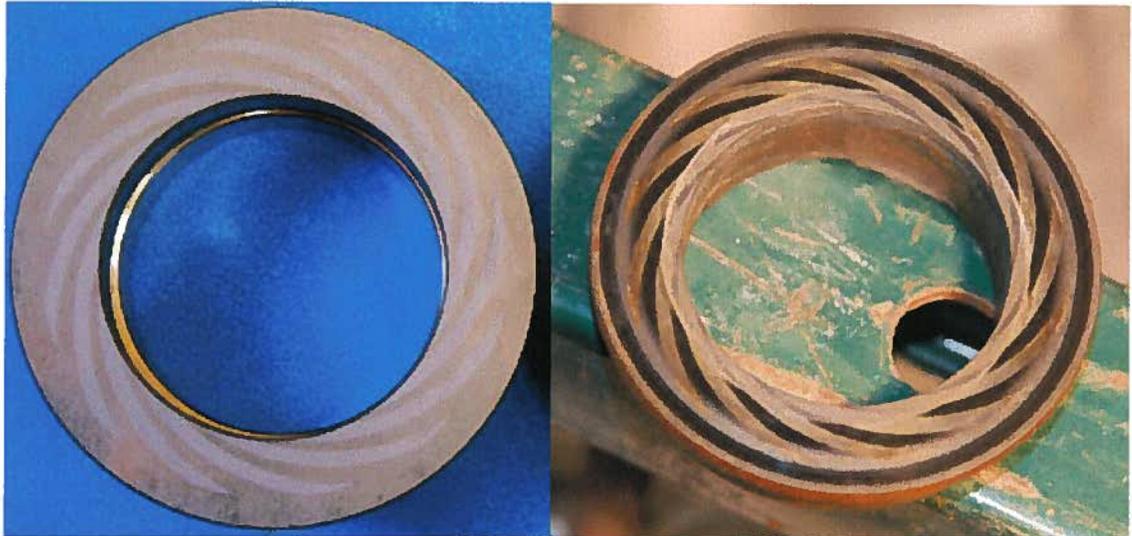
Figure 32. New Air Seal Silicon- Carbide Face Compared to Seal Face with 230 Hours of Operation

After filter disassembly, the air seal assembly was removed, disassembled and inspected. Figure 32 shows the stationary silicon-carbide seal face after 230 hours of operation compared to a new seal face. Inspection of the seal face used in testing showed no unanticipated wear. The air grooves appear to be in good shape and do not appear excessively worn.

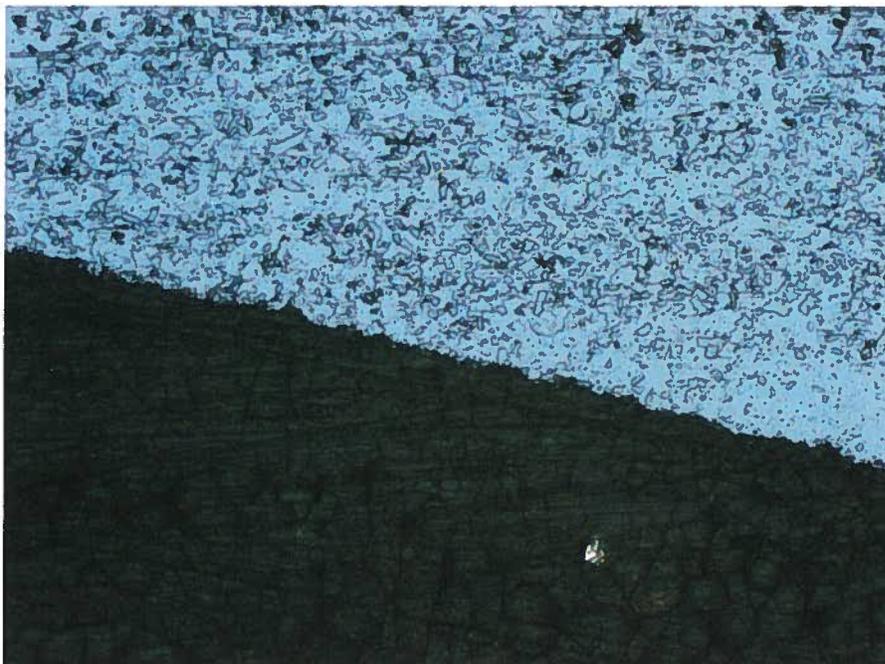
Figure 33. Air Seal Carbide Face at the Interface of an Air Groove at the Seal Dam – 10X Magnification

Figure 33 shows a picture of an interface between the air groove and the seal face. Note that the interface remains sharp and shows no excessive wear.
